Proposed Infrastructure Designation
under the *Planning Act 2016*

Charters Towers Fire and Rescue Station

3 – 5 Enterprise Road, Charters Towers QLD 4820

February 2019

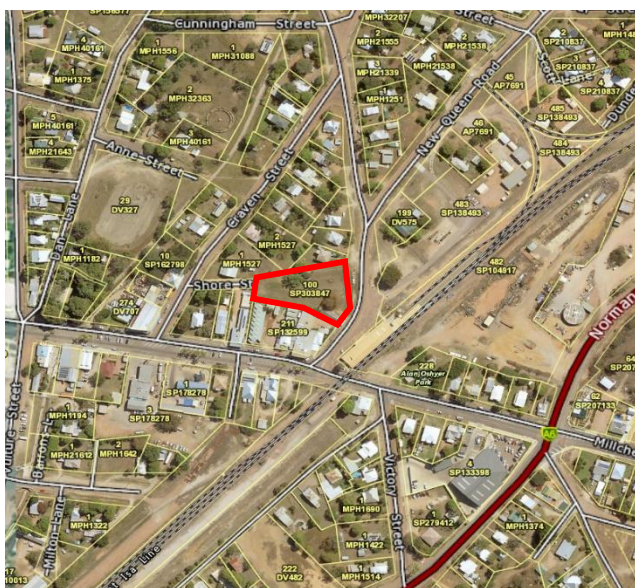
Figure 1 - Site Aerial (Source: QLD Globe)

The site as shown in Figure 1 and Figure 2 is currently occupied by a single storey building and has an irregular shape with an area of 3,814m². The allotment is freehold and owned by the State of Queensland (Represented by the Public Safety Business Agency). The site provides dual street frontage being approximately 72m to Enterprise Road and approximately 10m to Shore Street.

The single storey building on the subject land is located within the south eastern portion of the subject land, is currently unoccupied, is in poor condition and is considered beyond viable economic repair. The subject land is largely clear of vegetation, only containing several mature trees located within the northern and southern parts of the site.

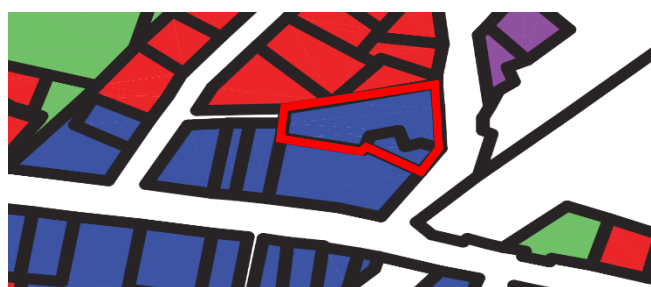
The Planning Scheme identifies the subject land as being in the Commercial zone as illustrated in Figure 3 below.

Figure 5 - Planning Scheme Zoning (Source – Charters Towers Planning Scheme)

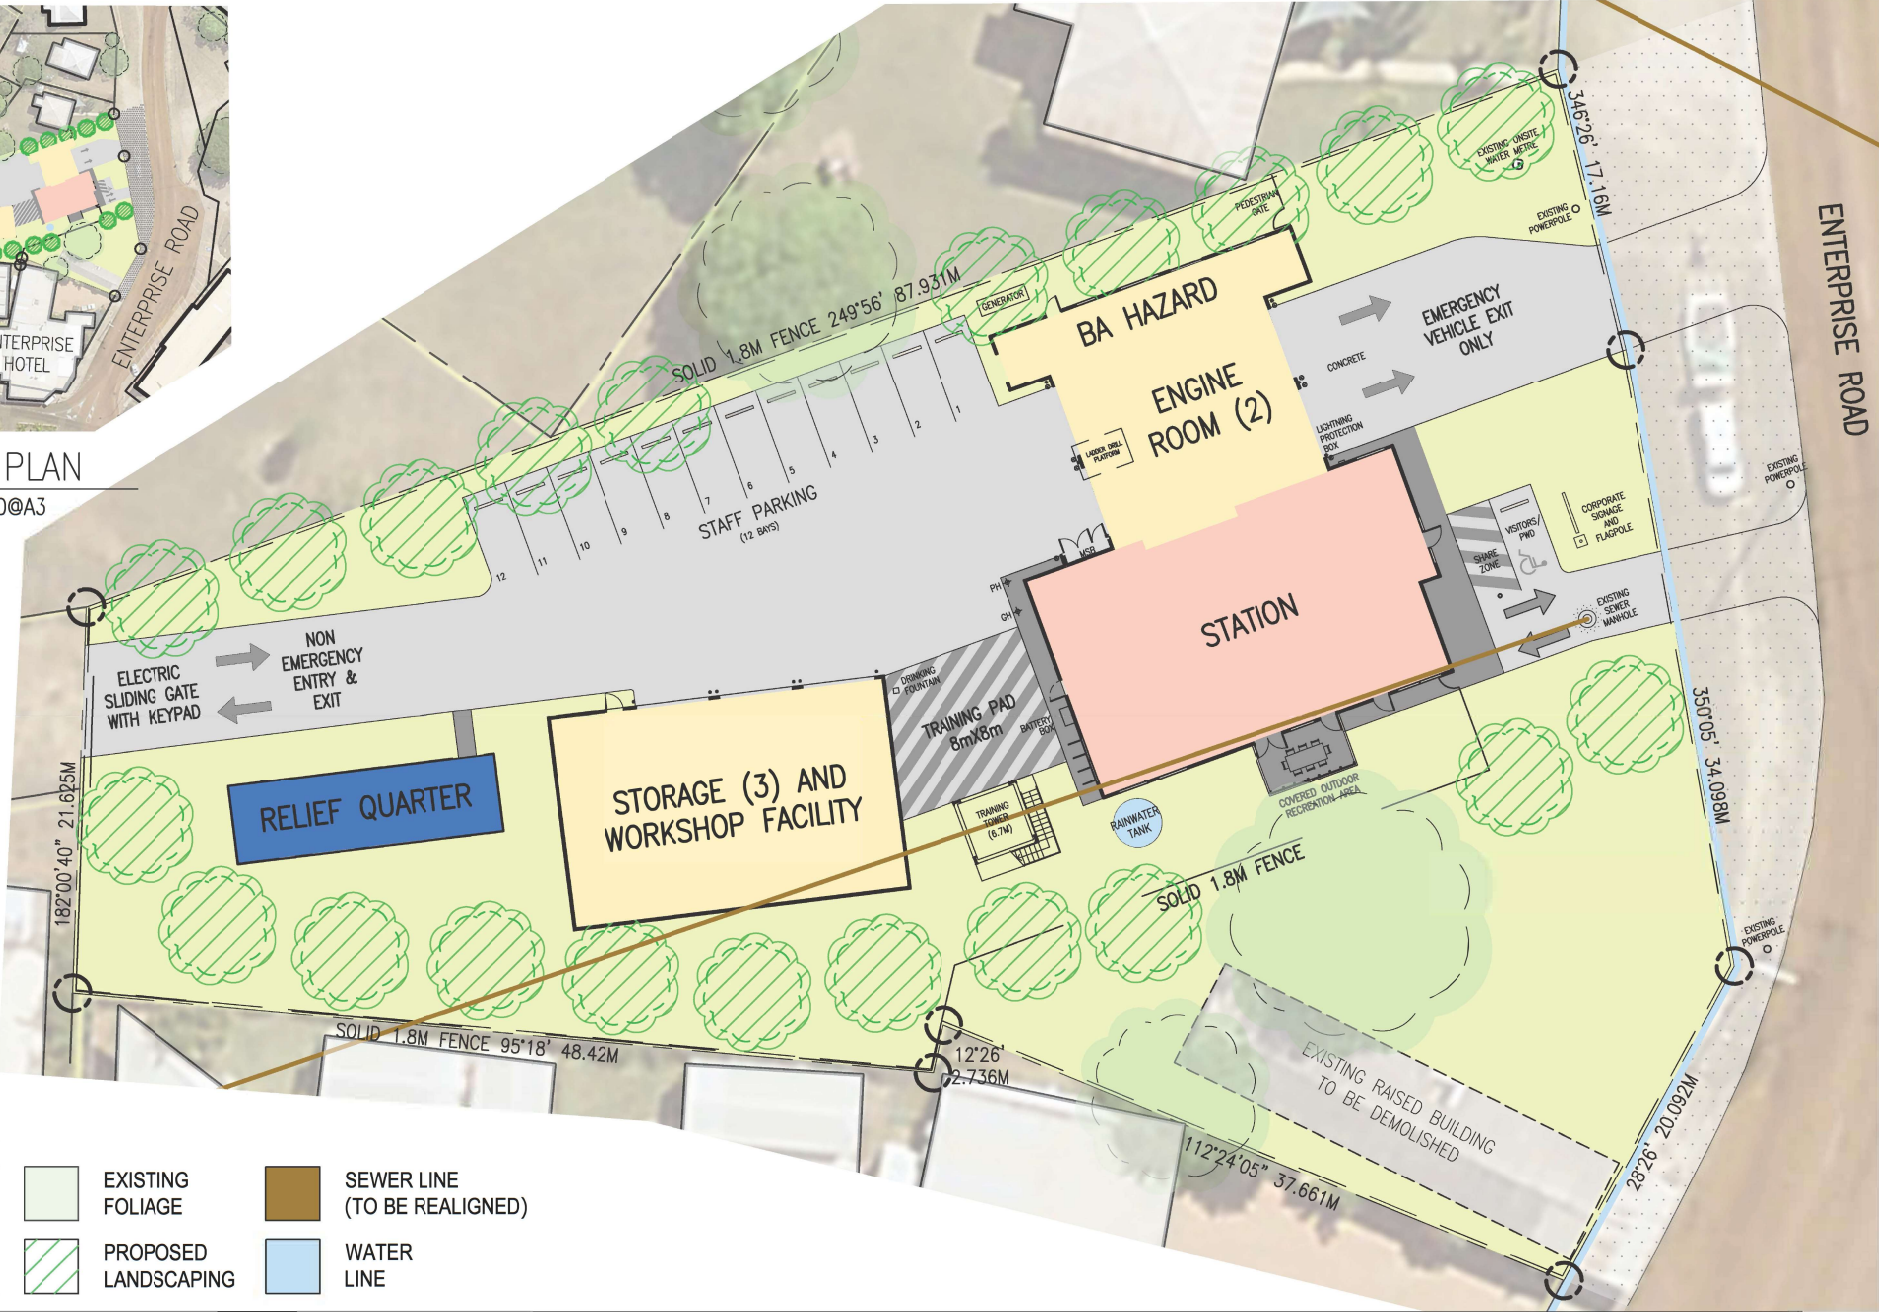
SEWER AND WATER LINES
APPROXIMATE ONLY AND TO BE
CONFIRMED VIA SURVEY PLAN

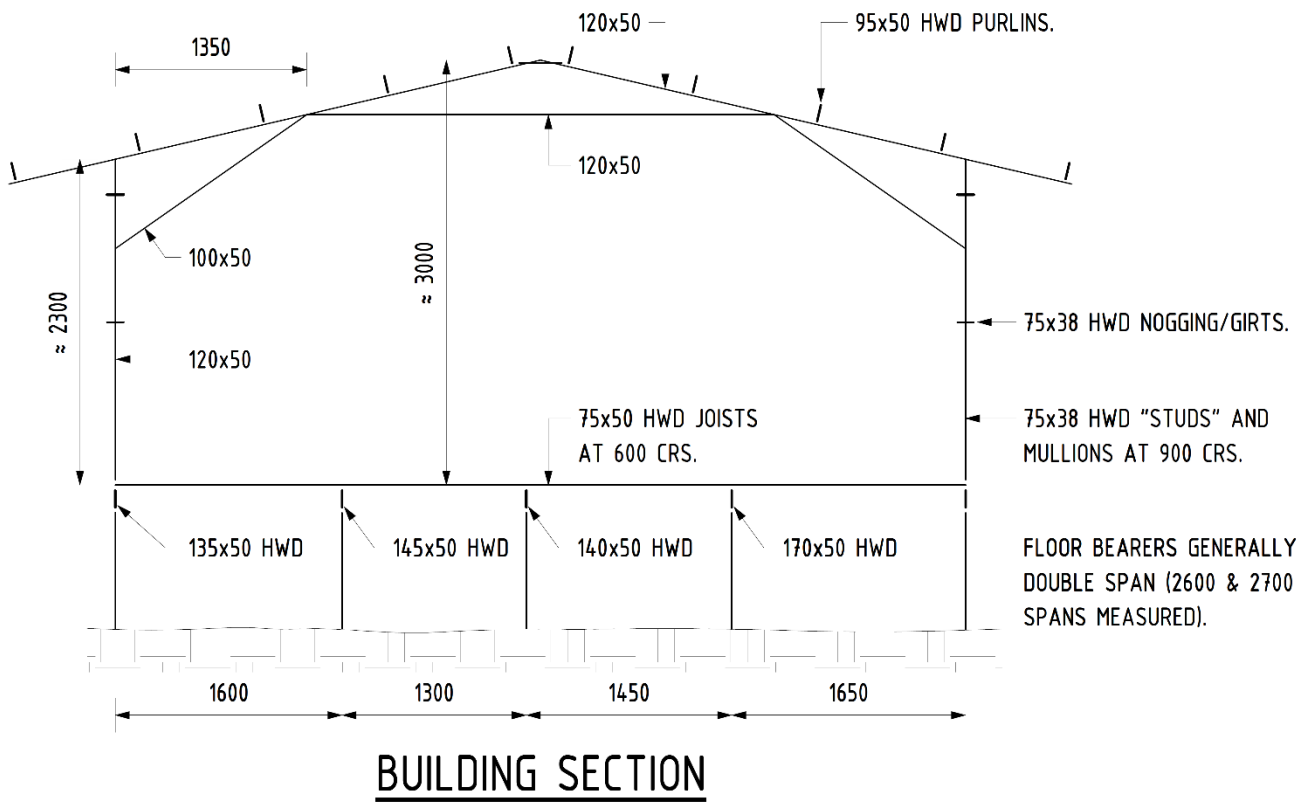
Image 2 – Typical Building Section

The building is timber framed on steel and timber stumps. A typical section is shown in image 2 with the main frames on a 2.7m bay spacing.

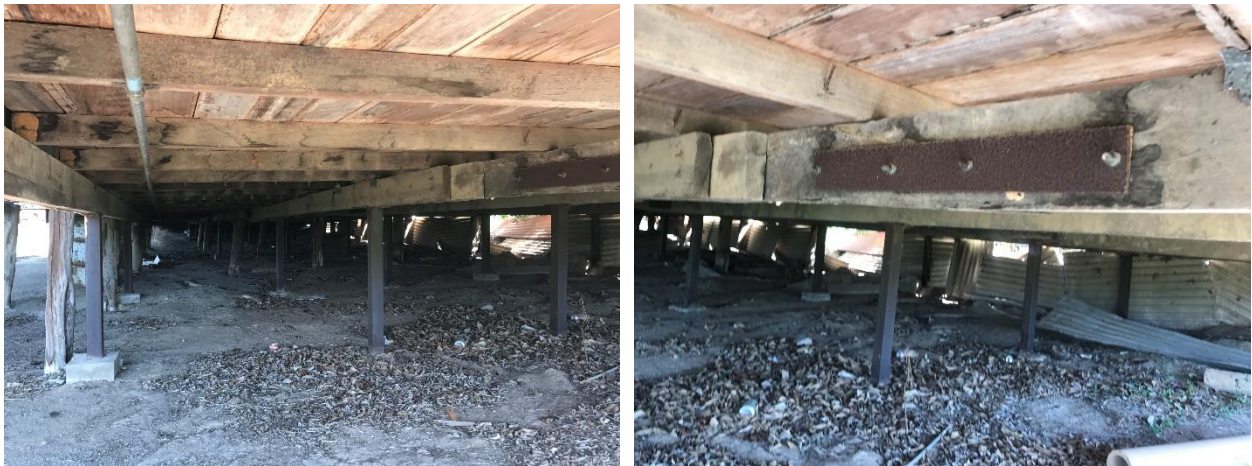
Steel and timber stumps support timber bearers of varying sizes. Various repair works were noted to have been completed to the bearers in several locations.

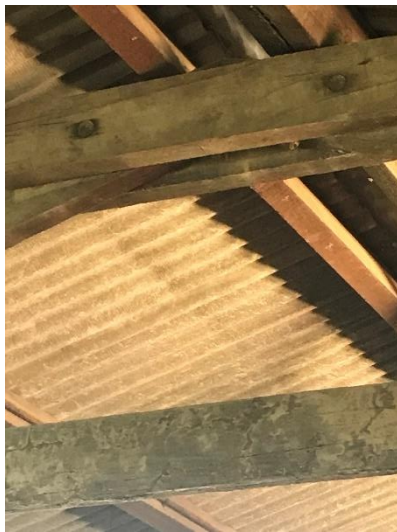
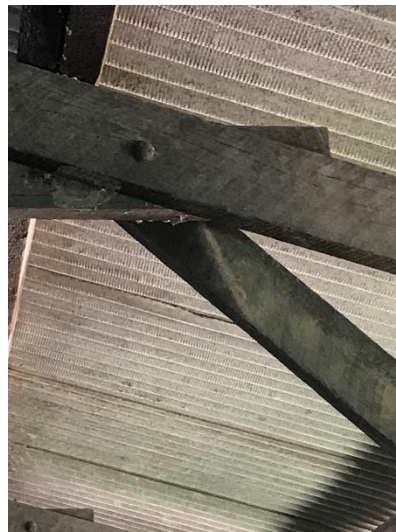
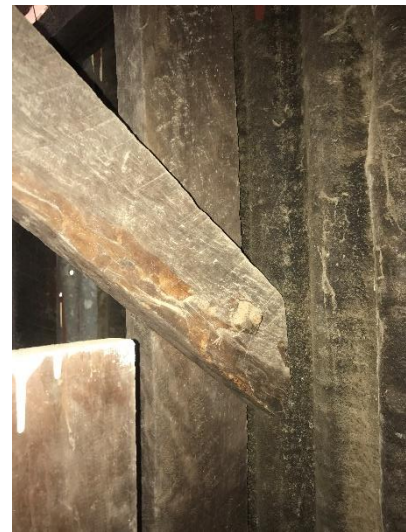
Bolted timber frames supporting roof purlins and wall girts are positioned at 2.7m centers along the length of the building.

The main timber frames are generally in reasonable condition. The bolted connections also appeared to be in reasonable condition, with limited splitting of members at bolt locations. Some bolts may need to be replaced.

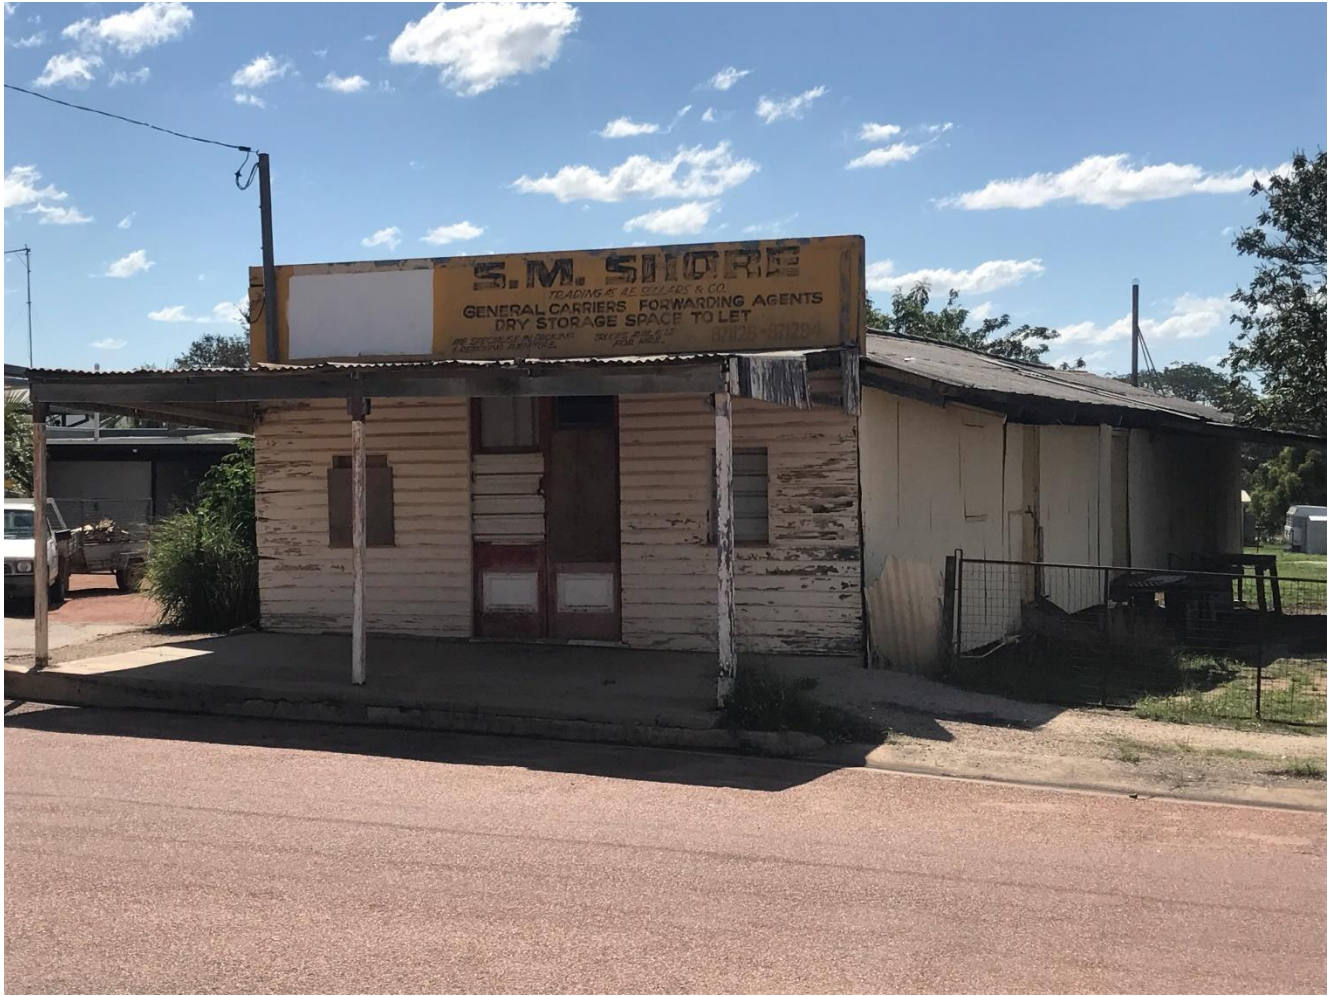
The main building frame has bolted connections, forming a braced frame.

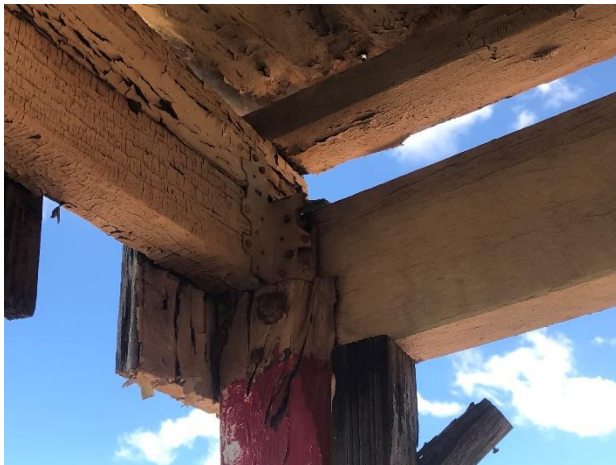
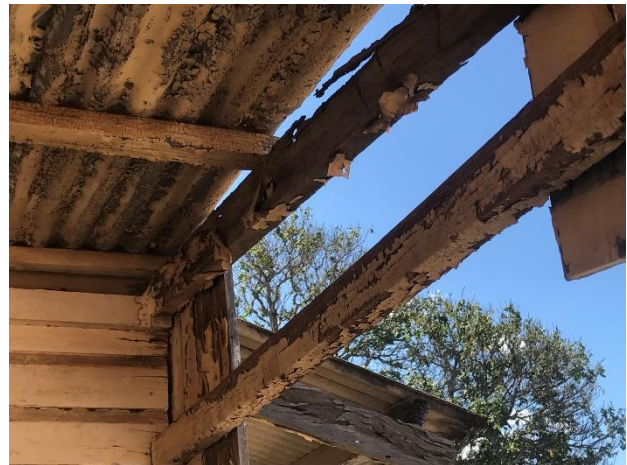
The building structure is generally in poor condition. Significant termite activity was observed, particularly to the front wall framing and cladding.

The front awning is in extremely poor condition with individual members rotted, damaged or termite affected. It is recommended that pedestrian access is prevented from this area.

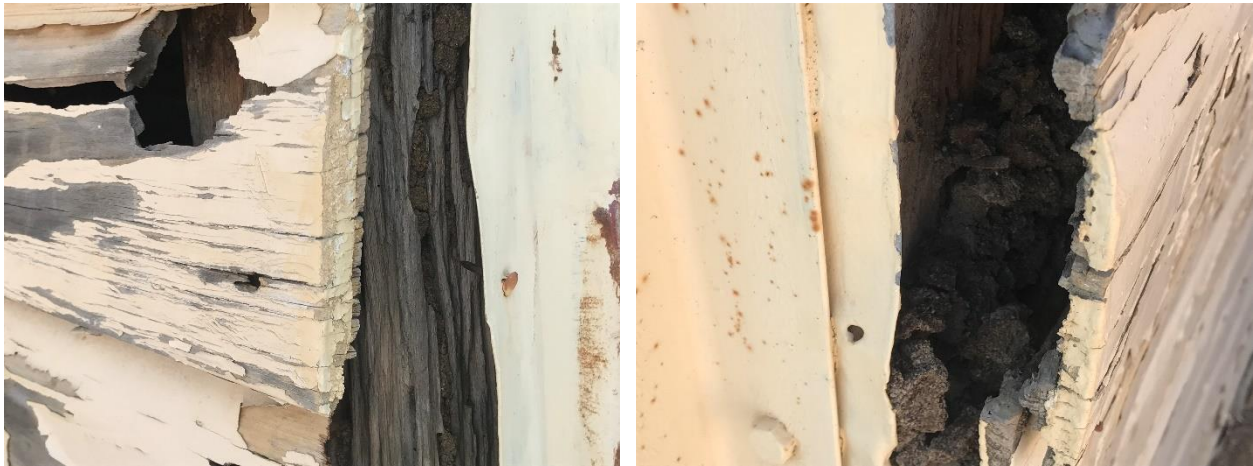
The front wall timber cladding and framing has severely deteriorated due to timber rot and termites.

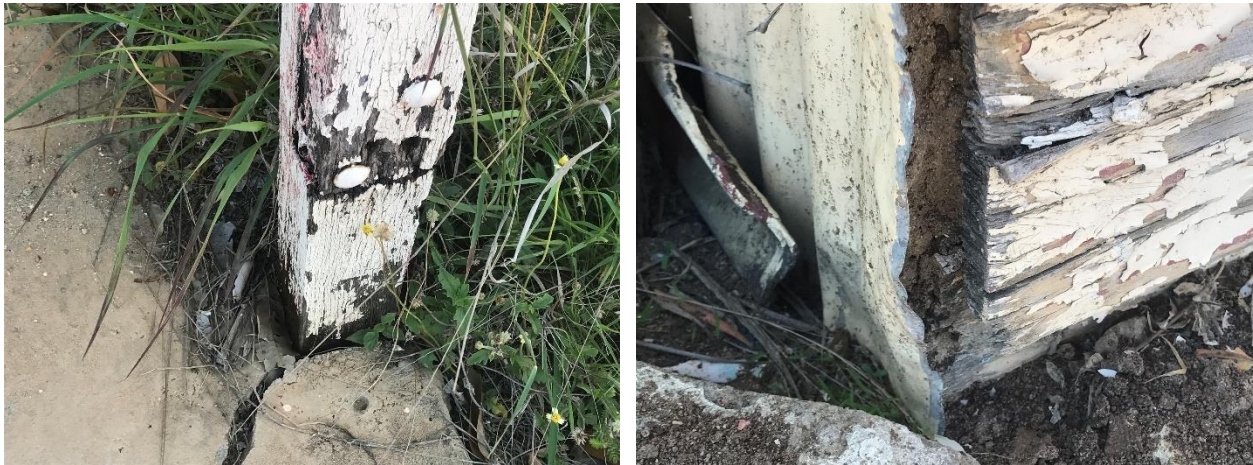
The timber awning support columns have rotted and where timber is in contact with the ground, termite intrusion and damage has occurred.

Significant damage has occurred to the front wall framing, cladding and awning of the building. Termite damage was severe and is likely to have damaged all structural elements to the front wall.

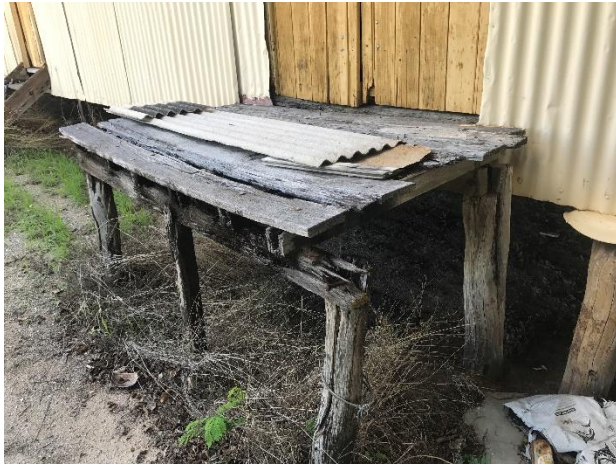
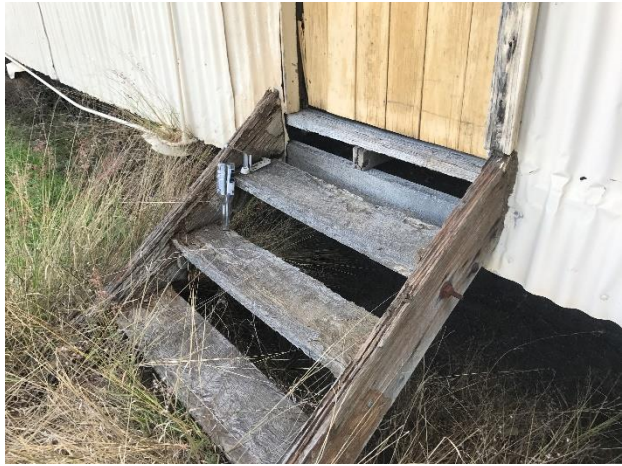
A set of timber stairs and small platform to the side of the building have also been affected by termites and timber rot. Both these elements are in extremely poor condition.

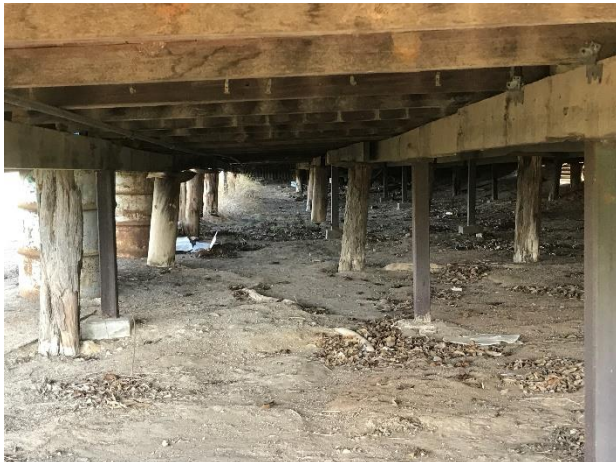
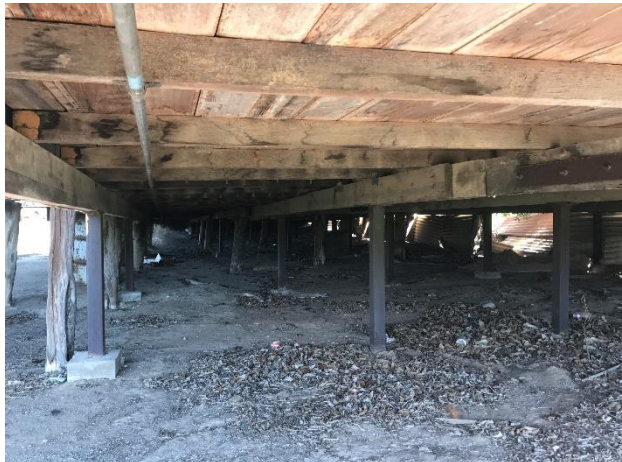
It appears several timber stumps have been replaced with steel posts. The remaining timber stumps are in poor condition with rot and potential termite damage evident. The depth of embedment for the timber stumps could not be determined. The timber stumps typically were not vertical.

The size of the steel post footings could not be determined.

The timber floor framing was generally in reasonable condition, with areas of repair previously undertaken to the timber bearers.

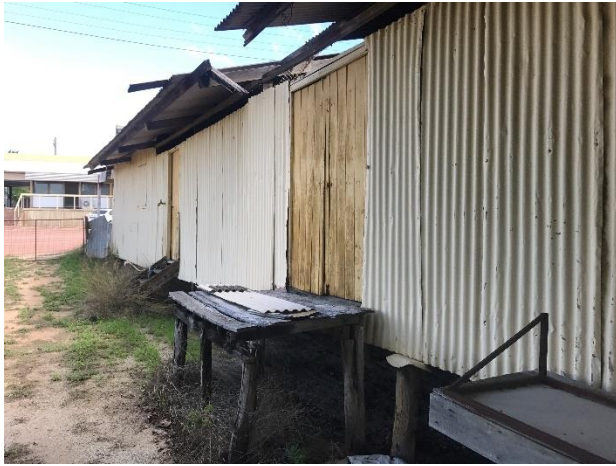
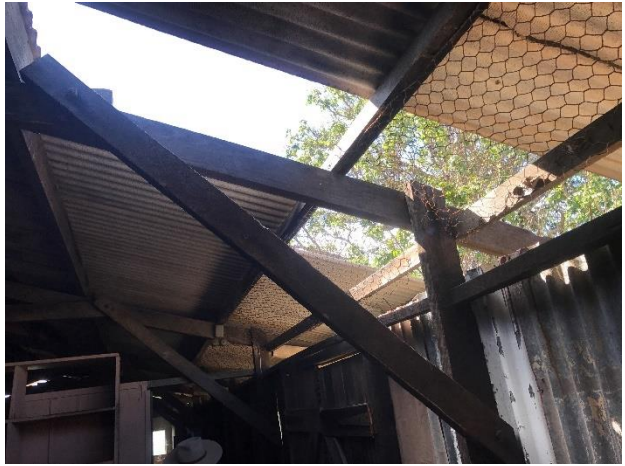
There are areas where roof sheeting is missing and where timber roof framing damaged.

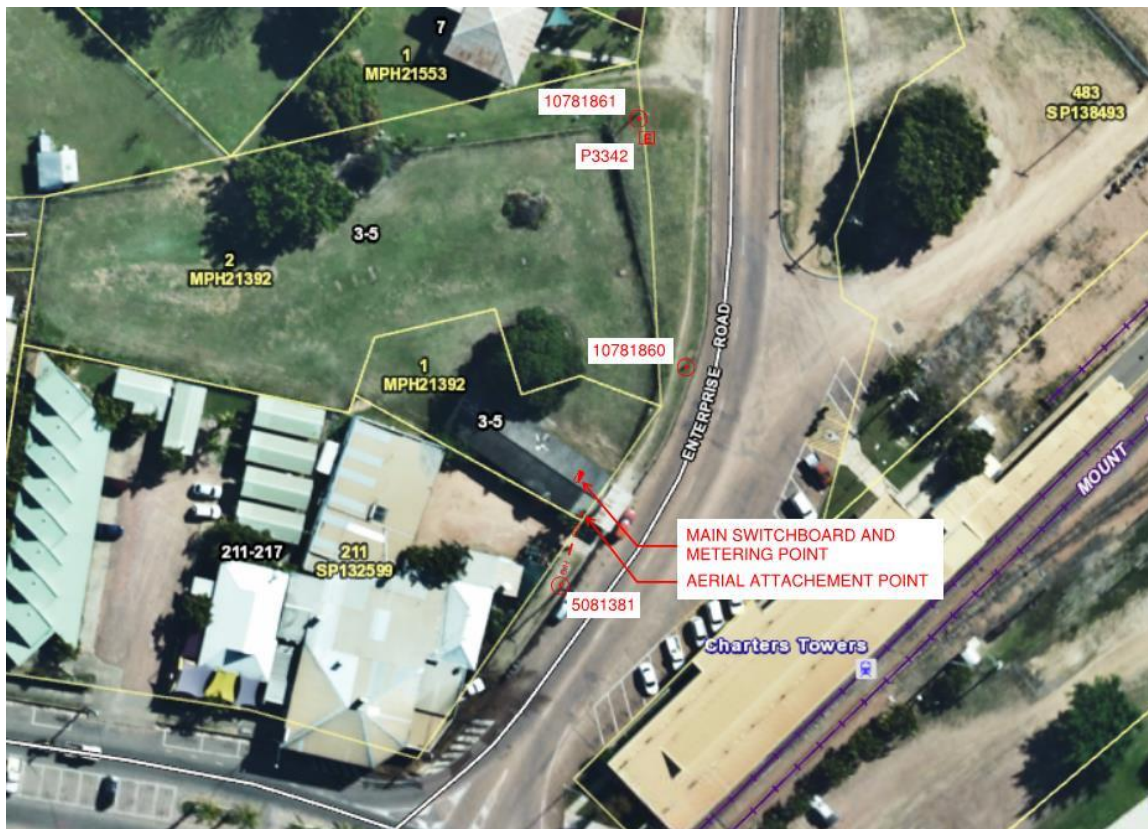
The site is currently supplied with a single-phase aerial connection to an existing Ergon Pole (#5081381) on Enterprise Road. The aerial service size and service fuse size could not be confirmed from visual inspection. The aerial cable and connection point are both in poor condition. It is recommended that the existing aerial service and connections be replaced with infrastructure compliant with the requirements of the current Queensland Electricity Connection and Metering Manual (QECMM). A number of Ergon Energy distribution poles are located around the boundary of the lot as per the below sketch.

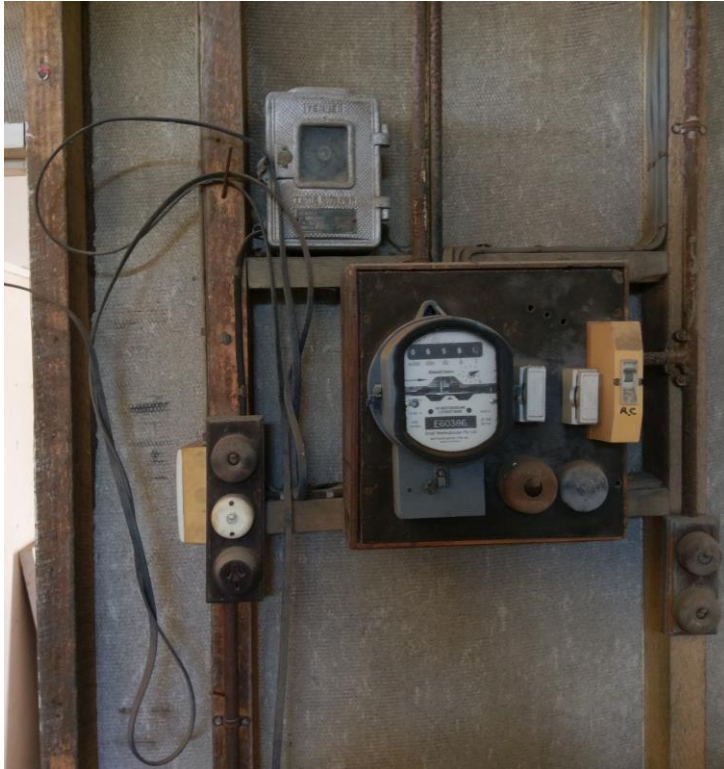
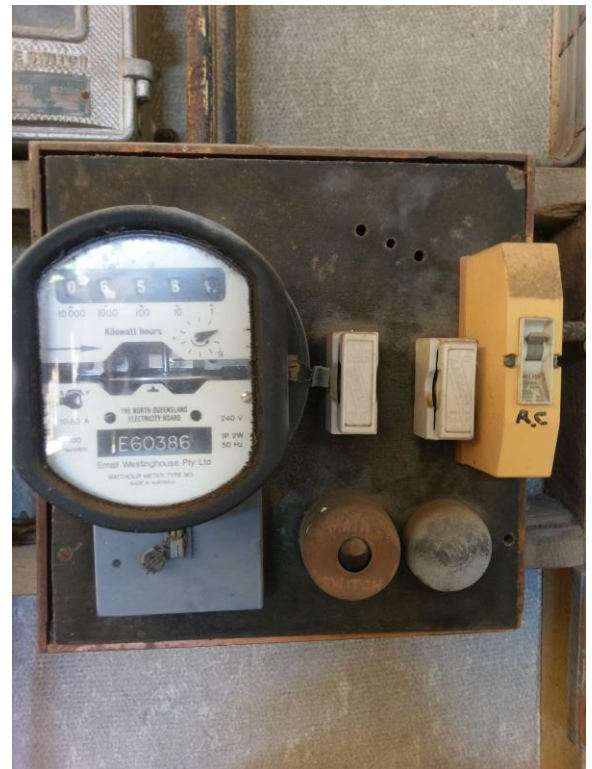
The existing main switchboard and meter panel are located adjacent to the entry to the large store room. The facility is provided with a single-phase analogue meter that is estimated to be over 20 years old. There were no metering isolation links installed and the meter is not located in a position that is compliant with the requirements of the QECMM. The existing metering installation is non-compliant with the current QECMM and would need to be replaced if the building was to be retained and refurbished.

The main switchboard for the existing building is of considerable age and is in very poor condition. The MSB is installed on a plywood frame with no cover to prevent accidental contact or operation. Due to the age of the installation, it is possible that the enclosure is constructed of ACM, but this could not be confirmed as no ACM register was available at the site. The MEN link and earthing stake could not be located to confirm condition, although it is likely that the existing water supply point is utilised as the earthing conductor. The existing MSB consists of:

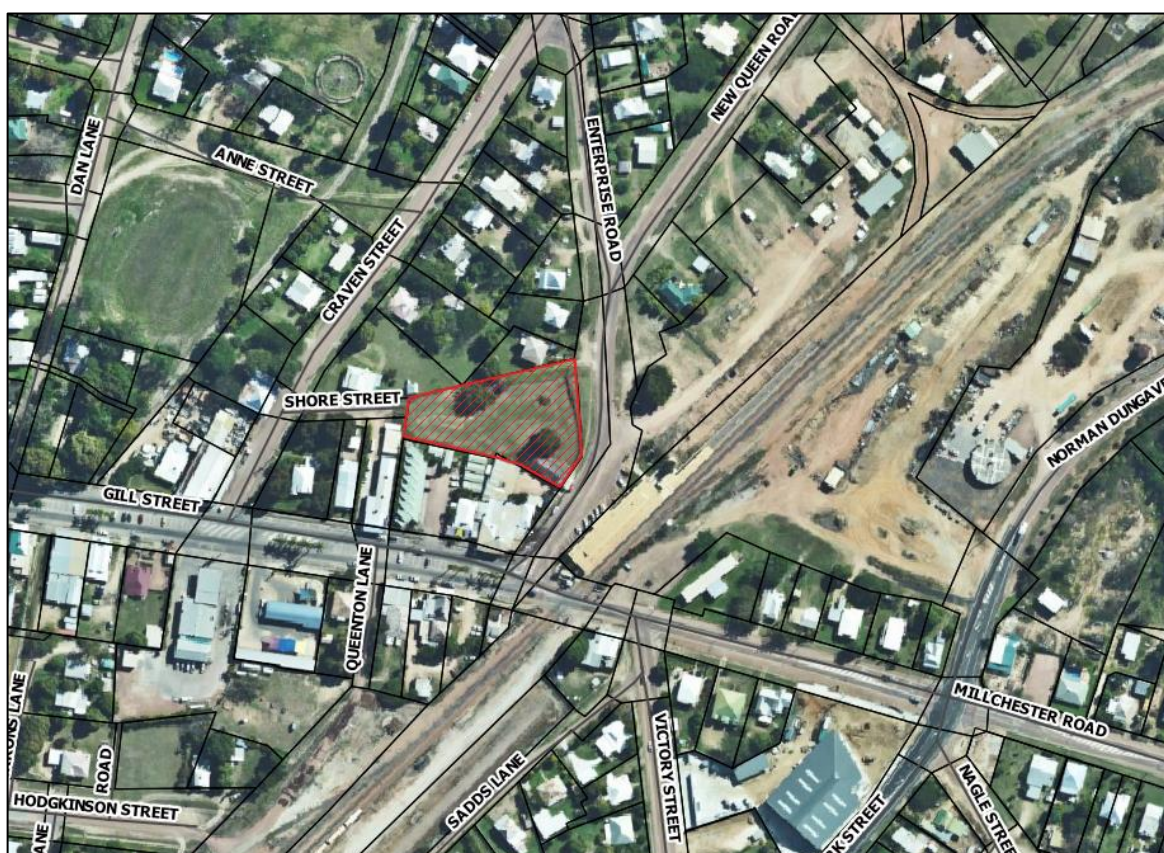
Figure 1.1 Area of Interest

Charters Towers is located within the Charters Towers Regional Council (CTRC) local government area (LGA). The designated flood event for planning purposes is the 1:500 Annual Exceedance Probability (AEP) flood event. The area of interest is illustrated in Figure 1.1.

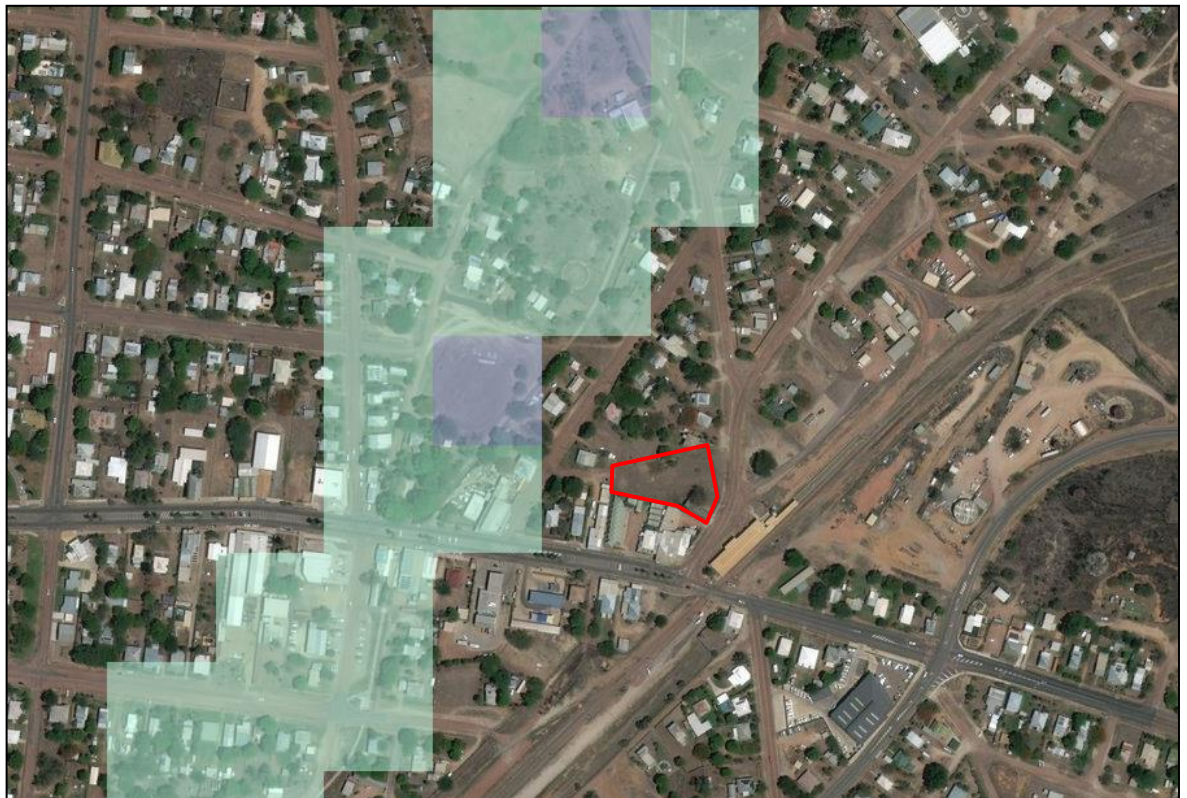
Figure 2.1 Burdekin River Level 2 Flood Investigation PMF Mapping

Figure 2.1 shows the extreme flood event (Probable Maximum Flood) flood extent in relation to the proposed QFES site from the *Burdekin River Basin Level 2 Flood Investigation Report* (KBR, 2015). It can be seen from this figure that the QFES station is unlikely to be impacted by flooding from a regional flood source.

The Department of Natural Resources and Mines (DNRM) *FloodCheck* online tool (<http://dnrm-floodcheck.esriaustraliaonline.com.au/floodcheck/>) was utilised to ascertain the risk of regional flooding to the proposed QFES site. Charters Towers is covered by the *Burdekin River Basin Level 2 Flood Investigation Report* (KBR, 2015). The results from this investigation show that the Site is not impacted by flooding from a regional system.

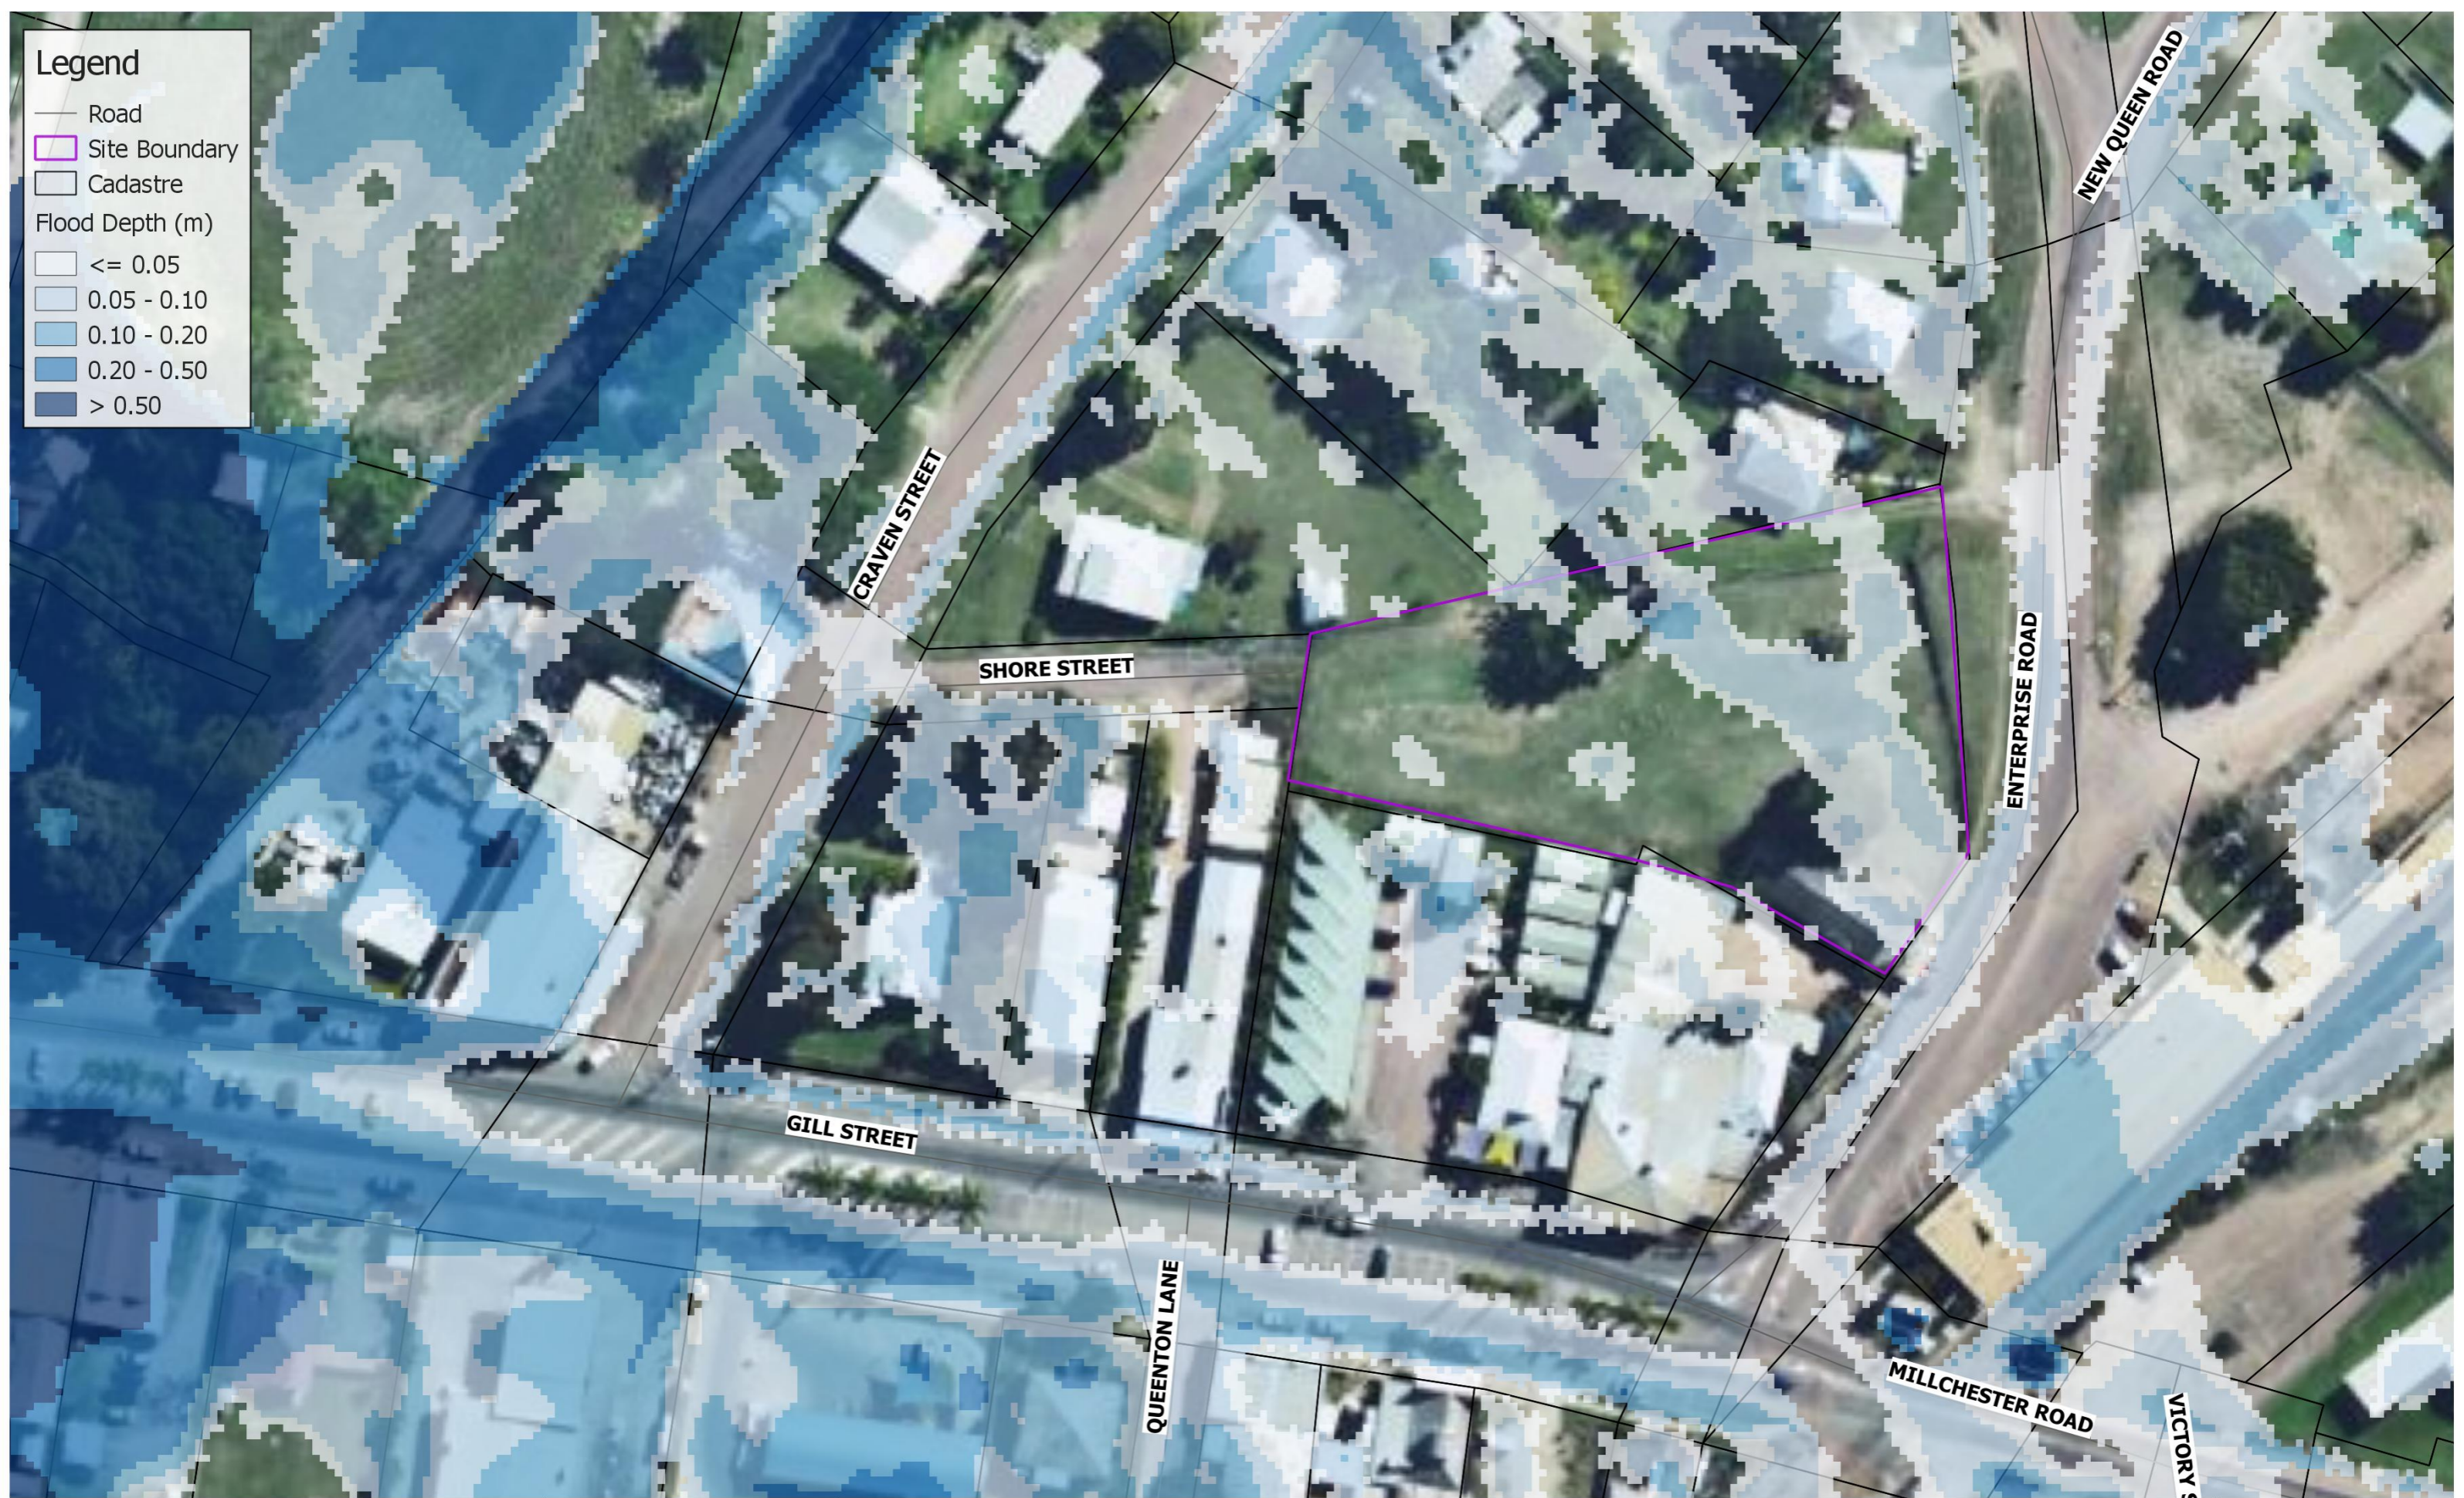
- Road
- ▭ Site Boundary
- ▭ Cadastre
- Flood Depth (m)
- ▭ ≤ 0.05
- ▭ 0.05 - 0.10
- ▭ 0.10 - 0.20
- ▭ 0.20 - 0.50
- ▭ > 0.50
