Proposed Infrastructure Designation
under the *Planning Act 2016*

Charters Towers Fire and Rescue Station

3 – 5 Enterprise Road, Charters Towers QLD 4820

February 2019

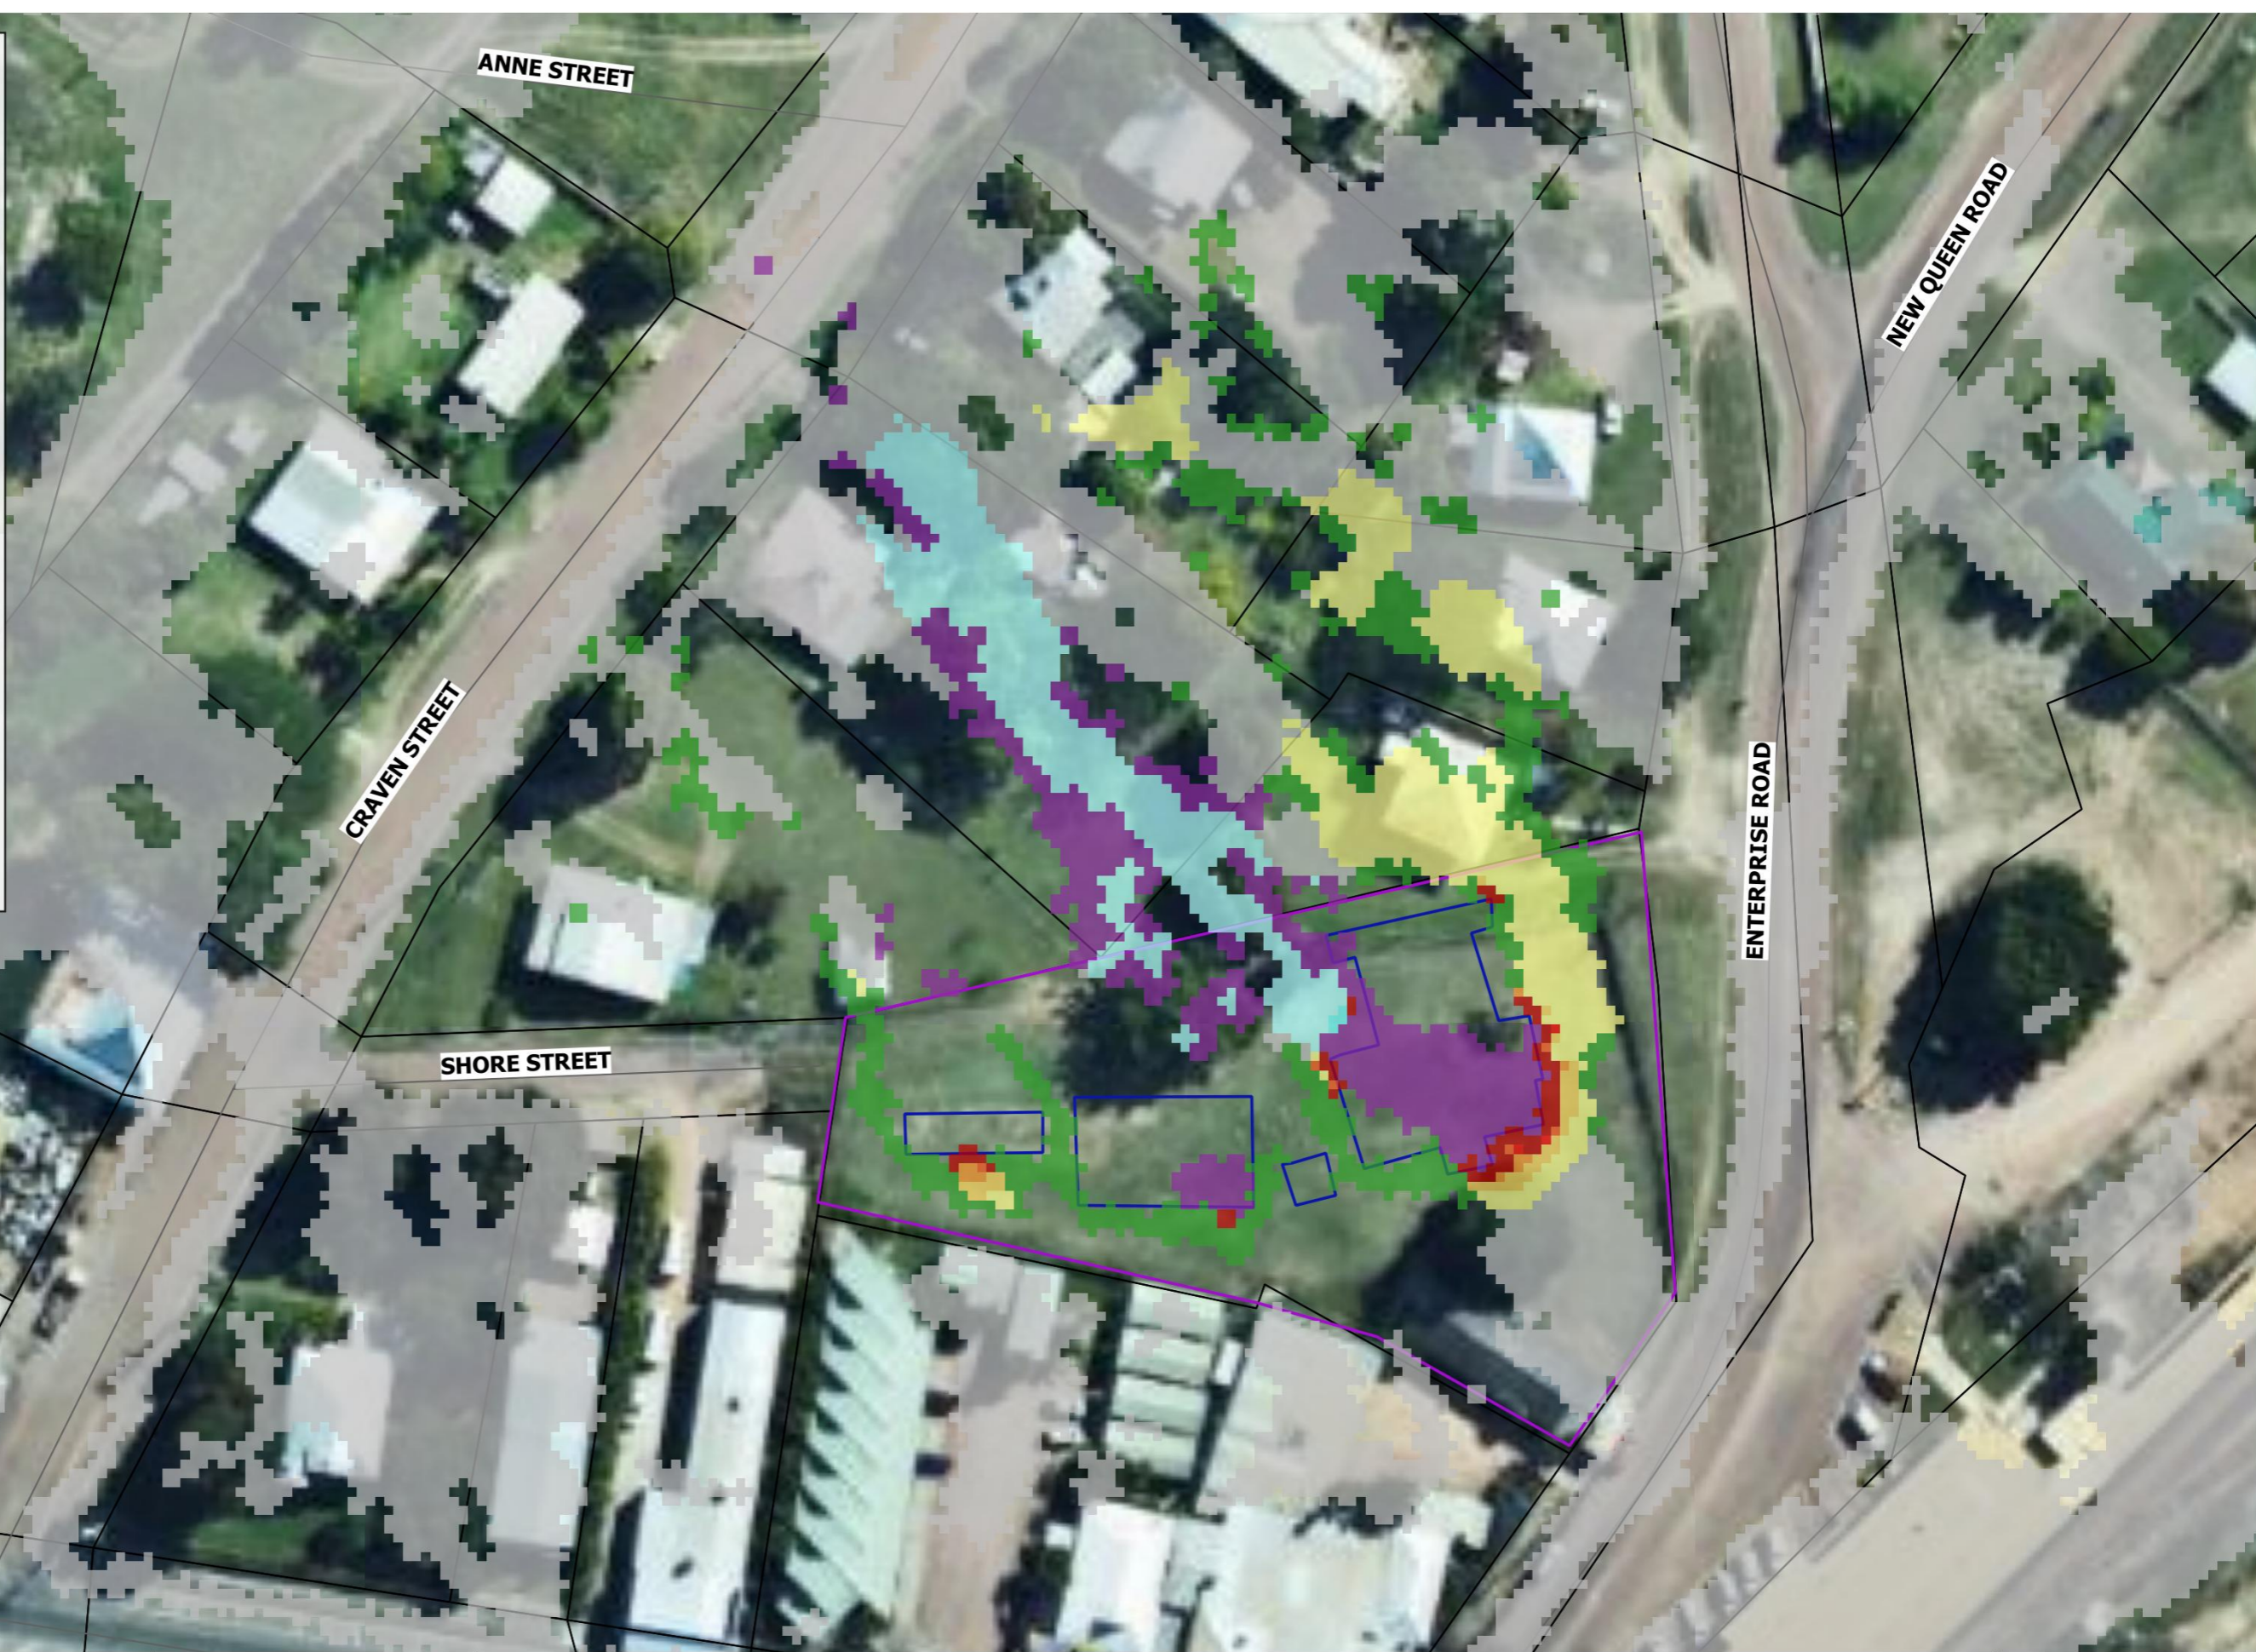
- ≤ -0.5
- -0.5 - -0.3
- -0.3 - -0.2
- -0.2 - -0.1
- -0.1 - -0.05
- -0.05 - -0.01
- -0.01 - 0.01
- 0.01 - 0.05
- 0.05 - 0.1
- 0.1 - 0.2
- 0.2 - 0.3
- 0.3 - 0.5
- > 0.5
- Was Wet Now Dry
- Was Dry Now Wet

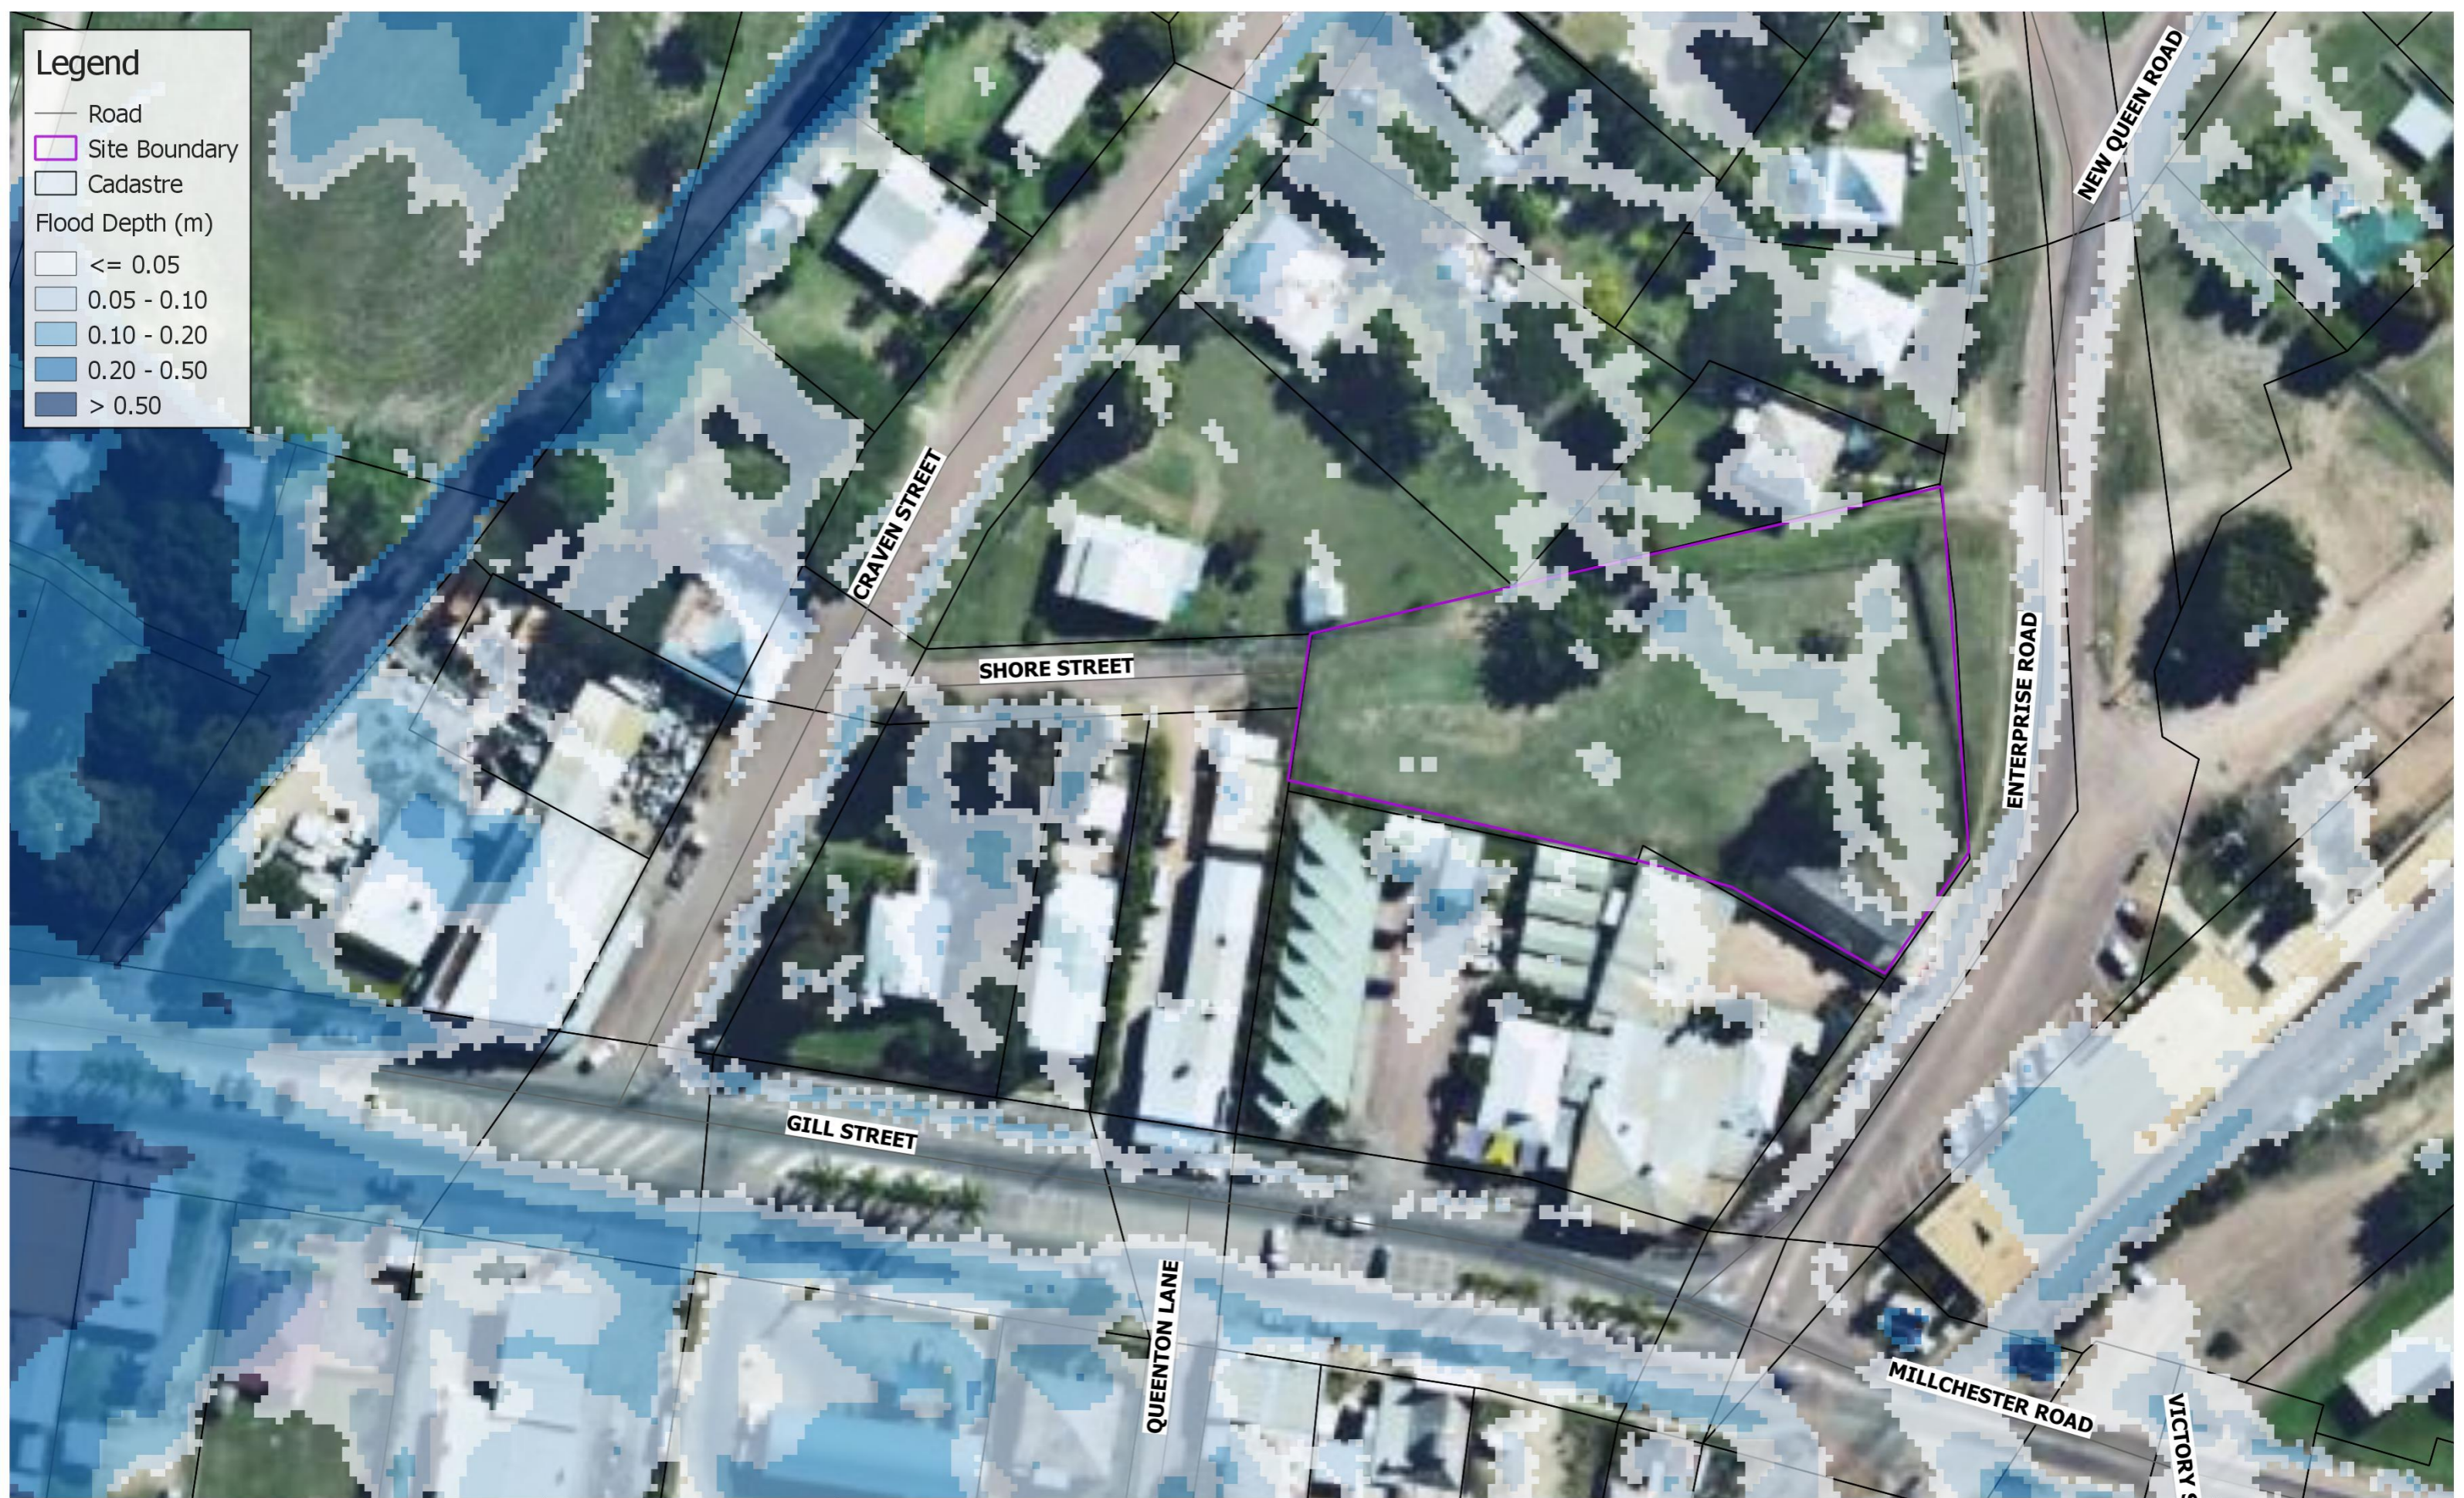
- Road
- ▭ Site Boundary
- ▭ Cadastre
- Flood Depth (m)
- ▭ ≤ 0.05
- ▭ 0.05 - 0.10
- ▭ 0.10 - 0.20
- ▭ 0.20 - 0.50
- ▭ > 0.50

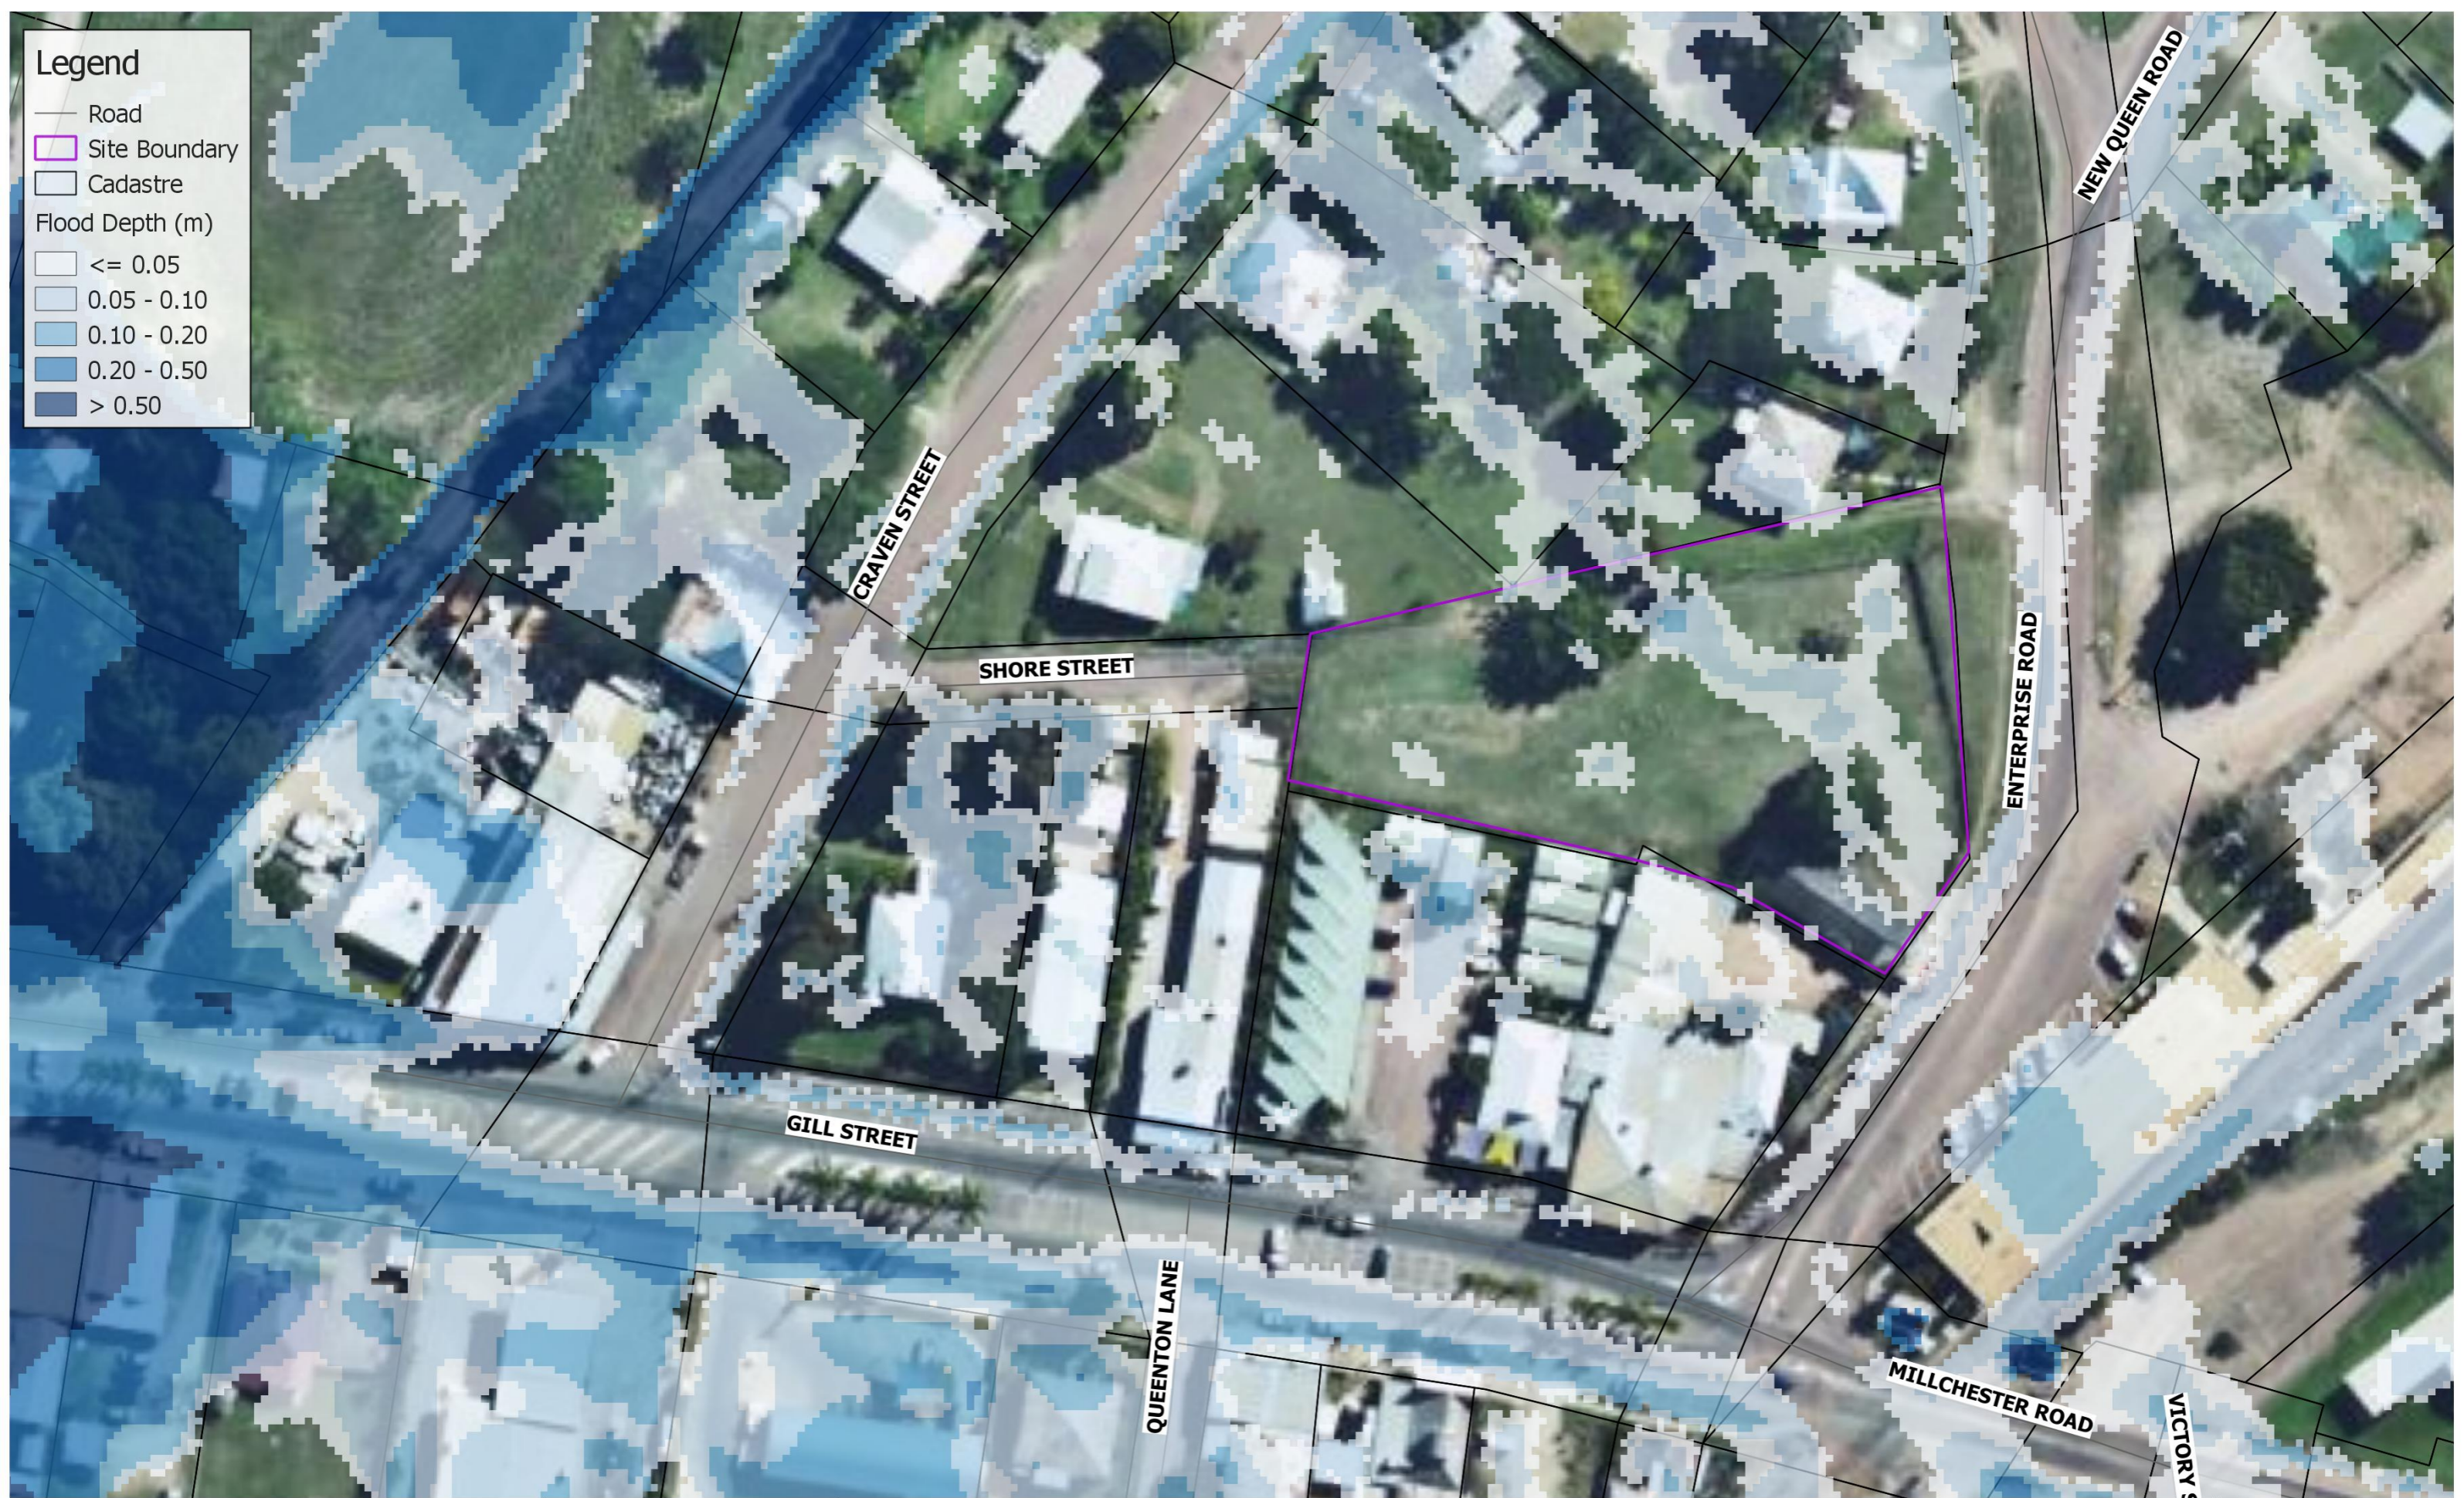
- Road
- ▭ Site Boundary
- ▭ Cadastre
- Flood Depth (m)
- ▭ ≤ 0.05
- ▭ 0.05 - 0.10
- ▭ 0.10 - 0.20
- ▭ 0.20 - 0.50
- ▭ > 0.50

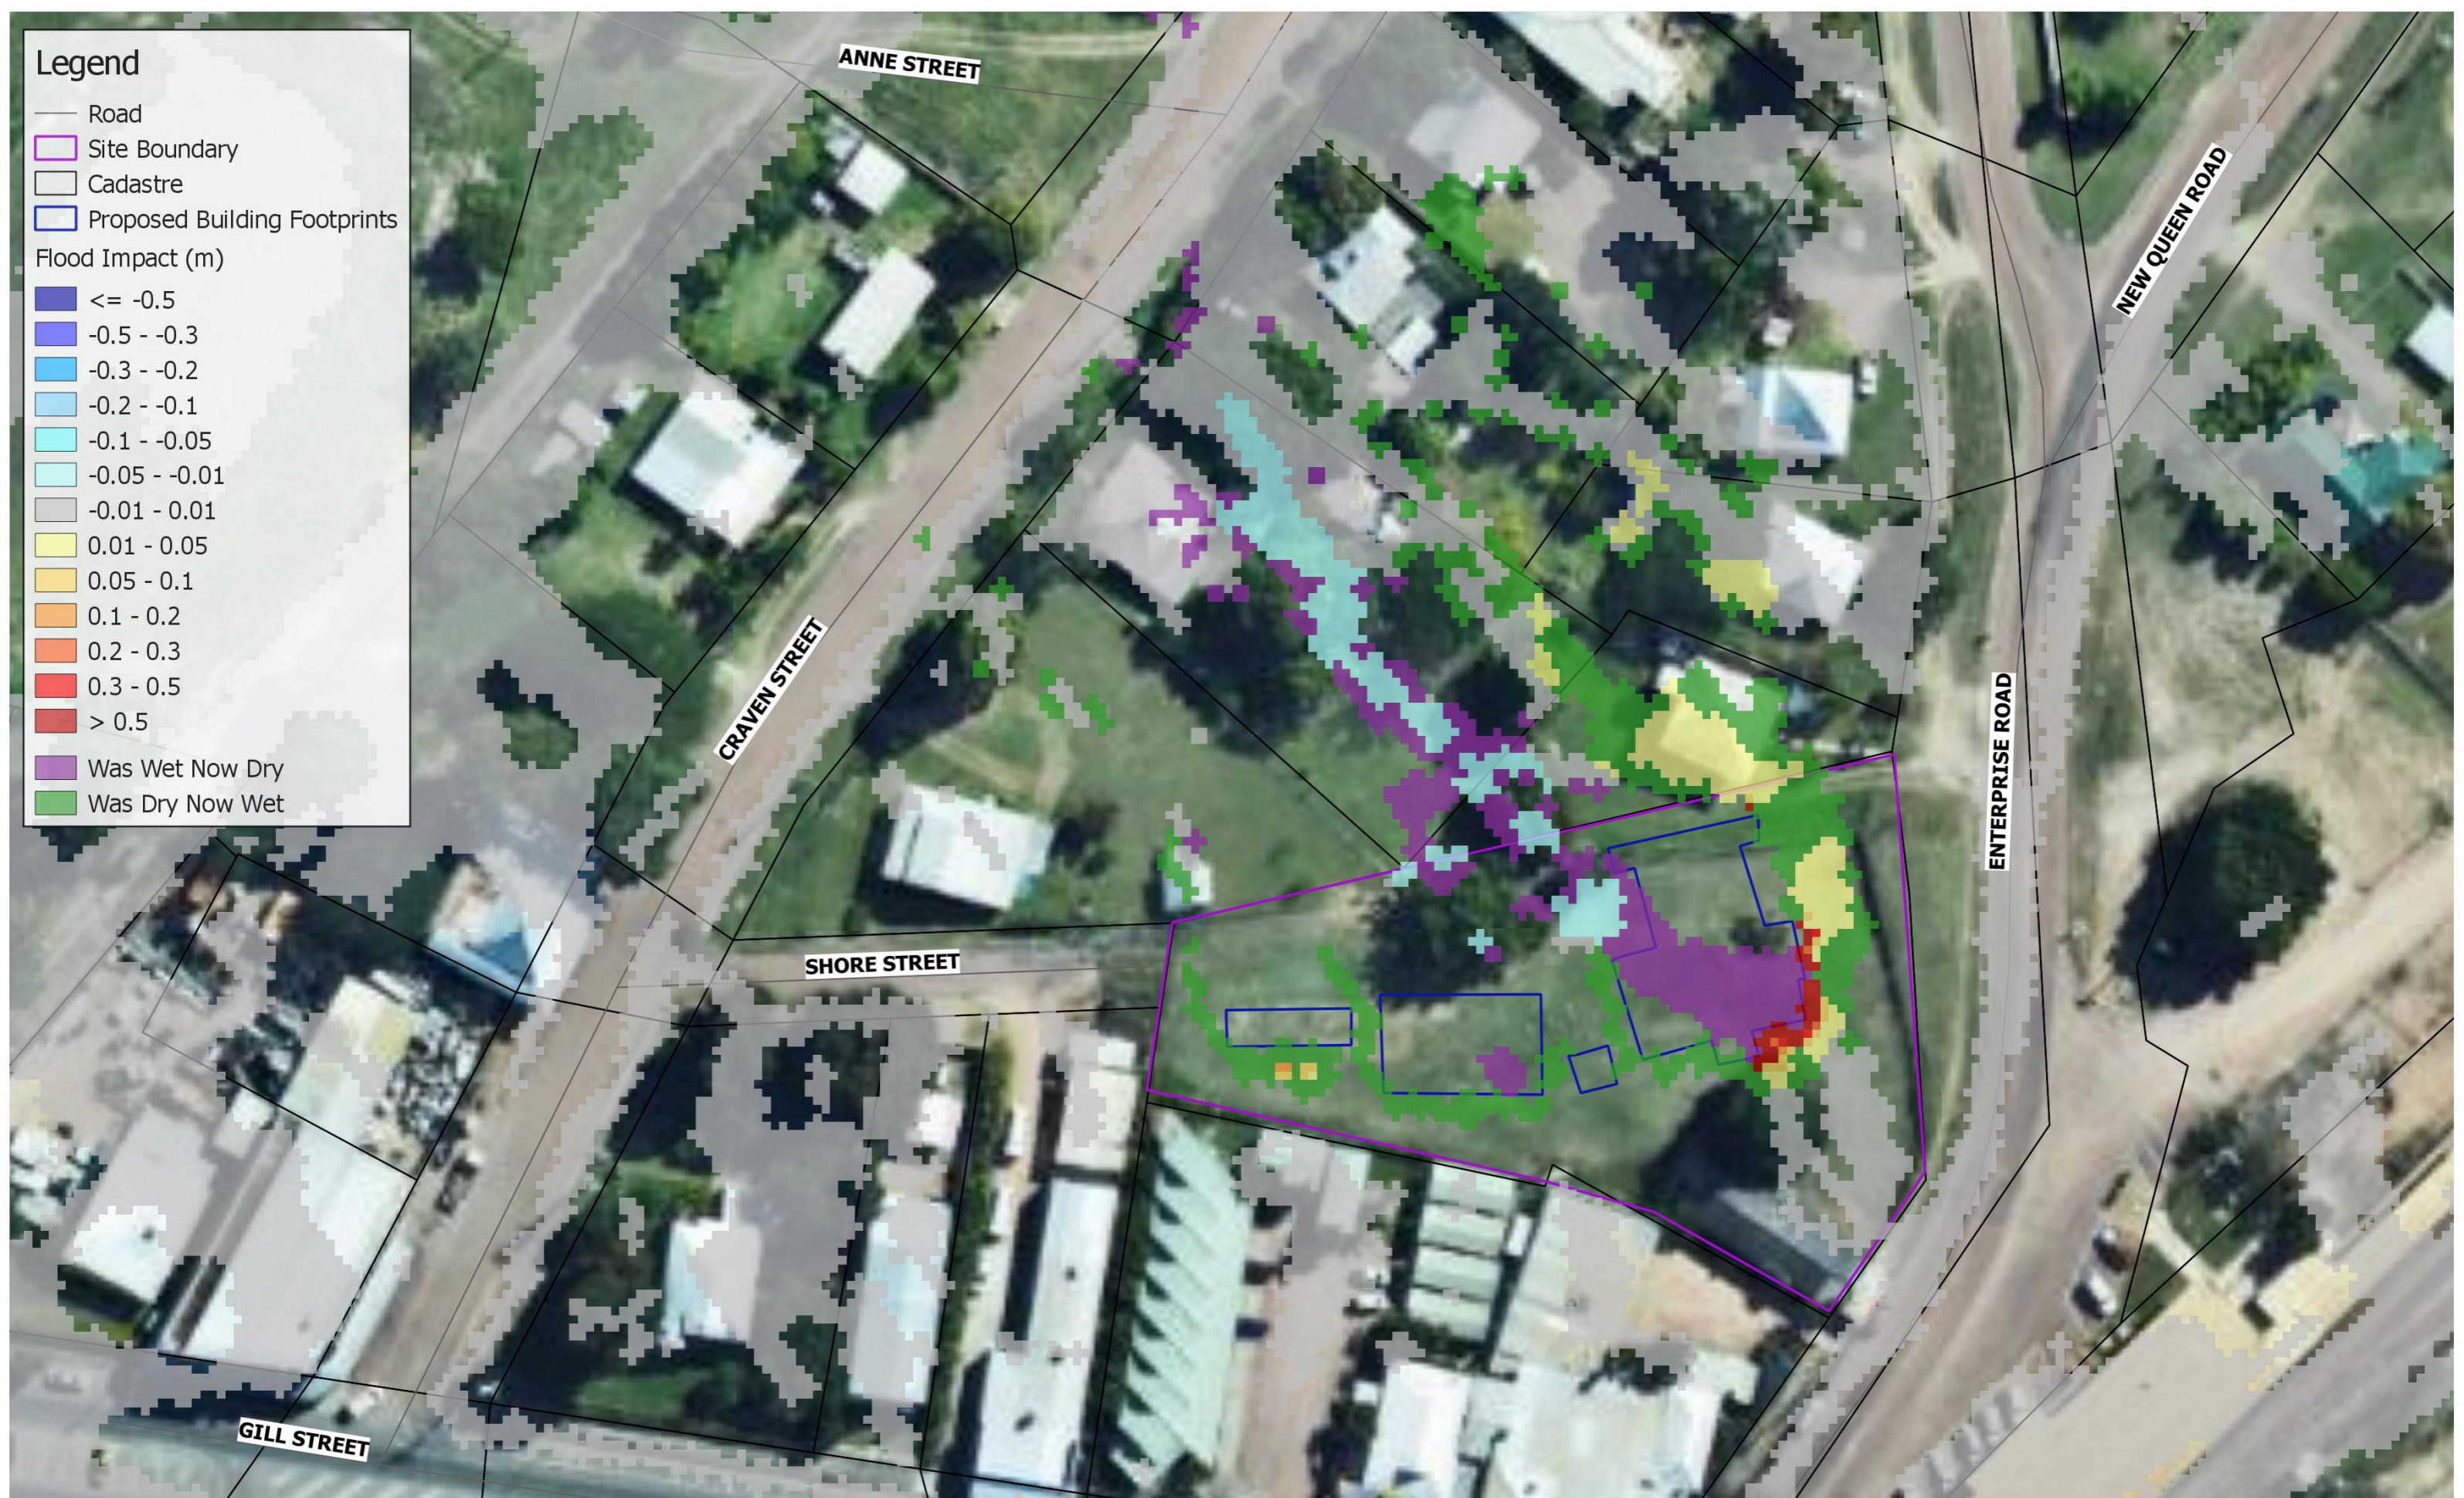
- Road
- Site Boundary
- Cadastre
- Proposed Building Footprints
- Flood Impact (m)
- ≤ -0.5
- -0.5 - -0.3
- -0.3 - -0.2
- -0.2 - -0.1
- -0.1 - -0.05
- -0.05 - -0.01
- -0.01 - 0.01
- 0.01 - 0.05
- 0.05 - 0.1
- 0.1 - 0.2
- 0.2 - 0.3
- 0.3 - 0.5
- > 0.5
- Was Wet Now Dry
- Was Dry Now Wet

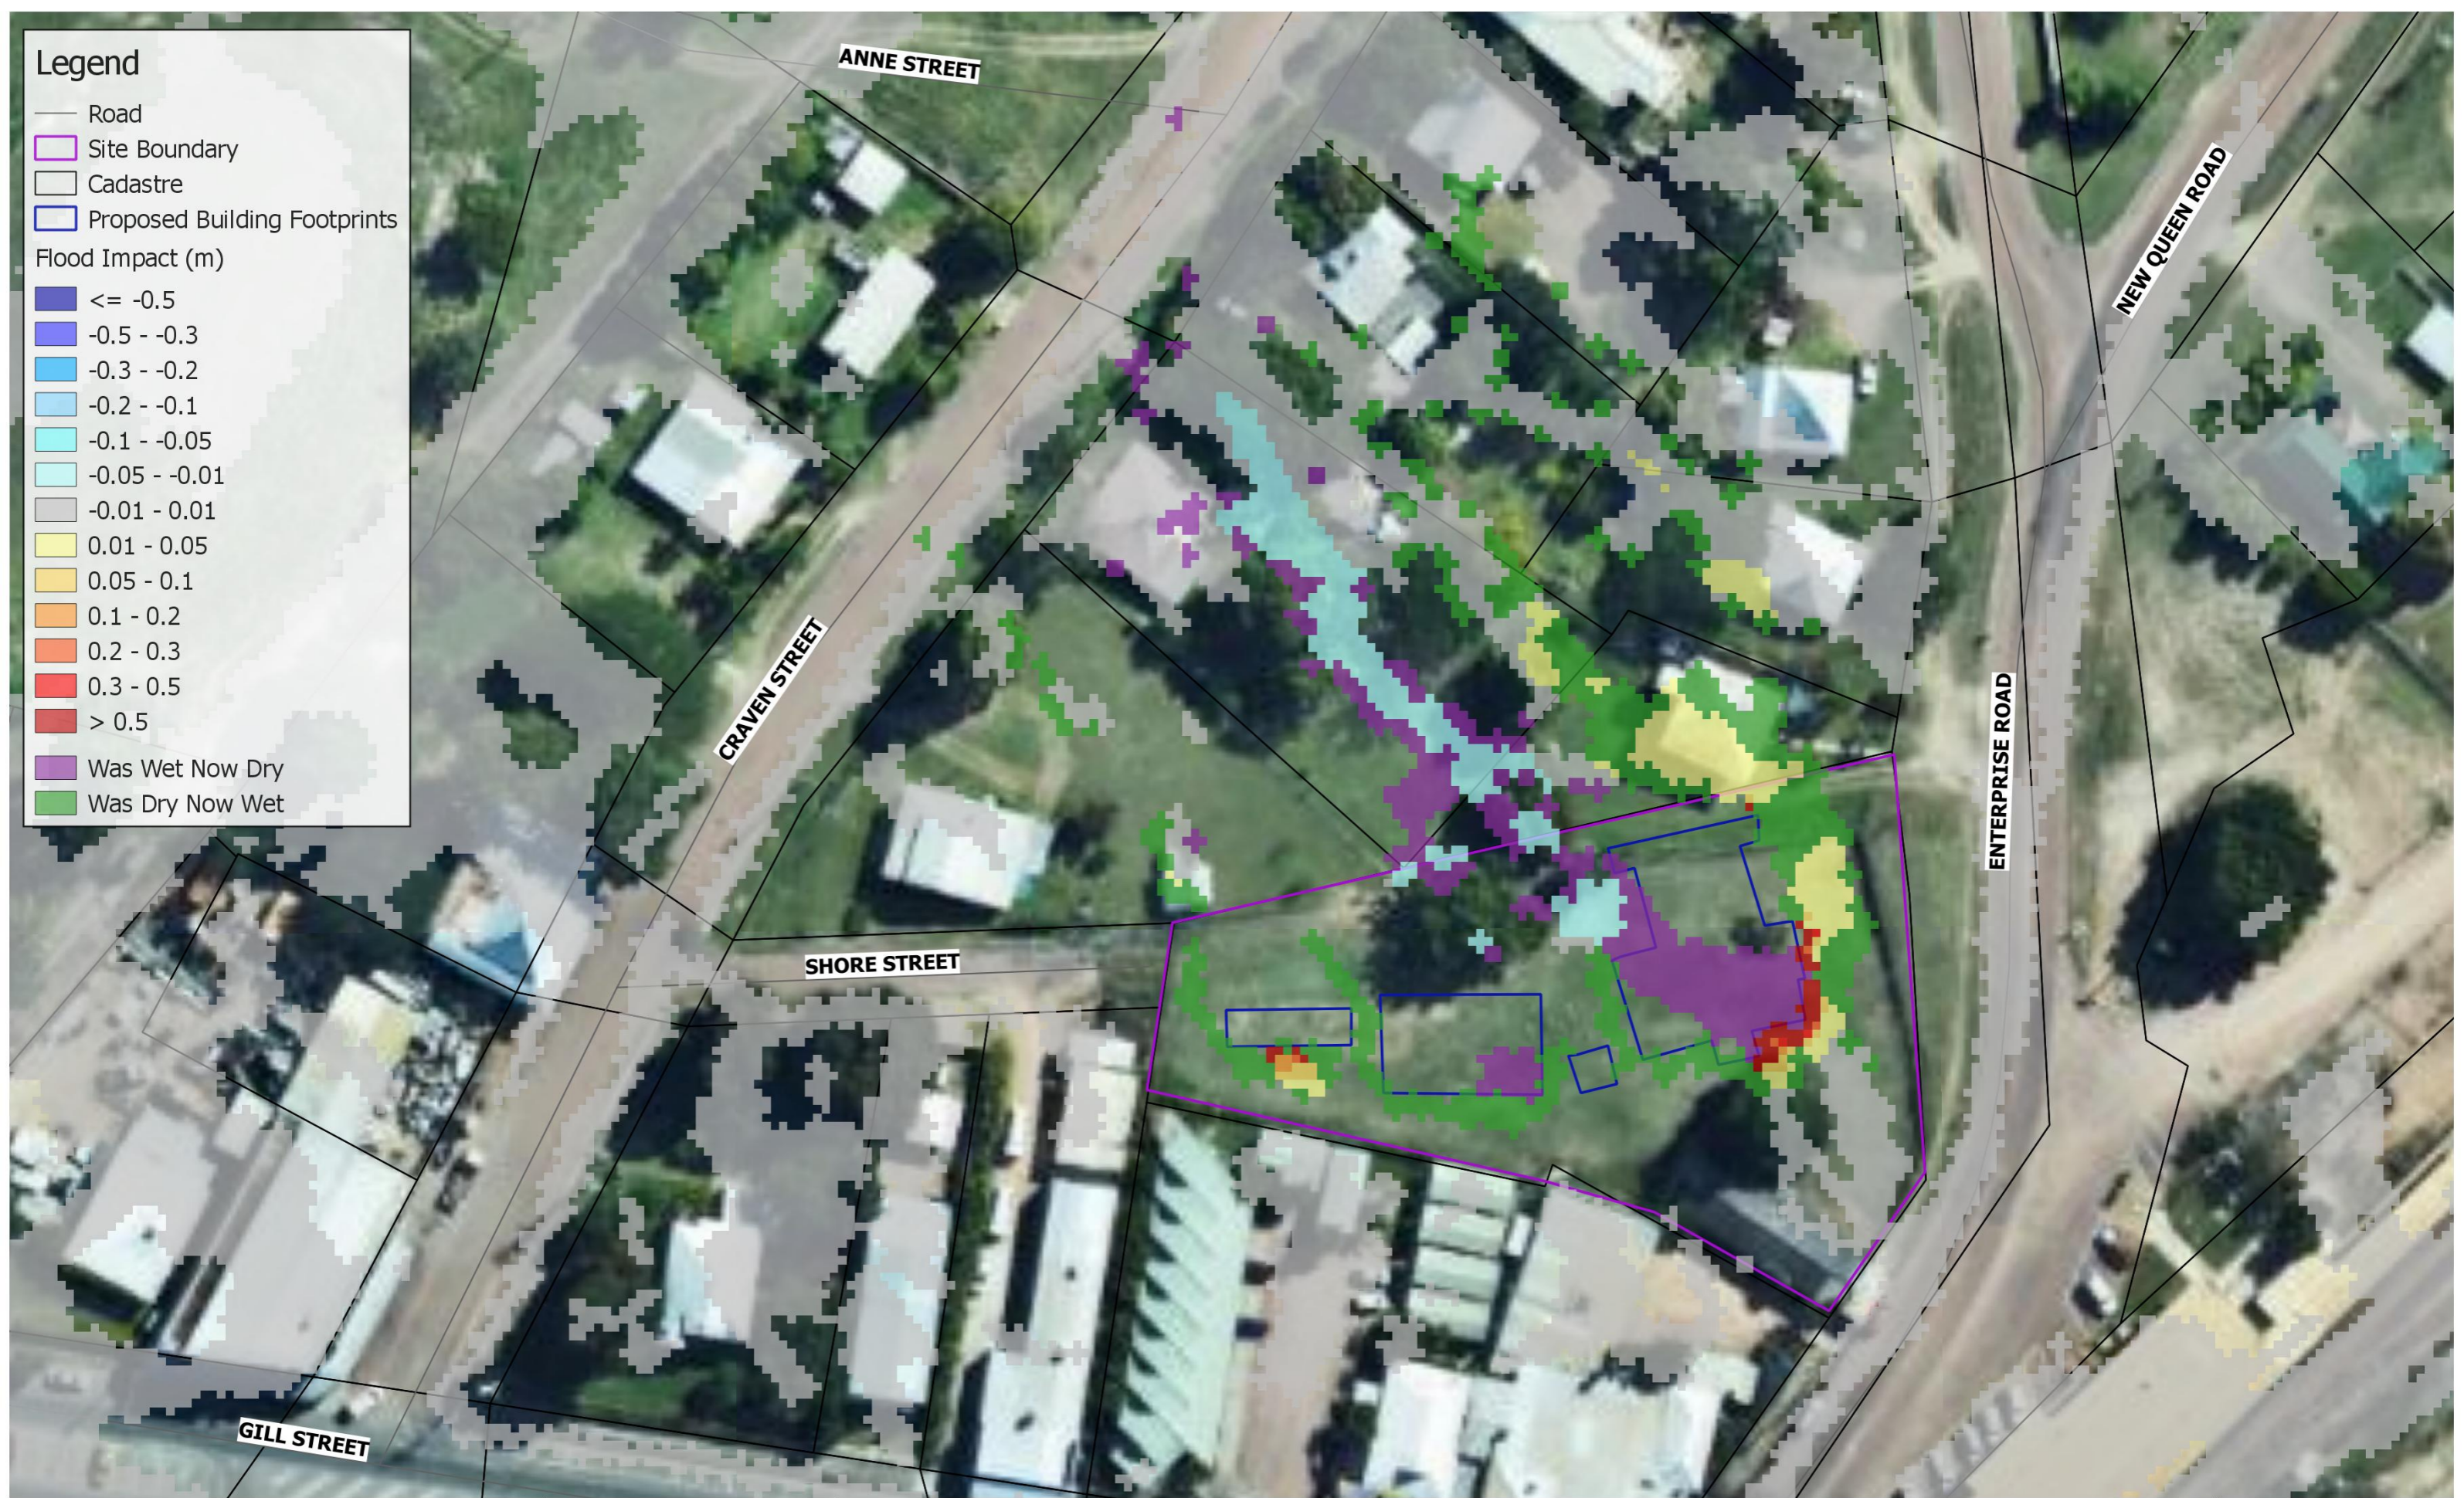
- Road
- Site Boundary
- Cadastre
- Proposed Building Footprints
- Flood Impact (m)**
- ≤ -0.5
- -0.5 - -0.3
- -0.3 - -0.2
- -0.2 - -0.1
- -0.1 - -0.05
- -0.05 - -0.01
- -0.01 - 0.01
- 0.01 - 0.05
- 0.05 - 0.1
- 0.1 - 0.2
- 0.2 - 0.3
- 0.3 - 0.5
- > 0.5
- Was Wet Now Dry
- Was Dry Now Wet

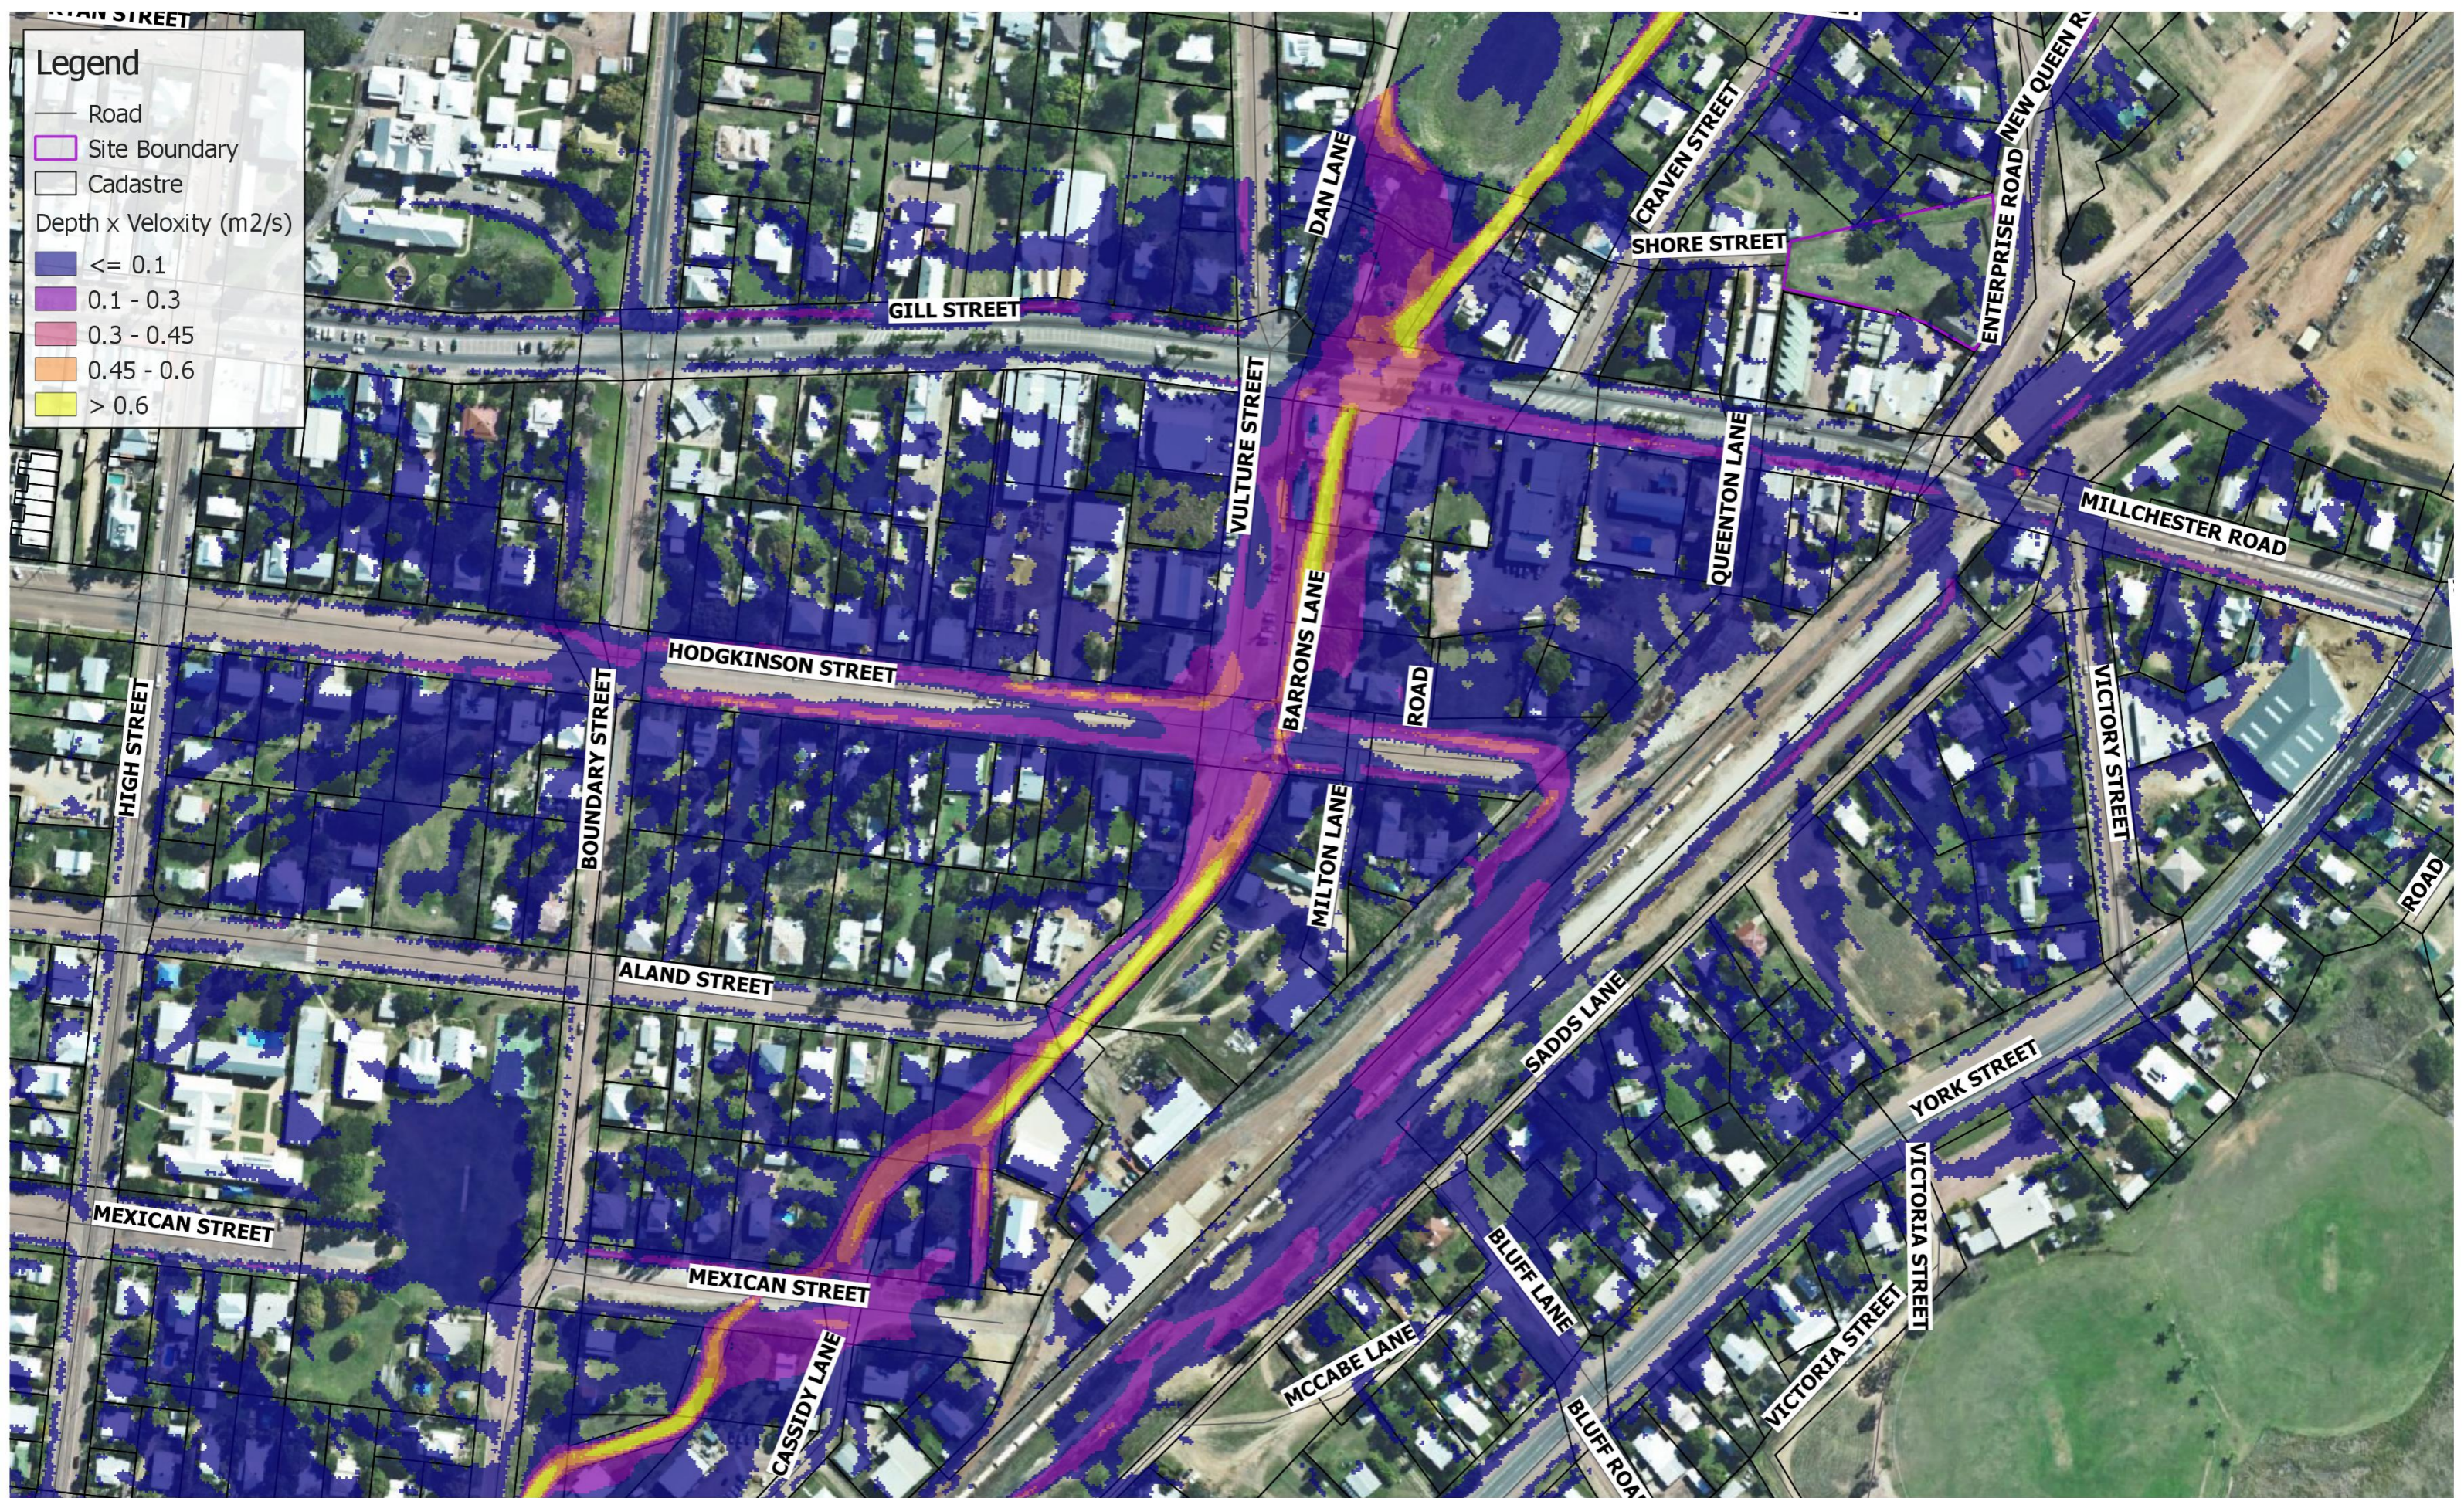
Charters Towers QFE S Flood and Stormwater Report
 1:50 AEP Flood Hazard
 Depth x Velocity Product

- Road
- Site Boundary
- Cadastre
- Depth x Velocity (m²/s)
- ≤ 0.1
- 0.1 - 0.3
- 0.3 - 0.45
- 0.45 - 0.6
- > 0.6
