Proposed Infrastructure Designation
under the *Planning Act 2016*

Charters Towers Fire and Rescue Station

3 – 5 Enterprise Road, Charters Towers QLD 4820

February 2019

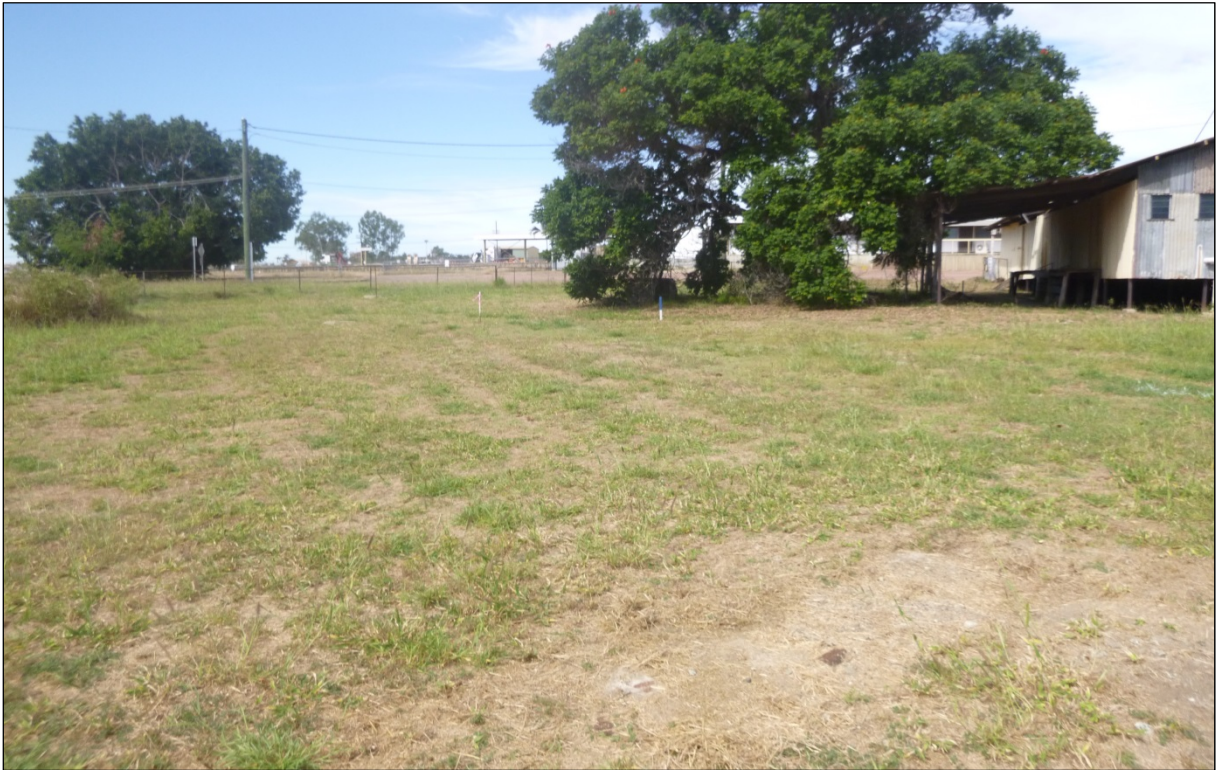
An Existing Conditions Report has also been prepared by STP Consultants and is provided at **Appendix 8**. This report identifies the existing building on the subject land:

Figures 2 and 3 show the general site conditions at the time of investigation field work.

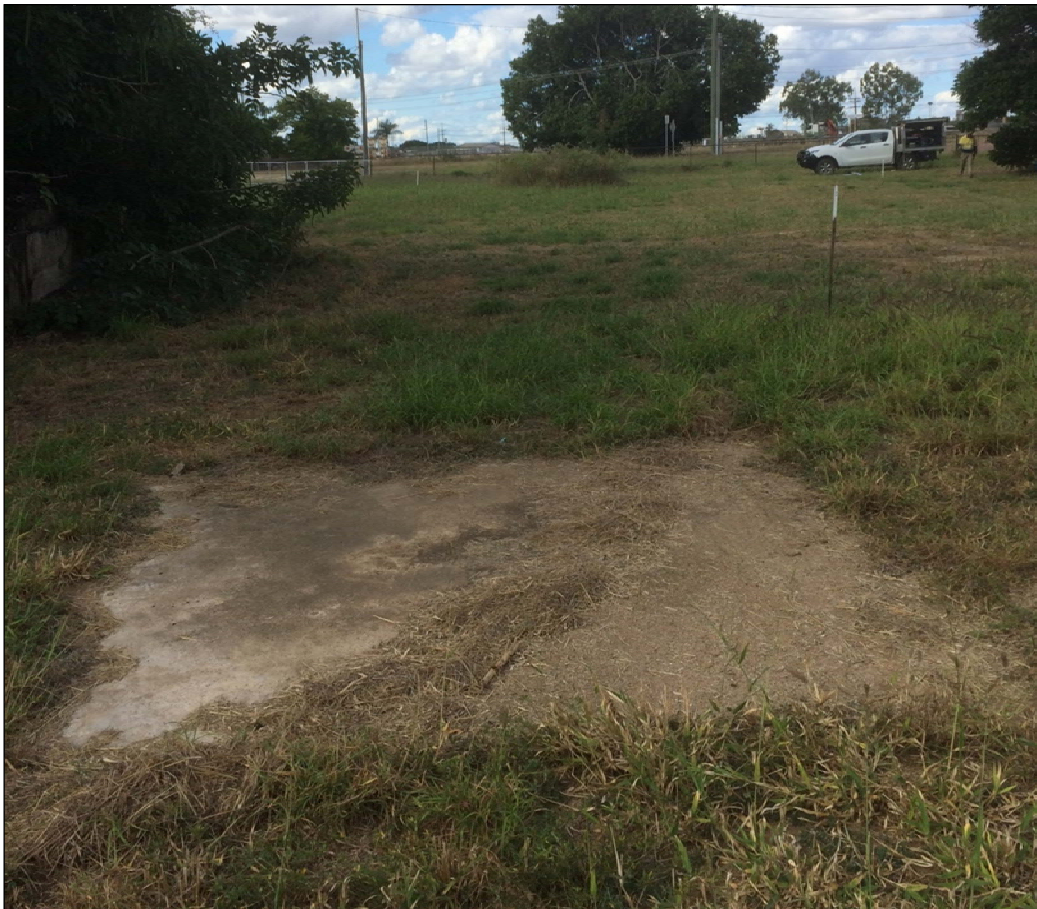
Figure 4: Pre-existing concrete slabs, located in the centre of the site. Photo looking east

- Pre-existing concrete slabs, which were generally located in the centre of the site, refer to Figure 4 below;
- Concrete footings, several metres long, which were located under both of the existing trees, refer to Figure 5 over the page;
- Possible bonded asbestos containing material (ACM), which appeared to be in sound condition, was observed sitting on top of one of the concrete footings, along the northern boundary of the site, refer to Figure 6 over the page; and
- A possible stockpile, which was located in the north-eastern portion of the site, refer to Figure 7.

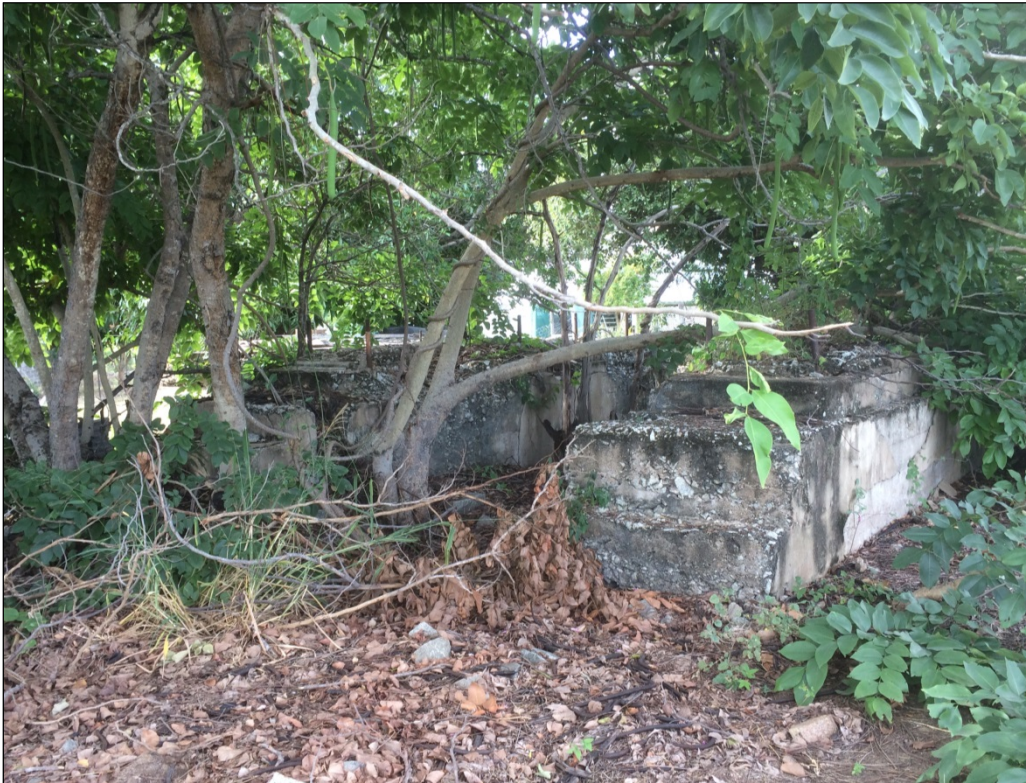
Figure 5: Concrete footings, located under the trees. Photo taken from centre of site, looking north

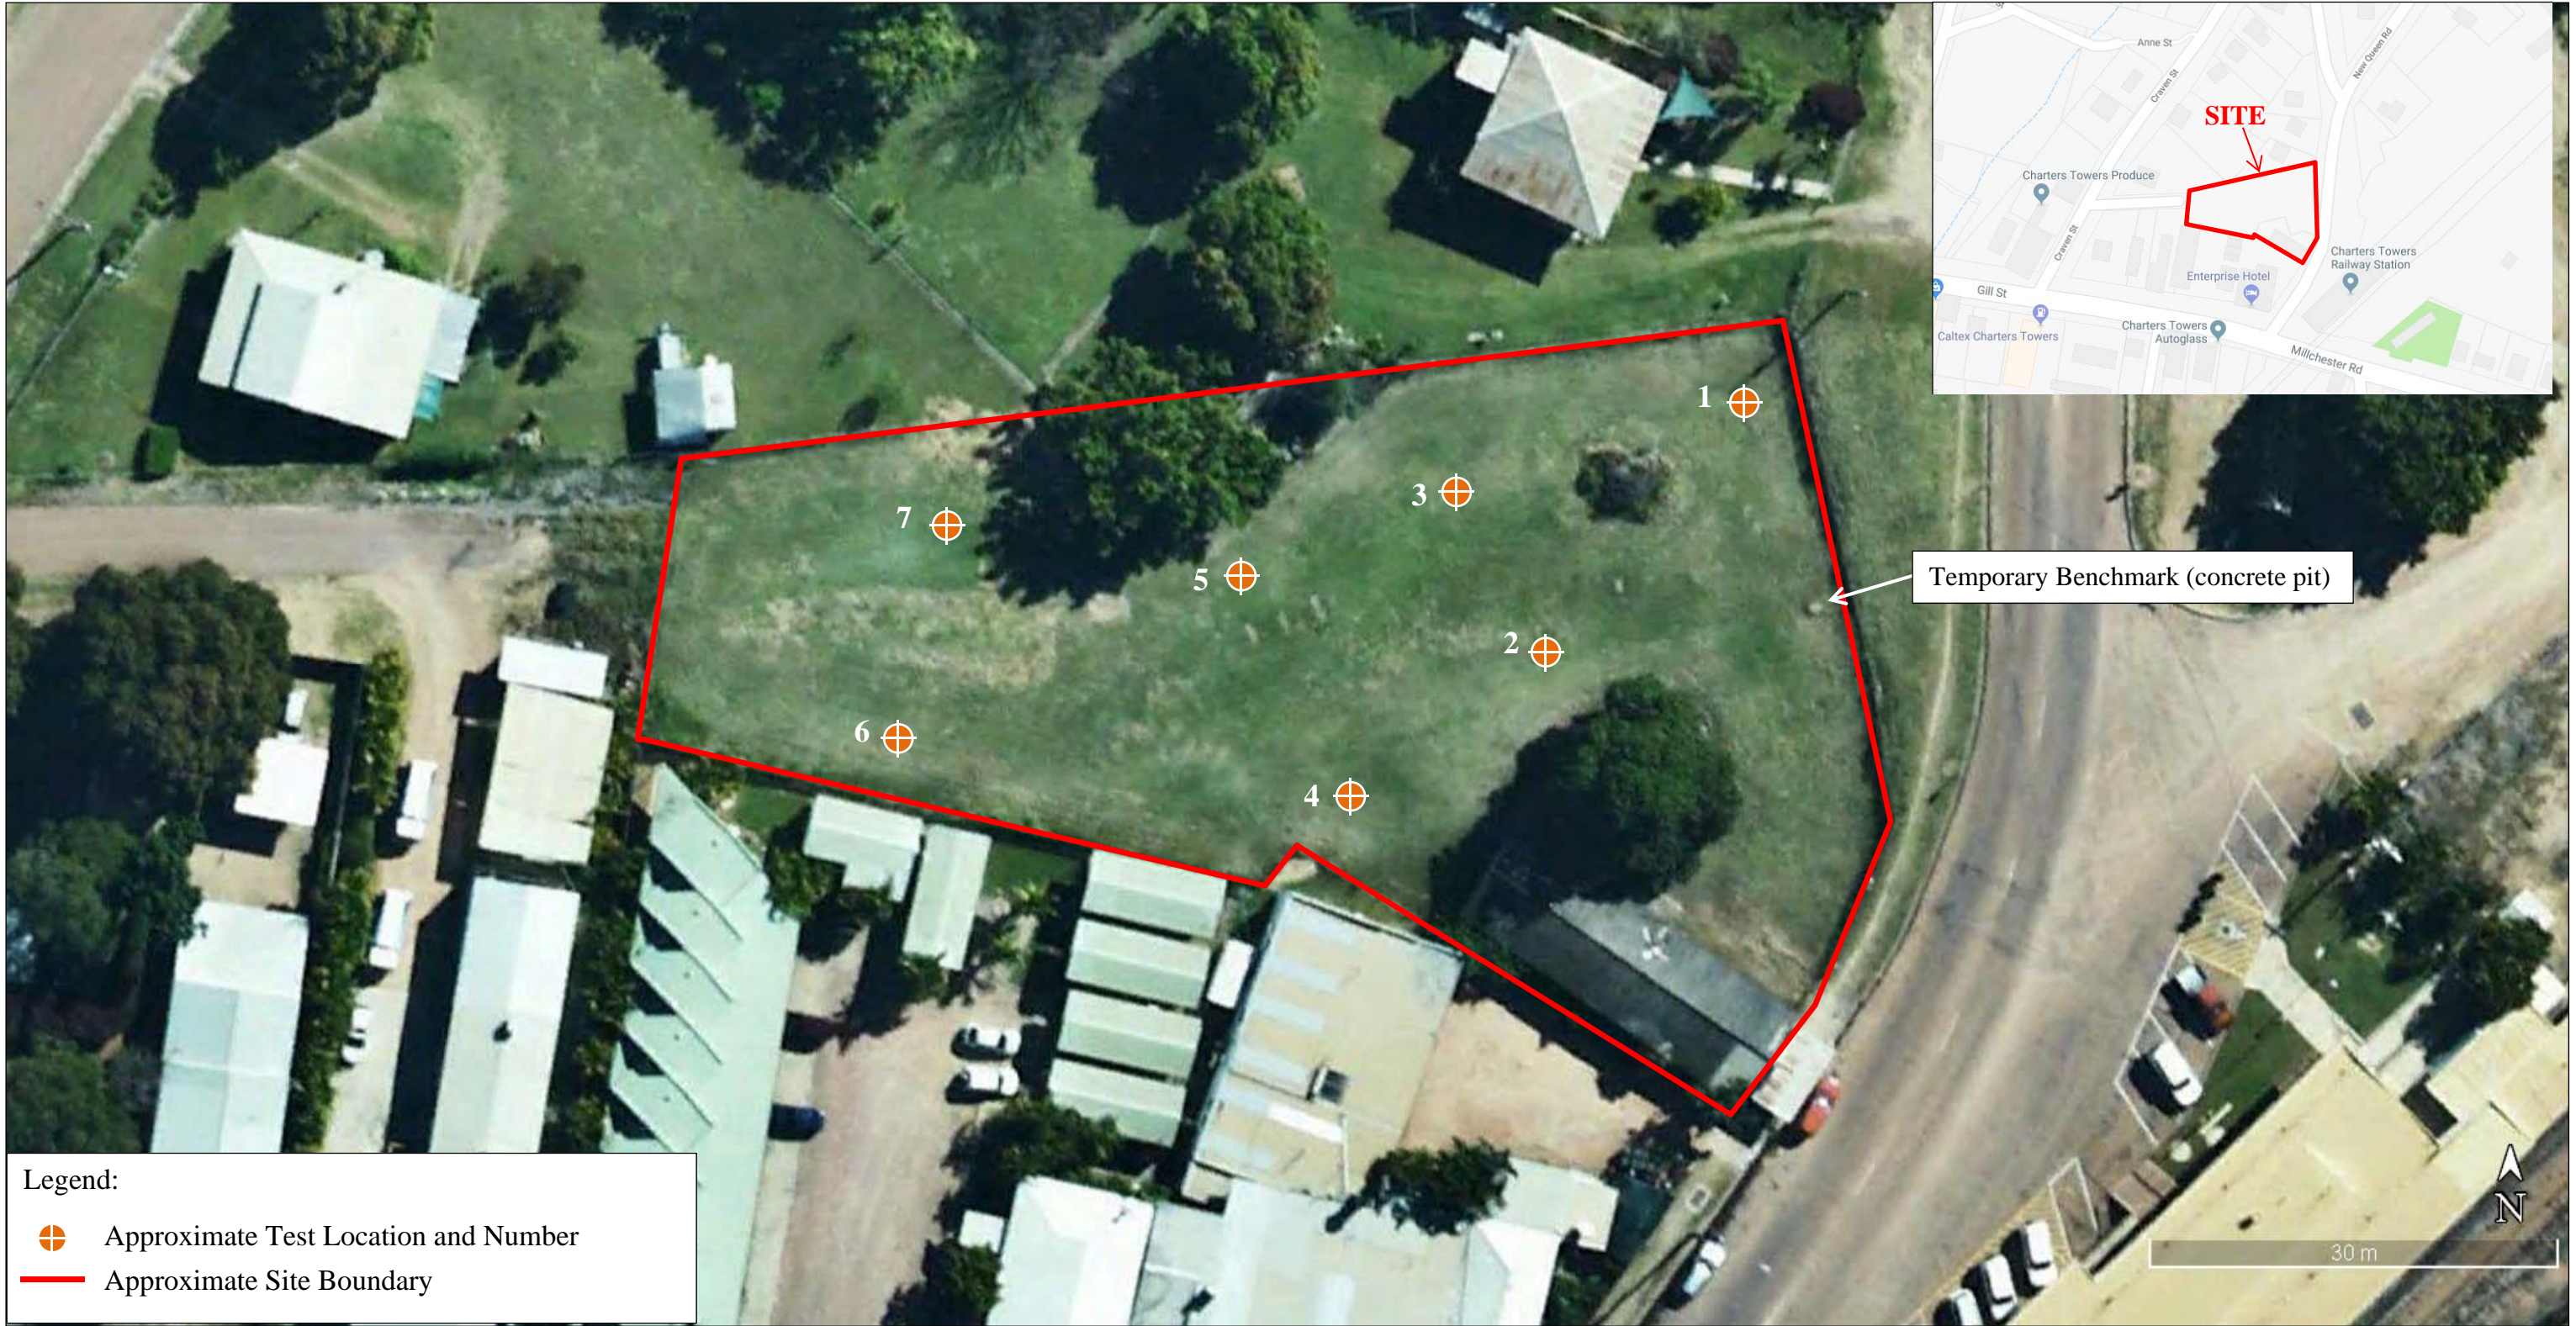
Douglas Partners Geotechnics Environment Groundwater	CLIENT: Public Safety Business Agency		TITLE: Site and Test Location Plan Proposed Fire Station 3-5 Enterprise Road, Charters Towers	PROJECT No: 93893.00	
	OFFICE: Townsville	DRAWN BY: KMF		DRAWING No: 1	
	SCALE: As shown	DATE: 8/3/16		REVISION: 168 0

The subsurface conditions encountered in the test bores, and the DCP results are presented in detail in the borehole logs in Appendix B. These should be read in conjunction with the notes about this report in Appendix A and the explanatory notes in Appendix B which comment on the sampling methods, soil descriptions and symbols and abbreviations used in their preparation.
