# Restoration Plan to Support RIDA Application Saraji East Project

Final V4  
15 July 2021

GT Environmental Pty Ltd  
[www.gtenvironmental.com.au](http://www.gtenvironmental.com.au)

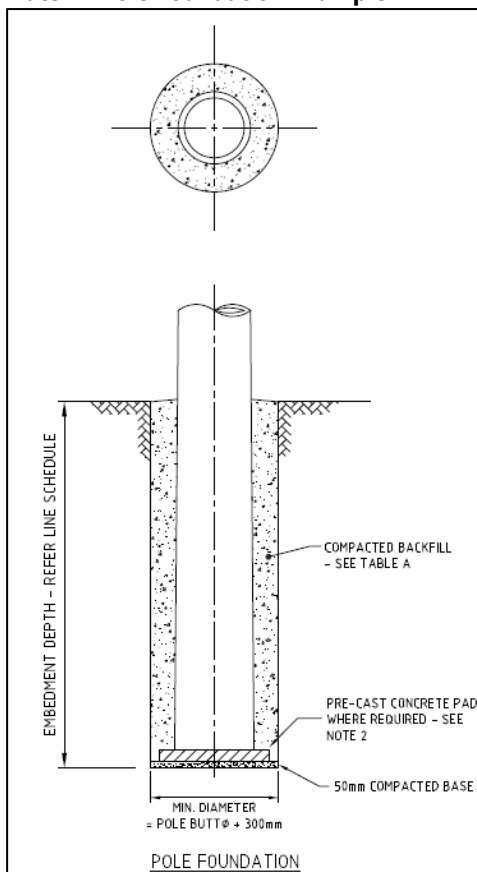
**Plate 2 Pole Foundation Example**

3. Remove loose spoil from the bottom of the hole and power ram bottom surface.
4. Spread and level a 50 mm layer of stabilised backfill as a base for all foundation types.
5. Firmly imbed the pre-cast concrete pad into the base material and level. Minimum pad diameter shall be equal to the pole butt diameter plus 100 mm.
6. Place the pole in position, ensuring it is oriented correctly and vertically plumb in each direction or raked.
7. Place the backfill in layers not exceeding 200 mm and power ram.

The foundation type and depth/size to be used at each site will be subject to detailed design and based on what is found during excavation of the pole hole. This may be determined through soils tests performed prior to construction, hand-penetrometer tests during construction or previous experience with adjacent sites.

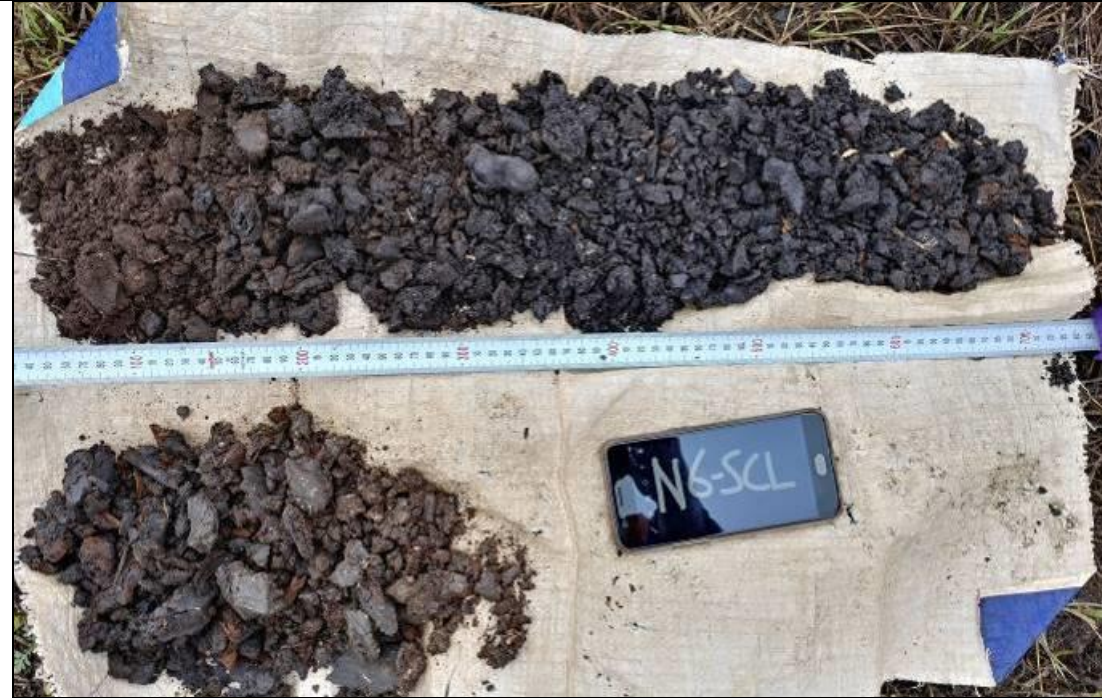
<b>Site N6</b> <b>(Previous N6-SCL as per photo)</b>

**Table 3-4: Soil Profile Morphology Summary Map Unit 1**

Horizon Depth (m), Boundary (Bdy)	Field Texture	Structure Strength	Inclusions Segregations	Colour, Mottle, Bleaching	Moisture Drainage	Roots	Depth (m) / Field pH / EC dS/m	Samples (m)	Observations
	A1 0.00-0.17 Abrupt	Clay Loam	Moderate, firm<30mm sub-angular	Nil	10YR3/2 Very dark greyish brown Nil mottles/bleach	Moderate moist, rapid	Few fine	0.10 / 7.0	0.00-0.10 0.20-0.30 0.50-0.60 0.80-0.90 0.90-1.00	Nil
	B21 0.17-0.89 Abrupt	Medium clay	Moderate, firm<50mm sub-angular	5% calcium carbonate nodules	10YR3/1 Very dark grey Very dark grey Nil mottles/bleach	Dry, moderate	Very fine, very few	0.30 / 7.0 0.60 / 8.0		
	B22 0.89-1.00	Medium clay	Moderate, firm<50mm sub-angular	5% calcium carbonate nodules	10YR3/2 Very dark greyish brown Nil mottles/bleach	Dry, moderate	Very fine, very few	0.90 / 8.5

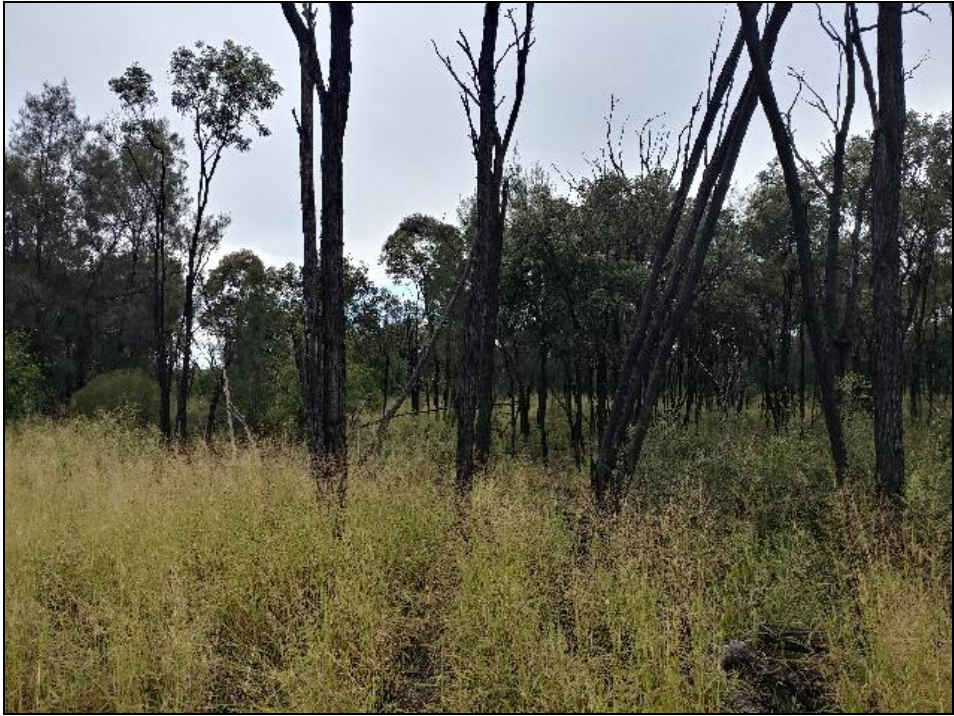
Item	Description
<b>Representative Site</b>	N17
<b>Representative Site photograph</b>

**Table 3-10: Map Unit 2**

<b>Location</b>	643797mE 7514822mN
<b>Current Use</b>	Grazing
<b>Site survey type</b>	Detailed, 50 mm hand auger.
<b>Vegetation</b>	Brigalow, Mount Coolibah
<b>Disturbance</b>	Nil disturbance
<b>Landform element /pattern</b>	Gently undulating plain, stream channel / depression
<b>Micro relief</b>	Nil microrelief
<b>Erosion</b>	Nil erosion
<b>Slope (%)</b>	<2% / <2%
<b>Drainage</b>	Well-moderate
<b>Surface coarse fragments</b>	No coarse fragments
<b>Surface condition</b>	Soft
<b>ASC Order (s)</b>	Black Sodosol
<b>Total area (ha)</b>	9.6 (Extends outside the project site > 10 ha)

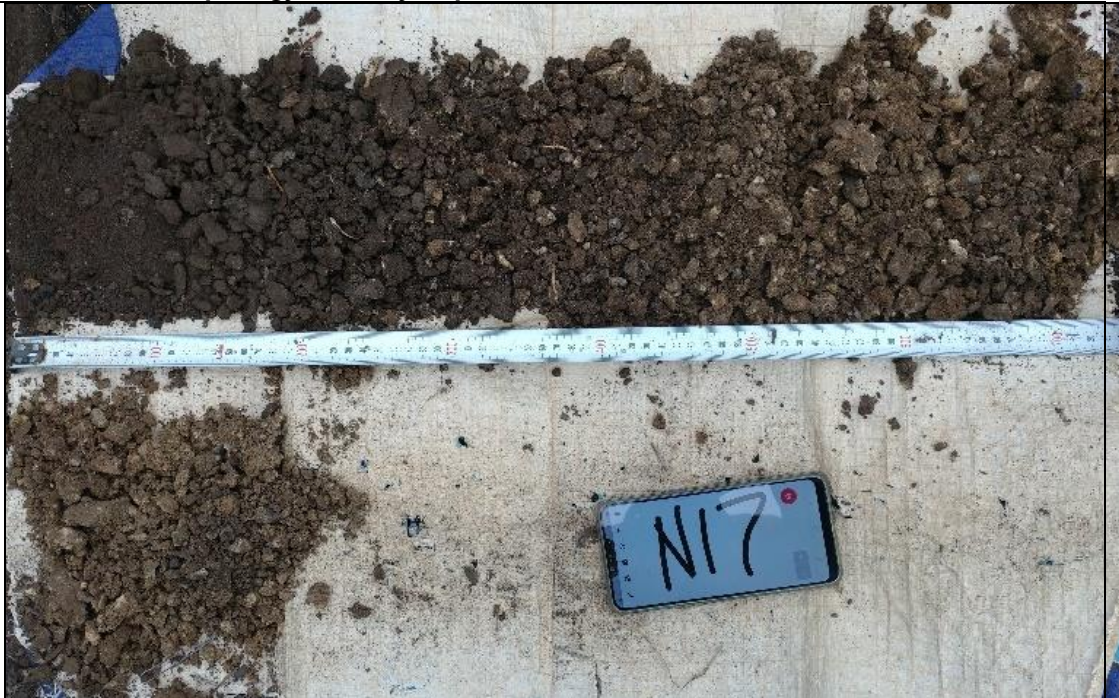
<div>Site N17</div>

**Table 3-11: Soil Profile Morphology Summary Map Unit 2**

Horizon Depth (m), Boundar -y (Bdy)	Field Texture	Structure Strength	Inclusions Segregatio -ns	Colour, Mottle, Bleaching	Moisture Drainage	Roots	Depth (m) / Field pH / EC dS/m	Samples (m)	Observati -ons
	A1 0.00-0.10 Abrupt	Loamy sand	Massive, loose	<1% coarse fragments	10YR3/1 Nil mottles / bleaching	Dry, well	Yes	0.10 / 8.5	0.00-0.10	Nil
	B21 0.10-0.20 Abrupt	Sandy loam	Moderate, very firm sub- angular <20mm	<1% coarse fragments	10YR3/1 Nil mottles / bleaching	Dry, well – moderate	Yes	0.20 / 8.5	0.10-0.20	
	B21 0.20-0.47 Abrupt	Sandy loam	Moderate, very firm sub- angular <10mm	<10% coarse fragments	10YR3/1 Nil mottles / bleaching	Dry, well – moderate	Yes	0.30 / 8.5	0.20-0.30	
B21 0.47-0.88 End of Borehole (EOBH)	Sandy loam	Moderate, very firm sub- angular <10mm	<20% coarse fragments	10YR4/2 Nil mottles / bleaching	Dry, well – moderate	Yes – 0.60m bgl	0.60 / 8.5	0.50-0.60 0.80-0.88

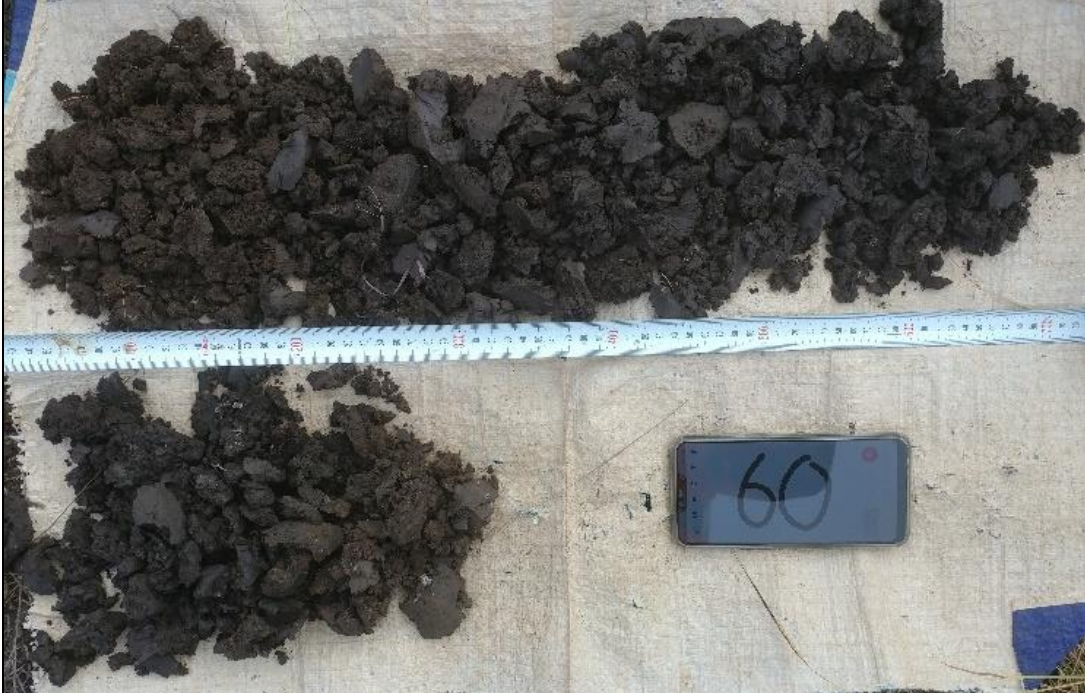
Site 60-SCL

**Table 3-18: Soil Profile Morphology Summary Map Unit 3**

Horizon Depth (m), Boundar -y (Bdy)	Field Texture	Structure Strength	Inclusions Segregatio- ns	Colour, Mottle, Bleaching	Moisture Drainage	Roots	Depth (m) / Field pH	Samples (m)
A1 0.0 – 0.13 Abrupt	Light clay	Moderate, Sub- rounded, peds <10 mm, soft	Nil	10YR3/2 Nil mottle / bleaching	Dry, well drained	Fine, very few	0.10 / 7.0	0.00-0.10 0.20-0.30 0.50-0.60 0.80-0.90 0.90-1.00	Nil
B21 0.13 – 0.41 Abrupt	Medium clay	Moderate, Subangular blocky, peds <20 mm, firm	Nil	10YR2/1 Nil mottle / bleaching	Dry, well drained	Very fine, very few	0.30 / 7.5		
B22 0.41 – 1.00	Medium clay	Moderate, Subangular blocky, peds <20 mm, firm	<2% calcium carbonate	10YR2/1 Nil mottle / bleaching	Dry, moderately well drained	Nil roots	0.60 / 7.0 0.90 / 7.0

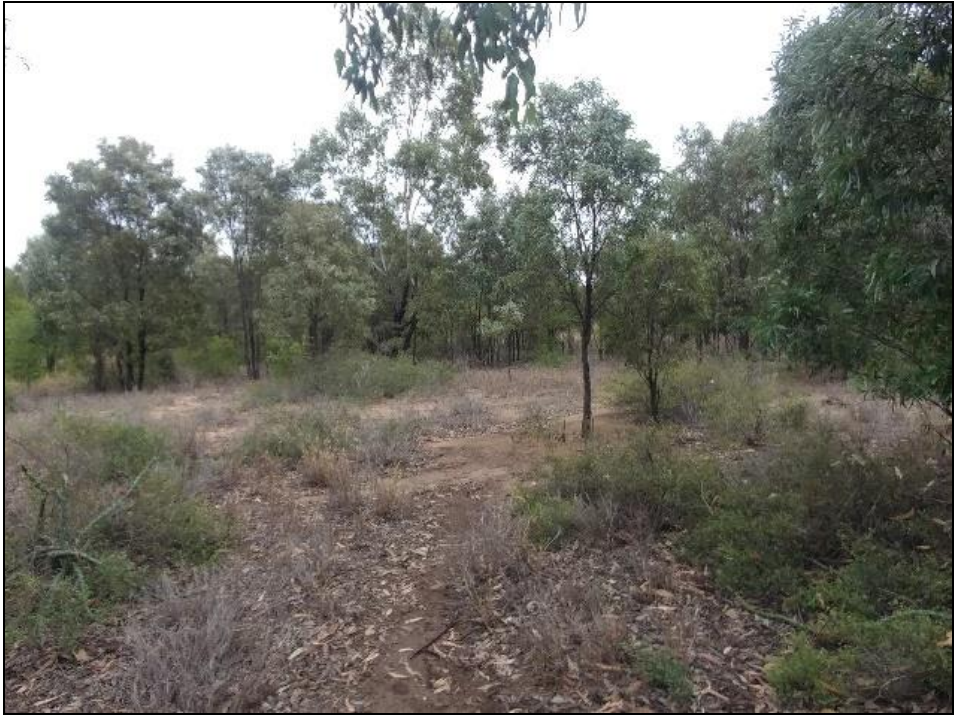
Item	Description
<b>Representative Site</b>	N20
<b>Representative Site photograph</b>

**Table 3-24: Map Unit 4**

<b>Location</b>	642943mE 7513907mN
<b>Current Use</b>	Grazing
<b>Site survey type</b>	Detailed, 50 mm hand auger.
<b>Vegetation</b>	Brigalow
<b>Disturbance</b>	Nil disturbance, clearing nearby outside the immediate drainage line area
<b>Landform element /pattern</b>	Very gently undulating plain, Alluvial depression, stream channel
<b>Micro relief</b>	Nil microrelief
<b>Erosion</b>	Nearby sheet and gully erosion
<b>Slope (%)</b>	1.0 / 0.0
<b>Drainage</b>	Well to well and moderate
<b>Surface coarse fragments</b>	<10% <5mm
<b>Surface condition</b>	Soft
<b>ASC Order (s)</b>	Black Dermosol
<b>Total area (ha)</b>	8.3 (Extends outside the project site > 10 ha)

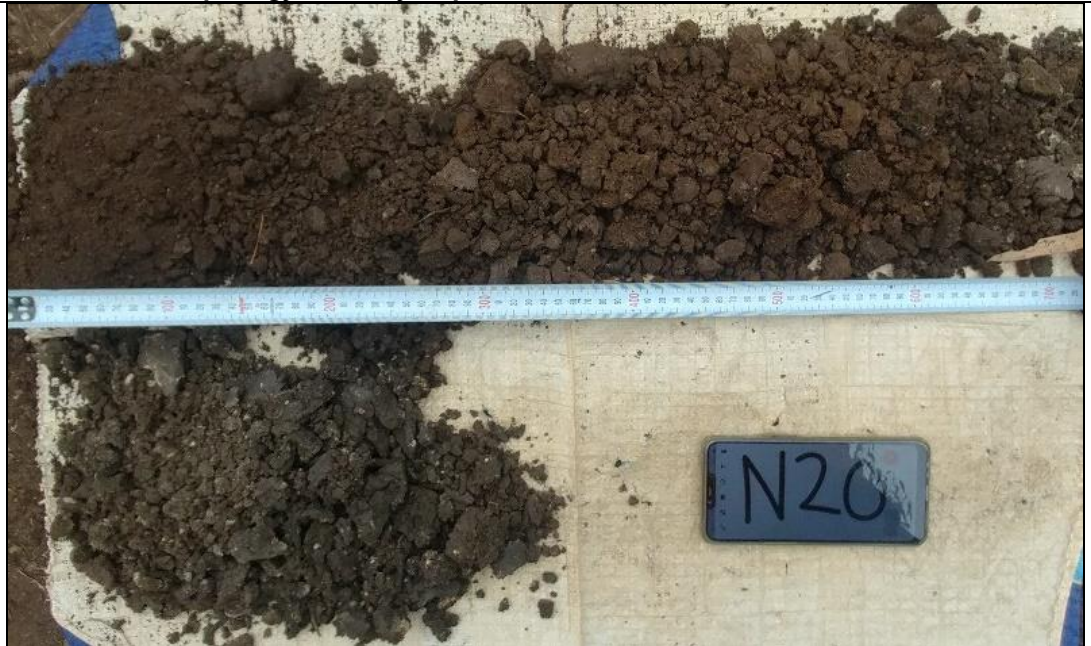
Site N20

**Table 3-25: Soil Profile Morphology Summary Map Unit 4**

Horizon Depth (m), Boundary (Bdy)	Field Texture	Structure Strength	Inclusions Segregations	Colour, Mottle, Bleaching	Moisture Drainage	Roots	Depth (m) / Field pH / EC dS/m	Samples (m)
A1 0.00-0.12 Abrupt	Sandy loam	Weak to moderate, soft sub-rounded <10mm	Nil	10YR3/1 Very dark grey Nil mottles / bleaching	Dry, well	Yes	0.10 / 8.5	0.00-0.10 0.20-0.30 0.50-0.60 0.80-0.90 0.9-1.00	Nil
B21 0.12-0.37 Abrupt	Sandy loam	Moderate, firm sub-rounded <10mm	Nil	10YR3/2 Very dark greyish brown Nil mottles / bleaching	Dry, well – moderate	Yes	0.20 / 8.5		
B22 0.37-0.68 Abrupt	Sandy loam	Moderate, firm sub-rounded <20mm	<2% calcium carbonate	7.5YR3/2 Dark brown Nil mottle / bleaching	Dry, well – moderate	Yes	0.30 / 8.5		
B23 0.68-0.85 Abrupt	Sandy clay loam	Moderate, very firm sub-rounded <20mm	<20% calcium carbonate	10YR3/2 Very dark greyish brown Nil mottles / bleaching	Dry, well – moderate	Yes	-

B24 0.85-1.00 EOBH	Sandy clay loam	Moderate, very firm sub-rounded <20mm	<5% calcium carbonate	10YR3/2 Very dark greyish brown Nil mottles / bleaching	Dry, well – moderate	Nil	0.90 / 8.5

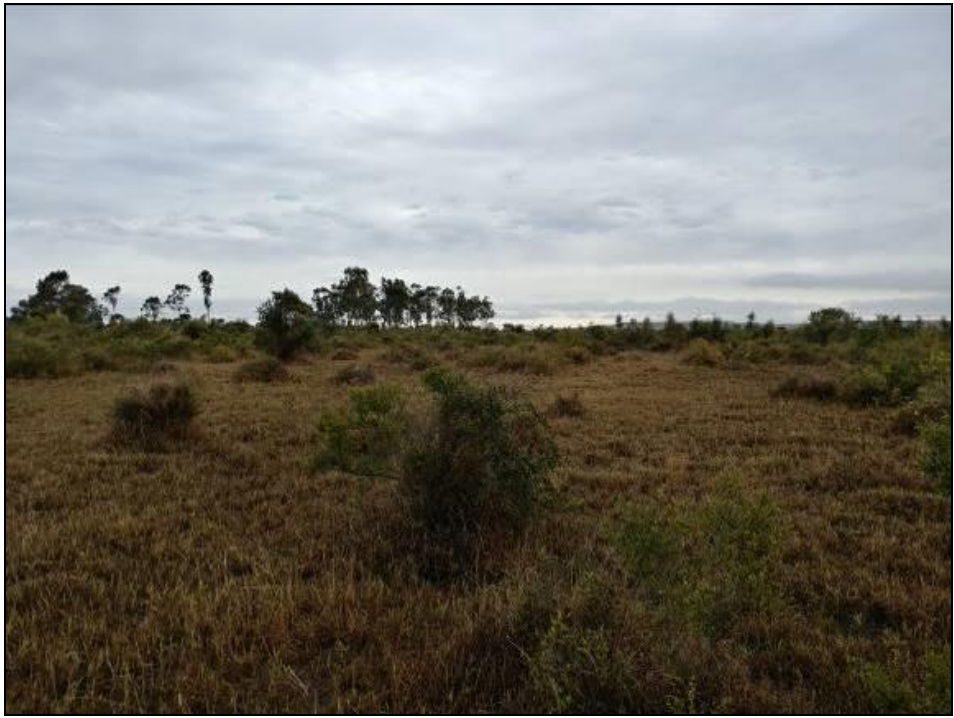
Item	Description
<b>Representative Site</b>	N5
<b>Representative Site photograph</b>

**Table 3-31: Map Unit 5**

<b>Location</b>	641792mE 7513825mN
<b>Current Use</b>	Grazing
<b>Site survey type</b>	Detailed, 50 mm hand auger.
<b>Vegetation</b>	Eucalyptus species
<b>Disturbance</b>	Semi-disturbed
<b>Landform element /pattern</b>	Very gently undulating plain mid-slope
<b>Micro relief</b>	Nil microrelief
<b>Erosion</b>	Nil erosion
<b>Slope (%)</b>	3.0/3.0
<b>Drainage</b>	Moderate
<b>Surface coarse fragments</b>	Nil
<b>Surface condition</b>	Soft
<b>ASC Order (s)</b>	Black dermosol (with minor grey dermosol variant, site N4)
<b>Total area (ha)</b>	18.3

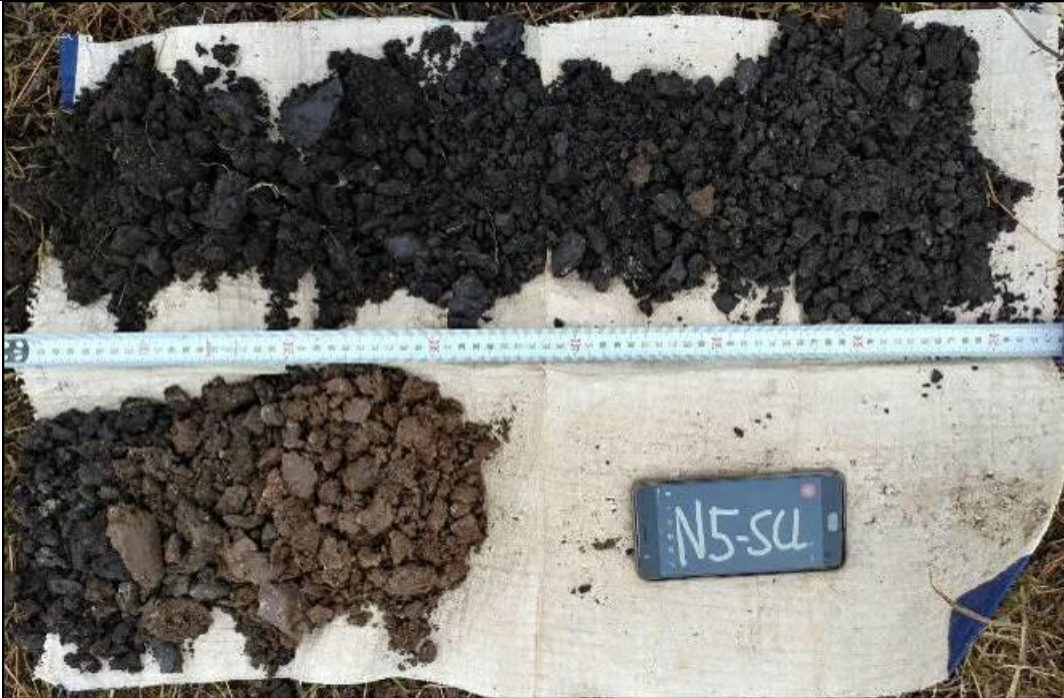
<p><b>Site N5</b> (Previously N5-SCL as per photo)</p>

**Table 3-32: Soil Profile Morphology Summary Map Unit 5**

Horizon Depth (m), Boundary (Bdy)	Field Texture	Structure Strength	Inclusions Segregations	Colour, Mottle, Bleaching	Moisture Drainage	Roots	Depth (m) / Field pH / EC dS/m	Samples (m)	Observations
A1 0.00-0.12 Abrupt	Sandy loam	Weak, soft <10mm sub-rounded	Nil	10YR3/1 Very dark grey Nil mottles/bleach	Moderate moist, rapid	Few fine	0.10 / 6.5	0.00-0.10 0.20-0.30 0.50-0.60 0.80-0.90 0.90-1.00	Nil
B21 0.12-0.45 Abrupt	Light clay with minor sand	Moderate, firm <30mm sub-angular	Nil	10YR2/1 Black Nil mottles/bleach	Moderately moist, moderate	Very fine, very few	0.30 / 7.5		
B22 0.45-0.80 Abrupt	Medium clay	Moderate, firm <30mm sub-angular	2% calcium carbonate nodules	10YR2/1 Black Nil mottles/bleach	Dry, moderate	Very fine, very few	0.60 / 8.0		
B23 0.80-1.00 EOBH	Medium clay	Moderate, strong <30mm sub-angular	2% calcium carbonate nodules	10YR3/3 Dark brown Nil mottles/bleach	Dry, moderate	Very fine, very few	0.90 / 8.0

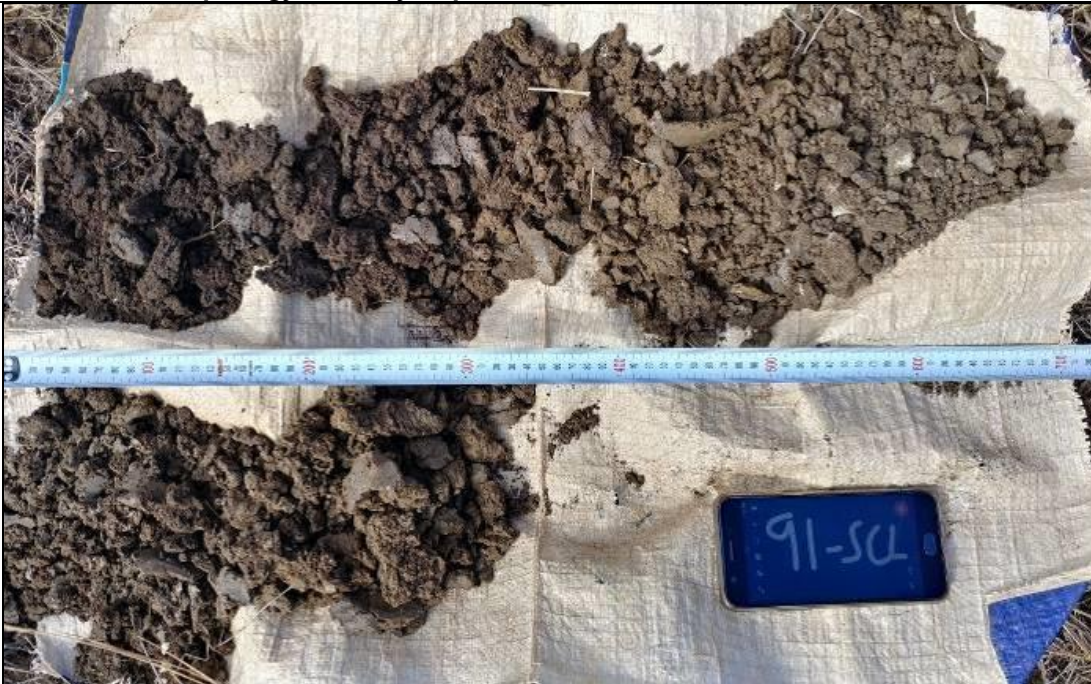
Site 91-SCL

**Table 3-39: Soil Profile Morphology Summary Map Unit 6**

Horizon Depth (m), Boundary (Bdy)	Field Texture	Structure Strength	Inclusions Segregations	Colour, Mottle, Bleaching	Moisture Drainage	Roots	Depth (m) / Field pH / EC dS/m	Samples (m)	Observations
	A1 0.00-0.12 Abrupt	Sandy Clay	Moderate, weak <20mm sub- angular	Nil	10YR2/1 Black Nil mottles/bleach	Dry, moderate	Few, fine	0.10 / 6.0	0.00-0.10 0.20-0.30 0.50-0.60 0.80-0.90 0.9-1.00	Nil
	B21 0.12-0.50 Clear	Light sandy clay	Moderate, firm 20- 50mm sub- angular	Nil	10YR2/2 Very dark brown Nil mottles/bleach	Dry, moderate	Few, fine	0.30 / 6.5		
B22 0.50-1.00 EOBH	Light clay	Moderate, firm 20- 50mm sub- angular blocky	<2% calcium carbonate nodules	10YR3/3 Dark brown Mottles <2% 10YR5/3 Brown Nil bleach	Dry, moderate	Very few, very fine	0.60 / 7.0 0.60 / 7.5

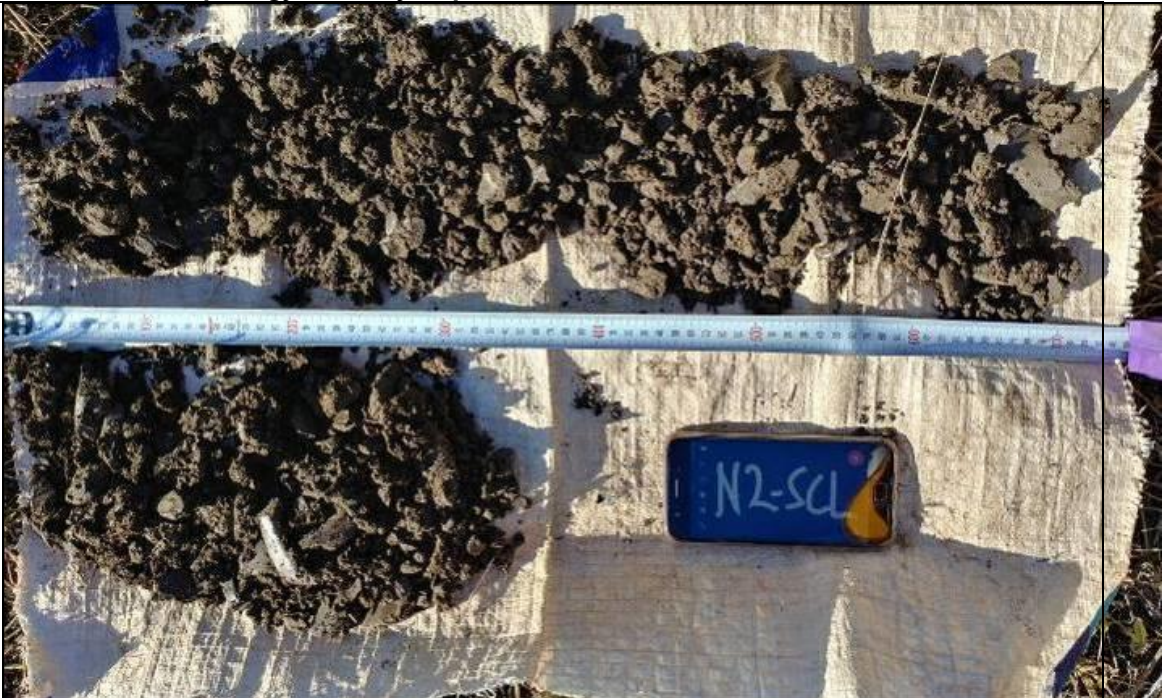
Site N2 (Previously N2-SCL as per photo)

**Table 3-47: Soil Profile Morphology Summary Map Unit 7**

Horizon Depth (m), Boundary (Bdy)	Field Texture	Structure Strength	Inclusions Segregations	Colour, Mottle, Bleaching	Moisture Drainage	Roots	Depth (m) / Field pH / EC dS/m	Samples (m)	Observations
A1 0.00-0.14 Abrupt	Light clay	Moderate, soft <10mm sub-angular	Nil	10YR3/1 Very dark grey Nil mottles/bleach	Moderate moist, moderate	Few fine	0.10 / 6.0	0.00-0.10 0.20-0.30 0.50-0.60 0.80-0.90 0.09-1.00	Nil	
B2 0.14-1.00 EOBH	Medium clay	Moderate, firm <10mm sub-angular	<2% black nodules	10YR4/2 Dark greyish brown Nil mottles/bleach	Dry, moderate	Very fine, very few	0.30 / 6.5 0.60 / 7.0 0.90 / 7.5

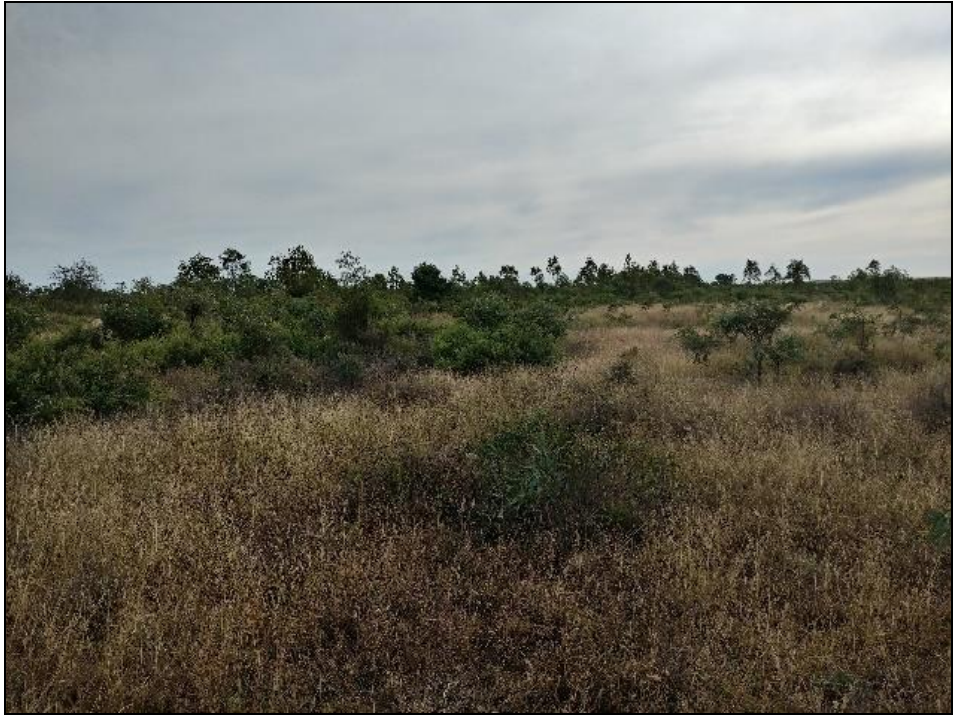
Item	Description
<b>Representative Site</b>	N13
<b>Representative Site photograph</b>

**Table 3-53: Map Unit 8**

<b>Location</b>	640940mE 7512735mN
<b>Current Use</b>	Grazing
<b>Site survey type</b>	Detailed - 50mm hand auger
<b>Vegetation</b>	Grasses
<b>Disturbance</b>	Extensive disturbance
<b>Landform element / pattern</b>	Gently undulating plains, mid-slope
<b>Micro relief</b>	Nil microrelief
<b>Erosion</b>	Nil erosion
<b>Slope (%)</b>	<2.0/<2.0
<b>Drainage</b>	Moderate – well
<b>Surface coarse fragments</b>	Nil
<b>Surface condition</b>	Firm
<b>ASC Order (s)</b>	Black Dermosol
<b>Total area (ha)</b>	3.3 (Extends outside the project site > 10 ha)

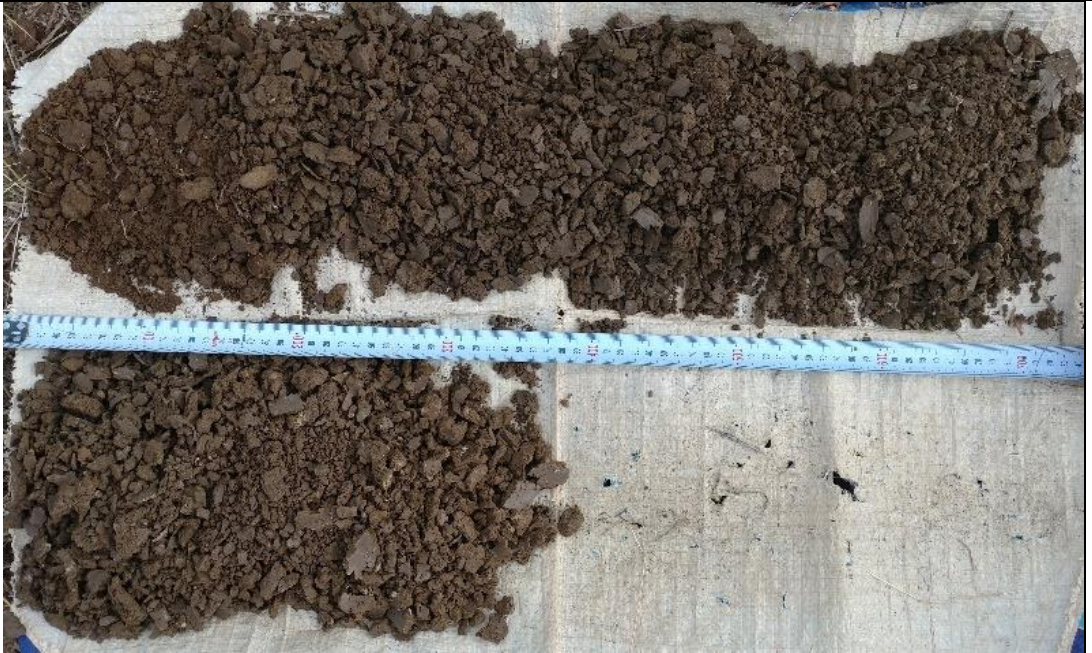
**Table 3-54: Soil Profile Morphology Summary Map Unit 8**

<b>Site N13</b>									
Horizon Depth (m), Boundary (Bdy)	Field Texture	Structure Strength	Inclusions Segregations	Colour, Mottle, Bleaching	Moisture Drainage	Roots	Depth (m) / Field pH / EC dS/m	Samples (m)	Observations
A1 0.00-0.15 Abrupt	Sandy clay loam	Weak to moderate. Soft, sub rounded <10mm	Nil	10YR3/2 Nil mottles/bleaching	Dry, well	Present	0.10 / 7.0	0.00-0.10 0.20-0.30 0.50-0.60 0.80-0.90 0.9-1.00	Nil
B21 0.15-0.75 gradual	Light clay	Weak to moderate. Firm, sub rounded <20mm	Nil	10YR3/2 Nil mottles/bleaching	Dry, moderate – well	Present	0.30 / 7.5 0.60 / 7.5		
B22 0.75-1.00 EOBH	Light clay	Weak to moderate. Firm, sub rounded <20mm	Nil	10YR3/2 Nil mottles/bleaching	Dry, moderate – well	Present	0.90 / 7.5

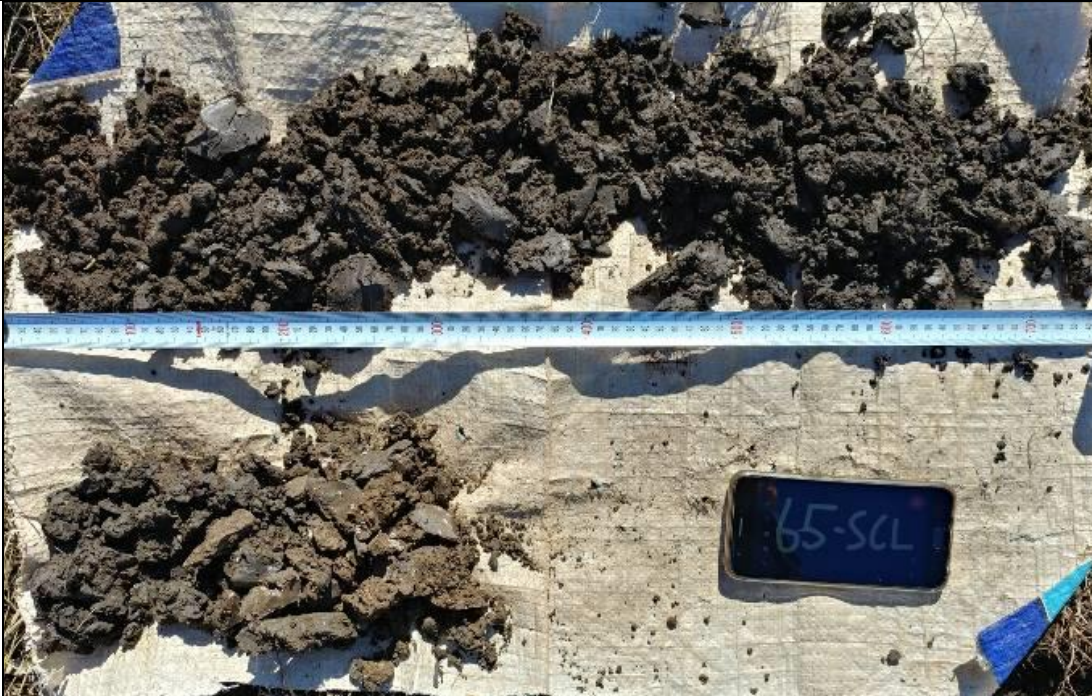
<div>Site 65-SCL</div>

**Table 3-61: Soil Profile Morphology Summary Map Unit 9**

Horizon Depth (m), Boundar -y (Bdy)	Field Texture	Structure Strength	Inclusions Segregatio- ns	Colour, Mottle, Bleaching	Moisture Drainage	Roots	Depth (m) / Field pH / EC dS/m	Samples (m)	Observati -ons
	A1 0.00-0.11 Abrupt	Light clay	Moderate, weak <10mm sub- angular	Nil	10YR3/1 Very dark grey Nil mottles/ bleach	Dry, moderate	Few fine	0.10 / 6.0	0.00-0.10 0.20-0.30 0.50-0.60 0.80-0.90 0.90-1.00	Nil
	B21 0.11-0.80 Abrupt	Medium clay	Moderate, weak <10mm sub- angular	Nil	10YR2/2 Very dark brown Nil mottles/ bleach	Dry, moderate	Very fine, very few	0.30 / 6.5 0.60 / 7.0		
B22 0.80-1.00 EOBH	Medium clay	Moderate, weak <10mm sub- angular	2% calcium carbonate nodules	10YR3/3 Dark brown Nil mottles/ bleach	Dry, moderate	Very fine, very few	0.90 / 7.5

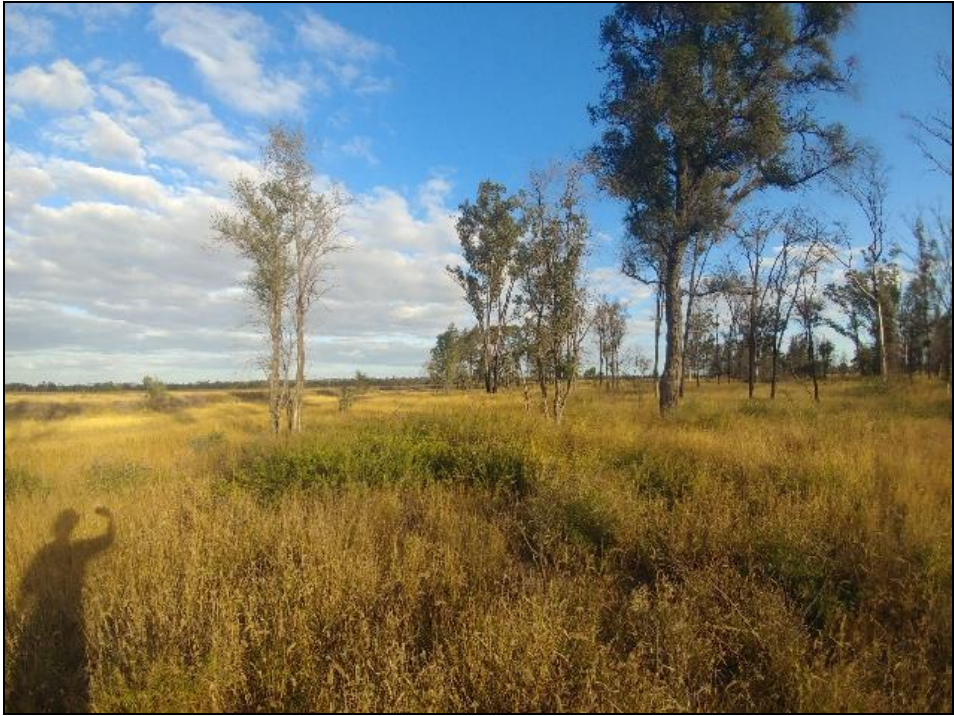
Item	Description
<b>Representative Site</b>	N43
<b>Representative Site photograph</b>

**Table 3-71: Map Unit 10**

<b>Location</b>	643716mE 7513193mN
<b>Current Use</b>	Grazing
<b>Site survey type</b>	Detailed - 50mm hand auger
<b>Vegetation</b>	Eucalyptus species
<b>Disturbance</b>	Semi disturbed,
<b>Landform element /pattern</b>	Gently Undulating Plains, Upper slope
<b>Micro relief</b>	Nil microrelief
<b>Erosion</b>	Nil erosion
<b>Slope (%)</b>	<2 / <2
<b>Drainage</b>	Well to well-moderate
<b>Surface coarse fragments</b>	Nil coarse fragments
<b>Surface condition</b>	Firm
<b>ASC Order (s)</b>	Black Sodosol
<b>Total area (ha)</b>	32.9

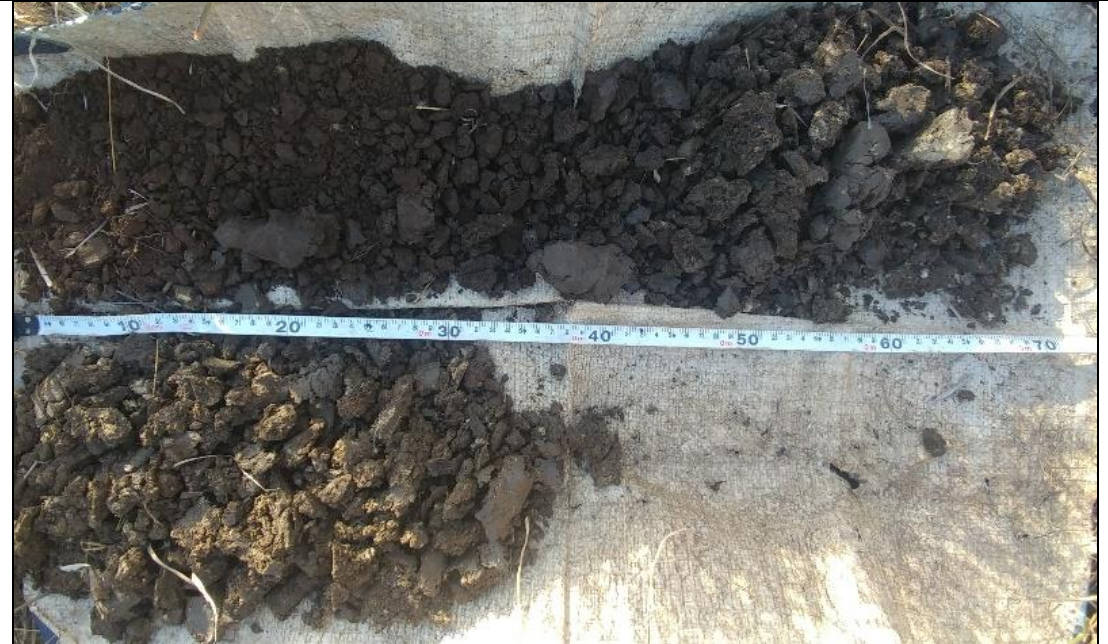
Site N43

**Table 3-72: Soil Profile Morphology Summary Map Unit 10**

Horizon Depth (m), Boundary (Bdy)	Field Texture	Structure Strength	Inclusions Segregations	Colour, Mottle, Bleaching	Moisture Drainage	Roots	Depth (m) / Field pH / EC dS/m	Samples (m)	Observations
	A11 0.0 – 0.06 Abrupt	Sandy clay loam	Massive	Nil	10YR3/2 Nil mottles / bleaching	Dry, well drained	Present	0.10 / 7.5	0.00-0.10	Nil
	A12 0.06 – 0.20 Gradual	Sandy clay loam	Weak, sub-rounded peds <10 mm	Nil	10YR3/2 Nil mottles / bleaching	Dry, well drained	Present	0.20 / 7.5	0.20-0.30	
	B21 0.20 – 0.46 Gradual	Sandy clay loam	Subangular blocky, moderate, peds <20 mm, firm	Nil	10YR3/2 Nil mottles / bleaching	Dry, well drained	Present	0.30 / 7.5	0.50-0.60	
	B22 0.46 – 1.00 EOBH	Medium clay, sandy	Subangular blocky, moderate, peds <20 mm, firm	<20% calcium carbonate	10YR3/3 Nil mottles / bleaching	Dry, well – moderate drained	Present	0.60 / 7.5 0.90 / 7.5	0.80-0.90 0.9-1.00

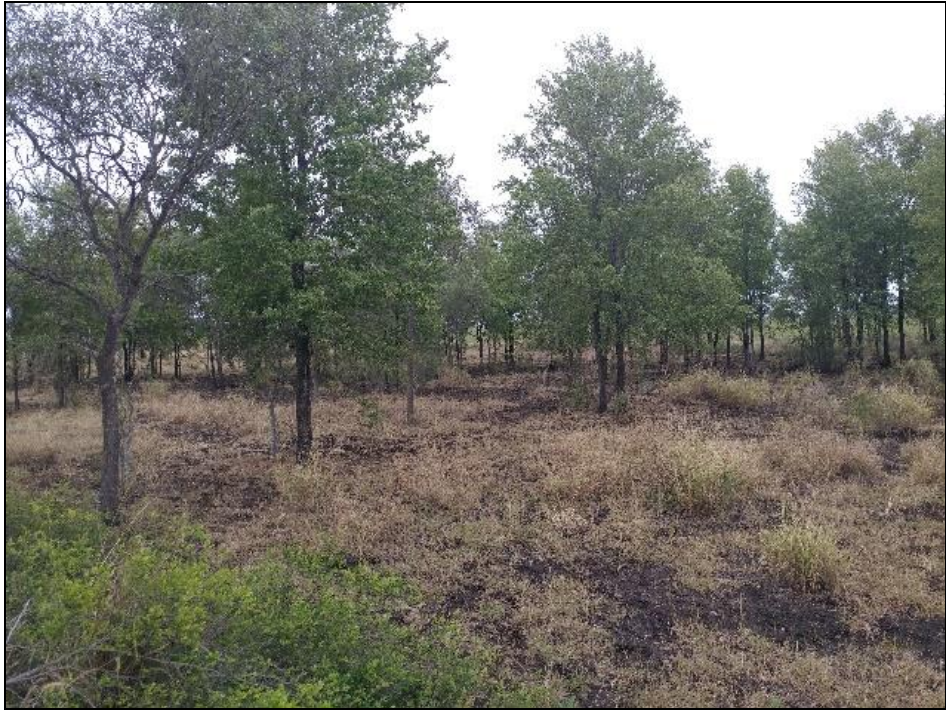
Item	Description
<b>Representative Site</b>	N23
<b>Representative Site photograph</b>

**Table 3-78: Map Unit 11**

<b>Location</b>	642838mE 7513991mN
<b>Current Use</b>	Grazing
<b>Site survey type</b>	Detailed - 50mm hand auger
<b>Vegetation</b>	Mixed vegetation
<b>Disturbance</b>	Cropping nearby disturbance
<b>Landform element / pattern</b>	Depression
<b>Micro relief</b>	Nil microrelief
<b>Erosion</b>	Minor sheet erosion
<b>Slope (%)</b>	<1% / <1%
<b>Drainage</b>	Well to well-moderate
<b>Surface coarse fragments</b>	Soft, <10% cf <5mm
<b>Surface condition</b>	Firm, crust with minor self mulching
<b>ASC Order (s)</b>	Grey Dermosol
<b>Total area (ha)</b>	6

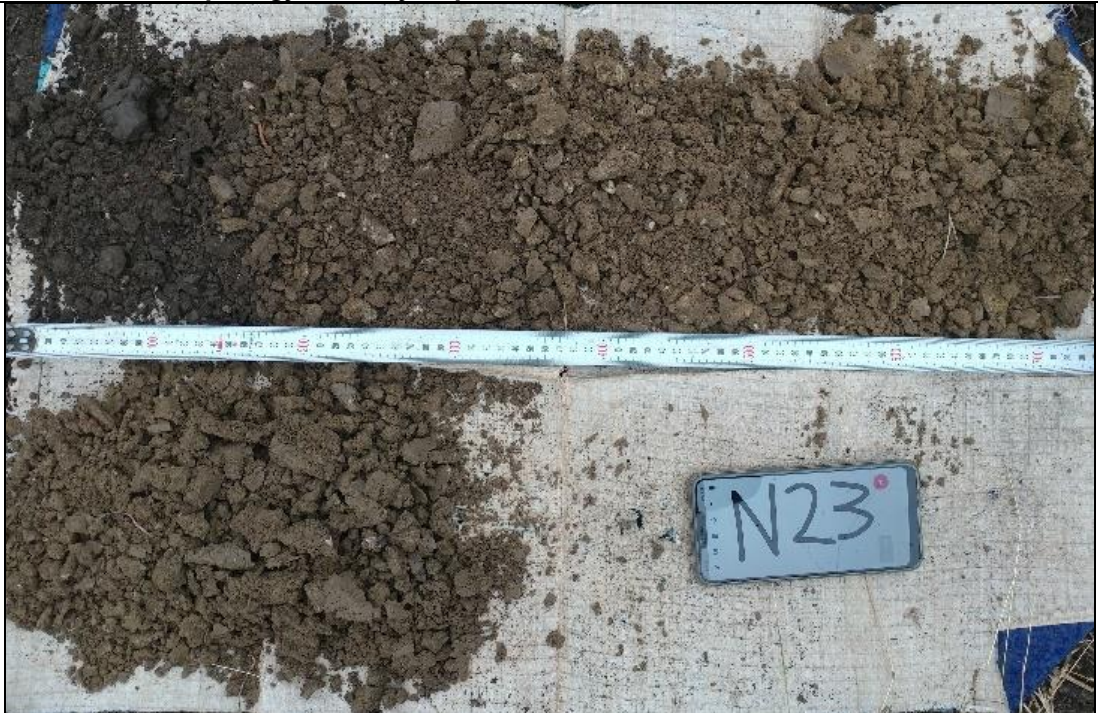
Site N23

**Table 3-79: Soil Profile Morphology Summary Map Unit 11**

Horizon Depth (m), Boundary (Bdy)	Field Texture	Structure Strength	Inclusions Segregations	Colour, Mottle, Bleaching	Moisture Drainage	Roots	Depth (m) / Field pH / EC dS/m	Samples (m)	Observations
A1 0.00-0.12 Abrupt	Clay loam	Weak, soft sub-rounded <10mm	Nil	10YR3/1 Very dark grey Nil mottles / bleaching	Dry, well	Present	0.10 / 8.5	0.00-0.10 0.20-0.30 0.50-0.60 0.80-0.90 0.90-1.00	Nil
B21 0.12-0.48 Abrupt	Light clay	Weak to moderate, firm sub-rounded <10mm	<5% weathered rock	10YR4/2 Dark greyish brown Nil mottles / bleaching	Dry, well – moderate	Present	0.30 / 8.5		
B22 0.48-1.00 EOBH	Light clay	Moderate, very firm sub-rounded <20mm	<5% calcium carbonate	10YR4/2 Dark greyish brown Nil mottles / bleaching	Dry, well – moderate	Present	0.60 / 8.5 0.90 / 8.5

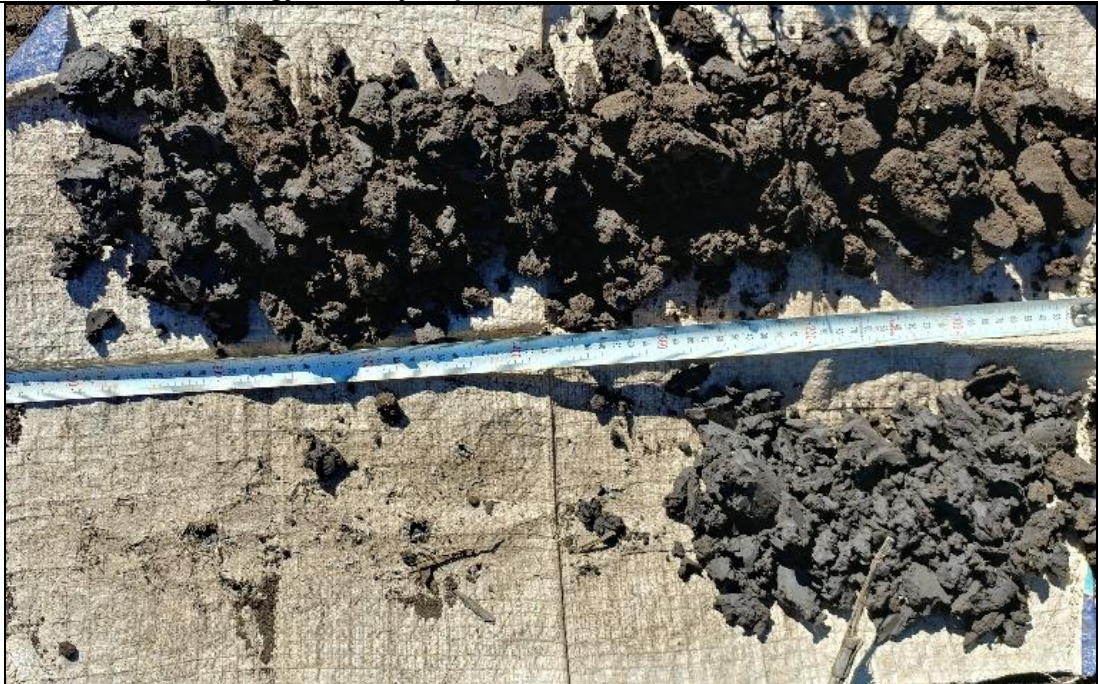
Site N35

**Table 3-86: Soil Profile Morphology Summary Map Unit 12**

Horizon Depth (m), Boundar-y (Bdy)	Field Texture	Structure Strength	Inclusions Segregati-ons	Colour, Mottle, Bleaching	Moisture Drainage	Roots	Depth (m) / Field pH / EC dS/m	Samples (m)	Observati-ons
A11 0.0 – 0.04 Abrupt	Light medium clay	Moderate, firm, sub-rounded peds 20-50 mm	Nil	10YR3/2 Nil mottles / bleaching	Dry, well drained	Present	0.10 / 8.0	0.00-0.10 0.20-0.30 0.50-0.60 0.80-0.90 0.90-1.00	Nil
A12 0.04 – 0.20 Abrupt	Medium clay	Moderate, firm, sub-rounded peds 50-80 mm	Nil	10YR3/2 Nil mottles / bleaching	Dry, well-moderate drained	Present	0.30 / 8.0		
B21 0.20 – 0.45 Abrupt	Medium heavy clay	Moderate, - strong firm, sub-rounded peds 50-80 mm	Nil	10YR2/1 Nil mottles / bleaching	Dry, well-moderate drained	Present	0.60 / 8.0		
B22 0.45 – 1.00 EOBH	Medium heavy clay	Moderate, - strong firm, sub-rounded peds 50-80 mm	Nil	10YR2/1 Nil mottles / bleaching	Dry, well-moderate drained	Nil	0.90 / 8.0

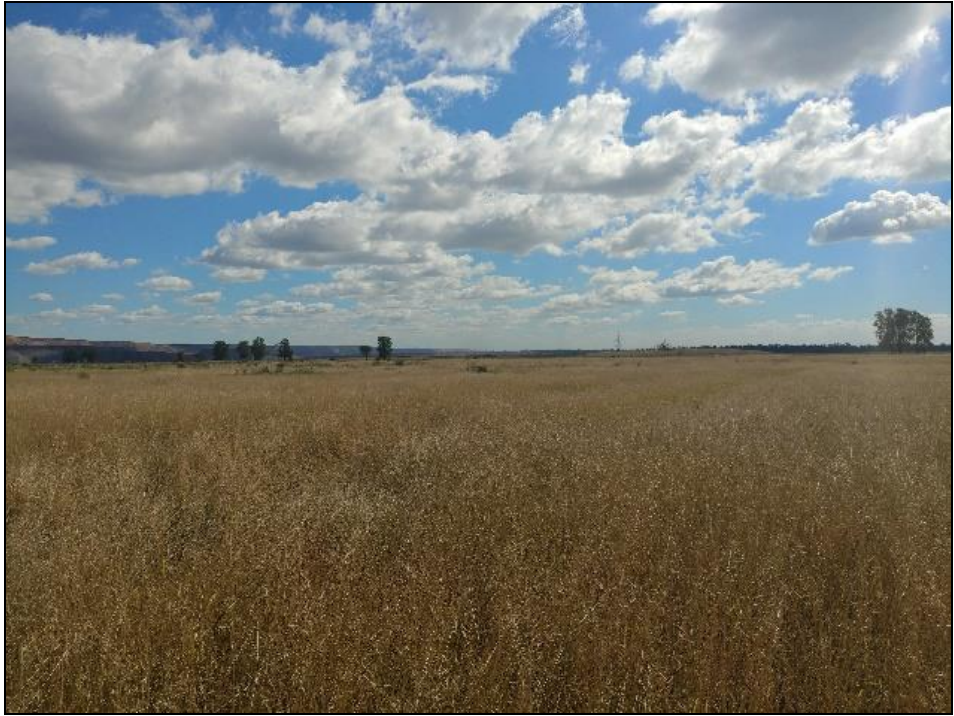
Item	Description
<b>Representative Site</b>	6-SCL
<b>Representative Site photograph</b>

**Table 3-92: Map Unit 13**

<b>Location</b>	641287mE 7510129mN
<b>Current Use</b>	Grazing
<b>Site survey type</b>	Detailed - 50mm hand auger
<b>Vegetation</b>	Grasses
<b>Disturbance</b>	Extensively disturbance
<b>Landform element / pattern</b>	Gently undulating plains, mid-slope
<b>Micro relief</b>	Nil microrelief
<b>Erosion</b>	Nil erosion
<b>Slope (%)</b>	2.0/2.0
<b>Drainage</b>	Well – moderate
<b>Surface coarse fragments</b>	Coarse fragments' <5mm <5%
<b>Surface condition</b>	Humid self-mulching with crust 2-6 mm thick, fine sand on surface.
<b>ASC Order (s)</b>	Black Vertosol
<b>Total area (ha)</b>	109

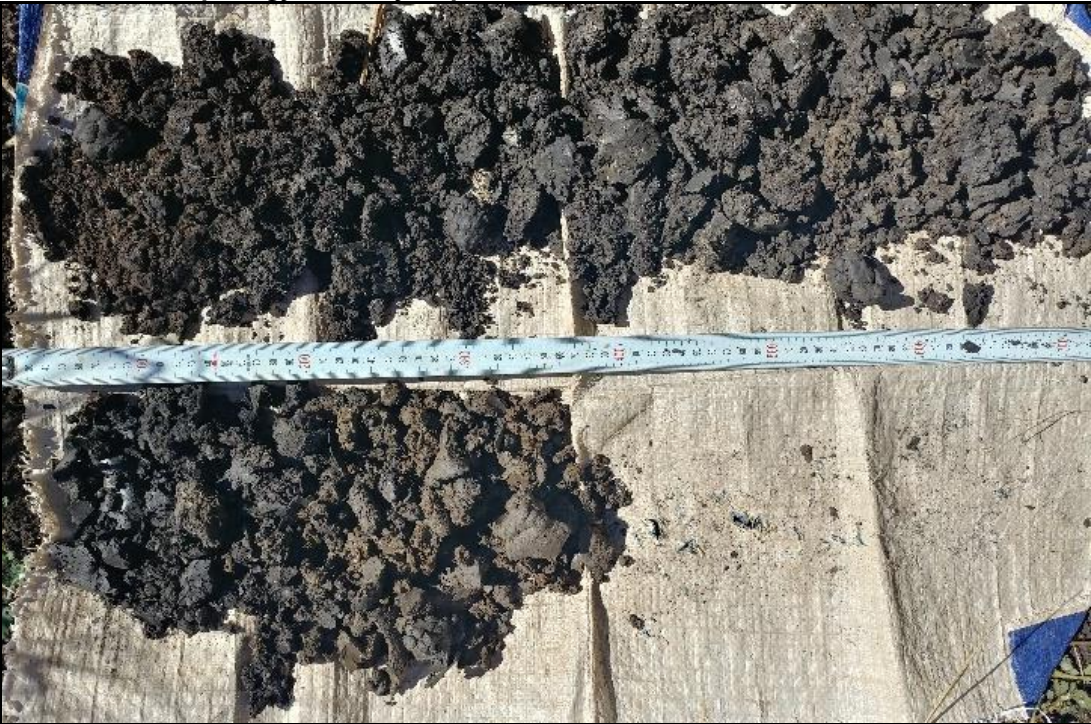
<div>Site 6-SCL</div>

**Table 3-93: Soil Profile Morphology Summary Map Unit 13**

Horizon Depth (m), Boundar-y (Bdy)	Field Texture	Structure Strength	Inclusions Segregatio-ns	Colour, Mottle, Bleaching	Moisture Drainage	Roots	Depth (m) / Field pH / EC dS/m	Samples (m)	Observati- ons
	A1 0.00 – 0.15 Abrupt	Light clay, sandy	Weak, firm Subangular blocky, peds 10-30 mm,	Nil	10YR2/1 Black Nil mottles / bleaching	Humid, Well – moderate drained	Fine, very few	0.10 / 6.5	0.00-0.10 0.20-0.30 0.50-0.60 0.80-0.90 0.90-1.00	Nil
	B21 0.15 – 0.30 Abrupt	Medium heavy clay	Weak, firm Subangular blocky, peds 20-30 mm,	Nil	10YR2/1 Black Nil mottles / bleaching	Humid, Well – moderate drained	Fine, very few	0.35 / 7.0		
	B22 0.30 – 0.80 Abrupt	Medium heavy clay	Weak to moderate, very firm Subangular blocky, peds 20-30 mm,	<5% calcium carbonate	10YR2/1 Black Nil mottles / bleaching	Humid, Well – moderate drained	Fine, very few	0.60 / 7.0		
B23 0.80 – 1.00 EOBH	Medium heavy clay, sandy	Weak to moderate, very firm Subangular blocky, peds 40-60 mm,	Nil	10YR4/2 Dark greyish brown Nil mottles / bleaching	Humid, Well – moderate drained	Nil roots	0.90 / 7.5

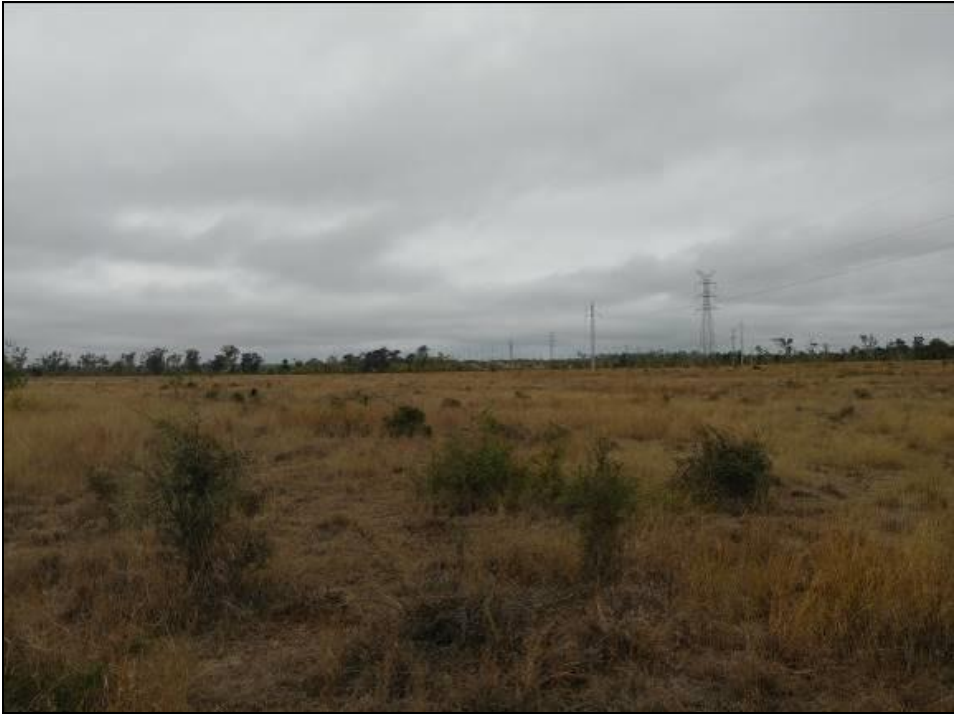
Item	Description
<b>Representative Site</b>	10-SCL
<b>Representative Site photograph</b>

**Table 3-99: Map Unit 14**

<b>Location</b>	642525mE 7510097mN
<b>Current Use</b>	Grazing
<b>Site survey type</b>	Detailed, 50 mm hand auger.
<b>Vegetation</b>	Buffel Grass
<b>Disturbance</b>	Extensive disturbance
<b>Landform element /pattern</b>	Very gently undulating plain, Mid-slope
<b>Micro relief</b>	Nil microrelief
<b>Erosion</b>	Nil erosion
<b>Slope (%)</b>	2.0/1.0
<b>Drainage</b>	Moderate
<b>Surface coarse fragments</b>	Nil coarse fragments
<b>Surface condition</b>	Soft
<b>ASC Order (s)</b>	Red Chromosol
<b>Total area (ha)</b>	27

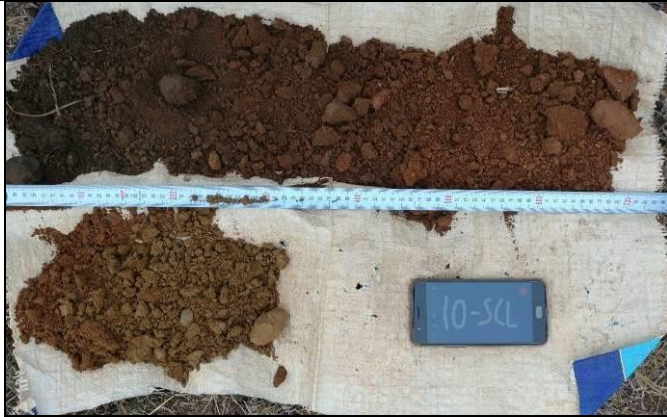
<b>Site 10-SCL</b>

**Table 3-100: Soil Profile Morphology Summary Map Unit 14**

Horizon Depth (m), Boundary (Bdy)	Field Texture	Structure Strength	Inclusions Segregations	Colour, Mottle, Bleaching	Moisture Drainage	Roots	Depth (m) / Field pH / EC dS/m	Samples (m)	Observations
A1 0.00-0.13 Abrupt	Sandy clay	Moderate, firm, <10mm sub-angular	<1% calcium carbonate nodules	10YR3/2 Very dark greyish brown Nil mottles/bleach	Dry, moderate	Few, fine	0.10 / 7.0	0.00-0.10 0.20-0.30 0.50-0.60 0.80-0.90 0.90-1.00	First borehole, 0.20 mbgl Second borehole 0.40 mbgl Refusal likely due to roots, no physical barrier
A2 0.13-0.39 Abrupt	Light sandy clay	Moderate, firm, <10mm sub-angular	Nil	10YR3/3 Dark Brown Nil mottles/bleach	Dry, moderate	Few, fine	0.30 / 7.0		
B21 0.39-0.84 Abrupt	Light sandy clay	Moderate, firm, <10mm sub-angular	<10% calcium carbonate nodules	5YR4/4 Reddish brown Nil mottles/bleach	Dry, moderate	Few, fine	0.60 / 7.5		
B22 0.84-1.00 EOBH	Light clay	Moderate, firm, <10mm sub-angular	<2% calcium carbonate nodules	10YR4/4 Dark yellowish brown Nil mottles/bleach	Dry, moderate	Very few, very fine	0.90 / 8.5

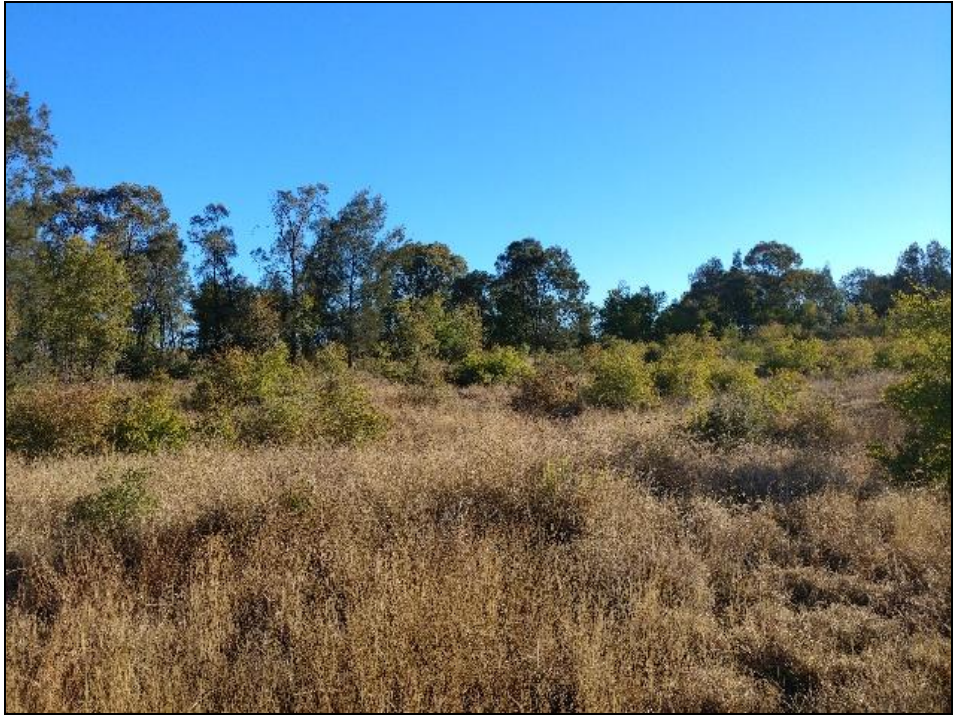
Item	Description
<b>Representative Site</b>	N38
<b>Representative Site photograph</b>

<b>Location</b>	645726mE 7510395mN
<b>Current Use</b>	Grazing
<b>Site survey type</b>	Detailed - 50mm hand auger
<b>Vegetation</b>	Mixed vegetation, eucalyptus species,
<b>Disturbance</b>	Semi disturbed
<b>Landform element / pattern</b>	GUP Lower slope to depression
<b>Micro relief</b>	Nil microrelief
<b>Erosion</b>	Nil erosion
<b>Slope (%)</b>	1% / 2%
<b>Drainage</b>	Well to well-moderate drained
<b>Surface coarse fragments</b>	<2% coarse fragments <5mm
<b>Surface condition</b>	Crust
<b>ASC Order (s)</b>	Black Vertosol
<b>Total area (ha)</b>	107.7
