# Restoration Plan to Support RIDA Application Saraji East Project

Final V4  
15 July 2021

GT Environmental Pty Ltd  
[www.gtenvironmental.com.au](http://www.gtenvironmental.com.au)

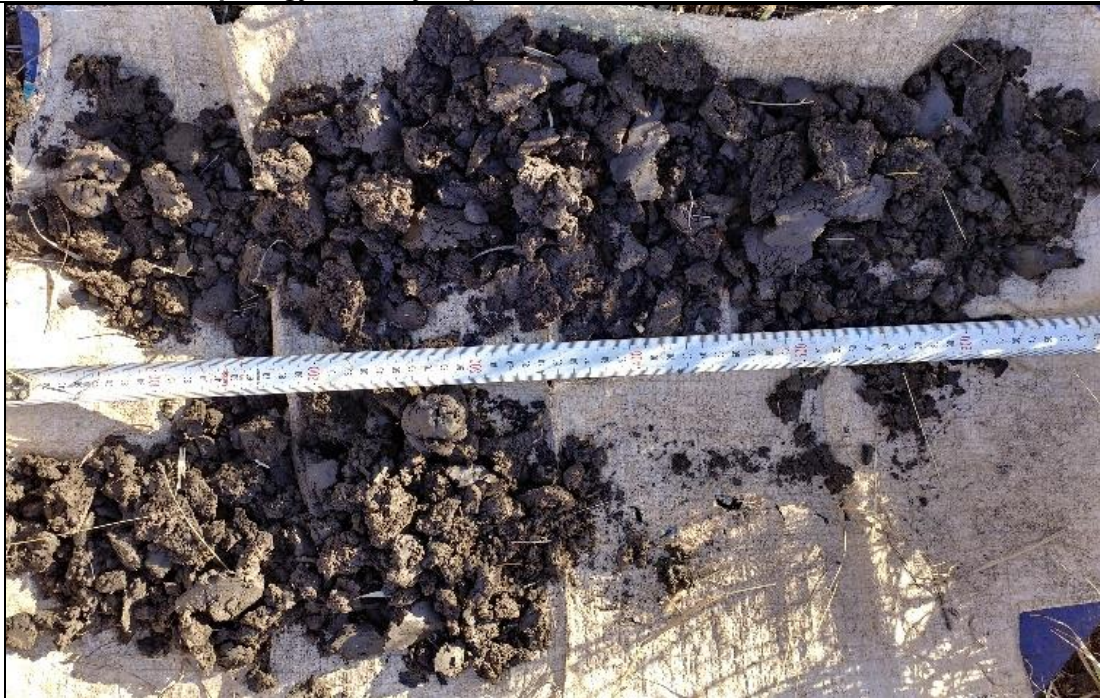
Site N38

Horizon Depth (m), Boundary (Bdy)	Field Texture	Structure Strength	Inclusions Segregations	Colour, Mottle, Bleaching	Moisture Drainage	Roots	Depth (m) / Field pH / EC dS/m	Samples (m)	Observations
	A11 0.0 – 0.12 Abrupt	Light clay	Moderate, firm, sub-angular <20 mm	Nil	10YR3/2 Nil mottles / bleaching	Dry, well drained	Present	0.10 / 7.0	0.00-0.10 0.20-0.30 0.50-0.60 0.80-0.90 0.9-1.00	Nil
	B21 0.12 – 0.90 Abrupt	Medium clay	Moderate-strong, strong, sub-angular <20 mm	Nil	10YR3/2 Nil mottles / bleaching	Dry, well-moderate drained	Present	0.30 / 7.5 0.60 / 7.5		
B22 0.90 – 1.00 EOBH	Medium clay	Moderate-strong, strong, sub-angular <20 mm	<2% calcium carbonate	10YR3/2 Nil mottles / bleaching	Dry, well-moderate drained	Present	0.90 / 8.0

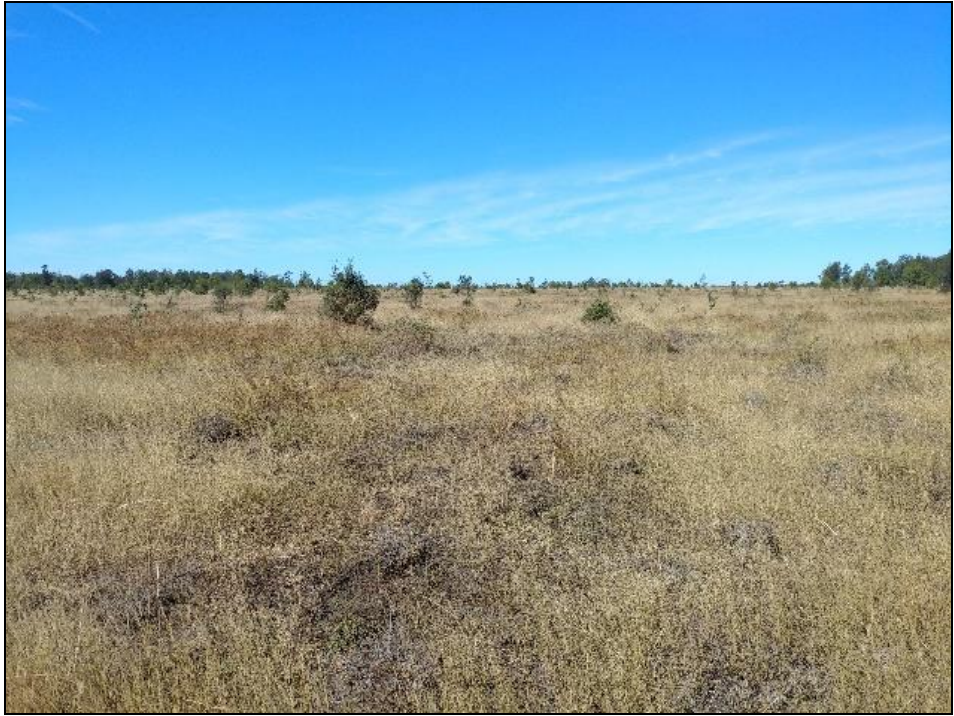
Item	Description
<b>Representative Site</b>	5-SCL-M (Mound)
<b>Representative Site photograph</b>

<b>Location</b>	641663mE 7508746mN
<b>Current Use</b>	Grazing
<b>Site survey type</b>	Detailed - 50mm hand auger
<b>Vegetation</b>	Grasses
<b>Disturbance</b>	Extensively disturbed
<b>Landform element / pattern</b>	Gently undulating plain, mid-slope
<b>Micro relief</b>	Gilgai microrelief present 40% coverage
<b>Erosion</b>	Nil erosion
<b>Slope (%)</b>	2% / 1%
<b>Drainage</b>	Well to moderately drained
<b>Surface coarse fragments</b>	Nil coarse fragments
<b>Surface condition</b>	Self-mulching with cracking
<b>ASC Order (s)</b>	Black Vertosol
<b>Total area (ha)</b>	383.0

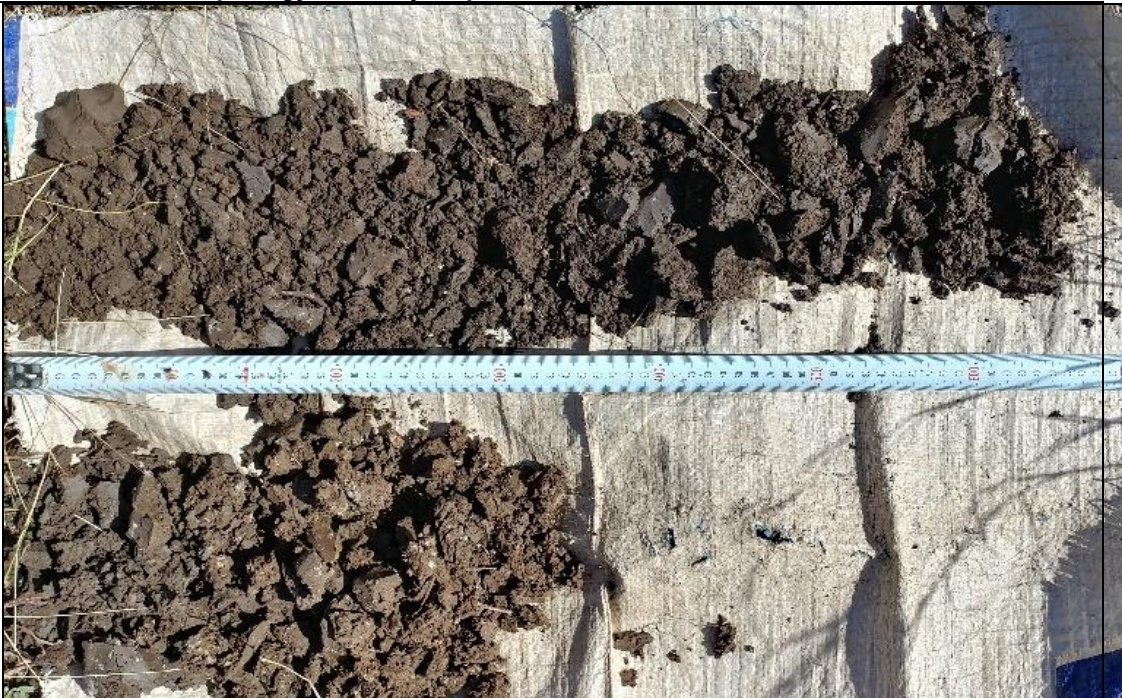
Site 5-SCL-M

Horizon Depth (m), Boundar -y (Bdy)	Field Texture	Structure Strength	Inclusions Segregatio- ns	Colour, Mottle, Bleaching	Moisture Drainage	Roots	Depth (m) / Field pH / EC dS/m	Samples (m)	Observati -ons
A1 0.00-0.12 Abrupt	Light clay	Moderate, soft <20mm sub- angular	Nil	10YR2/1 Nil mottle / bleaching	Humid, Well drained	Comm on, mediu m	0.10 / 6.5	0.00-0.10 0.20-0.30 0.50-0.60 0.80-0.90 0.90-1.00	Nil
B21 0.12-0.60 Abrupt	Medium heavy clay	Moderate, Firm <30mm sub- angular	Nil	10YR3/1 Nil mottle / bleaching	Humid, Well drained	Few, mediu m	0.30 / 7.0		
B22 0.60-1.00 EOBH	Medium heavy clay	Moderate, Firm <30mm sub- angular	<2% Calcium carbonate	10YR3/1 Nil mottle / bleaching	Humid, Well - moderate drained	Few, fine	0.10 / 7.0

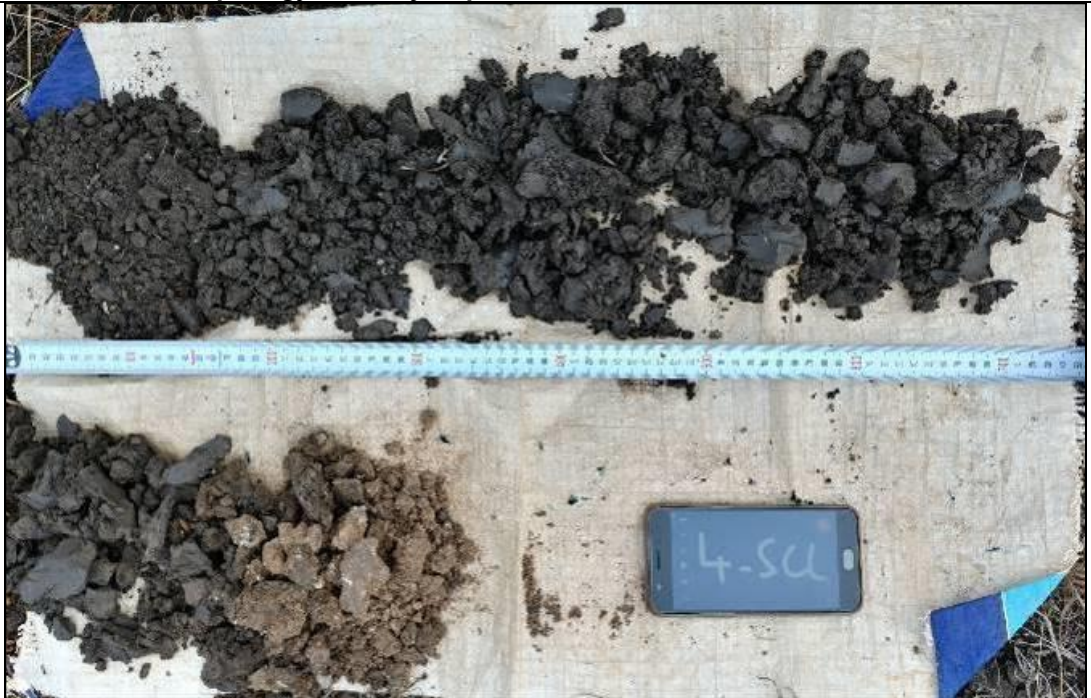
Site 4-SCL

Horizon Depth (m), Boundar -y (Bdy)	Field Texture	Structure Strength	Inclusions Segregatio- ns	Colour, Mottle, Bleaching	Moisture Drainage	Roots	Depth (m) / Field pH / EC dS/m	Samples (m)
A1 0.00-0.14 Abrupt	Light clay	Weak, firm, <10mm sub- angular	Nil inclusion or segregation s	10YR3/2 Very dark greyish brown Nil mottles/ble ach	Dry, moderate	Fine, few	0.10 / 6.5	0.00-0.10 0.20-0.30 0.50-0.60 0.80-0.90 0.90-1.00	Nil
B21 0.14-0.90 Abrupt	Medium clay	Moderate, firm <40% 20- 60mm, <20% 60- 100 sub- angular blocky peds	<1% calcium carbonate nodules	10YR3/2 Very dark greyish brown Nil mottles/ble ach	Dry, moderate	Very fine, very few	0.30 / 6.5 0.60 / 7.5		
B22 0.90-1.00 EOBH	Medium clay	Moderate, firm <40% 20- 60mm, <20% 60- 100 sub- angular blocky peds	2% calcium carbonate nodules	10YR4/2 Dark greyish brown Mottles 2% 10YR3/2 Very dark greyish brown Nil bleach	Dry, Imperfect	Very fine, very few	0.90 / 8.0

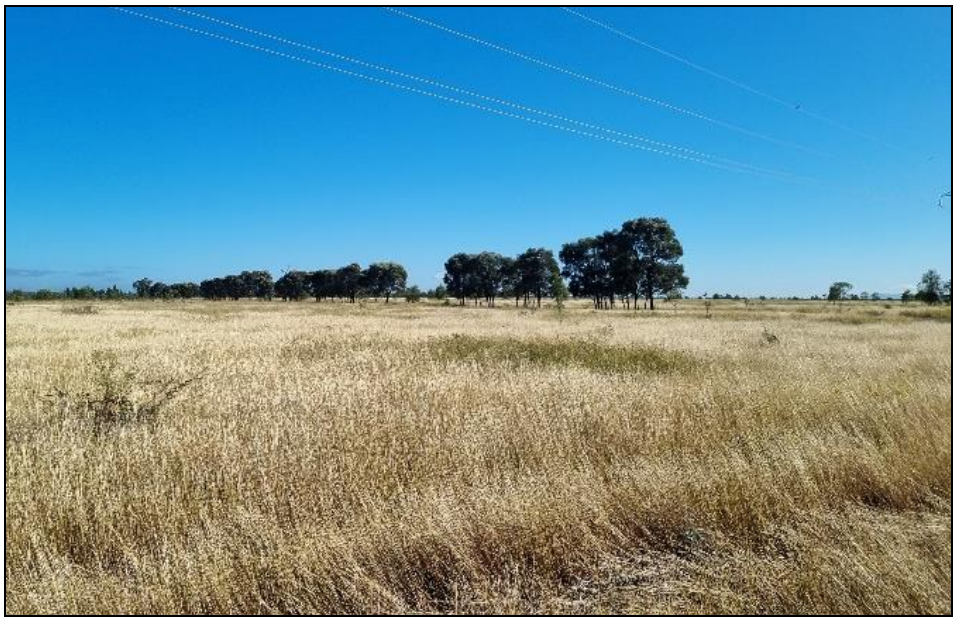
Item	Description
<b>Representative Site</b>	N46
<b>Representative Site photograph</b>

<b>Location</b>	641947mE 7512737mN
<b>Current Use</b>	Grazing
<b>Site survey type</b>	Detailed, 50 mm hand auger.
<b>Vegetation</b>	Spear grasses, sparse brigalow
<b>Disturbance</b>	Extensive clearing
<b>Landform element /pattern</b>	Gently undulating plains, mid-slope
<b>Micro relief</b>	Nil microrelief
<b>Erosion</b>	Nil erosion
<b>Slope (%)</b>	2.0/2.0
<b>Drainage</b>	Moderate well
<b>Surface coarse fragments</b>	Nil coarse fragments
<b>Surface condition</b>	Firm
<b>ASC Order (s)</b>	Black Dermosol
<b>Total area (ha)</b>	91

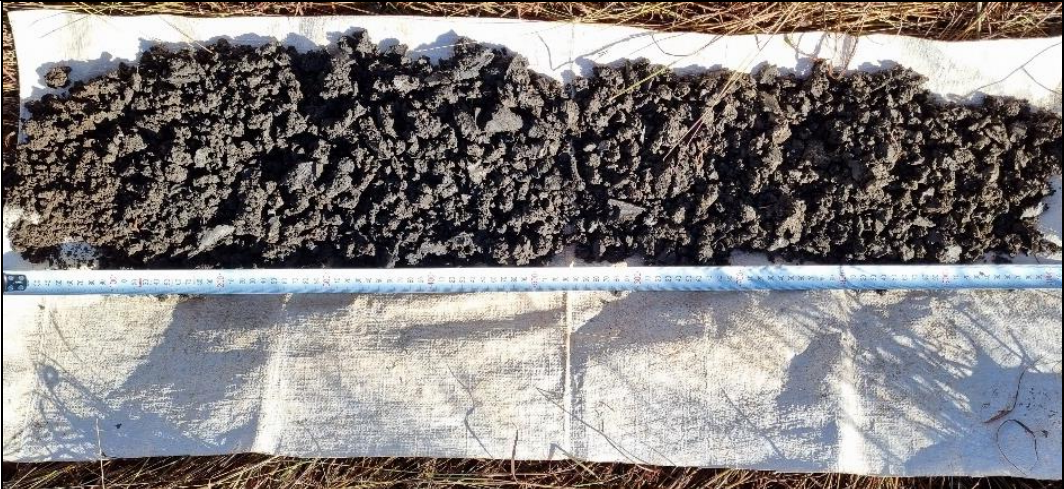
<b>Site N46</b>

<b>Horizon Depth (m), Boundar -y (Bdy)</b>	<b>Field Texture</b>	<b>Structure Strength</b>	<b>Inclusions Segregatio- ns</b>	<b>Colour, Mottle, Bleaching</b>	<b>Moisture Drainage</b>	<b>Roots</b>	<b>Depth (m) / Field pH / EC dS/m</b>	<b>Samples (m)</b>	<b>Observati -ons</b>
	A1 0.00-0.12 Clear 20- 50mm	Clay loam sandy	Moderate Firm Subangular blocky	Nil inclusions or segregations	10YR3/2 Very dark greyish brown Nil mottles or bleaching	Moderately moist Moderately well drained	Fine 1- 2mm Comm on	6.0	0.00-0.10 0.20-0.30 0.50-0.60 0.70-0.80 0.90-1.00	Nil
	B21 0.10-0.46 Clear 20- 50mm	Medium clay	Strong Very firm Angular blocky	Nil inclusions or segregations	10YR3/1 Very dark grey Nil mottles or bleaching	Moderately moist Moderately well drained	Fine 1- 2mm Comm on	7.5		
	B22 0.46-0.86 Clear 20- 50mm	Medium clay	Strong Very firm	<2% calcium carbonate 2-6mm	10YR3/1 Very dark grey Nil mottles or bleaching	Moderately moist Moderately well drained	Fine 1- 2mm Few	7.5

B23 0.86-1.00	Medium clay	Strong Strong	Nil inclusions or segregations	10YR4/2 Dark greyish brown Nil mottles or bleaching	Dry Moderately well drained	Fine 1- 2mm Few	7.5

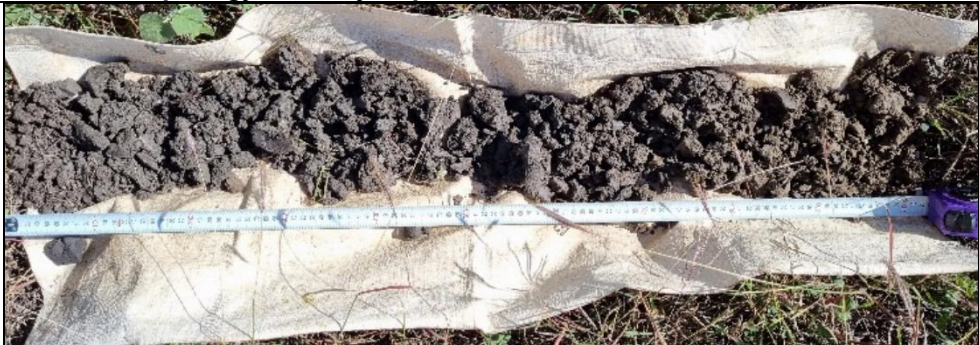
Site N57

Horizon Depth (m), Boundar -y (Bdy)	Field Texture	Structure Strength	Inclusions Segregatio- ns	Colour, Mottle, Bleaching	Moisture Drainage	Roots	Depth (m) / Field pH / EC dS/m	Samples (m)	Observati -ons	
A1 0.00-0.10 Abrupt 5-20mm	Light clay	Moderate Firm Angular blocky	Nil inclusions or segregations	10YR2/1 Black Nil mottles or bleaching	Moist Well drained	Fine 1- 2mm Few	7.0	0.00-0.10 0.20-0.30 0.50-0.60 0.70-0.80 0.90-1.00	Nil	
B21 0.10-0.50 Gradual 50- 100mm	Medium clay	Moderate Strong Subangular blocky	<2% calcium carbonate	10YR3/1 Very dark grey Nil mottles or bleaching	Dry Moderate well drained	Very fine <1mm Few	8.5			
B22 0.50-0.85 Clear 20- 50mm	Medium heavy clay	Moderate Strong Subangular blocky	Nil inclusions or segregations	10YR3/1 Very dark grey Nil mottles or bleaching	Dry Moderate well drained	Nil roots	8.5			
B23 0.85-1.00 EOBH	Medium heavy clay	Moderate Strong Subangular blocky	Nil inclusions or segregations	10YR4/3 Brown Nil mottles or bleaching	Dry Moderate well drained	Nil roots	6.5

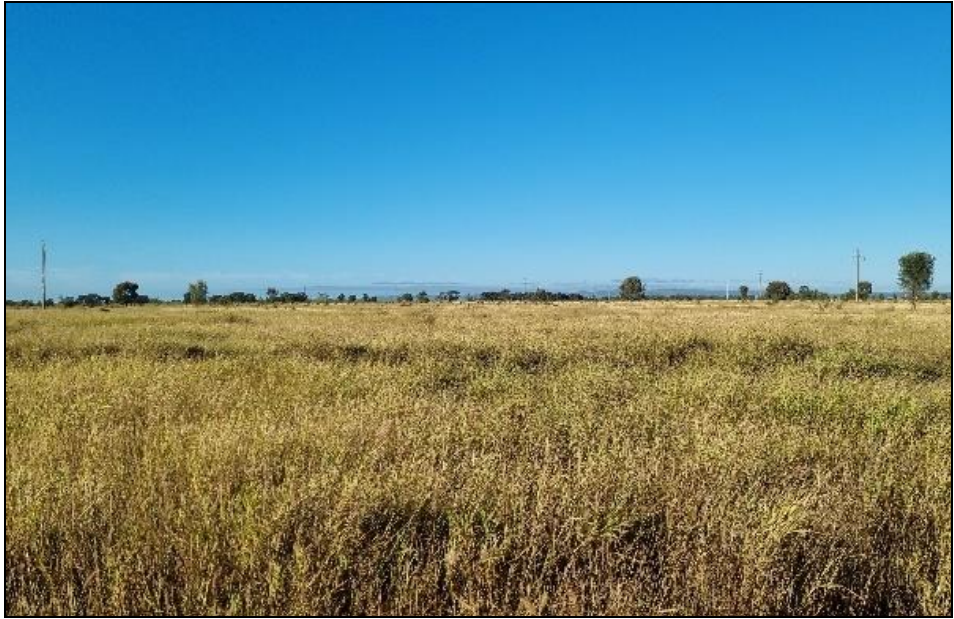
Item	Description
<b>Representative Site</b>	N56
<b>Representative Site photograph</b>

<b>Location</b>	641970mE 7512389mN
<b>Current Use</b>	Grazing
<b>Site survey type</b>	Detailed, 50 mm hand auger.
<b>Vegetation</b>	Bull Mitchell grass
<b>Disturbance</b>	Complete clearing, not cultivated
<b>Landform element /pattern</b>	Gently undulating plains, flat
<b>Micro relief</b>	Nil microrelief
<b>Erosion</b>	Nil erosion
<b>Slope (%)</b>	1.0/1.0
<b>Drainage</b>	Moderate well
<b>Surface coarse fragments</b>	Nil coarse fragments
<b>Surface condition</b>	Self-mulching
<b>ASC Order (s)</b>	Black Self mulching Vertosol
<b>Total area (ha)</b>	36

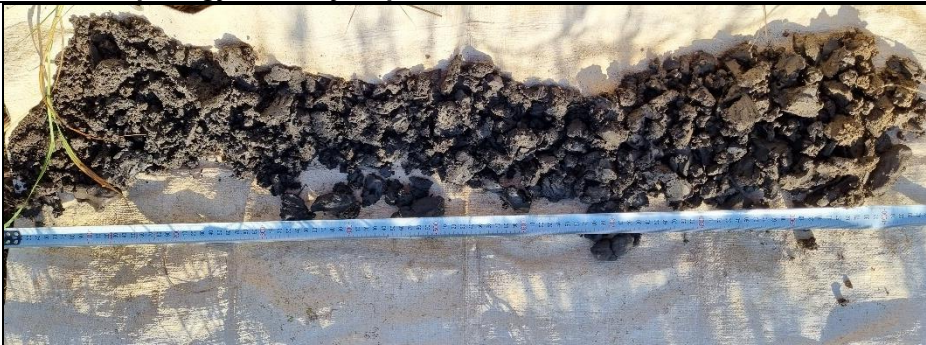
<b>Site N56</b>

Horizon Depth (m), Boundary (Bdy)	Field Texture	Structure Strength	Inclusions Segregations	Colour, Mottle, Bleaching	Moisture Drainage	Roots	Depth (m) / Field pH / EC dS/m	Samples (m)	Observations
	A1 0.00-0.10 Clear 20-50mm	Light clay	Moderate Firm	Nil inclusions or segregations	10YR3/1 Very dark grey Nil mottles or bleaching	Moderately moist Moderately well drained	Fine 1-2mm Few	6.5	0.00-0.10 0.20-0.30 0.50-0.60 0.70-0.80 0.90-1.00	Nil
	B21 0.10-0.65 Clear 20-50mm	Medium clay	Strong Very firm	<2% coarse fragments 6-20mm	10YR3/2 Very dark greyish brown Nil mottles or bleaching	Moderately moist Moderately well drained	Fine 1-2mm Few	7.5		
	B22 0.68-0.85 Clear 20-50mm	Medium heavy clay	Strong Very firm	Nil inclusions or segregations	10YR4/2 Dark greyish brown Nil mottles or bleaching	Dry Moderately well drained	Fine 1-2mm Few	7.5		
B22 0.85-1.00 EOBH	Medium heavy clay	Strong Very firm	Nil inclusions or segregations	10YR4/3 Brown Nil mottles or bleaching	Dry Moderately well drained	Fine 1-2mm Few	7.5

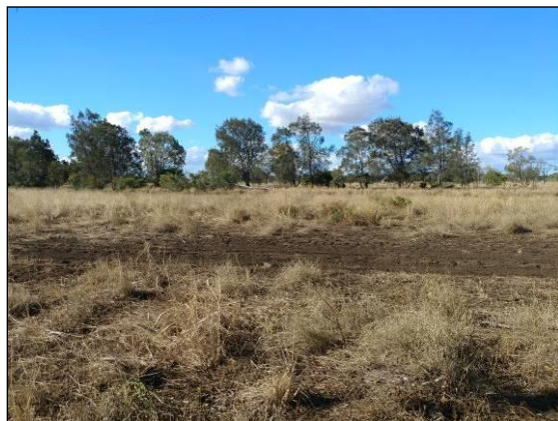
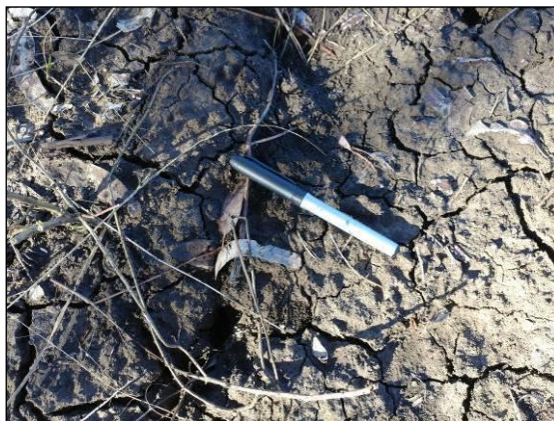
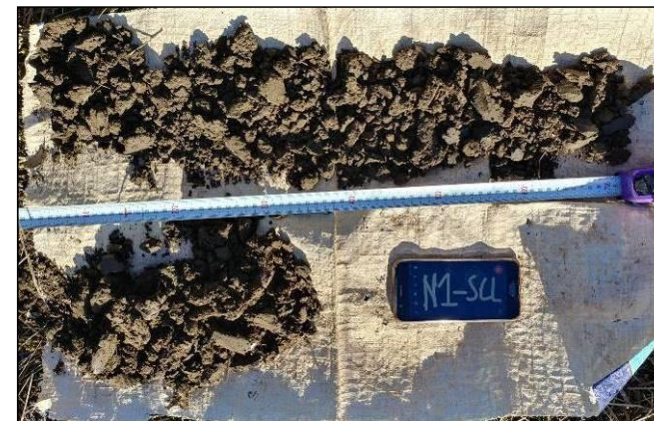
<b>Map Unit</b> 7	<b>Location (GDA94 ZONE 55):</b> 641005 mE 7512573 mN	<b>Aust. Soil Class.:</b> Crusting Black Vertosol	<b>Site Survey Type:</b> Detailed - 50mm hand auger	<b>Survey Date:</b> 30/06/2018
----------------------	--	--	--	-----------------------------------

Land use Landform Pattern, Element, Slope	Vegetation	Microrelief Disturbance Erosion	Surface condition, surface rock	Soil Profile Description									
				Horizon Depth (m), Boundary	Field Texture	Structure, Strength	Inclusions Segregations	Colour, Mottle, Bleaching	Moisture, Drainage	Roots	Depth (m) / Field pH	Sample (m)	Observations
Grazing Gently undulating plains, Open depression 2.0/1.0	Mount coolabah, semi-cleared	Nil microrelief Semi-cleared Nil erosion	Cracking, crust Nil coarse fragments	A11 0.00-0.02 Abrupt	Light clay	Moderate, firm <10mm sub- angular	Nil inclusions and segregations	10YR3/1 Very dark grey Nil mottles/bleach	Moderately moist, moderate	Few fine	0.02 / 6.5	0.00-0.10 0.20-0.30 0.50-0.60 0.80-0.90 0.90-1.00	Nil additional observations
				A12 0.02-0.10 Abrupt	Light clay	Moderate, firm 10- 30mm sub- angular	<1% calcium carbonate	10YR2/2 Very dark brown Nil mottles/bleach	Dry, moderate	Few fine	0.10 / 6.5

B21 0.10-0.70 Abrupt	Medium clay	Moderate, firm 10- 30mm sub- angular	2% calcium carbonate nodules	10YR2/2 Very dark brown Nil mottles/bleach	Dry, moderate	Very fine, very few	0.30 / 7.0 0.60 / 7.5		
				B22 0.70-1.00 EOBH	Medium clay	Moderate, firm 10- 30mm sub- angular	2% calcium carbonate nodules	10YR4/2 Dark greyish brown Nil mottles/bleach	Dry, moderate	Very fine, very few	0.90 / 7.5

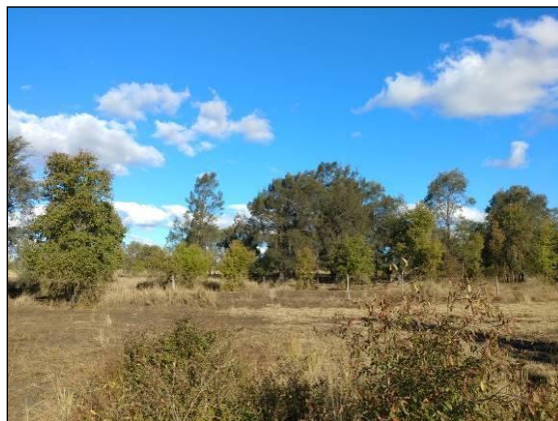
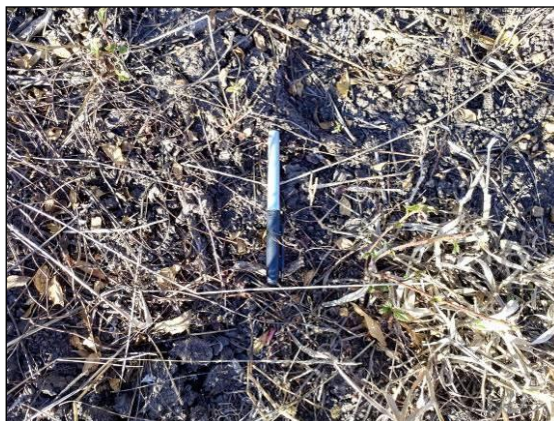
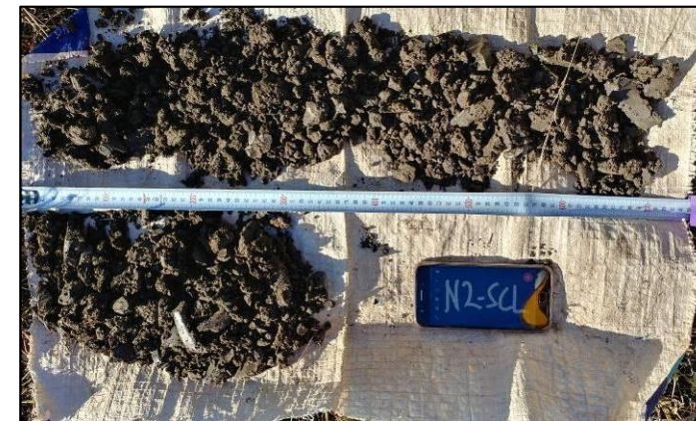
<b>Map Unit</b> 7	<b>Location (GDA94 ZONE 55):</b> 641096mE 7512914mN	<b>Aust. Soil Class.:</b> Crusting Grey Vertosol	<b>Site Survey Type:</b> Detailed - 50mm hand auger	<b>Survey Date:</b> 30/06/2018
----------------------	--	---	--	-----------------------------------

Land use Landform Pattern, Element, Slope	Vegetation	Microrelief Disturbance Erosion	Surface condition, surface rock	Soil Profile Description									
				Horizon Depth (m), Boundary	Field Texture	Structure, Strength	Inclusions Segregations	Colour, Mottle, Bleaching	Moisture, Drainage	Roots	Depth (m) / Field pH	Sample (m)	Observations
Grazing Very gently undulating plain 2.0/1.0	Various shrubs	Nil microrelief Nil to semi disturbance Nil erosion	Firm, crust Nil coarse fragments	A1 0.00-0.14 Abrupt	Light clay	Moderate, soft <10mm sub- angular	Nil inclusions and segregations	10YR3/1 Very dark grey Nil mottles/bleach	Moderate moist, moderate	Few fine	0.10 / 6.0	0.00-0.10 0.20-0.30 0.50-0.60 0.80-0.90 0.90-1.00	Nil additional observations
				B2 0.14-1.00 EOBH	Medium clay	Moderate, firm <10mm sub- angular	<2% black nodules	10YR4/2 Dark greyish brown Nil mottles/bleach	Dry, moderate	Very fine, very few	0.30 / 6.5 0.60 / 7.0 0.90 / 7.5

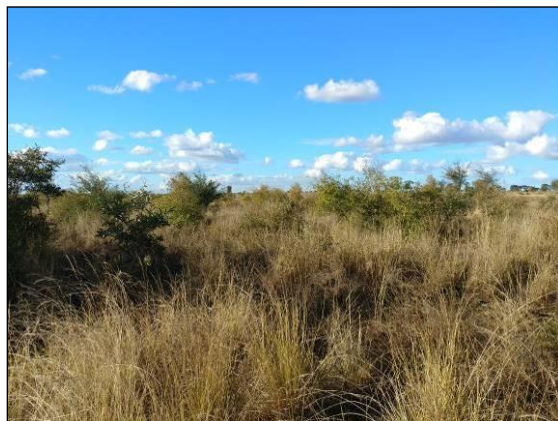
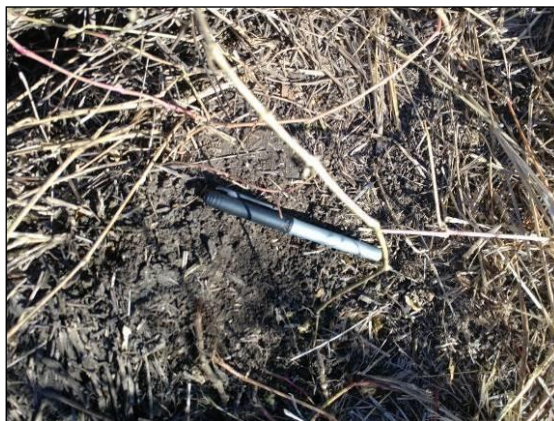
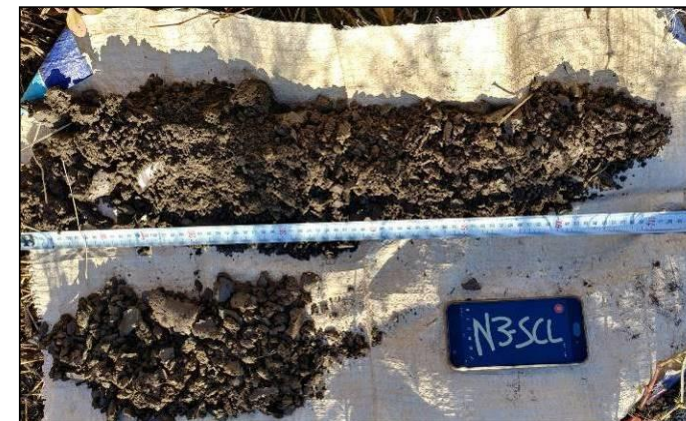
## SITE N3

Land use Landform Pattern, Element, Slope	Vegetation	Microrelief Disturbance Erosion	Surface condition, surface rock	Soil Profile Description									
				Horizon Depth (m), Boundary	Field Texture	Structure, Strength	Inclusions Segregations	Colour, Mottle, Bleaching	Moisture, Drainage	Roots	Depth (m) / Field pH	Sample (m)	Observations
Grazing Very gently undulating plain 2.0/1.0	Various shrubs	Nil microrelief Nil disturbance Nil erosion	Crusting, Nil coarse fragments	A1 0.00-0.16 Abrupt	Light clay	Weak, soft <10mm sub- angular	Nil inclusions and segregations	10YR3/1 Very dark grey Nil mottles/bleach	Moderate moist, moderate	Few fine	0.10 / 6.0	0.00-0.10 0.20-0.30 0.50-0.60 0.80-0.90 0.90-1.00	Nil additional observations
				B2 0.16-1.00 EOBH	Medium clay	Moderate, firm <10mm sub- angular	<2% black nodules	10YR4/2 Dark greyish brown Nil mottles/bleach	Dry, moderate	Very fine, very few	0.30 / 6.5 0.60 / 7.0 0.90 / 7.5

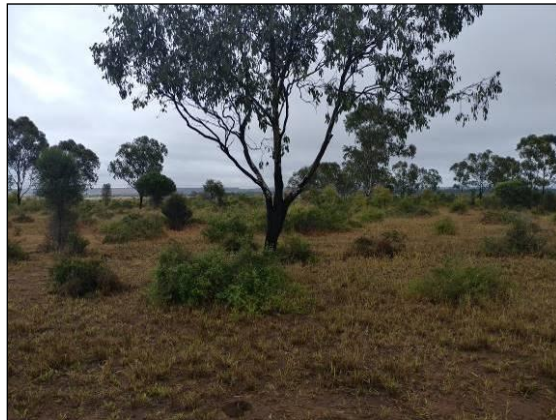
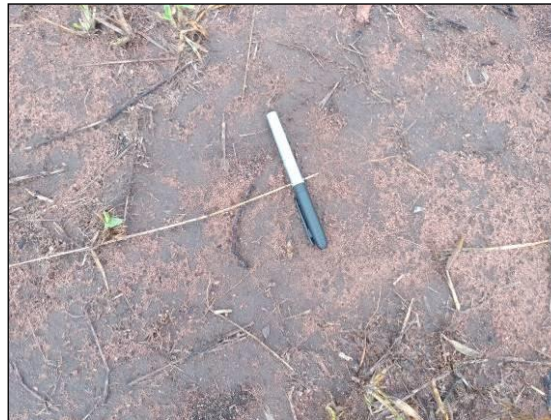
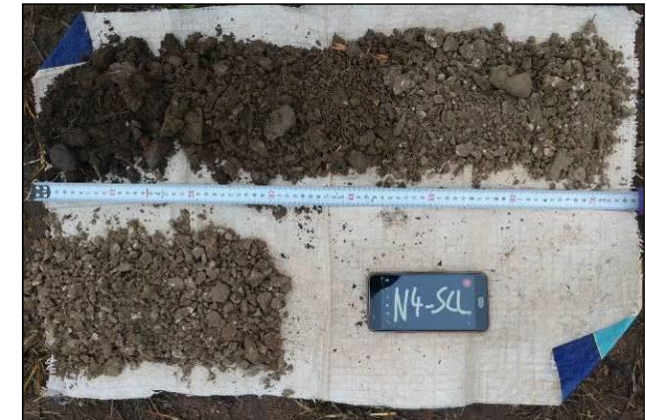
## SITE N4

Land use Landform Pattern, Element, Slope	Vegetation	Microrelief Disturbance Erosion	Surface condition, surface rock	Soil Profile Description									
				Horizon Depth (m), Boundary	Field Texture	Structure, Strength	Inclusions Segregations	Colour, Mottle, Bleaching	Moisture, Drainage	Roots	Depth (m) / Field pH	Sample (m)	Observations
Grazing Very gently undulating plain 2.0/1.0	Eucalyptus species	Nil microrelief Semi disturbed Nil erosion	Soft, <5% 2-6mm coarse fragments	A1 0.00-0.17 Abrupt	Sandy loam	Weak, soft <10mm sub- rounded	Nil inclusions and segregations	10YR3/2 Very dark greyish brown Nil mottles/bleach	Moderate moist, rapid	Few fine	0.10 / 6.0	0.00-0.10 0.20-0.30 0.50-0.60 0.80-0.90 0.90-1.00	Nil additional observations
				B21 0.17-0.44 Abrupt	Light clay with minor sand	Moderate, firm <30mm sub- angular	<2% pale red nodules	10YR4/2 Dark greyish brown Nil mottles/bleach	Moderately moist, moderate	Very fine, very few	0.30 / 7.5

B22 0.44-1.00 EOBH	Medium clay	Moderate, firm <30mm sub- angular	10-15% calcium carbonate nodules	10YR5/3 Brown Nil mottles/bleach	Dry, moderate	Very fine, very few	0.60 / 7.5 0.90 / 7.5

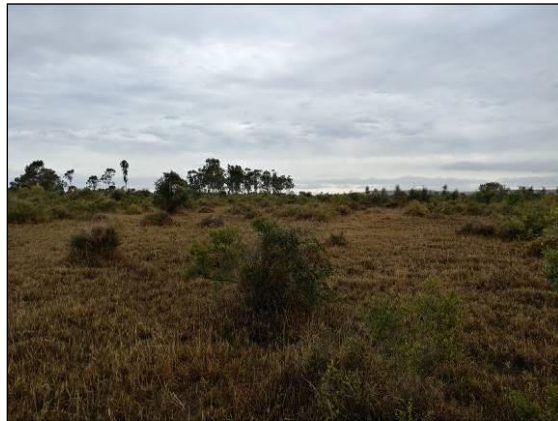
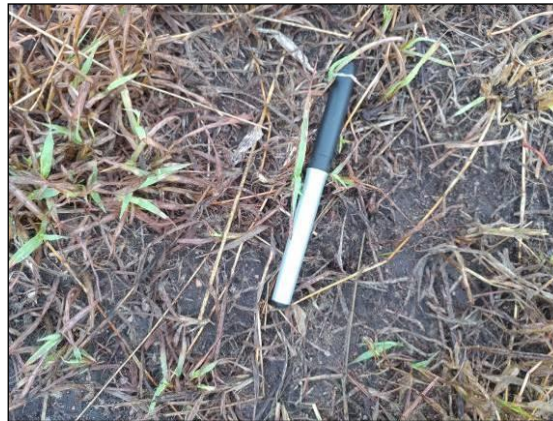
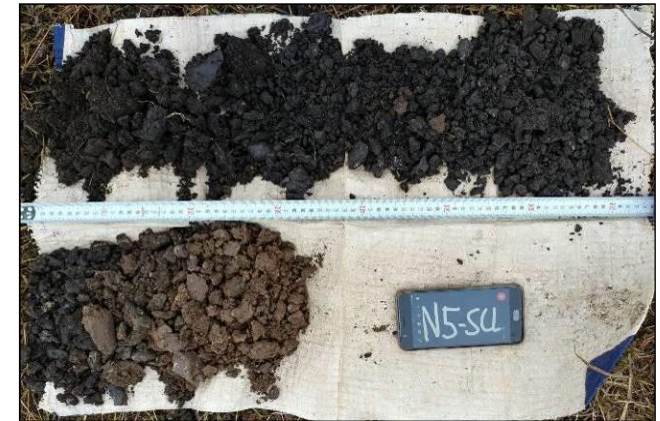
<b>Map Unit</b> 5	<b>Location (GDA94 ZONE 55):</b> 641792mE 7513825mN	<b>Aust. Soil Class.:</b> Black dermosol	<b>Site Survey Type:</b> Detailed - 50mm hand auger	<b>Survey Date:</b> 1/07/2018
----------------------	--	---	--	----------------------------------

Land use Landform Pattern, Element, Slope	Vegetation	Microrelief Disturbance Erosion	Surface condition, surface rock	Soil Profile Description									
				Horizon Depth (m), Boundary	Field Texture	Structure, Strength	Inclusions Segregations	Colour, Mottle, Bleaching	Moisture, Drainage	Roots	Depth (m) / Field pH	Sample (m)	Observations
Grazing Very gently undulating plain midslope 3.0/3.0	Sparse shrub species	Nil microrelief Nil disturbance Nil erosion	Soft, Nil coarse fragments	A1 0.00-0.12 Abrupt	Sandy loam	Weak, soft <10mm sub- rounded	Nil inclusions and segregations	10YR3/1 Very dark grey Nil mottles/bleach	Moderate moist, rapid	Few fine	0.10 / 6.5	0.00-0.10	Nil additional observations
				B21 0.12-0.45 Abrupt	Light clay with minor sand	Moderate, firm <30mm sub-angular	Nil inclusions and segregations	10YR2/1 Black Nil mottles/bleach	Moderately moist, moderate	Very fine, very few	0.30 / 7.5	0.20-0.30

B22 0.45-0.80 Abrupt	Medium clay	Moderate, firm <30mm sub-angular	2% calcium carbonate nodules	10YR2/1 Black Nil mottles/bleach	Dry, moderate	Very fine, very few	0.60 / 8.0	0.50-0.60	
				B23 0.80-1.00 EOBH	Medium clay	Strong, strong <30mm sub- angular	2% calcium carbonate nodules	10YR3/3 Dark brown Nil mottles/bleach	Dry, moderate	Very fine, very few	0.90 / 8.0	0.80-0.90 0.90-1.00

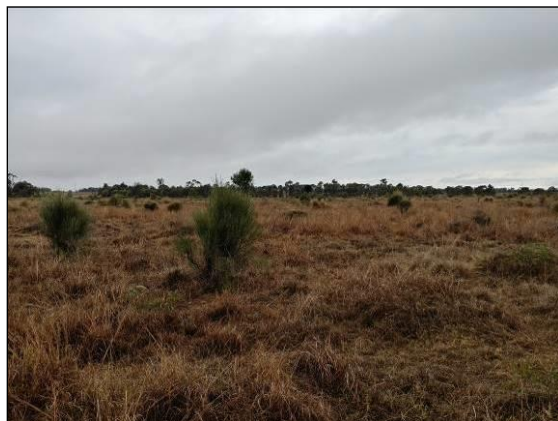
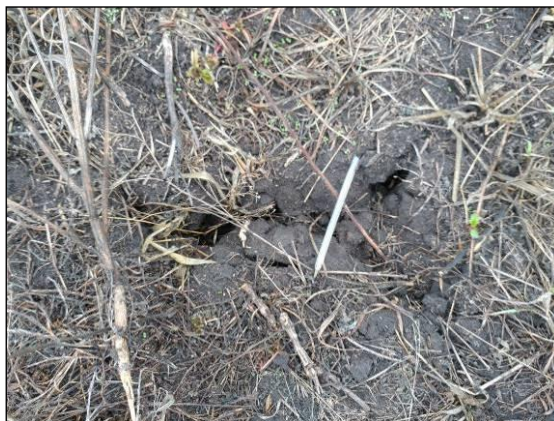
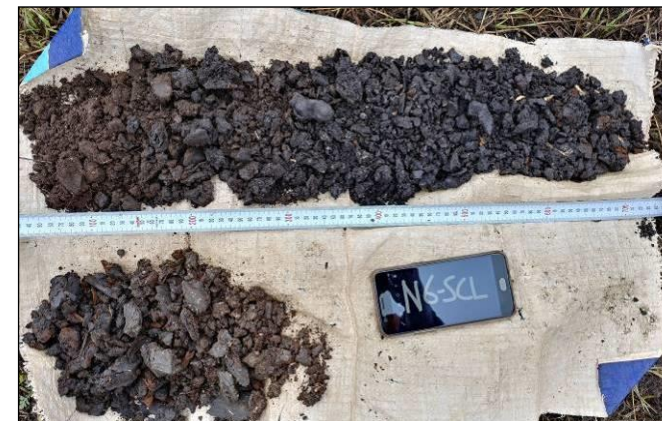
<b>Map Unit</b> 1	<b>Location (GDA94 ZONE 55):</b> 643271mE 7514881mN	<b>Aust. Soil Class.:</b> Black dermosol	<b>Site Survey Type:</b> Detailed - 50mm hand auger	<b>Survey Date:</b> 1/07/2018
----------------------	--	---	--	----------------------------------

Land use Landform Pattern, Element, Slope	Vegetation	Microrelief Disturbance Erosion	Surface condition, surface rock	Soil Profile Description									
				Horizon Depth (m), Boundary	Field Texture	Structure, Strength	Inclusions Segregations	Colour, Mottle, Bleaching	Moisture, Drainage	Roots	Depth (m) / Field pH	Sample (m)	Observations
Grazing Very gently undulating plain midslope 3.0/3.0	Buffel grass	Nil microrelief Semi disturbed Nil erosion	Cracking, soft Nil coarse fragments	A1 0.00-0.17 Abrupt	Clay Loam	Moderate, firm<30mm sub- angular	Nil inclusions and segregations	10YR3/2 Very dark greyish brown Nil mottles/bleach	Moderate moist, rapid	Few fine	0.10 / 7.0	0.00-0.10 0.20-0.30 0.50-0.60 0.77-0.87 0.90-1.00	Large root encountered at 0.60 mbgl
				B21 0.17-0.89 Abrupt	Medium clay	Moderate, firm<50mm sub- angular	5% calcium carbonate nodules	10YR3/1 Very dark grey Very dark grey Nil mottles/bleach	Dry, moderate	Very fine, very few	0.30 / 7.0 0.60 / 8.0

B22 0.89-1.00 EOBH	Medium clay	Strong , firm<50mm sub- angular	5% calcium carbonate nodules	10YR3/2 Very dark greyish brown Nil mottles/bleach	Dry, moderate	Very fine, very few	0.90 / 8.5

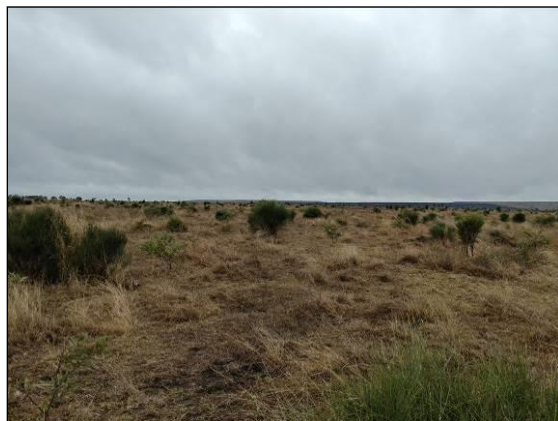
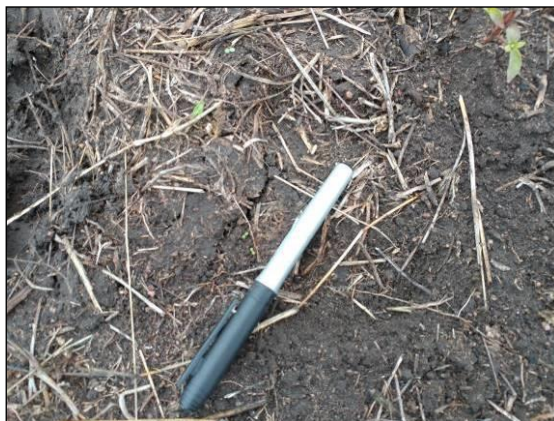
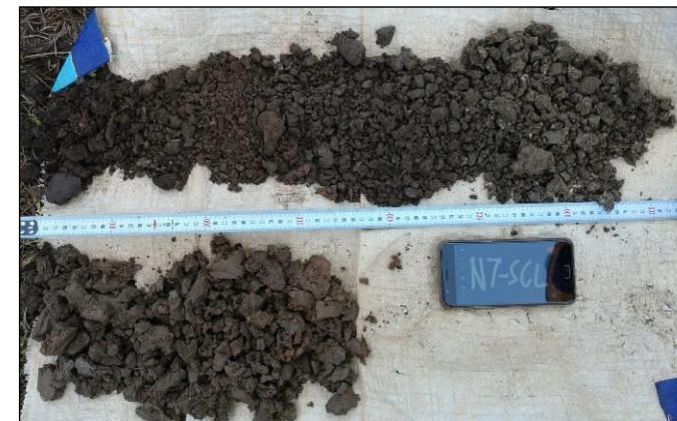
<b>Map Unit</b> 1	<b>Location (GDA94 ZONE 55):</b> 643071mE 7514453mN	<b>Aust. Soil Class.:</b> Black dermosol	<b>Site Survey Type:</b> Detailed - 50mm hand auger	<b>Survey Date:</b> 1/07/2018
----------------------	--	---	--	----------------------------------

Land use Landform Pattern, Element, Slope	Vegetation	Microrelief Disturbance Erosion	Surface condition, surface rock	Soil Profile Description									
				Horizon Depth (m), Boundary	Field Texture	Structure, Strength	Inclusions Segregations	Colour, Mottle, Bleaching	Moisture, Drainage	Roots	Depth (m) / Field pH	Sample (m)	Observations
Grazing Very gently undulating plain midslope 2.0/2.0	Buffel grass, nearby brigalow	Nil microrelief Nil disturbance Nil erosion	Firm, Nil coarse fragments	A1 0.00-0.15 Abrupt	Clay loam with minor sands	Moderate, firm<30mm sub- angular	Nil inclusions and segregations	10YR3/1 Very dark grey Black Nil mottles/bleach	Moderate moist, rapid	Few fine	0.10 / 6.5	0.00-0.10 0.20-0.30 0.50-0.60 0.80-0.90 0.90-1.00	Nil additional observations
				B21 0.15-0.50 Abrupt	Light clay with minor sands	Moderate, firm<50mm sub- angular	Nil inclusions and segregations	10YR3/1 Very dark grey Nil mottles/bleach	Dry, moderate	Very fine, very few	0.30 / 7.0

B22 0.50-0.70 Abrupt	Medium clay	Moderate, firm<50mm sub- angular	5% calcium carbonate nodules	10YR3/2 Very dark greyish brown Nil mottles/bleach	Dry, moderate	Very fine, very few	0.60 / 8.0		
				B23 0.70-1.00 EOBH	Medium clay	Strong, firm<50mm sub- angular	Nil inclusions and segregations	10YR3/2 Very dark greyish brown Nil mottles/bleach	Dry, moderate	Very fine, very few	0.90 / 8.0

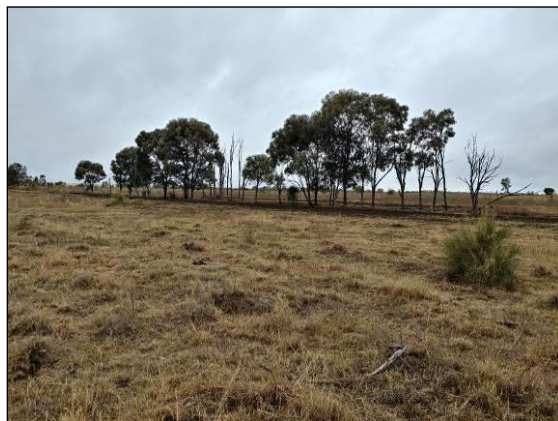
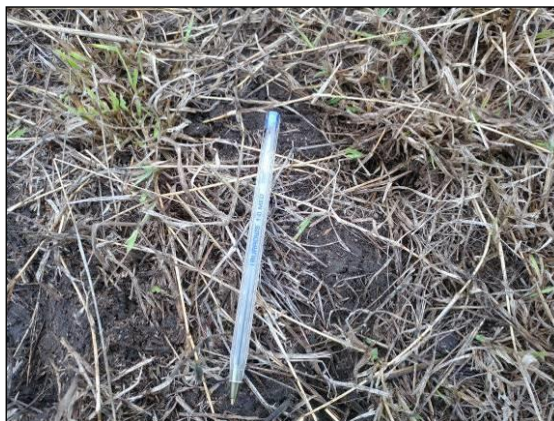
<b>Map Unit</b> 1	<b>Location (GDA94 ZONE 55):</b> 642368mE 7513895mN	<b>Aust. Soil Class.:</b> Black dermosol	<b>Site Survey Type:</b> Detailed - 50mm hand auger	<b>Survey Date:</b> 1/07/2018
----------------------	--	---	--	----------------------------------

Land use Landform Pattern, Element, Slope	Vegetation	Microrelief Disturbance Erosion	Surface condition, surface rock	Soil Profile Description									
				Horizon Depth (m), Boundary	Field Texture	Structure, Strength	Inclusions Segregations	Colour, Mottle, Bleaching	Moisture, Drainage	Roots	Depth (m) / Field pH	Sample (m)	Observations
Grazing Very gently undulating plain midslope 2.0/2.0	Buffel grass	Nil microrelief Extensively disturbed Nil erosion	Soft <10% 10- 15mm coarse fragments	A11 0.00-0.17 Abrupt	Sandy clay loam	Moderate, soft, sub- rounded	Nil inclusions and segregations	10YR3/1 Very dark grey Black Nil mottles/bleach	Moderate moist, rapid	Few fine	0.10 / 7.0	0.00-0.10 0.20-0.30 0.50-0.60 0.80-0.90 0.90-1.00	Nil additional observations
				A12 0.17-0.37 Abrupt	Clay loam	Moderate, soft, sub- angular	Nil inclusions and segregations	10YR4/1 Dark grey Nil mottles/bleach	Dry, moderate	Very fine, very few	0.30 / 7.5

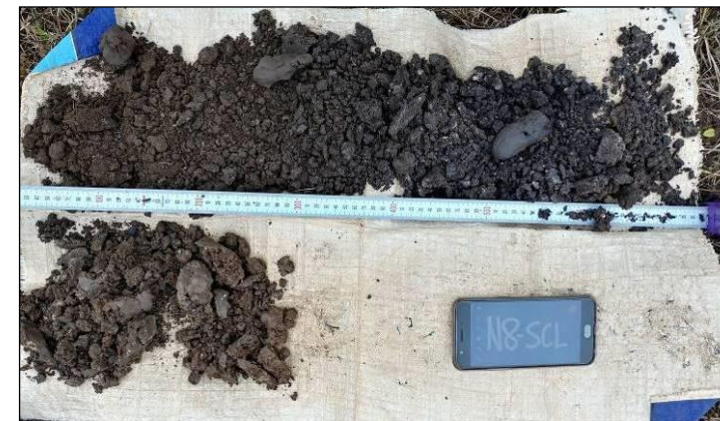
**Soil Profile**

B21 0.37-0.70 Abrupt	Medium clay	Moderate, soft, sub- angular	<2% calcium carbonate nodules	10YR3/1 Very dark grey Nil mottles/bleach	Dry, moderate	Very fine, very few	0.60 / 7.0		
				B22 0.70-1.00 EOBH	Medium clay	Moderate, soft, sub- angular	Nil inclusions and segregations	10YR4/2 Dark greyish brown Nil mottles/bleach	Dry, moderate	Very fine, very few	0.90 / 7.0

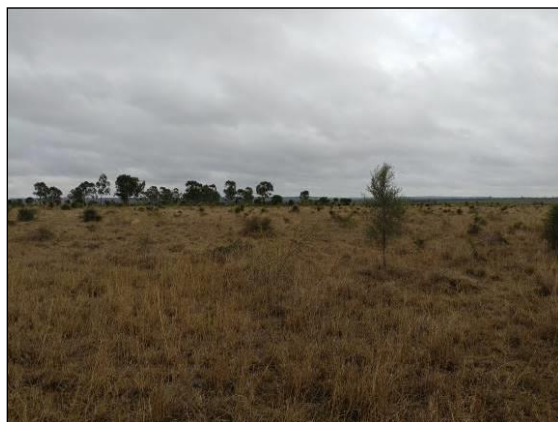
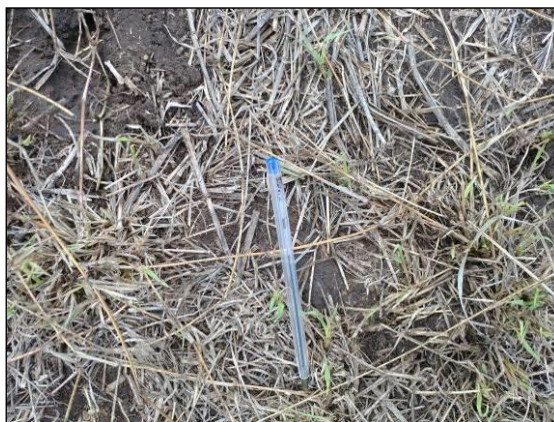
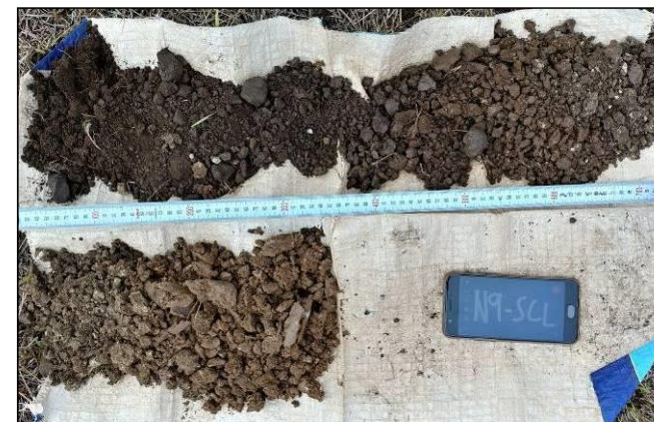
<b>Map Unit</b> 5	<b>Location (GDA94 ZONE 55):</b> 642032mE 7513619mN	<b>Aust. Soil Class.:</b> Black dermosol	<b>Site Survey Type:</b> Detailed - 50mm hand auger	<b>Survey Date:</b> 01/07/2018
----------------------	--	---	--	-----------------------------------

Land use Landform Pattern, Element, Slope	Vegetation	Microrelief Disturbance Erosion	Surface condition, surface rock	Soil Profile Description									
				Horizon Depth (m), Boundary	Field Texture	Structure, Strength	Inclusions Segregations	Colour, Mottle, Bleaching	Moisture, Drainage	Roots	Depth (m) / Field pH	Sample (m)	Observations
Very gently undulating plain mid slope 2.0/2.0	Buffel grass, Brigalow, and belah on fence line, 100 m nearby	Nil microrelief Nil disturbed Nil erosion	Soft, moist, Nil coarse fragments	A11 0.00-0.09 Abrupt	Sandy loam	Weak, loose	Nil inclusions and segregations	10YR2/2 Very dark brown Nil mottles	Moderate moist, rapid	Few fine	0.10 / 6.5	0.00-0.09 0.20-0.30 0.55-0.65 0.75-0.85 0.90-1.00	Nil additional observations
				A12 0.09-0.35 Clear	Sandy Loam	Weak, loose	Nil inclusions and segregations	10YR2/1 Black Nil mottles/bleach	Dry, moderate	Very fine, very few	0.30 / 7.5

B21 0.35-0.55 Abrupt	Medium clay	Moderate, strong, sub-angular <20 mm	Nil inclusions and segregations	10YR2/1 Black Nil mottles/bleach	Dry, moderate	Very fine, very few	-		
				B22 0.55-0.85 Abrupt	Medium clay	Moderate, strong, sub-angular <20 mm	<2% calcium carbonate nodules	10YR2/1 Black Nil mottles/bleach	Dry, moderate	-	0.60 / 8.5		
				B23 0.85-1.00 EOBH	Medium clay	Strong, strong, sub-angular <20 mm	Nil inclusions and segregations	10YR3/3 Dark brown Nil mottles/bleach	Dry, moderate	-	0.90 / 7.5

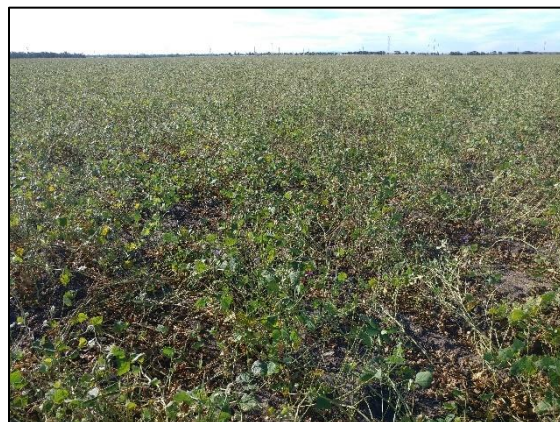
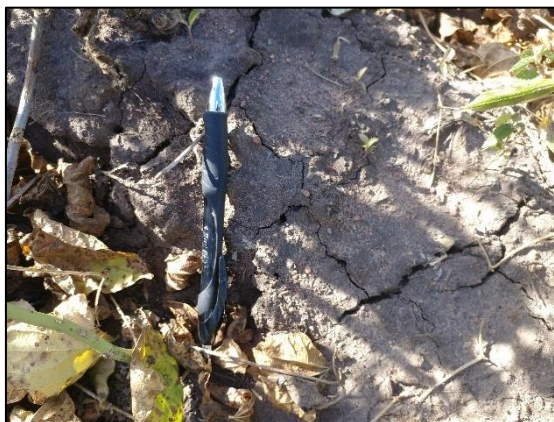
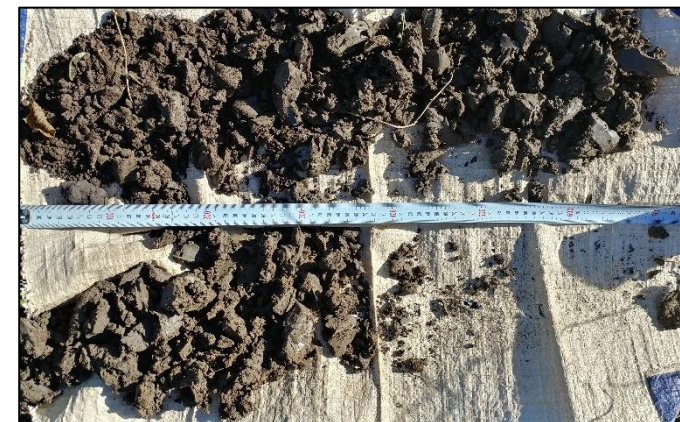
<b>Map Unit</b> 13	<b>Location (GDA94 ZONE 55):</b> 641522mE 7510593mN	<b>Aust. Soil Class.:</b> Black Vertosol	<b>Site Survey Type:</b> Detailed - 50mm hand auger	<b>Survey Date:</b> 04/06/2019
-----------------------	--	---	--	-----------------------------------

Land use Landform Pattern, Element, Slope	Vegetation	Microrelief Disturbance Erosion	Surface condition, surface rock	Soil Profile Description									
				Horizon Depth (m), Boundary	Field Texture	Structure, Strength	Inclusions Segregations	Colour, Mottle, Bleaching	Moisture, Drainage	Roots	Depth (m) / Field pH	Sample (m)	Observations
Cropping, Very gently undulating plain, mid-slope, 1% slope	Forage crops	Nil microrelief Extensive disturbance Nil erosion	Self-mulching with crust, minor sand on surface. Coarse fragments<5 mm <5%	A1 0.00 – 0.12 Abrupt	Light clay, sandy	Subangular blocky, Moderate peds 10-30 mm, firm	Nil inclusions and segregations	10YR2/1 Black Nil mottles / bleaching	Humid, well drained	Fine, very few	0.10 / 7.0	0.00-0.10 0.20-0.30 0.50-0.60 0.80-0.90 0.90-1.00	Nil additional observations
				B21 0.12 – 0.68 Abrupt	Medium heavy clay	Subangular blocky, Strong peds 20-30 mm, strong	<5% calcium carbonate	10YR2/1 Black Nil mottles / bleaching	Humid, well drained	Fine, very few	0.30 / 7.0 0.60 / 6.5

B22 0.68 – 1.00 EOBH	Medium heavy clay, sandy	Subangular blocky, Strong peds 40-60 mm, strong	<1% red nodules <2mm	10YR3/1 Very dark grey Nil mottles / bleaching	Humid, well drained	Nil	0.90 / 6.5

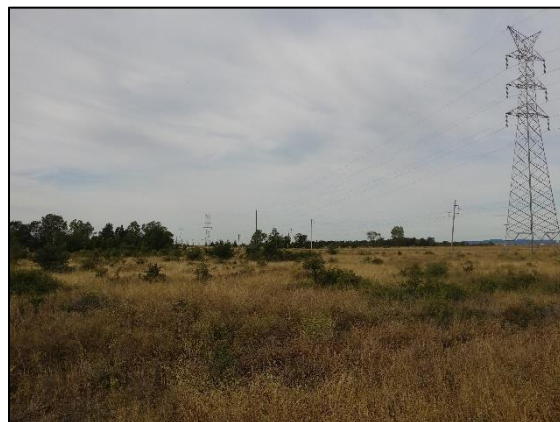
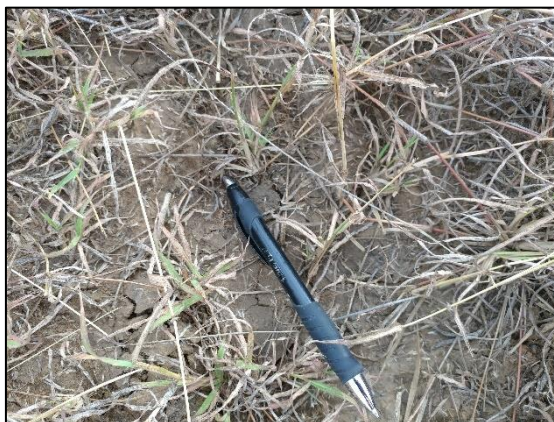
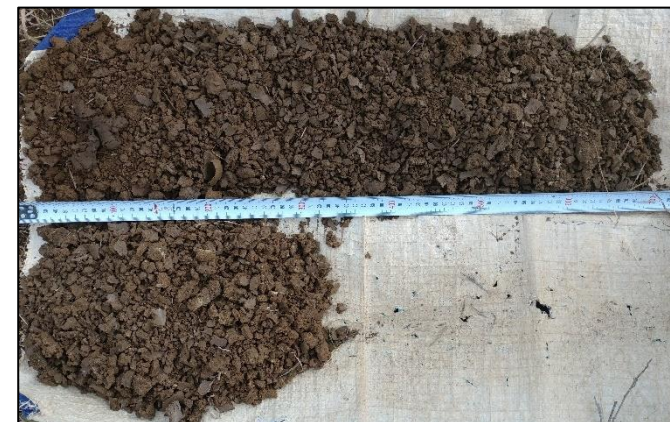
<b>Map Unit</b> 8	<b>Location (GDA94 ZONE 55):</b> 640984mE 7512975mN	<b>Aust. Soil Class.:</b> Black Dermosol	<b>Site Survey Type:</b> Detailed - 50mm hand auger	<b>Survey Date:</b> 05/06/2019
----------------------	--	---	--	-----------------------------------

Land use Landform Pattern, Element, Slope	Vegetation	Microrelief Disturbance Erosion	Surface condition, surface rock	Soil Profile Description									
				Horizon Depth (m), Boundary	Field Texture	Structure, Strength	Inclusions Segregations	Colour, Mottle, Bleaching	Moisture, Drainage	Roots	Depth (m) / Field pH	Sample (m)	Observations
GUP Mid-slope	Grasses	Nil microrelief Semi disturbance Nil erosion	Firm, Nil coarse fragments	A1 0.00-0.11 Abrupt	Sandy clay loam	Weak to moderate. Soft, sub rounded <10mm	Nil inclusions and segregations	10YR3/2 Very dark greyish brown Nil mottles/bleaching	Dry, well	Present	0.10 / 7.0	0.00-0.10 0.20-0.30 0.50-0.60 0.80-0.90 0.90-1.00	Nil additional observations
				B21 0.11-0.62 gradual	Light clay	Weak to moderate. Firm, sub rounded <20mm	Nil inclusions and segregations	10YR3/2 Very dark greyish brown Nil mottles/bleaching	Dry, moderate – well	Present	0.30 / 7.5 0.60 / 7.5

B22 0.62-1.00 EOBH	Light clay	Weak to moderate. Firm, sub rounded <20mm	Nil inclusions and segregations	10YR3/2 Very dark greyish brown Nil mottles/bleaching	Dry, moderate – well	Present	0.90 / 7.5

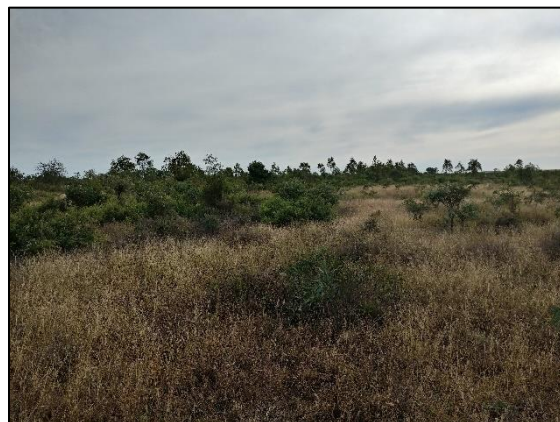
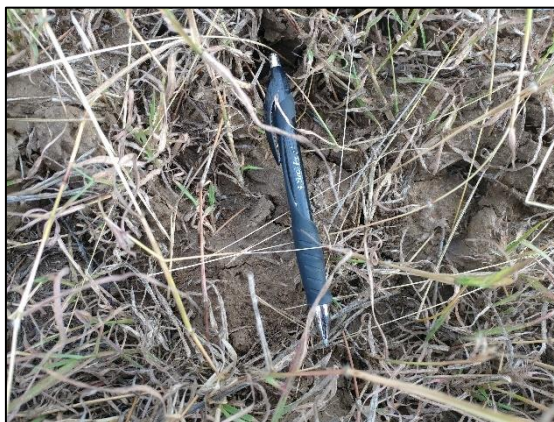
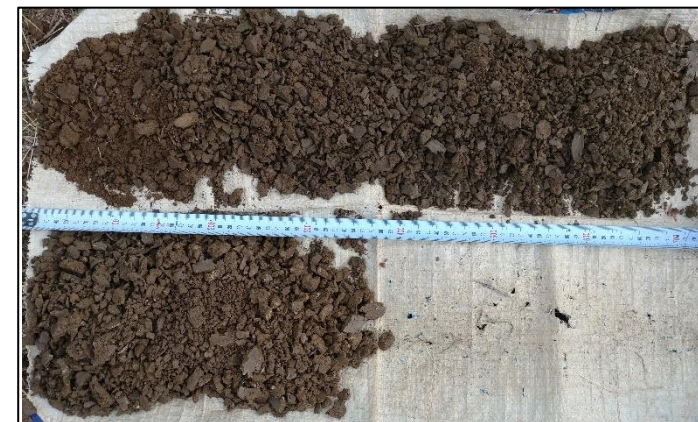
<b>Map Unit</b> 8	<b>Location (GDA94 ZONE 55):</b> 640940mE 7512735mN	<b>Aust. Soil Class.:</b> Black Dermosol	<b>Site Survey Type:</b> Detailed - 50mm hand auger	<b>Survey Date:</b> 05/06/2019
----------------------	--	---	--	-----------------------------------

Land use Landform Pattern, Element, Slope	Vegetation	Microrelief Disturbance Erosion	Surface condition, surface rock	Soil Profile Description									
				Horizon Depth (m), Boundary	Field Texture	Structure, Strength	Inclusions Segregations	Colour, Mottle, Bleaching	Moisture, Drainage	Roots	Depth (m) / Field pH	Sample (m)	Observations
GUP Mid-slope <2.0/<2.0	Grasses	Nil microrelief Extensive disturbance Nil erosion	Firm, Nil coarse fragments	A1 0.00-0.15 Abrupt	Sandy clay loam	Weak to moderate. Soft, sub rounded <10mm	Nil inclusions and segregations	10YR3/2 Very dark greyish brown Nil mottles/bleaching	Dry, well	Present	0.10 / 7.0	0.00-0.10 0.20-0.30 0.50-0.60 0.80-0.90 0.90-1.00	Nil additional observations
				B21 0.15-0.75 gradual	Light clay	Weak to moderate. Firm, sub rounded <20mm	Nil inclusions and segregations	10YR3/2 Very dark greyish brown Nil mottles/bleaching	Dry, moderate – well	Present	0.30 / 7.5 0.60 / 7.5

B22 0.75-1.00 EOBH	Light clay	Weak to moderate. Firm, sub rounded <20mm	Nil inclusions and segregations	10YR3/2 Very dark greyish brown Nil mottles/bleaching	Dry, moderate – well	Present	0.90 / 7.5

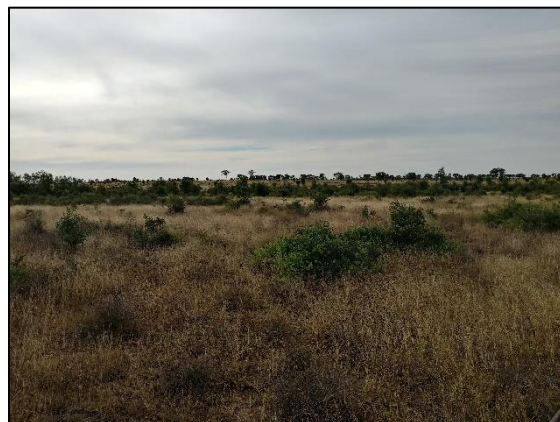
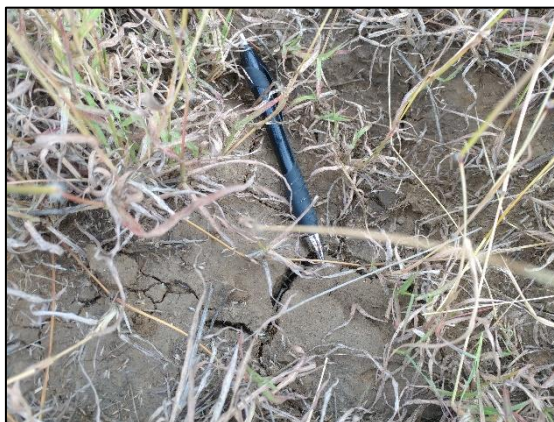
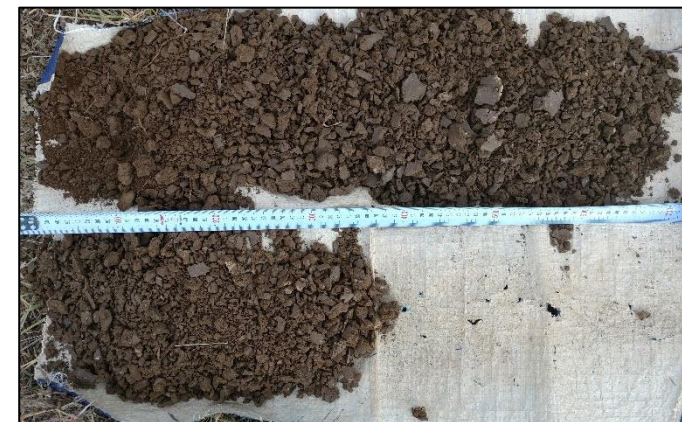
<b>Map Unit</b> 8	<b>Location (GDA94 ZONE 55):</b> 640810mE 7512936mN	<b>Aust. Soil Class.:</b> Black Dermosol	<b>Site Survey Type:</b> Detailed - 50mm hand auger	<b>Survey Date:</b> 05/06/2019
----------------------	--	---	--	-----------------------------------

Land use Landform Pattern, Element, Slope	Vegetation	Microrelief Disturbance Erosion	Surface condition, surface rock	Soil Profile Description									
				Horizon Depth (m), Boundary	Field Texture	Structure, Strength	Inclusions Segregations	Colour, Mottle, Bleaching	Moisture, Drainage	Roots	Depth (m) / Field pH	Sample (m)	Observations
GUP Mid-slope	Grasses	Nil microrelief Extensive disturbance Nil erosion	Firm. cracking, Nil coarse fragments	A1 0.00-0.15 Abrupt	Sandy clay loam	Weak to moderate. Soft, sub rounded <10mm	Nil inclusions and segregations	10YR3/2 Very dark greyish brown Nil mottles/bleaching	Dry, well	Present	0.10 / 7.0	0.00-0.10 0.20-0.30 0.50-0.60 0.80-0.90 0.90-1.00	Nil additional observations
				B21 0.15-0.75 gradual	Light clay	Weak to moderate. Firm, sub rounded <20mm	Nil inclusions and segregations	10YR3/2 Very dark greyish brown Nil mottles/bleaching	Dry, moderate – well	Present	0.30 / 7.5 0.60 / 7.5

B22 0.75-1.00 EOBH	Light clay	Weak to moderate. Firm, sub rounded <20mm	Nil inclusions and segregations	10YR3/2 Very dark greyish brown Nil mottles/bleaching	Dry, moderate – well	Present	0.90 / 7.5
