# Restoration Plan to Support RIDA Application Saraji East Project

Final V4  
15 July 2021

GT Environmental Pty Ltd  
[www.gtenvironmental.com.au](http://www.gtenvironmental.com.au)

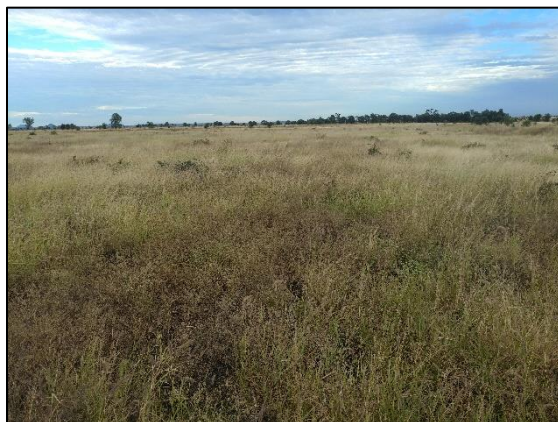
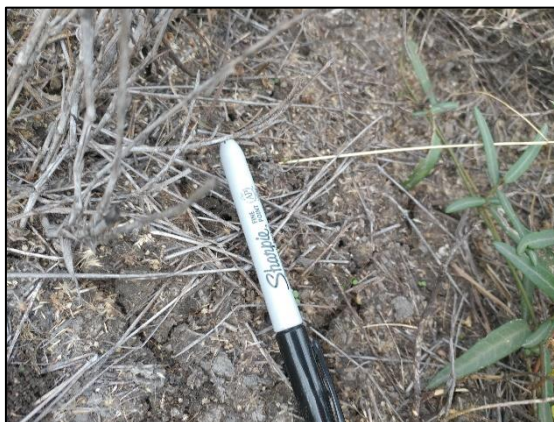
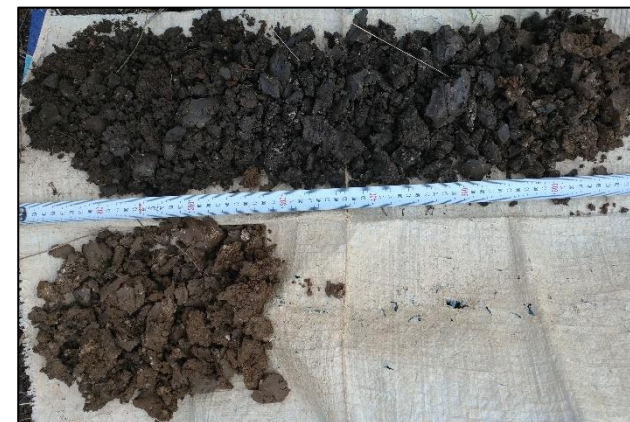
<b>Map Unit</b> 3	<b>Location (GDA94 ZONE 55):</b> 643200mE 7514334mN	<b>Aust. Soil Class.:</b> Black Vertosol	<b>Site Survey Type:</b> Detailed - 50mm hand auger	<b>Survey Date:</b> 06/06/2019
----------------------	--	---	--	-----------------------------------

Land use Landform Pattern, Element, Slope	Vegetation	Microrelief Disturbance Erosion	Surface condition, surface rock	Soil Profile Description									
				Horizon Depth (m), Boundary	Field Texture	Structure, Strength	Inclusions Segregations	Colour, Mottle, Bleaching	Moisture, Drainage	Roots	Depth (m) / Field pH	Sample (m)	Observations
Grazing, upper-slope, 1%/2% slope	Grasses	Nil microrelief  Nil erosion  Extensively disturbed	Self-mulching, Nil coarse fragments	A1 0.0 – 0.15 Abrupt	Light clay	Moderate, Sub- rounded, peds <10 mm, soft	Nil inclusions or segregations	10YR3/2 Very dark greyish brown Nil mottles	Dry, well drained	Fine, very few	0.10 / 7.0	0.00-0.10 0.20-0.30 0.55-0.60 0.80-0.90 0.90-1.00	Nil additional observations
				B21 0.15 – 0.55 Abrupt	Medium clay	Moderate, Subangular blocky, peds <20 mm, firm	Nil inclusions or segregations	10YR2/1 Black 2% brown mottle	Dry, well drained	Very fine, very few	0.30 / 7.5

B22 0.55 – 1.00 EOBH	Medium clay	Strong, Subangular blocky, peds <20 mm, firm	<2% calcium carbonate	7.5YR3/2 Dark brown Nil mottles	Dry, moderately well drained	Nil roots	0.60 / 7.0 0.90 / 7.0

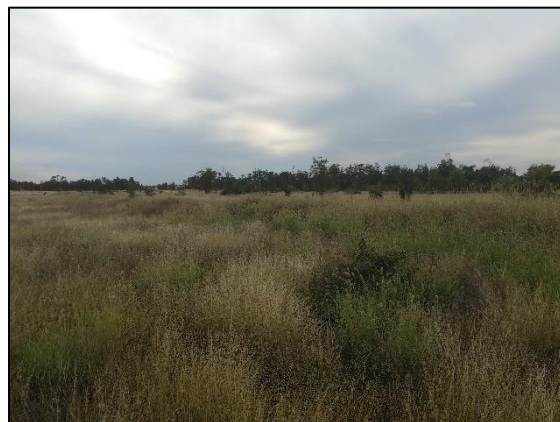
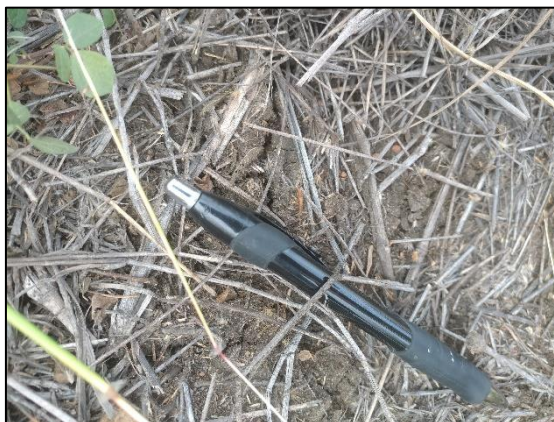
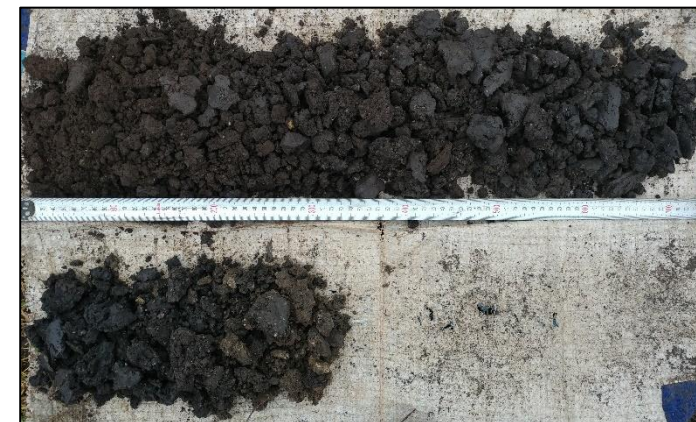
<b>Map Unit</b> 3	<b>Location (GDA94 ZONE 55):</b> 643734mE 7514136mN	<b>Aust. Soil Class.:</b> Black Vertosol	<b>Site Survey Type:</b> Detailed - 50mm hand auger	<b>Survey Date:</b> 06/06/2019
----------------------	--	---	--	-----------------------------------

Land use Landform Pattern, Element, Slope	Vegetation	Microrelief Disturbance Erosion	Surface condition, surface rock	Soil Profile Description									
				Horizon Depth (m), Boundary	Field Texture	Structure, Strength	Inclusions Segregations	Colour, Mottle, Bleaching	Moisture, Drainage	Roots	Depth (m) / Field pH	Sample (m)	Observations
Grazing, upper-slope, 1%/1% slope	Grasses	Nil microrelief  Nil erosion  extensively disturbed	Self- mulching, Nil coarse fragments	A1 0.0 – 0.12 Abrupt	Light clay	Moderate, Sub- rounded, peds <10 mm, soft	Nil inclusions or segregations	10YR3/2 Very dark greyish brown Nil mottles	Humid, well drained	Fine, very few	0.10 / 6.5	0.00-0.10 0.20-0.30 0.50-0.60 0.80-0.90 0.90-1.00	Nil additional observations
				B21 0.12 – 0.40 Abrupt	Medium clay	Moderate, Subangular blocky, peds <20 mm, firm	Nil inclusions or segregations	10YR3/2 Very dark greyish brown Nil mottles	Dry, well drained	Very fine, very few	0.30 / 6.5

B22 0.40 – 0.50 Abrupt	Medium clay	Moderate, Subangular blocky, peds <20 mm, very firm	Nil inclusions or segregations	7.5YR3/3 Dark brown 5% brown mottle	Dry, well drained	Very fine, very few	0.45 / 7.0		
				B23 0.50 – 0.80 Abrupt	Medium clay	Strong, Subangular blocky, peds <20 mm, very firm	<1% calcium carbonate	10YR3/2 Very dark greyish brown Nil mottles	Dry, moderately well drained	Nil roots	0.60 / 7.0		
				B24 0.80 – 1.00 EOBH	Medium clay	Strong, Subangular blocky, peds <20 mm, very firm	<2% calcium carbonate	10YR3/2 Nil mottles 5% brown mottle	Dry, moderately well drained	Nil roots	0.90 / 7.0

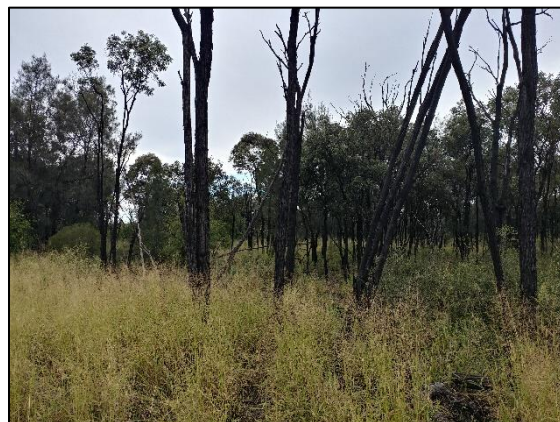
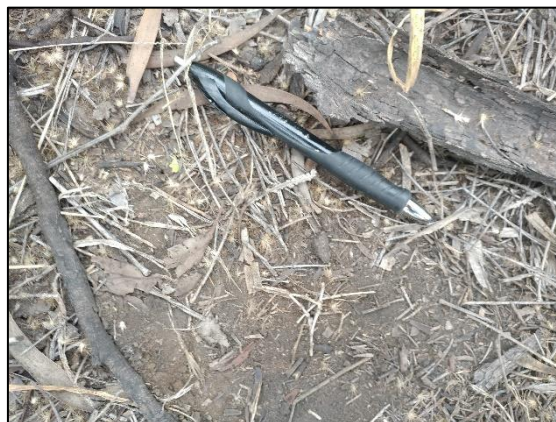
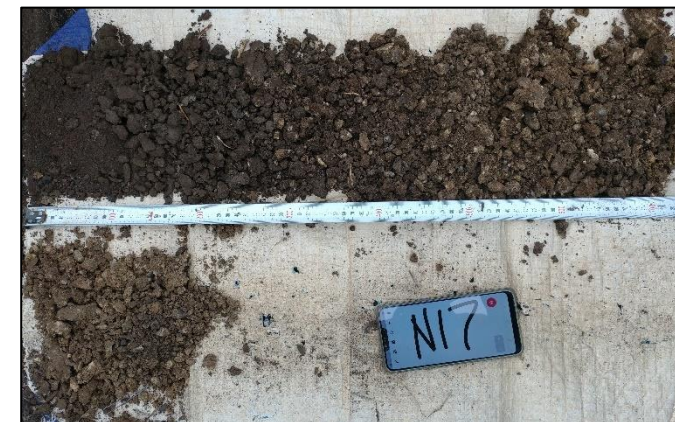
<b>Map Unit</b> 2	<b>Location (GDA94 ZONE 55):</b> 643797mE 7514822mN	<b>Aust. Soil Class.:</b> Black Sodosol	<b>Site Survey Type:</b> Detailed - 50mm hand auger	<b>Survey Date:</b> 06/06/2019
----------------------	--	--	--	-----------------------------------

Land use Landform Pattern, Element, Slope	Vegetation	Microrelief Disturbance Erosion	Surface condition, surface rock	Soil Profile Description									
				Horizon Depth (m), Boundary	Field Texture	Structure, Strength	Inclusions Segregations	Colour, Mottle, Bleaching	Moisture, Drainage	Roots	Depth (m) / Field pH	Sample (m)	Observations
Grazing GUP Stream channel / Depression <2% / <2%	Brigalow, Mount Coolibah	Nil microrelief Nil disturbance Nil erosion	Soft, Nil coarse fragments	A1 0.00-0.10 Abrupt	Loamy sand	Massive, loose	<1% coarse fragments	10YR3/1 Very dark grey Nil mottles / bleaching	Dry, well	Present	0.10 / 8.5	0.00-0.10 0.10-0.20 0.20-0.30 0.50-0.60 0.80-0.88	Nil additional observations
				B21 0.10-0.20 Abrupt	Sandy loam	Moderate, very firm sub- angular <20mm	<1% coarse fragments	10YR3/1 Very dark grey Nil mottles / bleaching	Dry, well – moderate	Present	0.20 / 8.5		
				B22 0.20-0.47 Abrupt	Sandy loam	Moderate, very firm sub- angular <10mm	<10% coarse fragments	10YR3/1 Very dark grey Nil mottles / bleaching	Dry, well – moderate	Present	0.30 / 8.5

B23 0.47-0.88 EOBH	Sandy loam	Moderate, very firm sub- angular <10mm	<20% coarse fragments	10YR4/2 Brown Nil mottles / bleaching	Dry, well – moderate	Present – 0.60mbgl	0.60 / 8.5

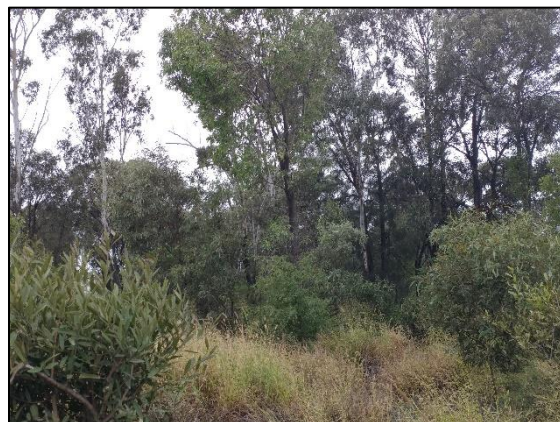
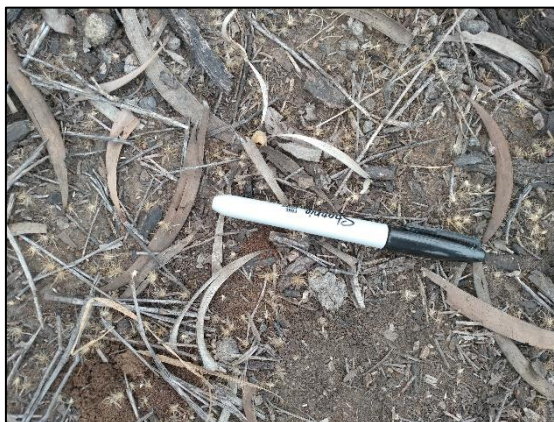
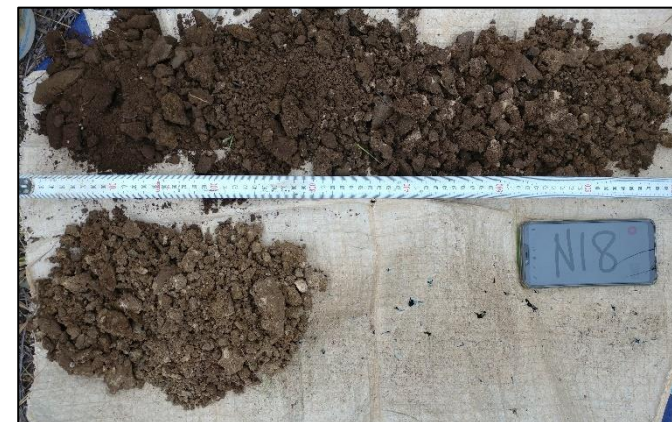
<b>Map Unit</b> 2	<b>Location (GDA94 ZONE 55):</b> 643600mE 7514680mN	<b>Aust. Soil Class.:</b> Black Sodosol	<b>Site Survey Type:</b> Detailed - 50mm hand auger	<b>Survey Date:</b> 06/06/2019
----------------------	--	--	--	-----------------------------------

Land use Landform Pattern, Element, Slope	Vegetation	Microrelief Disturbance Erosion	Surface condition, surface rock	Soil Profile Description									
				Horizon Depth (m), Boundary	Field Texture	Structure, Strength	Inclusions Segregations	Colour, Mottle, Bleaching	Moisture, Drainage	Roots	Depth (m) / Field pH	Sample (m)	Observations
GUP mid slope <1% / <1%	Brigalow, Mount Coolibah	Nil micro relief Nil disturbance Nil erosion	Soft, Nil coarse fragments	A1 0.00-0.14 Abrupt	Loamy sand	Massive, loose	<1% coarse fragments	10YR3/1 Very dark grey Nil mottles / bleaching	Dry, well	Present	0.10 / 8.5	0.00-0.10 0.20-0.30 0.50-0.60 0.80-0.90 0.90-1.00	Nil additional observations
				B21 0.14-0.32 Abrupt	Sandy loam	Moderate, very firm sub- angular <20mm	<1% coarse fragments	10YR3/1 Very dark grey Nil mottles / bleaching	Dry, well – moderate	Present	0.20 / 8.5		
				B22 0.32-0.60 Diffused	Sandy loam	Moderate, very firm sub- angular <10mm	<10% coarse fragments	10YR3/1 Very dark grey 2% 10YR6/4 mottle. Nil bleaching	Dry, well – moderate	Present	0.30 / 8.5

B23 0.60-1.00 EOBH	Sandy loam	Moderate, very firm sub- angular <10mm	<20% coarse fragments	10YR4/2 Brown Nil mottles / bleaching	Dry, well – moderate	Present – 0.60mbgl	0.60 / 8.5

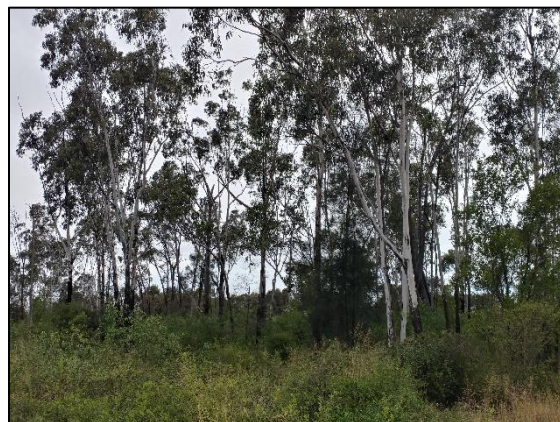
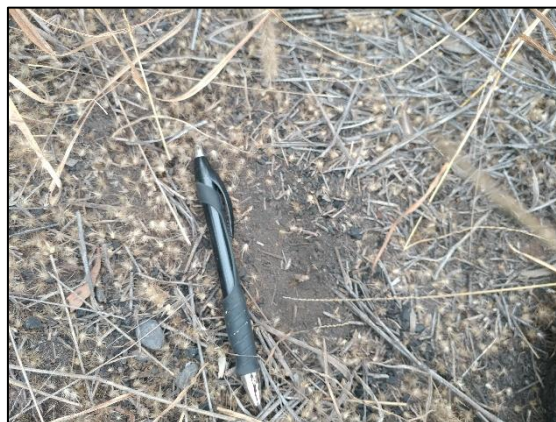
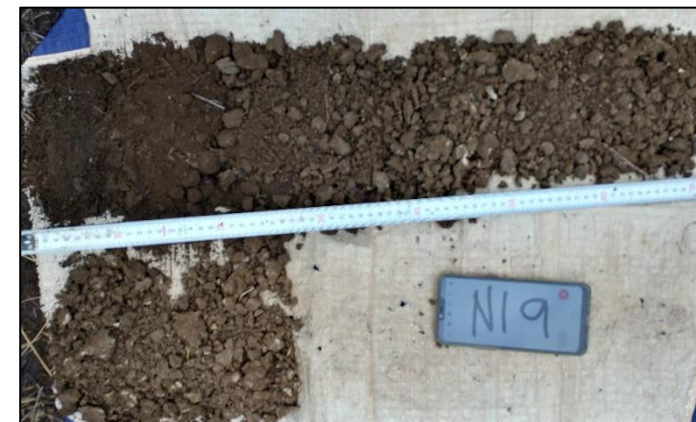
<b>Map Unit</b> 2	<b>Location (GDA94 ZONE 55):</b> 643668mE 7514813mN	<b>Aust. Soil Class.:</b> Black Sodosol	<b>Site Survey Type:</b> Detailed - 50mm hand auger	<b>Survey Date:</b> 06/06/2019
----------------------	--	--	--	-----------------------------------

Land use Landform Pattern, Element, Slope	Vegetation	Microrelief Disturbance Erosion	Surface condition, surface rock	Soil Profile Description									
				Horizon Depth (m), Boundary	Field Texture	Structure, Strength	Inclusions Segregations	Colour, Mottle, Bleaching	Moisture, Drainage	Roots	Depth (m) / Field pH	Sample (m)	Observations
GUP Upper slope <2% / <2%	Brigalow, Mount Coolibah	Nil micro relief Nil disturbance Nil erosion	Soft, Nil coarse fragments	A1 0.00-0.18 Abrupt	Loamy sand	Massive, loose	<1% coarse fragments	10YR3/1 Very dark grey Nil mottles / bleaching	Dry, well	Present	0.10 / 8.5	0.00-0.10 0.20-0.30 0.50-0.60 0.80-0.90 0.90-0.95	Nil additional observations
				B21 0.18-0.33 Abrupt	Sandy loam	Moderate, very firm sub-angular <20mm	<1% coarse fragments	10YR3/1 Very dark grey Nil mottles / bleaching	Dry, well – moderate	Present	0.20 / 8.5		
				B22 0.33-0.68 Diffuse	Sandy loam	Moderate, very firm sub-angular <10mm	<10% coarse fragments	10YR3/1 Very dark grey 2% 10YR6/4 mottle. Nil bleaching	Dry, well – moderate	Present	0.30 / 8.5

B23 0.68-0.95 EOBH	Sandy loam	Moderate, very firm sub-angular <10mm	<20% coarse fragments	10YR4/2 Brown Nil mottles / bleaching	Dry, well – moderate	Present – 0.60mbgl	0.60 / 8.5

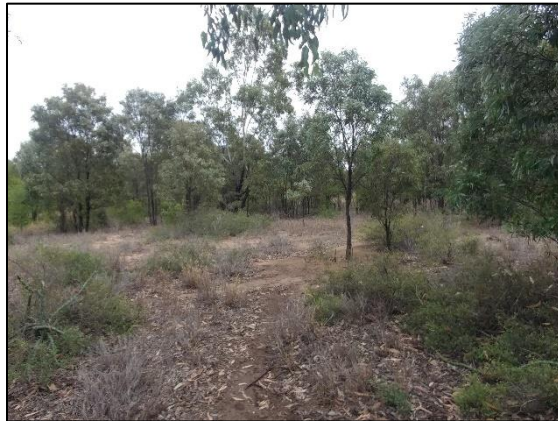
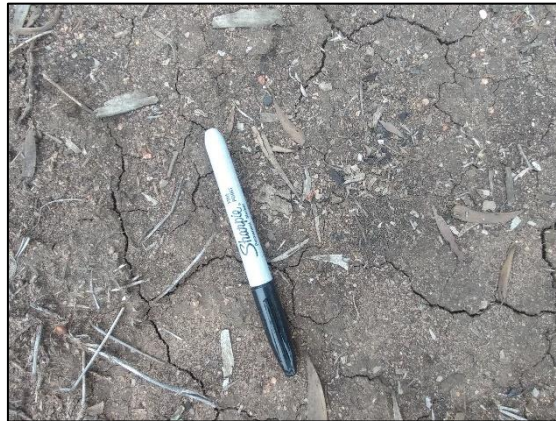
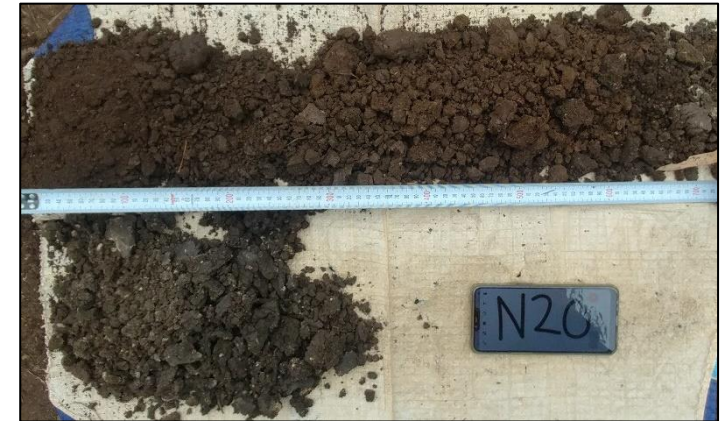
<b>Map Unit</b> 4	<b>Location (GDA94 ZONE 55):</b> 642943mE 7513907mN	<b>Aust. Soil Class.:</b> Black Dermosol	<b>Site Survey Type:</b> Detailed - 50mm hand auger	<b>Survey Date:</b> 07/06/2019
----------------------	--	---	--	-----------------------------------

Land use Landform Pattern, Element, Slope	Vegetation	Microrelief Disturbance Erosion	Surface condition, surface rock	Soil Profile Description									
				Horizon Depth (m), Boundary	Field Texture	Structure, Strength	Inclusions Segregations	Colour, Mottle, Bleaching	Moisture, Drainage	Roots	Depth (m) / Field pH	Sample (m)	Observations
Grazing Alluvial near stream channel 1% / 0%	Brigalow	Nil microrelief Nil disturbance Nearby sheet / gully erosion	Soft, <10% coarse fragments <5mm	A1 0.00-0.12 Abrupt	Sandy loam	Weak to moderate, soft sub-rounded <10mm	Nil inclusions / segregations	10YR3/1 Very dark grey Nil mottles / bleaching	Dry, well	Present	0.10 / 8.5	0.00-0.10 0.20-0.30 0.50-0.60 0.75-0.85 0.90-1.00	Nil additional observations
				B21 0.12-0.37 Abrupt	Sandy loam	Moderate, firm sub-rounded <10mm	Nil inclusions / segregations	10YR3/2 Very dark greyish brown Nil mottles / bleaching	Dry, well – moderate	Present	0.20 / 8.5

B22 0.37-0.68 Abrupt	Sandy loam	Moderate, firm sub-rounded <20mm	<2% calcium carbonate	7.5YR3/2 Dark brown Nil mottle / bleaching	Dry, well – moderate	Present	0.30 / 8.5		
				B23 0.68-0.85 Abrupt	Sandy clay loam	Moderate, very firm sub-rounded <20mm	<20% calcium carbonate	10YR3/2 Very dark greyish brown Nil mottles / bleaching	Dry, well – moderate	Present	-		
				B24 0.85-1.00 EOBH	Sandy clay loam	Moderate, very firm sub-rounded <20mm	<5% calcium carbonate	10YR3/2 Very dark greyish brown Nil mottles / bleaching	Dry, well – moderate	-	0.90 / 8.5

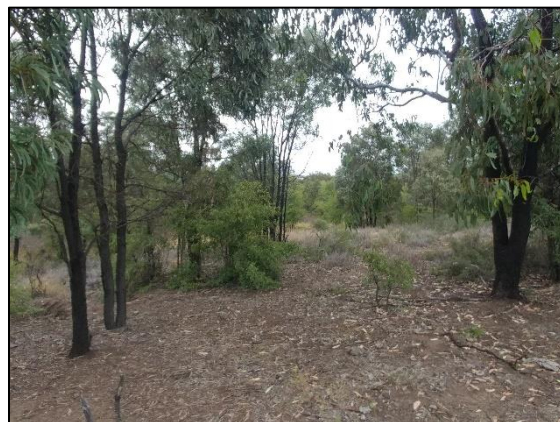
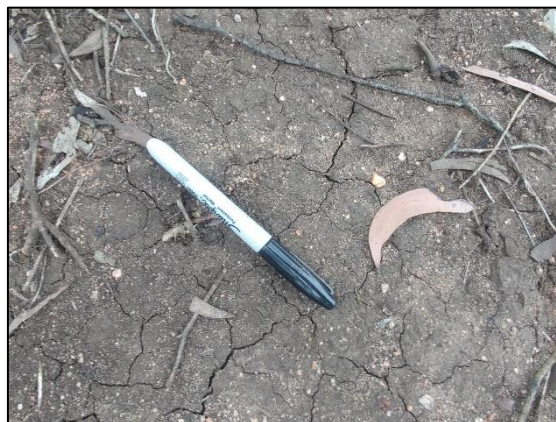
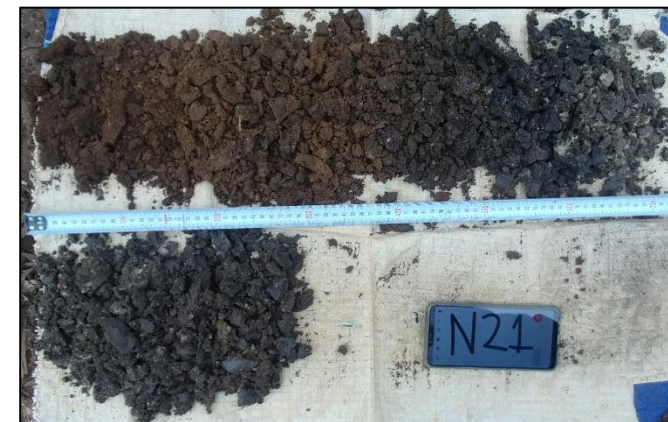
<b>Map Unit</b> 4	<b>Location (GDA94 ZONE 55):</b> 642847mE 7513907mN	<b>Aust. Soil Class.:</b> Black Dermosol	<b>Site Survey Type:</b> Detailed - 50mm hand auger	<b>Survey Date:</b> 07/06/2019
----------------------	--	---	--	-----------------------------------

Land use Landform Pattern, Element, Slope	Vegetation	Microrelief Disturbance Erosion	Surface condition, surface rock	Soil Profile Description									
				Horizon Depth (m), Boundary	Field Texture	Structure, Strength	Inclusions Segregations	Colour, Mottle, Bleaching	Moisture, Drainage	Roots	Depth (m) / Field pH	Sample (m)	Observations
Grazing Alluvial near stream channel 1% / 0%	Brigalow	Nil microrelief Nil disturbance Nearby sheet / gully erosion	Soft, <10% coarse fragments <5mm	A1 0.00-0.10 Abrupt	Sandy loam	Weak to moderate, soft sub-rounded <10mm	Nil inclusions / segregations	10YR3/1 Very dark grey Nil mottles / bleaching	Dry, well	Present	0.10 / 7.5	0.00-0.10	Nil additional observations
				B21 0.10-0.40 Abrupt	Sandy loam	Moderate, firm sub- rounded <10mm	Nil inclusions / segregations	10YR3/2 Very dark greyish brown Nil mottles / bleaching	Dry, well – moderate	Present	0.20 / 8.5	0.20-0.30

B22 0.40-0.58 Abrupt	Sandy loam	Moderate, firm sub- rounded <20mm	<2% calcium carbonate	7.5YR3/2 Dark brown Nil mottle / bleaching	Dry, well – moderate	Present	0.30 / 8.5	0.50-0.60	
				B23 0.58-0.90 Abrupt	Sandy clay loam	Moderate, very firm sub-rounded <20mm	10% calcium carbonate	10YR3/2 Very dark greyish brown Nil mottles / bleaching	Dry, well – moderate	Present	-	0.80-0.90	
				B24 0.90-1.00 EOBH	Sandy clay loam	Moderate, very firm sub-rounded <20mm	<5% calcium carbonate	10YR3/2 Very dark greyish brown Nil mottles / bleaching	Dry, well – moderate			0.90-1.00

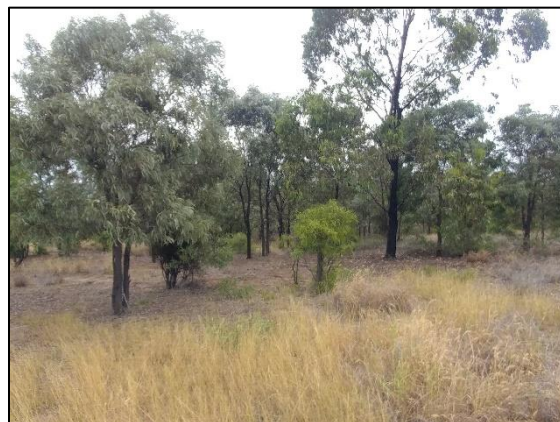
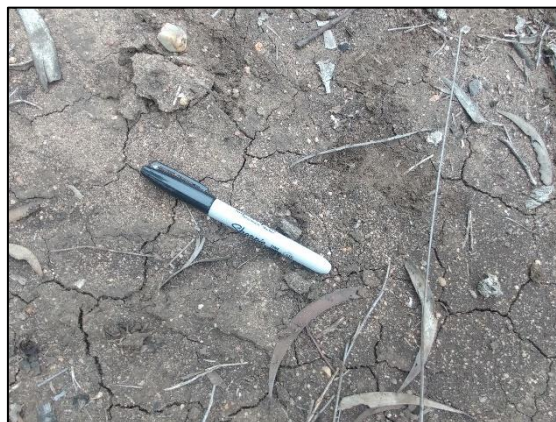
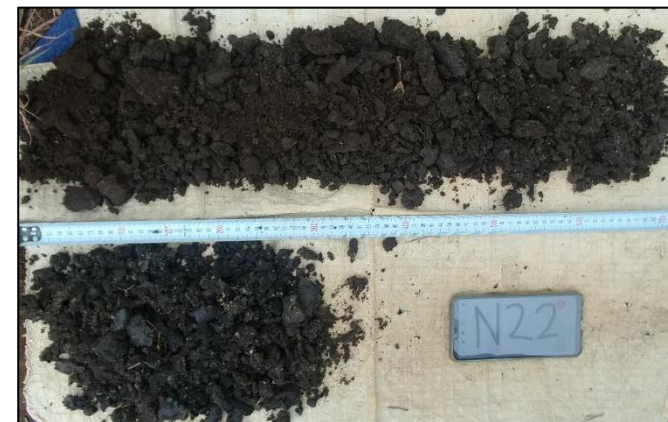
<b>Map Unit</b> 4	<b>Location (GDA94 ZONE 55):</b> 642838mE 7513991mN	<b>Aust. Soil Class.:</b> Black Dermosol	<b>Site Survey Type:</b> Detailed - 50mm hand auger	<b>Survey Date:</b> 07/06/2019
----------------------	--	---	--	-----------------------------------

Land use Landform Pattern, Element, Slope	Vegetation	Microrelief Disturbance Erosion	Surface condition, surface rock	Soil Profile Description									
				Horizon Depth (m), Boundary	Field Texture	Structure, Strength	Inclusions Segregations	Colour, Mottle, Bleaching	Moisture, Drainage	Roots	Depth (m) / Field pH	Sample (m)	Observations
Grazing Depression <1% / <1%	Brigalow woodlands	Nil microrelief Semi disturbance Minor sheet erosion	Soft, <10% coarse fragments <5mm	A1 0.00-0.11 Abrupt	Sandy loam	Weak to moderate, soft sub- rounded <10mm	Nil inclusions / segregations	10YR3/1 Very dark grey Nil mottles / bleaching	Dry, well	Present	0.10 / 7.5	0.00-0.10 0.20-0.30 0.50-0.60 0.80-0.90 0.90-1.00	Nil additional observations
				B21 0.11-0.48 Abrupt	Sandy loam	Moderate, firm sub- rounded <10mm	Nil inclusions / segregations	10YR3/1 Very dark grey Nil mottles / bleaching	Dry, well – moderate	Present	0.30 / 8.5

B22 0.48-1.00 EOBH	Sandy clay loam	Moderate, very firm sub- rounded <20mm	<5% calcium carbonate	10YR3/1 Very dark grey Nil mottles / bleaching	Dry, well – moderate	Present	0.60 / 8.5 0.90 / 8.5

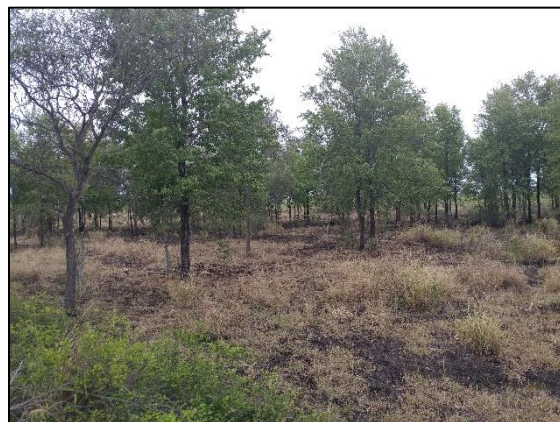
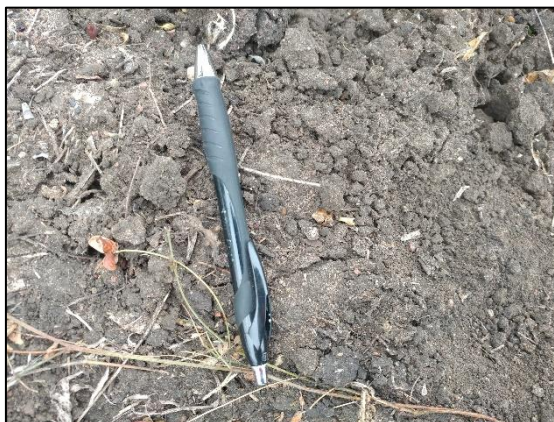
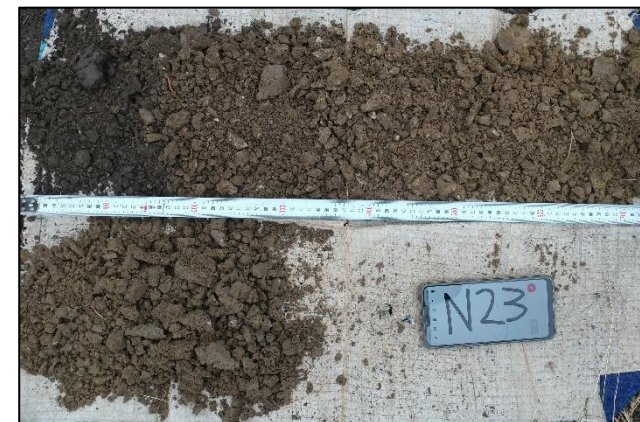
<b>Map Unit</b> 11	<b>Location (GDA94 ZONE 55):</b> 642506mE 7511103mN	<b>Aust. Soil Class.:</b> Grey Dermosol	<b>Site Survey Type:</b> Detailed - 50mm hand auger	<b>Survey Date:</b> 07/06/2019
-----------------------	--	--	--	-----------------------------------

Land use Landform Pattern, Element, Slope	Vegetation	Microrelief Disturbance Erosion	Surface condition, surface rock	Soil Profile Description									
				Horizon Depth (m), Boundary	Field Texture	Structure, Strength	Inclusions Segregations	Colour, Mottle, Bleaching	Moisture, Drainage	Roots	Depth (m) / Field pH	Sample (m)	Observations
Grazing Depression Alluvial / stream channel nearby <1% / <1%	Mixed vegetation	Nil microrelief Forage cropping nearby disturbance Nil erosion	Firm, crust with minor self-mulching Nil coarse fragments	A1 0.00-0.12 Abrupt	Clay loam	Weak, soft sub- rounded <10mm	Nil inclusions / segregations	10YR3/1 Very dark grey Nil mottles / bleaching	Dry, well	Present	0.10 / 8.5	0.00-0.10 0.20-0.30 0.50-0.60 0.80-0.90 0.90-1.00	Nil additional observations
				B21 0.12-0.48 gradual	Light clay	Weak to moderate, firm sub- rounded <10mm	<5% weathered rock	10YR4/2 Dark greyish brown Nil mottles / bleaching	Dry, well – moderate	Present	0.30 / 8.5

B22 0.48-1.00 EOBH	Light clay	Strong, very firm sub- rounded <20mm	<5% calcium carbonate	10YR4/2 Dark greyish brown Nil mottles / bleaching	Dry, well – moderate	Present	0.60 / 8.5 0.90 / 8.5

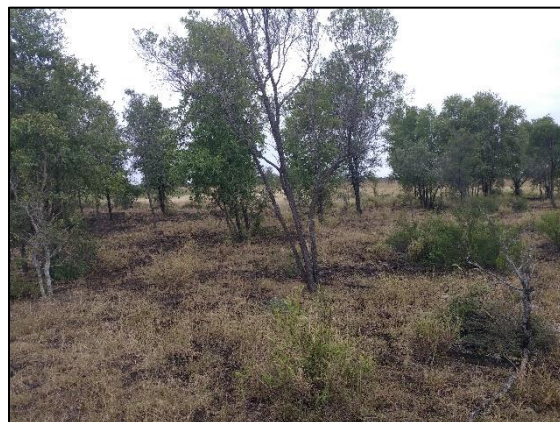
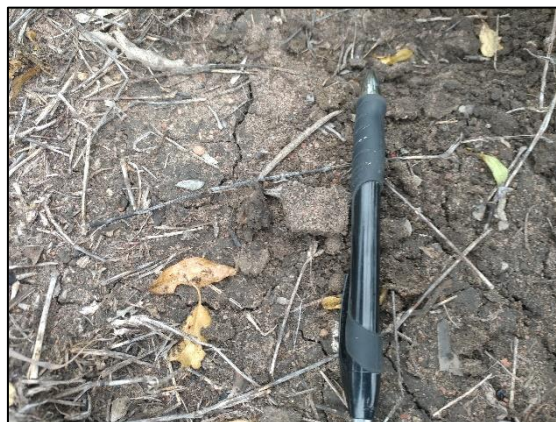
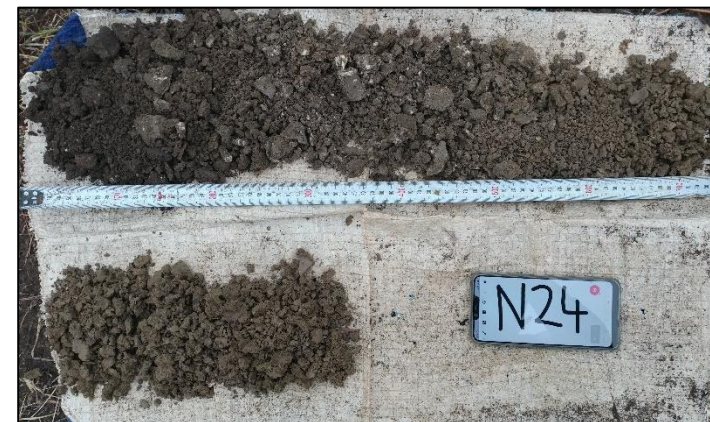
<b>Map Unit</b> 11	<b>Location (GDA94 ZONE 55):</b> 642250mE 7511049mN	<b>Aust. Soil Class.:</b> Grey Dermosol	<b>Site Survey Type:</b> Detailed - 50mm hand auger	<b>Survey Date:</b> 07/06/2019
-----------------------	--	--	--	-----------------------------------

Land use Landform Pattern, Element, Slope	Vegetation	Microrelief Disturbance Erosion	Surface condition, surface rock	Soil Profile Description									
				Horizon Depth (m), Boundary	Field Texture	Structure, Strength	Inclusions Segregations	Colour, Mottle, Bleaching	Moisture, Drainage	Roots	Depth (m) / Field pH	Sample (m)	Observations
Grazing Depression Alluvial / stream channel nearby <1% / <1%	Mixed vegetation	Nil microrelief Forage cropping nearby disturbance Nil erosion	Firm, crust Nil coarse fragments	A1 0.00-0.15 Abrupt	Clay loam	Weak, soft sub- rounded <10mm	Nil inclusions / segregations	10YR3/1 Very dark grey Nil mottles / bleaching	Dry, well	Present	0.10 / 8.5	0.00-0.10 0.20-0.30 0.50-0.60 0.80-0.90 0.90-1.00	Nil additional observations
				B21 0.15-0.50 gradual	Light clay	Weak to moderate, firm sub- rounded <10mm	<5% calcium carbonate	10YR4/2 Dark greyish brown Nil mottles / bleaching	Dry, well – moderate	Present	0.30 / 8.5

B22 0.50-1.00 EOBH	Light clay	Strong, very firm sub- rounded <20mm	Nil inclusions / segregations	10YR4/2 Dark greyish brown Nil mottles / bleaching	Dry, well – moderate	Present	0.60 / 8.5 0.90 / 8.5

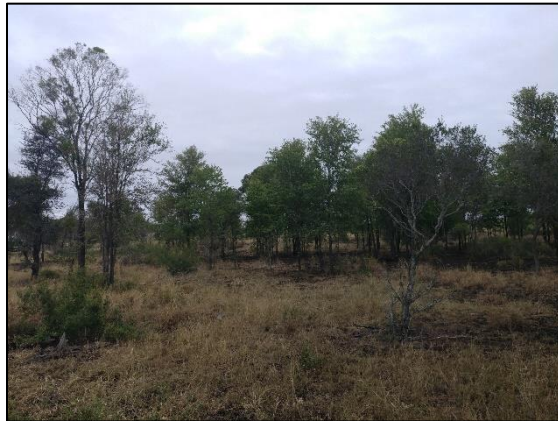
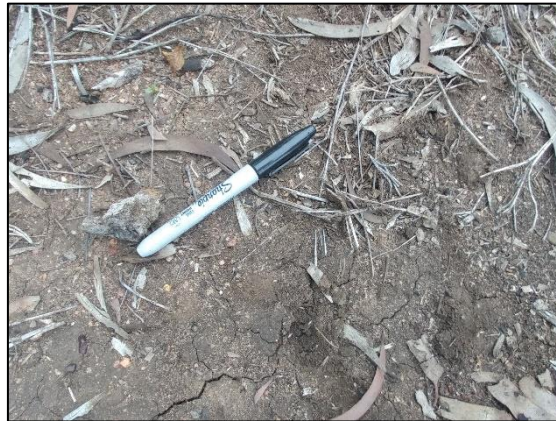
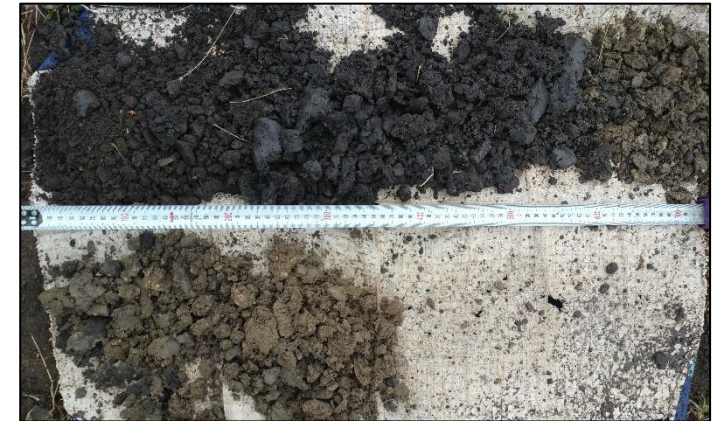
<b>Map Unit</b> 11	<b>Location (GDA94 ZONE 55):</b> 642810mE 7511185mN	<b>Aust. Soil Class.:</b> Grey Dermosol	<b>Site Survey Type:</b> Detailed - 50mm hand auger	<b>Survey Date:</b> 28/06/2019
-----------------------	--	--	--	-----------------------------------

Land use Landform Pattern, Element, Slope	Vegetation	Microrelief Disturbance Erosion	Surface condition, surface rock	Soil Profile Description									
				Horizon Depth (m), Boundary	Field Texture	Structure, Strength	Inclusions Segregations	Colour, Mottle, Bleaching	Moisture, Drainage	Roots	Depth (m) / Field pH	Sample (m)	Observations
Grazing Depression Alluvial / stream channel nearby <1% / <1%	Mixed vegetation	Nil microrelief Forage cropping nearby disturbance Nil erosion	Firm Nil coarse fragments	A1 0.00-0.12 Abrupt	Clay loam	Weak, soft sub- rounded <10mm	Nil inclusions / segregations	10YR3/1 Very dark grey Nil mottles / bleaching	Dry, well	Present	0.10 / 8.5	0.00-0.10 0.20-0.30 0.50-0.60 0.80-0.90 0.90-1.00	Nil additional observations
				B21 0.12-0.62 gradual	Light clay	Weak to moderate, firm sub- rounded <10mm	Nil inclusions / segregations	10YR4/2 Dark greyish brown Nil mottles / bleaching	Dry, well – moderate	Present	0.30 / 8.5

B22 0.62-1.00 EOBH	Light clay	Strong, very firm sub- rounded <20mm	<5% calcium carbonate	10YR4/2 Dark greyish brown Nil mottles / bleaching	Dry, well – moderate	Present	0.60 / 8.5 0.90 / 8.5

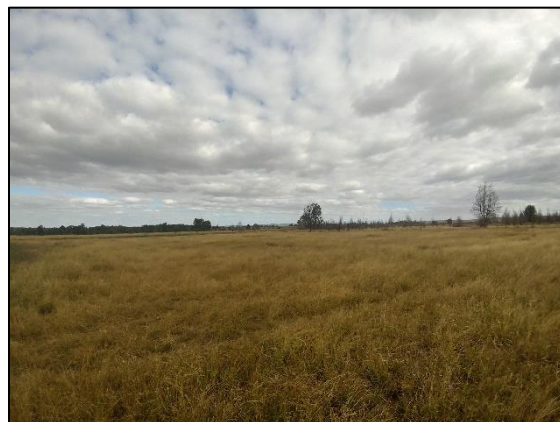
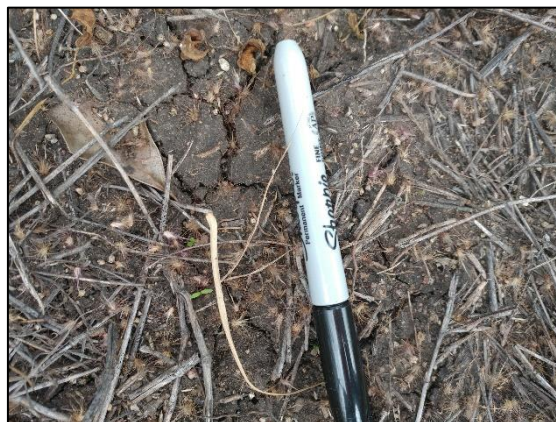
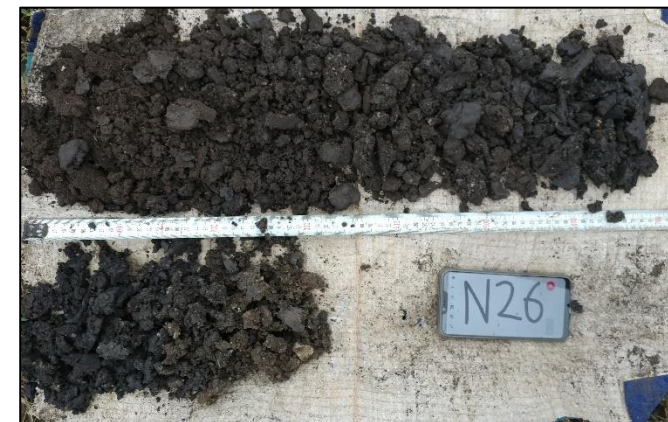
<b>Map Unit</b> 6	<b>Location (GDA94 ZONE 55):</b> 642370mE 7512434mN	<b>Aust. Soil Class.:</b> Black Dermosol	<b>Site Survey Type:</b> Detailed - 50mm hand auger	<b>Survey Date:</b> 28/06/2019
----------------------	--	---	--	-----------------------------------

Land use Landform Pattern, Element, Slope	Vegetation	Microrelief Disturbance Erosion	Surface condition, surface rock	Soil Profile Description									
				Horizon Depth (m), Boundary	Field Texture	Structure, Strength	Inclusions Segregations	Colour, Mottle, Bleaching	Moisture, Drainage	Roots	Depth (m) / Field pH	Sample (m)	Observations
Grazing GUP Lower slope 1% / 1%	Short grasses	Nil microrelief Extensive disturbance Nil erosion	Firm, crust Nil coarse fragments	A1 0.00-0.14 Clear	Sandy clay	Weak, soft sub- rounded <10mm	Nil inclusions / segregations	10YR3/1 Very dark grey Nil mottles/bleach	Dry, moderate	Few fine	0.10 / 6.0	0.00-0.10 0.20-0.30 0.50-0.60 0.80-0.90 0.90-1.00	Nil additional observations
				B21 0.14-0.33 clear	Medium clay	Weak to moderate, firm sub- rounded <10mm	Nil inclusions / segregations	10YR2/2 Very dark brown Nil mottles/bleach	Dry, moderate	Very fine, very few	0.30 / 6.5

B22 0.33-0.90 gradual	Medium clay	Moderate, firm sub- rounded <20mm	Nil inclusions / segregations	10YR3/3 Dark brown Nil mottles/bleach	Dry, moderate	Very fine, very few	0.60 / 7.0		
				B23 0.90-1.00 EOBH	Medium clay	Moderate, very firm sub- rounded <20mm	<2% calcium carbonate	10YR3/3 Dark brown Nil mottles/bleach	Dry, moderate	Very fine, very few	0.90 / 7.5

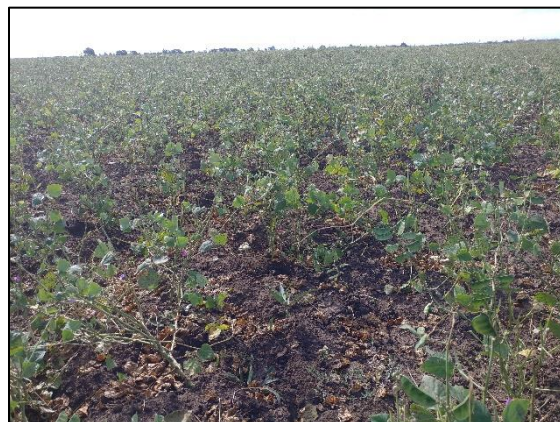
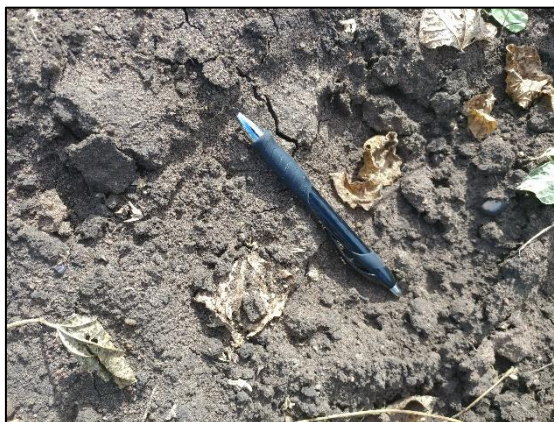
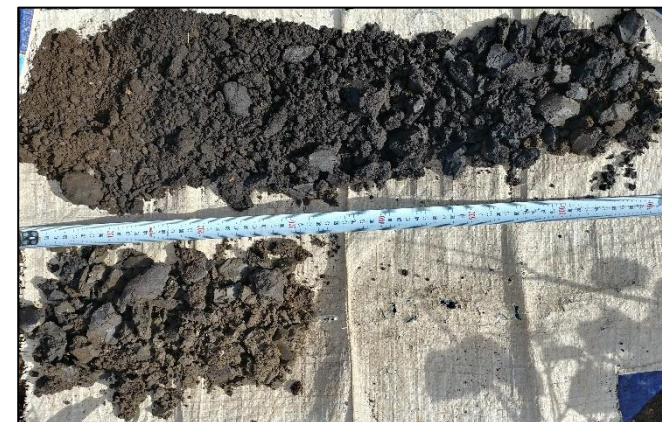
<b>Map Unit</b> 6	<b>Location (GDA94 ZONE 55):</b> 642614mE 7510764mN	<b>Aust. Soil Class.:</b> Black Dermosol	<b>Site Survey Type:</b> Detailed - 50mm hand auger	<b>Survey Date:</b> 28/06/2019
----------------------	--	---	--	-----------------------------------

Land use Landform Pattern, Element, Slope	Vegetation	Microrelief Disturbance Erosion	Surface condition, surface rock	Soil Profile Description									
				Horizon Depth (m), Boundary	Field Texture	Structure, Strength	Inclusions Segregations	Colour, Mottle, Bleaching	Moisture, Drainage	Roots	Depth (m) / Field pH	Sample (m)	Observations
Mid-slope, 1% slope	Forage cropping	Nil Microrelief  Nil erosion  Extensively cleared	Firm, Nil coarse fragments	A1 0.0 – 0.13 Abrupt	Sandy clay loam	Weak, sub- rounded peds 5-20 mm, firm	Nil inclusions or segregations	10YR3/1 Very dark grey Nil mottles	Humid, well drained	Fine, very few	0.10 / 6.5	0.00-0.10 0.20-0.30 0.50-0.60 0.80-0.90 0.90-1.00	Nil additional observations
				B21 0.13 – 0.50 gradual	Sandy clay loam	Moderate, peds 30-40 mm, very firm	Nil inclusions or segregations	10YR2/1 Black Nil mottles	Humid, well drained	Nil roots	0.30 / 6.5		
				B22 0.50 – 0.75 clear	Light clay, sandy	Subangular blocky, moderate, peds <20 mm, very firm	<2% calcium carbonate	10YR2/1 Nil mottles Black	Humid, moderately well drained	Nil roots	0.60 / 6.5

B23 0.75 – 1.00 EOBH	Medium clay, sandy	Subangular blocky, moderate, peds <20 mm, very firm	<2% calcium carbonate	10YR3/1 Very dark grey Nil mottles	Humid, moderately well drained	Nil roots	0.90 / 6.5

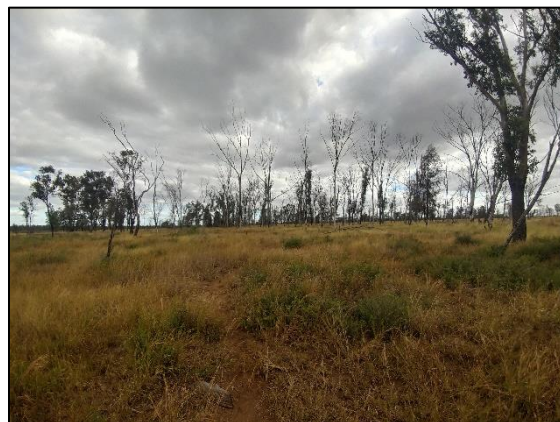
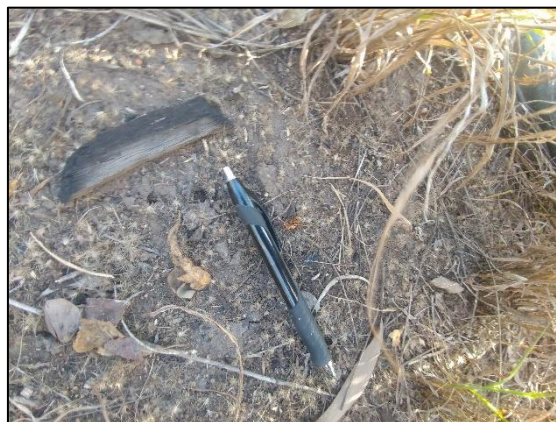
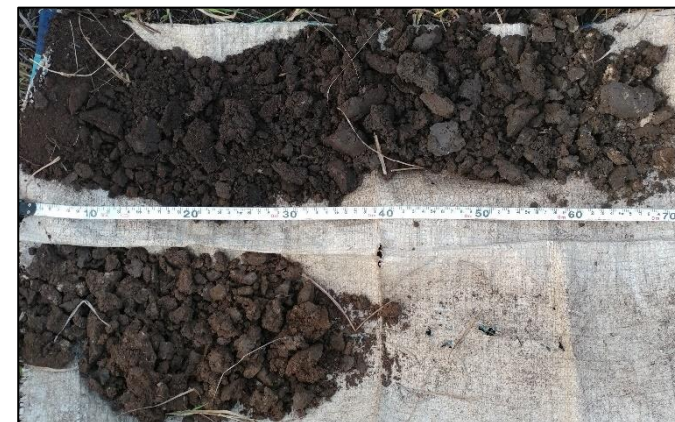
<b>Map Unit</b> 10	<b>Location (GDA94 ZONE 55):</b> 643924mE 7513310mN	<b>Aust. Soil Class.:</b> Black Sodosol	<b>Site Survey Type:</b> Detailed - 50mm hand auger	<b>Survey Date:</b> 28/07/2019
-----------------------	--	--	--	-----------------------------------

Land use Landform Pattern, Element, Slope	Vegetation	Microrelief Disturbance Erosion	Surface condition, surface rock	Soil Profile Description									
				Horizon Depth (m), Boundary	Field Texture	Structure, Strength	Inclusions Segregations	Colour, Mottle, Bleaching	Moisture, Drainage	Roots	Depth (m) / Field pH	Sample (m)	Observations
Grazing GUP lower slope <2% / <2%	Eucalyptus species	Nil microrelief Semi disturbed, contour banks nearby	Firm, Nil coarse fragments	A11 0.0 – 0.08 Abrupt	Sandy clay loam	Massive	Nil inclusions or segregations	10YR3/2 Very dark greyish brown Nil mottles / bleaching	Dry, well drained	Present	0.10 / 7.5	0.00-0.05 0.20-0.30 0.50-0.60 0.80-0.90 0.90-1.00	Nil additional observations
				A12 0.08 – 0.35 gradual	Sandy clay loam	Weak, sub- rounded peds <10 mm	Nil inclusions or segregations	10YR3/2 Very dark greyish brown Nil mottles / bleaching	Dry, well drained	Present	0.20 / 7.5

B22 0.35 – 0.60 gradual	Sandy clay loam	Subangular blocky, moderate, peds <20 mm, firm	Nil inclusions or segregations	10YR3/2 Very dark greyish brown Nil mottles / bleaching	Dry, well drained	Present	0.30 / 7.5		
				B23 0.60 – 1.00 EOBH	Medium clay, sandy	Subangular blocky, moderate, peds <20 mm, firm	<15% calcium carbonate	10YR3/3 Dark brown Nil mottles / bleaching	Dry, well – moderate drained	Present	0.60 / 7.5 0.90 / 7.5

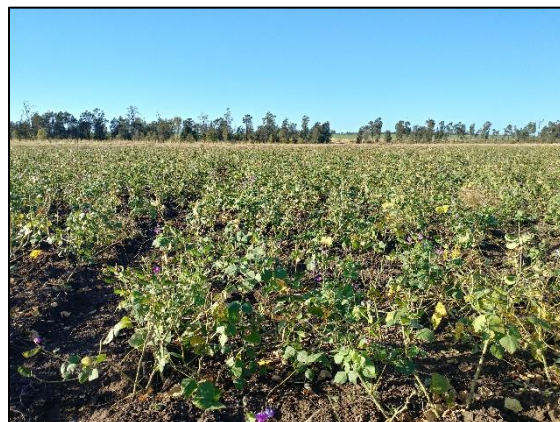
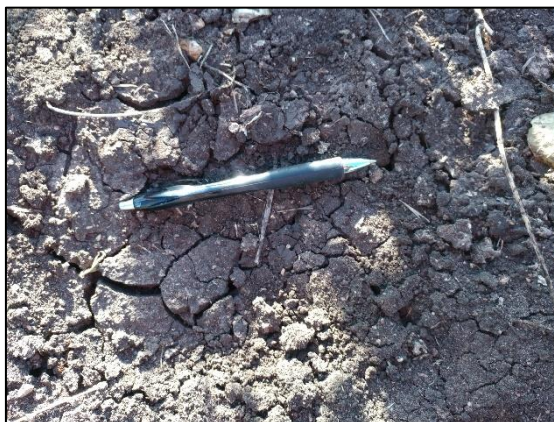
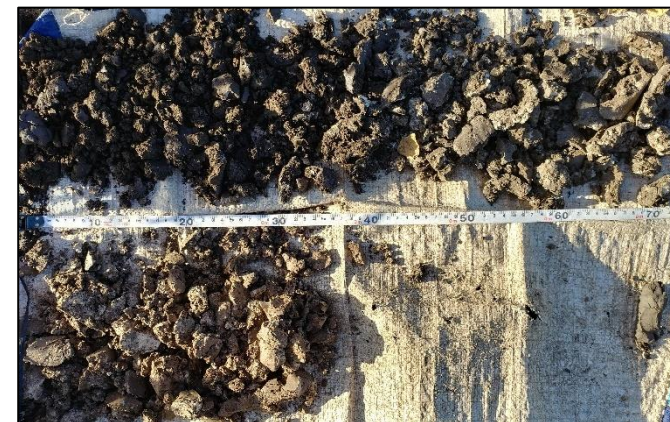
<b>Map Unit</b> 9	<b>Location (GDA94 ZONE 55):</b> 643062mE 7512049mN	<b>Aust. Soil Class.:</b> Black Vertosol	<b>Site Survey Type:</b> Detailed - 50mm hand auger	<b>Survey Date:</b> 28/06/2019
----------------------	--	---	--	-----------------------------------

Land use Landform Pattern, Element, Slope	Vegetation	Microrelief Disturbance Erosion	Surface condition, surface rock	Soil Profile Description									
				Horizon Depth (m), Boundary	Field Texture	Structure, Strength	Inclusions Segregations	Colour, Mottle, Bleaching	Moisture, Drainage	Roots	Depth (m) / Field pH	Sample (m)	Observations
Cropping / Grazing GUP mid slope 2% / 2%	Cropping	Nil microrelief Extensive disturbed, contour banks nearby	Cracking, self mulching Nil coarse fragments	A11 0.0 – 0.11 Abrupt	Light medium clay	Moderate, firm, sub- rounded peds <10 mm	<1% coarse fragments <2mm	10YR3/2 Very dark greyish brown Nil mottles / bleaching	Dry, well drained	Present	0.10 / 8.0	0.00-0.10 0.20-0.30 0.50-0.60 0.80-0.90 0.90-1.00	Nil additional observations
				B21 0.11 – 0.35 Abrupt	Medium clay	Moderate - strong, firm, sub-rounded peds 20 mm	<2% calcium carbonate	10YR3/2 Very dark greyish brown Nil mottles / bleaching	Dry, well- moderate drained	Present	0.30 / 8.0

B22 0.35 – 0.66 Clear	Medium clay	Moderate - strong, firm, sub-rounded peds 20 mm	<30% calcium carbonate	10YR3/2 Very dark greyish brown Nil mottles / bleaching	Dry, well- moderate drained	Present	0.60 / 8.0		
				B23 0.66 – 1.00 EOBH	Medium clay	Moderate - strong, firm, sub-rounded peds 20 mm	<20% calcium carbonate	10YR4/4 Dark yellowish brown Nil mottles / bleaching	Dry, well- moderate drained	Nil	0.90 / 8.0

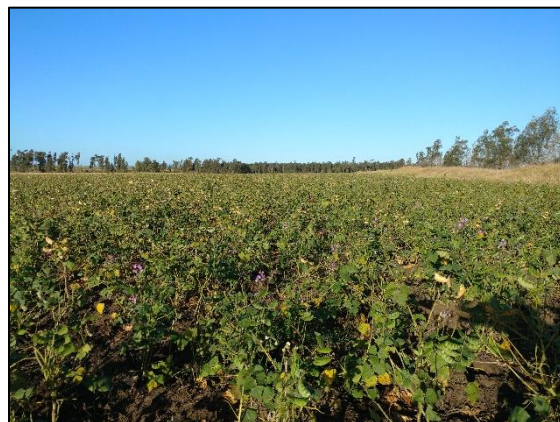
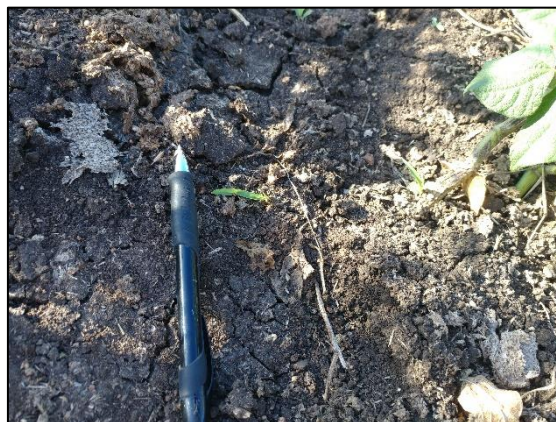
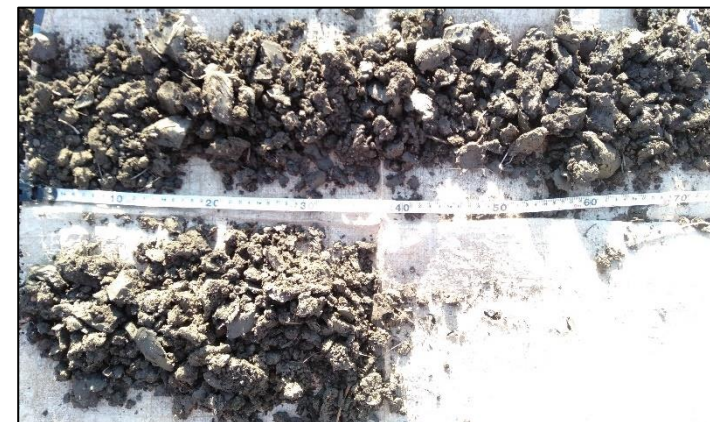
<b>Map Unit</b> 9	<b>Location (GDA94 ZONE 55):</b> 643464mE 7512936mN	<b>Aust. Soil Class.:</b> Black Vertosol	<b>Site Survey Type:</b> Detailed - 50mm hand auger	<b>Survey Date:</b> 29/06/2019
----------------------	--	---	--	-----------------------------------

Land use Landform Pattern, Element, Slope	Vegetation	Microrelief Disturbance Erosion	Surface condition, surface rock	Soil Profile Description									
				Horizon Depth (m), Boundary	Field Texture	Structure, Strength	Inclusions Segregations	Colour, Mottle, Bleaching	Moisture, Drainage	Roots	Depth (m) / Field pH	Sample (m)	Observations
Cropping / Grazing GUP upper slope 2% / 2%	Cropping	Nil microrelief Extensive disturbed, contour banks nearby	Cracking, self mulching, Nil coarse fragments	A11 0.0 – 0.11 Abrupt	Light medium clay	Moderate, firm, sub- rounded peds <10 mm	<1% coarse fragments <2mm	10YR3/2 Very dark greyish brown Nil mottles / bleaching	Dry, well drained	Present	0.10 / 8.0	0.00-0.10 0.20-0.30 0.50-0.60 0.80-0.90 0.90-1.00	Nil additional observations
				B21 0.11 – 0.35 Abrupt	Medium clay	Moderate - strong, firm, sub-rounded peds 20 mm	<2% calcium carbonate	10YR3/2 Very dark greyish brown Nil mottles / bleaching	Dry, well- moderate drained	Present	0.30 / 8.0

B22 0.35 – 0.66 Clear	Medium clay	Moderate - strong, firm, sub-rounded peds 20 mm	<30% calcium carbonate	10YR3/2 Very dark greyish brown Nil mottles / bleaching	Dry, well- moderate drained	Present	0.60 / 8.0		
				B23 0.66 – 1.00 EOBH	Medium clay	Moderate - strong, firm, sub-rounded peds 20 mm	<10% calcium carbonate	10YR4/4 Dark yellowish brown Nil mottles / bleaching	Dry, well- moderate drained	Nil	0.90 / 8.0

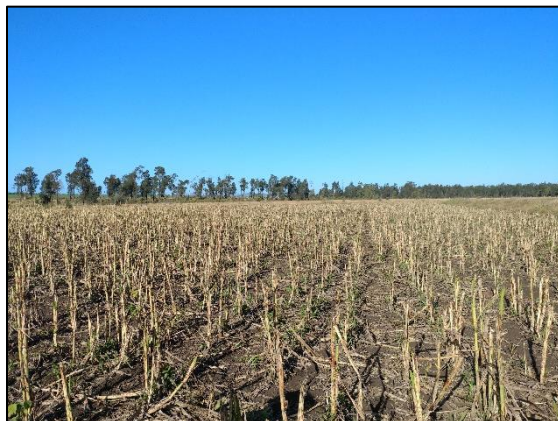
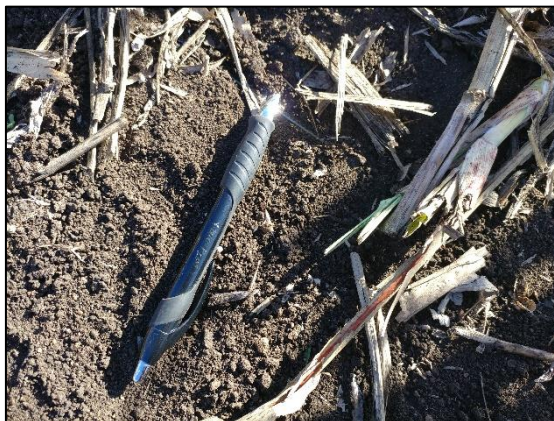
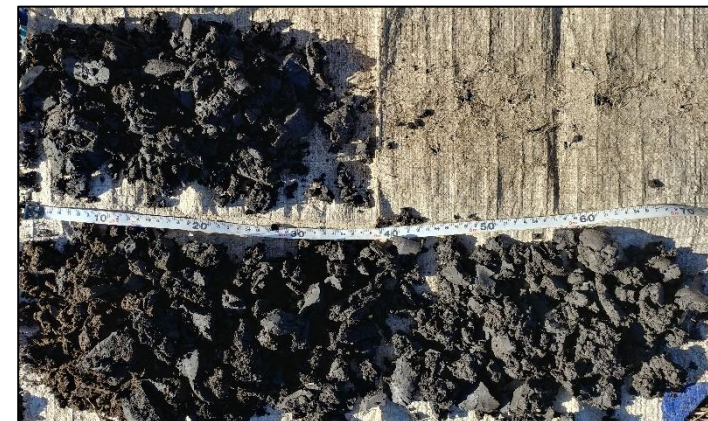
<b>Map Unit</b> 9	<b>Location (GDA94 ZONE 55):</b> 643487mE 7512205mN	<b>Aust. Soil Class.:</b> Black Vertosol	<b>Site Survey Type:</b> Detailed - 50mm hand auger	<b>Survey Date:</b> 29 29/06/2019
----------------------	--	---	--	--------------------------------------

Land use Landform Pattern, Element, Slope	Vegetation	Microrelief Disturbance Erosion	Surface condition, surface rock	Soil Profile Description									
				Horizon Depth (m), Boundary	Field Texture	Structure, Strength	Inclusions Segregations	Colour, Mottle, Bleaching	Moisture, Drainage	Roots	Depth (m) / Field pH	Sample (m)	Observations
Cropping / Grazing GUP Lower slope / flat plain <1% / 1%	Cropping	Nil microrelief Extensive disturbed, contour banks nearby	Firm, self mulching Nil coarse fragments	A11 0.0 – 0.10 Abrupt	Light clay	Weak, firm, sub- rounded peds <10 mm	Nil inclusions or segregations	10YR3/2 Very dark greyish brown Nil mottles / bleaching	Dry, well drained	Present	0.10 / 8.0	0.00-0.10 0.20-0.30 0.50-0.60 0.80-0.90 0.90-1.00	Nil additional observations
				B21 0.11 – 0.50 Abrupt	Medium clay	Moderate - strong, firm, sub- angular peds <20 mm	Nil inclusions or segregations	10YR3/1 Very dark grey Nil mottles / bleaching	Dry, well- moderate drained	Present	0.30 / 8.0

B22 0.50 – 1.00 EOBH	Medium clay	Moderate - strong, firm, sub- angular peds <20 mm	<2% calcium carbonate	10YR3/1 Very dark grey Nil mottles / bleaching	Dry, well- moderate drained	Present	0.60 / 7.0 0.90 / 7.0

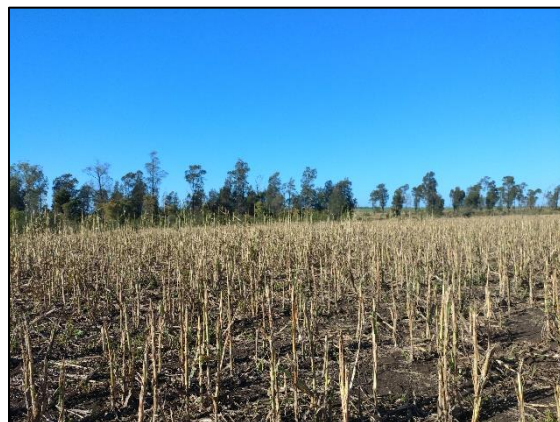
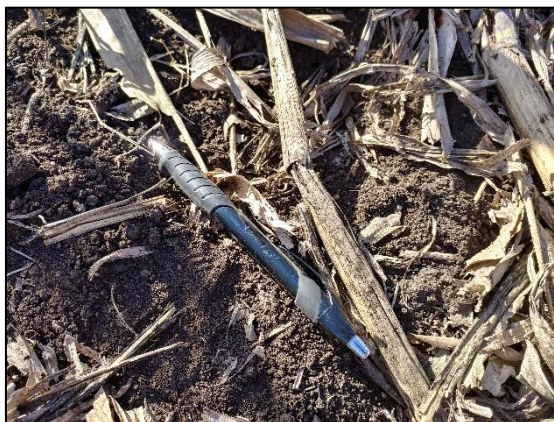
<b>Map Unit</b> 9	<b>Location (GDA94 ZONE 55):</b> 644077mE 7512794mN	<b>Aust. Soil Class.:</b> Black Vertosol	<b>Site Survey Type:</b> Detailed - 50mm hand auger	<b>Survey Date:</b> 29/06/2019
----------------------	--	---	--	-----------------------------------

Land use Landform Pattern, Element, Slope	Vegetation	Microrelief Disturbance Erosion	Surface condition, surface rock	Soil Profile Description									
				Horizon Depth (m), Boundary	Field Texture	Structure, Strength	Inclusions Segregations	Colour, Mottle, Bleaching	Moisture, Drainage	Roots	Depth (m) / Field pH	Sample (m)	Observations
Cropping / Grazing GUP Lower slope / flat plain <1% / 1%	Cropping	Nil microrelief Extensive disturbed, contour banks nearby	Firm, self mulching Nil coarse fragments	A11 0.0 – 0.10 Abrupt	Light clay	Weak, firm, sub- rounded peds <10 mm	Nil inclusions or segregations	10YR3/2 Very dark greyish brown Nil mottles / bleaching	Dry, well drained	Present	0.10 / 8.0	0.00-0.10 0.20-0.30 0.50-0.60 0.80-0.90 0.90-1.00	Nil additional observations
				B21 0.11 – 0.53 Abrupt	Medium clay	Moderate - strong, firm, sub- angular peds 20-40 mm	Nil inclusions or segregations	10YR3/1 Very dark grey Nil mottles / bleaching	Dry, well- moderate drained	Present	0.30 / 8.0

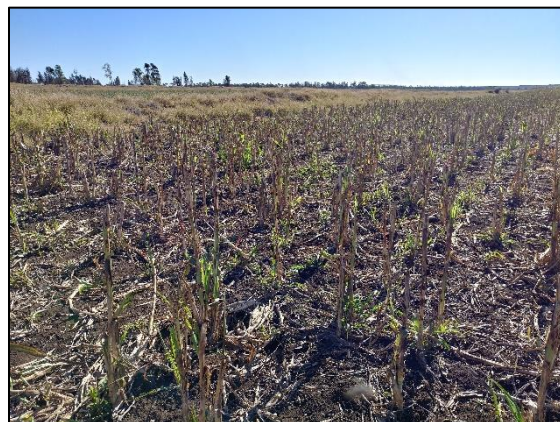
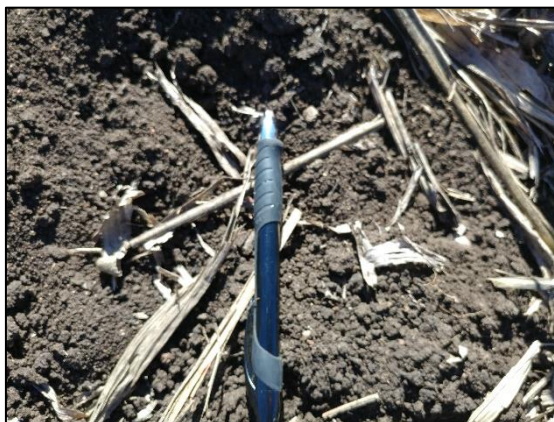
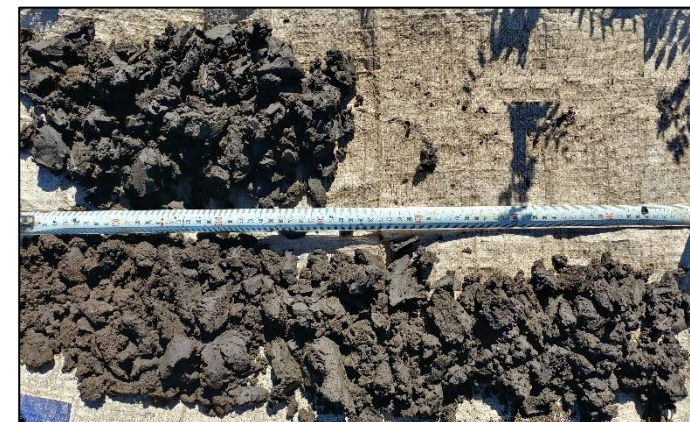
<b>Map Unit</b> 9	<b>Location (GDA94 ZONE 55):</b> 643707mE 7512426mN	<b>Aust. Soil Class.:</b> Black Vertosol	<b>Site Survey Type:</b> Detailed - 50mm hand auger	<b>Survey Date:</b> 29/06/2019
----------------------	--	---	--	-----------------------------------

Land use Landform Pattern, Element, Slope	Vegetation	Microrelief Disturbance Erosion	Surface condition, surface rock	Soil Profile Description									
				Horizon Depth (m), Boundary	Field Texture	Structure, Strength	Inclusions Segregations	Colour, Mottle, Bleaching	Moisture, Drainage	Roots	Depth (m) / Field pH	Sample (m)	Observations
Cropping / Grazing GUP Lower slope / flat plain <1% / 1%	Cropping	Nil microrelief Extensive disturbed, contour banks nearby	Self-mulching, firm, Nil coarse fragments	A11 0.0 – 0.12 Abrupt	Light clay	Weak, firm, sub-rounded peds <10 mm	Nil inclusions / segregations	10YR3/2 Very dark greyish brown Nil mottles / bleaching	Dry, well drained	Present	0.10 / 8.0	0.00-0.10 0.20-0.30 0.50-0.60 0.80-0.90 0.90-1.00	Nil additional observations
				B21 0.12 – 0.45 Abrupt	Medium clay	Moderate - strong, firm, sub-angular peds 20-40 mm	Nil inclusions / segregations	10YR3/1 Very dark grey Nil mottles / bleaching	Dry, well- moderate drained	Present	0.30 / 8.0

B22 0.45 – 0.60 Abrupt	Medium clay	Moderate - strong, firm, sub-angular peds 30-60 mm	Nil inclusions / segregations	10YR3/1 Very dark grey Nil mottles / bleaching	Dry, well- moderate drained	Present	0.60 / 7.0		
				B22 0.60 – 1.00 EOBH	Medium clay	Moderate - strong, firm, sub-angular peds 30-60 mm	<2% calcium carbonate	10YR3/1 Very dark grey Nil mottles / bleaching	Dry, well- moderate drained	Present	0.90 / 7.0
