# Restoration Plan to Support RIDA Application Saraji East Project

Final V4  
15 July 2021

GT Environmental Pty Ltd  
[www.gtenvironmental.com.au](http://www.gtenvironmental.com.au)

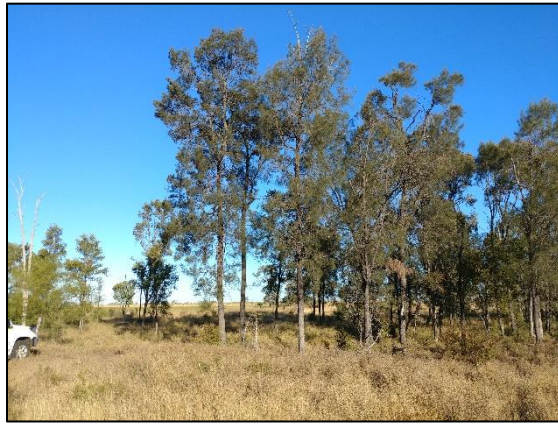
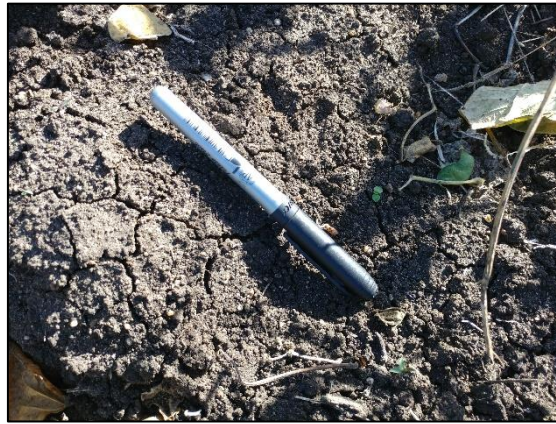
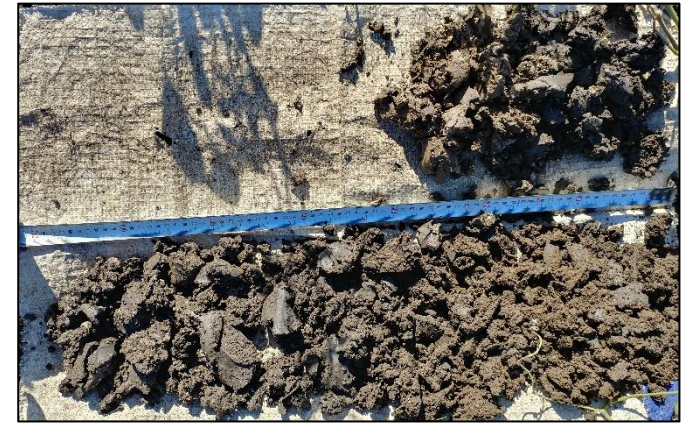
<b>Map Unit</b> 9	<b>Location (GDA94 ZONE 55):</b> 643069mE 7512379mN	<b>Aust. Soil Class.:</b> Black Vertosol	<b>Site Survey Type:</b> Detailed - 50mm hand auger	<b>Survey Date:</b> 29/06/2019
----------------------	--	---	--	-----------------------------------

<u>Land use</u> <u>Landform</u> <u>Pattern,</u> <u>Element,</u> <u>Slope</u>	<u>Vegetation</u>	<u>Microrelief</u> <u>Disturbance</u> <u>Erosion</u>	<u>Surface</u> <u>condition,</u> <u>surface rock</u>	<u>Soil Profile Description</u>									
				<u>Horizon</u> <u>Depth (m),</u> <u>Boundary</u>	<u>Field</u> <u>Texture</u>	<u>Structure,</u> <u>Strength</u>	<u>Inclusions</u> <u>Segregations</u>	<u>Colour, Mottle,</u> <u>Bleaching</u>	<u>Moisture,</u> <u>Drainage</u>	<u>Roots</u>	<u>Depth (m) /</u> <u>Field pH</u>	<u>Sample (m)</u>	<u>Observations</u>
Grazing GUP mid slope 2% / 2%	Grasses, tall woodland nearby	Nil microrelief Extensive disturbed, contour banks nearby	Self mulching, firm, Nil coarse fragments	A11 0.0 – 0.20 Abrupt	Light medium clay	Moderate, firm, sub- rounded peds < 10 mm	Nil inclusions / segregations	10YR3/2 Very dark greyish brown Nil mottles / bleaching	Dry, well drained	Present	0.10 / 8.0	0.00-0.10 0.20-0.30 0.50-0.60 0.80-0.90 0.90-1.00	Nil additional observations

B21 0.20 – 0.46 Abrupt	Medium clay	Moderate - strong, firm, sub-rounded peds 20 mm	Nil inclusions / segregations	10YR3/2 Very dark greyish brown Nil mottles / bleaching	Dry, well- moderate drained	Present	0.30 / 8.0		
				B22 0.46 – 0.80 Abrupt	Medium clay	Moderate - strong, firm, sub-rounded peds 20 mm	<2% calcium carbonate	10YR3/2 Very dark greyish brown Nil mottles / bleaching	Dry, well- moderate drained	Present	0.60 / 8.0		
				B23 0.80 – 1.00 EOBH	Medium clay	Moderate - strong, firm, sub-rounded peds 20 mm	<2% calcium carbonate	10YR4/4 Dark yellowish brown Nil mottles / bleaching	Dry, well- moderate drained	Nil	0.90 / 8.0

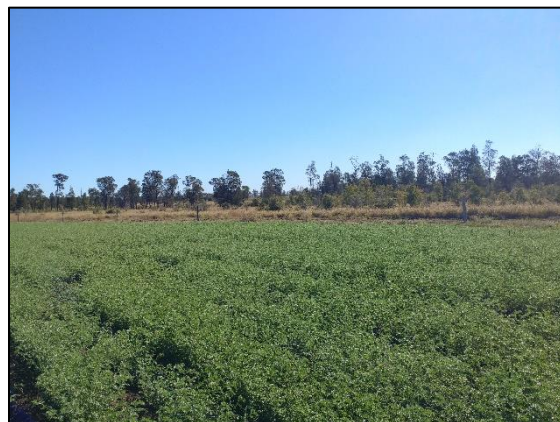
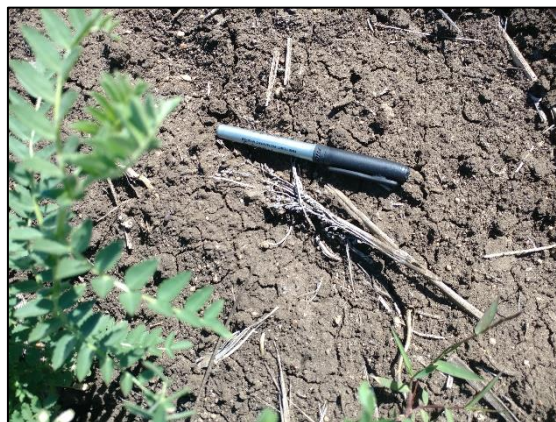
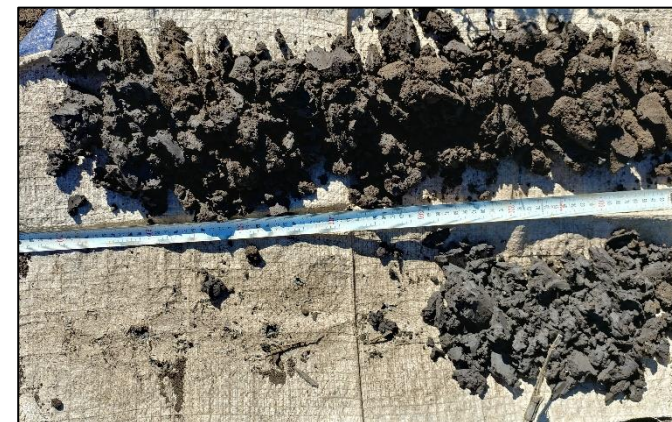
<b>Map Unit</b> 12	<b>Location (GDA94 ZONE 55):</b> 643659mE 7511986mN	<b>Aust. Soil Class.:</b> Black Vertosol	<b>Site Survey Type:</b> Detailed - 50mm hand auger	<b>Survey Date:</b> 29/06/2019
-----------------------	--	---	--	-----------------------------------

Land use Landform Pattern, Element, Slope	Vegetation	Microrelief Disturbance Erosion	Surface condition, surface rock	Soil Profile Description									
				Horizon Depth (m), Boundary	Field Texture	Structure, Strength	Inclusions Segregation s	Colour, Mottle, Bleaching	Moisture, Drainage	Roots	Depth (m) / Field pH	Sample (m)	Observations
Cropping / Grazing GUP mid slope 2% / 2%	Cropping	Nil microrelief Extensive disturbed, Nil erosion	Self-mulching, crust, Nil coarse fragments	A11 0.0 – 0.04 Abrupt	Light medium clay	Moderate, firm, sub-rounded peds 20-50 mm	Nil inclusions / segregations	10YR3/2 Very dark greyish brown Nil mottles / bleaching	Dry, well drained	Present	0.10 / 8.0	0.00-0.04 0.20-0.30 0.50-0.60 0.80-0.90 0.90-1.00	Nil additional observations
				A12 0.04 – 0.20 Abrupt	Medium clay	Moderate, firm, sub-rounded peds 50-80 mm	Nil inclusions / segregations	10YR3/2 Very dark greyish brown Nil mottles / bleaching	Dry, well- moderate drained	Present	0.30 / 8.0

B21 0.20 – 0.45 Abrupt	Medium heavy clay	Moderate, - strong firm, sub-rounded peds 50-80 mm	Nil inclusions / segregations	10YR2/1 Black Nil mottles / bleaching	Dry, well- moderate drained	Present	0.60 / 8.0		
				B22 0.45 – 1.00 EOBH	Medium heavy clay	Moderate, - strong firm, sub-rounded peds 50-80 mm	Nil inclusions / segregations	10YR2/1 Black Nil mottles / bleaching	Dry, well- moderate drained	Nil	0.90 / 8.0

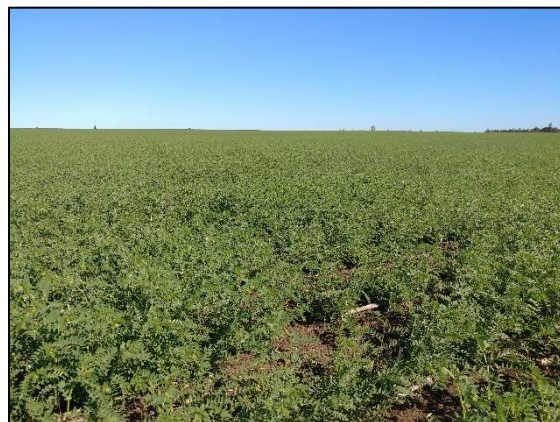
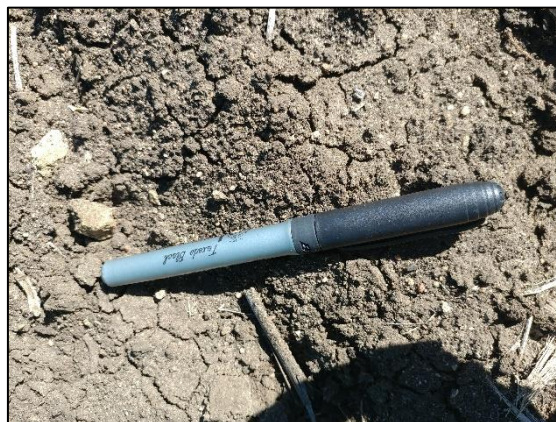
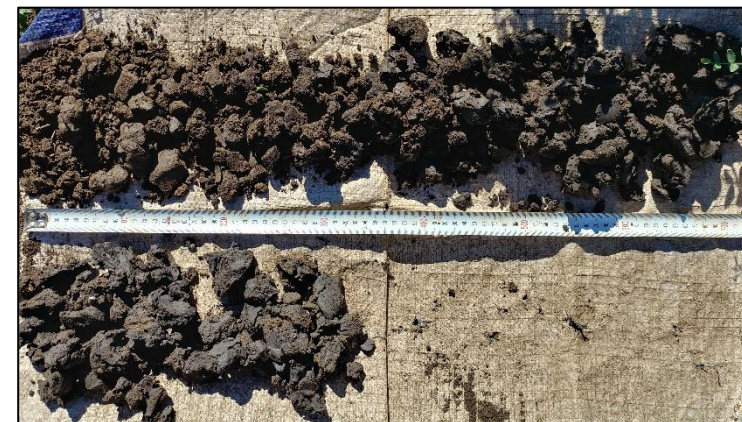
<b>Map Unit</b> 12	<b>Location (GDA94 ZONE 55):</b> 644933mE 7511241mN	<b>Aust. Soil Class.:</b> Black Vertosol	<b>Site Survey Type:</b> Detailed - 50mm hand auger	<b>Survey Date:</b> 30/06/2019
-----------------------	--	---	--	-----------------------------------

Land use Landform Pattern, Element, Slope	Vegetation	Microrelief Disturbance Erosion	Surface condition, surface rock	Soil Profile Description									
				Horizon Depth (m), Boundary	Field Texture	Structure, Strength	Inclusions Segregation s	Colour, Mottle, Bleaching	Moisture, Drainage	Roots	Depth (m) / Field pH	Sample (m)	Observations
Cropping / Grazing GUP mid slope 2% / 2%	Cropping	Nil microrelief Extensive disturbed, Nil erosion	Self-mulching, crust, Nil coarse fragments	A11 0.0 – 0.06 Abrupt	Light medium clay	Moderate, firm, sub-rounded peds 20-50 mm	Nil inclusions / segregations	10YR3/2 Very dark greyish brown Nil mottles / bleaching	Dry, well drained	Present	0.10 / 8.0	0.00-0.05 0.20-0.30 0.50-0.60 0.80-0.90 0.90-1.00	Nil additional observations
				A12 0.06 – 0.22 Abrupt	Medium clay	Moderate, firm, sub-rounded peds 50-80 mm	Nil inclusions / segregations	10YR3/2 Very dark greyish brown Nil mottles / bleaching	Dry, well- moderate drained	Present	0.30 / 8.0

B21 0.22 – 0.50 Abrupt	Medium heavy clay	Moderate, - strong firm, sub-rounded peds 50-80 mm	Nil inclusions / segregations	10YR2/1 Black Nil mottles / bleaching	Dry, well- moderate drained	Present	0.60 / 8.0		
				B22 0.50 – 1.00 EOBH	Medium heavy clay	Moderate, - strong firm, sub-rounded peds 50-80 mm	Nil inclusions / segregations	10YR2/1 Black Nil mottles / bleaching	Dry, well- moderate drained	Nil	0.90 / 8.0

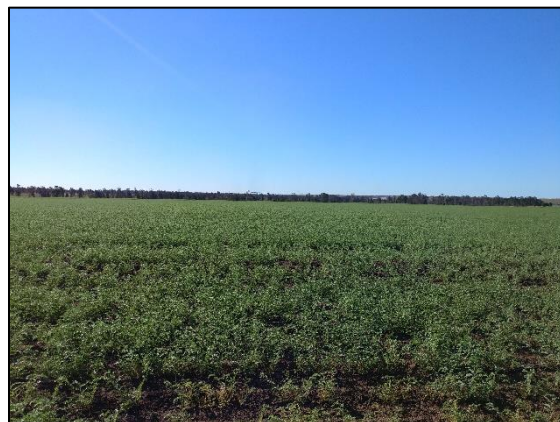
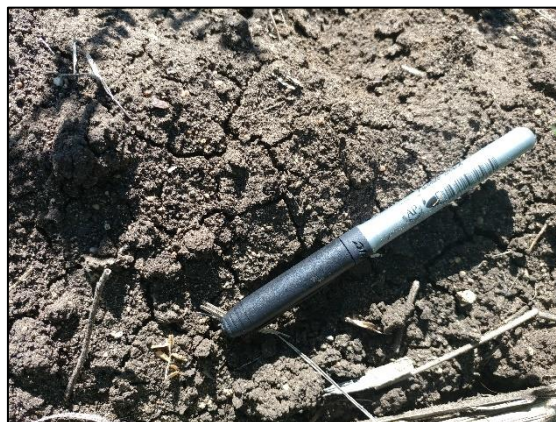
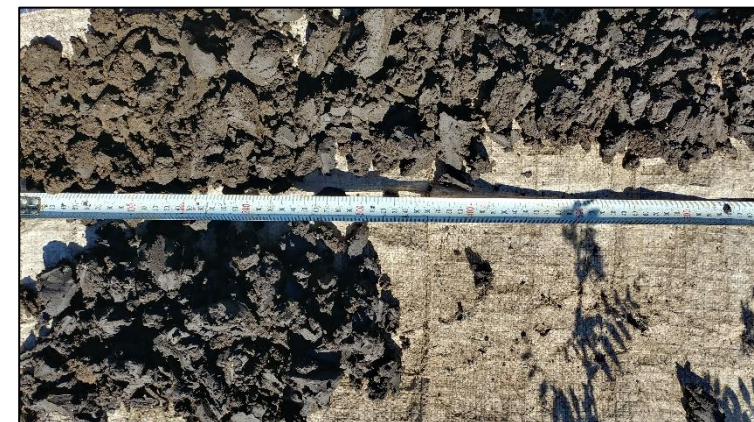
<b>Map Unit</b> 12	<b>Location (GDA94 ZONE 55):</b> 643706mE 7511439mN	<b>Aust. Soil Class.:</b> Black Vertosol	<b>Site Survey Type:</b> Detailed - 50mm hand auger	<b>Survey Date:</b> 30/06/2019
-----------------------	--	---	--	-----------------------------------

Land use Landform Pattern, Element, Slope	Vegetation	Microrelief Disturbance Erosion	Surface condition, surface rock	Soil Profile Description									
				Horizon Depth (m), Boundary	Field Texture	Structure, Strength	Inclusions Segregations	Colour, Mottle, Bleaching	Moisture, Drainage	Roots	Depth (m) / Field pH	Sample (m)	Observations
Cropping / Grazing GUP mid slope 2% / 2%	Cropping	Nil microrelief Extensive disturbed, Nil erosion	Self-mulching, crust, Nil coarse fragments	A11 0.00 – 0.05 Abrupt	Light medium clay	Moderate, firm, sub-rounded peds 20-50 mm	Nil inclusions / segregations	10YR3/2 Very dark greyish brown Nil mottles / bleaching	Dry, well drained	Present	0.10 / 8.0	0.00-0.05 0.20-0.30 0.50-0.60 0.80-0.90 0.90-1.00	Nil additional observations
				A12 0.05 – 0.20 Abrupt	Medium clay	Moderate, firm, sub-rounded peds 50-80 mm	Nil inclusions / segregations	10YR3/2 Very dark greyish brown Nil mottles / bleaching	Dry, well- moderate drained	Present	0.30 / 8.0

B21 0.20 – 0.47 Abrupt	Medium heavy clay	Moderate, - strong firm, sub-rounded peds 50-80 mm	Nil inclusions / segregations	10YR2/1 Black Nil mottles / bleaching	Dry, well- moderate drained	Present	0.60 / 8.0		
				B22 0.47 – 1.00 EOBH	Medium heavy clay	Moderate, - strong firm, sub-rounded peds 50-80 mm	Nil inclusions / segregations	10YR2/1 Black Nil mottles / bleaching	Dry, well- moderate drained	Nil	0.90 / 8.0

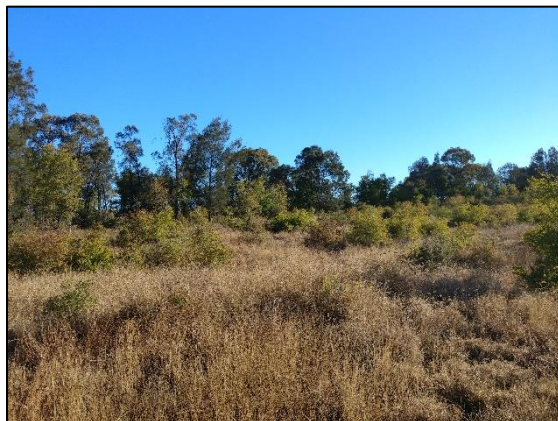
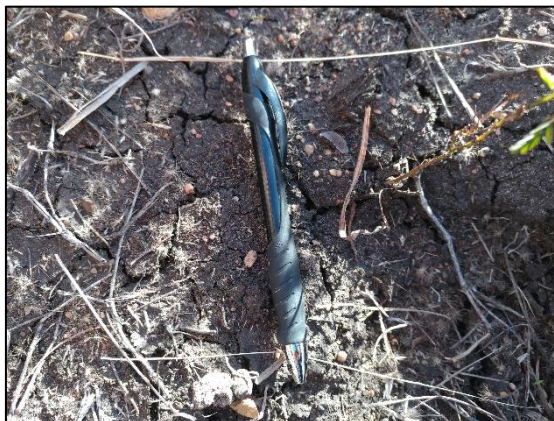
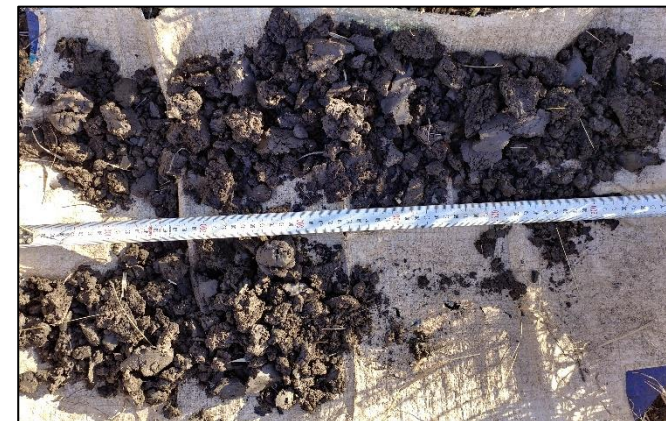
<b>Map Unit</b> 15	<b>Location (GDA94 ZONE 55):</b> 645726mE 7510395mN	<b>Aust. Soil Class.:</b> Black Vertosol	<b>Site Survey Type:</b> Detailed - 50mm hand auger	<b>Survey Date:</b> 30/06/2019
-----------------------	--	---	--	-----------------------------------

Land use Landform Pattern, Element, Slope	Vegetation	Microrelief Disturbance Erosion	Surface condition, surface rock	Soil Profile Description									
				Horizon Depth (m), Boundary	Field Texture	Structure, Strength	Inclusions Segregations	Colour, Mottle, Bleaching	Moisture, Drainage	Roots	Depth (m) / Field pH	Sample (m)	Observations
Grazing GUP Lower slope to depression 1% / 2%	Mixed vegetation, eucalyptus species, Grasses	Nil microrelief Semi disturbed, Nil erosion	Crust, <2% coarse fragments <5mm	A11 0.0 – 0.12 Abrupt	Light clay	Moderate, firm, sub- angular <20 mm	Nil inclusions / segregations	10YR3/2 Very dark greyish brown Nil mottles / bleaching	Dry, well drained	Present	0.10 / 7.0	0.00-0.10 0.20-0.30 0.50-0.60 0.80-0.90 0.90-1.00	Nil additional observations
				B21 0.12 – 0.90 Abrupt	Medium clay	Moderate- strong, strong, sub- angular <20 mm	Nil inclusions / segregations	10YR3/2 Very dark greyish brown Nil mottles / bleaching	Dry, well- moderate drained	Present	0.30 / 7.5 0.60 / 7.5

B22 0.90 – 1.00 EOBH	Medium clay	Moderate- strong, strong, sub- angular <20 mm	<2% calcium carbonate	10YR3/2 Very dark greyish brown Nil mottles / bleaching	Dry, well- moderate drained	Present	0.90 / 8.0

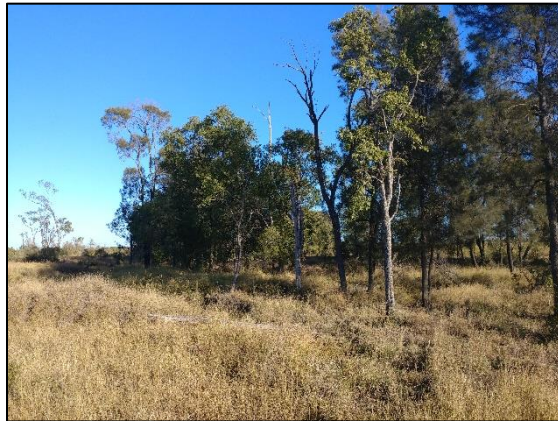
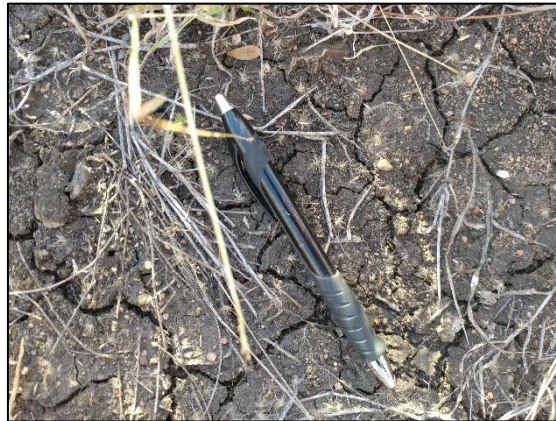
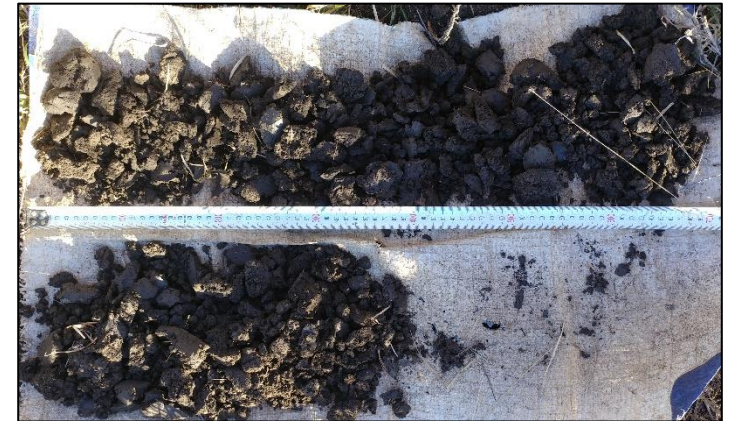
<b>Map Unit</b> 15	<b>Location (GDA94 ZONE 55):</b> 645496mE 7510399mN	<b>Aust. Soil Class.:</b> Black Vertosol	<b>Site Survey Type:</b> Detailed - 50mm hand auger	<b>Survey Date:</b> 30/06/2019
-----------------------	--	---	--	-----------------------------------

Land use Landform Pattern, Element, Slope	Vegetation	Microrelief Disturbance Erosion	Surface condition, surface rock	Soil Profile Description									
				Horizon Depth (m), Boundary	Field Texture	Structure, Strength	Inclusions Segregations	Colour, Mottle, Bleaching	Moisture, Drainage	Roots	Depth (m) / Field pH	Sample (m)	Observations
Grazing GUP Lower slope to depression 1% / 2%	Mixed vegetation, eucalyptus species, Grasses	Nil microrelief Semi disturbed, Nil erosion	Crust, <2% coarse fragments <5mm	A11 0.0 – 0.13 Abrupt	Light clay	Moderate, firm, sub- angular <20 mm	Nil inclusions / segregations	10YR3/2 Very dark greyish brown Nil mottles / bleaching	Dry, well drained	Present	0.10 / 7.0	0.00-0.10 0.20-0.30 0.50-0.60 0.80-0.90 0.90-1.00	Nil additional observations
				B21 0.13 – 0.85 Abrupt	Medium clay	Moderate- strong, strong, sub- angular <20 mm	Nil inclusions / segregations	10YR3/2 Very dark greyish brown Nil mottles / bleaching	Dry, well- moderate drained	Present	0.30 / 7.5 0.60 / 7.5

B22 0.85 – 1.00 EOBH	Medium clay	Moderate- strong, strong, sub- angular <20 mm	<2% calcium carbonate	10YR3/2 Very dark greyish brown Nil mottles / bleaching	Dry, well- moderate drained	Present	0.90 / 8.0

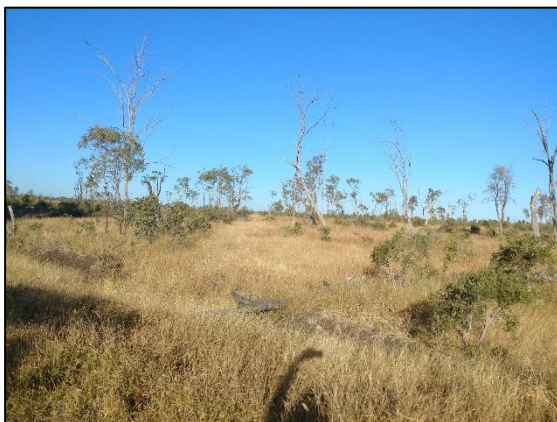
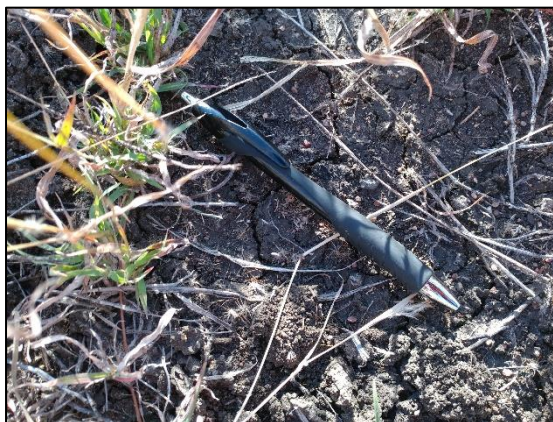
<b>Map Unit</b> 15	<b>Location (GDA94 ZONE 55):</b> 644518mE 7510978mN	<b>Aust. Soil Class.:</b> Black Vertosol	<b>Site Survey Type:</b> Detailed - 50mm hand auger	<b>Survey Date:</b> 30/06/2019
-----------------------	--	---	--	-----------------------------------

Land use Landform Pattern, Element, Slope	Vegetation	Microrelief Disturbance Erosion	Surface condition, surface rock	Soil Profile Description									
				Horizon Depth (m), Boundary	Field Texture	Structure, Strength	Inclusions Segregations	Colour, Mottle, Bleaching	Moisture, Drainage	Roots	Depth (m) / Field pH	Sample (m)	Observations
Grazing GUP mid slope 1% / 2%	Mixed vegetation, eucalyptus species, Grasses	Nil microrelief Semi disturbed, Nil erosion	Crust, <2% coarse fragments <5mm	A11 0.0 – 0.14 Abrupt	Light clay	Moderate, firm, sub- angular <20 mm	Nil inclusions / segregations	10YR3/2 Very dark greyish brown Nil mottles / bleaching	Dry, well drained	Present	0.10 / 7.0	0.00-0.10 0.20-0.30 0.50-0.60 0.80-0.90 0.90-1.00	Nil additional observations
				B21 0.14 – 1.00 EOBH	Medium clay	Moderate- strong, strong, sub- angular <20 mm	Nil inclusions / segregations	10YR3/2 Very dark greyish brown Nil mottles / bleaching	Dry, well- moderate drained	Present	0.30 / 7.5 0.60 / 7.5 0.90 / 8.0

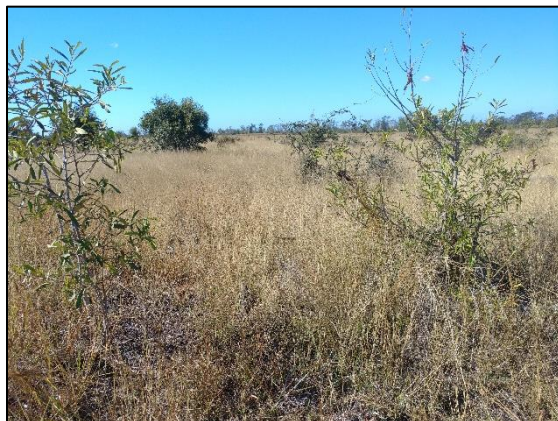
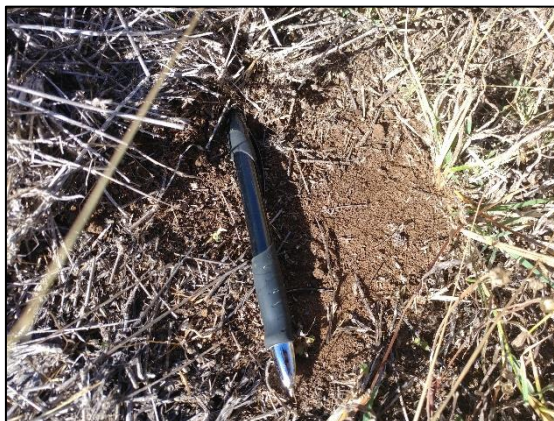
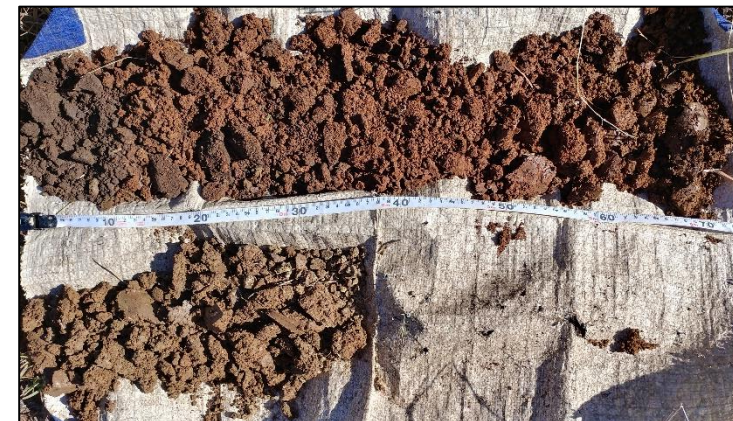
<b>Map Unit</b> 14	<b>Location (GDA94 ZONE 55):</b> 642742mE 7510104mN	<b>Aust. Soil Class.:</b> Red Chromosol	<b>Site Survey Type:</b> Detailed - 50mm hand auger	<b>Survey Date:</b> 30/06/2019
-----------------------	--	--	--	-----------------------------------

Land use Landform Pattern, Element, Slope	Vegetation	Microrelief Disturbance Erosion	Surface condition, surface rock	Soil Profile Description									
				Horizon Depth (m), Boundary	Field Texture	Structure, Strength	Inclusions Segregations	Colour, Mottle, Bleaching	Moisture, Drainage	Roots	Depth (m) / Field pH	Sample (m)	Observations
Grazing GUP Mid - lower slope <2% / <2%	Grasses, shrubs	Nil microrelief Extensive disturbed, Nil erosion	Firm Nil coarse fragments	A11 0.0 – 0.12 Abrupt	Sandy loam	Weak- moderate, firm, sub- rounded <20 mm	Nil inclusions / segregations	10YR3/2 Very dark greyish brown Nil mottles / bleaching	Dry, well drained	Present	0.10 / 6.5	0.00-0.10 0.20-0.30 0.50-0.60 0.80-0.90 0.90-1.00	Nil additional observations
				B21 0.12 – 0.70 Abrupt	Sandy clay loam	Moderate, firm, sub- angular <20 mm	Nil inclusions / segregations	5YR4/3 Reddish brown Nil mottles / bleaching	Dry, well- moderate drained	Present	0.30 / 7.0 0.60 / 7.5

B22 0.70 – 1.00 EOBH	Light clay	Moderate, firm, sub- angular <20 mm	<5% calcium carbonate	7.5YR4/4 Brown Nil mottles / bleaching	Dry, well- moderate drained	Present	0.90 / 7.5

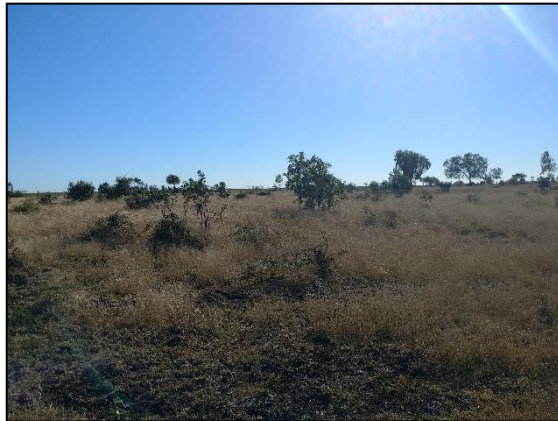
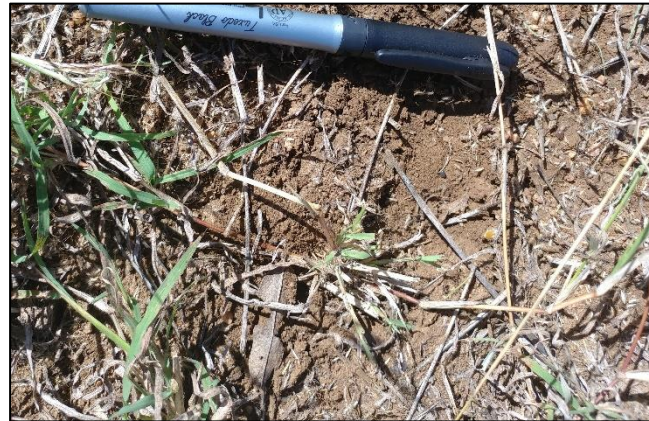
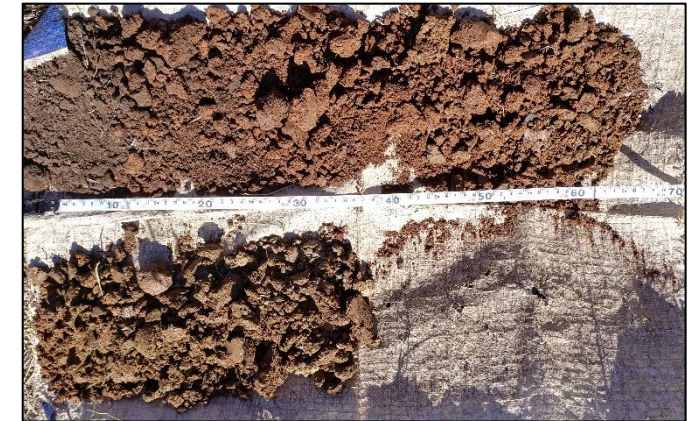
<b>Map Unit</b> 14	<b>Location (GDA94 ZONE 55):</b> 642252mE 7510143mN	<b>Aust. Soil Class.:</b> Red Chromosol	<b>Site Survey Type:</b> Detailed - 50mm hand auger	<b>Survey Date:</b> 01/07/2019
-----------------------	--	--	--	-----------------------------------

Land use Landform Pattern, Element, Slope	Vegetation	Microrelief Disturbance Erosion	Surface condition, surface rock	Soil Profile Description									
				Horizon Depth (m), Boundary	Field Texture	Structure, Strength	Inclusions Segregations	Colour, Mottle, Bleaching	Moisture, Drainage	Roots	Depth (m) / Field pH	Sample (m)	Observations
Grazing GUP Mid - lower slope <2% / <2%	Grasses	Nil microrelief Extensive disturbed, Nil erosion	Firm Nil coarse fragments	A11 0.0 – 0.14 Clear	Sandy loam	Weak- moderate, firm, sub- rounded <20 mm	Nil inclusions / segregations	10YR3/2 Very dark greyish brown Nil mottles / bleaching	Dry, well drained	Present	0.10 / 6.5	0.00-0.10 0.20-0.30 0.50-0.60 0.80-0.90 0.90-1.00	Nil additional observations
				B21 0.14 – 0.70 Abrupt	Light clay	Moderate, firm, sub- angular <20 mm	Nil inclusions / segregations	5YR4/3 Reddish brown Nil mottles / bleaching	Dry, well- moderate drained	Present	0.30 / 7.0 0.60 / 7.5

B22 0.70 – 1.00 EOBH	Light clay	Moderate, firm, sub- angular <20 mm	<5% calcium carbonate	7.5YR4/4 Brown Nil mottles / bleaching	Dry, well- moderate drained	Present	0.90 / 7.5

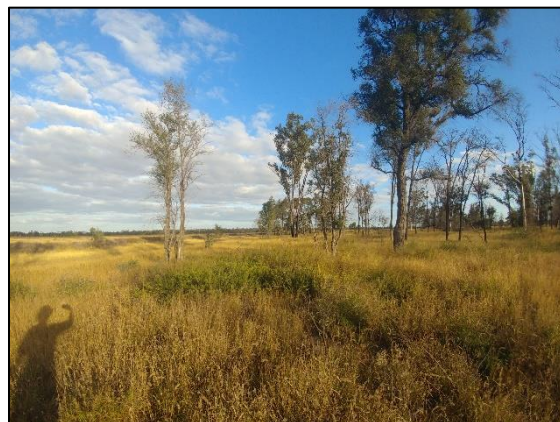
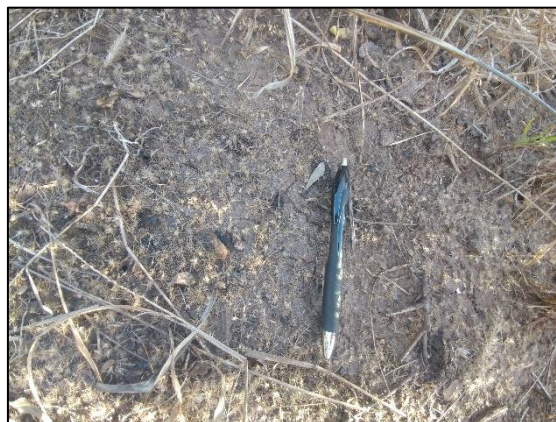
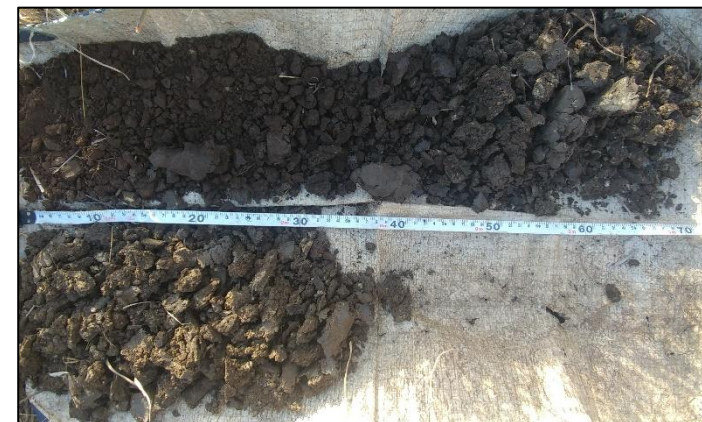
<b>Map Unit</b> 10	<b>Location (GDA94 ZONE 55):</b> 643716mE 7513193mN	<b>Aust. Soil Class.:</b> Black Sodosol	<b>Site Survey Type:</b> Detailed - 50mm hand auger	<b>Survey Date:</b> 011/07/2019
-----------------------	--	--	--	------------------------------------

Land use Landform Pattern, Element, Slope	Vegetation	Microrelief Disturbance Erosion	Surface condition, surface rock	Soil Profile Description									
				Horizon Depth (m), Boundary	Field Texture	Structure, Strength	Inclusions Segregations	Colour, Mottle, Bleaching	Moisture, Drainage	Roots	Depth (m) / Field pH	Sample (m)	Observations
Grazing GUP upper slope <2% / <2%	Eucalyptus species	Nil microrelief Semi disturbed, contour banks nearby Nil erosion	Firm, Nil coarse fragments	A11 0.0 – 0.06 Abrupt	Sandy clay loam	Massive	Nil inclusions or segregations	10YR3/2 Very dark greyish brown Nil mottles / bleaching	Dry, well drained	Present	0.10 / 7.5	0.00-0.10 0.20-0.30 0.50-0.60 0.80-0.90 0.90-1.00	Nil additional observations
				A12 0.06 – 0.20 gradual	Sandy clay loam	Weak, sub- rounded peds <10 mm	Nil inclusions or segregations	10YR3/2 Very dark greyish brown Nil mottles / bleaching	Dry, well drained	Present	0.20 / 7.5

B21 0.20 – 0.46 gradual	Sandy clay loam	Subangular blocky, moderate, peds <20 mm, firm	Nil inclusions or segregations	10YR3/2 Very dark greyish brown Nil mottles / bleaching	Dry, well drained	Present	0.30 / 7.5		
				B22 0.46 – 1.00 EOBH	Medium clay, sandy	Subangular blocky, moderate, peds <20 mm, firm	<20% calcium carbonate	10YR3/3 Dark reddish brown Nil mottles / bleaching	Dry, well – moderate drained	Present	0.60 / 7.5 0.90 / 7.5

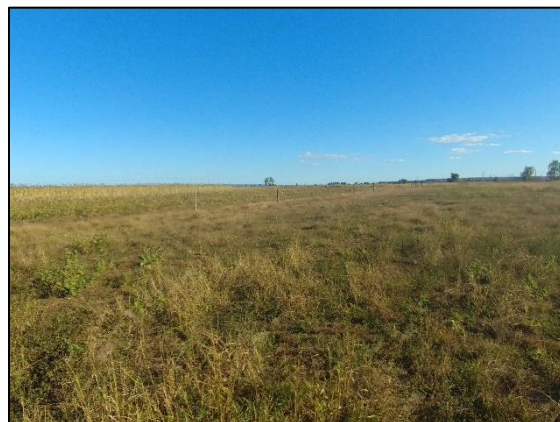
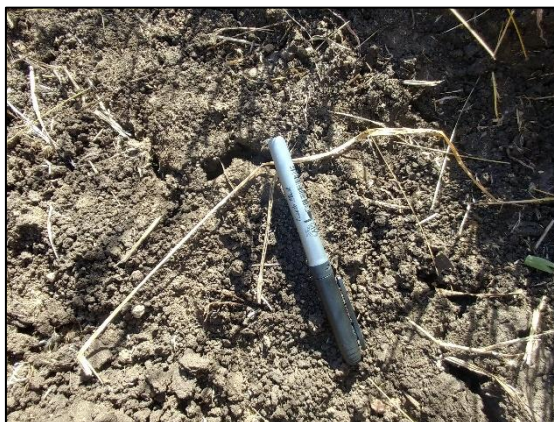
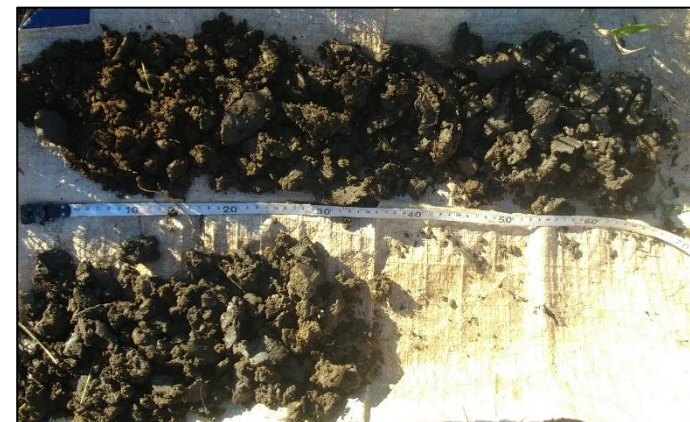
<b>Map Unit</b> 17	<b>Location (GDA94 ZONE 55):</b> 643817mE 7508323mN	<b>Aust. Soil Class.:</b> Black Vertosol	<b>Site Survey Type:</b> Detailed - 50mm hand auger	<b>Survey Date:</b> 01/07/2019
-----------------------	--	---	--	-----------------------------------

Land use Landform Pattern, Element, Slope	Vegetation	Microrelief Disturbance Erosion	Surface condition, surface rock	Soil Profile Description									
				Horizon Depth (m), Boundary	Field Texture	Structure, Strength	Inclusions Segregations	Colour, Mottle, Bleaching	Moisture, Drainage	Roots	Depth (m) / Field pH	Sample (m)	Observations
Grazing GUP Lower slope 1% / 1%	Short grasses	Nil microrelief Extensive disturbance Nil erosion	Cracking, self- mulching, Nil coarse fragments	A1 0.00-0.15 Abrupt	Light clay	Weak, soft sub- rounded <10mm	Nil inclusions / segregations	10YR3/1 Very dark grey Nil mottles/bleach	Dry, moderate	Few fine	0.10 / 6.0	0.00-0.10 0.20-0.30 0.50-0.60 0.80-0.90 0.90-1.00	Nil additional observations
				B21 0.15-0.45 Abrupt	Medium clay	Weak to moderate, firm sub- rounded <10mm	Nil inclusions / segregations	10YR2/2 Very dark brown Nil mottles/bleach	Dry, moderate	Very fine, very few	0.30 / 6.5

B22 0.45-1.00 EOBH	Medium clay	Moderate, firm sub- rounded <20mm	Nil inclusions / segregations	10YR3/3 Dark brown Nil mottles/bleach	Dry, moderate	Very fine, very few	0.60 / 7.0 0.90 / 7.0

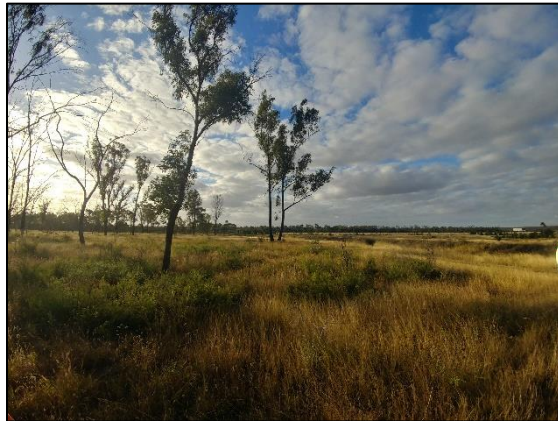
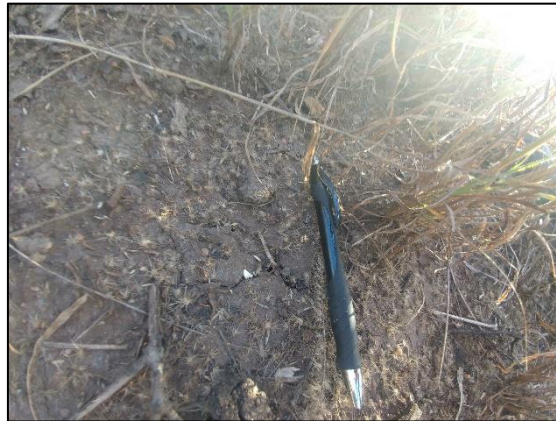
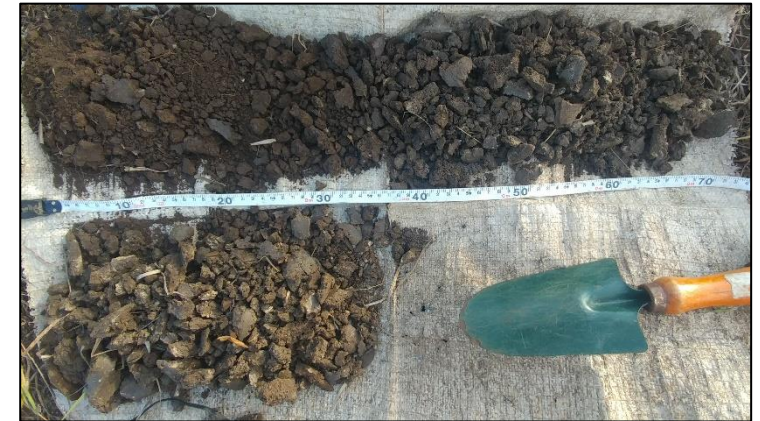
<b>Map Unit</b> 10	<b>Location (GDA94 ZONE 55):</b> 643622mE 7513388mN	<b>Aust. Soil Class.:</b> Black Sodosol	<b>Site Survey Type:</b> Detailed - 50mm hand auger	<b>Survey Date:</b> 01/07/2019
-----------------------	--	--	--	-----------------------------------

Land use Landform Pattern, Element, Slope	Vegetation	Microrelief Disturbance Erosion	Surface condition, surface rock	Soil Profile Description									
				Horizon Depth (m), Boundary	Field Texture	Structure, Strength	Inclusions Segregations	Colour, Mottle, Bleaching	Moisture, Drainage	Roots	Depth (m) / Field pH	Sample (m)	Observations
Grazing GUP upper slope <2% / <2%	Eucalyptus species	Nil microrelief Semi disturbed, contour banks nearby	Firm, Nil coarse fragments	A11 0.0 – 0.09 Abrupt	Sandy clay loam	Massive	Nil inclusions or segregations	10YR3/2 Very dark greyish brown Nil mottles / bleaching	Dry, well drained	Present	0.10 / 7.5	0.00-0.10 0.20-0.30 0.50-0.60 0.80-0.90 0.90-1.00	Nil additional observations
				A12 0.09 – 0.25 gradual	Sandy clay loam	Weak, sub- rounded peds <10 mm	Nil inclusions or segregations	10YR3/2 Very dark greyish brown Nil mottles / bleaching	Dry, well drained	Present	0.20 / 7.5

B22 0.25 – 0.50 gradual	Sandy clay loam	Subangular blocky, moderate, peds <20 mm, firm	Nil inclusions or segregations	10YR3/2 Very dark greyish brown Nil mottles / bleaching	Dry, well drained	Present	0.30 / 7.5		
				B23 0.50 – 1.00 EOBH	Medium clay, sandy	Subangular blocky, moderate, peds <20 mm, firm	<20% calcium carbonate	10YR3/3 Dark brown Nil mottles / bleaching	Dry, well – moderate drained	Present	0.60 / 7.5 0.90 / 7.5

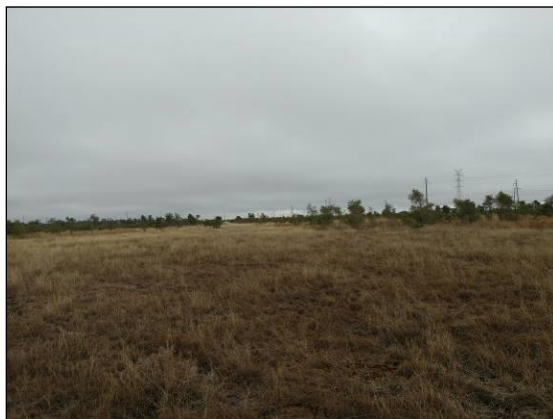
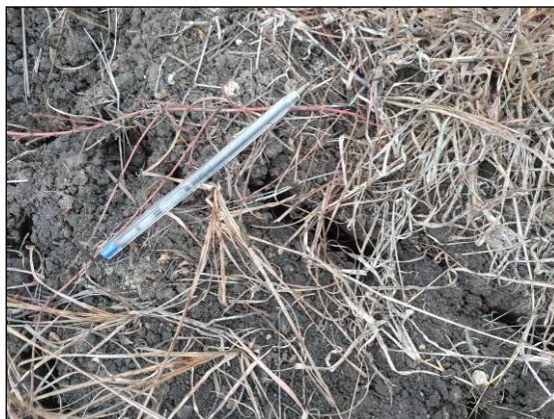
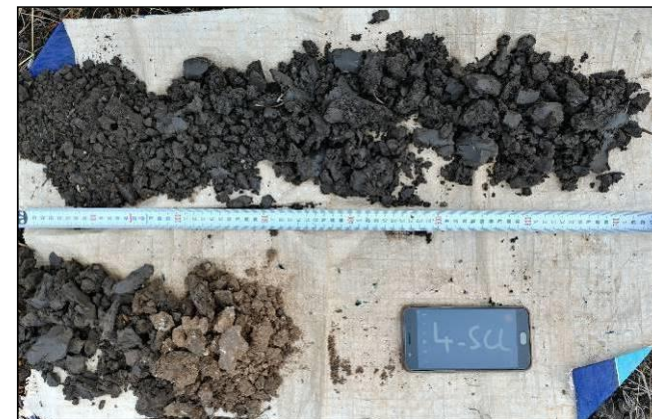
<b>Map Unit</b> 17	<b>Location (GDA94 ZONE 55):</b> 643527mE 7507664mN	<b>Aust. Soil Class.:</b> Black Vertosol	<b>Site Survey Type:</b> Detailed - 50mm hand auger	<b>Survey Date:</b> 30/06/2018
-----------------------	--	---	--	-----------------------------------

Land use Landform Pattern, Element, Slope	Vegetation	Microrelief Disturbance Erosion	Surface condition, surface rock	Soil Profile Description									
				Horizon Depth (m), Boundary	Field Texture	Structure, Strength	Inclusions Segregations	Colour, Mottle, Bleaching	Moisture, Drainage	Roots	Depth (m) / Field pH	Sample (m)	Observations
Grazing, Very gently undulating plains, upper slope, <1.0/1.0	Cleared, very sparse mixed regrowth	Nil microrelief Semi cleared, Nil erosion	Cracking, self mulching Nil coarse fragments	A1 0.00-0.14 Abrupt	Light clay	Weak, firm, <10mm sub-angular	Nil inclusion or segregations	10YR3/2 Very dark greyish brown Nil mottles/bleach	Dry, moderate	Fine, few	0.10 / 6.5	0.00-0.10 0.20-0.30 0.50-0.60 0.70-0.80 0.90-1.00	Nil additional observations
				B21 0.14-0.90 Abrupt	Medium clay	Moderate, firm <40% 20-60mm, <20% 60-100 sub- angular blocky peds	<1% calcium carbonate nodules	10YR3/2 Very dark greyish brown Nil mottles/bleach	Dry, moderate	Very fine, very few	0.30 / 6.5 0.60 / 7.5

B22 0.90-1.00 EOBH	Medium clay	Moderate, firm <40% 20-60mm, <20% 60-100 sub- angular blocky peds	2% calcium carbonate nodules	10YR4/2 Dark greyish brown Mottles 2% 10YR3/2 Very dark greyish brown Nil bleach	Dry, Imperfect	Very fine, very few	0.90 / 8.0

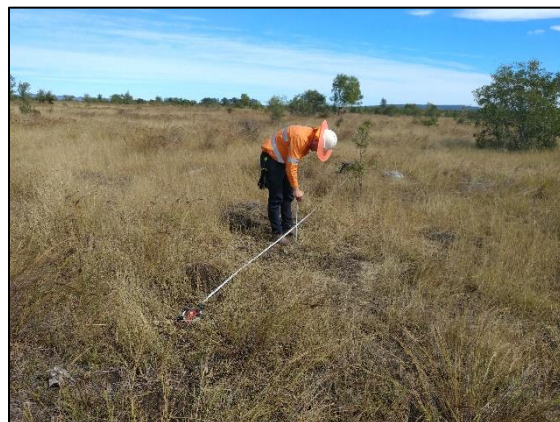
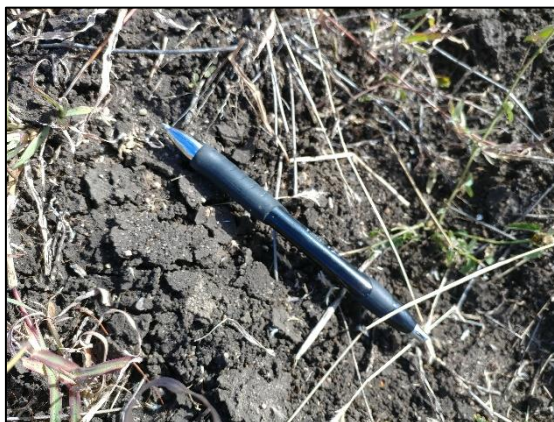
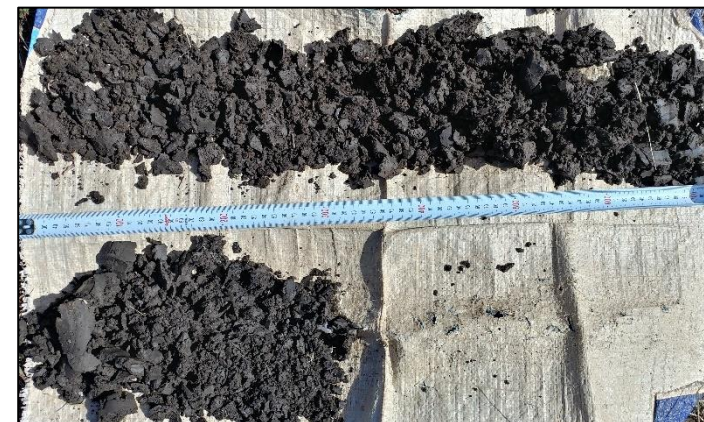
<b>Map Unit</b> 16	<b>Location (GDA94 ZONE 55):</b> 642166mE 7508999mN	<b>Aust. Soil Class.:</b> Black Vertosol	<b>Site Survey Type:</b> Detailed - 50mm hand auger	<b>Survey Date:</b> 04/06/2019
-----------------------	--	---	--	-----------------------------------

Land use Landform Pattern, Element, Slope	Vegetation	Microrelief Disturbance Erosion	Surface condition, surface rock	Soil Profile Description									
				Horizon Depth (m), Boundary	Field Texture	Structure, Strength	Inclusions Segregations	Colour, Mottle, Bleaching	Moisture, Drainage	Roots	Depth (m) / Field pH	Sample (m)	Observations
Gently undulating plain 2.0/2.0	Grasses, recent regrowth and shrubs	Microrelief present – Depression <0.2m deep, 40% coverage Extensive clearing Nil Erosion	Self-mulching with cracking Nil coarse fragments	A1 0.00-0.17 Abrupt	Light medium clay	Weak, firm <20mm sub-angular	<1% Calcium carbonate <2mm	10YR3/1 Very dark grey Nil mottle / bleaching	Dry, Well drained	Common, medium	0.10 / 6.5	0.00-0.10 0.20-0.30 0.50-0.60 0.80-0.90 0.90-1.00	Nil additional observations
				B2 0.17-1.00 EOBH	Medium heavy clay	Moderate, Very firm 20-40mm sub-angular	<2% Calcium carbonate <2mm	10YR3/2 Very dark greyish brown Nil mottle / bleaching	Dry, Moderate drained	Few, medium	0.30 / 6.5 0.60 / 6.5 0.90 / 6.5

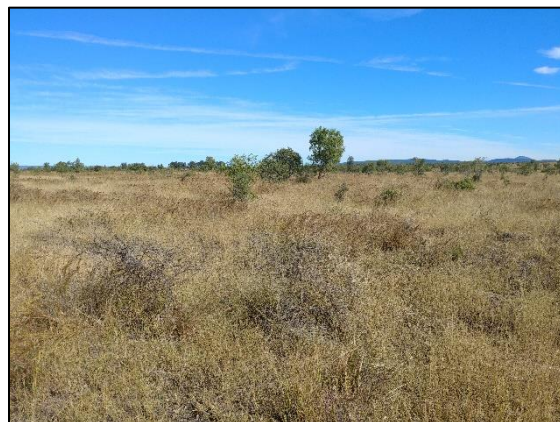
## SITE 5-SCL-Mound

<b>Map Unit</b> 16	<b>Location (GDA94 ZONE 55):</b> 642163mE 7508998mN	<b>Aust. Soil Class:</b> Black Vertosol	<b>Site Survey Type:</b> Detailed - 50mm hand auger	<b>Survey Date:</b> 04/06/2019
-----------------------	--	--	--	-----------------------------------

Land use Landform Pattern, Element, Slope	Vegetation	Microrelief Disturbance Erosion	Surface condition, surface rock	Soil Profile Description									
				Horizon Depth (m), Boundary	Field Texture	Structure, Strength	Inclusions Segregations	Colour, Mottle, Bleaching	Moisture, Drainage	Roots	Depth (m) / Field pH	Sample (m)	Observations
Gently undulating plain, mid-slope 2.0/2.0	101	Microrelief present – Mound 40% coverage Extensive clearing Nil Erosion	Self-mulching with cracking Nil coarse fragments	A1 0.00-0.12 Abrupt	Light clay	Moderate, soft <20mm sub-angular	Nil inclusions and segregations	10YR2/1 Black Nil mottle / bleaching	Humid, Well drained	Common, medium	0.10 / 6.5	0.00-0.10 0.20-0.30 0.50-0.60 0.80-0.90 0.90-1.00	Nil additional observations
				B21 0.12-0.60 Abrupt	Medium heavy clay	Moderate, Firm <30mm sub-angular	Nil inclusions and segregations	10YR3/1 Very dark grey Nil mottle / bleaching	Humid, Well drained	Few, medium	0.30 / 7.0

B22 0.60-1.00 EOBH	Medium heavy clay	Moderate, Firm <30mm sub-angular	<2% Calcium carbonate	10YR3/1 Very dark grey Nil mottle / bleaching	Humid, Well - moderate drained	Few, fine	0.10 / 7.0

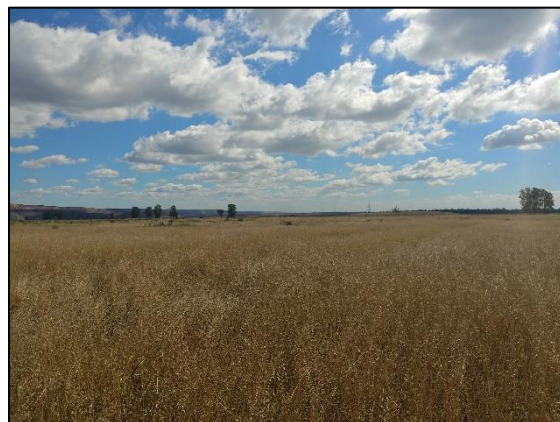
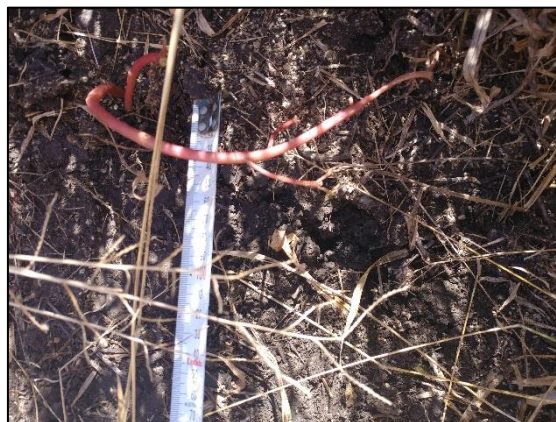
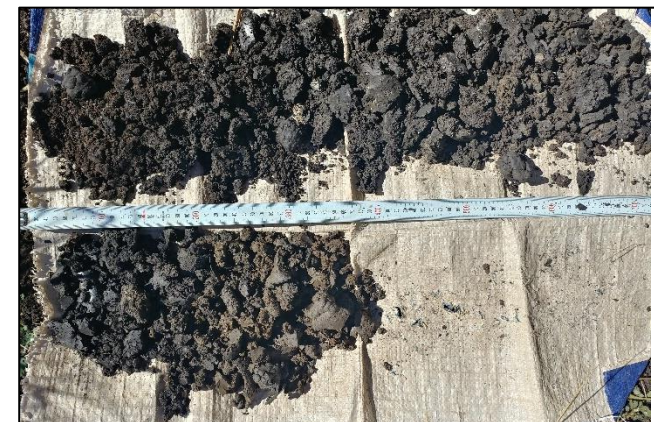
<b>Map Unit</b> 13	<b>Location (GDA94 ZONE 55):</b> 641287mE 7510129mN	<b>Aust. Soil Class:</b> Black Vertosol	<b>Site Survey Type:</b> Detailed - 50mm hand auger	<b>Survey Date:</b> 03/06/2019
-----------------------	--	--	--	-----------------------------------

Land use Landform Pattern, Element, Slope	Vegetation	Microrelief Disturbance Erosion	Surface condition, surface rock	Soil Profile Description									
				Horizon Depth (m), Boundary	Field Texture	Structure, Strength	Inclusions Segregations	Colour, Mottle, Bleaching	Moisture, Drainage	Roots	Depth (m) / Field pH	Sample (m)	Observations
Grazing, mid-slope, 2.0/2.0	Grasses	Nil microrelief Extensive disturbance Nil erosion	Humid self- mulching with crust 2-6, fine sand on surface. Coarse fragments` <5 mm <5%	A1 0.00 – 0.15 Abrupt	Light clay, sandy	Weak, firm Subangular blocky, peds 10-30 mm,	Nil inclusions and segregations	10YR2/1 Black Nil mottles / bleaching	Humid, Well – moderate drained	Fine, very few	0.10 / 6.5	0.00-0.10 0.20-0.30 0.50-0.60 0.80-0.90 0.90-1.00	Nil additional observations
				B21 0.15 – 0.30 Abrupt	Medium heavy clay	Weak, firm Subangular blocky, peds 20-30 mm,	Nil inclusions and segregations	10YR2/1 Black Nil mottles / bleaching	Humid, Well – moderate drained	Fine, very few	0.35 / 7.0

B22 0.30 – 0.80 Abrupt	Medium heavy clay	Weak to moderate, very firm Subangular blocky, peds 20-30 mm,	<5% calcium carbonate	10YR2/1 Black Nil mottles / bleaching	Humid, Well – moderate drained	Fine, very few	0.60 / 7.0		
				B23 0.80 – 1.00 EOBH	Medium heavy clay, sandy	Moderate, very firm Subangular blocky, peds 40-60 mm,	Nil inclusions and segregations	10YR4/2 Dark greyish brown Nil mottles / bleaching	Humid, Well – moderate drained	Nil roots	0.90 / 7.5

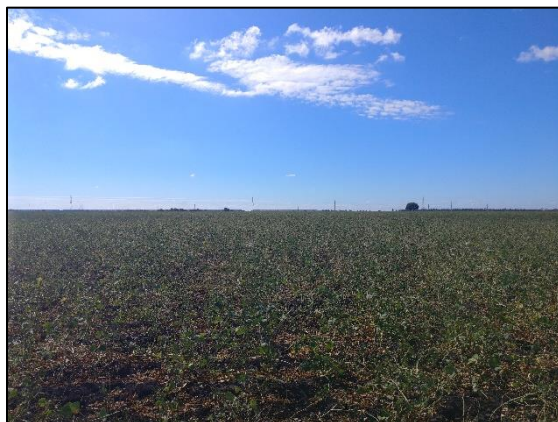
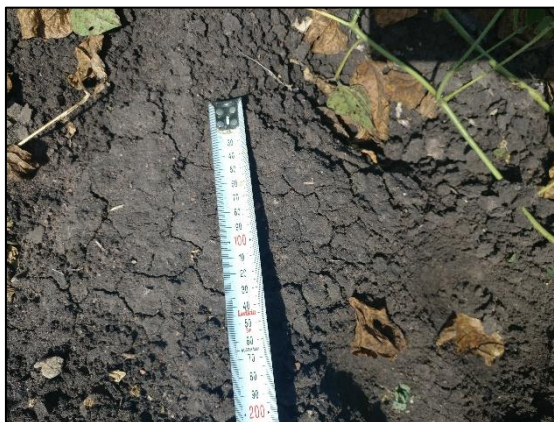
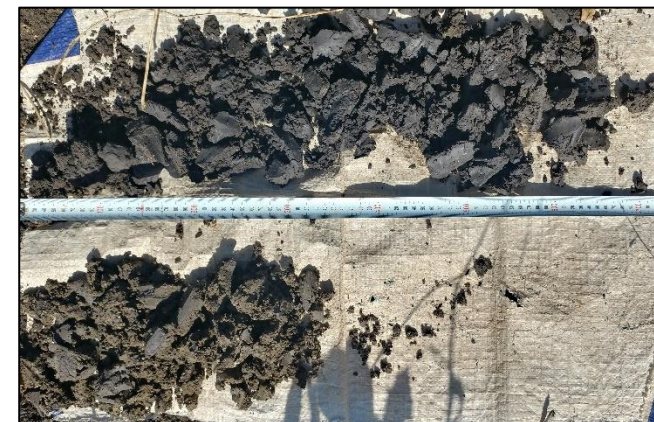
<b>Map Unit</b> 13	<b>Location (GDA94 ZONE 55):</b> 641298mE 7510328mN	<b>Aust. Soil Class:</b> Black Vertosol	<b>Site Survey Type:</b> Detailed - 50mm hand auger	<b>Survey Date:</b> 03/06/2019
-----------------------	--	--	--	-----------------------------------

Land use Landform Pattern, Element, Slope	Vegetation	Microrelief Disturbance Erosion	Surface condition, surface rock	Soil Profile Description									
				Horizon Depth (m), Boundary	Field Texture	Structure, Strength	Inclusions Segregations	Colour, Mottle, Bleaching	Moisture, Drainage	Roots	Depth (m) / Field pH	Sample (m)	Observations
Cropping, Very gently undulating plain, mid-slope, 1% slope	Forage crops	Nil microrelief Extensive disturbance  Nil erosion	Self-mulching fine sand on surface. Coarse fragments <5 mm <5%	A1 0.00 – 0.14 Abrupt	Light clay, sandy	Subangular blocky, peds 10-30 mm, firm	Nil inclusions and segregations	10YR2/1 Black Nil mottles / bleaching	Humid, well drained	Fine, very few	0.10 / 7.0	0.00-0.10 0.20-0.30 0.50-0.60 0.80-0.90 0.90-1.00	Nil additional observations
				B21 0.14 – 0.70 Abrupt	Medium heavy clay	Subangular blocky, peds 20-30 mm, strong	<5% calcium carbonate	10YR2/1 Black Nil mottles / bleaching	Humid, well drained	Fine, very few	0.30 / 7.0 0.60 / 6.5

B22 0.70 – 1.00 EOBH	Medium heavy clay, sandy	Subangular blocky, peds 40-60 mm, strong	<1% red nodules <2mm	10YR3/1 Very dark grey Nil mottles / bleaching	Humid, well drained	Nil roots	0.90 / 6.5

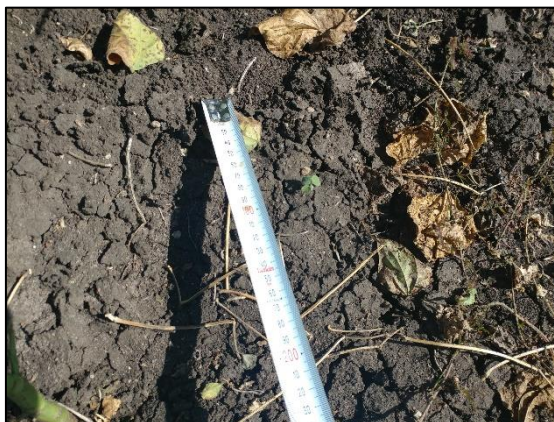
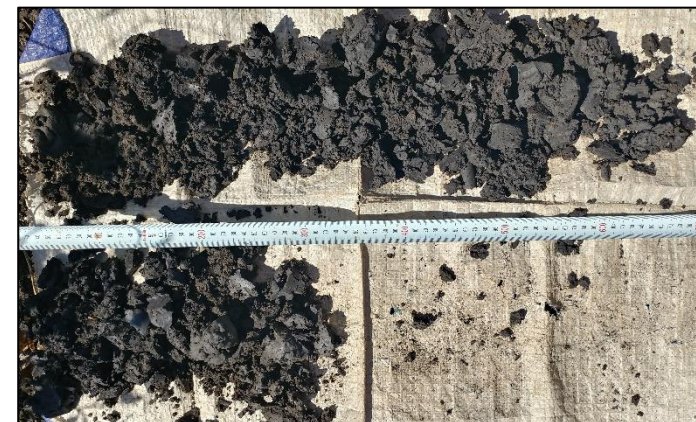
Land use Landform Pattern, Element, Slope	Vegetation	Microrelief Disturbance Erosion	Surface condition, surface rock	Soil Profile Description									
				Horizon Depth (m), Boundary	Field Texture	Structure, Strength	Inclusions Segregations	Colour, Mottle, Bleaching	Moisture, Drainage	Roots	Depth (m) / Field pH	Sample (m)	Observations
Cropping, mid-slope, 2% slope	Forage crops	Nil microrelief Extensive disturbance Nil erosion	Humid, self- mulching occasional coarse fragments <5mm	A1 0.0 – 0.10 Abrupt	Medium Clay	Subangular blocky, peds 20-30 mm, firm	Nil inclusions and segregations	10YR2/1 Black Nil mottles / bleaching	Humid, well drained	Fine, very few	0.10 / 6.5	0.00-0.10 0.20-0.30 0.50-0.60 0.80-0.90 0.90-1.00	Nil additional observations
				B21 0.10 – 0.70 Abrupt	Medium heavy clay	Subangular blocky, peds 20-30 mm, strong	Nil inclusions and segregations	10YR2/1 Black Nil mottles / bleaching	Humid, well drained	Fine, very few	0.30 / 6.5 0.60 / 7.0

B22 0.70 – 1.00 EOBH	Medium heavy clay	Subangular blocky, peds 40-60 mm, strong	Nil inclusions and segregations	10YR3/2 Very dark greyish brown Nil mottles / bleaching	Humid, well drained	Nil roots	0.90 / 6.5

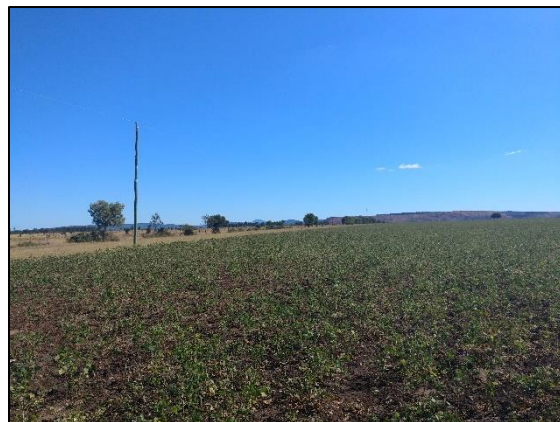
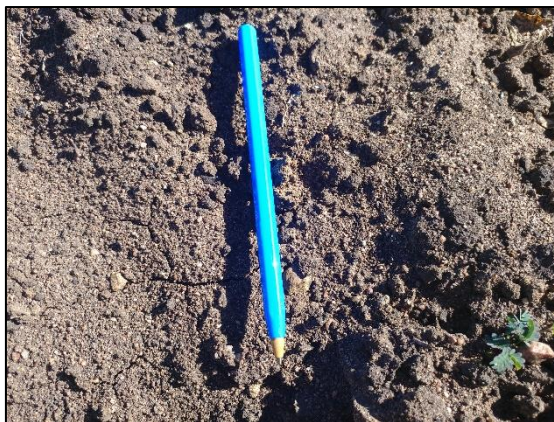
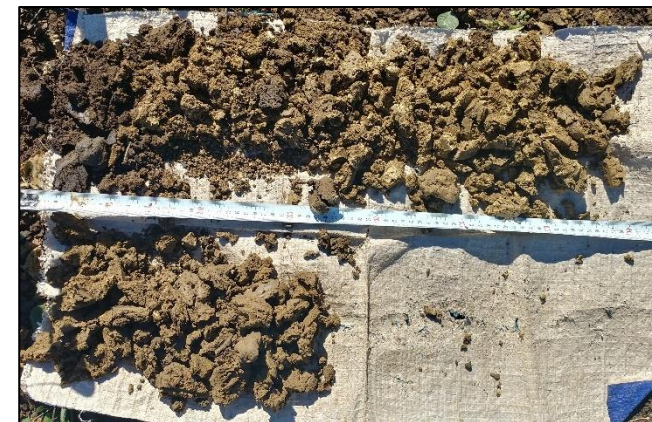
Land use Landform Pattern, Element, Slope	Vegetation	Microrelief Disturbance Erosion	Surface condition, surface rock	Soil Profile Description									
				Horizon Depth (m), Boundary	Field Texture	Structure, Strength	Inclusions Segregations	Colour, Mottle, Bleaching	Moisture, Drainage	Roots	Depth (m) / Field pH	Sample (m)	Observations
Cropping, mid-slope, 2% slope	Forage crops	Nil microrelief Nil erosion  Extensively disturbed for cropping	Self-mulching, Nil coarse fragments	A1 0.0 – 0.07 Abrupt	Light clay, sandy	Subangular blocky, peds 20-30 mm, firm	Nil inclusions and segregations	10YR3/2 Greyish brown Nil mottles / bleaching	Humid, well drained	Fine, very few	0.10 / 6.5	0.00-0.10 0.20-0.30 0.50-0.60 0.80-0.90 0.90-1.00	Nil additional observations
				B21 0.07 – 0.60 Abrupt	Light clay, sandy	Subangular blocky, peds 20-30 mm, strong	20% calcium carbonate	10YR4/3 Brown Mottle: 5% 10YR6/4 light yellowish brown	Humid, moderately well drained	Fine, very few	0.30 / 7.0 0.60 / 7.0

B22 0.60 – 1.00 EOBH	Medium clay	Subangular blocky, moderate, peds 40-60 mm, firm	Nil inclusions and segregations	10YR4/4 Dark yellowish brown Nil mottles / bleaching	dry, well drained	Nil roots	0.90 / 7.0
