# Restoration Plan to Support RIDA Application Saraji East Project

Final V4  
15 July 2021

GT Environmental Pty Ltd  
[www.gtenvironmental.com.au](http://www.gtenvironmental.com.au)

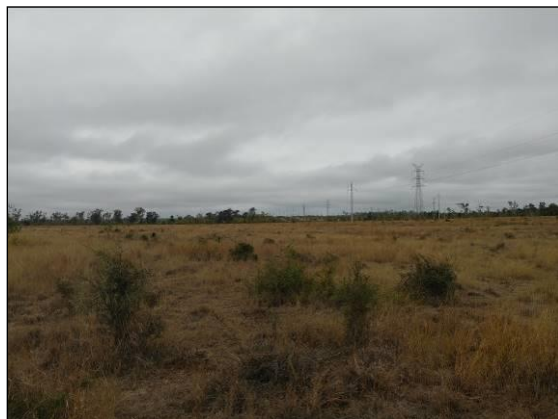
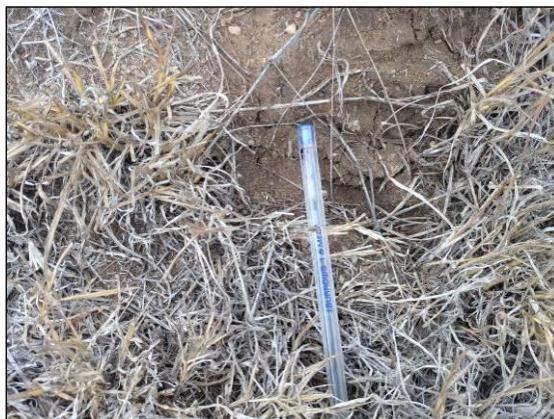
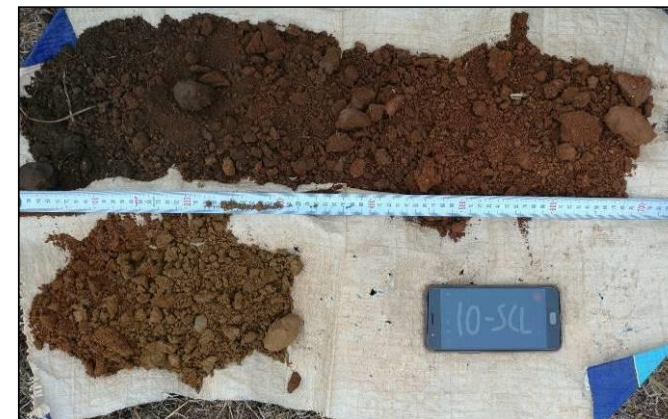
<b>Map Unit</b> 14	<b>Location (GDA94 ZONE 55):</b> 642525mE 7510097mN	<b>Aust. Soil Class.:</b> Red Chromosol	<b>Site Survey Type:</b> Detailed - 50mm hand auger	<b>Survey Date:</b> 30/06/2018
-----------------------	--	--	--	-----------------------------------

Land use Landform Pattern, Element, Slope	Vegetation	Microrelief Disturbance Erosion	Surface condition, surface rock	Soil Profile Description									
				Horizon Depth (m), Boundary	Field Texture	Structure, Strength	Inclusions Segregations	Colour, Mottle, Bleaching	Moisture, Drainage	Roots	Depth (m) / Field pH	Sample (m)	Observations
Grazing Very gently undulating plain, Midslope 2.0/1.0	Buffel grass	Nil microrelief Extensive cleared Nil erosion	Soft, Nil coarse fragments	A1 0.00-0.13 Abrupt	Sandy clay	Moderate, firm, <10mm sub-angular	<1% calcium carbonate nodules	10YR3/2 Very dark greyish brown Nil mottles / bleaching	Dry, moderate	Few, fine	0.10 / 7.0	0.00-0.10	First borehole,
				A2 0.13-0.39 Abrupt	Light sandy clay	Moderate, firm, <10mm sub-angular	Nil inclusion or segregations	10YR3/3 Dark Brown Nil mottles / bleaching	Dry, moderate	Few, fine	0.30 / 7.0	0.20-0.30	0.20 mbgl
				B21 0.39-0.84 Abrupt	Light sandy clay	Moderate, firm, <10mm sub-angular	<10% calcium carbonate nodules	5YR4/4 Reddish brown Nil mottles / bleaching	Dry, moderate	Few, fine	0.60 / 7.5	0.50-0.60	Second

B22 0.84-1.00 EOBH	Light clay	Moderate, firm, <10mm sub-angular	<2% calcium carbonate nodules	10YR4/4 Dark yellowish brown Nil mottles/bleach	Dry, moderate	Very few, very fine	0.90 / 8.5	0.70-0.80	borehole 0.40

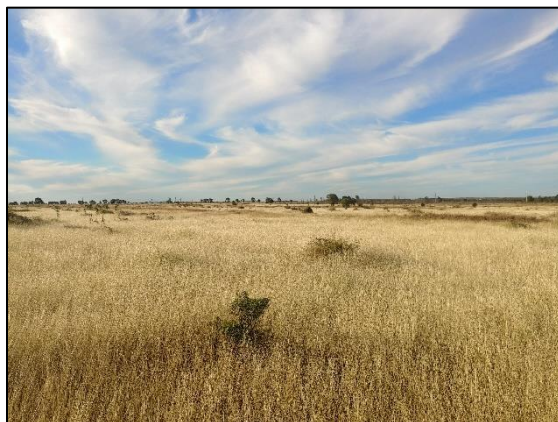
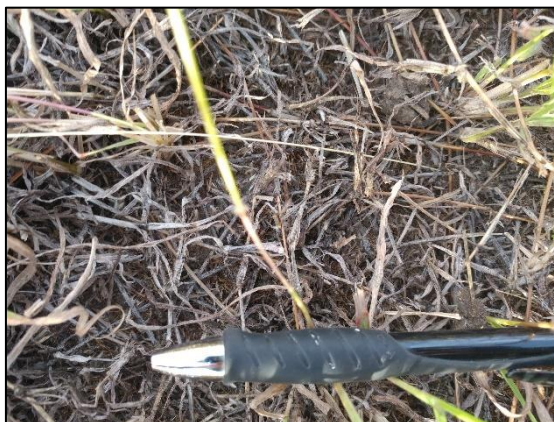
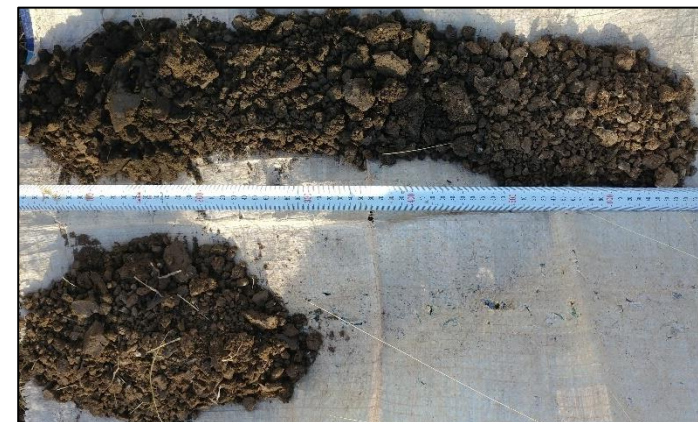
<b>Map Unit</b> 6	<b>Location (GDA94 ZONE 55):</b> 641452mE 7512060mN	<b>Aust. Soil Class.:</b> Black Dermosol	<b>Site Survey Type:</b> Detailed - 50mm hand auger	<b>Survey Date:</b> 05/06/2019
----------------------	--	---	--	-----------------------------------

Land use Landform Pattern, Element, Slope	Vegetation	Microrelief Disturbance Erosion	Surface condition, surface rock	Soil Profile Description									
				Horizon Depth (m), Boundary	Field Texture	Structure, Strength	Inclusions Segregations	Colour, Mottle, Bleaching	Moisture, Drainage	Roots	Depth (m) / Field pH	Sample (m)	Observations
Upper- slope, 2% slope	Grasses, with Brigalow nearby	Nil Microrelief  Nil erosion  Extensively cleared	Firm, Nil coarse fragments	A1 0.0 – 0.12 gradual	Sandy clay loam	Weak, sub- rounded peds <10 mm, soft	Nil inclusions or segregations	10YR2/2 Very dark brown Nil mottles / bleaching	Humid, well drained	Fine, very few	0.10 / 6.5	0.00-0.10 0.20-0.30 0.50-0.60 0.80-0.90 0.90-1.00	Nil additional observations
				B21 0.12 – 0.22 gradual	Sandy clay loam	Weak, peds <10 mm, very firm	Nil inclusions or segregations	10YR2/2 Very dark brown Nil mottles / bleaching	Humid, well drained	Fine, very few	0.20 / 6.5

B22 0.22 – 0.55 gradual	Light clay, sandy	Subangular blocky, moderate, peds <20 mm, very firm	<2% calcium carbonate	10YR3/2 Very dark greyish brown Nil mottles / bleaching	Humid, moderate y well drained	Nil roots	0.30 / 6.5		
				B23 0.55 – 1.00 EOBH	Medium clay, sandy	Subangular blocky, moderate, peds <20 mm, very firm	<2% calcium carbonate	10YR3/2 Very dark greyish brown Nil mottles / bleaching	Humid, moderate y well drained	Nil roots	0.60 / 7.0 0.90 / 6.5

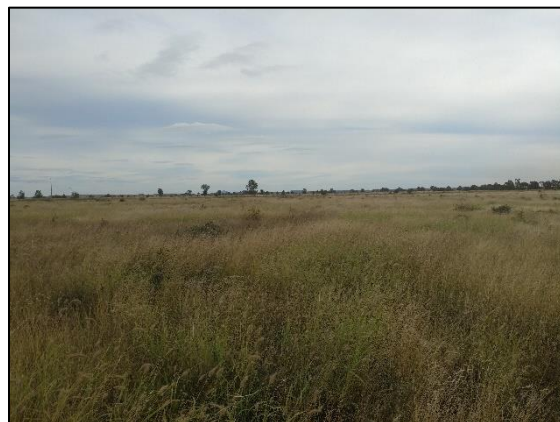
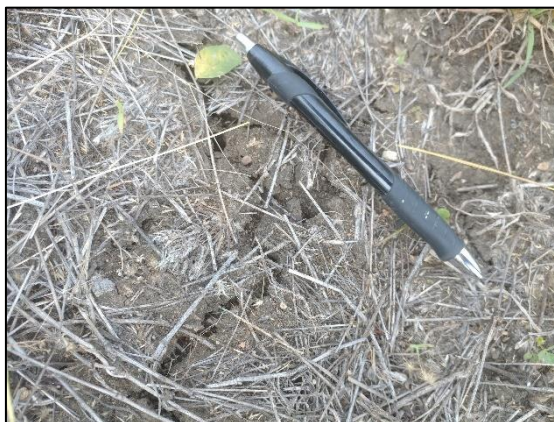
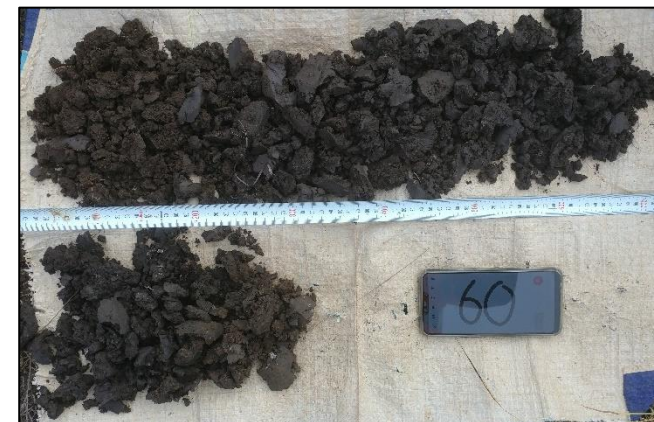
<b>Map Unit</b> 3	<b>Location (GDA94 ZONE 55):</b> 643839mE 7514447mN	<b>Aust. Soil Class.:</b> Black Vertosol	<b>Site Survey Type:</b> Detailed - 50mm hand auger	<b>Survey Date:</b> 07/06/2019
----------------------	--	---	--	-----------------------------------

Land use Landform Pattern, Element, Slope	Vegetation	Microrelief Disturbance Erosion	Surface condition, surface rock	Soil Profile Description									
				Horizon Depth (m), Boundary	Field Texture	Structure, Strength	Inclusions Segregation s	Colour, Mottle, Bleaching	Moisture, Drainage	Roots	Depth (m) / Field pH	Sample (m)	Observations
Grazing, upper-slope, 0% / 2% slope	Grasses	Nil microrelief Extensively disturbed Nil erosion	Self-mulching, cracking, Nil coarse fragments	A1 0.0 – 0.13 Abrupt	Light clay	Moderate, Sub- rounded, peds <10 mm, soft	Nil inclusions or segregations	10YR3/2 Very dark greyish brown Nil mottles / bleaching	Dry, well drained	Fine, very few	0.10 / 7.0	0.00-0.10 0.20-0.30 0.50-0.60 0.80-0.90 0.90-1.00	Nil additional observations
				B21 0.13 – 0.41 Abrupt	Medium clay	Moderate, Subangular blocky, peds <20 mm, firm	Nil inclusions or segregations	10YR2/1 Black Nil mottles / bleaching	Dry, well drained	Very fine, very few	0.30 / 7.5

B22 0.41 – 1.00 EOBH	Medium clay	Moderate, Subangular blocky, peds <20 mm, firm	<2% calcium carbonate	10YR2/1 Black Nil mottles / bleaching	Dry, moderately well drained	Nil roots	0.60 / 7.0 0.90 / 7.0

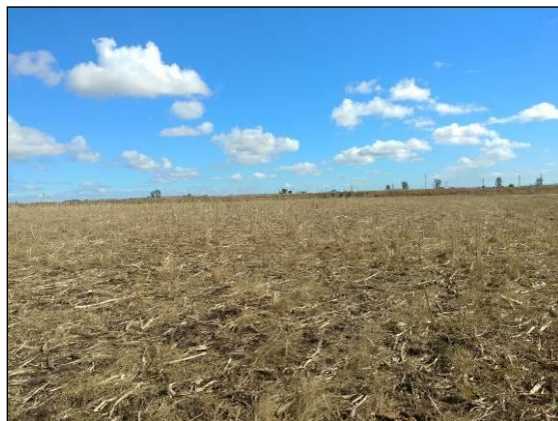
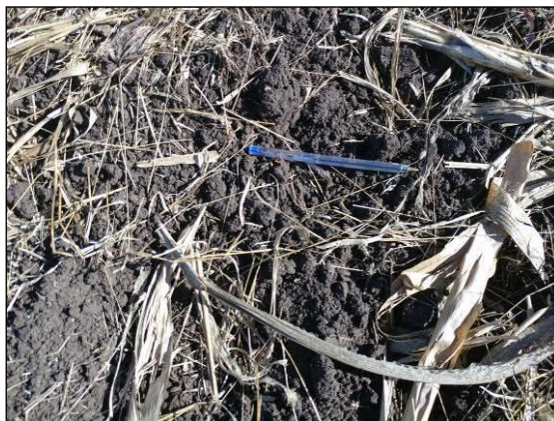
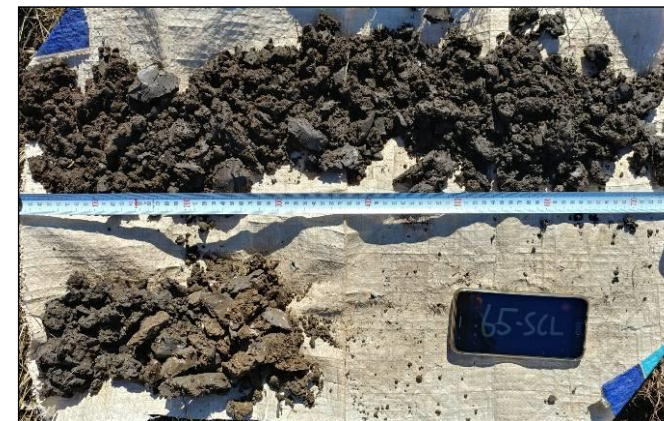
<b>Map Unit</b> 9	<b>Location (GDA94 ZONE 55):</b> 643019mE 7513552mN	<b>Aust. Soil Class.:</b> Black Vertosol	<b>Site Survey Type:</b> Detailed - 50mm hand auger	<b>Survey Date:</b> 30/06/2018
----------------------	--	---	--	-----------------------------------

Land use Landform Pattern, Element, Slope	Vegetation	Microrelief Disturbance Erosion	Surface condition, surface rock	Soil Profile Description									
				Horizon Depth (m), Boundary	Field Texture	Structure, Strength	Inclusions Segregations	Colour, Mottle, Bleaching	Moisture, Drainage	Roots	Depth (m) / Field pH	Sample (m)	Observations
Cropping Very gently undulating plain Flat plain 1.0/1.0	Cropping, Brigalow 100-200m nearby	Nil microrelief Cropping disturbance Nil erosion	Soft, self-mulching, Nil coarse fragments	A1 0.00-0.11 Abrupt	Light clay	Moderate, weak <10mm sub-angular	Nil inclusions and segregations	10YR3/1 Very dark grey Nil mottles / bleaching	Dry, moderate	Few fine	0.10 / 6.0	0.00-0.10 0.20-0.30 0.50-0.60 0.80-0.90 0.90-1.00	Nil additional observations
				B21 0.11-0.80 Abrupt	Medium clay	Moderate, weak <10mm sub-angular	Nil inclusions and segregations	10YR2/2 Very dark brown Nil mottles / bleaching	Dry, moderate	Very fine, very few	0.30 / 6.5 0.60 / 7.0

B22 0.80-1.00 EOBH	Medium clay	Moderate, weak <10mm sub-angular	2% calcium carbonate nodules	10YR3/3 Dark brown Nil mottles / bleaching	Dry, moderate	Very fine, very few	0.90 / 7.5

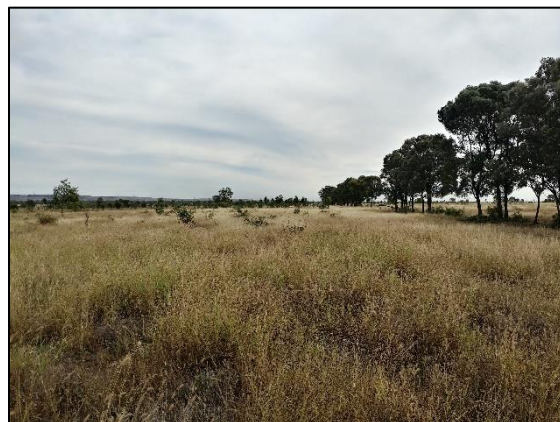
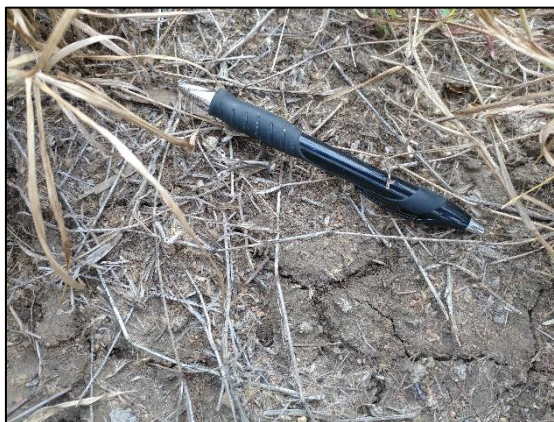
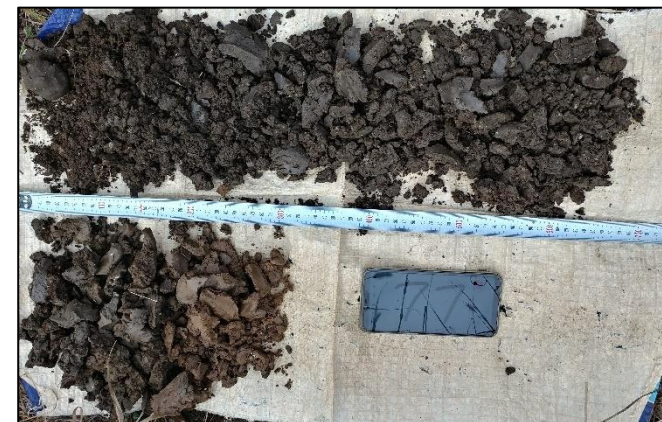
<b>Map Unit</b> 18	<b>Location (GDA94 ZONE 55):</b> 641884mE 7512916mN	<b>Aust. Soil Class.:</b> Black Dermosol	<b>Site Survey Type:</b> Detailed - 50mm hand auger	<b>Survey Date:</b> 07/06/2019
-----------------------	--	---	--	-----------------------------------

Land use Landform Pattern, Element, Slope	Vegetation	Microrelief Disturbance Erosion	Surface condition, surface rock	Soil Profile Description									
				Horizon Depth (m), Boundary	Field Texture	Structure, Strength	Inclusions Segregations	Colour, Mottle, Bleaching	Moisture, Drainage	Roots	Depth (m) / Field pH	Sample (m)	Observations
Grazing, Gently undulating plain upper-slope, 1% / 2% slope	Grasses, with Brigalow scrub nearby	Nil microrelief Extensive disturbance Nil erosion	Firm, minor crust Nil coarse fragments	A1 0.0 – 0.13 Abrupt	Sandy clay loam	Weak, Sub- rounded, peds <10 mm, soft	Nil inclusions or segregations	10YR3/1 Very dark grey Nil mottles / bleaching	Humid, well drained	Fine, very few	0.10 / 7.5	0.00-0.10 0.20-0.30 0.50-0.60 0.80-0.90 0.90-1.00	Nil additional observations
				B21 0.13 – 0.39 gradual	Medium clay	Moderate, Subangular blocky, peds <20 mm, firm	Nil inclusions or segregations	10YR3/2 Very dark greyish brown Nil mottles / bleaching	Dry, well drained	Very fine, very few	0.30 / 7.5

B22 0.39 – 0.90 clear	Medium clay	Moderate, Subangular blocky, peds <20 mm, firm	<2% calcium carbonate	10YR3/2 Very dark greyish brown Nil mottles / bleaching	Dry, moderately well drained	Very fine, very few	0.60 / 7.0		
				B23 0.90 – 1.00 EOBH	Medium clay	Strong, Subangular blocky, peds <20 mm, firm	<2% calcium carbonate	10YR4/2 Dark greyish brown Nil mottles / bleaching	Dry, moderately well drained	Very fine, very few	0.90 / 7.0

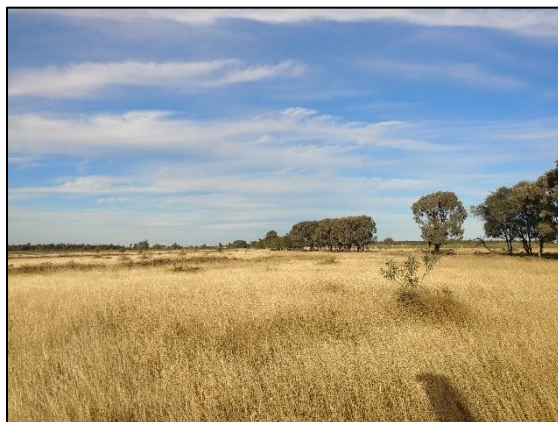
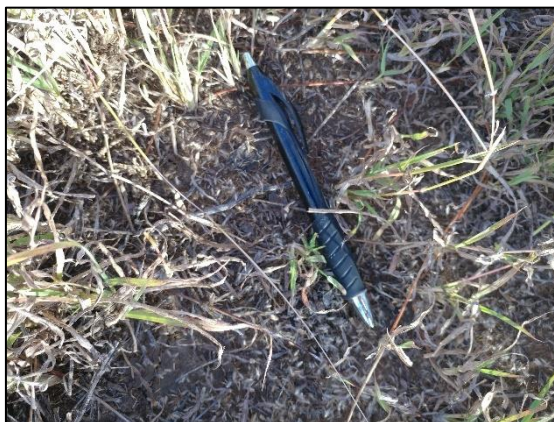
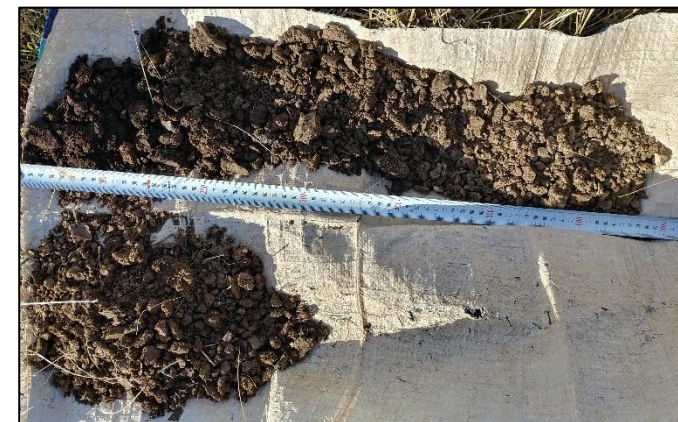
<b>Map Unit</b> 6	<b>Location (GDA94 ZONE 55):</b> 642045mE 7511689mN	<b>Aust. Soil Class.:</b> Black Dermosol	<b>Site Survey Type:</b> Detailed - 50mm hand auger	<b>Survey Date:</b> 05/06/2019
----------------------	--	---	--	-----------------------------------

Land use Landform Pattern, Element, Slope	Vegetation	Microrelief Disturbance Erosion	Surface condition, surface rock	Soil Profile Description									
				Horizon Depth (m), Boundary	Field Texture	Structure, Strength	Inclusions Segregations	Colour, Mottle, Bleaching	Moisture, Drainage	Roots	Depth (m) / Field pH	Sample (m)	Observations
Grazing Gently undulating plain Upper- slope, 2% slope	Grasses, with Brigalow nearby	Nil Microrelief  Nil erosion  Extensively cleared	Firm, Nil coarse fragments	A1 0.0 – 0.11 Abrupt	Sandy clay loam	Weak, sub- rounded peds <10 mm, soft	Nil inclusions or segregations	10YR2/2 Very dark brown Nil mottles / bleaching	Humid, well drained	Fine, very few	0.10 / 6.5	0.00-0.10 0.20-0.30 0.50-0.60 0.80-0.90 0.90-1.00	Nil additional observations
				A2 0.11 – 0.22 clear	Sandy clay loam	Weak, peds <10 mm, very firm	Nil inclusions or segregations	10YR2/2 Nil mottles / bleaching	Humid, well drained	Nil roots	0.20 / 6.5

B21 0.22 – 0.49 gradual	Light clay, sandy	Subangular blocky, moderate, peds <20 mm, very firm	<2% calcium carbonate	10YR3/1 Very dark grey Nil mottles / bleaching	Humid, moderately well drained	Nil roots	0.30 / 7.0		
				B22 0.49 – 1.00 EOBH	Medium clay, sandy	Subangular blocky, moderate, peds <20 mm, very firm	<1% calcium carbonate	10YR3/2 Very dark greyish brown Nil mottles / bleaching	Humid, moderately well drained	Nil roots	0.60 / 7.0 0.90 / 6.5

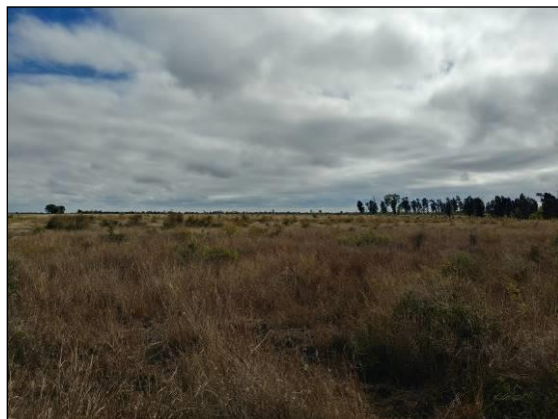
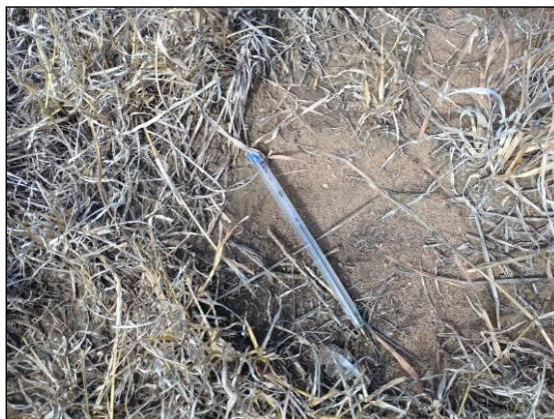
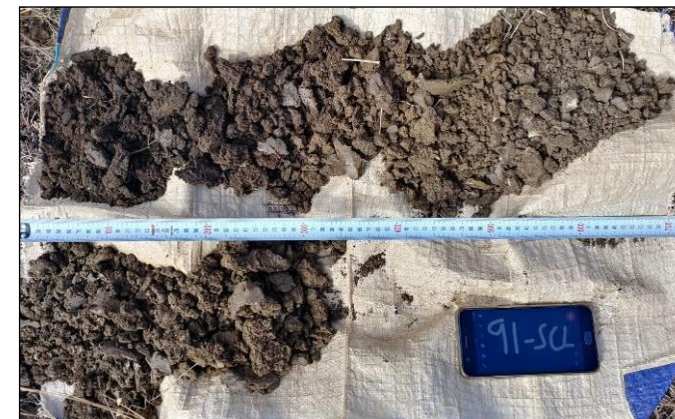
<b>Map Unit</b> 6	<b>Location (GDA94 ZONE 55):</b> 643899mE 7510777mN	<b>Aust. Soil Class.:</b> Black Dermosol	<b>Site Survey Type:</b> Detailed - 50mm hand auger	<b>Survey Date:</b> 30/06/2018
----------------------	--	---	--	-----------------------------------

Land use Landform Pattern, Element, Slope	Vegetation	Microrelief Disturbance Erosion	Surface condition, surface rock	Soil Profile Description									
				Horizon Depth (m), Boundary	Field Texture	Structure, Strength	Inclusions Segregations	Colour, Mottle, Bleaching	Moisture, Drainage	Roots	Depth (m) / Field pH	Sample (m)	Observations
Grazing, Gently undulating plain, Midslope 2.0/1.0	Cleared, nearby remnant Belah	Nil microrelief Extensive disturbance Nil erosion	Firm, Nil coarse fragments	A1 0.00-0.12 Abrupt	Sandy Clay	Moderate, weak <20mm sub- angular	Nil inclusions and segregations	10YR2/1 Black Nil mottles / bleaching	Dry, moderate	Few, fine	0.10 / 6.0	0.00-0.10 0.20-0.30 0.50-0.60 0.80-0.90 0.90-1.00	Nil additional observations
				B21 0.12-0.50 Clear	Light sandy clay	Moderate, firm 20- 50mm sub- angular	Nil inclusions and segregations	10YR2/2 Very dark brown Nil mottles / bleaching	Dry, moderate	Few, fine	0.30 / 6.5

B22 0.50-1.00 EOBH	Light clay	Moderate, firm 20- 50mm sub- angular blocky	<2% calcium carbonate nodules	10YR3/3 Dark brown Mottles: <2% 10YR5/3 Brown Nil bleach	Dry, moderate	Very few, very fine	0.60 / 7.0 0.60 / 7.5

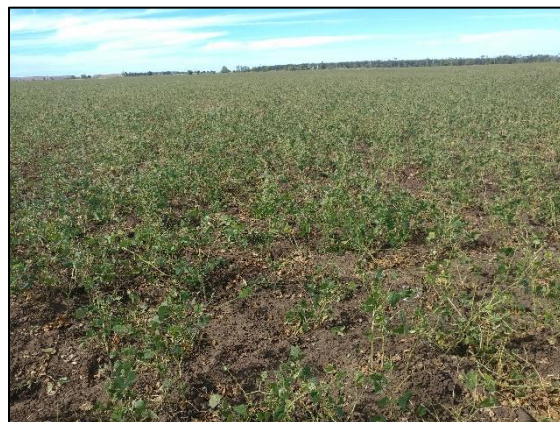
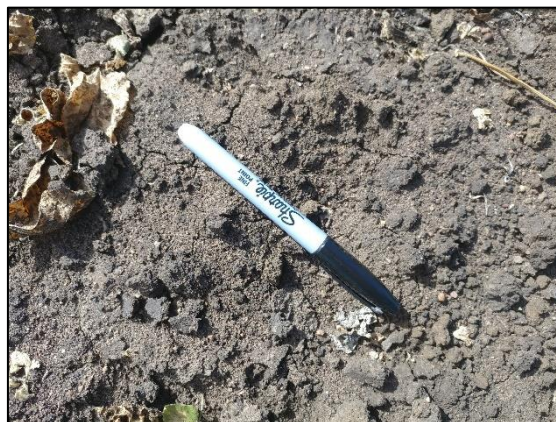
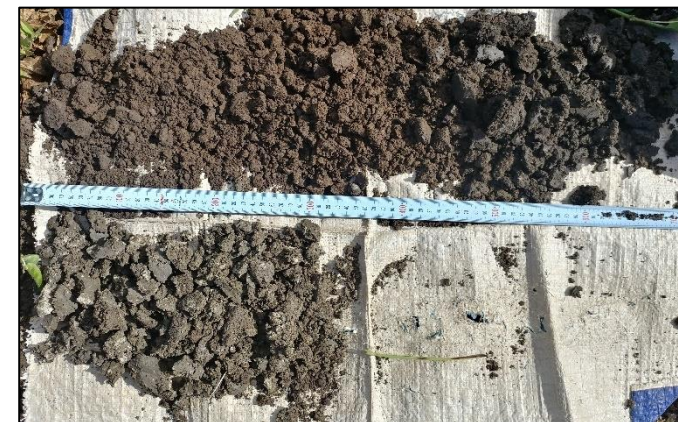
<b>Map Unit</b> 6	<b>Location (GDA94 ZONE 55):</b> 642351mE 7510427mN	<b>Aust. Soil Class.:</b> Black Dermosol	<b>Site Survey Type:</b> Detailed - 50mm hand auger	<b>Survey Date:</b> 04/06/2019
----------------------	--	---	--	-----------------------------------

Land use Landform Pattern, Element, Slope	Vegetation	Microrelief Disturbance Erosion	Surface condition, surface rock	Soil Profile Description									
				Horizon Depth (m), Boundary	Field Texture	Structure, Strength	Inclusions Segregations	Colour, Mottle, Bleaching	Moisture, Drainage	Roots	Depth (m) / Field pH	Sample (m)	Observations
Grazing Gently undulating plain Mid-slope, 1%/ 1% slope	Forage cropping	Nil Microrelief Extensive disturbance Nil erosion	Firm, Nil coarse fragments	A1 0.0 – 0.08 Abrupt	Sandy loam	Weak, sub- rounded peds 5-20 mm, firm	Nil inclusions or segregations	10YR3/1 Very dark grey Nil mottles / bleaching	Humid, well drained	Fine, very few	0.05 / 6.5	0.00-0.10 0.20-0.30 0.50-0.60 0.80-0.90 0.90-1.00	Nil additional observations
				B21 0.08 – 0.47 Abrupt	Sandy clay loam	Moderate, peds 30-40 mm, very firm	Nil inclusions or segregations	10YR3/2 Very dark greyish brown Nil mottles / bleaching	Humid, well drained	Nil roots	0.30 / 6.5

B22 0.47 – 0.70 Abrupt	Light clay, sandy	Subangular blocky, moderate, peds <30 mm, very firm	<1% calcium carbonate	10YR2/1 Black Nil mottles / bleaching	Humid, moderately well drained	Nil roots	0.60 / 6.5		
				B23 0.70 – 1.00 EOBH	Medium clay, sandy	Subangular blocky, moderate, peds <20 mm, very firm	<10% calcium carbonate	10YR3/2 Very dark greyish brown Nil mottles / bleaching	Humid, moderately well drained	Nil roots	0.90 / 6.5

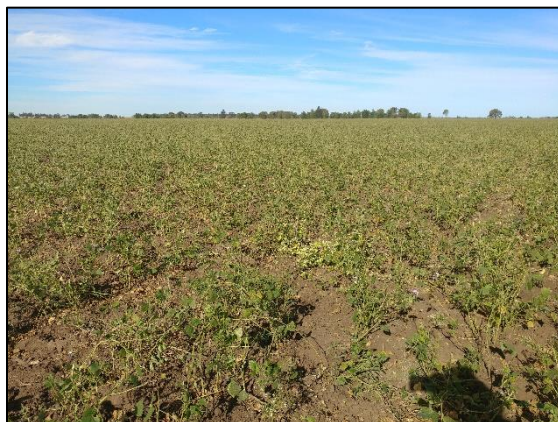
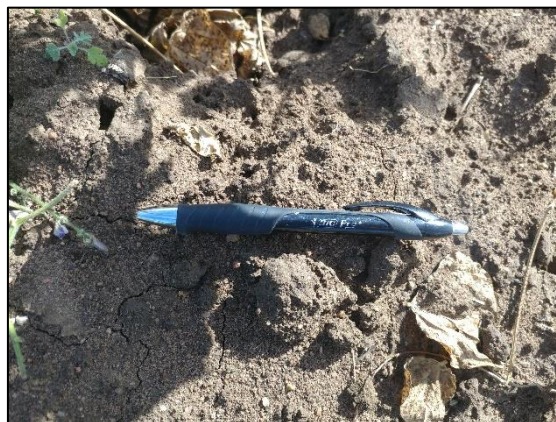
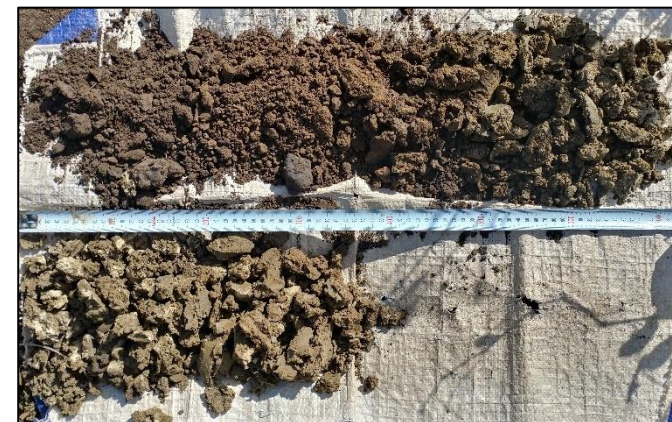
<b>Map Unit</b> 6	<b>Location (GDA94 ZONE 55):</b> 7510427mE 7511265mN	<b>Aust. Soil Class.:</b> Black Dermosol	<b>Site Survey Type:</b> Detailed - 50mm hand auger	<b>Survey Date:</b> 04/06/2019
----------------------	---	---	--	-----------------------------------

Land use Landform Pattern, Element, Slope	Vegetation	Microrelief Disturbance Erosion	Surface condition, surface rock	Soil Profile Description									
				Horizon Depth (m), Boundary	Field Texture	Structure, Strength	Inclusions Segregations	Colour, Mottle, Bleaching	Moisture, Drainage	Roots	Depth (m) / Field pH	Sample (m)	Observations
Grazing Gently undulating plain Mid-slope, <1% / 1% slope	Forage cropping	Nil Microrelief Extensive disturbance Nil erosion	Firm, Nil coarse fragments	A1 0.0 – 0.18 Abrupt	Sandy loam	Weak, sub- rounded peds 5-20 mm, firm	Nil inclusions or segregations	10YR3/1 Very dark grey Nil mottles / bleaching	Humid, well drained	Fine, very few	0.10 / 6.5	0.00-0.10 0.20-0.30 0.50-0.60 0.80-0.90 0.90-1.00	Nil additional observations
				B21 0.18 – 0.50 Abrupt	Sandy clay loam	Moderate, peds 30-40 mm, very firm	Nil inclusions or segregations	10YR2/2 Very dark brown Nil mottles / bleaching	Humid, well drained	Nil roots	0.30 / 6.5

B22 0.50 – 1.00 EOBH	Light clay, sandy	Subangular blocky, moderate, peds <40 mm, very firm	<5% calcium carbonate	10YR3/3 Dark brown Mottles: Nil mottles / bleaching	Humid, moderately well drained	Nil roots	0.60 / 6.5

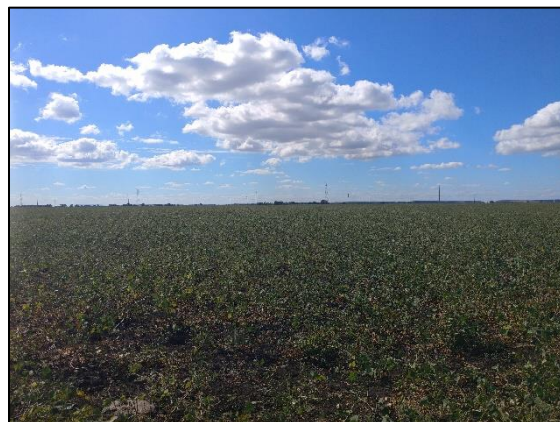
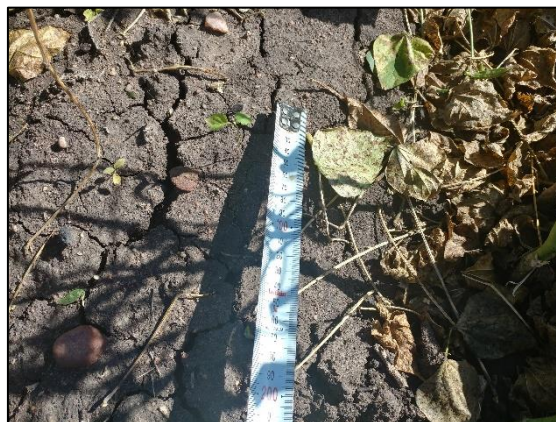
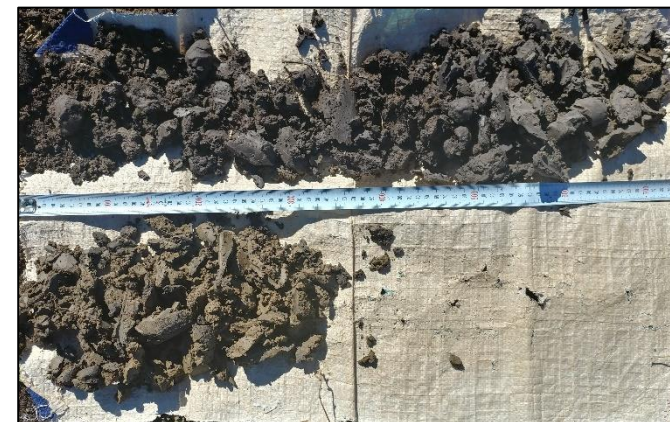
<b>Map Unit</b> 13	<b>Location (GDA94 ZONE 55):</b> 641820mE 7510822mN	<b>Aust. Soil Class.:</b> Black Vertosol	<b>Site Survey Type:</b> Detailed - 50mm hand auger	<b>Survey Date:</b> 03/06/2019
-----------------------	--	---	--	-----------------------------------

Land use Landform Pattern, Element, Slope	Vegetation	Microrelief Disturbance Erosion	Surface condition, surface rock	Soil Profile Description									
				Horizon Depth (m), Boundary	Field Texture	Structure, Strength	Inclusions Segregations	Colour, Mottle, Bleaching	Moisture, Drainage	Roots	Depth (m) / Field pH	Sample (m)	Observations
Cropping Gently undulating plain , upper- slope, 1% / 2% slope	Forage crops	Nil microrelief Extensive disturbance Nil erosion	Self-mulching, minor crust, Nil coarse fragments	A1 0.0 – 0.17 Abrupt	Light clay	Subangular blocky, weak, peds <20 mm, firm	<5% coarse fragments	10YR3/1 Very dark grey Nil mottles / bleaching	Humid, well drained	Fine, very few	0.10 / 6.5	0.00-0.10 0.20-0.30 0.50-0.60 0.80-0.90 0.90-1.00	Nil additional observations
				B2 0.17 – 1.00 EOBH	Medium clay	Subangular blocky, strong, weak, peds <30 mm, very firm	<1% coarse fragments	10YR3/1 Very dark grey Nil mottles / bleaching	Humid, Moderately well drained	Nil roots	0.30 / 7.0 0.60 / 7.0 0.90 / 6.5

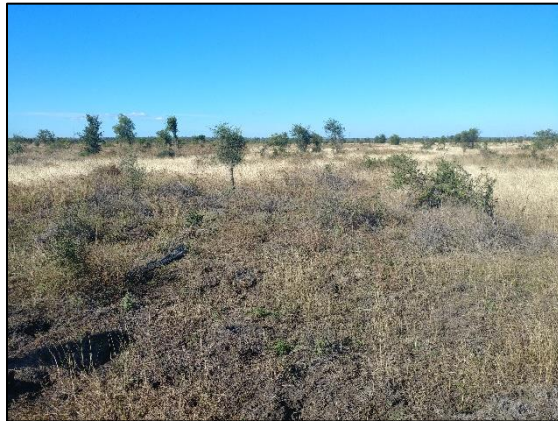
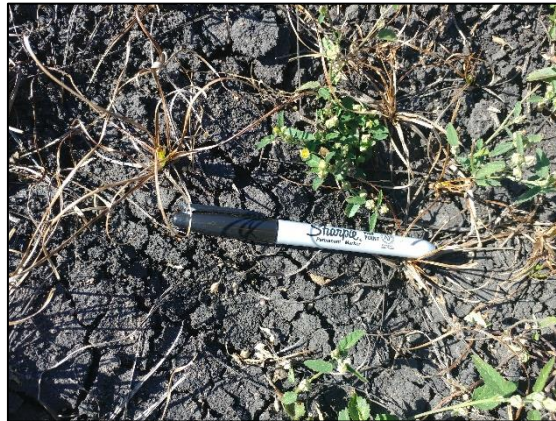
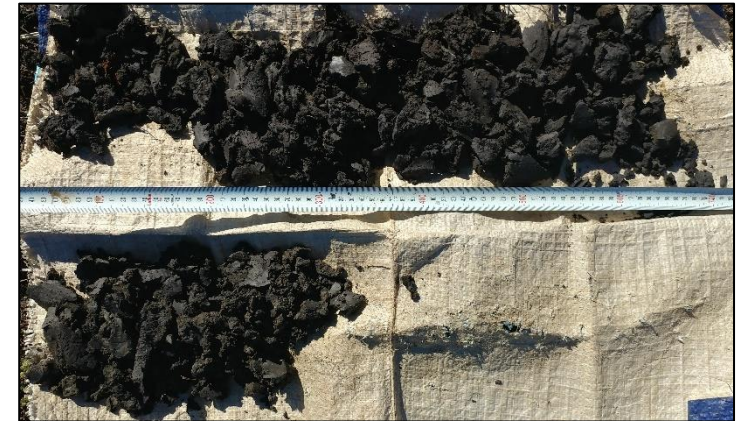
<b>Map Unit</b> 16	<b>Location (GDA94 ZONE 55):</b> 641451mE 7509683mN	<b>Aust. Soil Class.:</b> Black Vertosol	<b>Site Survey Type:</b> Detailed - 50mm hand auger	<b>Survey Date:</b> 03/06/2019
-----------------------	--	---	--	-----------------------------------

Land use Landform Pattern, Element, Slope	Vegetation	Microrelief Disturbance Erosion	Surface condition, surface rock	Soil Profile Description									
				Horizon Depth (m), Boundary	Field Texture	Structure, Strength	Inclusions Segregations	Colour, Mottle, Bleaching	Moisture, Drainage	Roots	Depth (m) / Field pH	Sample (m)	Observations
Grazing, Gently undulating plain mid-slope, 1% / 2% slope	Grasses, recent regrowth and shrubs	Normal gilgai <0.2 m deep, 30-40% coverage  Nil erosion  Extensively disturbed for cropping	Self-mulching, minor crust, Nil coarse fragments	A1 0.0 – 0.13 Abrupt	Medium Clay	Subangular blocky, moderate, peds <20 mm, soft	Nil inclusions or segregations	10YR3/1 Very dark grey Nil mottles / bleaching	Humid, well drained	Fine, very few	0.10 / 6.5	No samples taken	Nil additional observations
				B21 0.13 – 0.62 Abrupt	Medium clay	Subangular blocky, moderate, peds <30 mm, firm	Nil inclusions or segregations	10YR3/1 Very dark grey Nil mottles / bleaching	Humid, well drained	Nil roots	0.30 / 7.0 0.60 / 7.0

B22 0.62 – 1.00 EOBH	Medium clay	Subangular blocky, strong, peds <30 mm, very firm	<2% calcium carbonate	10YR3/1 Very dark grey Nil mottles / bleaching	Humid, moderately well drained	Nil roots	0.90 / 6.5

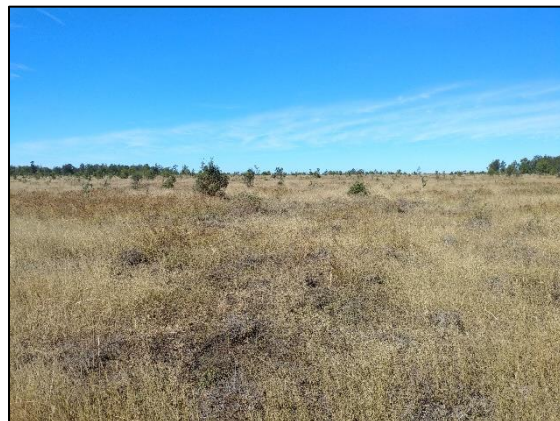
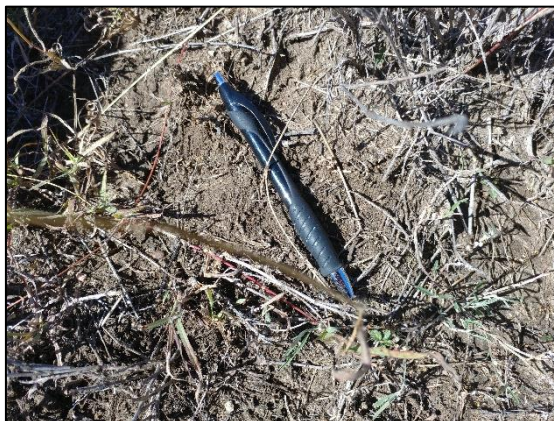
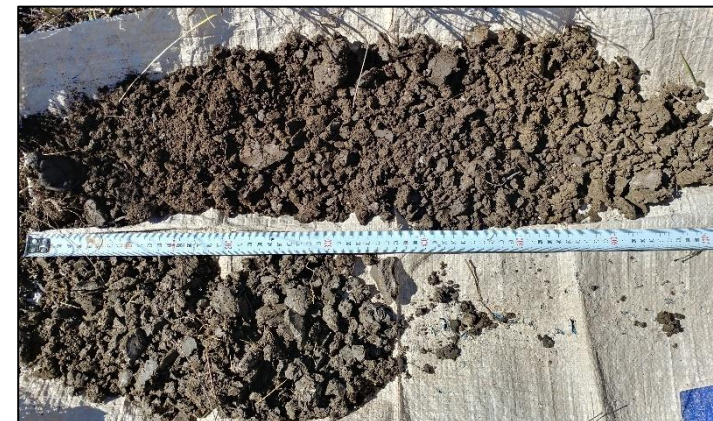
<b>Map Unit</b> 16	<b>Location (GDA94 ZONE 55):</b> 641663mE 7508746mN	<b>Aust. Soil Class.:</b> Black Vertosol	<b>Site Survey Type:</b> Detailed - 50mm hand auger	<b>Survey Date:</b> 03/06/2019
-----------------------	--	---	--	-----------------------------------

Land use Landform Pattern, Element, Slope	Vegetation	Microrelief Disturbance Erosion	Surface condition, surface rock	Soil Profile Description									
				Horizon Depth (m), Boundary	Field Texture	Structure, Strength	Inclusions Segregations	Colour, Mottle, Bleaching	Moisture, Drainage	Roots	Depth (m) / Field pH	Sample (m)	Observations
Grazing, Gently undulating plain mid-slope, 2% / 1%	Grasses, recent regrowth and shrubs	Crabhole gilgai <0.2 m deep, 30% coverage Nil erosion Extensively disturbed	Self-mulching, Nil coarse fragments	A1 0.0 – 0.12 Abrupt	Light clay	Subangular blocky, moderate, peds <20 mm, soft	Nil inclusions or segregations	10YR2/1 Black Nil mottles / bleaching	Humid, well drained	Fine, very few	0.10 / 6.5	0.00-0.10 0.20-0.30 0.50-0.60 0.80-0.90 0.90-1.00	Nil additional observations
				B21 0.12 – 0.50 Abrupt	Medium heavy clay	Subangular blocky, moderate, peds <30 mm, firm	Nil inclusions or segregations	10YR2/1 Black Nil mottles / bleaching	Humid, well drained	Fine, very few	0.30 / 7.0 0.60 / 7.0

B22 0.50 – 1.00 EOBH	Medium heavy clay	Subangular blocky, strong, peds <30 mm, very firm	<2% calcium carbonate	10YR2/1 Black Nil mottles / bleaching	Humid, moderately well drained	Nil roots	0.90 / 6.5

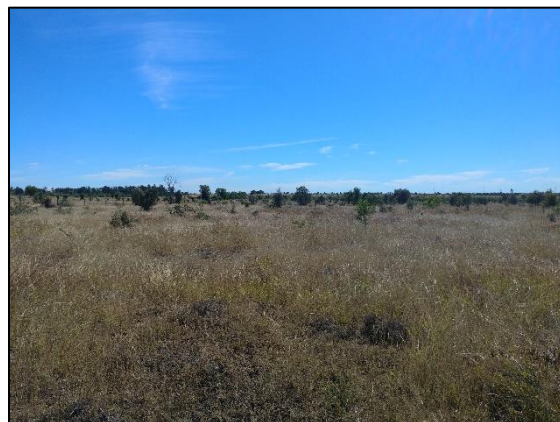
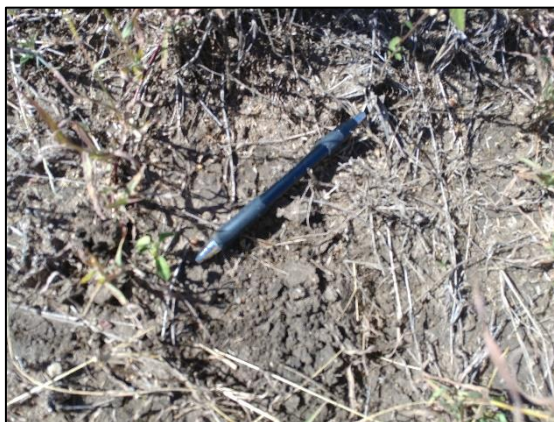
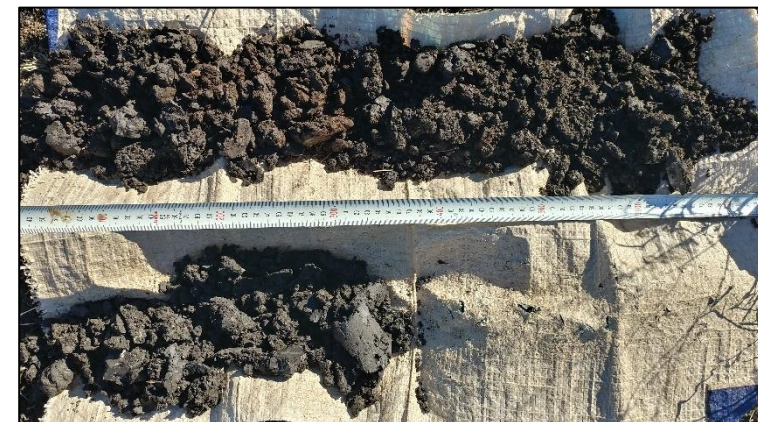
<b>Map Unit</b> 16	<b>Location (GDA94 ZONE 55):</b> 641658mE 7508739mN	<b>Aust. Soil Class.:</b> Black Vertosol	<b>Site Survey Type:</b> Detailed - 50mm hand auger	<b>Survey Date:</b> 03/06/2019
-----------------------	--	---	--	-----------------------------------

Land use Landform Pattern, Element, Slope	Vegetation	Microrelief Disturbance Erosion	Surface condition, surface rock	Soil Profile Description									
				Horizon Depth (m), Boundary	Field Texture	Structure, Strength	Inclusions Segregation s	Colour, Mottle, Bleaching	Moisture, Drainage	Roots	Depth (m) / Field pH	Sample (m)	Observations
Grazing, Gently undulating plain mid-slope, 2%, Gilgai depression	Grasses, recent regrowth and shrubs	Crabhole gilgai <0.2 m deep, 30% coverage Nil erosion Extensively disturbed	Self-mulching, Nil coarse fragments	A1 0.0 – 0.10 Abrupt	Medium Clay	Subangular blocky, moderate, peds <20 mm, soft	Nil inclusions or segregations	10YR2/1 Black Nil mottles / bleaching	Humid, well drained	Fine, very few	0.10 / 6.5	0.00-0.10 0.20-0.30 0.50-0.60 0.80-0.90 0.90-1.00	Nil additional observations
				B21 0.10 – 0.60 Abrupt	Medium heavy clay	Subangular blocky, moderate, peds <30 mm, firm	Nil inclusions or segregations	10YR2/1 Black Nil mottles / bleaching	Humid, well drained	Fine, very few	0.30 / 7.0 0.60 / 7.0

B22 0.60 – 1.00 EOBH	Medium heavy clay	Subangular blocky, strong, peds <30 mm, very firm	<2% calcium carbonate	10YR2/1 Black Nil mottles / bleaching	Humid, moderately well drained	Nil roots	0.90 / 6.5

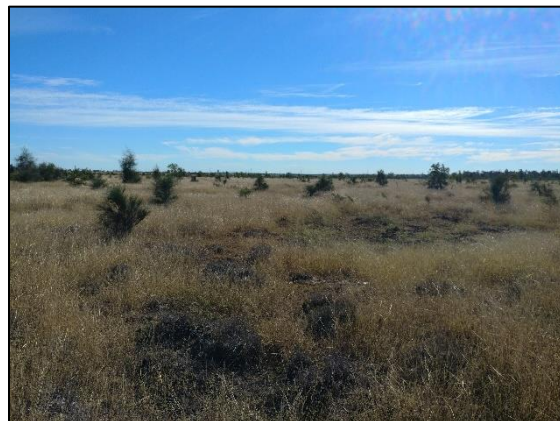
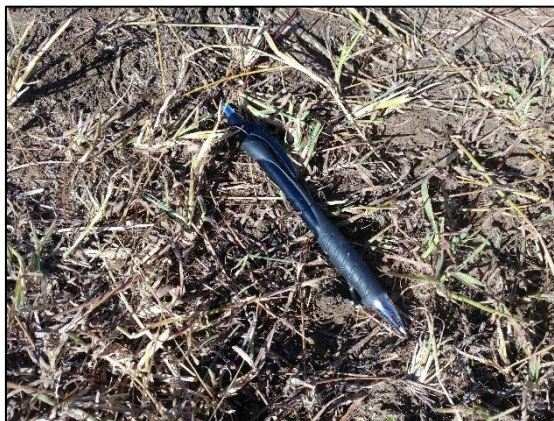
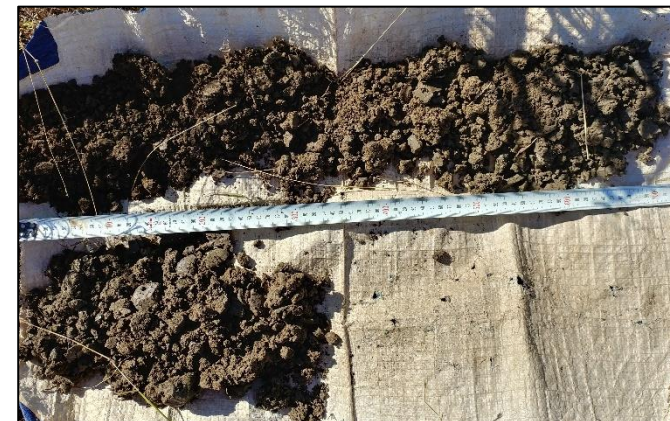
<b>Map Unit</b> 16	<b>Location (GDA94 ZONE 55):</b> 641736mE 7508275mN	<b>Aust. Soil Class.:</b> Black Vertosol	<b>Site Survey Type:</b> Detailed - 50mm hand auger	<b>Survey Date:</b> 04/06/2019
-----------------------	--	---	--	-----------------------------------

Land use Landform Pattern, Element, Slope	Vegetation	Microrelief Disturbance Erosion	Surface condition, surface rock	Soil Profile Description									
				Horizon Depth (m), Boundary	Field Texture	Structure, Strength	Inclusions Segregations	Colour, Mottle, Bleaching	Moisture, Drainage	Roots	Depth (m) / Field pH	Sample (m)	Observations
Grazing Gently undulating plain mid-slope, 2%, Gilgai depression	Grasses, recent regrowth and shrubs	Crabhole gilgai <0.2 m deep, 50% coverage Nil erosion Extensively disturbed	Self-mulching, Nil coarse fragments	A1 0.0 – 0.12 Abrupt	Light clay	Subangular blocky, moderate, peds <10 mm, soft	Nil inclusions or segregations	10YR3/1 Very dark grey Nil mottles / bleaching	Humid, well drained	Fine, very few	0.10 / 6.5	0.00-0.10 0.20-0.30 0.50-0.60 0.80-0.90 0.90-1.00	Nil additional observations
				B21 0.12 – 0.60 Abrupt	Medium clay	Subangular blocky, moderate, peds <30 mm, firm	Nil inclusions or segregations	10YR3/2 Very dark greyish brown Nil mottles / bleaching	Humid, well drained	Fine, very few	0.30 / 7.0 0.60 / 7.0

B22 0.60 – 1.00 EOBH	Medium heavy clay	Subangular blocky, strong, peds <30 mm, very firm	<2% calcium carbonate	10YR4/2 Dark greyish brown Nil mottles / bleaching	Humid, moderately well drained	Nil roots	0.90 / 6.5

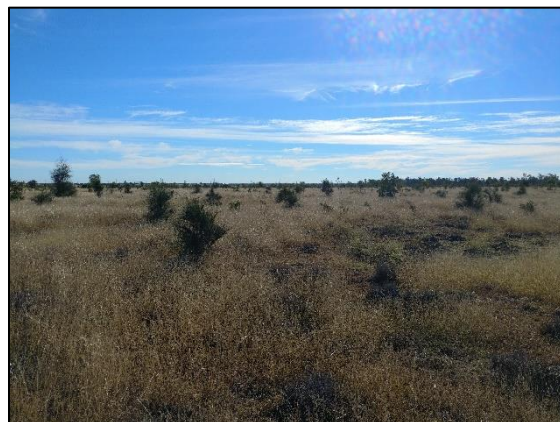
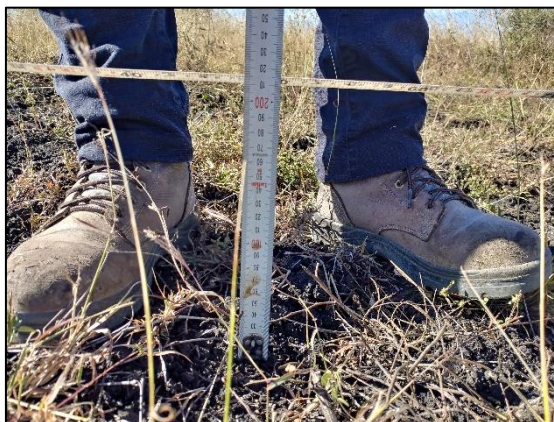
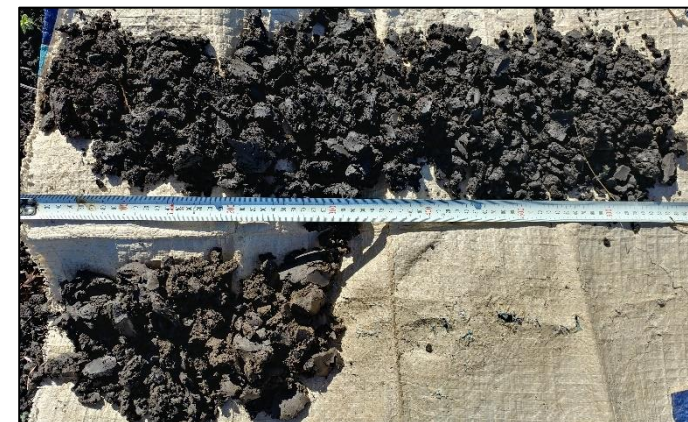
<b>Map Unit</b> 16	<b>Location (GDA94 ZONE 55):</b> 641732mE 7508275mN	<b>Aust. Soil Class.:</b> Black Vertosol	<b>Site Survey Type:</b> Detailed - 50mm hand auger	<b>Survey Date:</b> 04/06/2019
-----------------------	--	---	--	-----------------------------------

Land use Landform Pattern, Element, Slope	Vegetation	Microrelief Disturbance Erosion	Surface condition, surface rock	Soil Profile Description									
				Horizon Depth (m), Boundary	Field Texture	Structure, Strength	Inclusions Segregations	Colour, Mottle, Bleaching	Moisture, Drainage	Roots	Depth (m) / Field pH	Sample (m)	Observations
Grazing Gently undulating plain mid-slope, 2%, Gilgai depression	Grasses, recent regrowth and shrubs	Crabhole gilgai <0.22 m deep, 50% coverage Nil erosion Extensively disturbed	Self-mulching, Nil coarse fragments	A1 0.0 – 0.10 Abrupt	Light Medium Clay	Subangular blocky, moderate, peds <20 mm, weak	<1% calcium carbonate	10YR3/1 Very dark grey Nil mottles / bleaching	Humid, well drained	Fine, very few	0.10 / 7.0	0.00-0.10 0.20-0.30 0.50-0.60 0.83-0.90 0.90-1.00	Nil additional observations
				B21 0.10 – 0.83 Abrupt	Medium heavy clay	Subangular blocky, moderate, peds 20-40 mm, very firm	<2% calcium carbonate	10YR3/1 Very dark grey Nil mottles / bleaching	Dry, moderately well drained	Fine, very few	0.30 / 6.5 0.60 / 6.5

B23 0.83 – 1.00 EOBH	Medium heavy clay	Subangular blocky, strong, peds 20-40 mm, very firm	Nil inclusions or segregations	10YR3/2 Very dark greyish brown Nil mottles / bleaching	Dry, moderately well drained	Nil roots	0.90 / 6.5

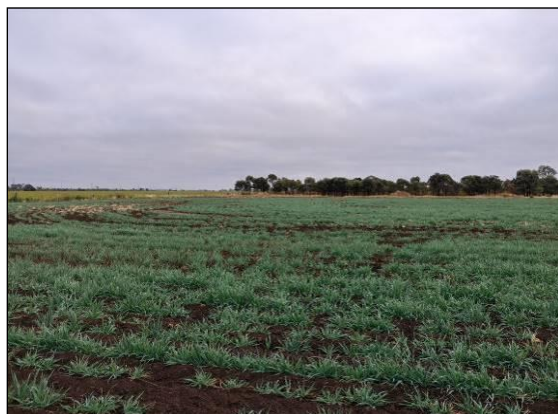
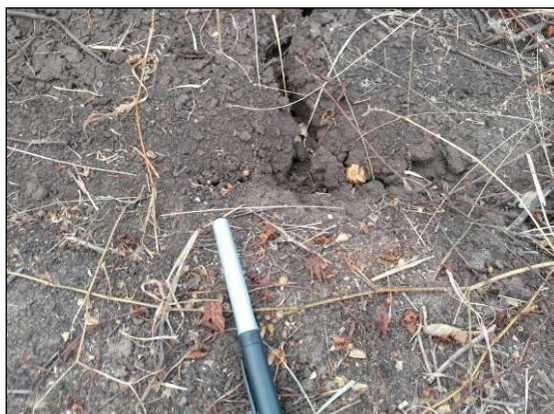
<b>Map Unit</b> 17	<b>Location (GDA94 ZONE 55):</b> 644310mE 7508052mN	<b>Aust. Soil Class.:</b> Black Vertosol	<b>Site Survey Type:</b> Detailed - 50mm hand auger	<b>Survey Date:</b> 30/06/2018
-----------------------	--	---	--	-----------------------------------

Land use Landform Pattern, Element, Slope	Vegetation	Microrelief Disturbance Erosion	Surface condition, surface rock	Soil Profile Description									
				Horizon Depth (m), Boundary	Field Texture	Structure, Strength	Inclusions Segregations	Colour, Mottle, Bleaching	Moisture, Drainage	Roots	Depth (m) / Field pH	Sample (m)	Observations
Cropping Flat plain, level, 0.0/0.0%	Cropping	Nil microrelief Cropping disturbance Nil erosion	Cracking, surface mulch Nil coarse fragments	A1 0.0-0.13 Abrupt	Light clay	Weak, firm, <10mm sub-angular	2% 2-6mm coarse fragments	10YR3/2 Very dark greyish brown Nil mottles / bleaching	Dry, moderate	Fine, few	0.10 / 6.5	0.00-0.10	Nil additional observations
				B21 0.13-0.38 Abrupt	Medium clay	Moderate, firm <40% 20-60mm, <20% 60-100 sub- angular blocky peds	<1% black nodules <1% calcium carbonate nodules	10YR3/2 Very dark greyish brown Nil mottles / bleaching	Dry, moderate	Very fine, very few	0.30 / 6.5	0.20-0.30

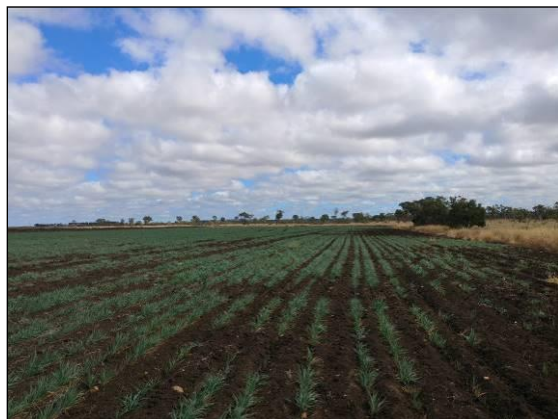
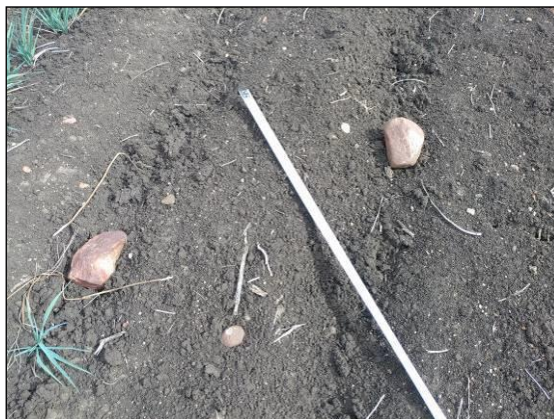
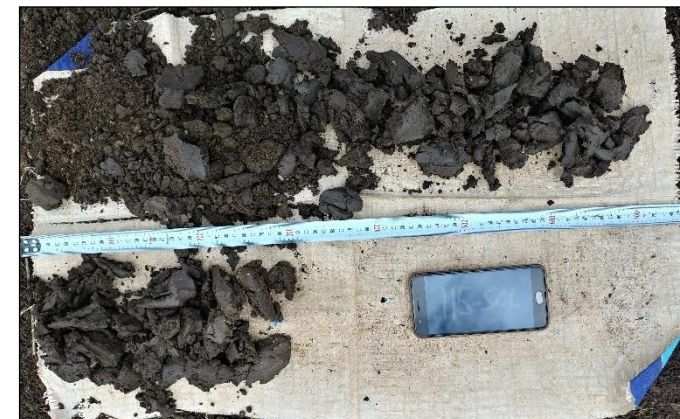
<b>Map Unit</b> 17	<b>Location (GDA94 ZONE 55):</b> 645410mE 7509123mN	<b>Aust. Soil Class.:</b> Black Vertosol	<b>Site Survey Type:</b> Detailed - 50mm hand auger	<b>Survey Date:</b> 30/06/2018
-----------------------	--	---	--	-----------------------------------

Land use Landform Pattern, Element, Slope	Vegetation	Microrelief Disturbance Erosion	Surface condition, surface rock	Soil Profile Description									
				Horizon Depth (m), Boundary	Field Texture	Structure, Strength	Inclusions Segregations	Colour, Mottle, Bleaching	Moisture, Drainage	Roots	Depth (m) / Field pH	Sample (m)	Observations
Cropping Very gently undulating plain Flat plain 1.0/1.0	Cropping	Nil microrelief Cropping disturbance Nil erosion	Soft, loose 2-5% medium pebbles >600mm	A1 0.00-0.16 Abrupt	Light clay	Moderate, weak <10mm sub- angular blocky	<2% calcium carbonate nodules	10YR3/2 Very dark greyish brown Nil mottles / bleaching	Dry, moderate	Few fine	0.10 / 6.0	0.00-0.10 0.20-0.30 0.50-0.60 0.80-0.90 0.90-1.00	Nil additional observations
				B2 0.16-1.00 EOBH	Medium clay	Strong, firm <10mm sub- angular blocky	Nil inclusions and segregations	10YR3/2 Very dark greyish brown Nil mottles / bleaching	Dry, moderate	Very fine, very few	0.30 / 6.5 0.60 / 7.0 0.90 / 7.5

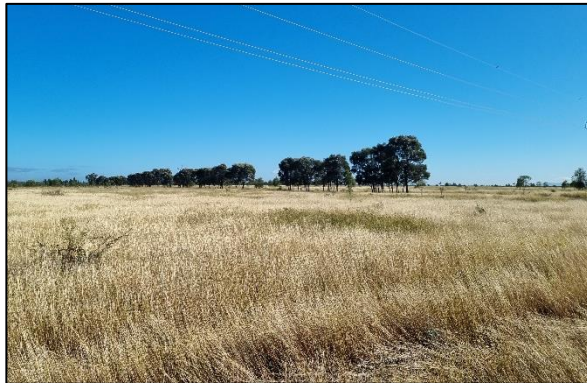
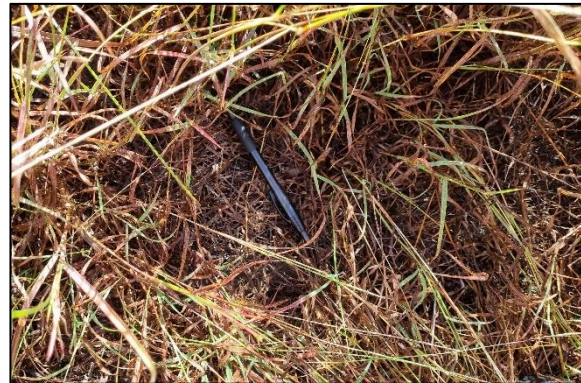
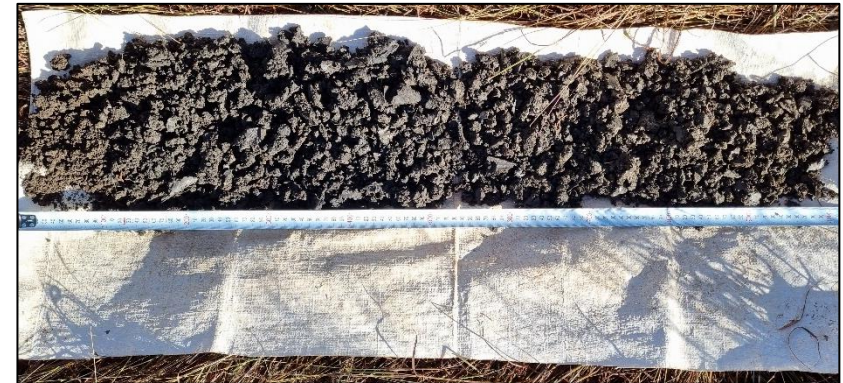
<b>Site N46</b>	Map Unit: 18	Location (mE/mS GDA94 ZONE 55): 641947 7512737	Australian Soil Class: Black Dermosol	Soil Survey Type: Detailed 50 mm hand auger	Survey Date: 01/05/2021
-----------------	-----------------	---	--	--	----------------------------

Land use / Landform Pattern / Element / Slope	Vegetation / Microrelief / Disturbance / Erosion	Surface condition / surface rock	Soil Profile Description								
			Horizon / Depth (m / Boundary	Field Texture	Structure / Strength / Pedality	Inclusions / Segregations	Colour / Mottle / Bleaching	Moisture / Drainage	Roots Size / Abundance	Depth (m) / Field pH	Sample (m) / Observations
Grazing Gently undulating plain Mid-slope 2%/2%	Spear grass, sparse brigalow Nil microrelief Extensive clearing	Firm Nil coarse fragments	A1 0.00-0.12 Clear 20-50mm	Clay loam sandy	Moderate Firm Subangular blocky	Nil inclusions or segregations	10YR3/2 Very dark greyish brown Nil mottles or bleaching	Moderately moist Moderately well drained	Fine 1- 2mm Common	6.0	0.00-0.10 0.20-0.30 0.50-0.60 0.70-0.80
			B21 0.10-0.46 Clear 20-50mm	Medium clay	Strong Very firm Angular blocky	Nil inclusions or segregations	10YR3/1 Very dark grey Nil mottles or bleaching	Moderately moist Moderately well drained	Fine 1- 2mm Common	7.5	0.90-1.00

B22 0.46-0.86 Clear 20-50mm	Medium clay	Strong Very firm	<2% calcium carbonate 2-6mm	10YR3/1 Very dark grey Nil mottles or bleaching	Moderately moist Moderately well drained	Fine 1- 2mm Few	7.5	Rainfall night before
			B23 0.86-1.00 EOBH	Medium clay	Strong Strong	Nil inclusions or segregations	10YR4/2 Dark greyish brown Nil mottles or bleaching	Dry Moderately well drained	Fine 1- 2mm Few	7.5

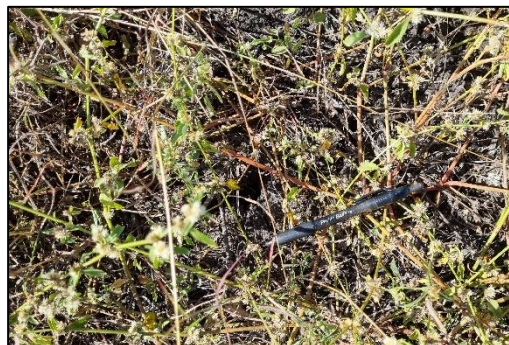
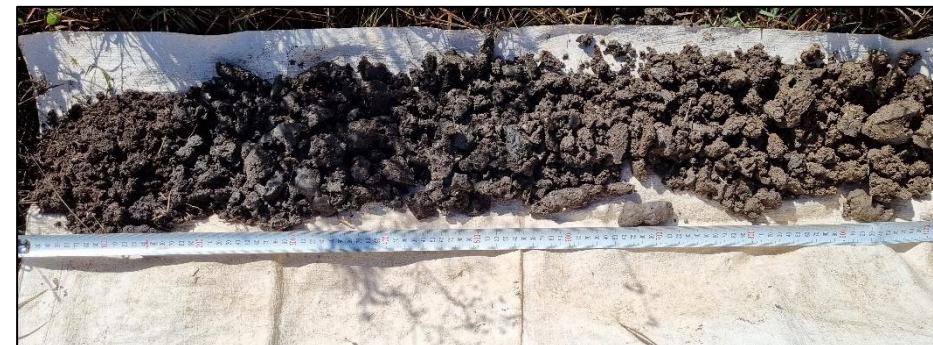
Land use / Landform Pattern / Element / Slope	Vegetation / Microrelief / Disturbance / Erosion	Surface condition / surface rock	Soil Profile Description								
			Horizon / Depth (m / Boundary	Field Texture	Structure / Strength / Pedality	Inclusions / Segregations	Colour / Mottle / Bleaching	Moisture / Drainage	Roots Size / Abundance	Depth (m) / Field pH	Sample (m) / Observations
Grazing Gently undulating plain Flat 0%/<1%	Brigalow nearby Nil microrelief Extensive clearing	Self-mulching Nil coarse fragments Moist	A1 0.00-0.08 Clear 20-50mm	Light clay	Moderate Firm Angular blocky	Nil inclusions or segregations	10YR2/1 Black Nil mottles or bleaching	Moist Well drained	Fine 1- 2mm Few	7.0	0.00-0.08 0.20-0.30 0.50-0.60
			B21 0.08-0.40 Sharp <5mm	Medium clay	Moderate Strong Subangular blocky	<2% calcium carbonate	10YR3/2 Very dark greyish brown Nil mottles or bleaching	Moderately moist Well drained	Very fine <1mm Few	8.0	0.70-0.80 0.90-1.00

B22 0.40-0.80 Clear 20-50mm	Medium clay / medium heavy clay	Moderate Strong Subangular blocky	2-10% calcium carbonate	10YR3/2 Very dark greyish brown Nil mottles or bleaching	Dry Moderately well drained	Very fine <1mm Few	8.0	
			B23 0.80-1.00 EOBH	Medium clay	Strong Strong Subangular blocky	Nil inclusions or segregations	10YR3/3 Dark brown Nil mottles or bleaching	Dry Moderately well drained	Nil roots	8.0
