# Restoration Plan to Support RIDA Application Saraji East Project

Final V4  
15 July 2021

GT Environmental Pty Ltd  
[www.gtenvironmental.com.au](http://www.gtenvironmental.com.au)

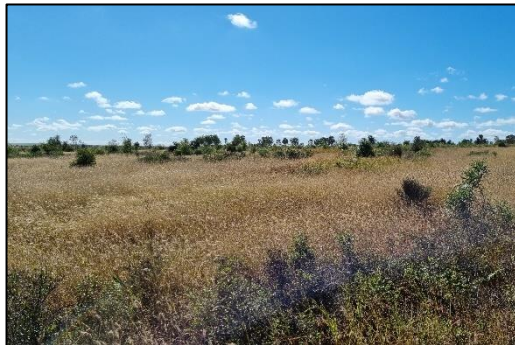
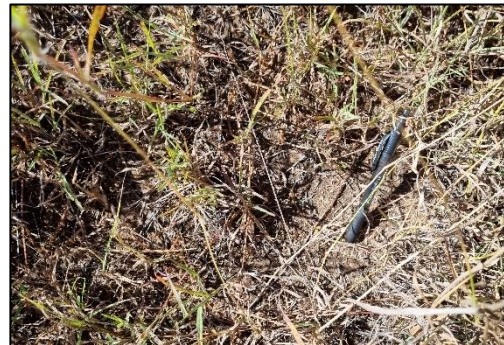
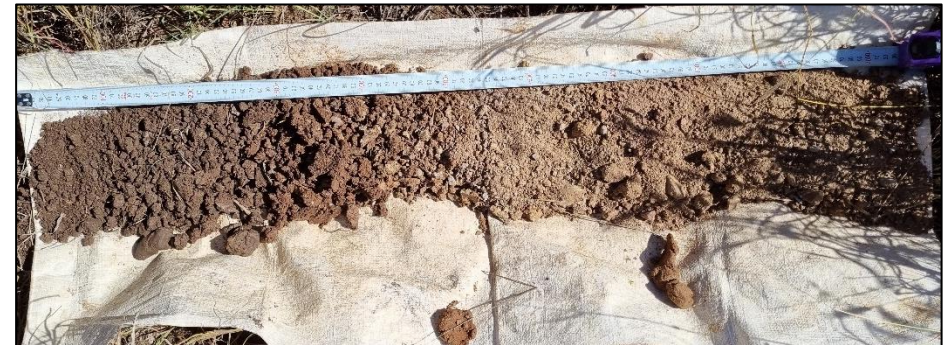
Land use / Landform Pattern / Element / Slope	Vegetation / Microrelief / Disturbance / Erosion	Surface condition / surface rock	Soil Profile Description								
			Horizon / Depth (m / Boundary	Field Texture	Structure / Strength / Pedality	Inclusions / Segregations	Colour / Mottle / Bleaching	Moisture / Drainage	Roots Size / Abundance	Depth (m) / Field pH	Sample (m) / Observations
Grazing Undulating plain Mid-slope 2%/2%	Current bush, bull Mitchell grass Nil microrelief Extensive clearing	Firm Nil coarse fragments	A1 0.00-0.10 Clear 20-50mm	Sandy clay loam	Massive Weak	Nil inclusions or segregations	10YR3/2 Very dark greyish brown Nil mottles or bleaching	Moderately moist Rapidly drained	Very fine <1mm Common	7.0	0.00-0.10 0.20-0.30 0.50-0.60 0.70-0.80
			B21 0.10-0.30 Gradual 50- 100mm	Sandy clay loam	Moderate Weak Subangular blocky	Nil inclusions or segregations	10YR3/2 Very dark greyish brown Nil mottles or bleaching	Dry Well drained	Very fine <1mm Common	7.0	0.90-1.00

B22 0.30-0.45 Gradual 50- 100mm	Sandy clay loam	Moderate Firm Subangular blocky	Nil inclusions or segregations	7.5YR3/4 Nil mottles or bleaching	Dry Well drained	Nil roots	7.5	
			B23 0.45-1.00 EOBH	Sandy loam / Sandy clay loam	Massive Weak Subangular blocky	2-10% coarse fragments	10YR3/4 Nil mottles or bleaching	Dry Rapidly drained	Nil roots	7.5

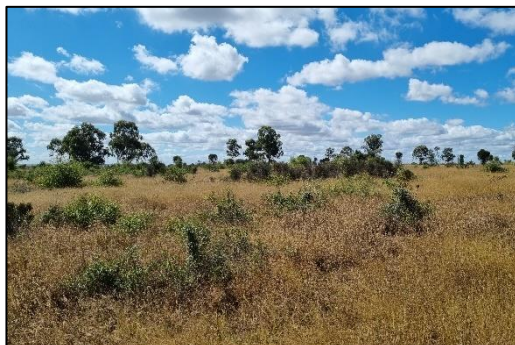
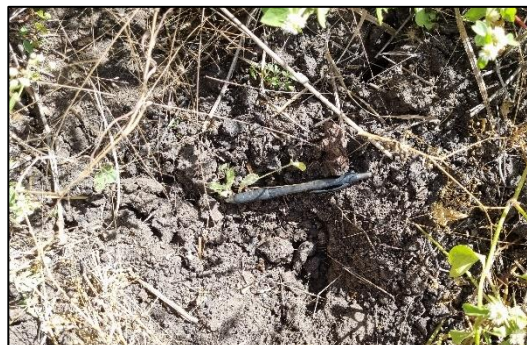
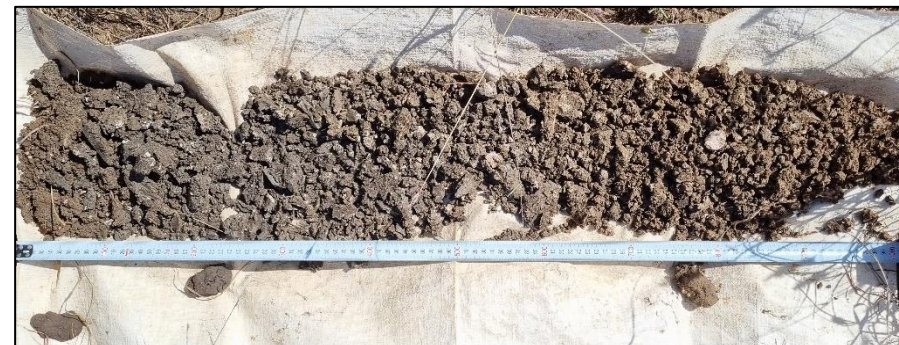
<b>Site N49</b>	Map Unit: 19	Location (mE/mS GDA94 ZONE 55): 641677 7513512	Australian Soil Class: Black self-mulching Vertosol	Soil Survey Type: Detailed 50 mm hand auger	Survey Date: 01/05/2021
-----------------	-----------------	---	--	--	----------------------------

Land use / Landform Pattern / Element / Slope	Vegetation / Microrelief / Disturbance / Erosion	Surface condition / surface rock	Soil Profile Description								
			Horizon / Depth (m / Boundary	Field Texture	Structure / Strength / Pedality	Inclusions / Segregations	Colour / Mottle / Bleaching	Moisture / Drainage	Roots Size / Abundance	Depth (m) / Field pH	Sample (m) / Observations
Grazing Gently undulating plain Upper slope 2%/2%	Current bush, Bull Mitchell grass Nil microrelief Extensive clearing	Self-mulching Nil coarse fragments	A1 0.00-0.13 Clear 20-50mm	Light clay	Moderate Very firm	<2% calcium carbonate	10YR3/2 Very dark greyish brown Nil mottles or bleaching	Dry Moderately well drained	Fine 1- 2mm Common	6.0	0.00-0.10 0.20-0.30 0.50-0.60
			B21 0.13-0.61 Clear 20-50mm	Light medium clay	Moderate Firm	2-10% calcium carbonate	10YR3/2 Very dark greyish brown Nil mottles or bleaching	Dry Moderately well drained	Very fine <1mm Few	8.0	0.70-0.80 0.90-1.00

B22 0.61-1.00 EOBH	Clay loam	Moderate Firm	Nil inclusions or segregations	10YR4/2 Dark greyish brown Nil mottles or bleaching	Dry Moderately well drained	Nil roots	8.0

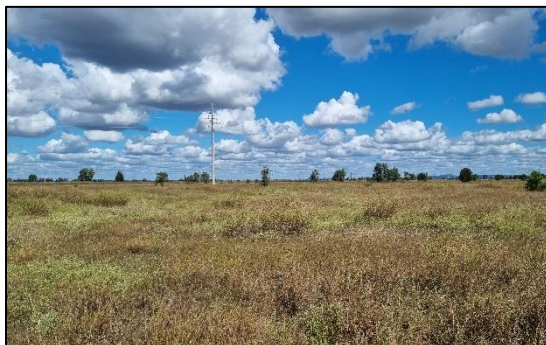
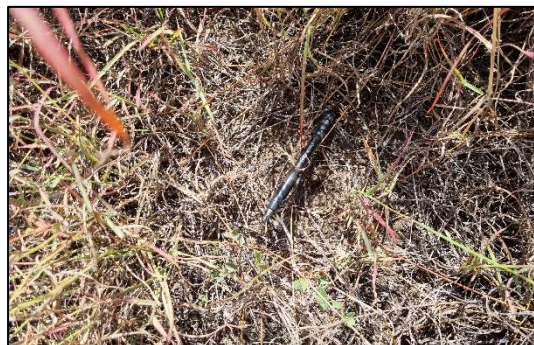
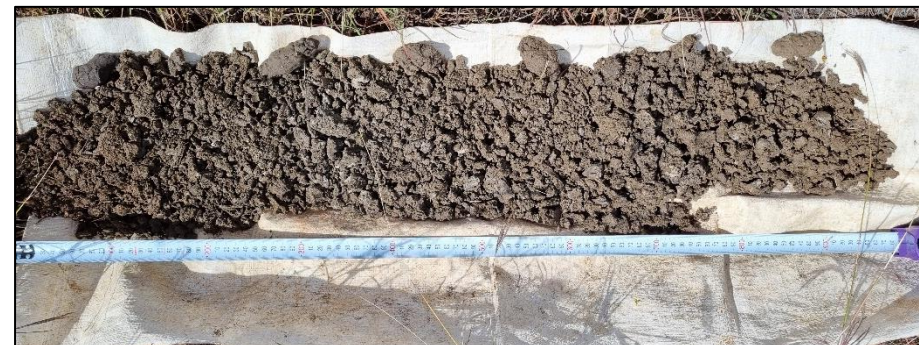
<b>Site N50</b>	Map Unit: 18	Location (mE/mS GDA94 ZONE 55): 642495 7513615	Australian Soil Class: Black Dermosol	Soil Survey Type: Detailed 50 mm hand auger	Survey Date: 01/05/2021
-----------------	-----------------	---	--	--	----------------------------

Land use / Landform Pattern / Element / Slope	Vegetation / Microrelief / Disturbance / Erosion	Surface condition / surface rock	Soil Profile Description								
			Horizon / Depth (m / Boundary	Field Texture	Structure / Strength / Pedality	Inclusions / Segregations	Colour / Mottle / Bleaching	Moisture / Drainage	Roots Size / Abundance	Depth (m) / Field pH	Sample (m) / Observations
Grazing Gently undulating plain Flat 0%/0%	Grasses Nil microrelief Complete clearing, not cultivated	Firm Nil coarse fragments	A1 0.00-0.09 Abrupt 5-20mm	Clay loam, sandy	Moderate Firm Subangular blocky	Nil inclusions or segregations	10YR3/1 Very dark grey Nil mottles or bleaching	Dry Moderately well drained	Fine 1- 2mm Few	7.0	0.00-0.09 0.20-0.30 0.50-0.60 0.70-0.80 0.90-1.00
			B21 0.09-0.31 Abrupt 5-20mm	Medium clay	Moderate Firm Angular blocky	<2% calcium carbonate <2mm	10YR3/2 Very dark greyish brown Nil mottles or bleaching	Dry Moderately well drained	Fine 1- 2mm Few	7.5

B22 0.31-0.62 Abrupt 5-20mm	Medium clay	Moderate Firm Angular blocky	<2% calcium carbonate 2-6mm	10YR3/2 Very dark greyish brown Nil mottles or bleaching	Dry Moderately well drained	Fine 1- 2mm Few	7.5	
			B23 0.62-0.85 Abrupt 5-20mm	Medium clay	Moderate Very firm Angular blocky	<2% calcium carbonate <2mm	10YR3/3 Dark brown Nil mottles or bleaching	Dry Moderately well drained	Nil roots	8.0	
			B24 0.85-1.00 EOBH	Medium clay	Moderate Very firm Subangular blocky	Nil inclusions or segregations	10YR3/2 Very dark greyish brown Nil mottles or bleaching	Moderately moist Well drained	Nil roots	8.0

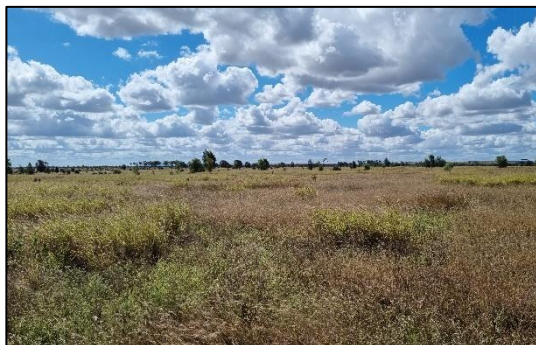
**Landscape**

<b>Site N51</b>	Map Unit: 18	Location (mE/mS GDA94 ZONE 55): 642242 7513413	Australian Soil Class: Black Dermosol	Soil Survey Type: Detailed 50 mm hand auger	Survey Date: 01/05/2021
-----------------	-----------------	---	--	--	----------------------------

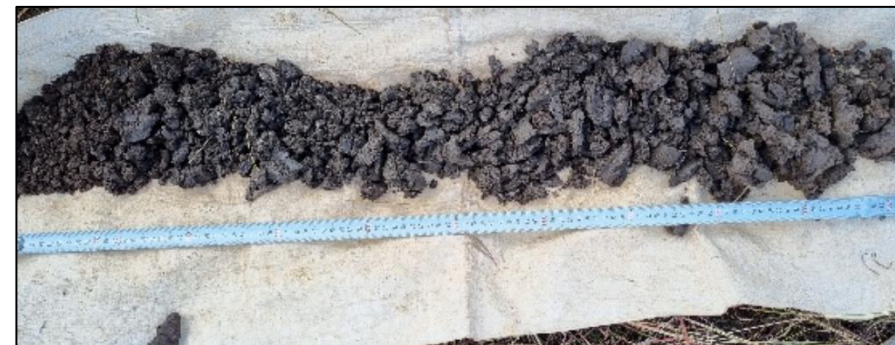
**Soil Profile**

Land use / Landform Pattern / Element / Slope	Vegetation / Microrelief / Disturbance / Erosion	Surface condition / surface rock	Soil Profile Description								
			Horizon / Depth (m / Boundary	Field Texture	Structure / Strength / Pedality	Inclusions / Segregations	Colour / Mottle / Bleaching	Moisture / Drainage	Roots Size / Abundance	Depth (m) / Field pH	Sample (m) / Observations
Grazing Gently undulating plain Flat 0%/0%	Grasses Nil microrelief Complete clearing, not cultivated	Firm Nil coarse fragments	A1 0.00-0.09 Abrupt 5-20mm	Clay loam, sandy	Moderate Firm Subangular blocky	Nil inclusions or segregations	10YR2/1 Black Nil mottles or bleaching	Moderately moist Well drained	Fine 1- 2mm Few	6.5	0.00-0.09 0.13-0.23 0.23-0.30
			B21 0.09-0.23 Abrupt 5-20mm	Medium clay	Moderate Strong Subangular blocky	Nil inclusions or segregations	10YR3/1 Very dark grey Nil mottles or bleaching	Moderately moist Well drained	Fine 1- 2mm Few	8.0	0.52-0.60 0.70-0.80 0.90-1.00

B22 0.23-0.52 Abrupt 5-20mm	Medium clay	Moderate Strong Subangular blocky	<2% calcium carbonate	10YR3/1 Very dark grey Nil mottles or bleaching	Dry Moderately well drained	Very fine <1mm Few	8.0	
			B23 0.52-0.85 Abrupt 5-20mm	Medium clay	Strong Strong Subangular blocky	Nil inclusions or segregations	10YR3/1 Very dark grey Nil mottles or bleaching	Dry Well drained	Nil roots	8.0	
			B24 0.85-1.00 EOBH	Medium clay	Strong Very firm Subangular blocky	Nil inclusions or segregations	10YR3/2 Very dark greyish brown Nil mottles or bleaching	Moderately moist Well drained	Nil roots	8.0

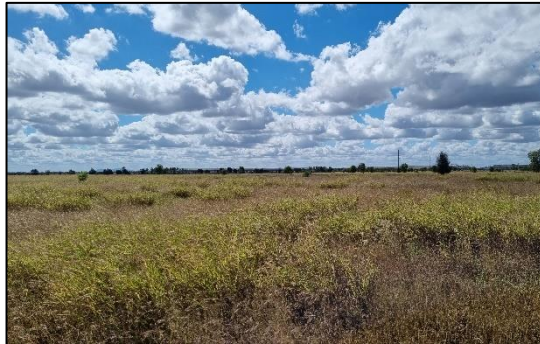
**Landscape**

<b>Site N52</b>	Map Unit: 18	Location (mE/mS GDA94 ZONE 55): 642079 7513098	Australian Soil Class: Black Dermosol	Soil Survey Type: Detailed 50 mm hand auger	Survey Date: 01/05/2021
-----------------	-----------------	---	--	--	----------------------------

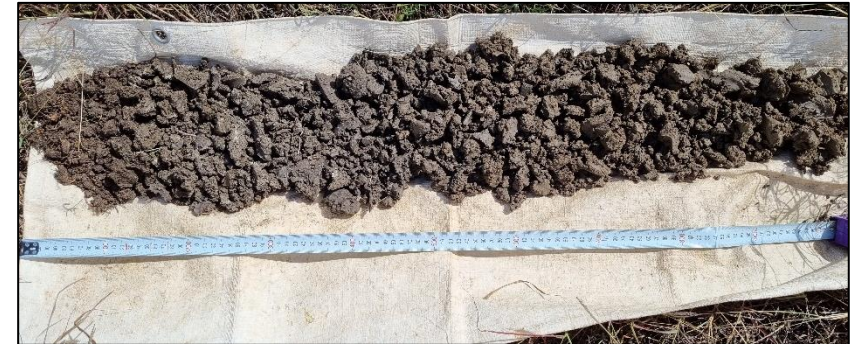
**Soil Profile**

Land use / Landform Pattern / Element / Slope	Vegetation / Microrelief / Disturbance / Erosion	Surface condition / surface rock	Soil Profile Description								
			Horizon / Depth (m / Boundary	Field Texture	Structure / Strength / Pedality	Inclusions / Segregations	Colour / Mottle / Bleaching	Moisture / Drainage	Roots Size / Abundance	Depth (m) / Field pH	Sample (m) / Observations
Grazing Gently undulating plain Flat 0%/0%	Grasses Nil microrelief Complete clearing, not cultivated	Firm Nil coarse fragments	A1 0.00-0.12 Clear 20-50mm	Clay loam sandy	Moderate Weak Subangular blocky	Nil inclusions or segregations	10YR3/1 Very dark grey Nil mottles or bleaching	Moderately moist Moderately well drained	Fine 1- 2mm Few	6.5	0.00-0.10 0.20-0.30 0.50-0.60 0.70-0.80 0.90-1.00
			B21 0.12-0.45	Medium clay	Moderate Very firm Angular blocky	2-10% calcium carbonate 2-6mm	10YR3/2 Very dark greyish brown Nil mottles or bleaching	Moderately moist Moderately well drained	Fine 1- 2mm Few	7.5

B22 0.45-0.65	Medium clay	Moderate Firm Angular blocky Possible lenticular	Nil inclusions or segregations	10YR3/3 Dark brown Nil mottles or bleaching	Dry	Fine 1- 2mm Few	7.5	
			B23 0.65-0.80 Abrupt 5-20mm	Medium heavy clay	Strong Firm Subangular blocky	Nil inclusions or segregations	10YR4/2 Dark greyish brown Nil mottles or bleaching	Dry	Nil roots	8.0	
			B23 0.80-1.00	Medium heavy clay	Strong Very firm Subangular blocky	Nil inclusions or segregations	10YR4/3 Brown Nil mottles or bleaching	Dry	Nil roots	8.0

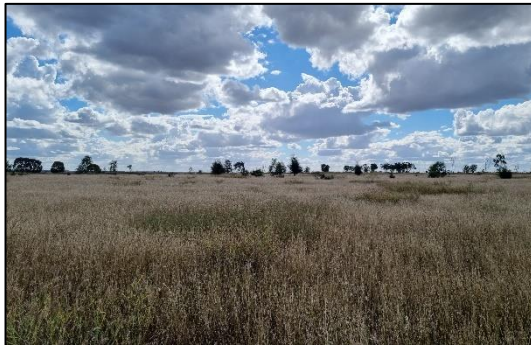
**Landscape**

<b>Site N53</b>	Map Unit: 18	Location (mE/mS GDA94 ZONE 55): 642729 7513832	Australian Soil Class: Black Dermosol	Soil Survey Type: Detailed 50 mm hand auger	Survey Date: 01/05/2021
-----------------	-----------------	---	--	--	----------------------------

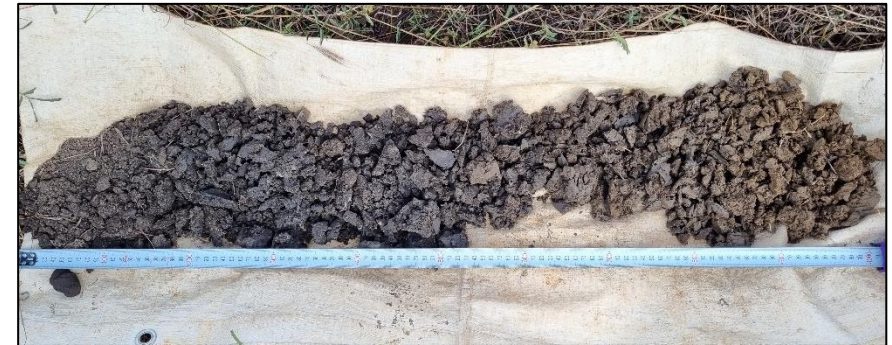
**Soil Profile**

Land use / Landform Pattern / Element / Slope	Vegetation / Microrelief / Disturbance / Erosion	Surface condition / surface rock	Soil Profile Description								
			Horizon / Depth (m / Boundary	Field Texture	Structure / Strength / Pedality	Inclusions / Segregations	Colour / Mottle / Bleaching	Moisture / Drainage	Roots Size / Abundance	Depth (m) / Field pH	Sample (m) / Observations
Grazing Gently undulating plain Flat 0%/0%	Grasses Nil microrelief Complete clearing, not cultivated	Firm Nil coarse fragments	A1 0.00-0.12 Abrupt 5-20mm	Sandy clay loam	Weak Weak Angular blocky	Nil inclusions or segregations	10YR2/2 Very dark brown Nil mottles or bleaching	Moderately moist Well drained	Fine 1- 2mm Common	7.0	0.00-0.10 0.20-0.30 0.50-0.60 0.72-0.80 0.90-1.00
			B21 0.12-0.45 Abrupt 5-20mm	Medium clay	Moderate Very firm Angular blocky	<2% coarse fragments	10YR2/2 Very dark brown Nil mottles or bleaching	Dry Moderately well drained	Fine 1- 2mm Few	7.5

B22 0.45-0.72 Abrupt 5-20mm	Medium clay	Moderate Very firm Sub-angular blocky	Nil inclusions or segregations	10YR2/2 Very dark brown Nil mottles or bleaching	Dry Moderately well drained	Nil roots	8.0	
			B23 0.72-1.00 EOBH	Medium clay	Moderate Very firm Sub-angular blocky	Nil inclusions or segregations	10YR3/1 Very dark grey Nil mottles or bleaching	Dry Moderately well drained	Nil roots	7.5

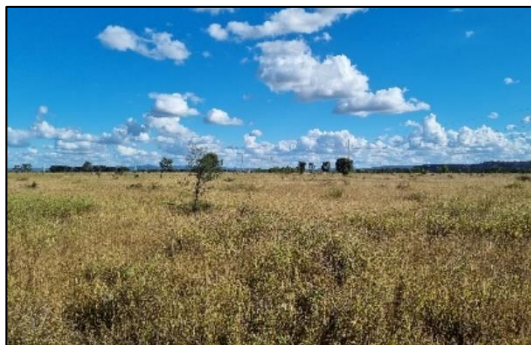
**Landscape**

<b>Site N54</b>	Map Unit: 20	Location (mE/mS GDA94 ZONE 55): 641925 7512253	Australian Soil Class: Black self-mulching Vertosol	Soil Survey Type: Detailed 50 mm hand auger	Survey Date: 01/05/2021
-----------------	-----------------	---	--	--	----------------------------

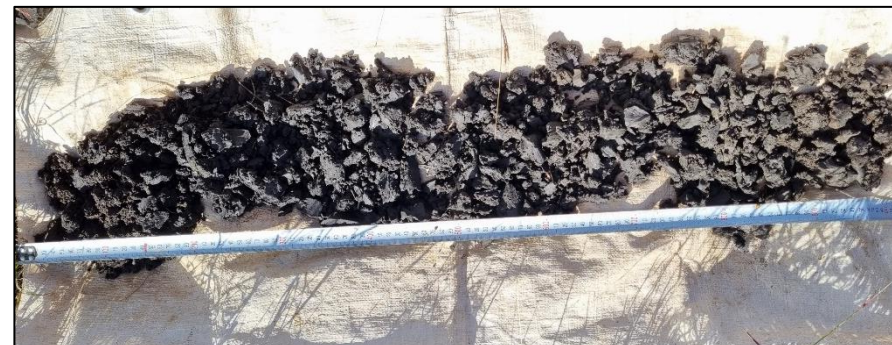
**Soil Profile**

Land use / Landform Pattern / Element / Slope	Vegetation / Microrelief / Disturbance / Erosion	Surface condition / surface rock	Soil Profile Description								
			Horizon / Depth (m / Boundary	Field Texture	Structure / Strength / Pedality	Inclusions / Segregations	Colour / Mottle / Bleaching	Moisture / Drainage	Roots Size / Abundance	Depth (m) / Field pH	Sample (m) / Observations
Grazing Gently undulating plain Flat 0%/0%	Bull Mitchell grass, Nil microrelief Complete clearing, not cultivated	Self-mulching, cracking Nil coarse fragments	A1 0.00-0.12 Abrupt 5-20mm	Light medium clay	Moderate Very firm Angular blocky	Nil inclusions or segregations	10YR3/1 Very dark grey Nil mottles or bleaching	Moderately moist Moderately well drained	Fine 1- 2mm Common	7.0	0.00-0.10 0.20-0.30 0.50-0.60 0.70-0.80 0.90-1.00
			B21 0.12-0.34 Clear 20-50mm	Medium clay	Strong Very firm Angular blocky	<2% calcium carbonate	10YR2/1 Black Nil mottles or bleaching	Moderately moist Moderately well drained	Fine 1- 2mm Few	8.0

B22 0.34-0.88 Clear 20-50mm	Medium clay	Strong Very firm Angular blocky lenticular	Nil inclusions or segregations	10YR3/1 Very dark grey Nil mottles or bleaching	Dry Moderately well drained	Very fine <1mm Few	8.0	
			B23 0.88-1.00 EOBH	Medium heavy clay	Strong Very firm Angular blocky	Nil inclusions or segregations	10YR3/2 Very dark greyish brown Nil mottles or bleaching	Dry Moderately well drained	Nil roots	7.5

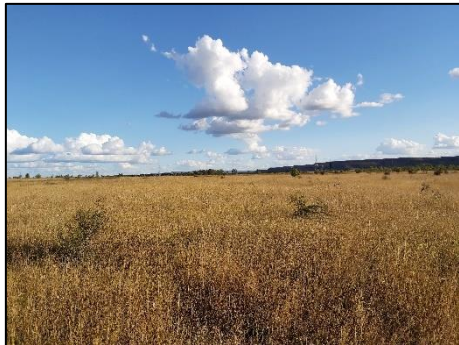
**Landscape**

<b>Site N55</b>	Map Unit: 6	Location (mE/mS GDA94 ZONE 55): 641290 7513322	Australian Soil Class: Black Dermosol	Soil Survey Type: Detailed 50 mm hand auger	Survey Date: 01/05/2021
-----------------	----------------	---	--	--	----------------------------

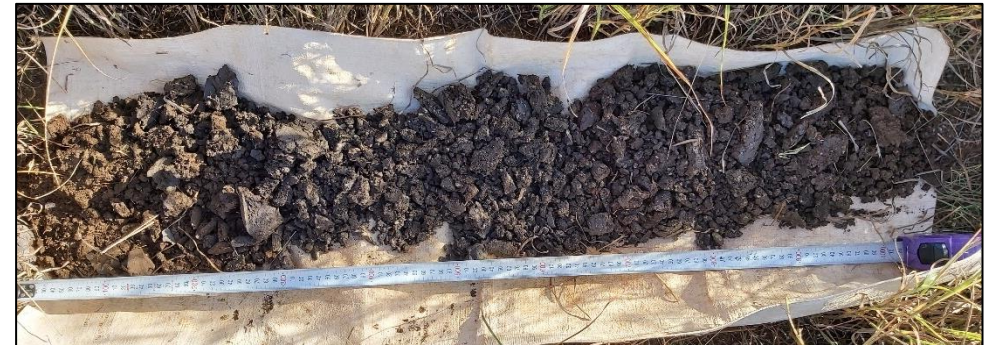
**Soil Profile**

Land use / Landform Pattern / Element / Slope	Vegetation / Microrelief / Disturbance / Erosion	Surface condition / surface rock	Soil Profile Description								
			Horizon / Depth (m / Boundary	Field Texture	Structure / Strength / Pedality	Inclusions / Segregations	Colour / Mottle / Bleaching	Moisture / Drainage	Roots Size / Abundance	Depth (m) / Field pH	Sample (m) / Observations
Grazing Undulating plain Mid-slope 2%/2%	Current Bush, Bull Mitchell grass Nil microrelief Extensive clearing	Firm Nil coarse fragments	A1 0.00-0.12 Gradual 50- 100mm	Sandy clay loam	Massive Weak	Nil inclusions or segregations	10YR2/2 Very dark brown Nil mottles or bleaching	Moderately moist Rapidly drained	Very fine <1mm Common	6.5	0.00-0.10 0.15-0.25 0.25-0.30
			B21 0.12-0.25 Gradual 50- 100mm	Medium clay	Moderate Strong Subangular blocky	Nil inclusions or segregations	10YR2/1 Black Nil mottles or bleaching	Dry Moderately well drained	Very fine <1mm Common	6.5	0.50-0.60 0.70-0.80 0.90-1.00

B22 0.25-0.85 Gradual 50- 100mm	Medium clay	Moderate Strong Subangular blocky	<2% coarse fragments	10YR2/1 Black Nil mottles or bleaching	Dry Well drained	Nil roots	8.0	
			B23 0.85-1.00 EOBH	Medium clay to sandy clay loam	Moderate Very firm Subangular blocky	Nil inclusions or segregations	10YR3/3 Dark brown Nil mottles or bleaching	Dry Well drained	Nil roots	8.0

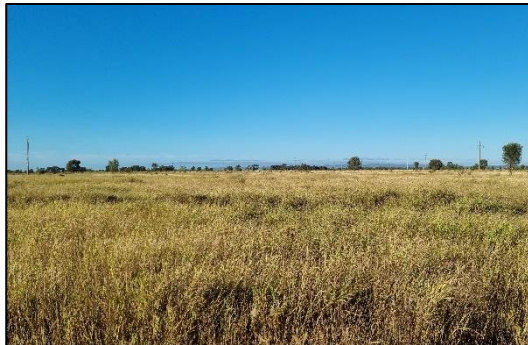
**Landscape**

<b>Site N56</b>	Map Unit: 20	Location (mE/mS GDA94 ZONE 55): 641970 7512389	Australian Soil Class: Black Self mulching Vertosol	Soil Survey Type: Detailed 50 mm hand auger	Survey Date: 02/05/2021
-----------------	-----------------	---	--	--	----------------------------

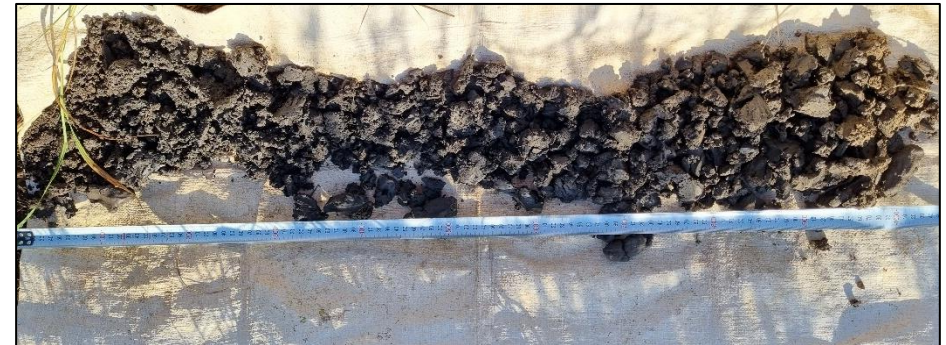
**Soil Profile**

Land use / Landform Pattern / Element / Slope	Vegetation / Microrelief / Disturbance / Erosion	Surface condition / surface rock	Soil Profile Description								
			Horizon / Depth (m / Boundary	Field Texture	Structure / Strength / Pedality	Inclusions / Segregations	Colour / Mottle / Bleaching	Moisture / Drainage	Roots Size / Abundance	Depth (m) / Field pH	Sample (m) / Observations
Grazing Gently undulating plain Flat 1%/1%	Bull Mitchell grass Nil microrelief Complete clearing, not cultivated	Self-mulching, cracking Nil coarse fragments	A1 0.00-0.10 Clear 20-50mm	Light clay	Moderate Firm	Nil inclusions or segregations	10YR3/1 Very dark grey Nil mottles or bleaching	Moderately moist Moderately well drained	Fine 1- 2mm Few	6.5	0.00-0.10 0.20-0.30 0.50-0.60 0.70-0.80 0.90-1.00
			B21 0.10-0.65 Clear 20-50mm	Medium clay	Strong Very firm	<2% coarse fragments 6-20mm	10YR3/2 Very dark greyish brown Nil mottles or bleaching	Moderately moist Moderately well drained	Fine 1- 2mm Few	7.5

B22 0.68-0.85 Clear 20-50mm	Medium heavy clay	Strong Very firm	Nil inclusions or segregations	10YR4/2 Dark greyish brown Nil mottles or bleaching	Dry Moderately well drained	Fine 1- 2mm Few	7.5	
			B22 0.85-1.00 EOBH	Medium heavy clay	Strong Very firm	Nil inclusions or segregations	10YR4/3 Brown Nil mottles or bleaching	Dry Moderately well drained	Fine 1- 2mm Few	7.5

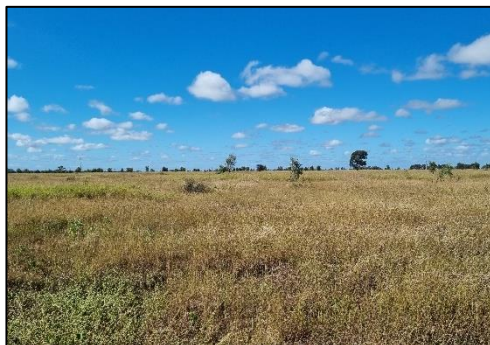
**Landscape**

<b>Site N57</b>	Map Unit: 19	Location (mE/mS GDA94 ZONE 55): 641884 7513451	Australian Soil Class: Black self-mulching Vertosol	Soil Survey Type: Detailed 50 mm hand auger	Survey Date: 02/05/2021
-----------------	-----------------	---	--	--	----------------------------

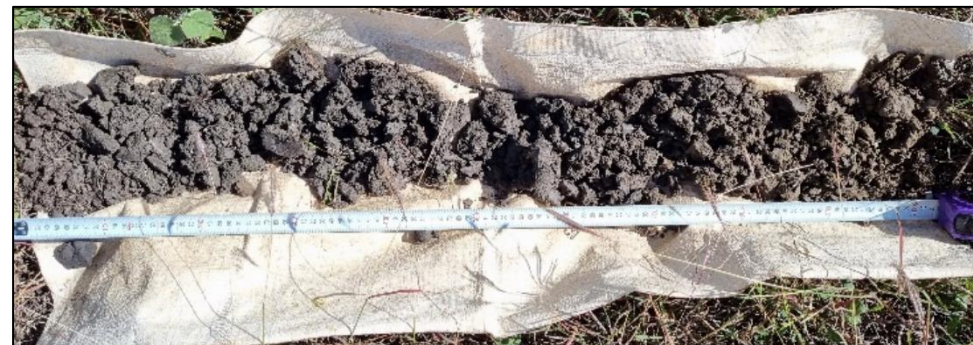
**Soil Profile**

Land use / Landform Pattern / Element / Slope	Vegetation / Microrelief / Disturbance / Erosion	Surface condition / surface rock	Soil Profile Description								
			Horizon / Depth (m / Boundary	Field Texture	Structure / Strength / Pedality	Inclusions / Segregations	Colour / Mottle / Bleaching	Moisture / Drainage	Roots Size / Abundance	Depth (m) / Field pH	Sample (m) / Observations
Grazing Gently undulating plain Mid-slope 1.%/1.1%	Sparse Brigalow nearby Nil microrelief Extensive clearing	Self-mulching Nil coarse fragments	A1 0.00-0.10 Abrupt 5-20mm	Light clay	Moderate Firm Angular blocky	Nil inclusions or segregations	10YR2/1 Black Nil mottles or bleaching	Moist Well drained	Fine 1- 2mm Few	7.0	0.00-0.10
			B21 0.10-0.50 Gradual 50- 100mm	Medium clay	Moderate Strong Subangular blocky	<2% calcium carbonate	10YR3/1 Very dark grey Nil mottles or bleaching	Dry Moderate well drained	Very fine <1mm Few	8.5	0.20-0.30

B22 0.50-0.85 Clear 20-50mm	Medium heavy clay	Moderate Strong Subangular blocky	Nil inclusions or segregations	10YR3/1 Very dark grey Nil mottles or bleaching	Dry Moderate well drained	Nil roots	8.5	0.50-0.60
			B23 0.85-1.00 EOBH	Medium heavy clay	Moderate Strong Subangular blocky	Nil inclusions or segregations	10YR4/3 Brown Nil mottles or bleaching	Dry Moderate well drained	Nil roots	6.5	0.70-0.80 0.90-1.00

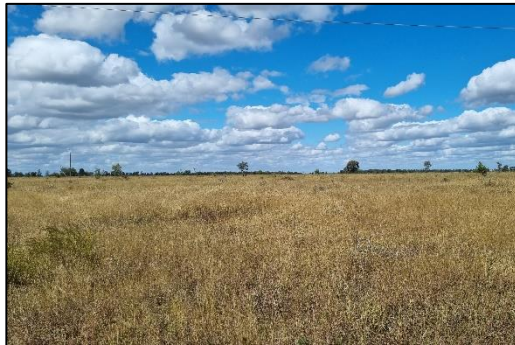
**Landscape**

<b>Site N58</b>	Map Unit: 20	Location (mE/mS GDA94 ZONE 55): 641792 7512652	Australian Soil Class: Black self-mulching Vertosol	Soil Survey Type: Detailed 50 mm hand auger	Survey Date: 02/05/2021
-----------------	-----------------	---	--	--	----------------------------

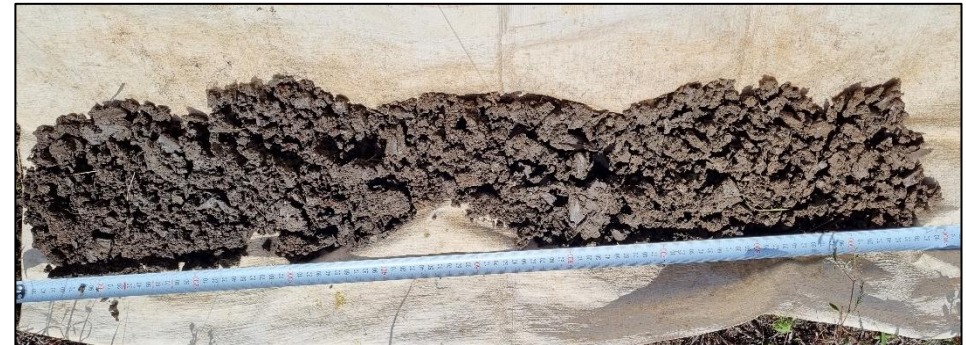
**Soil Profile**

Land use / Landform Pattern / Element / Slope	Vegetation / Microrelief / Disturbance / Erosion	Surface condition / surface rock	Soil Profile Description								
			Horizon / Depth (m / Boundary	Field Texture	Structure / Strength / Pedality	Inclusions / Segregations	Colour / Mottle / Bleaching	Moisture / Drainage	Roots Size / Abundance	Depth (m) / Field pH	Sample (m) / Observations
Grazing Gently undulating plain Flat <1%/<1%	Bull Mitchell grass Nil microrelief Complete clearing, not cultivated	Self-mulching, cracking Nil coarse fragments	A1 0.00-0.11 Abrupt 5-20mm	Light clay	Moderate Firm Subangular blocky	Nil inclusions or segregations	10YR2/1 Black Nil mottles or bleaching	Moderately moist Moderately well drained	Fine 1- 2mm Few	7.5	0.00-0.10 0.20-0.30 0.50-0.60
			B21 0.11-0.45 Clear 20-50mm	Medium clay	Strong Very firm Angular blocky	<2% calcium carbonate 2-6mm	10YR3/1 Very dark grey Nil mottles or bleaching	Dry Moderately well drained	Fine 1- 2mm Few	7.5	0.66-0.76 0.90-1.00

B22 0.45-0.76 Clear 20-50mm	Medium clay	Strong Very firm Angular blocky	2-10% calcium carbonate 2-6mm	10YR3/1 Very dark grey Nil mottles or bleaching	Dry Moderately well drained	Fine 1- 2mm Few	7.5	
			B23 0.76-1.00 EOBH	Medium heavy clay	Moderate Very firm Angular blocky	<2% calcium carbonate 2-6mm	10YR4/2 Dark greyish brown Nil mottles or bleaching	Dry Moderately well drained	Nil roots	7.5

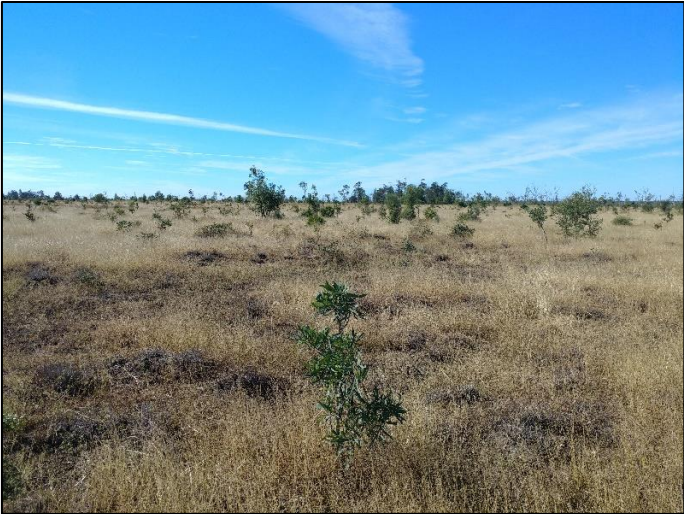
Site No.	Location - mE, mN (GDA94 Zone 55)	Map Unit	Comments	Pictures
NC-1	641651 7508111	16	Gently undulating plain, lower slope, 1%, 2% Crabhole gilgai, 50% coverage <200 mm deep Surface – cracking and self mulching

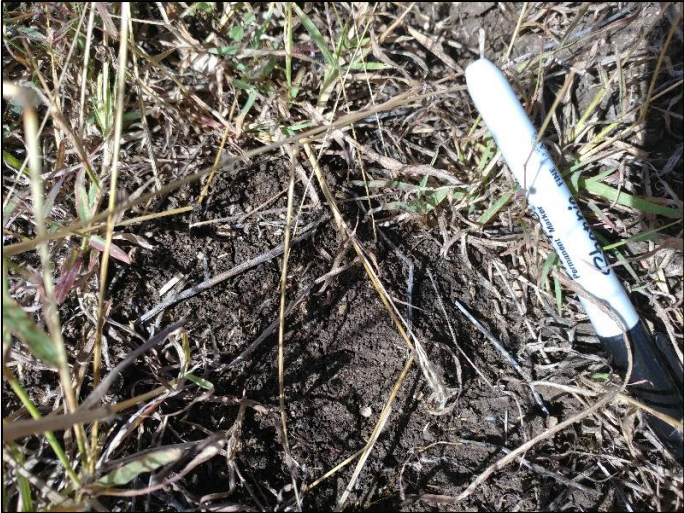
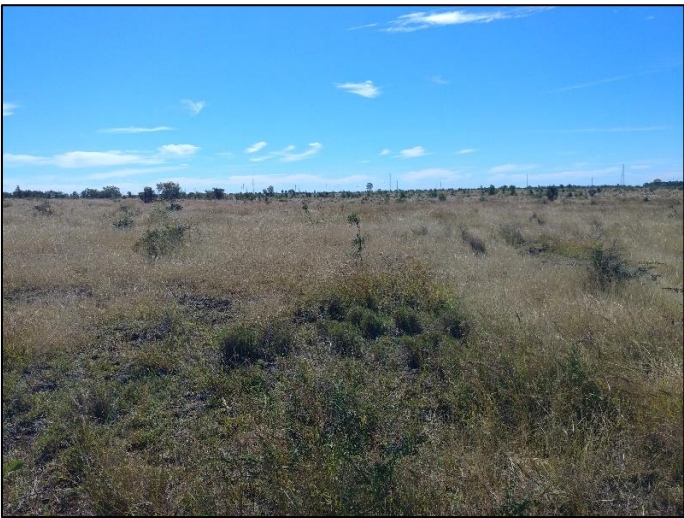
Site No.	Location - mE, mN (GDA94 Zone 55)	Map Unit	Comments	Pictures
NC-2	641972 7509347	16	Gently undulating plain, lower slope, 1% Crabhole and linear gilgai, 50% coverage 150-200 mm deep Surface – cracking and self mulching

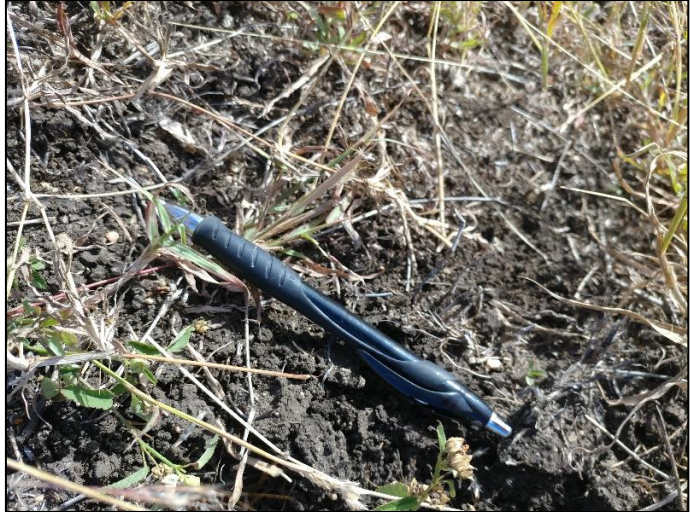
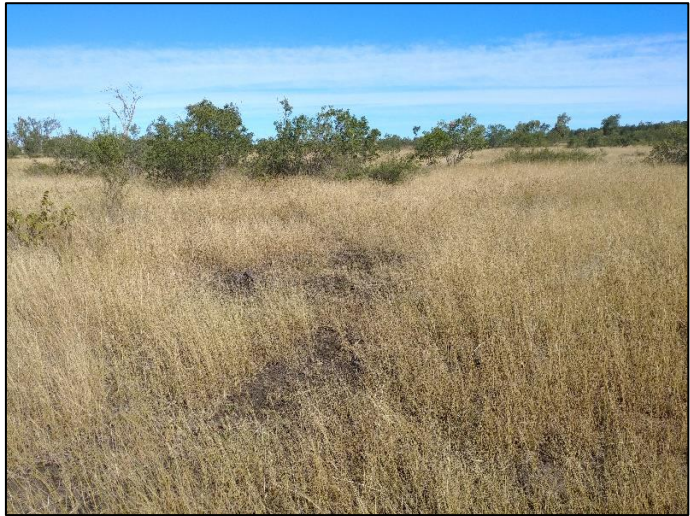
Site No.	Location - mE, mN (GDA94 Zone 55)	Map Unit	Comments	Pictures
NC-3	642749 7508963	16	Gently undulating plain, lower slope, 1% Normal gilgai, 40% coverage 150-200 mm deep Surface – cracking and self mulching

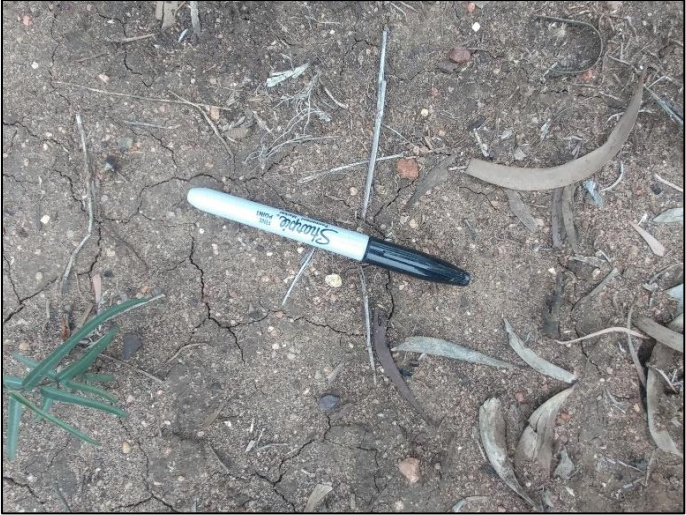
Site No.	Location - mE, mN (GDA94 Zone 55)	Map Unit	Comments	Pictures
NC-4	642189 7511009	11	Wide depression, drainage line Soft surface, with <2% <6mm coarse fragments

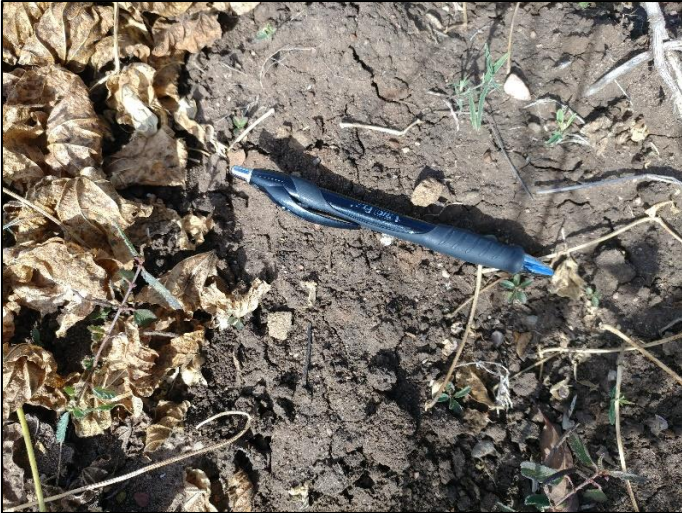
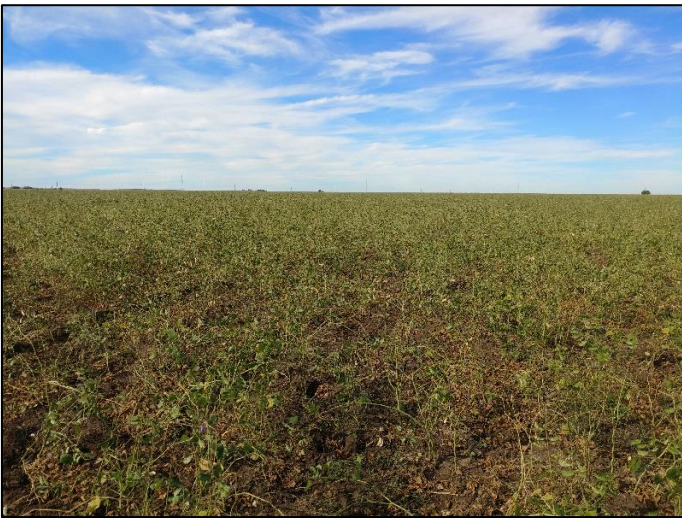
Site No.	Location - mE, mN (GDA94 Zone 55)	Map Unit	Comments	Pictures
NC-5	641073 7510547	13	Gently undulating plain, Cropping, extensively disturbed, lower slope Surface cracking, light clay, no coarse fragments

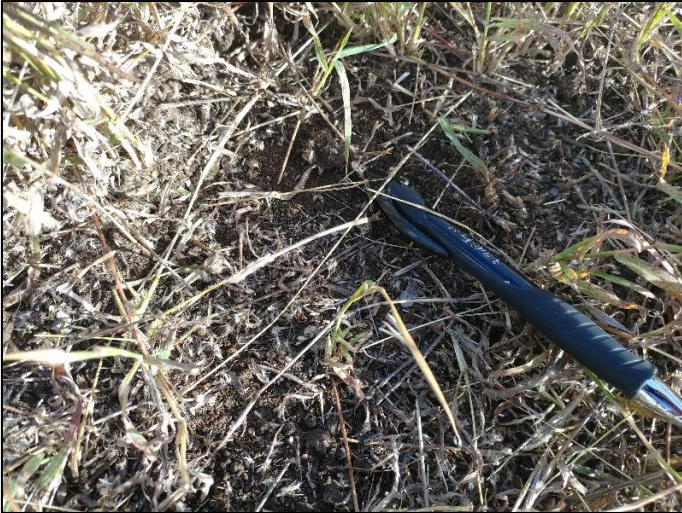
Site No.	Location - mE, mN (GDA94 Zone 55)	Map Unit	Comments	Pictures
NC-8	641519 7511677	6	Gently undulating plain, mid slope Firm, sandy clay loam, no coarse fragments

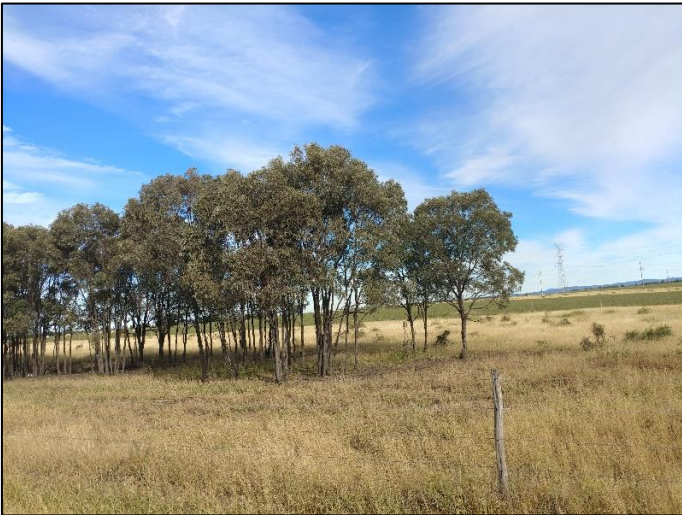
NC-9	641777 7511708	6	Gently undulating plain, mid slope, Sparse Brigalow Firm, sandy clay loam, no coarse fragments

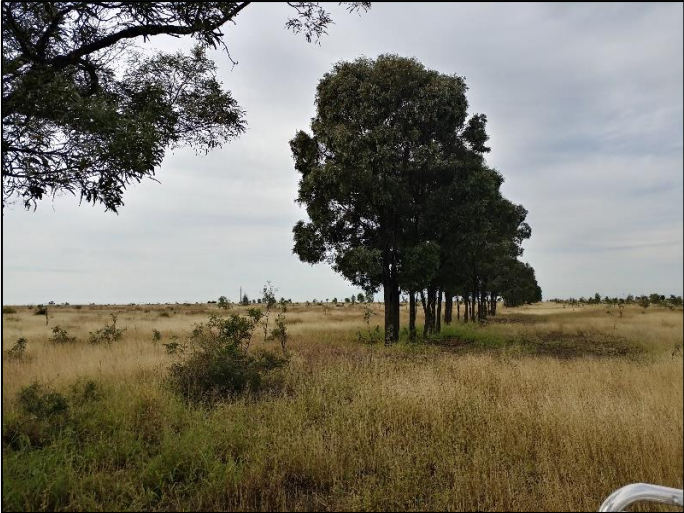
Site No.	Location - mE, mN (GDA94 Zone 55)	Map Unit	Comments	Pictures
NC-11	641676 7513156	19	Gently undulating plain, lower slope, 1%, 2% Limited disturbance, Brigalow Surface – cracking and self mulching, light clay

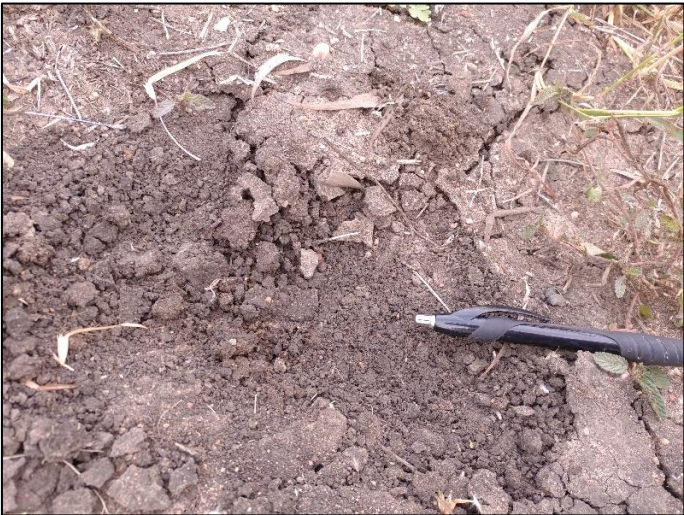
NC-12	642118 7512668	6	Gently undulating plain, flat plain Limited disturbance, Brigalow Surface – Firm, clay loam sandy

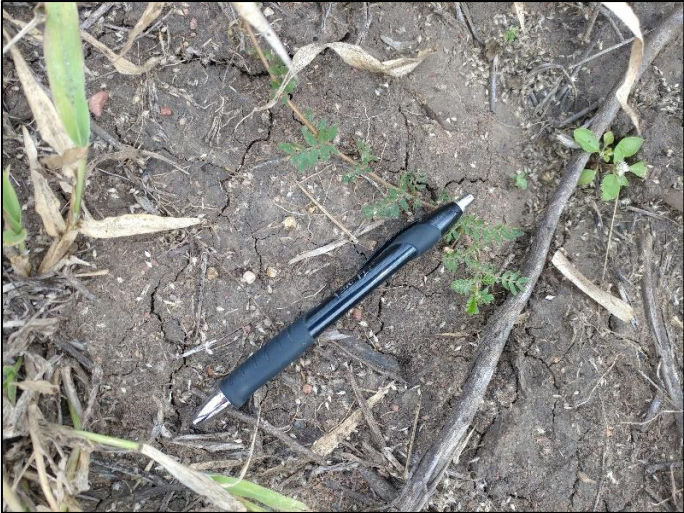
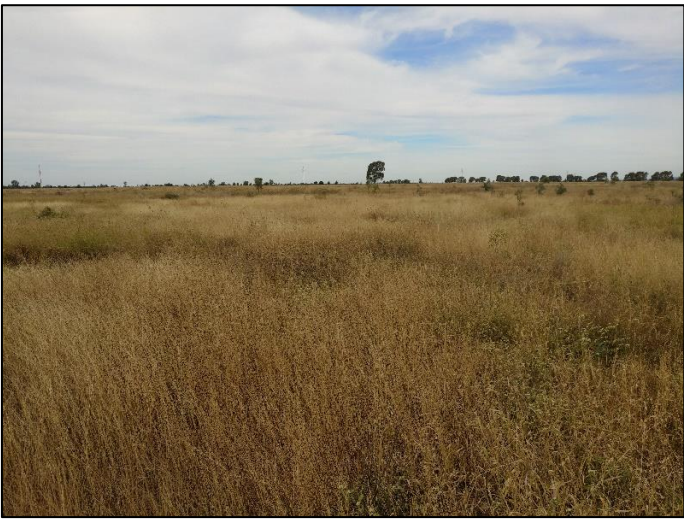
Site No.	Location - mE, mN (GDA94 Zone 55)	Map Unit	Comments	Pictures
NC-13	641869 7513464	19	Gently undulating plain, crest, 1%, 0% Limited disturbance, Brigalow Surface – Self mulching, black light clay

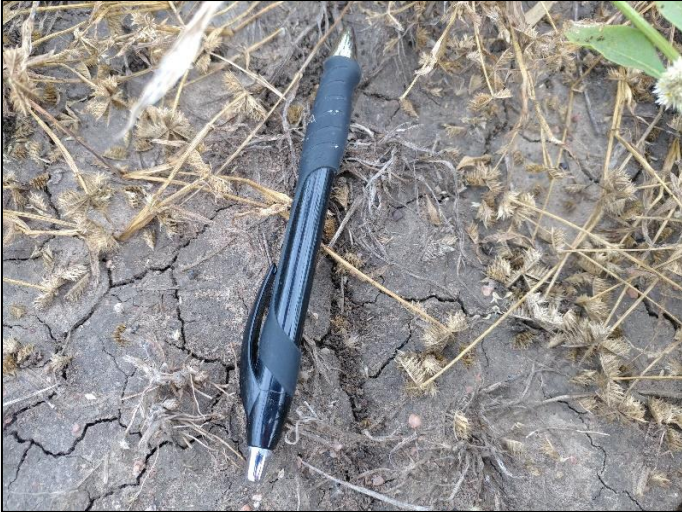
Site No.	Location - mE, mN (GDA94 Zone 55)	Map Unit	Comments	Pictures
NC-14	642641 7514052	18	Gently undulating plain, crest, 1%, 0% Limited disturbance, Brigalow, Belah Surface -, clay loam sandy 10YR3/1

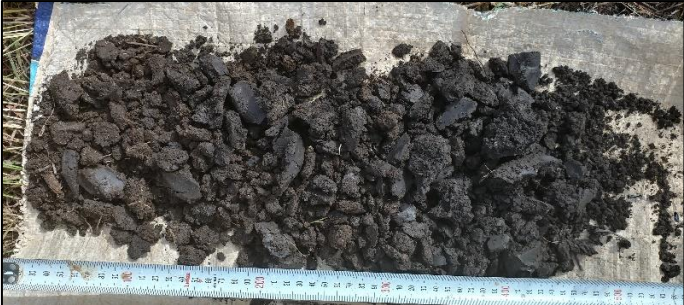
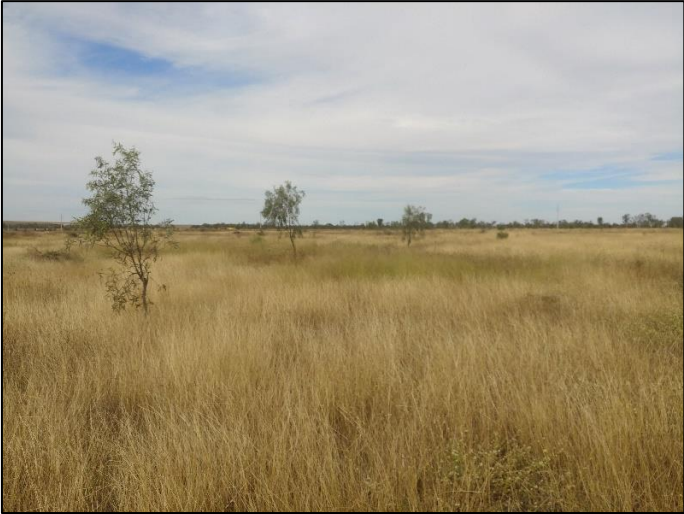
Site No.	Location - mE, mN (GDA94 Zone 55)	Map Unit	Comments	Pictures
NC-15	643244 7514499	1	<p>Gently undulating plain, lower slope &lt;2%</p> <p>Limited disturbance, Brigalow</p> <p>Surface – cracking 2-6 mm, light clay, no coarse fragments</p> <p>0.00 – 0.11 m</p> <p>Clay loam</p> <p>Moderate, firm, peds &lt;20 mm</p> <p>10YR3/1</p> <p>0.11 – 0.30+ m</p> <p>Medium clay</p> <p>Moderate, very firm, peds 20-40 mm</p> <p>10YR2/1</p>

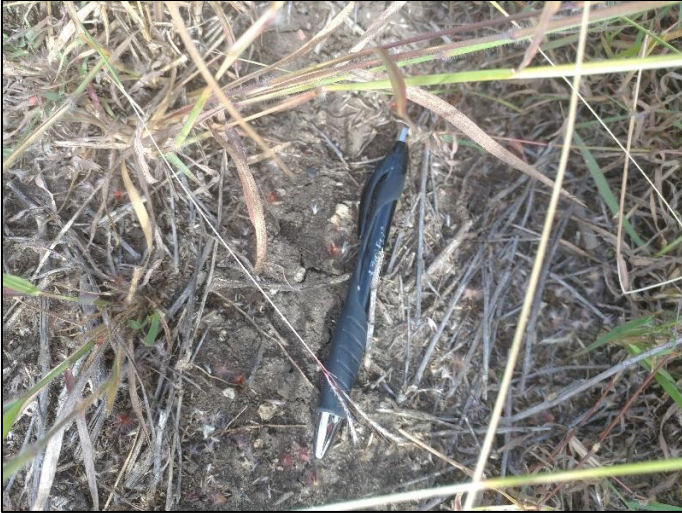
Site No.	Location - mE, mN (GDA94 Zone 55)	Map Unit	Comments	Pictures
NC-16	642934 7514283	1	<p>Gently undulating plain, mid slope &lt;2%</p> <p>Limited disturbance</p> <p>Surface – cracking 2-6 mm, light clay, no coarse fragments</p> <p>0.00 – 0.11 m</p> <p>Clay loam</p> <p>Moderate, firm, peds &lt;20 mm</p> <p>10YR3/2</p> <p>0.11 – 0.45+ m</p> <p>Medium clay</p> <p>Moderate, very firm, peds 20-40 mm</p> <p>10YR2/1</p>

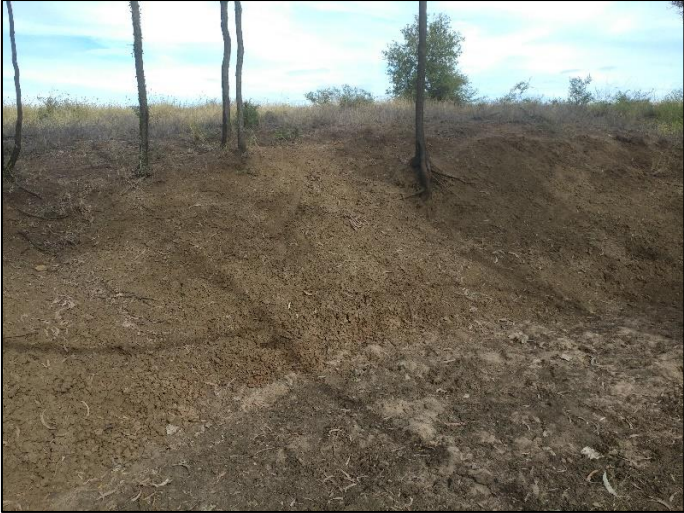
Site No.	Location - mE, mN (GDA94 Zone 55)	Map Unit	Comments	Pictures
NC-17	643327 7514558	2	Gully erosion, drainage line  0-0.30 m sandy loam 0.30-1.00 m + Sandy clay loam

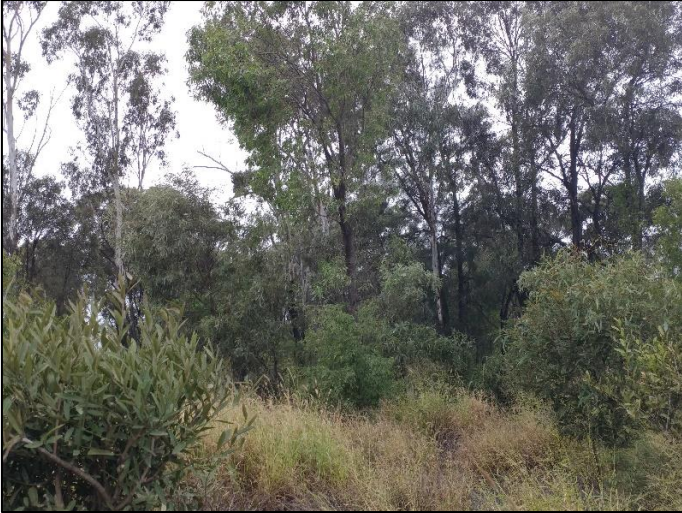
Site No.	Location - mE, mN (GDA94 Zone 55)	Map Unit	Comments	Pictures
NC-18	643487 7514650	2	Gully erosion, drainage line Gums Surface non-cracking

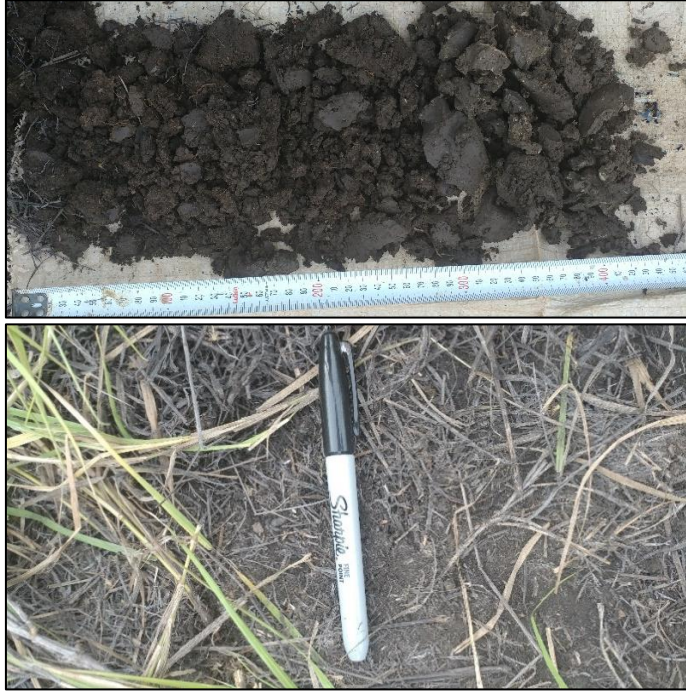
NC-19	644123 7514610	1	<p>Gently undulating plain, upper slope 1%, 2% Limited disturbance, Surface – cracking &lt;2 mm, and self mulching, light clay, no coarse fragments</p> <p>0.00 – 0.11 m Clay loam Moderate, firm, peds &lt;10 mm 10YR3/2</p> <p>0.11 – 0.30 m Medium clay Moderate, subangular blocky, peds &lt;20 mm 10YR2/1</p> <p>0.30 – 0.40+ m Medium clay with &lt;2% calcium carbonate Moderate, subangular blocky, peds &lt;20 mm 10YR2/1</p>

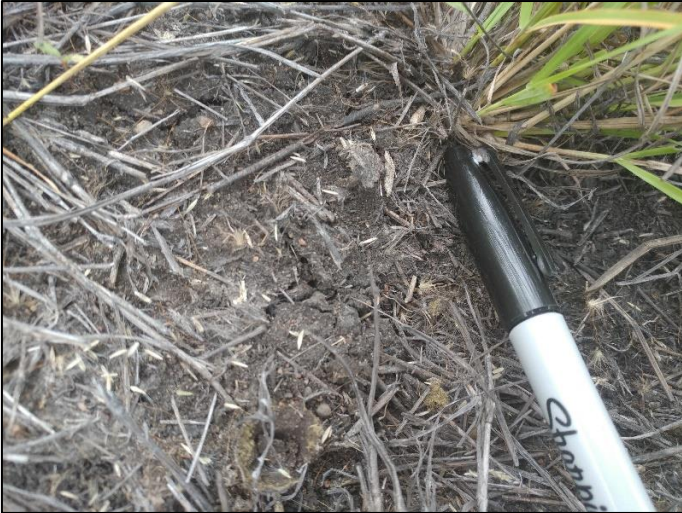
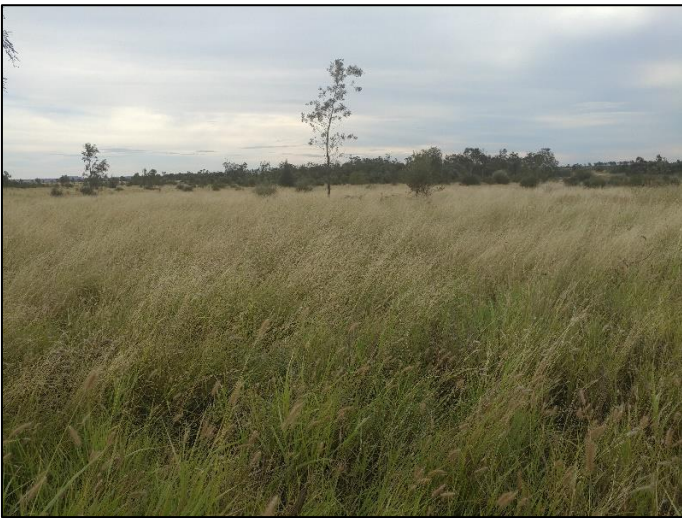
Site No.	Location - mE, mN (GDA94 Zone 55)	Map Unit	Comments	Pictures
NC-20	643734 7514870	2	Gently undulating plain, lower slope 1%, 2% Limited disturbance, Surface – cracking <2 mm, and self mulching, clay loam, no coarse fragments Brigalow, Belah

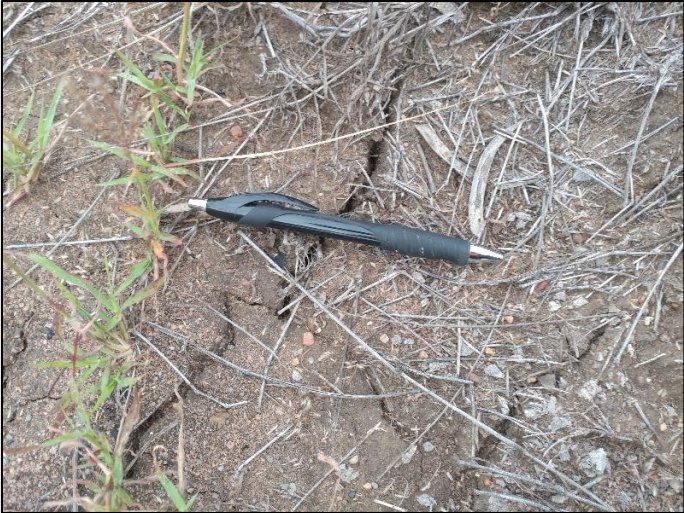
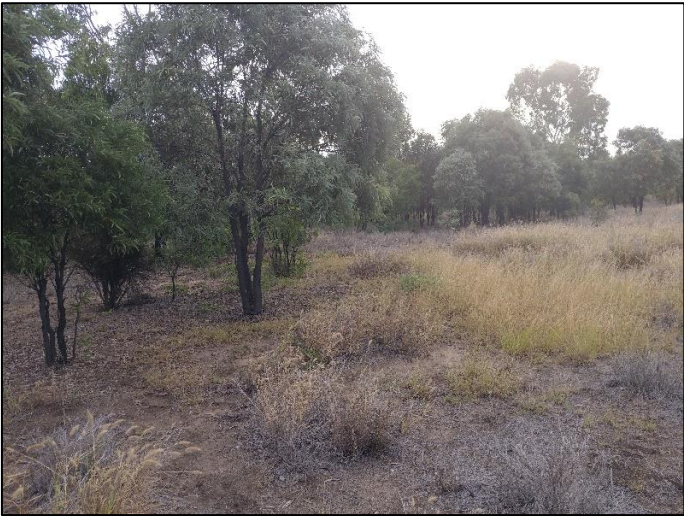
Site No.	Location - mE, mN (GDA94 Zone 55)	Map Unit	Comments	Pictures
NC-22	642804 7514097	4	Gently undulating plain, lower slope 1%, 2% Wide depression, inactive drainage line Brigalow, Belah Surface – cracking 2-8 mm, and self mulching, sandy clay loam <2% coarse fragments <2 mm

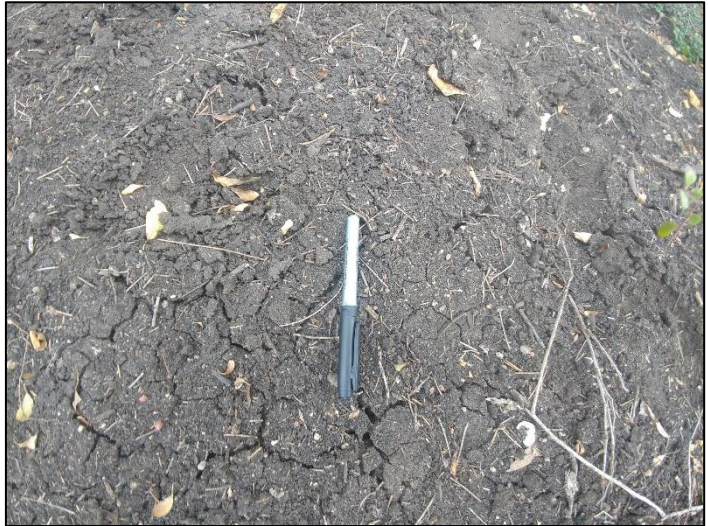
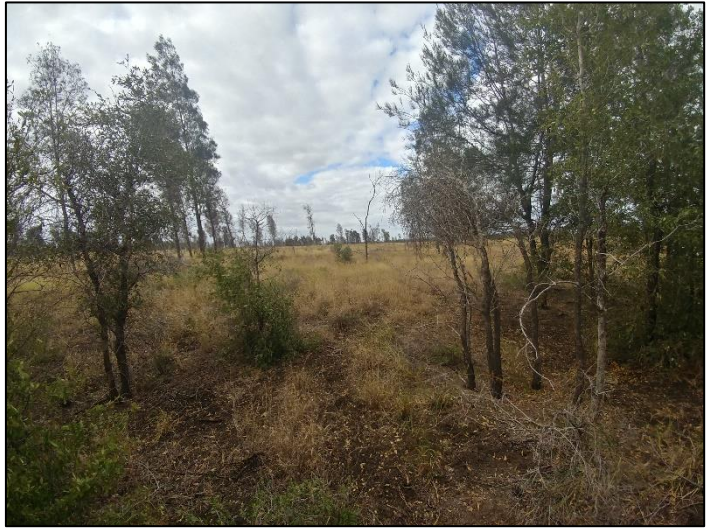
NC-26	643047 7512703	9	Gently undulating plain, lower slope 1%, Surface light clay, self mulching, no coarse fragments Cropping nearby

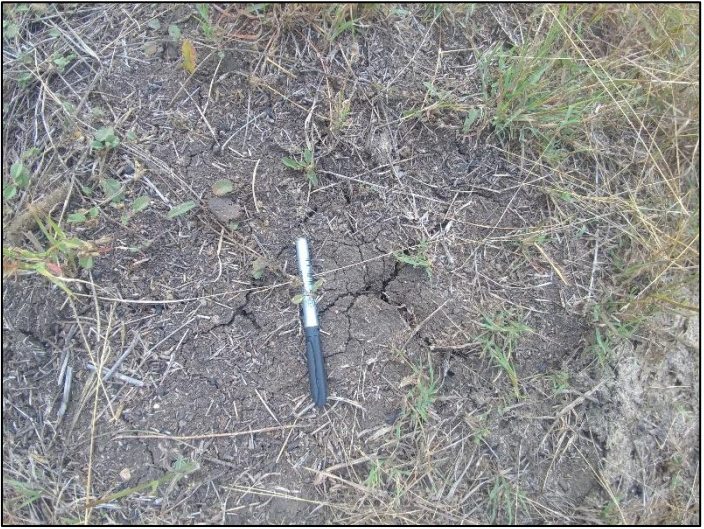
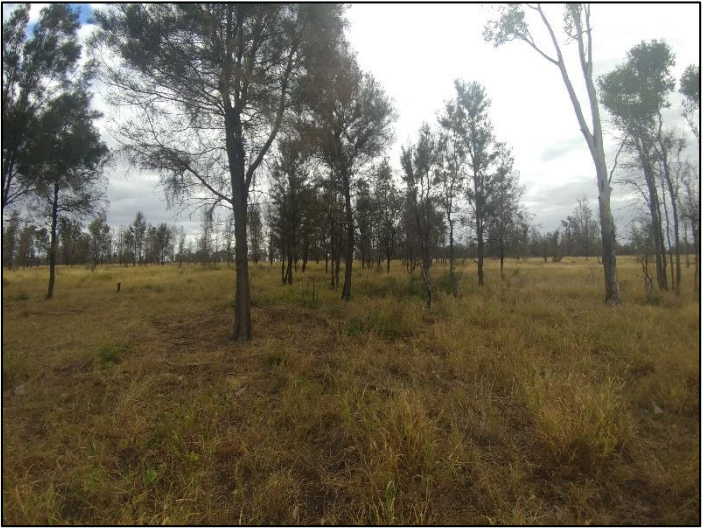
NC-27	643449 7512385	9	Gently undulating plain, flat plain <1% slope Surface light clay, self mulching, no coarse fragments Cropping nearby
