# Restoration Plan to Support RIDA Application Saraji East Project

Final V4  
15 July 2021

GT Environmental Pty Ltd  
[www.gtenvironmental.com.au](http://www.gtenvironmental.com.au)

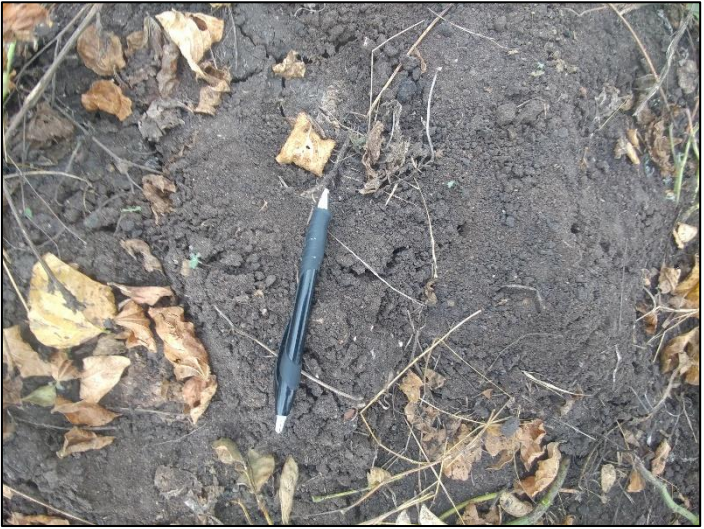
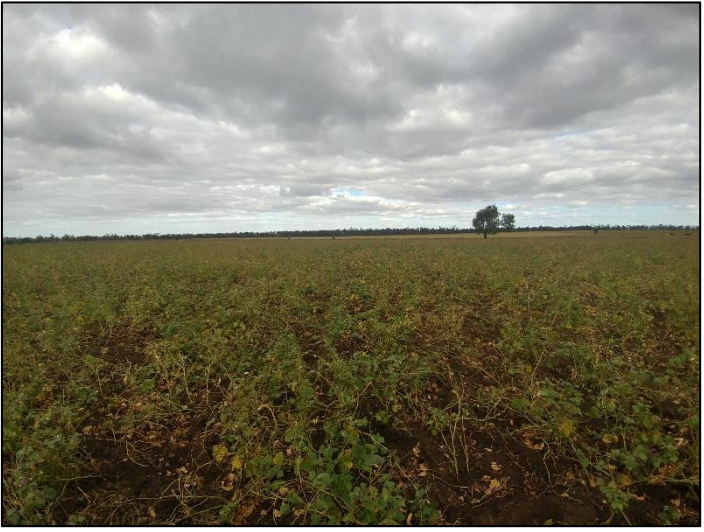
NC-28	643790 7513018	9	Gently undulating plain, lower slope 1%, Surface light clay, self mulching, no coarse fragments Cropping nearby

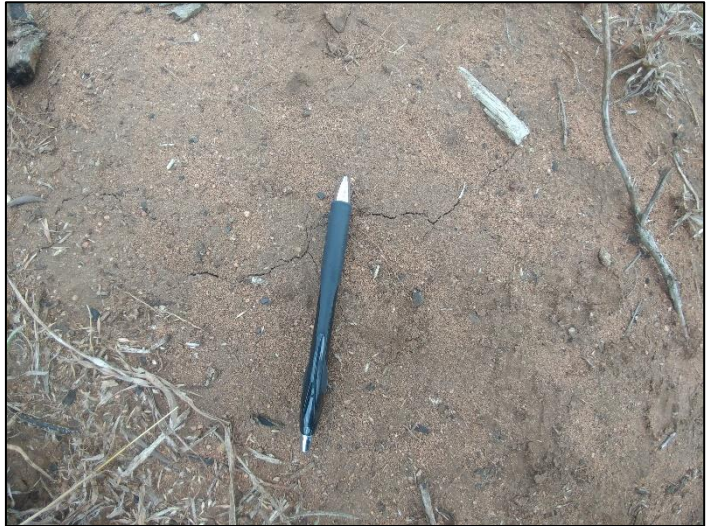
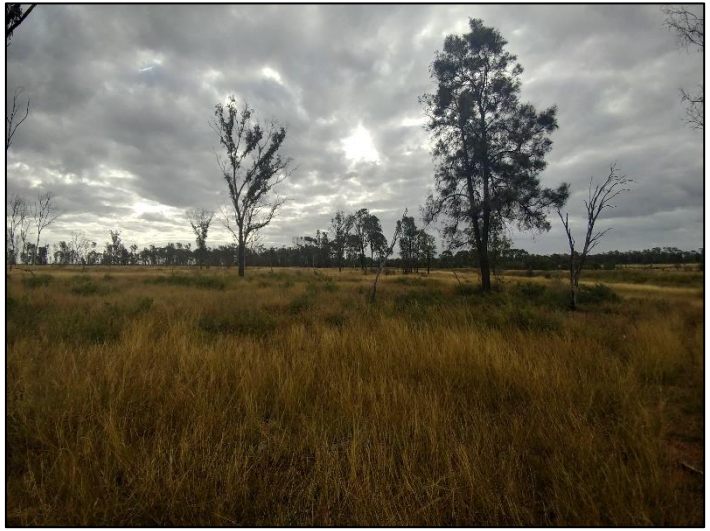
NC-29	643707 7513294	10	Gently undulating plain, upper slope 2%, 2% Surface sandy clay loam, no coarse fragments

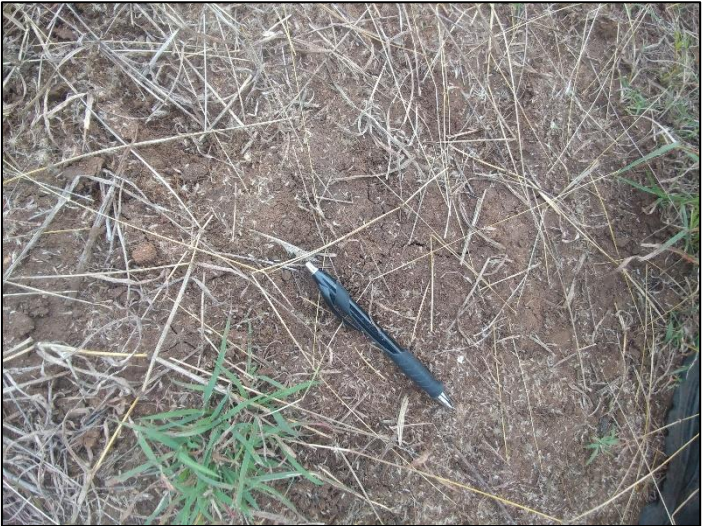
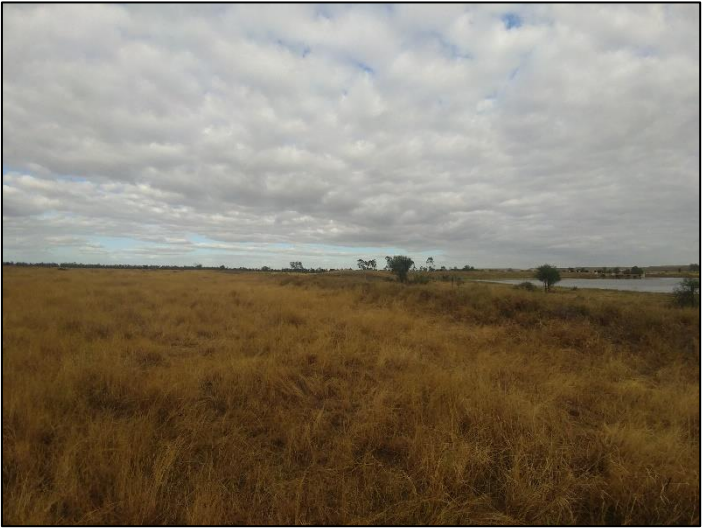
NC-30	643918 7513548	10	Gently undulating plain, upper slope 2% Surface sandy clay loam, <2% <2mm coarse fragments

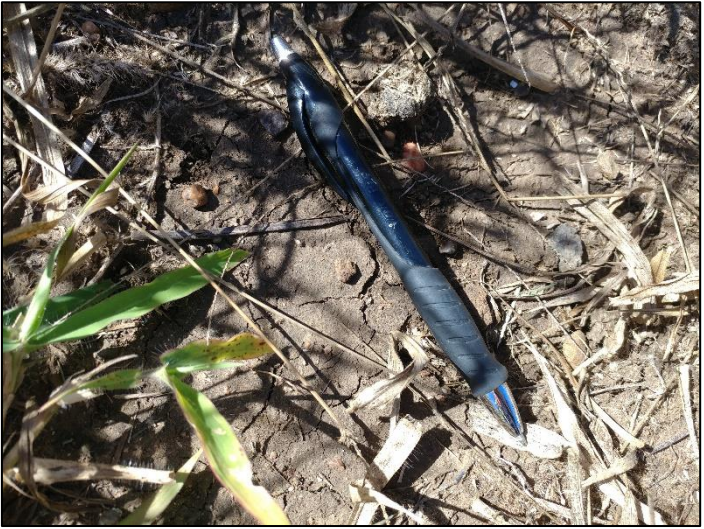
NC-31	643165 7511509	12	Gently undulating plain, lower slope 1% Surface light clay, minor crusting, no coarse fragments Limited disturbance

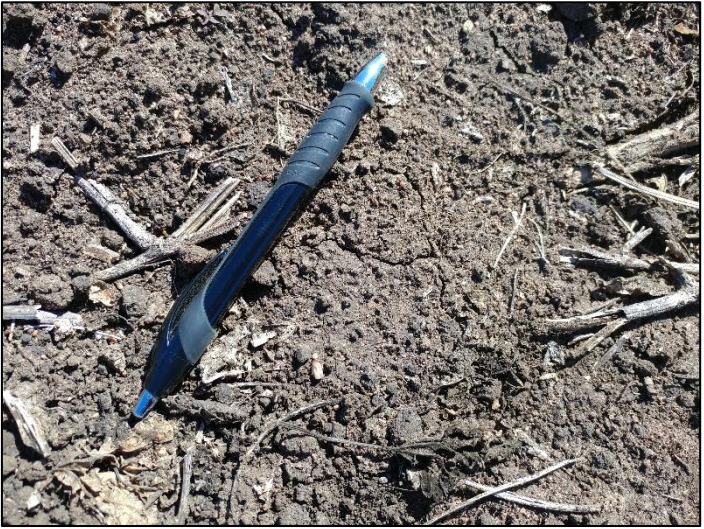
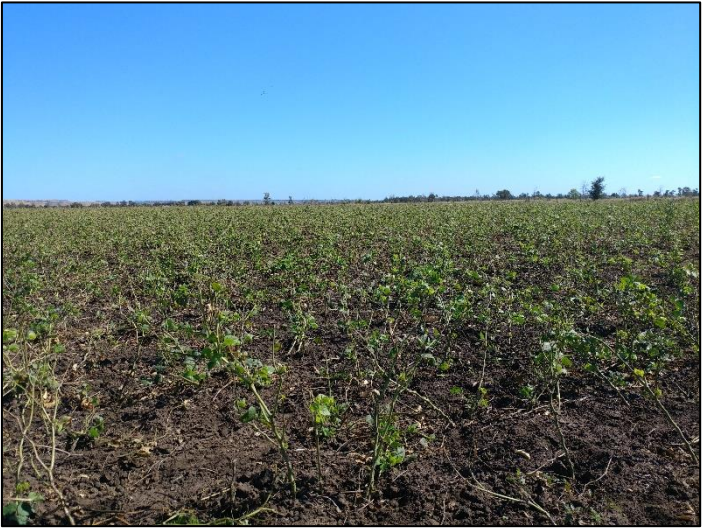
NC-32	643661 7511295	6	Gently undulating plain, mid slope 1%, 1% Surface, soft, sandy clay loam, no coarse fragments Forage cropping disturbance

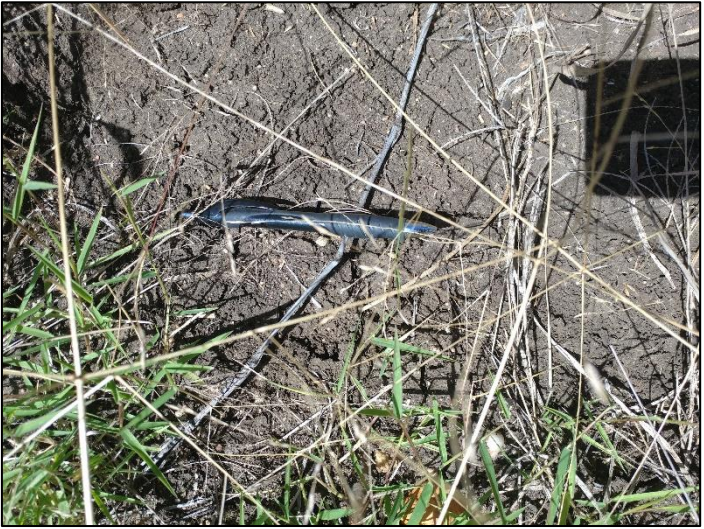
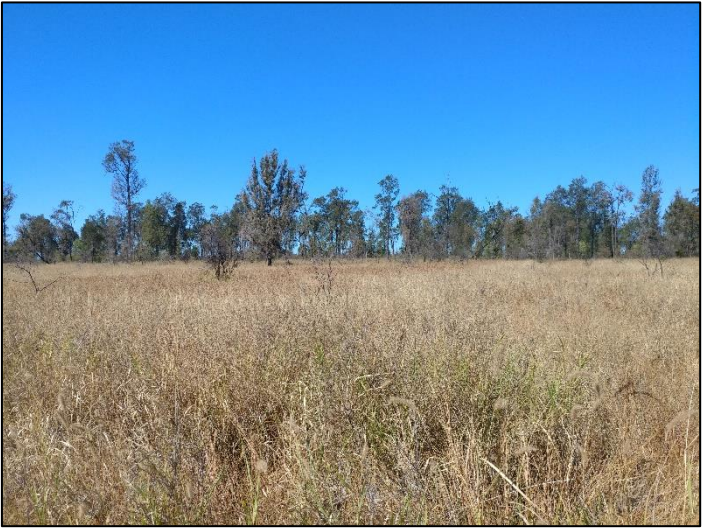
NC-34	644122 7512307	12	Gently undulating plain, flat plain Surface light clay 10YR3/2, cracking 2 mm, no coarse fragments Limited disturbance

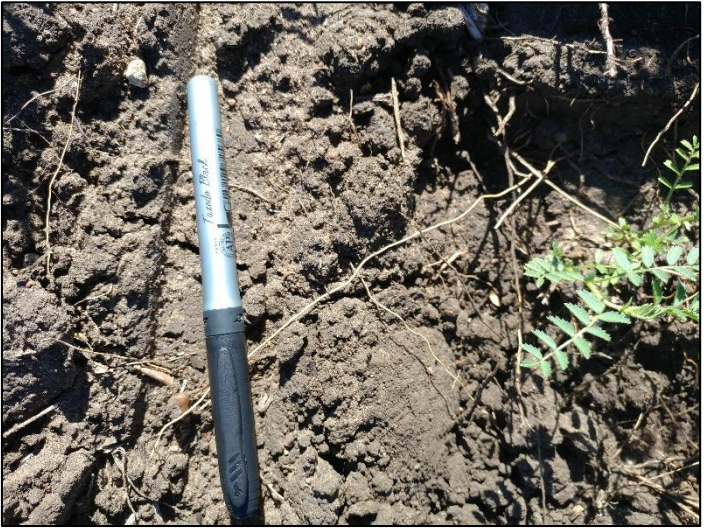
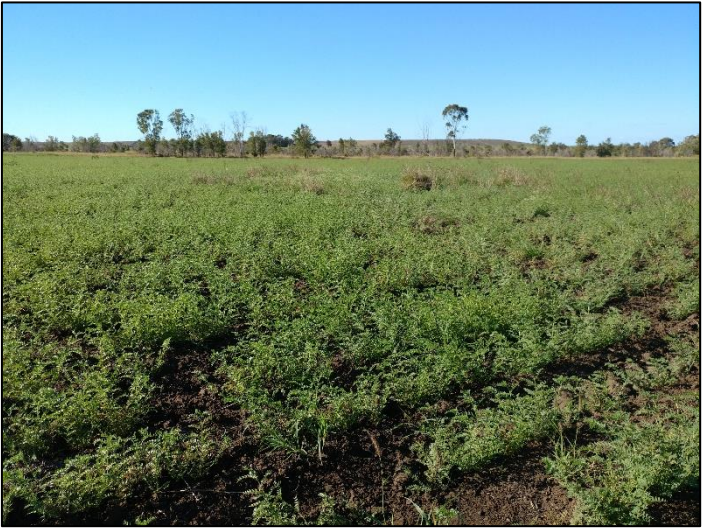
NC-36	645158 7511201	12	Gently undulating plain, mid slope 1%, 1% Surface light clay 10YR3/2, cracking <2 mm, self mulching, no coarse fragments Cropping disturbance

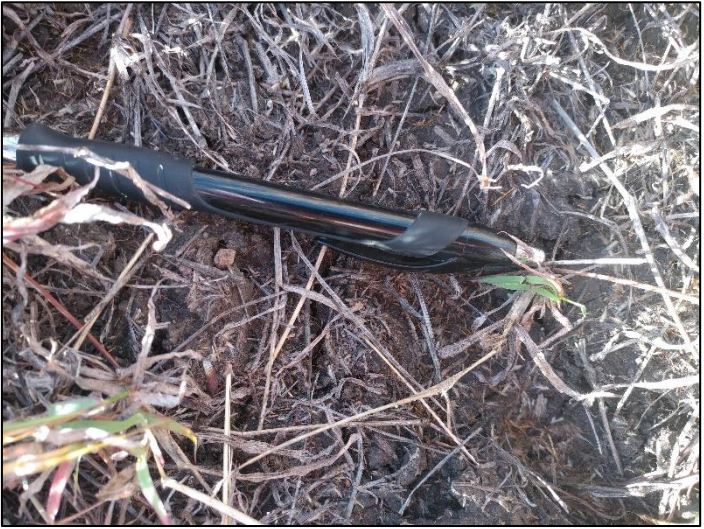
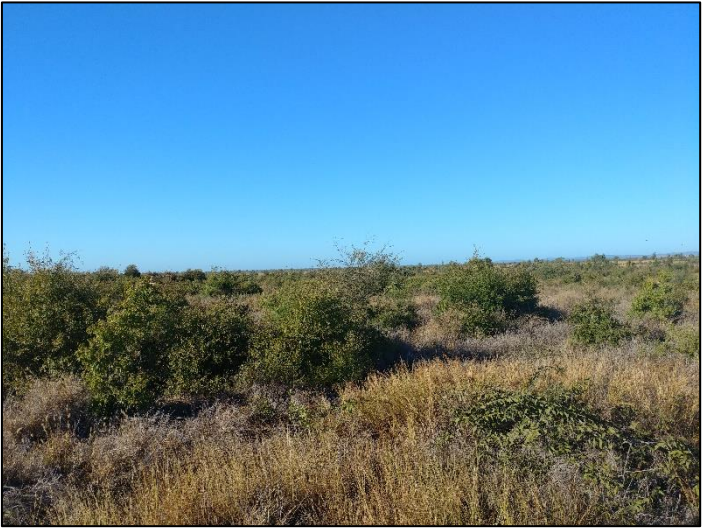
NC-37	644857 7511101	12	Gently undulating plain, upper slope <2%, <3% Surface light clay 10YR3/2, cracking 2-6 mm, no coarse fragments

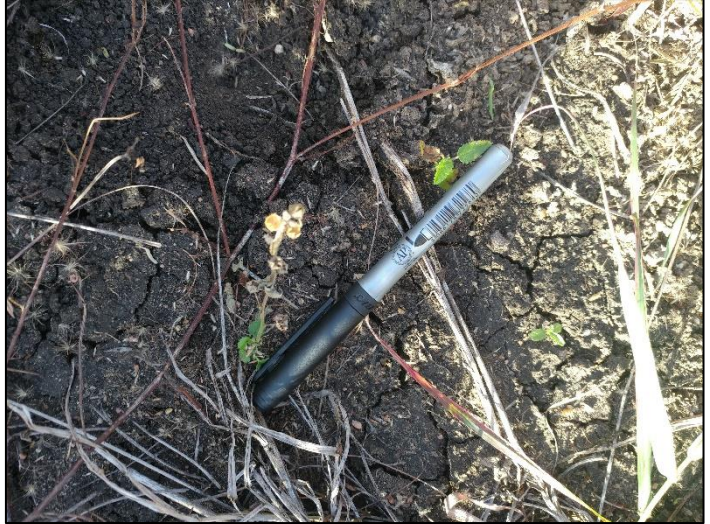
Site No.	Location - mE, mN (GDA94 Zone 55)	Map Unit	Comments	Pictures
NC-38	645563 7511106	12	Gently undulating plain, upper slope 2%, 2% Surface light clay 10YR3/2, cracking 2-6 mm, no coarse fragments

A close-up photograph of dark, moist soil with visible vertical and horizontal cracks. A black marker with a silver band is placed on the soil surface to provide a scale. Some dry, thin plant stems are scattered around the soil.

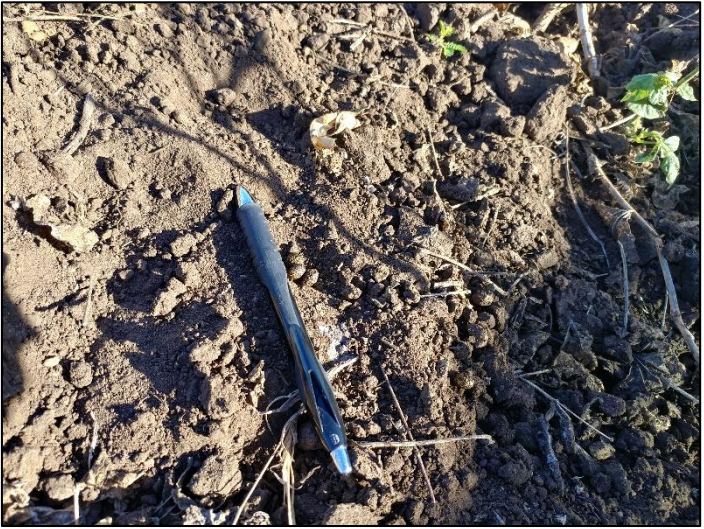
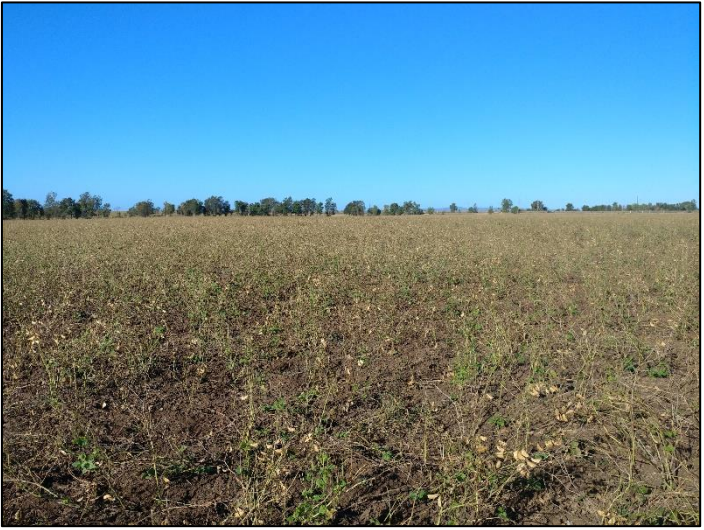
NC-39	642769 7511490	12	Gently undulating plain, mid slope 2%, 2% Surface light clay 10YR3/2, firm, no coarse fragments Forage cropping disturbance

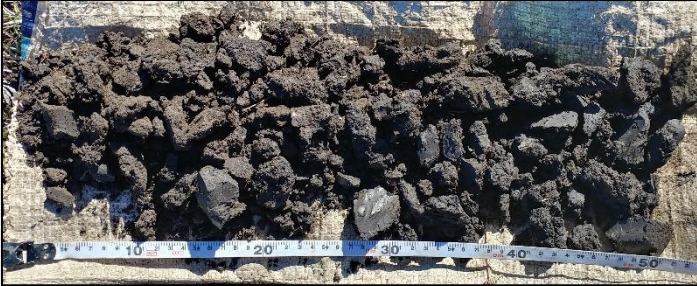
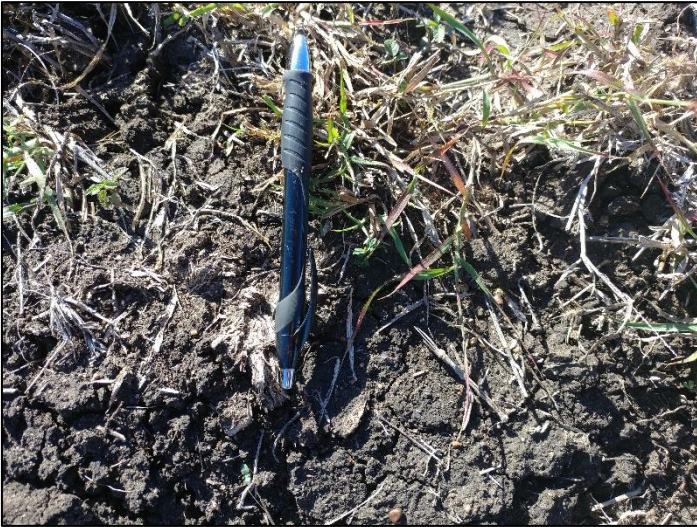
Site No.	Location - mE, mN (GDA94 Zone 55)	Map Unit	Comments	Pictures
NC-40	642555 7510052	16	<p>Gently undulating plain, upper slope 1%, 1%</p> <p>Surface light clay 10YR3/2, self mulching, no coarse fragments.</p> <p>Gilgai located in area, map boundary</p> <p>Limited disturbance</p> <p>0.00 – 0.20 m</p> <p>Light clay, moderate, 10YR3/2</p> <p>0.20 – 0.40+ m</p> <p>Medium clay, subangular blocky, 10YR3/1</p>

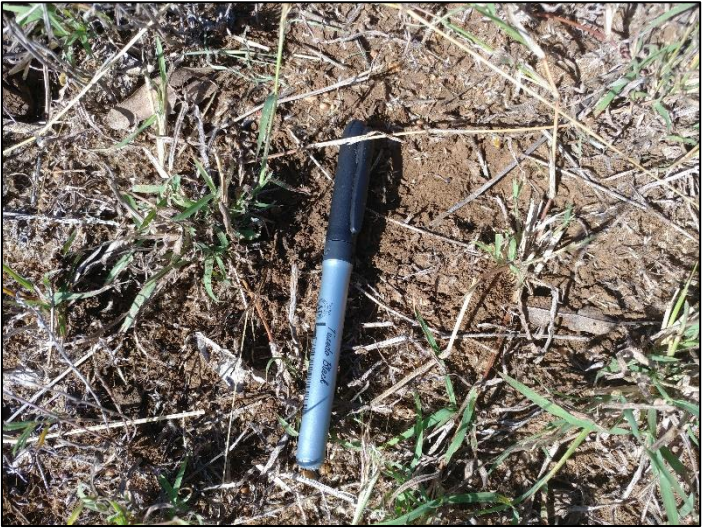
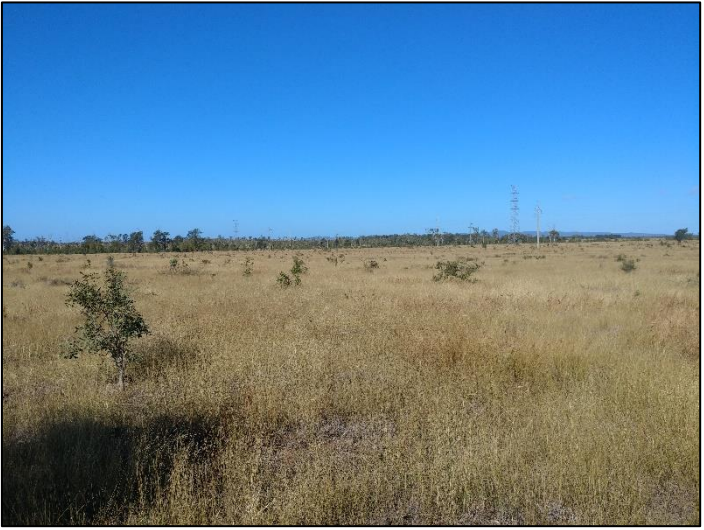
NC-41	642161 7510152	14	<p>Brown surface colour to the north, change to grey surface colour nearby towards the south</p> <p>Surface - firm, sandy loam, 10YR3/3 No coarse fragments, mid slope 1%</p>

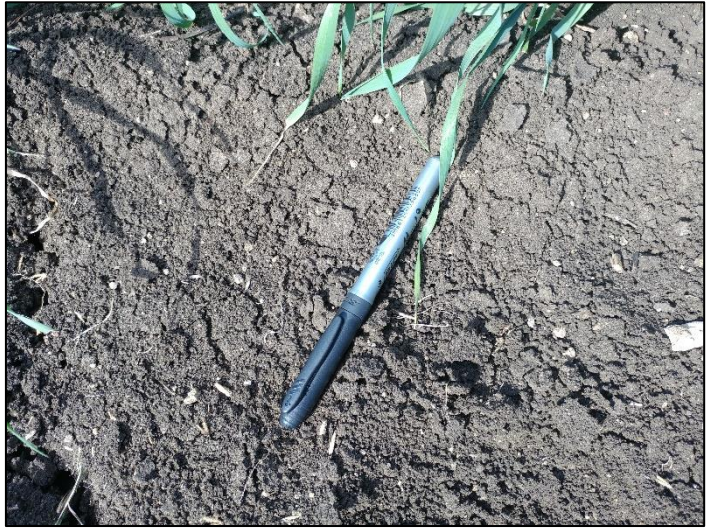
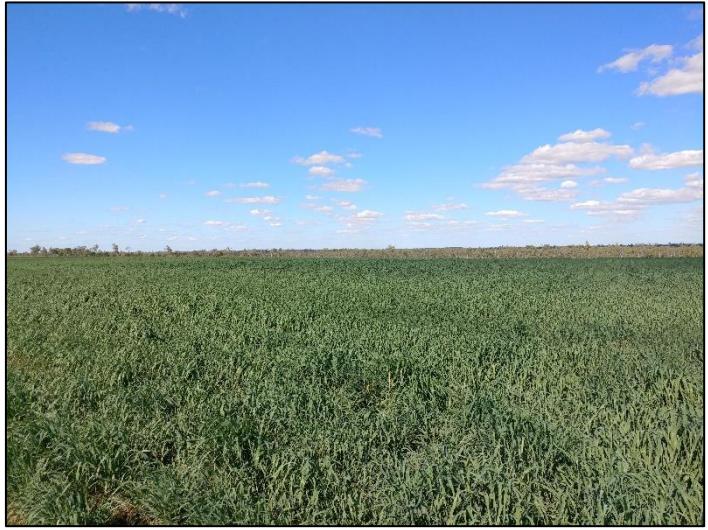
NC-44	645697 7508528	17	Gently undulating plain, mid slope <2%, 1% Surface light clay 10YR3/2, cracking <2 mm, self mulching, <2% coarse fragments Cropping disturbance

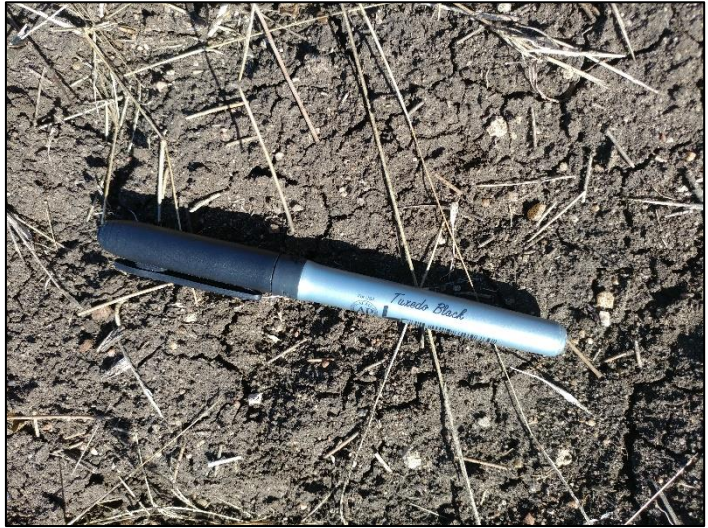
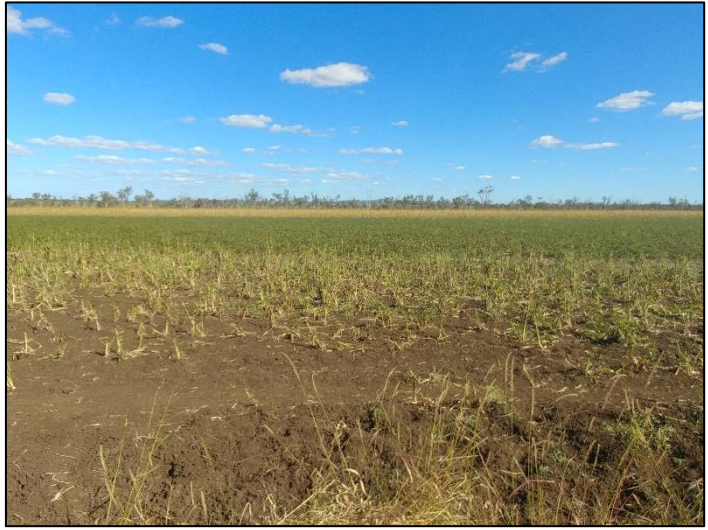
NC-45	644367 7509819	17	Gently undulating plain, mid slope 1%, 1% Surface light clay 10YR3/2, cracking <2 mm, self mulching, <2% coarse fragments Cropping disturbance

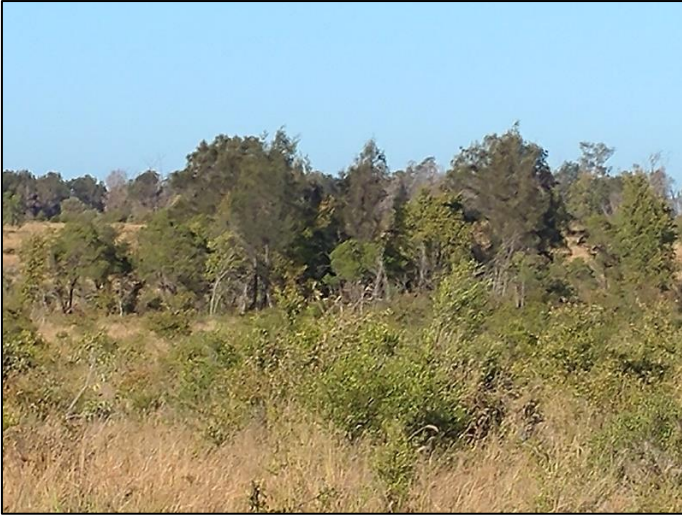
Site No.	Location - mE, mN (GDA94 Zone 55)	Map Unit	Comments	Pictures
NC-46	644024 7510908	15	Gently undulating plain, lower slope 2%, 1% Surface light clay 10YR3/2, cracking 2-6 mm, No coarse fragments

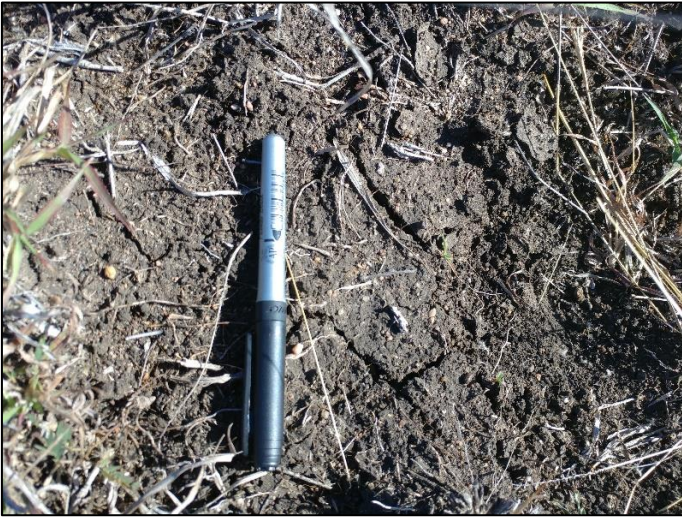
NC-47	640942 7512659	8	Gently undulating plain, mid slope 1%, 1% Surface light clay 10YR3/2, cracking 2-6 mm, no coarse fragments

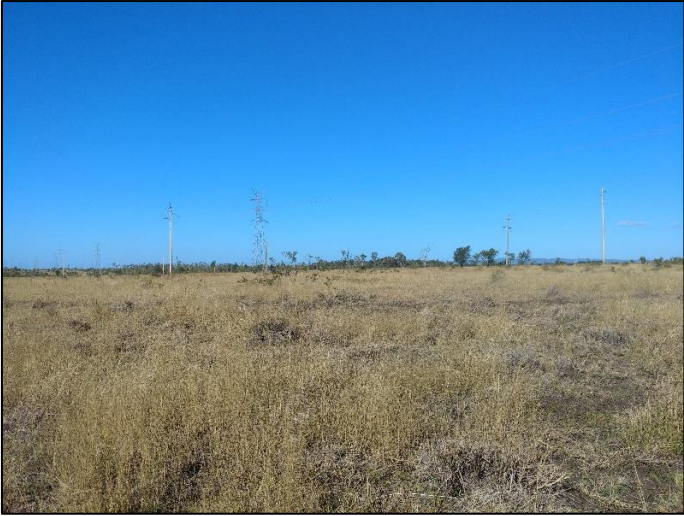
Site No.	Location - mE, mN (GDA94 Zone 55)	Map Unit	Comments	Pictures
NC-48	640883 7512861	8	Gently undulating plain, mid slope 1%, 1% Surface light clay 10YR3/2, cracking 2-6 mm, no coarse fragments

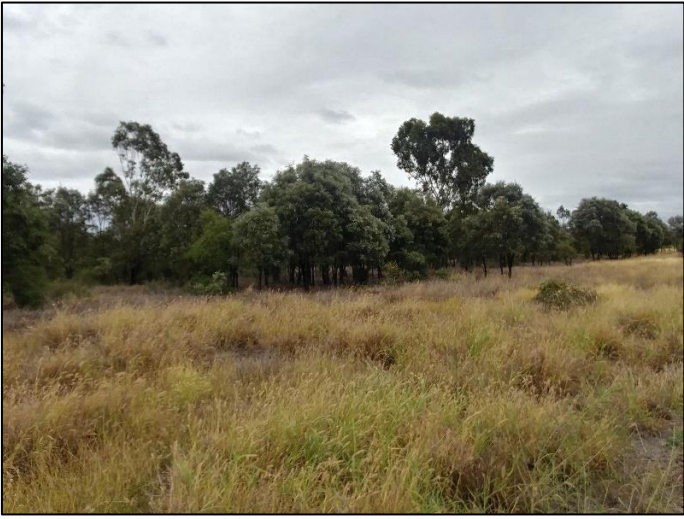
NC-49	642978 7511443	11	Wide depression, drainage line, lower slope 2%, 1% Surface sandy light clay,, No coarse fragments Sheet erosion

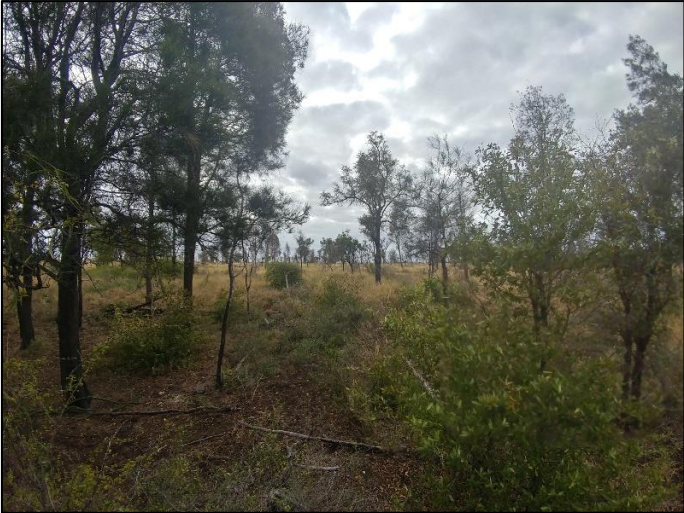
Site No.	Location - mE, mN (GDA94 Zone 55)	Map Unit	Comments	Pictures
NC-50	643674 7513508	4	Wide depression, drainage line, lower slope 2% Surface sandy light clay,, No coarse fragments Sheet erosion

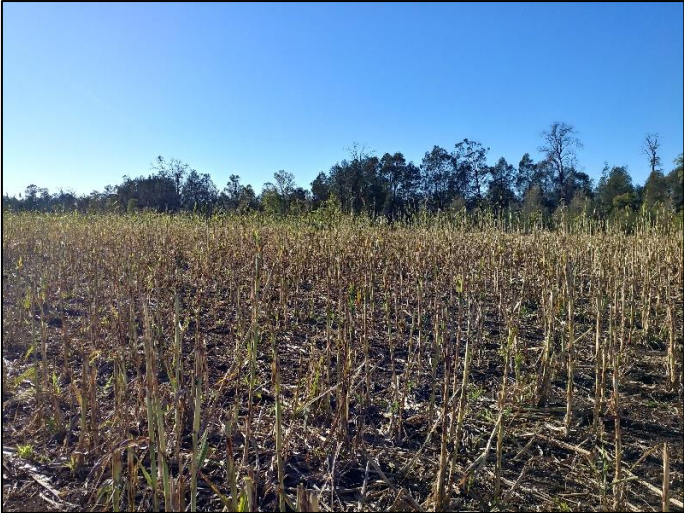
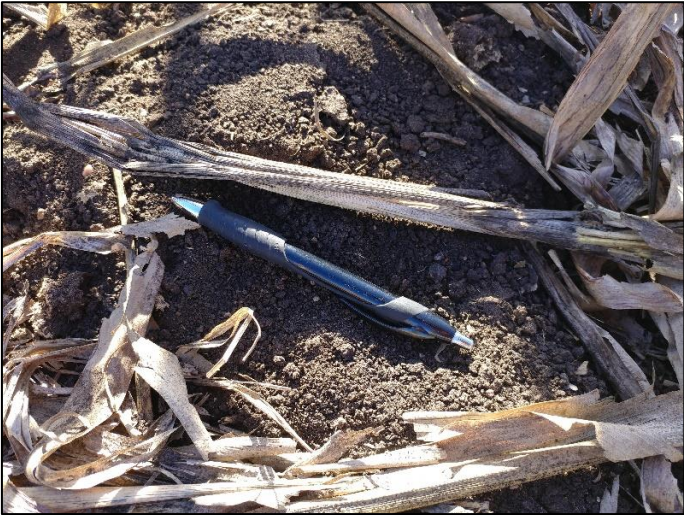
Site No.	Location - mE, mN (GDA94 Zone 55)	Map Unit	Comments	Pictures
NC-52	643635 7512290	9	Gently undulating plain, lower slope 2%, 2% Surface light clay, self mulching, no coarse fragments Cropping disturbance

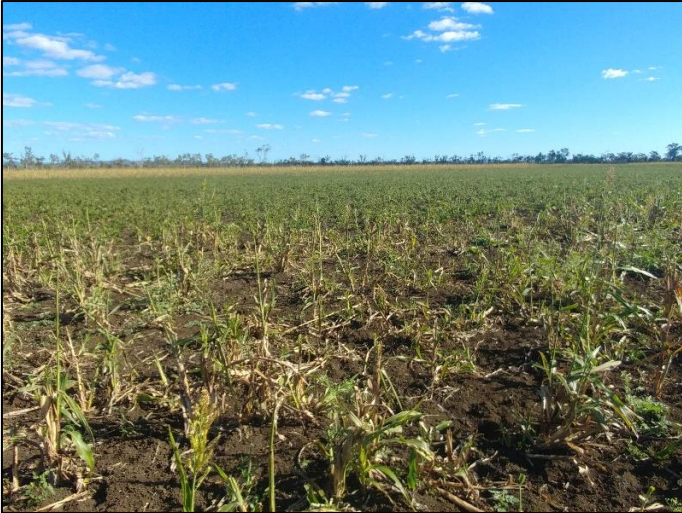
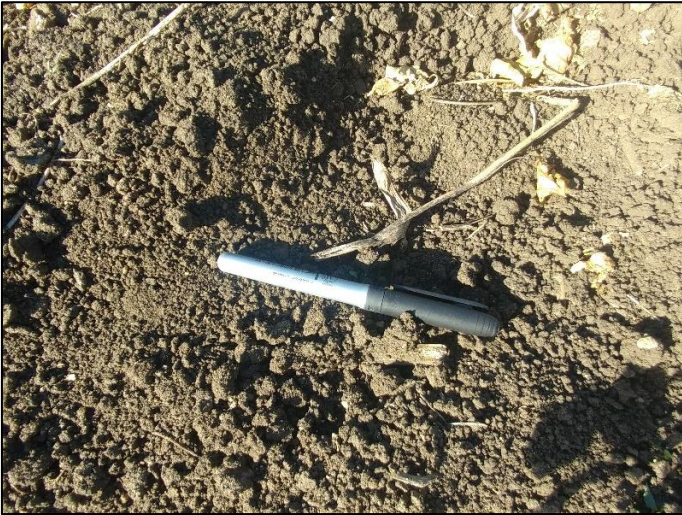
Site No.	Location - mE, mN (GDA94 Zone 55)	Map Unit	Comments	Pictures
NC-54	645704 7510053	17	Gently undulating plain, upper slope 1%, 1% Surface light clay, self mulching, no coarse fragments Cropping disturbance

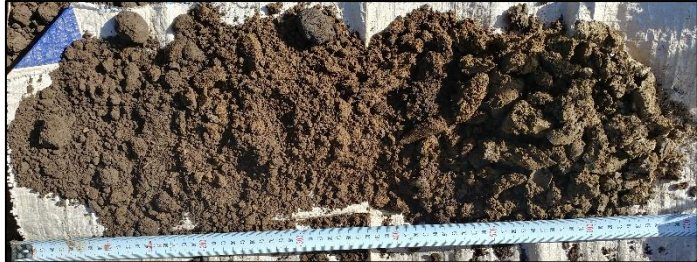
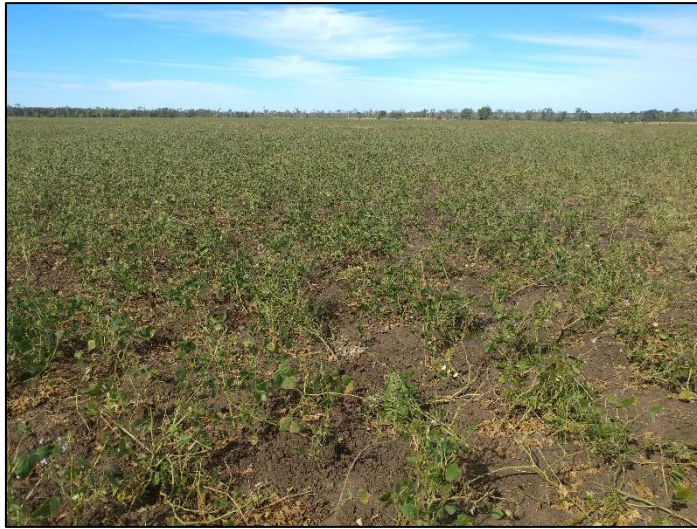
Site No.	Location - mE, mN (GDA94 Zone 55)	Map Unit	Comments	Pictures
NC-56	643093 7510114	14	<p>Gently undulating plain, mid slope 1%</p> <p>Surface - firm, sandy loam, 10YR3/3, no coarse fragments</p> <p>0.00 – 0.10 m Sandy loam 10YR3/3</p> <p>0.10 – 0.42 m Sandy clay loam 5YR4/3</p> <p>0.42 – 0.65 + m Sandy clay loam 7.5Y4/4 &lt;5% calcium carbonate</p>

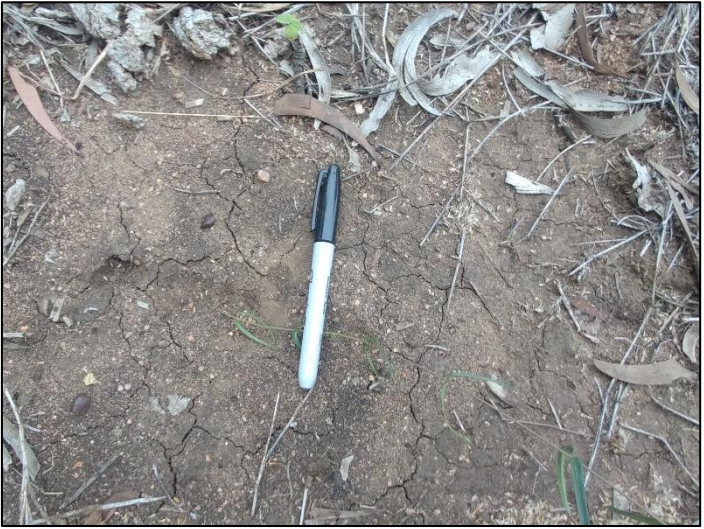
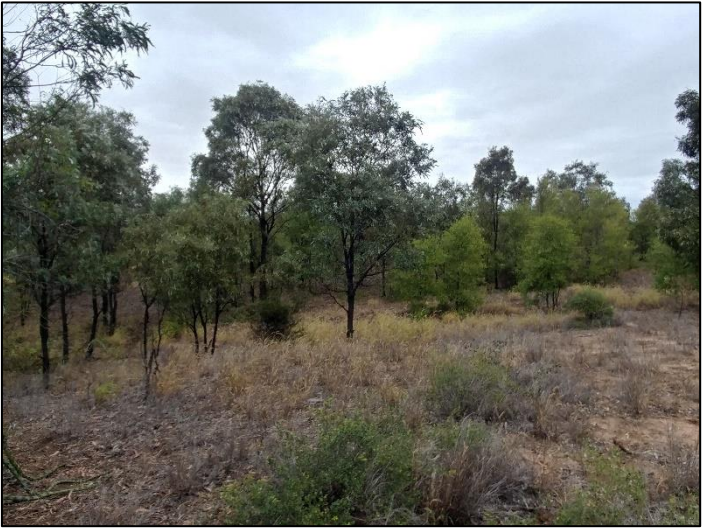
NC-57	642985 7513858	4	<p>Gently undulating plain, lower slope 1%, 2%</p> <p>Wide depression, inactive drainage line</p> <p>Brigalow, Belah</p> <p>Surface – firm, cracking 2 mm, sandy clay loam</p> <p>&lt;2% coarse fragments &lt;2 mm</p>

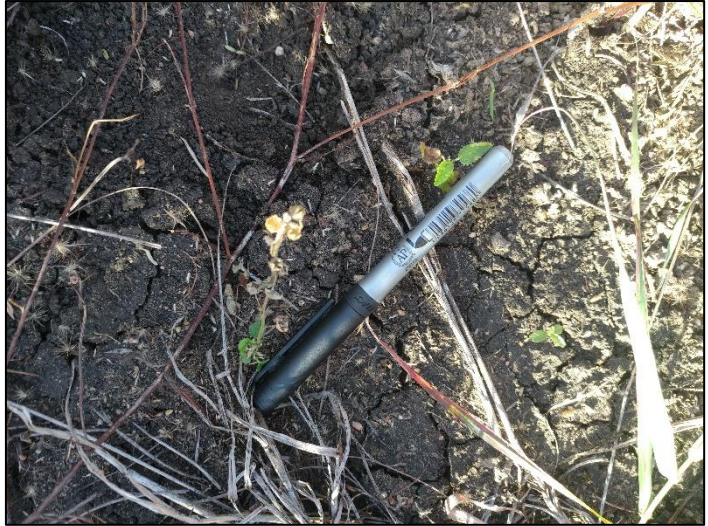
Site No.	Location - mE, mN (GDA94 Zone 55)	Map Unit	Comments	Pictures
NC-58	644239 7511127	15	Gently undulating plain, mid slope 2%, 1% Surface light clay 10YR3/2, cracking 2-6 mm, No coarse fragments

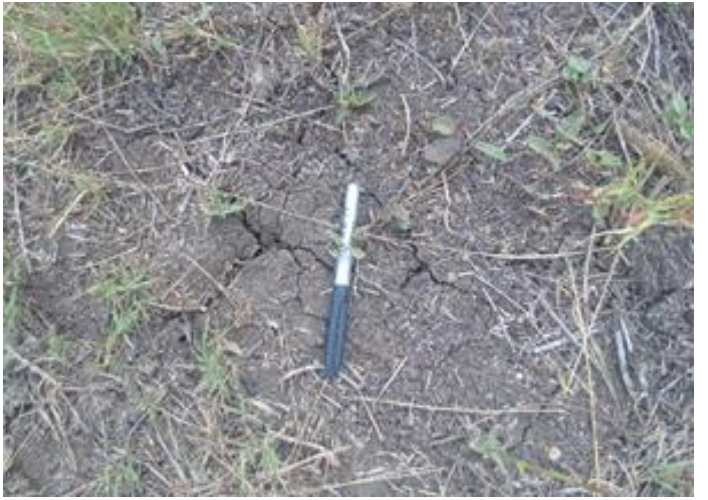
NC-59	644073 7514265	3	Gently undulating plain, upper slope 1%, 2% Brigalow, Belah Limited disturbance, Surface – cracking 2-8 mm, and self mulching, sandy clay loam, no coarse fragments

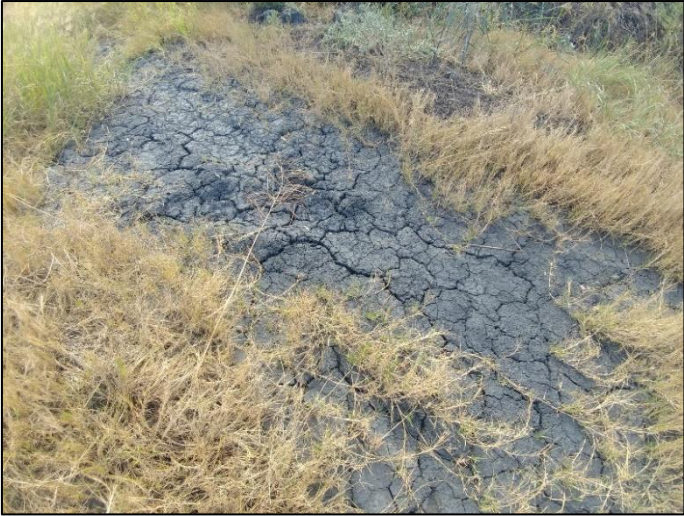
Site No.	Location - mE, mN (GDA94 Zone 55)	Map Unit	Comments	Pictures
NC-62	641100 7512707	7	Wide depression, surface hard setting with cracking 2-6mm. Surface texture light clay.

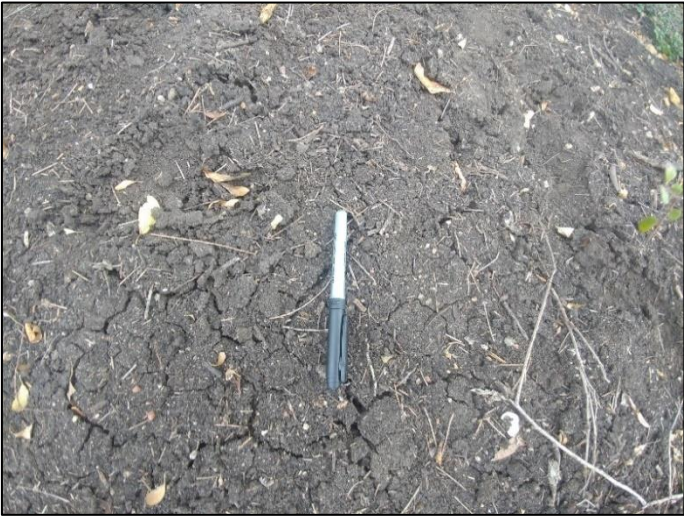
NC-63	641030 7513411	7	Wide depression, surface firm with cracking 2-6mm. Surface texture light clay.

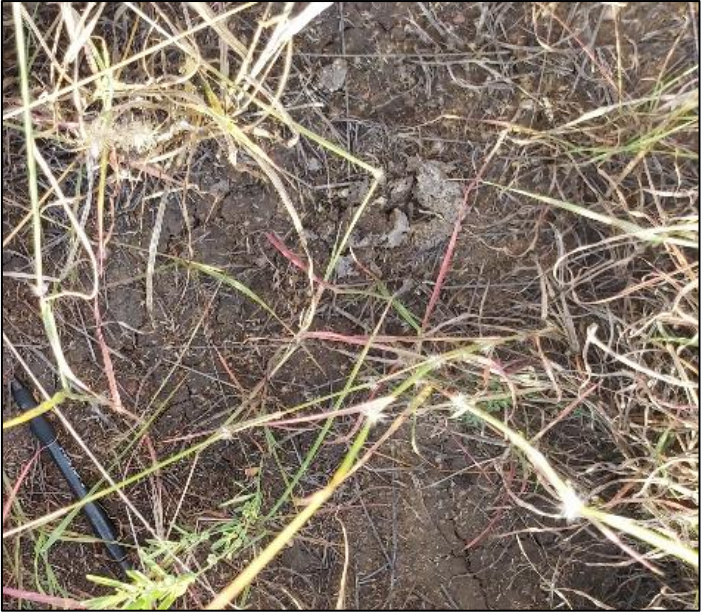
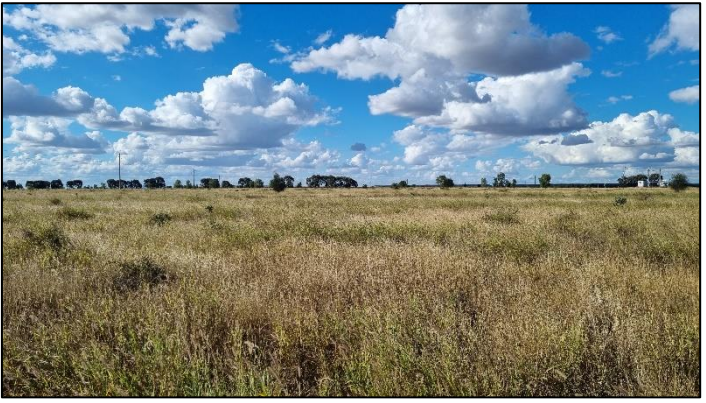
Site No.	Location - mE, mN (GDA94 Zone 55)	Map Unit	Comments	Pictures
NC-64	641815 7512824	20	Nil microrelief, extensive clearing Surface light clay with cracking, 10YR3/2 very dark greyish brown

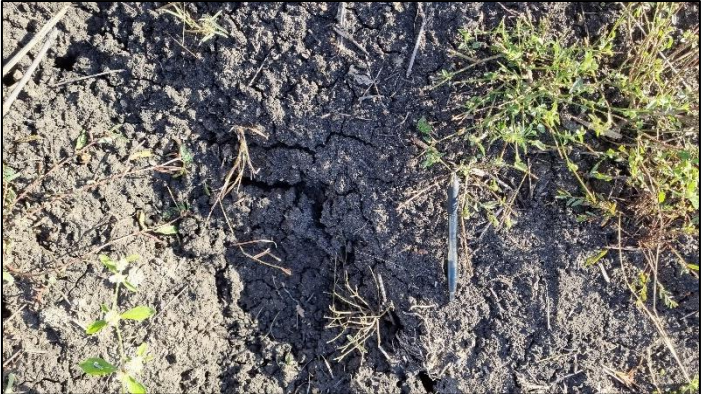
Site No.	Location - mE, mN (GDA94 Zone 55)	Map Unit	Comments	Pictures
NC-65	642145 7512424	20	Grazing, level plain, flat Normal gilgai observed, <20% coverage, area less than 10 ha, aggregated with Map Unit 20 Complete clearing Surface self-mulching with nil coarse fragments

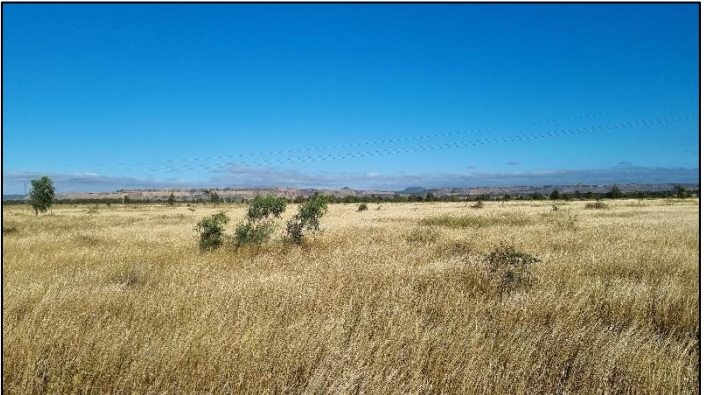
NC-66	642040 7512523	20	Grazing, level plain, flat Nil microrelief Complete clearing Surface self-mulching with nil coarse fragments

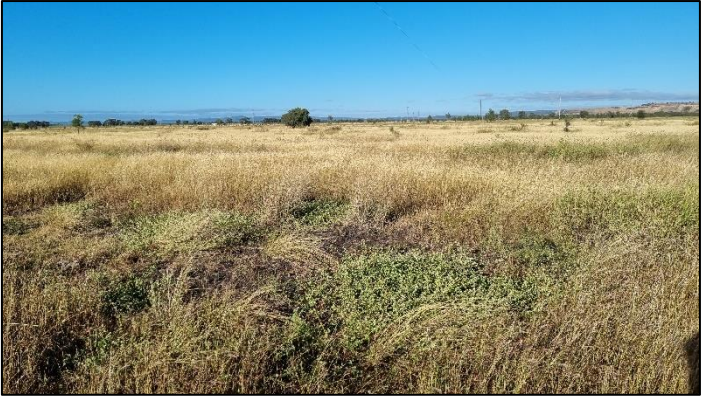
Site No.	Location - mE, mN (GDA94 Zone 55)	Map Unit	Comments	Pictures
NC-67	642071 7512485	20	Grazing, level plain, flat Nil microrelief in immediate area Normal gilgai begins to the east Complete clearing Surface self-mulching with nil coarse fragments

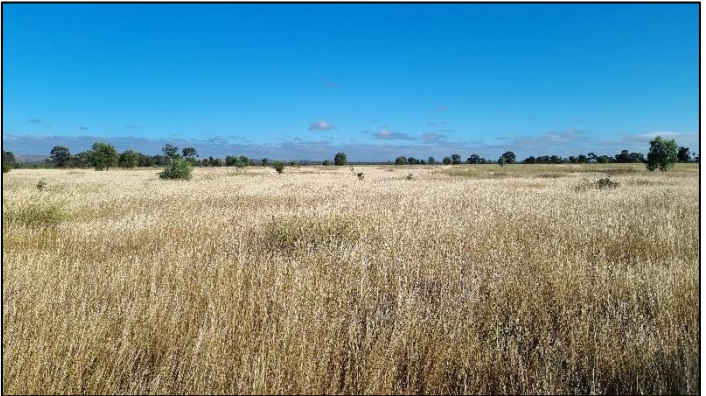
NC-68	641951 7513006	18	Grazing, gently undulating plain, flat, 0% / 1% slope Nil microrelief observed in area or along transect to site 77-SCL Surface texture, Clay loam sandy

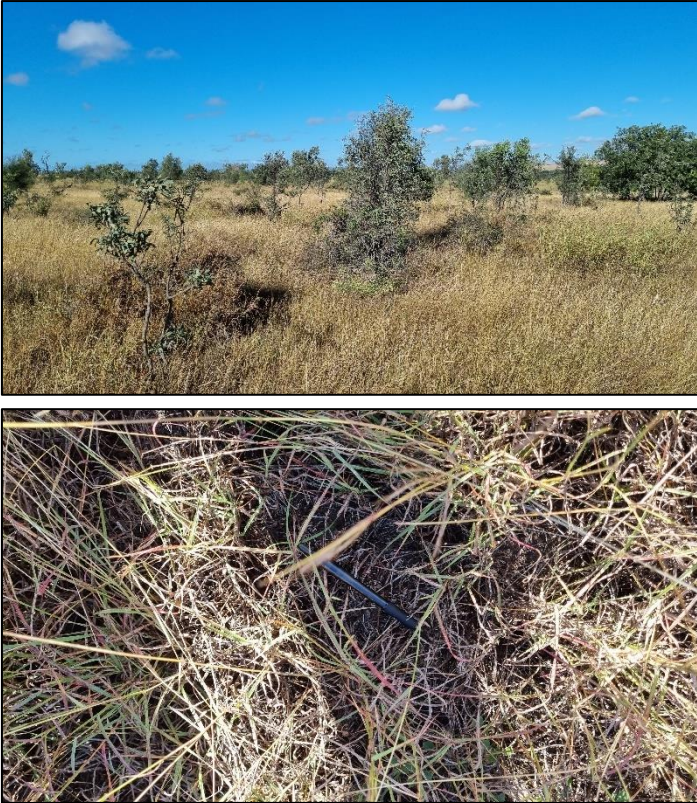
Site No.	Location - mE, mN (GDA94 Zone 55)	Map Unit	Comments	Pictures
NC-69	641577 7513080	18	Grazing, gently undulating plain, mid slope Brigalow regrowth, nil microrelief Surface firm, clay loam, sandy, 10YR3/2 very dark greyish brown

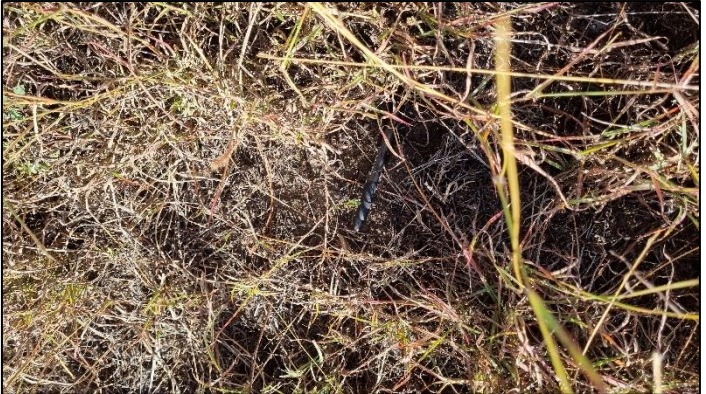
Site No.	Location - mE, mN (GDA94 Zone 55)	Map Unit	Comments	Pictures
NC-70	641635 7513191	18	Grazing, gently undulating plain Surface firm, clay loam sandy

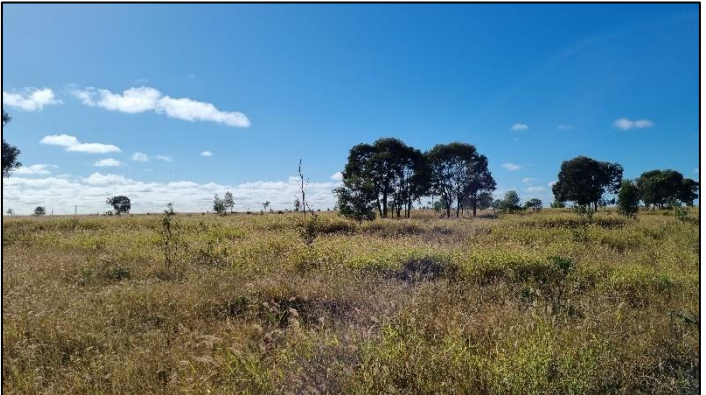
NC-71	641749 7512962	18	Grazing, gently undulating plain, upper slope <2% Surface firm, clay loam sandy

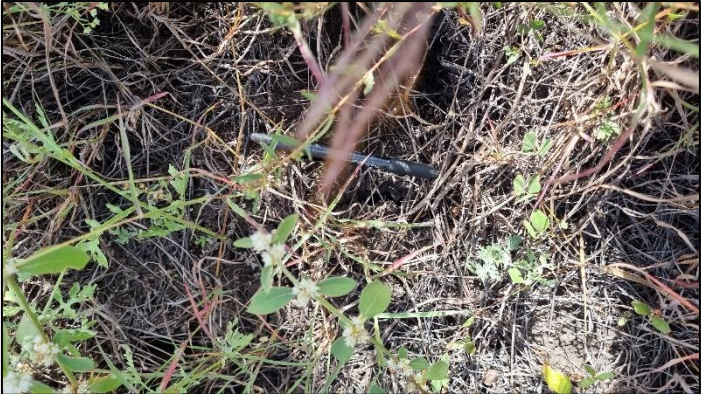
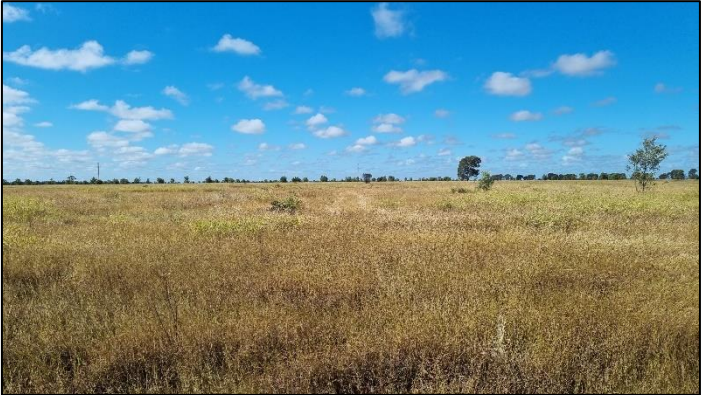
Site No.	Location - mE, mN (GDA94 Zone 55)	Map Unit	Comments	Pictures
NC-72	641914 7513441	19	Grazing, gently undulating plain, upper slope Nil microrelief, complete clearing, not cultivated Surface firm, light clay, 10YR3/2 very dark greyish brown, self-mulching

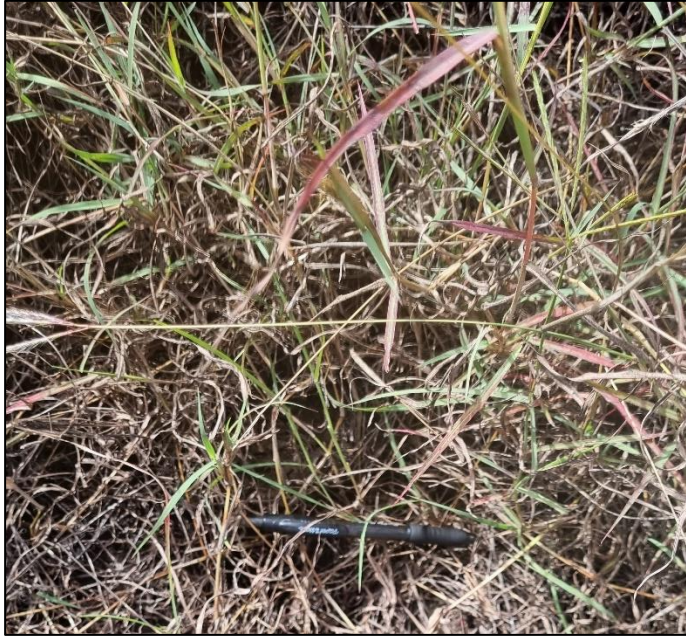
Site No.	Location - mE, mN (GDA94 Zone 55)	Map Unit	Comments	Pictures
NC-73	641851 7513420	19	Grazing, gently undulating plain, upper slope Nil microrelief, complete clearing, not cultivated Surface firm, light clay, 10YR3/2 very dark greyish brown, self-mulching

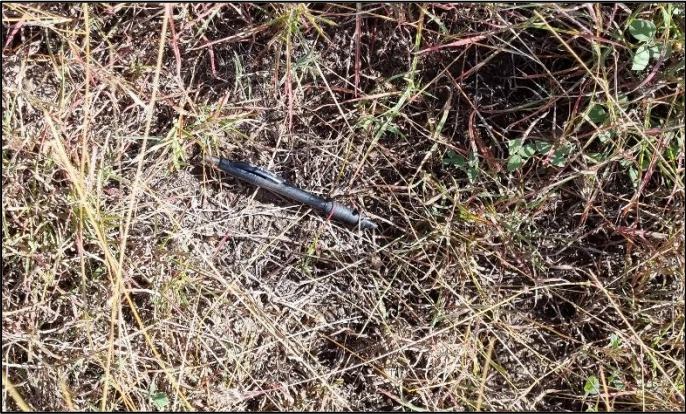
Site No.	Location - mE, mN (GDA94 Zone 55)	Map Unit	Comments	Pictures
NC-74	641503 7513177	18	Grazing, gently undulating plain, mid slope Various regrowth, nil microrelief Surface firm, no cracking, clay loam sandy, 10YR3/2 very dark greyish brown

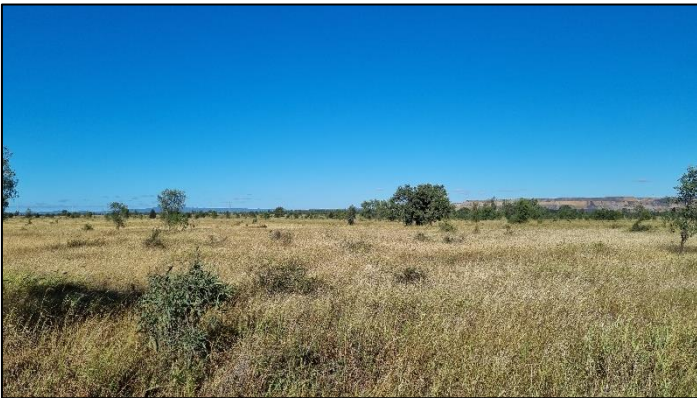
NC-75	641318 7513030	18	Grazing, gently undulating plain, simple slope 3% / 3% Nil microrelief, complete clearing, cultivated Surface firm, clay loam sandy

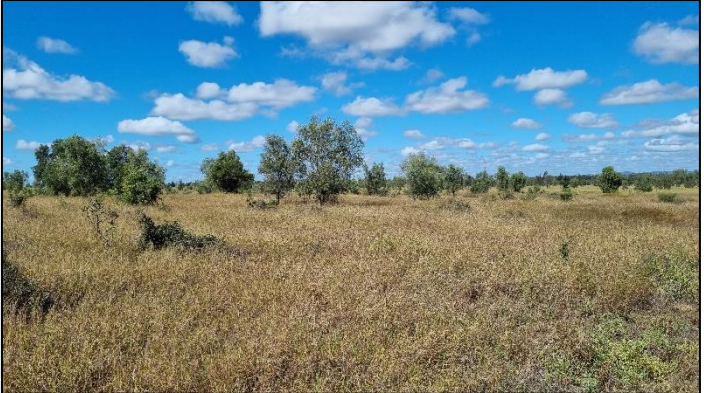
Site No.	Location - mE, mN (GDA94 Zone 55)	Map Unit	Comments	Pictures
NC-76	641267 7512983	6	Grazing, gently undulating plain, lower slope <2%/3% Nil microrelief Surface firm, sandy clay loam, 10YR3/2 very dark greyish brown Boundary observed between NC-75 and NC-76
