# Restoration Plan to Support RIDA Application Saraji East Project

Final V4  
15 July 2021

GT Environmental Pty Ltd  
[www.gtenvironmental.com.au](http://www.gtenvironmental.com.au)

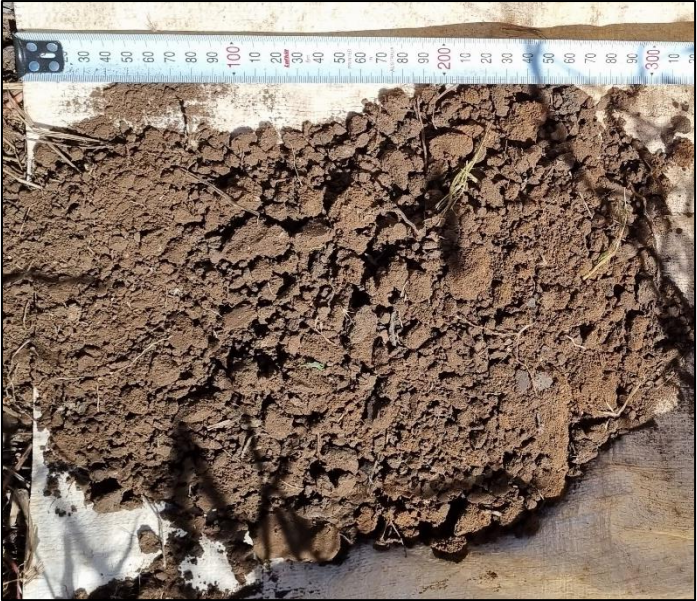
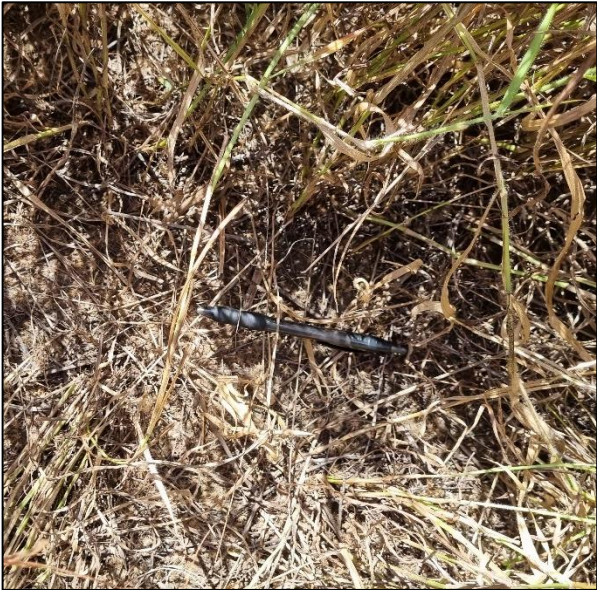
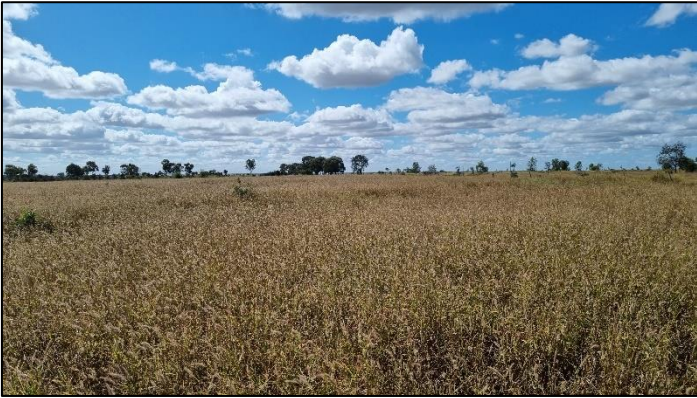
Site No.	Location - mE, mN (GDA94 Zone 55)	Map Unit	Comments	Pictures
NC-77	641559 7513265	18	<p>Grazing, gently undulating plain, simple slope 3%/3%</p> <p>Nil microrelief, complete clearing</p> <p>Surface firm</p> <ul style="list-style-type: none"> <li>0.00-0.10m, Clay loam, sandy, 10YR3/1 very dark grey</li> <li>0.10-0.30m+, Light clay, sandy, 10YR3/2 very dark greyish brown</li> </ul>

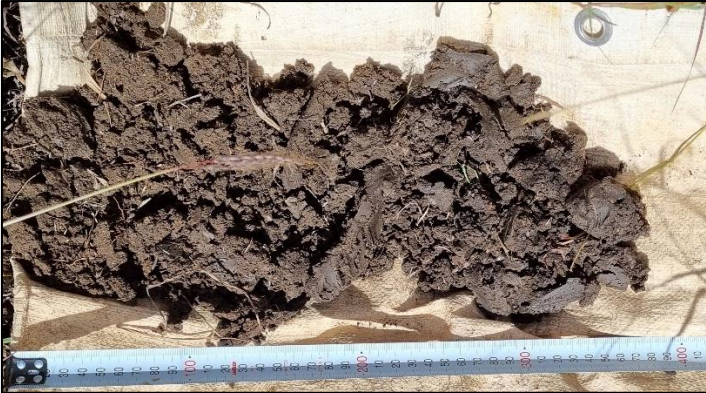
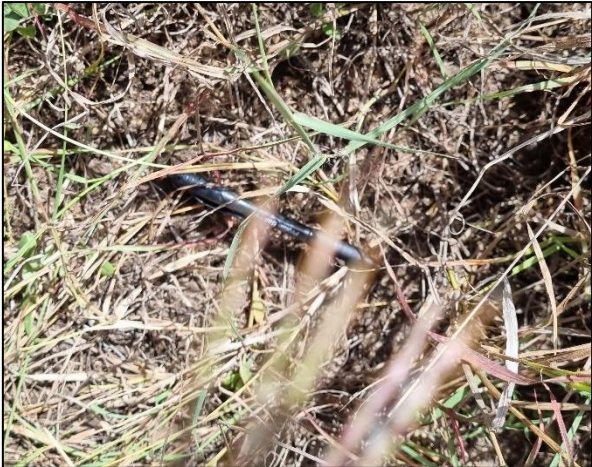
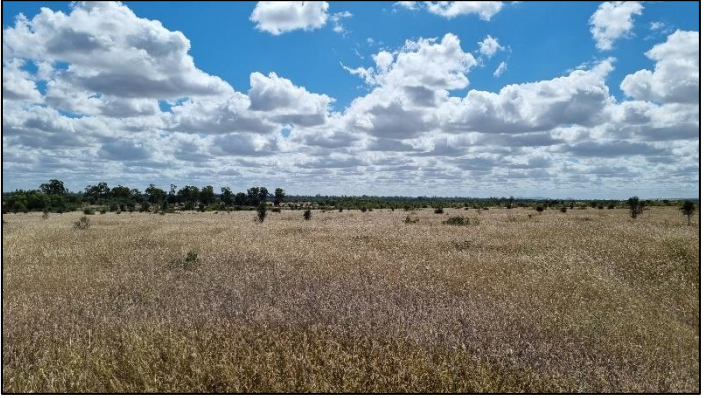
Site No.	Location - mE, mN (GDA94 Zone 55)	Map Unit	Comments	Pictures
NC-78	641444 7513398	6	<p>Grazing, gently undulating plain, mid slope 2%</p> <p>Grasses</p> <p>Nil microrelief</p> <p>Complete clearing, not cultivated</p> <ul style="list-style-type: none"> <li>A1, 0.00-0.12m, Sandy clay loam, 7.5YR3/3 dark brown</li> <li>B21, 0.12-0.34+, medium clay, 10YR3/2 very dark greyish brown</li> </ul>

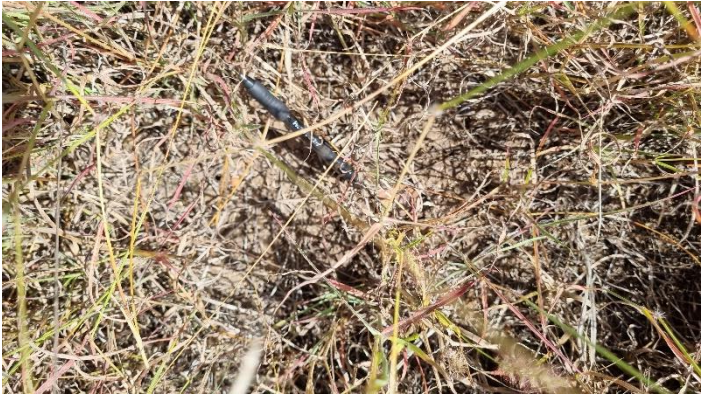
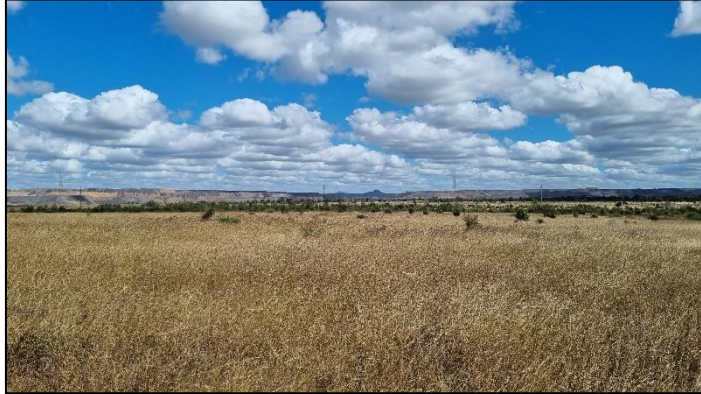
Site No.	Location - mE, mN (GDA94 Zone 55)	Map Unit	Comments	Pictures
NC-79	641336 7513255	6	<p>Grazing, gently undulating plain, mid slope</p> <p>Grasses, nil microrelief, complete clearing, not cultivated</p> <p>Surface firm,</p> <ul style="list-style-type: none"> <li>• A1, 0.00-0.12m, sandy clay loam 7.5YR3/3 dark brown</li> <li>• B21, 0.12-0.34m+, medium clay, 10YR3/2 very dark greyish brown</li> </ul>

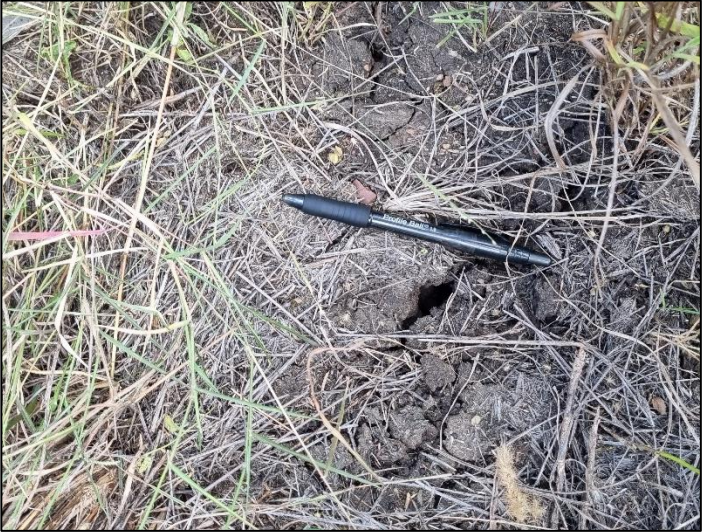
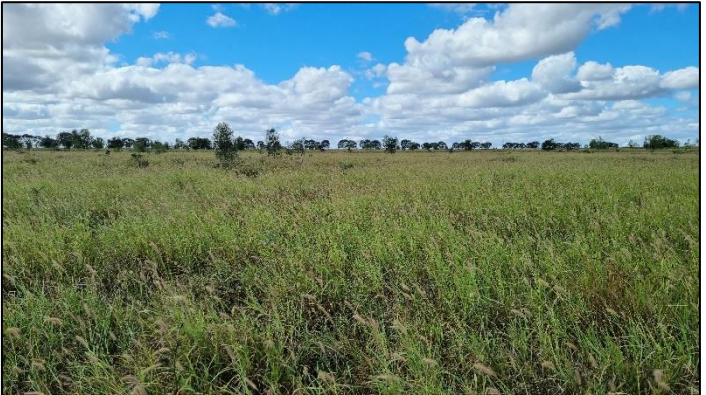
Site No.	Location - mE, mN (GDA94 Zone 55)	Map Unit	Comments	Pictures
NC-80	641391 7512856	6	Grazing, gently undulating plain, mid slope 2%/2% Nil microrelief, complete clearing, not cultivated Surface self-mulching cracking, light clay, 10YR3/1 very dark grey

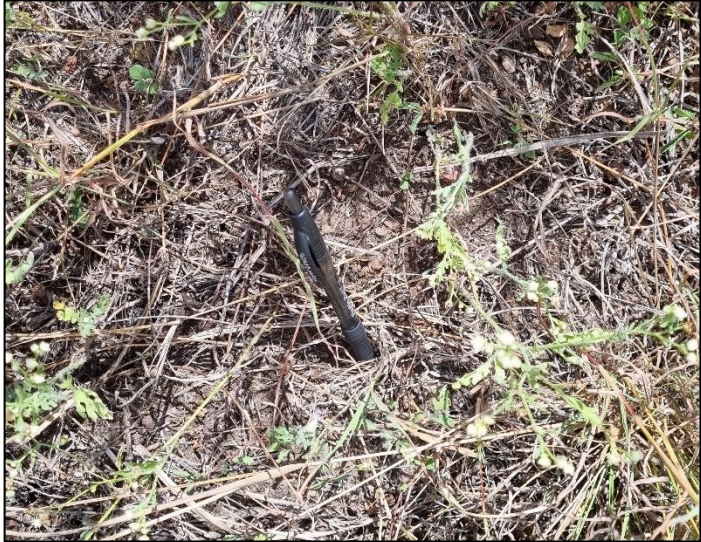
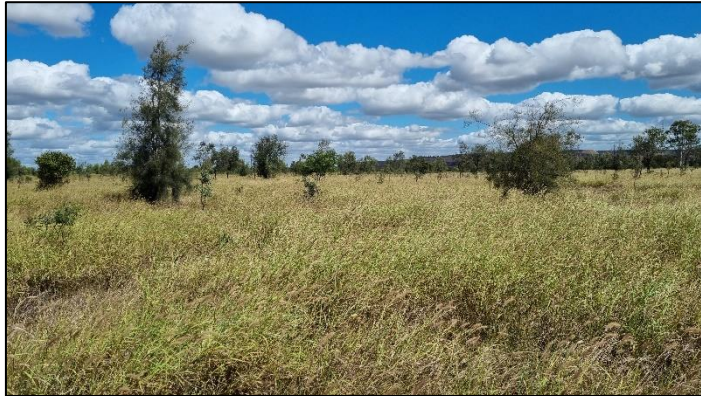
Site No.	Location - mE, mN (GDA94 Zone 55)	Map Unit	Comments	Pictures
NC-81	641512 7512735	6	Grazing, gently undulating plain, lower slope Bull Mitchell grass, mixed regrowth, extensive clearing Surface firm with no cracking or coarse fragments, sandy clay loam, 10YR3/2 very dark greyish brown

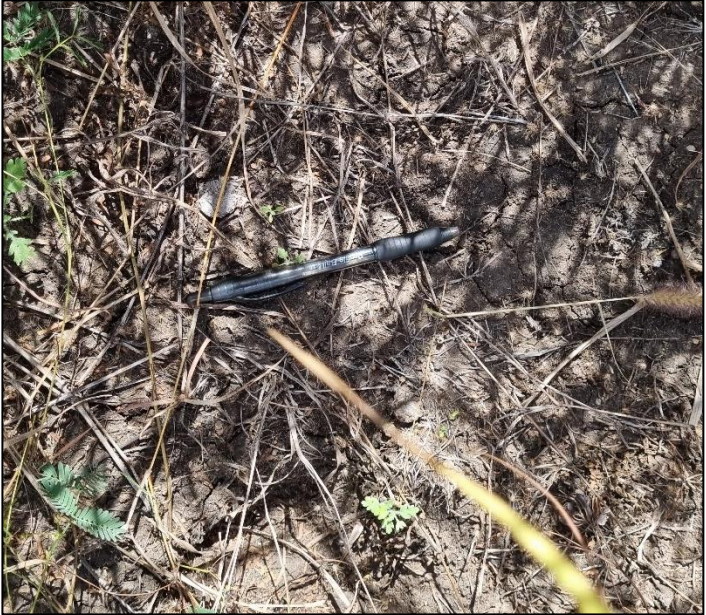
Site No.	Location - mE, mN (GDA94 Zone 55)	Map Unit	Comments	Pictures
NC-82	641616 7512602	6	Grazing, gently undulating plain, mid slope <2% Nil microrelief, extensive clearing Surface firm, sandy clay loam, 10YR3/2 very dark greyish brown

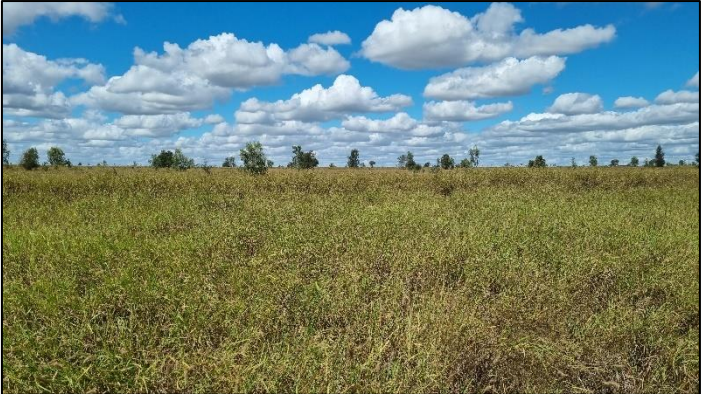
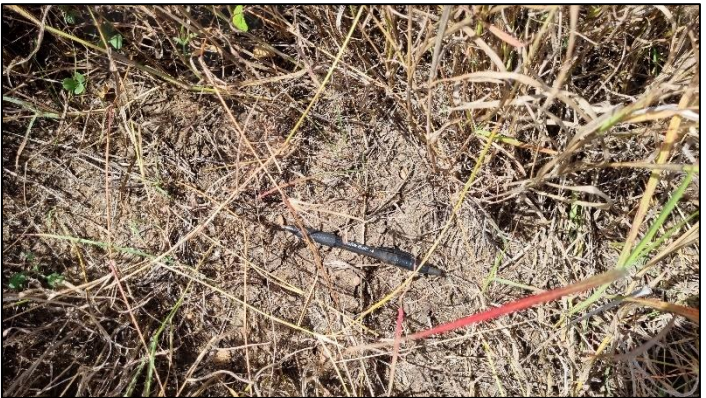
Site No.	Location - mE, mN (GDA94 Zone 55)	Map Unit	Comments	Pictures
NC-83	641670 7512506	20	Nil microrelief, extensive clearing Surface light clay with cracking and self mulching, 10YR3/2 very dark greyish brown

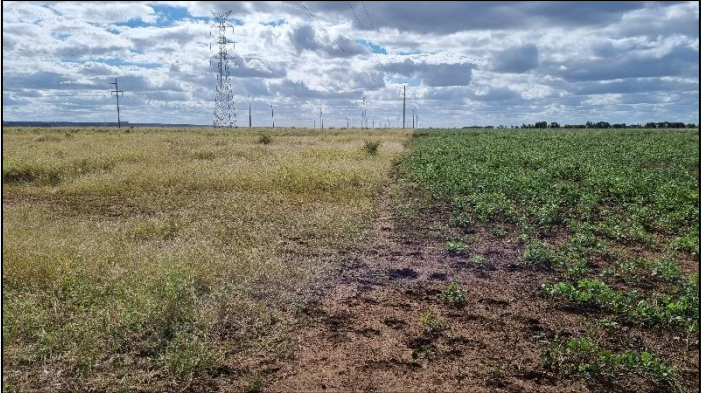
Site No.	Location - mE, mN (GDA94 Zone 55)	Map Unit	Comments	Pictures
NC-86	642366 7510364	14	South of boundary, reddish brown surface colour begins towards to the south

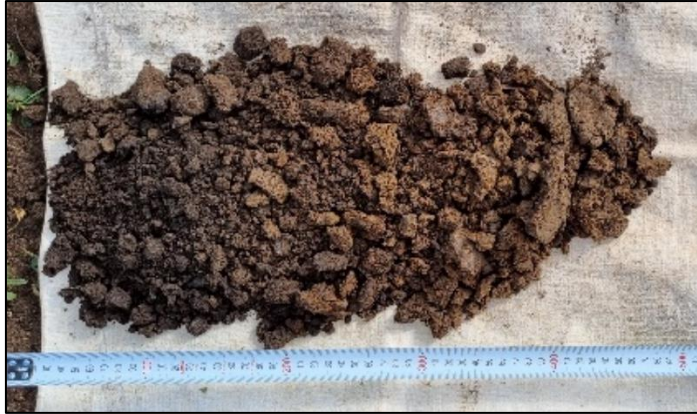
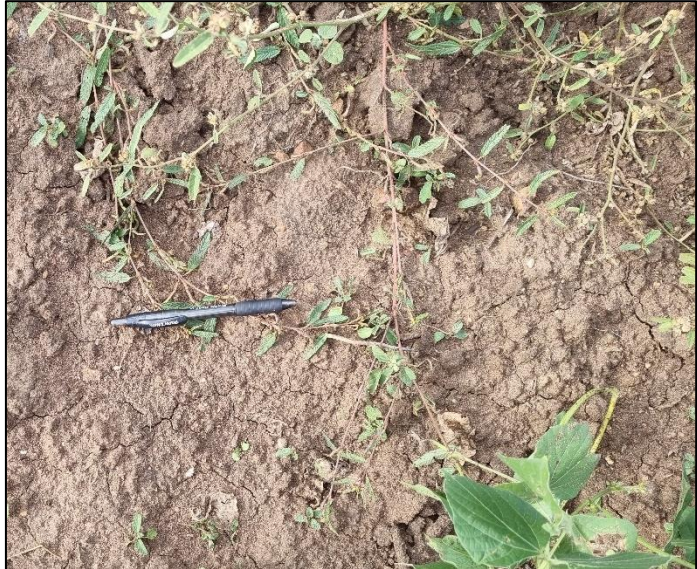
Site No.	Location - mE, mN (GDA94 Zone 55)	Map Unit	Comments	Pictures
NC-88	641880 7510244	13	<p>Forage cropping, surface firm, mid slope &lt;2%</p> <ul style="list-style-type: none"> <li>0.00-0.10m, sandy clay loam, weak, 10YR3/2 greyish brown</li> <li>0.10-0.14m, light clay, weak, 10YR4/3 brown</li> <li>0.14-0.40+m, light clay, strong, 10YR4/3 brown, with 5% mottle 10YR4/4 dark yellowish brown</li> </ul> <p>As per site 9-SCL</p> <p>Aggregated with Map Unit 13 due to polygon size being less than 10 ha</p>

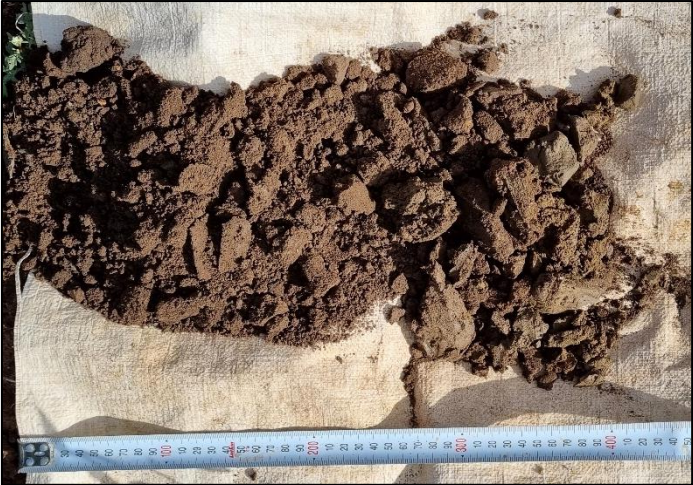
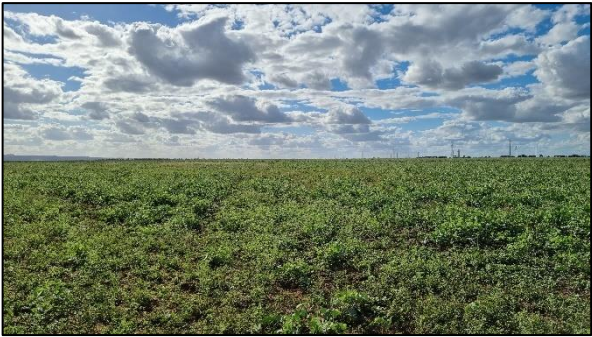
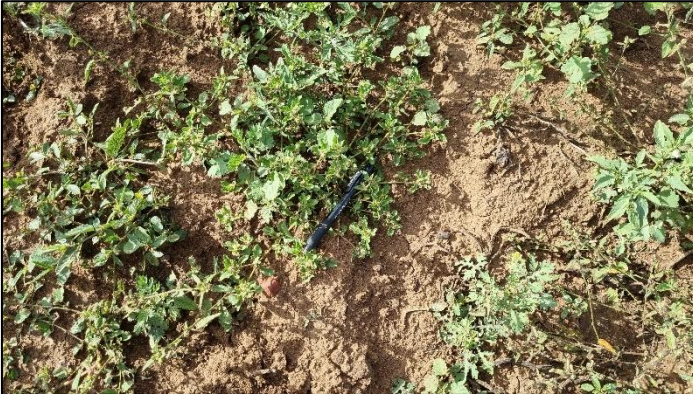
Site No.	Location - mE, mN (GDA94 Zone 55)	Map Unit	Comments	Pictures
NC-89	642019 7510231	13	<p>Forage cropping, surface firm, flat</p> <p>Nil microrelief</p> <ul style="list-style-type: none"> <li>0.00-0.12m, sandy clay loam, weak, very firm 10YR3/2 greyish brown</li> <li>0.10-0.45m, light clay, moderate, firm, 10YR4/3 brown, nil mottles</li> </ul> <p>As per site 9-SCL</p> <p>Aggregated with Map Unit 13 due to polygon size being less than 10 ha</p>

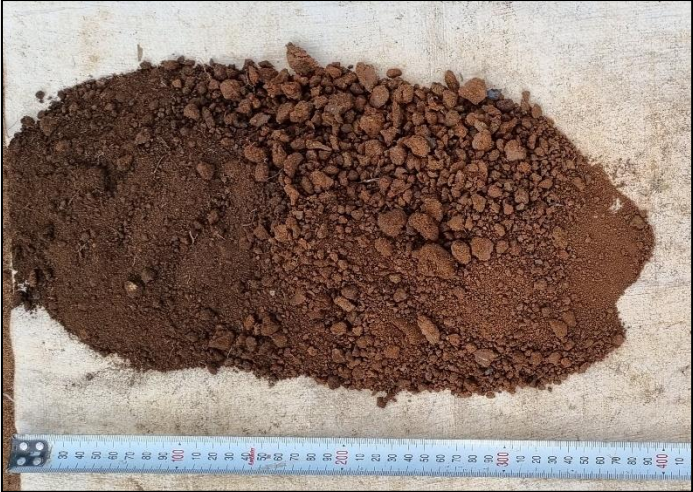
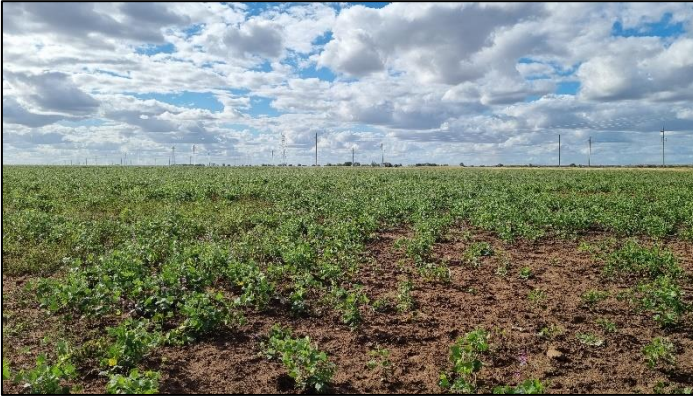
Site No.	Location - mE, mN (GDA94 Zone 55)	Map Unit	Comments	Pictures
NC-90	642122 7510236	14	<p>Grazing, gently undulating plain, flat</p> <p>Extensive disturbance, forage cropping</p> <p>Surface firm</p> <ul style="list-style-type: none"> <li>• 0.00-0.12m, sandy loam, weak, 10YR3/2 greyish brown</li> <li>• 0.12-0.40+m, Light clay, moderate 5YR4/3 reddish brown</li> </ul>

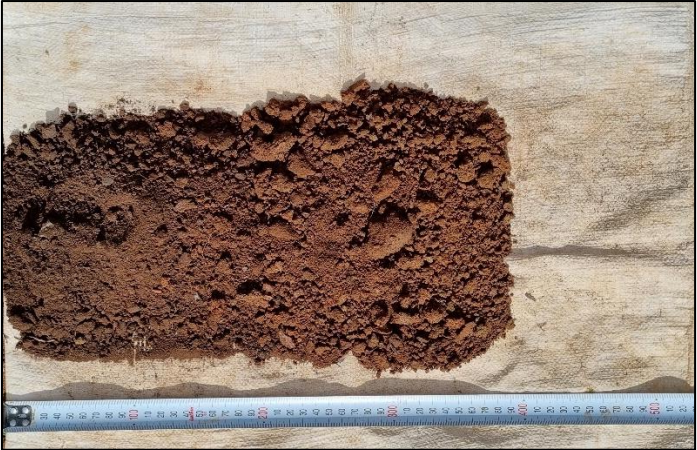
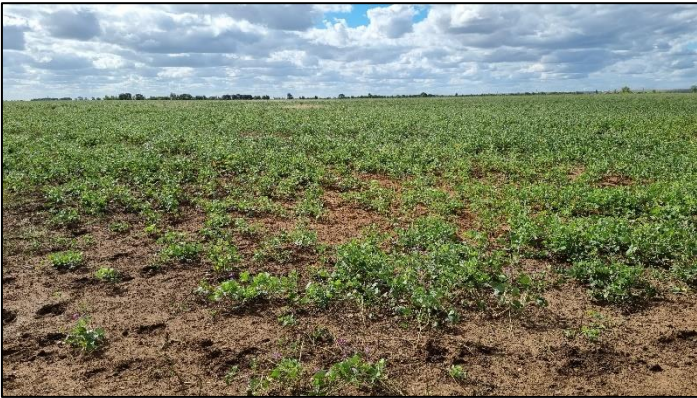
Site No.	Location - mE, mN (GDA94 Zone 55)	Map Unit	Comments	Pictures
NC-91	642063 7510332	14	<p>Grazing, gently undulating plain, mid slope &lt;1%</p> <p>Extensive disturbance, forage cropping</p> <p>Surface firm</p> <ul style="list-style-type: none"> <li>• 0.00-0.14m, sandy loam, weak, 10YR3/2 greyish brown</li> <li>• 0.14-0.40+m, Light clay, moderate 5YR4/3 reddish brown</li> </ul>

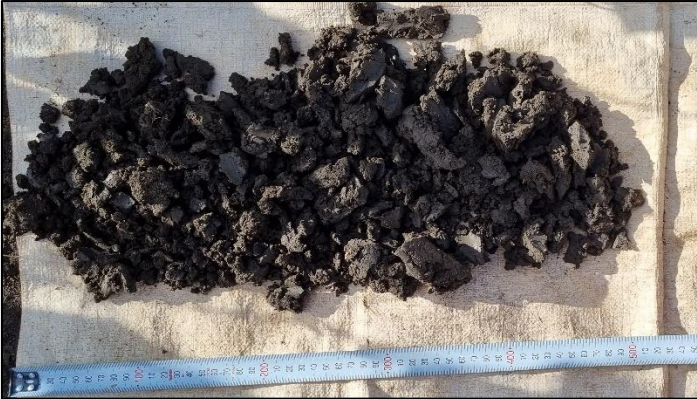
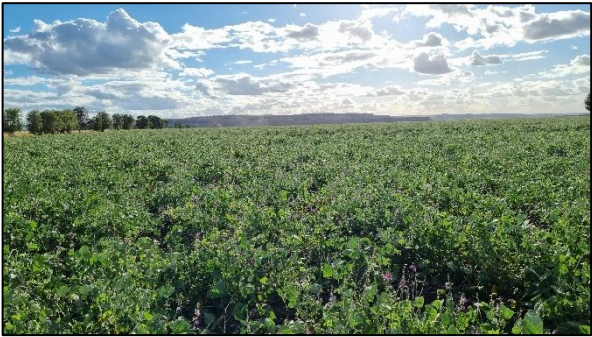
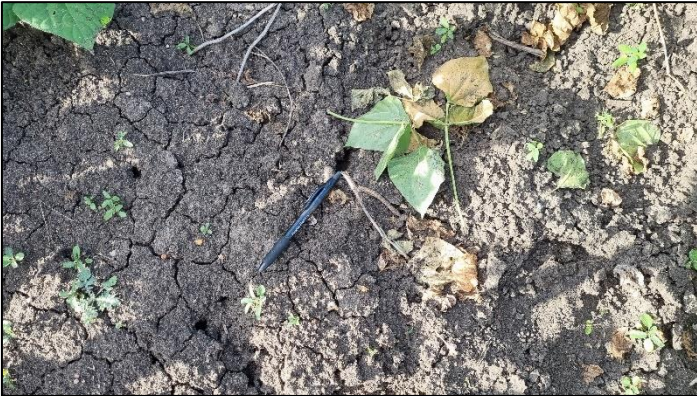
Site No.	Location - mE, mN (GDA94 Zone 55)	Map Unit	Comments	Pictures
NC-92	641808 7510250	13	<p>Gently undulating plain, flat 1%/1%</p> <p>Nil microrelief, complete clearing, forage cropping</p> <p>Surface firm, nil coarse fragments</p> <ul style="list-style-type: none"> <li>A1, 0.00-0.11m, Light clay, moderate, firm, 10YR2/1 Black, nil mottles, nil inclusions, moderately moist, moderately well drained, roots fine/few</li> <li>B21, 0.11-0.40+m, Medium clay, moderate, firm, 10YR2/1 Black, nil mottles, nil inclusions, moderately moist, moderately well drained, roots fine/few</li> </ul>

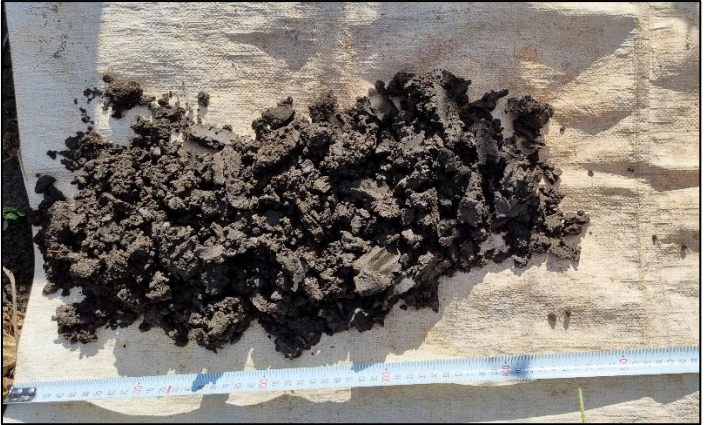
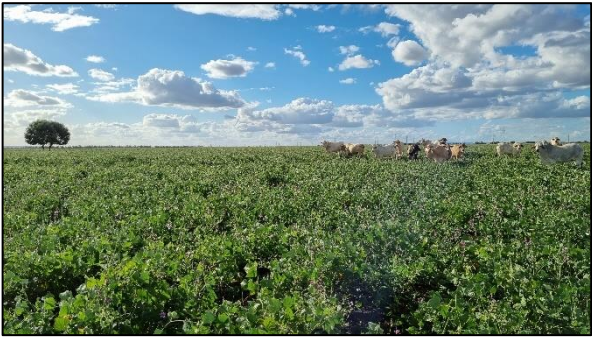
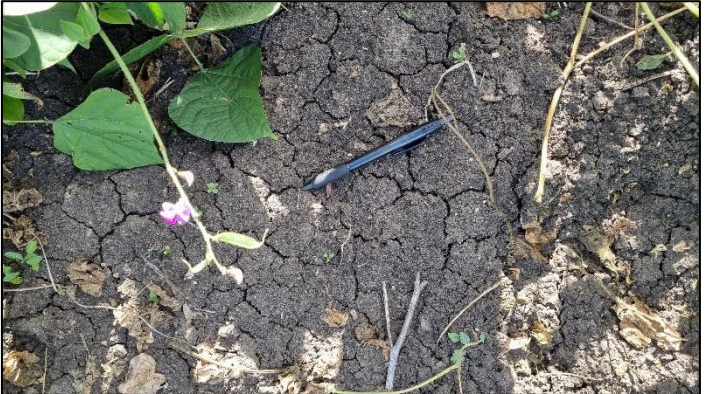
Site No.	Location - mE, mN (GDA94 Zone 55)	Map Unit	Comments	Pictures
NC-93	641880 7510362	13	<p>Gently undulating plain, mid slope 1%</p> <p>Nil microrelief, complete clearing, forage cropping</p> <p>Surface firm, nil coarse fragments</p> <ul style="list-style-type: none"> <li>• A1, 0.00-0.11m, Light clay, moderate, 10YR2/1 Black</li> <li>• B21, 0.11-0.40+m, Medium clay, moderate, 10YR2/1 Black</li> </ul>

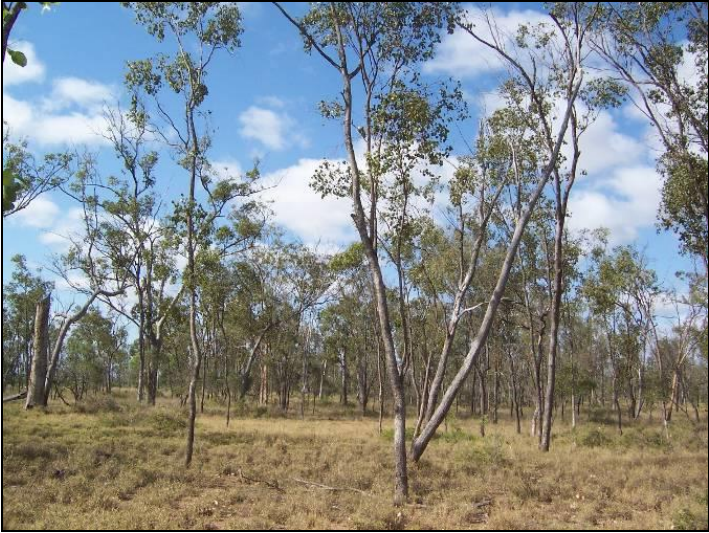
Item	Description
SMU	A1
Representative Site Number	Site 38
Representative Site photograph

Site survey type	Detailed. Hand auger.
Vegetation	Poplar box, moreton bay ash, areas of Brigalow mixed scrub
Location	639822E 7515013N
Disturbance	The area is semi-cleared woodland
Landform element /pattern	Low lying flat plain / alluvial plain
Micro relief	Nil
Permeability	Moderate to high
Slope (%)	<1.0
Drainage	Moderate
Surface coarse fragments	Nil
Surface condition	Cracking medium clay with some areas having a friable surface flake and some areas being weakly (finely) self-mulching. Surface is firm to hard setting
Substrate	Alluvium
ASC Order (s)	Red brown sodosol
Land suitability summary	<p><b>Estimated effective rooting depth:</b> 0.60-0.70 m</p> <p><b>Estimated soil water storage:</b> 50 mm</p> <p><b>Cropping suitability class:</b> 5</p> <p><b>Grazing suitability class:</b> 3</p> <p>Preferred Use: Light Grazing</p> <p><b>Agricultural Land Class:</b> <i>GTE assessment - C2</i></p>

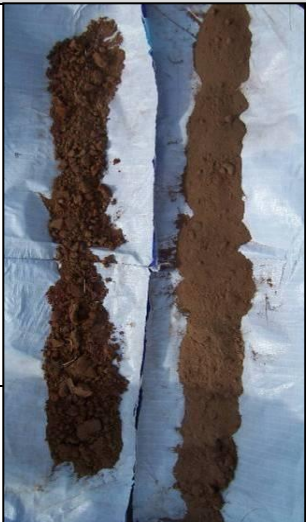
Site 38	Depth (cm)	Description	pH

0-40	Brown (7.5YR3/4), sandy loam, loose, massive structure, no crust, field pH 5.5, no inclusions, dry, clear boundary to;	5.5
	40-100	Reddish brown (5YR4/6), sandy clay, moderate to coarse angular blocky (5-10 mm), field pH 6.0, no inclusions, occasional orange mottles, moist. End of Borehole	6.0

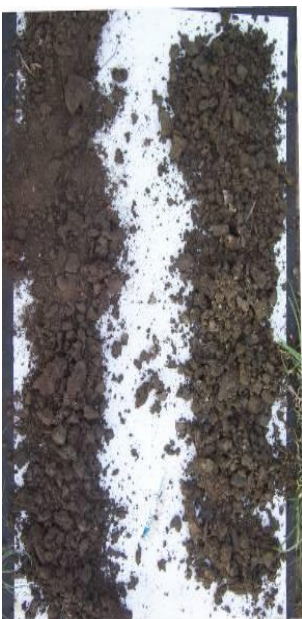
Site 10	Depth (cm)	Description	pH

0 – 2	A11, weak sandy crust, massive	7.0
	2 – 10	A12, dark greyish brown (10YR4/3), silty to sandy clay, strong sub-angular blocky (5-10 mm), no inclusions, moist, clear boundary change to;	7.5
	10-50	B21, very dark greyish brown (10YR3/1), medium heavy clay sandy, coarse and hard angular blocky (10-15 mm), field pH 8.0, moist, gradual boundary change to,	8.0
	50 – 90+	B22, greyish brown (10YR4/4), medium heavy clay, coarse angular blocky (10-15 mm), field pH 8.0, few mottles, dry. End of Borehole	8.0

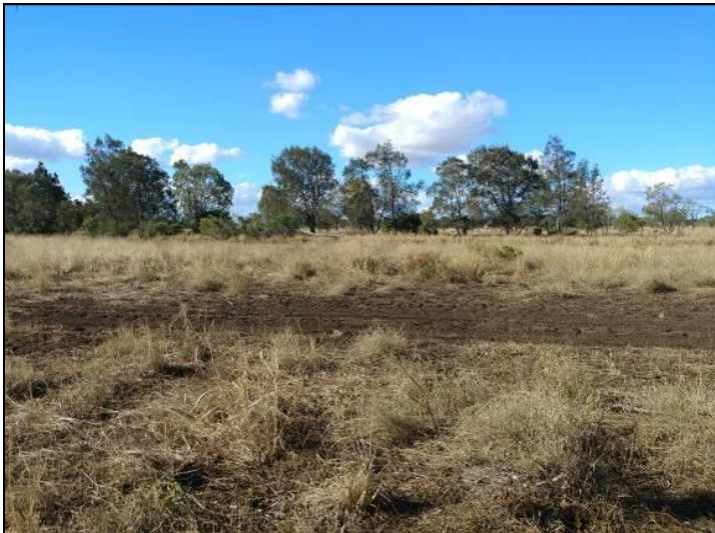
Item	Description
SMU	A2g
Representative Site	N1
Representative Site photograph

Location	641005mE 7512573mN
Current Use	Grazing
Site survey type	Detailed, 50 mm hand auger.
Vegetation	Mount coolabah, semi-cleared
Disturbance	Semi-cleared
Landform element / pattern	Very gently undulating plain / Open depression
Micro relief	Nil microrelief
Erosion	Nil erosion
Slope (%)	2.0/1.0
Drainage	Moderate
Surface coarse fragments	Nil coarse fragments
Surface condition	Firm <10mm peds, cracking 2-6mm, crust
ASC Order (s)	Crusting Grey Vertosol (minor sub-dominant black vertosol)
Land suitability summary	<b>Estimated effective rooting depth:</b> 1.00 m <b>Estimated soil water storage:</b> 120 mm <b>Regional Frameworks class:</b> 3 <b>Grazing suitability class:</b> 2 <b>Agricultural Land Class:</b> A1
Erosion potential	Low to moderate based on surface crusting attributes
Soil quality for mine rehabilitation	<u>Recommended topsoil strip depth:</u> 0.00-0.10 mbgl <u>Recommended topsoil use:</u> Suitable - Recommended for slope and level plain application. <u>Recommended subsoil strip depth:</u> 0.10-0.30 mbgl <u>Recommended subsoil use:</u> Subsoils may be marginal for use as supporting subsoils on level plains. Additional laboratory analysis for dispersive (ESP) attributes may allow soils to be used on slopes.

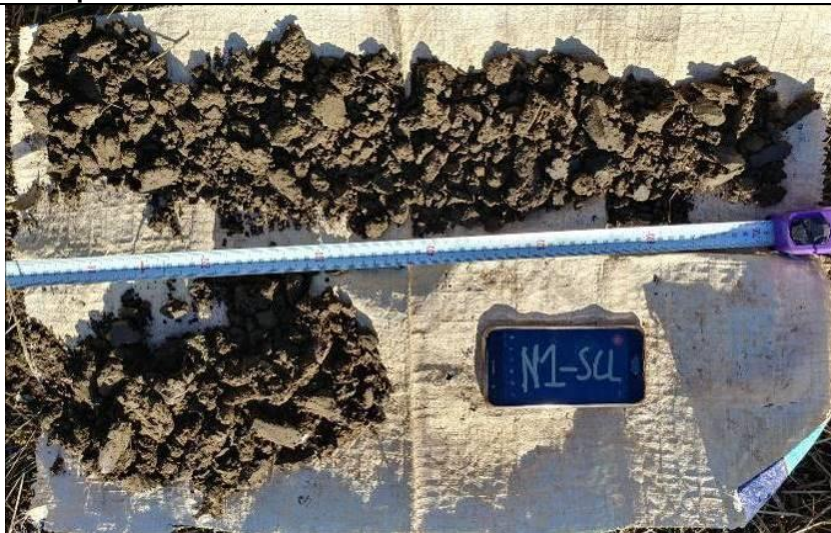
Site N1 (Previously N1-SCL as per photo)

Horizon Depth (m), Boundary (Bdy)	Field Texture	Structure Strength	Inclusions Segregations	Colour, Mottle, Bleaching	Moisture Drainage	Roots	Depth (m) / Field pH / EC dS/m	Samples (m)	Observations
	A11 0.00-0.02 Abrupt	Light clay	Moderate, firm <10m sub-angular	Nil inclusions and segregations	10YR3/1 Very dark grey Nil mottles Nil bleaching	Moderate moist, moderate	Few fine	0.02 / 6.5	0.00-0.10 0.20-0.30 0.50-0.60 0.80-0.90 0.09-1.00	Nil
	A12 0.02-0.10 Abrupt	Light clay	Moderate, firm 10-30mm sub-angular	<1% calcium carbonate	10YR2/2 Very dark brown Nil mottles Nil bleaching	Dry, moderate	Few fine	0.10 / 6.5		
	B21 0.10-0.70 Abrupt	Medium clay	Moderate, firm 10-30mm sub-angular	2% calcium carbonate nodules	10YR2/2 Very dark brown Nil mottles Nil bleaching	Dry, moderate	Very fine, very few	0.30 / 7.0 0.60 / 7.5		
B22 0.70-1.00 End of Borehole (EOBH)	Medium clay	Moderate, firm 10-30mm sub-angular	2% calcium carbonate nodules	10YR4/2 Dark greyish brown Nil mottles Nil bleaching	Dry, moderate	Very fine, very few	0.90 / 7.5

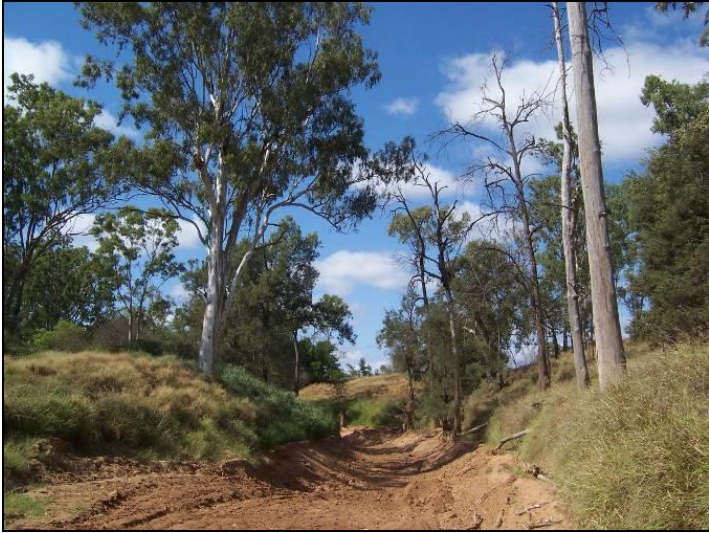
Item	Description
SMU	A3
Representative Site Number	Site 52
Representative Site photograph

Site survey type	Soil Pit
Vegetation	Blue gums, river oaks, poplar box and moreton bay ash
Location	641114E 7515890N
Disturbance	Open woodland
Landform element /pattern	Creek channel benches on drainage lines / alluvial plain
Micro relief	Nil
Permeability	High
Slope (%)	<0.5
Drainage	Slow
Surface coarse fragments	Nil
Surface condition	Loose, sandy
Substrate	Alluvium of sand, silt, clay and gravels
ASC Order (s)	Brown rudisol / tenosol
Land suitability summary	<p><b>Estimated effective rooting depth:</b> 0.70 m</p> <p><b>Estimated soil water storage:</b> 70 mm</p> <p><b>Cropping suitability class:</b> 5</p> <p><b>Grazing suitability class:</b> 3</p> <p>Preferred Use: Natural Areas – Light grazing</p> <p><b>Agricultural Land Class:</b> <i>GTE assessment - C3</i></p>
Erosion potential	<p>Laboratory results indicated;</p> <ul style="list-style-type: none"> <li>Calcium and magnesium ratio (as calculated using Burgess. (2003) SMU exchangeable cations, calcium and magnesium results of 2.3;</li> <li>ESP is low throughout.</li> </ul> <p><i>GTE assessment - Erosion potential through reviewing sodicity, soil texture and structure are considered</i></p>

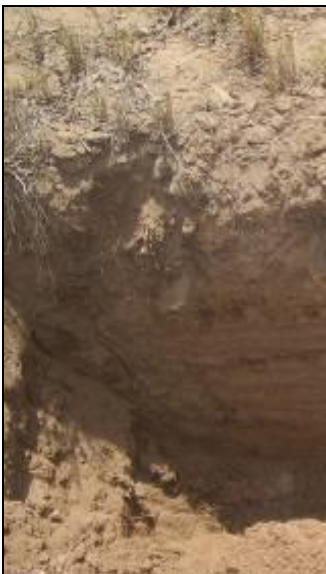
Site 52	Depth (cm)	Description	pH

0 – 50	A11, Brown (7.5YR4/4), silty loam, loose, weak/massive structure, well drained, no inclusions, dry, gradual boundary change to;	6.0
	50 – 120+	A12, Brown (7.5YR5/6), sandy clay, coarse angular blocky 10-15 mm), no inclusions. End of Borehole	7.0

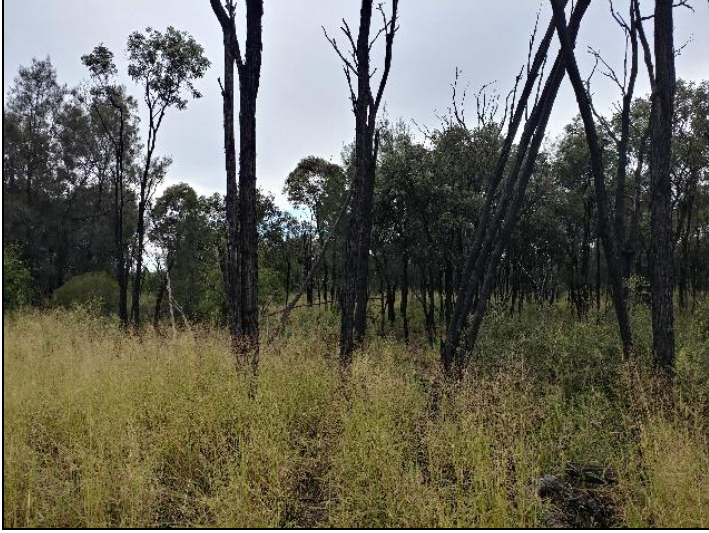
Item	Description
SMU	A4
Representative Site	N17
Representative Site photograph

Location	643797mE 7514822mN
Current Use	Grazing
Site survey type	Detailed, 50 mm hand auger.
Vegetation	Brigalow, Mount Coolibah
Disturbance	Nil disturbance
Landform element /pattern	Gently undulating plain, stream channel / depression
Micro relief	Nil microrelief
Erosion	Nil erosion
Slope (%)	<2% / <2%
Drainage	Well-moderate
Surface coarse fragments	No coarse fragments
Surface condition	Soft
ASC Order (s)	Black Dermosol
Land suitability summary	<b>Estimated effective rooting depth:</b> 0.60 m <b>Estimated soil water storage:</b> 49 mm <b>Regional Frameworks class:</b> 5 <b>Grazing suitability class:</b> 5 <b>Agricultural Land Class:</b> C3
Erosion potential	Laboratory results indicated. <ul style="list-style-type: none"> <li>ESP is low throughout</li> </ul> Erosion potential is assessed as low to moderate due to surface texture.

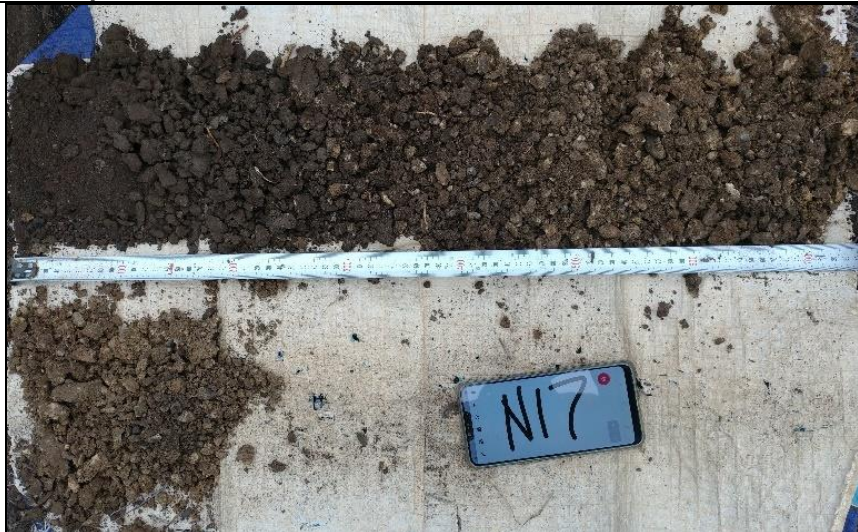
Site N17

Horizon Depth (m), Bound- ary (Bdy)	Field Texture	Structure Strength	Inclusions Segregati- ons	Colour, Mottle, Bleaching	Moisture Drainage	Roots	Depth (m) / Field pH / EC dS/m	Samples (m)
A1 0.00- 0.10 Abrupt	Loamy sand	Massive, loose	<1% coarse fragments	10YR3/1 Very dark grey Nil mottles / bleaching	Dry, well	Yes	0.10 / 8.5	0.00-0.10 0.20-0.30 0.50-0.60 0.80-0.90 0.9-1.00	Nil
B21 0.10- 0.20 Abrupt	Sandy loam	Moderate, very firm sub- angular <20mm	<1% coarse fragments	10YR3/1 Very dark grey Nil mottles / bleaching	Dry, well – moderate	Yes	0.20 / 8.5		
B21 0.20- 0.47 Abrupt	Sandy loam	Moderate, very firm sub- angular <10mm	<10% coarse fragments	10YR3/1 Very dark grey Nil mottles / bleaching	Dry, well – moderate	Yes	0.30 / 8.5		
B21 0.47- 0.88EOB H	Sandy loam	Moderate, very firm sub- angular <10mm	<20% coarse fragments	10YR4/2 Brown Nil mottles / bleaching	Dry, well – moderate	Yes – 0.60m bgl	0.60 / 8.5

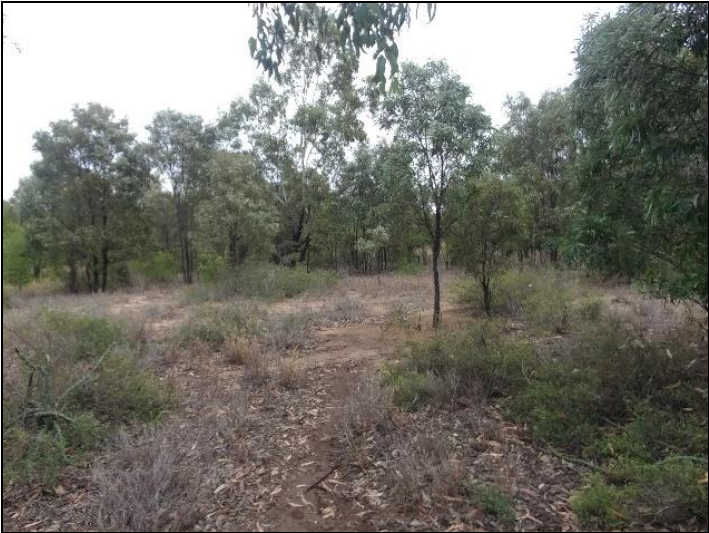
Item	Description
SMU	A4c
Representative Site	N20
Representative Site photograph

Location	642943mE 7513907mN
Current Use	Grazing
Site survey type	Detailed, 50 mm hand auger.
Vegetation	Brigalow
Disturbance	Nil disturbance, clearing nearby outside the immediate drainage line area
Landform element /pattern	Very gently undulating plain, Alluvial depression, stream channel
Micro relief	Nil microrelief
Erosion	Nearby sheet and gully erosion
Slope (%)	1.0 / 0.0
Drainage	Well to well and moderate
Surface coarse fragments	<10% <5mm
Surface condition	Firm, minor cracking
ASC Order (s)	Black Dermosol
Land suitability summary	<b>Estimated effective rooting depth:</b> 0.85 m <b>Estimated soil water storage:</b> 73 mm <b>Regional Frameworks class:</b> 5 <b>Grazing suitability class:</b> 4 <b>Agricultural Land Class:</b> C3
Erosion potential	Laboratory results indicated. <ul style="list-style-type: none"> <li>• ESP is low throughout</li> </ul> Erosion potential is assessed as low.

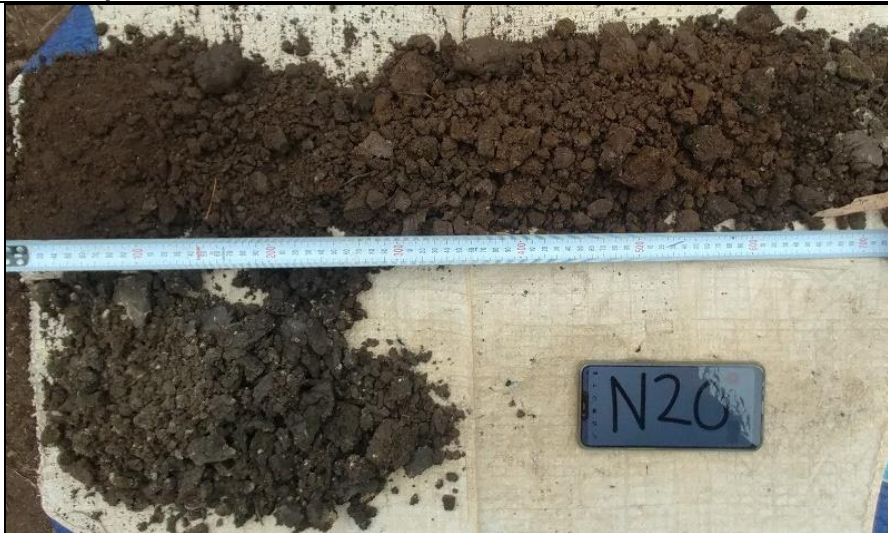
Site N20

**Table 39: Soil Profile Description for Site N20**

Horizon Depth (m), Bound- ary (Bdy)	Field Texture	Structure Strength	Inclusions Segregati- ons	Colour, Mottle, Bleaching	Moisture Drainage	Roots	Depth (m) / Field pH / EC dS/m	Samples (m)
A1 0.00- 0.12 Abrupt	Sandy loam	Weak to moderate, soft sub- rounded <10mm	Nil inclusions / segregation	10YR3/1 Very dark grey Nil mottles / bleaching	Dry, well	Yes	0.10 / 8.5	0.00-0.10 0.20-0.30 0.50-0.60 0.80-0.90 0.9-1.00	Nil
B21 0.12- 0.37 Abrupt	Sandy loam	Moderate, firm sub- rounded <10mm	Nil inclusions / segregation	10YR3/2 Very dark greyish brown Nil mottles / bleaching	Dry, well – moderate	Yes	0.20 / 8.5		
B22 0.37- 0.68 Abrupt	Sandy loam	Moderate, firm sub- rounded <20mm	<2% calcium carbonate	7.5YR3/2 Dark brown Nil mottle / bleaching	Dry, well – moderate	Yes	0.30 / 8.5		
B23 0.68- 0.85 Abrupt	Sandy clay loam	Moderate, very firm sub- rounded <20mm	<20% calcium carbonate	10YR3/2 Very dark greyish brown Nil mottles / bleaching	Dry, well – moderate to imperfect	Yes	-

B24 0.85- 1.00 EOBH	Sandy clay loam	Moderate, very firm sub- rounded <20mm	<5% calcium carbonate	10YR3/2 Very dark greyish brown Nil mottles / bleaching	Dry, well – moderate to imperfect	Nil	0.90 / 8.5

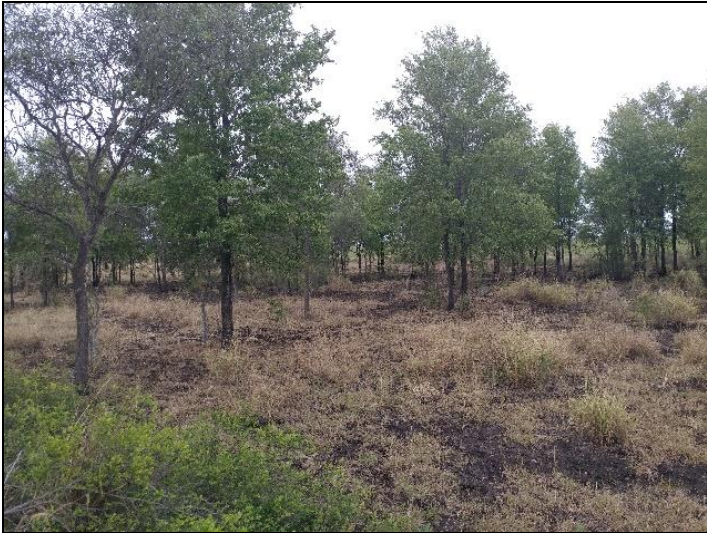
Item	Description
SMU	A5
Representative Site	N23
Representative Site photograph

Location	642838mE 7513991mN
Current Use	Grazing
Site survey type	Detailed - 50mm hand auger
Vegetation	Mixed vegetation
Disturbance	Cropping nearby disturbance
Landform element / pattern	Depression
Micro relief	Nil microrelief
Erosion	Minor sheet erosion
Slope (%)	<1% / <1%
Drainage	Well to well-moderate
Surface coarse fragments	Soft, <10% cf <5mm
Surface condition	Minor cracking
ASC Order (s)	Grey Dermosol
Land suitability summary	<b>Estimated effective rooting depth:</b> 1.00 m <b>Estimated soil water storage:</b> 90-100 mm <b>Regional Frameworks class:</b> 4 <b>Grazing suitability class:</b> 3 <b>Agricultural Land Class:</b> B
Erosion potential	Laboratory results indicated. <ul style="list-style-type: none"> <li>ESP is low throughout</li> </ul> Erosion potential is assessed as low.
Soil quality for mine rehabilitation	<u>Recommended topsoil strip depth:</u> 0.00-0.10 mbgl <u>Recommended topsoil use:</u> Suitable - Recommended for slope and level plain application. <u>Recommended subsoil strip depth:</u> 0.10-0.45 mbgl

Item	Description
	<u>Recommended subsoil use:</u> Suitable for support topsoil placement, slopes or level plains. Subsoils below 0.50 mbgl present strongly alkaline pH levels and force to disrupt peds greater than 3, suitable for capping waste rock.
<b>AASS/PASS Assessment</b>	<i>GTE Assessment - Very low field indication of PASS. Nil field indicators of AASS</i>
<b>Total area (ha)</b>	8

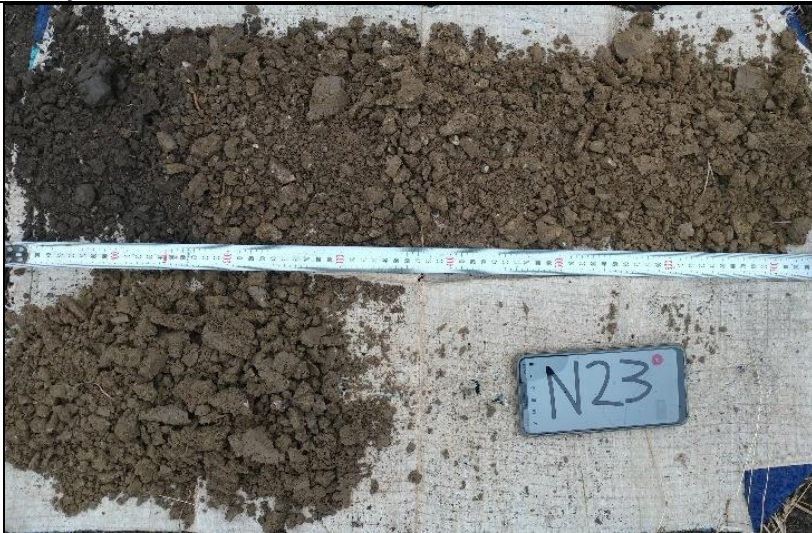
Site N23

**Table 41: Soil Profile Description for Site N23**

Horizon Depth (m), Bound- ary (Bdy)	Field Texture	Structure Strength	Inclusions Segregati- ons	Colour, Mottle, Bleaching	Moisture Drainage	Roots	Depth (m) / Field pH / EC dS/m	Samples (m)
A1 0.00- 0.12 Abrupt	Clay loam	Weak, soft sub- rounded <10mm	Nil inclusions / segregation s	10YR3/1 Very dark grey Nil mottles / bleaching	Dry, well	Prese nt	0.10 / 8.5	0.00-0.10 0.20-0.30 0.50-0.60 0.80-0.90 0.9-1.00	Nil
B21 0.12- 0.48 Abrupt	Light clay	Weak to moderate, firm sub- rounded <10mm	<5% weathered rock	10YR4/2 Dark greyish brown Nil mottles / bleaching	Dry, well – moderate	Prese nt	0.30 / 8.5		
B22 0.48- 1.00 EOBH	Light clay	Moderate, very firm sub- rounded <20mm	<5% calcium carbonate	10YR4/2 Dark greyish brown Nil mottles / bleaching	Dry, well – moderate	Prese nt	0.60 / 8.5 0.90 / 8.5

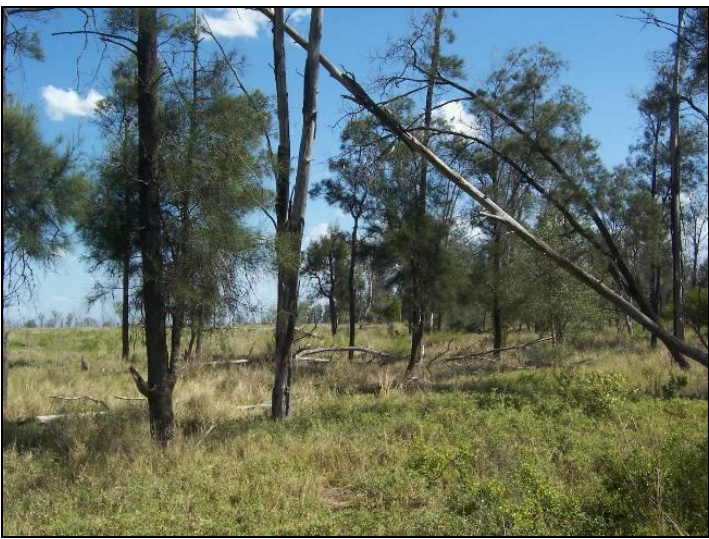
Item	Description
SMU	B1
Representative Site Number	Site 1
Representative Site photograph

Site survey type	Detailed. Hand auger.
Vegetation	Small remnant Brigalow and belah softwood scrub
Location	642377E 7508687N
Disturbance	Mostly cleared with areas of cropping
Landform element /pattern	Midslope, gently undulating plain
Micro relief	Nil
Permeability	Moderate
Slope (%)	1.0-2.0
Drainage	Moderate
Surface coarse fragments	Possibly few small rounded ironstone and carbonate nodules.
Surface condition	Cracking, strong fine self-mulching
Substrate	Mixed sediments
ASC Order (s)	Black vertosol
Land suitability summary	<p><b>Estimated effective rooting depth:</b> 1.00 m</p> <p><b>Estimated soil water storage:</b> 100 mm</p> <p><b>Cropping suitability class:</b> 2</p> <p><b>Grazing suitability class:</b> 1</p> <p>Preferred Use: Grazing with opportunistic cropping</p> <p><b>Agricultural Land Class:</b> <i>GTE assessment - A1</i></p> <p><i>Regional Frameworks: 3</i></p>

Erosion potential	<p>Laboratory results indicated;</p> <ul style="list-style-type: none"> <li>ESP is low in the upper subsoil layers and increases slowly down the profile becoming sodic below 0.5 mbgl.</li> </ul> <p><i>GTE assessment - Erosion potential for dispersion is assessed as low, increasing very slightly with depth.</i></p> <p><i>Appropriate management of bare earths must be considered when stockpiling and for reuse of this SMU</i></p>

Item	Description
	<i>for rehabilitation activities.</i>
<b>Soil quality for mine rehabilitation</b>	<p><u>Recommended topsoil strip depth:</u> 0.00-0.50 mbgl</p> <p><u>Recommended topsoil use:</u> Excellent quality topsoil which could be taken deeper than the 50 cm nominated depth (up to 90cm) or double stripped. The material is suitable for use on all rehabilitation areas and should ideally be placed to a depth of 20 cm or more.</p> <p><u>Recommended subsoil strip depth:</u> Nil</p> <p><u>Recommended subsoil use:</u> Further testing is recommended to check for saline and sodic subsoil, otherwise current laboratory results suggest a subsoil stripping depth may be taken to 0.90 mbgl.</p> <p><i>GTE recommendation – subsoils may be used as either additional topsoil reserves or as supporting buried subsoils for topsoil placement.</i></p>
<b>AASS/PASS Assessment</b>	<i>GTE Assessment - Very low field indication of PASS. Nil field indicators of AASS</i>

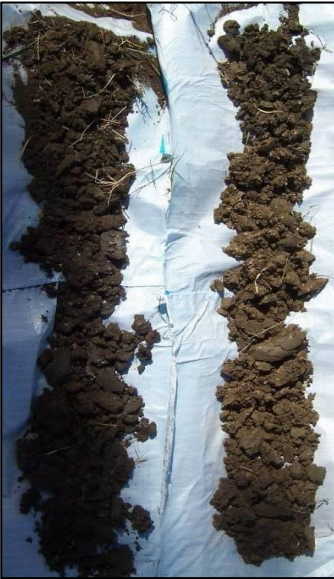
Site 1	Depth (cm)	Description	pH

**Table 43: Soil Profile Description**

0 – 5	A1, Brown (7.5YR4/2), light medium clay, <2 mm strong granular, no inclusions. clear boundary change to;	7.5
	5 – 40	B21, Dark brown (10YR3/2), medium clay, 3-5 mm strong angular blocky, field pH 7.5, no carbonate nodules, dry, clear boundary change to,	7.5
	40-100	B22, Dark brown (10YR3/2), medium heavy clay, 5-10 mm strong lenticular structure, field pH 8.0, some carbonate nodules, moist, gradual boundary change to,	8.0
	100 – 120+	B23, Greyish brown (10YR4/3), medium heavy clay, 10-15mm coarse angular blocky, field pH 8.5, increasing carbonate nodules. Moist. End of Borehole	8.5

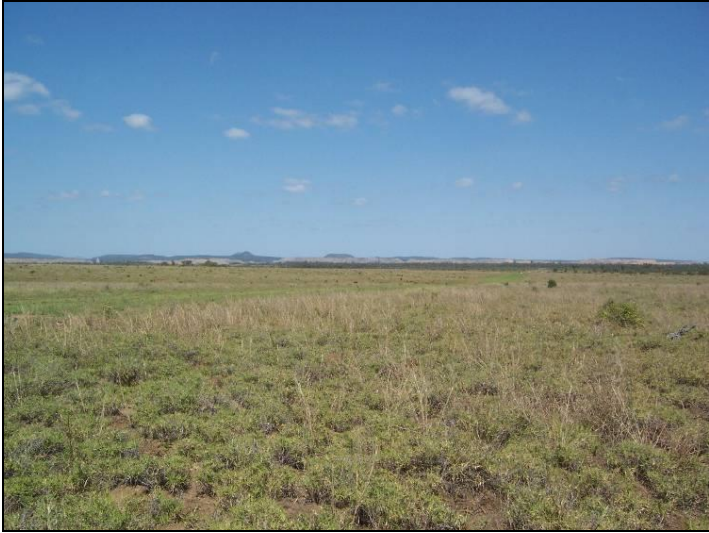
Item	Description
SMU	B2
Representative Site Number	Site 27
Representative Site photograph

Site survey type	Detailed. Hand auger.
Vegetation	Cleared Brigalow and Dawson Gum
Location	642384E 7514949N
Disturbance	The area has been cleared
Landform element /pattern	Upper midslope, undulating plain
Micro relief	Minor linear gilgai may be present, but none were observed in detailed or check
Permeability	Slow
Slope (%)	2.0
Drainage	Imperfect
Surface coarse fragments	Some rounded ironstone
Surface condition	Blade ploughed
Substrate	Unconsolidated calcareous Tertiary sediments
ASC Order (s)	Brown dermosol
Land suitability summary	<p><b>Estimated effective rooting depth:</b> 0.70 m</p> <p><b>Estimated soil water storage:</b> 070 mm</p> <p><b>Cropping suitability class:</b> 4</p> <p><b>Grazing suitability class:</b> 2</p> <p>Preferred Use: Grazing with opportunistic forage</p> <p><b>Agricultural Land Class:</b> <i>GTE assessment - C1</i></p>

Erosion potential	<p>Laboratory results indicated;</p> <ul style="list-style-type: none"> <li>ESP is low in the topsoil layers and increases slowly down the profile becoming sodic below 0.8 mbgl.</li> </ul> <p><i>GTE assessment - Erosion potential for dispersion is assessed as low, increasing very slightly with depth. Appropriate management of bare earths must be considered when stockpiling and for reuse of this SMU for rehabilitation activities.</i></p>

Item	Description
<b>Soil quality for mine rehabilitation</b>	<p><u>Recommended topsoil strip depth:</u> 0.00-0.30 mbgl</p> <p><u>Recommended topsoil use:</u> Topsoil should not be taken deeper than the 30 cm nominated depth as below this depth the subsoil is quite hard and coarse structured which would seal if placed on rehabilitation.</p> <p>The material is suitable for use on flatter rehabilitation areas as it tends to erode. It should ideally be placed to a depth of 20 cm or more</p> <p><u>Recommended subsoil strip depth:</u> Nil</p> <p><u>Recommended subsoil use:</u> Subsoils are not saline or sodic but are still not very good quality for reuse on rehabilitation.</p> <p><i>GTE recommendation – subsoils may be used as supporting buried subsoils for topsoil placement or capping for waste rock to a depth of 1.00 mbgl</i></p>
<b>AASS/PASS Assessment</b>	<i>GTE Assessment - Very low field indication of PASS. Nil field indicators of AASS</i>

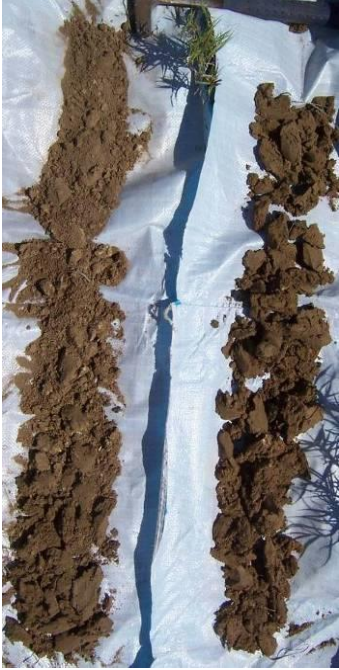
Site 27	Depth (cm)	Description	pH

**Table 45: Soil Profile Description**

0 – 20	AP, Yellowish brown (10YR6/4), weakly cracking fine sandy clay, 2mm weak blocky, field pH 6.5, no inclusions, dry, clear change to,	7.5
	20 – 40	B21, Yellowish brown (10YR6/4), medium clay - sandy, 5-10mm strong angular blocky, field pH 8.5, trace (5%) soft carbonate, moist, gradual change to,	7.5
	40-120	B22, Greyish brown (10YR5/4), medium heavy clay, 10-15mm coarse angular blocky, field pH 8.5, moderate calcareous concretions, moist.	8.0

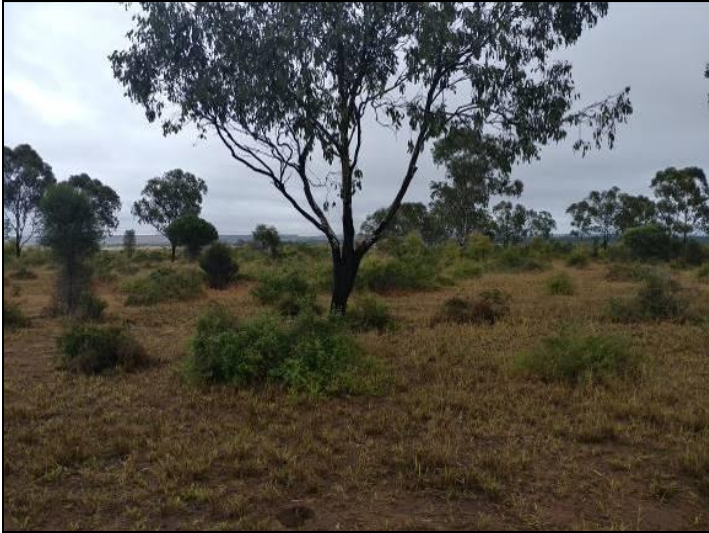
Item	Description
SMU	B2g
Representative Site	N4
Representative Site photograph

Location	641871mE 7513601mN
Current Use	Grazing
Site survey type	Detailed, 50 mm hand auger.
Vegetation	Eucalyptus species
Disturbance	Semi-disturbed
Landform element /pattern	Very gently undulating plain mid-slope
Micro relief	Nil microrelief
Erosion	Nil erosion
Slope (%)	2.0/1.0
Drainage	Imperfect
Surface coarse fragments	2-6mm coarse fragments
Surface condition	Soft
ASC Order (s)	Black chromosol (with minor grey chromosol variant, site N4)
Land suitability summary	<b>Estimated effective rooting depth:</b> 1.00 mbgl <b>Estimated soil water storage:</b> 90 mm <b>Regional Frameworks class:</b> 3 <b>Grazing suitability class:</b> 2 <b>Agricultural Land Class:</b> A1
Erosion potential	Laboratory results indicated. <ul style="list-style-type: none"> <li>ESP is low in the surface and upper subsoil layers and increases down the profile becoming sodic below 0.5mbgl.</li> </ul> Erosion potential is assessed as low to moderate due to sodic attributes increasing in subsoils.

Soil quality for mine rehabilitation	<u>Recommended topsoil strip depth:</u> 0.00-0.00 mbgl <u>Recommended topsoil use:</u> Not suitable due to texture grade of the surface. <u>Recommended subsoil strip depth:</u> Nil

Item	Description
	<p><u>Recommended subsoil use:</u> Subsoils, unlike topsoil have value in they are assessed as suitable in 0.20-0.30 mbgl; however, the sodic conditions beneath 0.30 mbgl suggests that stripping of this subsoil layer would be very difficult and risk contamination from the soil layers above and below.</p> <p>Therefore, soils for the profile are recommended for capping waste rock unless soil amelioration to reduce salt levels is applied.</p>
<b>AASS/PASS Assessment</b>	<i>GTE Assessment - Very low field indication of PASS. Nil field indicators of AASS</i>
<b>Total area (ha)</b>	18.3
