# Restoration Plan to Support RIDA Application Saraji East Project

Final V4  
15 July 2021

GT Environmental Pty Ltd  
[www.gtenvironmental.com.au](http://www.gtenvironmental.com.au)

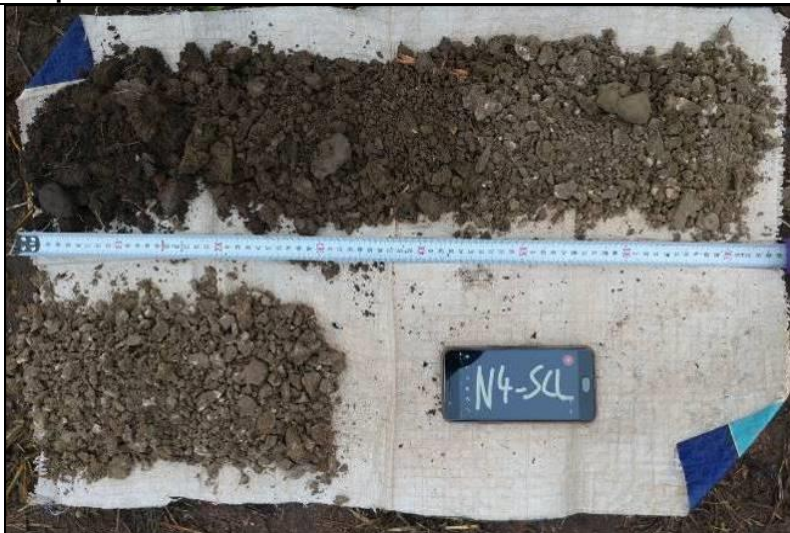
Site N4 (Previously N4-SCL as per photo)

**Table 47: Soil Profile Description for Site N4**

Horizon Depth (m), Boundary (Bdy)	Field Texture	Structure Strength	Inclusions Segregations	Colour, Mottle, Bleaching	Moisture Drainage	Roots	Depth (m) / Field pH / EC dS/m	Samples (m)	Observations
	A1 0.00-0.17 Abrupt	Sandy loam	Weak, soft <10mm sub-rounded	Nil inclusions and segregation s	10YR3/2 Very dark greyish brown Nil mottles/bleach	Moderate moist, rapid	Few fine	0.10 / 6.0	0.00-0.10 0.20-0.30 0.50-0.60 0.80-0.90 0.90-1.00	Nil
	B21 0.17-0.44 Abrupt	Light clay with minor sand	Moderate, firm <30mm sub-angular	<2% pale red nodules	10YR4/2 Dark greyish brown Nil mottles/bleach	Moderately moist, moderate	Very fine, very few	0.30 / 7.5		
	B22 0.44-1.00 EOBH	Medium clay	Moderate, firm <30mm sub-angular	10-15% calcium carbonate nodules	10YR5/3 Brown Nil mottles/bleach	Dry, moderate	Very fine, very few	0.60 / 7.5 0.90 / 7.5

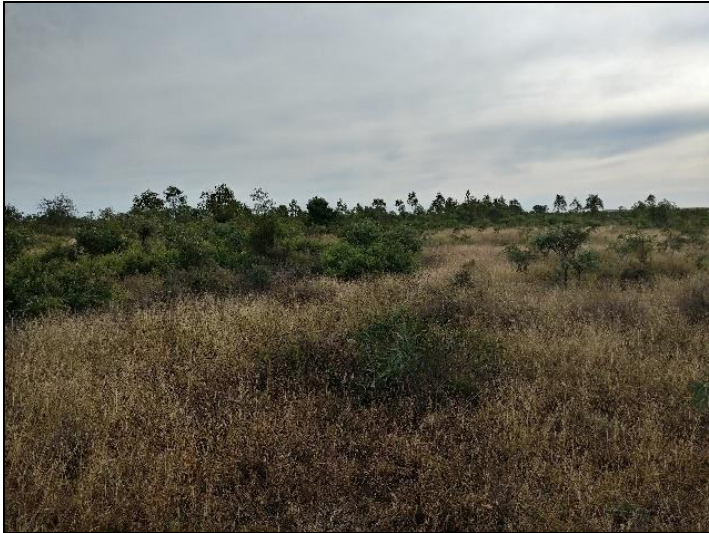
Item	Description
SMU	B2s
Representative Site	N13
Representative Site photograph

Location	640940mE 7512735mN
Current Use	Grazing
Site survey type	Detailed - 50mm hand auger
Vegetation	Grasses
Disturbance	Extensive disturbance
Landform element / pattern	Gently undulating plains, mid-slope
Micro relief	Nil microrelief
Erosion	Nil erosion
Slope (%)	<2.0/<2.0
Drainage	Moderate – well
Surface coarse fragments	Nil coarse fragments
Surface condition	Firm, cracking
ASC Order (s)	Black Chromosol
Land suitability summary	<b>Estimated effective rooting depth:</b> 1.00 m <b>Estimated soil water storage:</b> 1.00-1.10 mm <b>Regional Frameworks class:</b> 3 <b>Grazing suitability class:</b> 2 <b>Agricultural Land Class:</b> A1
Erosion potential	Laboratory results indicated. <ul style="list-style-type: none"> <li>ESP is low throughout</li> </ul> Erosion potential is assessed as low.
Soil quality for mine rehabilitation	<u>Recommended topsoil strip depth:</u> 0.00-0.15 mbgl <u>Recommended topsoil use:</u> Highly suitable - Recommended for slope and level plain application. <u>Recommended subsoil strip depth:</u> 0.15-0.60 mbgl <u>Recommended subsoil use:</u> Suitable for support topsoil placement, slopes or level plains.

Item	Description
	Subsoils below 0.60 mbgl present increase salt content levels which may be marginally unsuitable for supporting topsoils. Recommendation is suitable for capping waste rock unless soil amelioration to reduce salt levels is applied.
<b>AASS/PASS Assessment</b>	<i>GTE Assessment - Very low field indication of PASS. Nil field indicators of AASS</i>
<b>Total area (ha)</b>	108

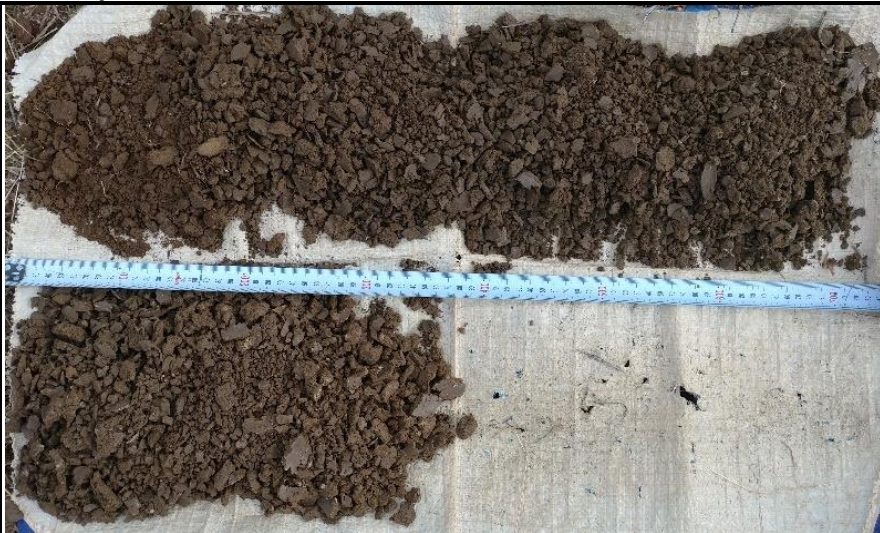
Site N13

**Table 49: Soil Profile Description for N13**

Horizon Depth (m), Bound- ary (Bdy)	Field Texture	Structure Strength	Inclusions Segregati- ons	Colour, Mottle, Bleaching	Moisture Drainage	Roots	Depth (m) / Field pH / EC dS/m	Samples (m)
A1 0.00- 0.15 Abrupt	Sandy clay loam	Weak to moderate. Soft, sub rounded <10mm	Nil	10YR3/2 Very dark greyish brown Nil mottles/ bleaching	Dry, well	Presen t	0.10 / 7.0	0.00-0.10 0.20-0.30 0.50-0.60 0.80-0.90 0.9-1.00	Nil
B21 0.15- 0.75 gradual	Light clay	Weak to moderate. Firm, sub rounded <20mm	Nil	10YR3/2 Very dark greyish brown Nil mottles/ bleaching	Dry, moderate – well	Presen t	0.30 / 7.5 0.60 / 7.5		
B22 0.75- 1.00 EOBH	Light clay	Weak to moderate. Firm, sub rounded <20mm	Nil	10YR3/2 Very dark greyish brown Nil mottles/ bleaching	Dry, moderate – well	Presen t	0.90 / 7.5

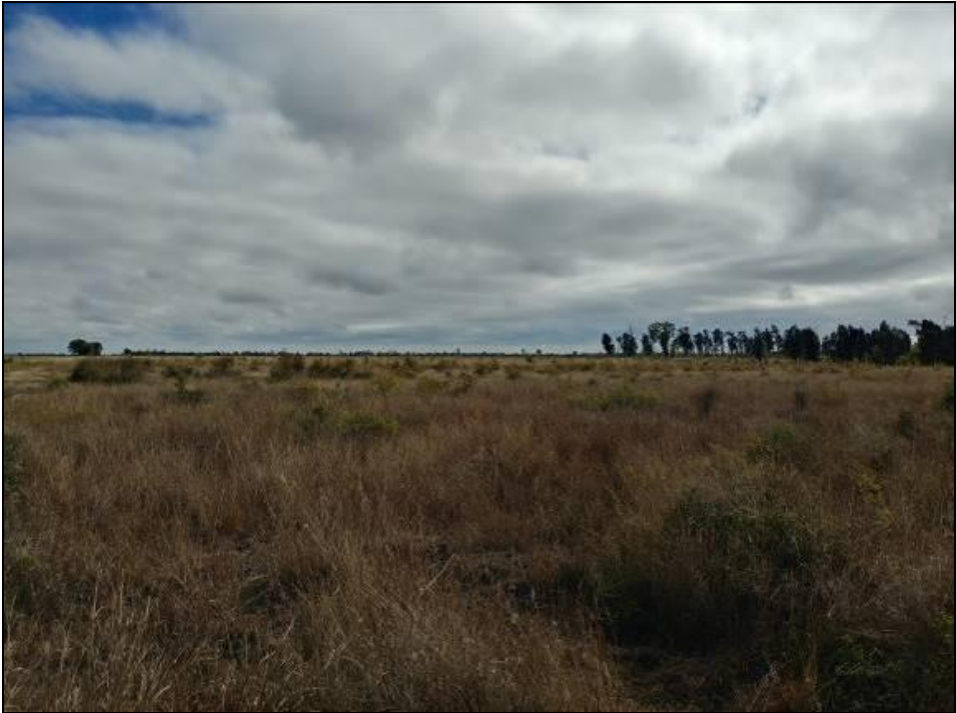
Item	Description
SMU	B2bl
Representative Site	91-SCL
Representative Site photograph

Location	643899mE 7510777mN
Current Use	Grazing
Site survey type	Detailed - 50mm hand auger
Vegetation	Cleared, nearby remnant Belah
Disturbance	Extensive disturbance
Landform element /pattern	Very gently undulating plain, mid-slope
Micro relief	Nil microrelief
Erosion	Nil erosion
Slope (%)	2.0/1.0
Drainage	Moderate
Surface coarse fragments	Nil coarse fragments
Surface condition	Minor cracking, firm
ASC Order (s)	Black Dermosol
Land suitability summary	<b>Estimated effective rooting depth:</b> 1.00 mbgl <b>Estimated soil water storage:</b> 70-90 mm <b>Regional Frameworks class:</b> 4 <b>Grazing suitability class:</b> 3 <b>Agricultural Land Class:</b> B
Erosion potential	Laboratory results indicated. <ul style="list-style-type: none"> <li>ESP is low throughout with other SMU sites</li> </ul>

Item	Description
	Erosion potential is assessed as low.
<b>Soil quality for mine rehabilitation</b>	<p><u>Recommended topsoil strip depth:</u> 0.00-0.10 mbgl</p> <p><u>Recommended topsoil use:</u> Suitable - Recommended for slope and level plain application.</p> <p><u>Recommended subsoil strip depth:</u> 0.10-0.80 mbgl</p> <p><u>Recommended subsoil use:</u> Suitable for support topsoil placement, slopes or level plains. Subsoils below 0.80 mbgl present increase salt content levels which may be marginally unsuitable for supporting topsoils. Recommendation is suitable for capping waste rock unless soil amelioration to reduce salt levels is applied.</p>
<b>AASS/PASS Assessment</b>	<i>GTE Assessment - Very low field indication of PASS. Nil field indicators of AASS</i>
<b>Total area (ha)</b>	470.4

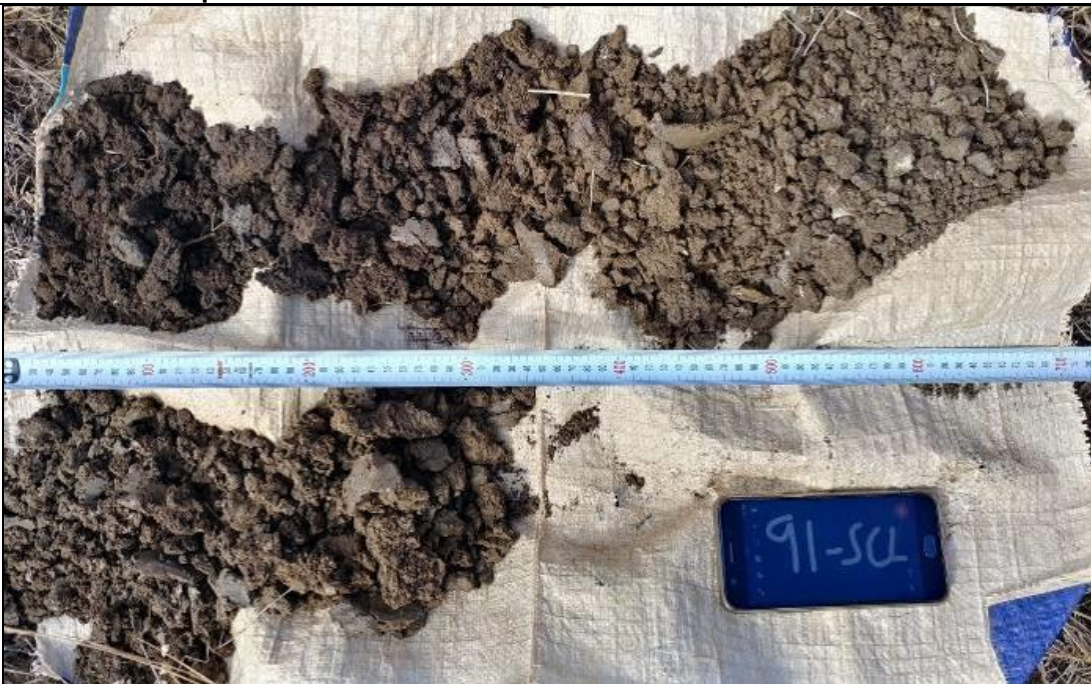
Site 91-SCL

**Table 51: Soil Profile Description for Site 91-SCL**

Horizon Depth (m), Bound- ary (Bdy)	Field Texture	Structure Strength	Inclusions Segregati- ons	Colour, Mottle, Bleaching	Moisture Drainage	Roots	Depth (m) / Field pH / EC dS/m	Samples (m)
A1 0.00- 0.12 Abrupt	Sandy Clay	Moderate, weak <20mm sub- angular	Nil inclusions and segregation s	10YR2/1 Black Nil mottles /bleach	Dry, moderate	Few, fine	0.10 / 6.0	0.00-0.10 0.20-0.30 0.50-0.60 0.80-0.90 0.9-1.00	Nil
B21 0.12- 0.50 Clear	Light sandy clay	Moderate, firm 20- 50mm sub- angular	Nil inclusions and segregation s	10YR2/2 Very dark brown Nil mottles/ bleach	Dry, moderate	Few, fine	0.30 / 6.5		
B22 0.50- 1.00 EOBH	Light clay	Moderate, firm 20- 50mm sub- angular blocky	<2% calcium carbonate nodules	10YR3/3 Dark brown Mottles <2% 10YR5/3 Brown Nil bleach	Dry, moderate	Very few, very fine	0.60 / 7.0 0.60 / 7.5

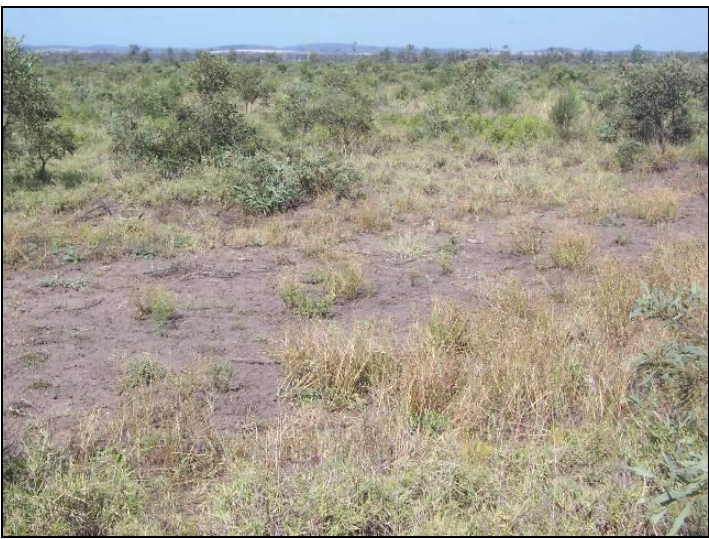
Item	Description
SMU	B3
Representative Site Number	Site 222 (mound) / 223 (depression)
Representative Site photograph

Site survey type	Detailed. Hand auger.
Vegetation	Brigalow regrowth / bare
Location	640300E 7520760N / 640300E 7520760N
Disturbance	The area has been cleared
Landform element /pattern	Relic alluvial plain
Micro relief	Inter-gilgai positions of gilgaied landform
Permeability	Very slow
Slope (%)	<0.5
Drainage	Poor
Surface coarse fragments	5-10% mixed gravels with ironstone / Some mixed gravels with ironstone and quartz
Surface condition	Firm sandy. Non-cracking Crusting and cracking
Substrate	Unconsolidated calcareous mixed sediments
ASC Order (s)	Brown dermosol
Land suitability summary	<b>Estimated effective rooting depth:</b> 0.70 m (mound) 0.40 m (depression) <b>Estimated soil water storage:</b> 85 mm (mound), 50 mm (depression) <b>Cropping suitability class:</b> 4 <b>Grazing suitability class:</b> 2 Preferred Use: Grazing with opportunistic forage <b>Agricultural Land Class:</b> <i>GTE assessment - C1</i>

Erosion potential	Laboratory results indicated; <ul style="list-style-type: none"> <li>ESP is low in the topsoil layers and increases significantly down the profile becoming sodic below 0.1 mbgl.</li> </ul> <i>GTE assessment - Erosion potential for dispersion is assessed as low, increasing significantly with depth. Appropriate management of bare earths must be considered when stockpiling, specifically subsoils and</i>

Item	Description
	<i>for reuse of this SMU for rehabilitation activities.</i>
<b>Soil quality for mine rehabilitation</b>	<p><u>Recommended topsoil strip depth:</u> 0.00-0.30 mbgl</p> <p><u>Recommended topsoil use:</u> These soils are traditionally variable in quality – particularly between mounds and depression positions. The mounds are better quality than many other melon hole situations and are not excessively saline or sodic above about 50 cm depth. Nevertheless, topsoil should not be taken deeper than the 30 cm because of the risk of contamination from saline subsoil. The material is suitable for use on flatter rehabilitation areas as it tends to erode. It should ideally be placed to a depth of 20 cm or more</p> <p><u>Recommended subsoil strip depth:</u> Nil</p> <p><u>Recommended subsoil use:</u> Nil, no stripping recommendations for subsoils provided.</p> <p><i>GTE recommendation – reuse as capping for waste rock due to saline and dispersive attributes to a depth of 0.90 mbgl</i></p>

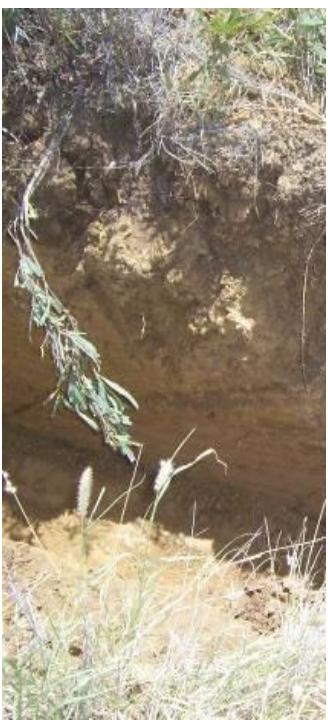
Site 222	Depth (cm)	Description	pH

**Table 53: Soil Profile Description - Mound**

0 – 5	A1, Brown (10YR4/4), Sandy clay, weak sub-angular blocky, field pH 7.0, no inclusions, dry, clear change boundary to,	7.0
	5 – 40	B21, Brown (10YR4/3), medium clay, 5-10 mm strong angular blocky, trace soft carbonate, moist, clear change boundary to,	8.5
	40-100	B22, Greyish brown (10YR5/4), medium heavy clay, 10-15 mm coarse angular blocky, moderate calcareous concretions, moist. End of borehole.	8.5

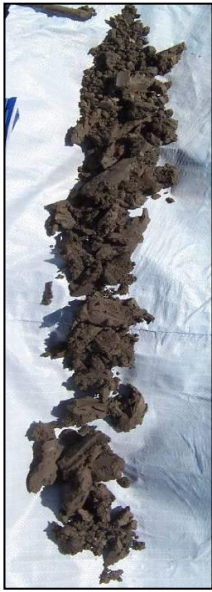
Site 223	Depth (cm)	Description	pH

**Table 54: Soil Profile Description – Depression**

0 – 4	A1, Dark brown (10YR3/2), fine sandy clay, <2 mm weak blocky, occasional (<2%) carbonate nodules, dry, clear boundary change to	8.0
	4 – 40	B21, Dark brown (10YR3/1), sandy medium clay, 5-10 mm strong sub-angular blocky / lenticular, trace soft carbonate, moist, clear boundary change to,	8.5
	40-100	B22, Greyish brown (10YR4/4), medium heavy clay, 10-20 mm coarse sub-angular blocky, moderate (5-10%) calcareous concretions, moist, End of borehole.	8.5

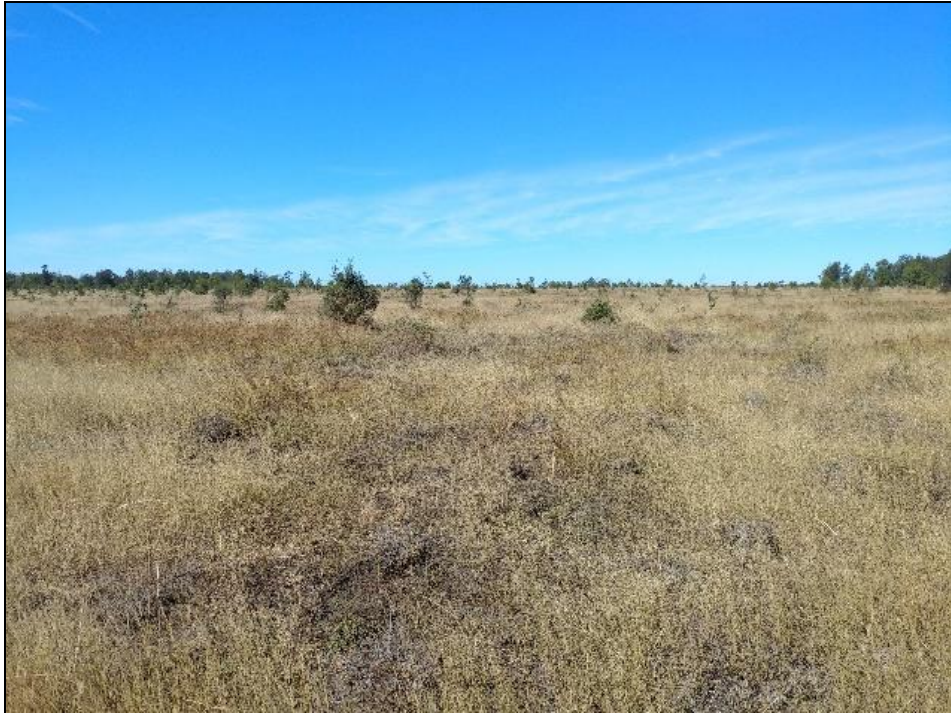
Item	Description
SMU	B3bl
Representative Site	5-SCL-M (Mound)
Representative Site photograph

Location	641663mE 7508746mN
Current Use	Grazing
Site survey type	Detailed - 50mm hand auger
Vegetation	Grasses
Disturbance	Extensively disturbed
Landform element / pattern	Gently undulating plain, mid-slope
Micro relief	Gilgai microrelief present 40% coverage
Erosion	Nil erosion
Slope (%)	2% / 1%
Drainage	Well to moderately drained
Surface coarse fragments	Nil coarse fragments
Surface condition	Self-mulching, minor crust, cracking 2-6+mm
ASC Order (s)	Black Vertosol
Land suitability summary	<b>Estimated effective rooting depth:</b> 1.00 m <b>Estimated soil water storage:</b> 100 – 120 mm <b>Regional Frameworks class:</b> 4 <b>Grazing suitability class:</b> 3 <b>Agricultural Land Class:</b> B
Erosion potential	Low to moderate based on surface crusting attributes

Item	Description
<b>Soil quality for mine rehabilitation</b>	<u>Recommended topsoil strip depth:</u> 0.00-0.10 mbgl <u>Recommended topsoil use:</u> Highly suitable - Recommended for slope and level plain application. <u>Recommended subsoil strip depth:</u> 0.10-1.00 mbgl <u>Recommended subsoil use:</u> Subsoils may suitable for use as supporting subsoils on level plains. Additional laboratory analysis for dispersive (ESP) attributes may allow soils to be used on slopes.
<b>AASS/PASS Assessment</b>	<i>GTE Assessment - Very low field indication of PASS. Nil field indicators of AASS</i>
<b>Total area (ha)</b>	466

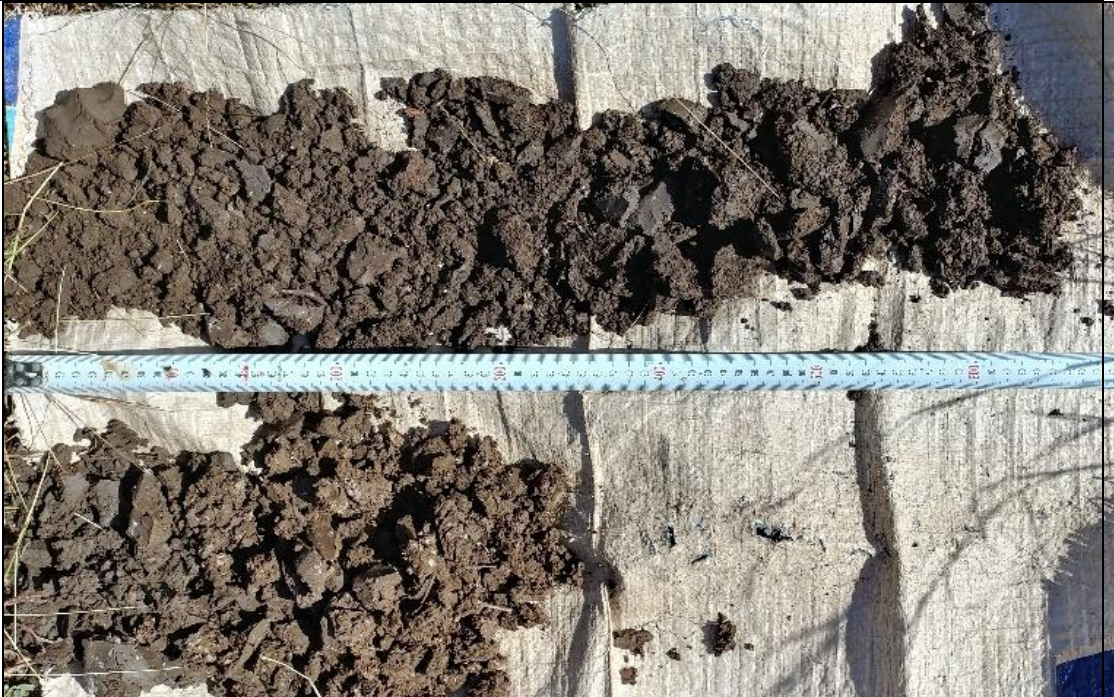
Site 5-SCL- M

**Table 56: Soil Profile Description for Site 5-SCL(Mound)**

Horizon Depth (m), Bound- ary (Bdy)	Field Texture	Structure Strength	Inclusions Segregati- ons	Colour, Mottle, Bleaching	Moisture Drainage	Roots	Depth (m) / Field pH / EC dS/m	Samples (m)	Observa- tions
A1 0.00- 0.12 Abrupt	Light clay	Moderate, soft <20mm sub- angular	Nil inclusions and segregation	10YR2/1 Black Nil mottles / bleaching	Humid, Well drained	Com mon, medi- um	0.10 / 6.5	0.00-0.10 0.20-0.30 0.50-0.60 0.80-0.90 0.9-1.00	Nil
B21 0.12- 0.60 Abrupt	Medium heavy clay	Moderate, Firm <30mm sub- angular	Nil inclusions and segregation	10YR2/2 Very dark brown Nil mottles / bleaching	Humid, Well drained	Few, medi- um	0.30 / 7.0		
B22 0.60- 1.00	Medium heavy clay	Moderate, Firm <30mm subangular	<2% Calcium carbonate	10YR3/3 Dark brown Mottles: <2% 10YR5/3 Brown Nil bleach	Humid, Well - moderate drained	Few, fine	0.10 / 7.0

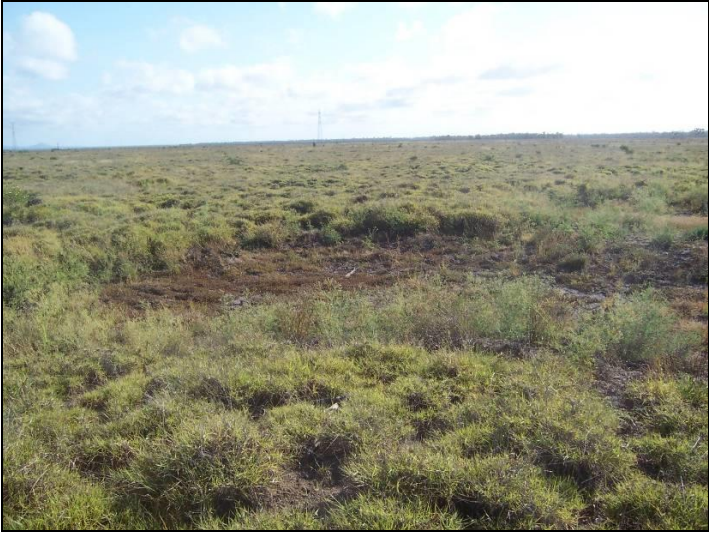
Item	Description
SMU	B4
Representative Site Number	Site 118 (mound) / 117 (depression)
Representative Site photograph

Site survey type	Detailed. Hand auger.
Vegetation	Cleared
Location	638593E 7516484N / 638626E 7516181N
Disturbance	Cleared
Landform element /pattern	Relic alluvial plain
Micro relief	Melan holes up to 90 cm deep.
Permeability	Very slow
Slope (%)	<0.5
Drainage	Poor
Surface coarse fragments	Minor gravels, some mixed gravels with ironstone and quartz
Surface condition	Firm, non-cracking
Substrate	Mixed sediments
ASC Order (s)	Black vertosol
Land suitability summary	<p><b>Estimated effective rooting depth:</b> 0.20 m (mound) 0.40 m (depression)</p> <p><b>Estimated soil water storage:</b> 20 mm (mound), 40mm (depression)</p> <p><b>Cropping suitability class:</b> 5</p> <p><b>Grazing suitability class:</b> 3/4</p> <p>Preferred Use: Grazing</p> <p><b>Agricultural Land Class:</b> <i>GTE assessment - C2</i></p>

Erosion potential	<p>Laboratory results indicated;</p> <ul style="list-style-type: none"> <li>ESP is in strongly sodic in the topsoil layers and decreases with depth in the mound profile becoming sodic below 0.3 m. ESP is non-sodic in topsoil and increases to moderate with depth in the depression profile becoming sodic below 0.2 m.</li> </ul> <p><i>GTE assessment - Erosion potential for dispersion is assessed as moderate. Appropriate management of bare earths must be considered when stockpiling and for reuse of this SMU for rehabilitation activities.</i></p>

Item	Description
<b>Soil quality for mine rehabilitation</b>	<p><u>Recommended topsoil strip depth:</u> 0.00-0.20 mbgl (mound) and 0.00 mbgl (depression)</p> <p><u>Recommended topsoil use:</u> Melon hole soils often vary considerably between mounds and depression positions. The flat areas between depressions (mounds) offer rehabilitation potential however the dark crusting clay depressions should be avoided.</p> <p>It is important that stripping does not go too deep as useable topsoil will be contaminated. The material is preferred on flatter rehabilitation areas and should ideally be placed to a depth of 20 cm or more.</p> <p><u>Recommended subsoil strip depth:</u> Nil</p> <p><u>Recommended subsoil use:</u> Nil, no stripping recommendations for subsoils provided.</p> <p><i>GTE recommendation – potential reuse as capping for waste rock due to saline and dispersive attributes to a depth of 0.90 mbgl</i></p>

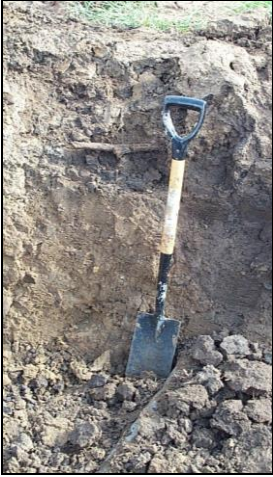
Site 118	Depth (cm)	Description	pH

0 – 20	A1, Brown (10YR5/3), fine sandy clay, 2 mm granular, no inclusions, dry, clear boundary change to,	6.5
	20 – 50	B21, Dark brown (10YR3/2), medium clay- sandy, 5-10 mm strong angular blocky, moist, clear boundary change to,	7.5
	50-100	B22, Yellowish brown (10YR5/4), medium heavy clay, 10-20 mm very coarse angular blocky, moderate calcareous concretions, moist. End of borehole.	8.5

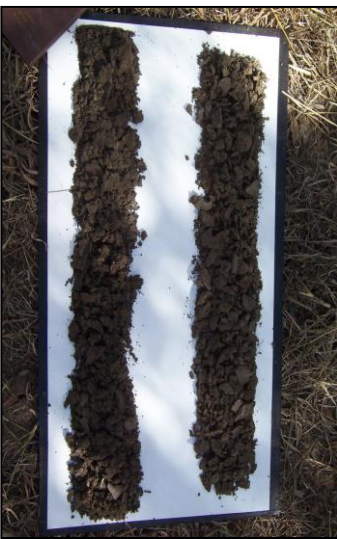
Site 223	Depth (cm)	Description	pH

0 – 3	A1, Dark Brown (10YR3/2), fine sandy clay, 2-4 mm granular, field pH 6.5, no inclusions, dry, Cracking with weak sandy crust. medium heavy clay, granular, 10YR3/2 clear boundary change to,	8.0
	3 – 40	B21, Dark (10YR3/1), medium clay, 5 mm strong angular blocky, no inclusions, moist, clear boundary change to,	8.5
	40-100	B22, Yellowish brown (10YR5/4), medium heavy clay, very coarse angular blocky, 5% orange mottles. End of borehole.	8.5

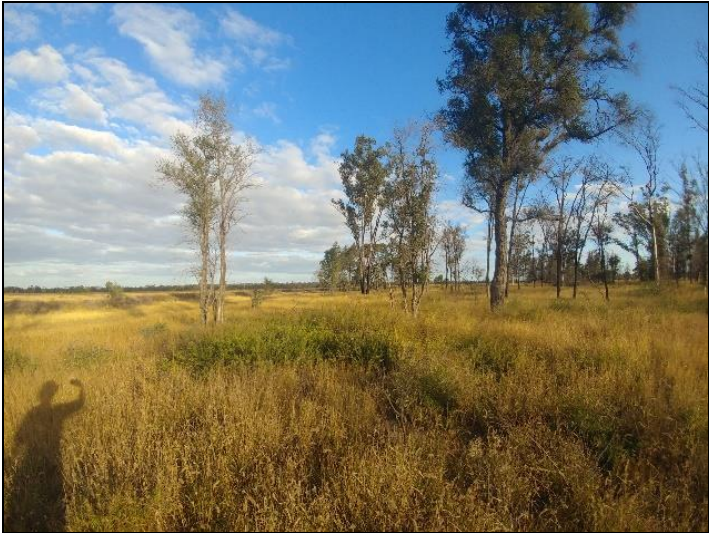
Item	Description
SMU	B5
Representative Site	N43
Representative Site photograph

Location	643716mE 7513193mN
Current Use	Grazing
Site survey type	Detailed - 50mm hand auger
Vegetation	Eucalyptus species
Disturbance	Semi disturbed,
Landform element /pattern	Gently Undulating Plains, Upper slope
Micro relief	Nil microrelief
Erosion	Nil erosion
Slope (%)	<2 / <2
Drainage	Well to well-moderate
Surface coarse fragments	Nil coarse fragments
Surface condition	Firm, minor cracking
ASC Order (s)	Black Dermosol
Land suitability summary	<b>Estimated effective rooting depth:</b> 1.00 m <b>Estimated soil water storage:</b> 90 - 110 mm <b>Regional Frameworks class:</b> 5 <b>Grazing suitability class:</b> 3 <b>Agricultural Land Class:</b> C1
Erosion potential	Laboratory results indicated. <ul style="list-style-type: none"> <li>ESP is low throughout</li> </ul> Erosion potential is assessed as low.
Soil quality for mine rehabilitation	<u>Recommended topsoil strip depth:</u> Nil <u>Recommended topsoil use:</u> Not suitable due to structure grade (Massive). Soil amelioration and mixing of other suitable topsoils may improve soils to 0.00-0.20 mbgl <u>Recommended subsoil strip depth:</u> 0.20-0.60 mbgl

Item	Description
	<b>Recommended subsoil use:</b> Subsoils, unlike topsoil have value in they are assessed as suitable in 0.20-0.60 mbgl; suitable for support topsoil placement, slopes or level plains. Subsoils below 0.60 mbgl present increase salt content levels which may be marginally unsuitable for supporting topsoils. Recommendation is suitable for capping waste rock unless soil amelioration to reduce salt levels is applied.
<b>AASS/PASS Assessment</b>	<i>GTE Assessment - Very low field indication of PASS. Nil field indicators of AASS</i>
<b>Total area (ha)</b>	32.9

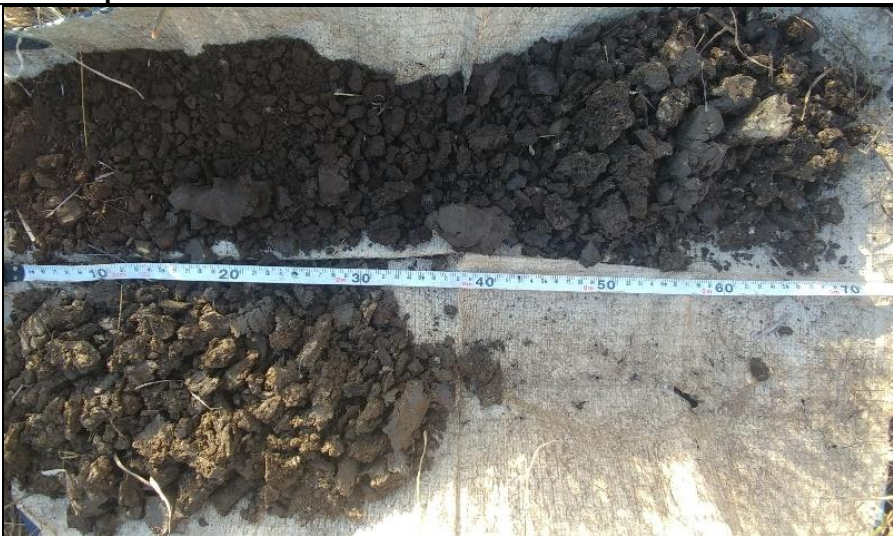
Site N43

Horizon Depth (m), Bound- ary (Bdy)	Field Texture	Structure Strength	Inclusions Segregati- ons	Colour, Mottle, Bleaching	Moisture Drainage	Roots	Depth (m) / Field pH / EC dS/m	Samples (m)	Observa- tions
A11 0.0 – 0.06 Abrupt	Sandy clay loam	Massive	Nil inclusions or segregation s	10YR3/2 Very dark greyish brown Nil mottles / bleaching	Dry, well drained	Presen t	0.10 / 7.5	0.00-0.10 0.20-0.30 0.50-0.60 0.80-0.90 0.9-1.00	Nil
A12 0.06 – 0.20 Gradual	Sandy clay loam	Weak, sub- rounded peds <10 mm	Nil inclusions or segregation s	10YR3/2 Very dark greyish brown Nil mottles / bleaching	Dry, well drained	Presen t	0.20 / 7.5		
B21 0.20 – 0.46 Gradual	Sandy clay loam	Subangula r blocky, moderate, peds <20 mm, firm	Nil inclusions or segregation s	10YR3/2 Very dark greyish brown Nil mottles / bleaching	Dry, well drained	Presen t	0.30 / 7.5		
B22 0.46 – 1.00 EOBH	Medium clay, sandy	Subangula r blocky, moderate, peds <20 mm, firm	<20% calcium carbonate	10YR3/3 Dark reddish brown Nil mottles / bleaching	Dry, well – moderate drained	Presen t	0.60 / 7.5 0.90 / 7.5

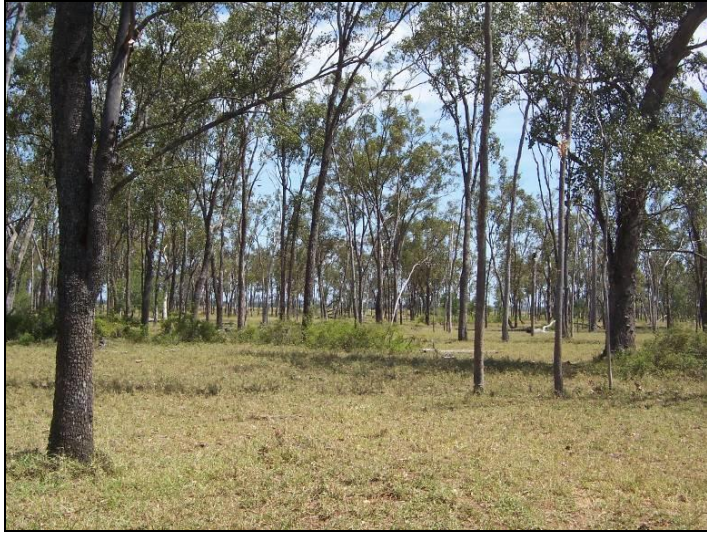
Item	Description
SMU	E1
Representative Site Number	Site 173
Representative Site photograph

Site survey type	Detailed. Hand auger.
Vegetation	Poplar box, silver leaf ironbark, bloodwood and moreton bay ash
Location	636794E 7521234N
Disturbance	Open woodland
Landform element /pattern	Relic alluvial plain
Micro relief	Nil
Permeability	High
Slope (%)	<1.0
Drainage	Rapid
Surface coarse fragments	No coarse fragments reported
Surface condition	Loose, sandy
Substrate	Alluvium
ASC Order (s)	Yellow Chromosol
Land suitability summary	<p><b>Estimated effective rooting depth:</b> 1.20+ m</p> <p><b>Estimated soil water storage:</b> 60 mm</p> <p><b>Cropping suitability class:</b> 5</p> <p><b>Grazing suitability class:</b> 3</p> <p>Preferred use: opportunistic cropping and grazing</p> <p><b>Agricultural Land Class:</b> <i>GTE assessment - C2</i></p>
Erosion potential	<p>Laboratory results indicated;</p> <ul style="list-style-type: none"> <li>ESP is sodic in the topsoil and decreases with depth profile becoming non-sodic below 0.40 mbgl.</li> <li>Calcium and magnesium ratio are high to very high.</li> </ul> <p><i>GTE assessment - Erosion potential for dispersion is assessed as low decreasing with depth. Appropriate</i></p>

Item	Description
	<i>management of bare topsoil earths must be considered when stockpiling and for reuse of this SMU for rehabilitation activities.</i>
<b>Soil quality for mine rehabilitation</b>	<p><u>Recommended soil strip depth:</u> 0.00-0.50 mbgl</p> <p><u>Recommended soil use:</u> The loose surface topsoil for reuse in mine rehabilitation may be stripped moist or dry. These soils offer large quantities of good porous material with a variety of applications in mine rehabilitation. Stripping depth will normally exceed 60 cm. The material is suitable for use on most rehabilitation areas as it tends to infiltrate water rapidly and remain loose. It should ideally be placed to a depth of 20 cm or more</p> <p><u>Recommended subsoil strip depth:</u> 0.50 – 1.00 mbgl</p> <p><u>Recommended subsoil use:</u> Possibly strip further to 1.00 mbgl.</p> <p><i>GTE recommendation – subsoils may be used as either additional topsoil reserves or as supporting buried subsoils for topsoil placement.</i></p>

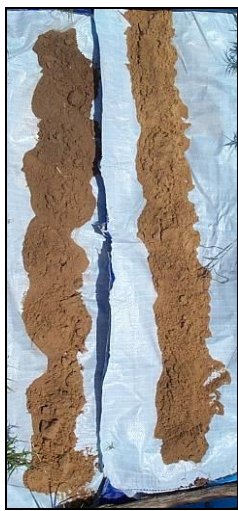
Site 173	Depth (cm)	Description	pH

0 – 30	A11, Fine medium brown (10.5YR5/3) loose sandy loam, massive, no inclusions, dry, gradual boundary to;	7.5
	30 – 120	B21, Pale yellowish brown (10YR6/5), coarse sandy loam, loose, no inclusions, moist. End of borehole.	8.0

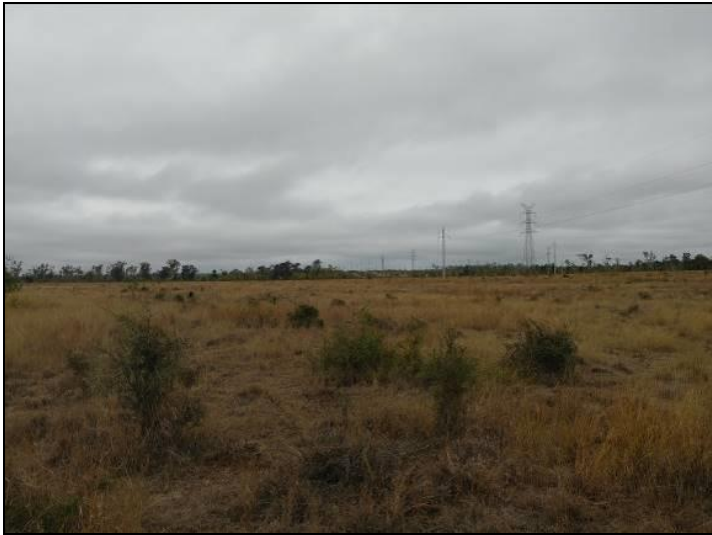
Item	Description
SMU	E1r
Representative Site	10-SCL
Representative Site photograph

Location	642525mE 7510097mN
Current Use	Grazing
Site survey type	Detailed, 50 mm hand auger.
Vegetation	Buffel Grass
Disturbance	Extensive disturbance
Landform element /pattern	Very gently undulating plain, Mid-slope
Micro relief	Nil microrelief
Erosion	Nil erosion
Slope (%)	2.0/1.0
Drainage	Moderate
Surface coarse fragments	Nil coarse fragments
Surface condition	Minor cracking, loose
ASC Order (s)	Red Chromosol (Brown Chromosol sub-dominant)
Land suitability summary	<b>Estimated effective rooting depth:</b> 1.00 m <b>Estimated soil water storage:</b> 70-100 mm <b>Regional Frameworks class:</b> 4 <b>Grazing suitability class:</b> 3 <b>Agricultural Land Class:</b> B
Erosion potential	Laboratory results indicated. <ul style="list-style-type: none"> <li>ESP is low throughout</li> </ul> Erosion potential is assessed as low.

Soil quality for mine rehabilitation	<u>Recommended topsoil strip depth:</u> Nil <u>Recommended topsoil use:</u> Not suitable due to the texture grade (Sandy). Soil amelioration and mixing of other suitable topsoils may improve soils to 0.00-0.15 mbgl <u>Recommended subsoil strip depth:</u> 0.15-1.00 mbgl

Item	Description
	<b>Recommended subsoil use:</b> Subsoils, unlike topsoil have value in they are assessed as suitable in 0.15-1.00 mbgl; suitable for support topsoil placement, slopes or level plains.
<b>AASS/PASS Assessment</b>	<i>GTE Assessment - Very low field indication of PASS. Nil field indicators of AASS</i>
<b>Total area (ha)</b>	33.2

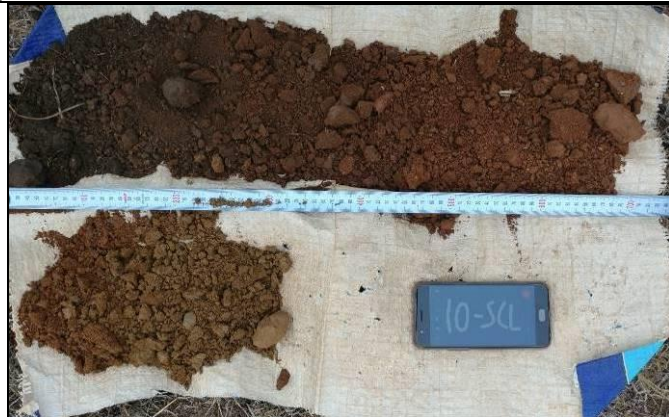
Site 10-SCL

Horizon Depth (m), Bound- ary (Bdy)	Field Texture	Structure Strength	Inclusions Segregati- ons	Colour, Mottle, Bleaching	Moisture Drainage	Roots	Depth (m) / Field pH / EC dS/m	Samples (m)
A1 0.00- 0.13 Abrupt	Sandy clay	Moderate, firm, <10mm sub- angular	<1% calcium carbonate nodules	10YR3/2 Very dark greyish brown Nil mottles/ bleach	Dry, moderate	Few, fine	0.10 / 7.0	0.00-0.10 0.20-0.30 0.50-0.60 0.80-0.90 0.90-1.00	Nil
A2 0.13- 0.39 Abrupt	Light sandy clay	Moderate, firm, <10mm sub- angular	Nil inclusion or segregation s	10YR3/3 Dark Brown Nil mottles/ bleach	Dry, moderate	Few, fine	0.30 / 7.0		
B21 0.39- 0.84 Abrupt	Light sandy clay	Moderate, firm, <10mm sub- angular	<10% calcium carbonate nodules	5YR4/4 Reddish brown Nil mottles /bleach	Dry, moderate	Few, fine	0.60 / 7.5		
B22 0.84- 1.00 EOBH	Light clay	Moderate, firm, <10mm sub- angular	<2% calcium carbonate nodules	10YR4/4 Dark yellowish brown Nil mottles/ bleach	Dry, moderate	Very few, very fine	0.90 / 8.5

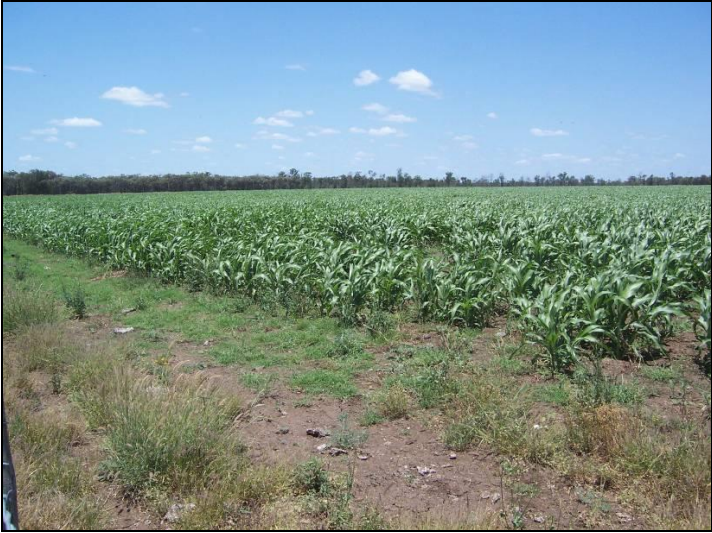
Item	Description
SMU	E2
Representative Site Number	Site 110
Representative Site photograph

Site survey type	Detailed. Hand auger.
Vegetation	Previously mountain coolibah
Location	644308E 7508055N
Disturbance	Cultivation
Landform element /pattern	Gently undulating plain, flat
Micro relief	Nil
Permeability	Moderate
Slope (%)	1.0
Drainage	Moderately well drained
Surface coarse fragments	No coarse fragments reported
Surface condition	Fine, self-mulching and cracking.
Substrate	Weathered calcareous material and basalt
ASC Order (s)	Black Vertosol
Land suitability summary	<p><b>Estimated effective rooting depth:</b> 0.90-1.00 m</p> <p><b>Estimated soil water storage:</b> 100+ mm</p> <p><b>Cropping suitability class:</b> 2</p> <p><b>Grazing suitability class:</b> 2</p> <p><b>Regional Frameworks class:</b> 3</p> <p>Preferred Use: Opportunistic Cropping and grazing</p> <p><b>Agricultural Land Class:</b> <i>GTE assessment - A1</i></p>

Erosion potential	<p>Laboratory results indicated;</p> <ul style="list-style-type: none"> <li>ESP is non-sodic in the topsoil and increases with depth profile becoming sodic below 0.30 mbgl.</li> <li>Calcium and magnesium ratio are high throughout.</li> </ul>

Item	Description
	<i>GTE assessment - Erosion potential for dispersion is assessed as low increasing potentially with depth. Appropriate management of bare earths must be considered when stockpiling and for reuse of this SMU for rehabilitation activities.</i>
<b>Soil quality for mine rehabilitation</b>	<p><u>Recommended soil strip depth:</u> 0.00-0 40 mbgl</p> <p><u>Recommended soil use:</u> These soils are high quality clay soils with a high moisture retention capacity however the establishment of permanent pasture cover on rehabilitation may take considerable time as problems occur with germination of fine seeded plants in the shrinking and swelling medium.</p> <p>The soils are often saline below 50 cm depth, so a depth cut from 40 cm is nominated. The material is more suited for use on flatter rehabilitation areas as it tends to erode, and the establishment of a protective surface cover may take longer than expected. It should ideally be placed to a depth of 20 cm or more.</p> <p><u>Recommended subsoil strip depth:</u> Nil</p> <p><u>Recommended subsoil use:</u> The soils are often saline below 50 cm depth</p> <p>Nil, no stripping recommendations for subsoils provided.</p> <p><i>GTE recommendation – potential reuse as capping for waste rock due to saline and dispersive attributes to a depth of 1.25 mbgl</i></p>

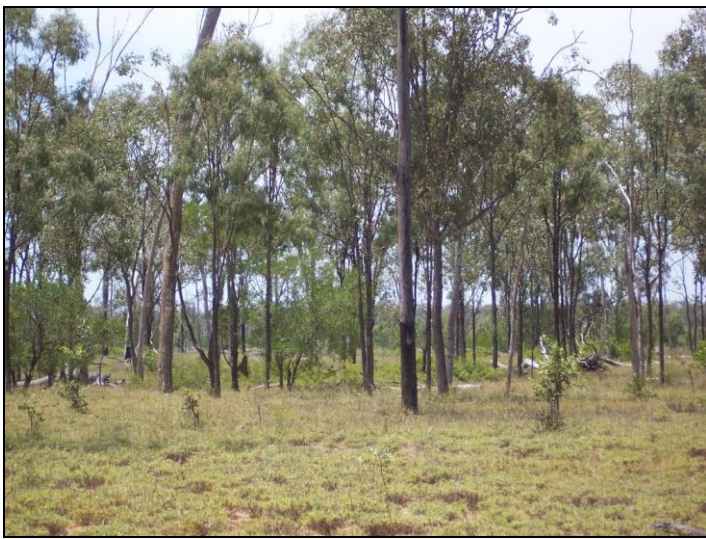
Item	Description
SMU	E3
Representative Site Number	Site 169
Representative Site photograph

Site survey type	Detailed. Hand auger.
Vegetation	Poplar box and occasional moreton bay ash.
Location	644308E 7508055N
Disturbance	Limited clearing
Landform element /pattern	Level plain
Micro relief	Nil
Permeability	Very slow
Slope (%)	<1.0
Drainage	Imperfect
Surface coarse fragments	No coarse fragments reported
Surface condition	Sandy – firm to hard setting
Substrate	Mixed relic alluvial sediments
ASC Order (s)	Brown sodosol
Land suitability summary	<p><b>Estimated effective rooting depth:</b> 0.40 m</p> <p><b>Estimated soil water storage:</b> 30 mm</p> <p><b>Cropping suitability class:</b> 5</p> <p><b>Grazing suitability class:</b> 4</p> <p>Preferred Use: Light grazing</p> <p><b>Agricultural Land Class:</b> <i>GTE assessment – C3</i></p>
Erosion potential	<p>Laboratory results indicated;</p> <ul style="list-style-type: none"> <li>ESP is non-sodic in the topsoil and increases with depth profile becoming sodic below 0.40 mbgl.</li> <li>Calcium and magnesium ratio is high and decreases to moderate in subsoils</li> </ul> <p><i>GTE assessment - Erosion potential for dispersion is assessed as low increasing potentially with depth. Appropriate management of bare earths must be considered when stockpiling and for reuse of this SMU</i></p>

Item	Description
	<i>for rehabilitation activities.</i>
<b>Soil quality for mine rehabilitation</b>	<p><u>Recommended soil strip depth:</u> 0.00-0.20 mbgl</p> <p><u>Recommended soil use:</u> Stripping of these soils should not proceed into the clayey subsoil as the material is hard, impervious and generally dispersive. It is preferable to take less soil than risk contamination with the poor subsoil. Use should normally be limited to rehabilitation of level sites.</p> <p><u>Recommended subsoil strip depth:</u> Nil</p> <p><u>Recommended subsoil use:</u> As per topsoil recommendation, the clayey subsoil as the material is hard, impervious and generally dispersive</p> <p>Nil, no stripping recommendations for subsoils provided.</p> <p><i>GTE recommendation – reuse as capping for waste rock due to saline and dispersive attributes to a depth of 0.90 mbgl</i></p>
<b>AASS/PASS Assessment</b>	<i>GTE Assessment - Very low field indication of PASS. Nil field indicators of AASS</i>

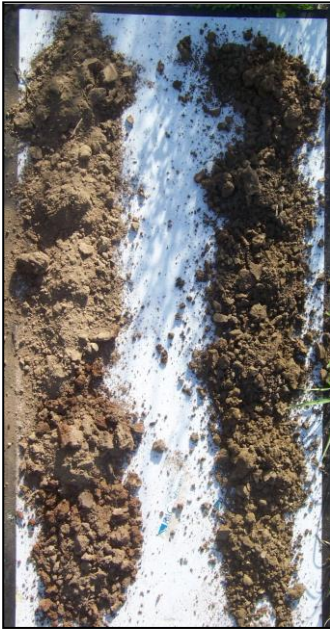
Site 169	Depth (cm)	Description	pH

0 – 40	A1, Dark Reddish Brown (5YR3/3), sandy loam, massive, no inclusions, dry, clear boundary change.	5.5
	40 – 45	A2, Sporadic bleaching; abrupt boundary to;	5.5
	45-100+	B21. Yellowish brown (10YR5/6), sandy clay, mottled, moderate blocky structure, no inclusions, moist. End of borehole.	6.0

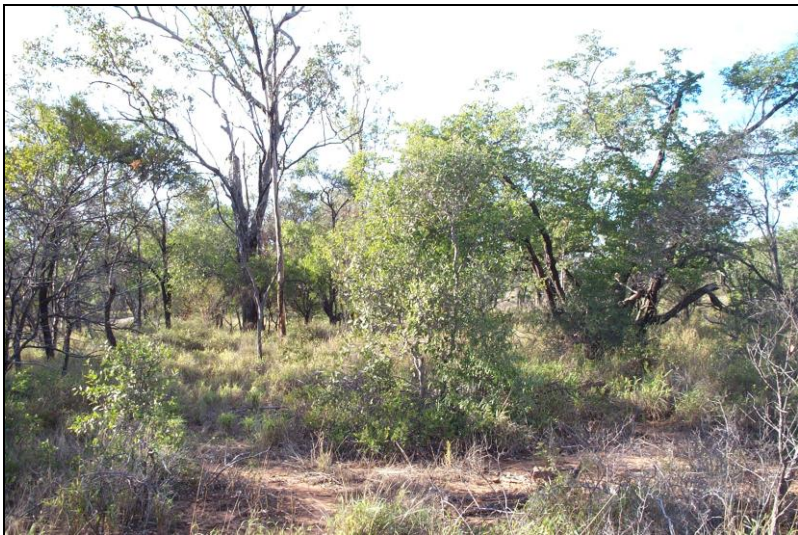
Item	Description
SMU	T1
Representative Site Number	Site PD-51 Peak Downs Site
Representative Site photograph

Site survey type	Detailed. Hand auger.
Vegetation	Poplar box mixed woodlands with associated ironbark bauhinia, Brigalow, Dawson Gum and buffel grass.
Location	n/a
Disturbance	No erosion or disturbance
Landform element /pattern	Level plain, flat
Micro relief	Nil
Permeability	<i>GTE assessment – moderate</i>
Slope (%)	0.0
Drainage	<i>GTE assessment – well to moderate</i>
Surface coarse fragments	No coarse fragments reported
Surface condition	Sandy loam, firm
Substrate	n/a
ASC Order (s)	Brown sodosol
Land suitability summary	<p><b>Estimated effective rooting depth:</b> 0.15-0.25 m</p> <p><b>Estimated soil water storage:</b> 25-50 mm</p> <p><b>Cropping suitability class:</b> 5</p> <p><b>Grazing suitability class:</b> 4</p> <p>Preferred Use: n/a</p> <p><b>Agricultural Land Class:</b> C3</p>
Erosion potential	<p>Laboratory results indicated;</p> <ul style="list-style-type: none"> <li>ESP is non-sodic in the topsoil and increases with depth profile becoming sodic to highly sodic below 0.10 mbgl.</li> <li>Calcium and magnesium ratio are high and decreases to moderate in subsoils.</li> </ul> <p><i>GTE assessment – Erosion potential for dispersion is assessed as low in topsoils increasing with depth.</i></p>

Item	Description
	<i>Appropriate management of bare earths must be considered when stockpiling and for reuse of this SMU for rehabilitation activities.</i>
<b>Soil quality for mine rehabilitation</b>	<p><u>Recommended soil strip depth:</u> 0.00-0.20 mbgl</p> <p><u>Recommended soil use:</u> The upper sandy loam may be stripped to the harder pale coloured clay subsoil. In most cases 20 cm of soil would be available for stripping.</p> <p>The preferred rehabilitation application is Flat sites only due to high erosion potential.</p> <p><u>Recommended subsoil strip depth:</u> Nil</p> <p><u>Recommended subsoil use:</u> Nil, no stripping recommendations for subsoils provided.</p> <p><i>GTE recommendation – reuse as capping for waste rock due to saline and dispersive attributes to a depth of 0.60 mbgl</i></p>
<b>AASS/PASS Assessment</b>	<i>GTE Assessment - Very low field indication of PASS. Nil field indicators of AASS</i>

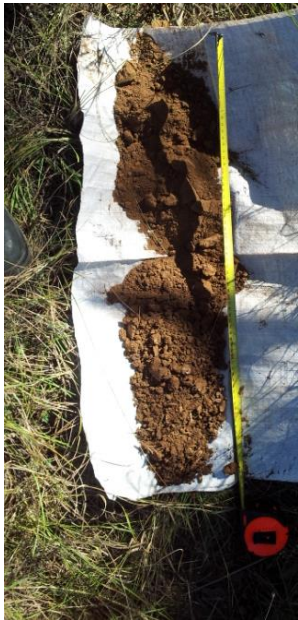
Site PD-169	Depth (cm)	Description	pH

0 – 30	A1, Fine Sandy Loam, 10YR4/4, massive structure, nil inclusions	6.0
	30 – 80	B21, Sandy Clay, 10YR4/4, coarse angular blocky, poorly drained, manganese nodules. End of borehole	6.5

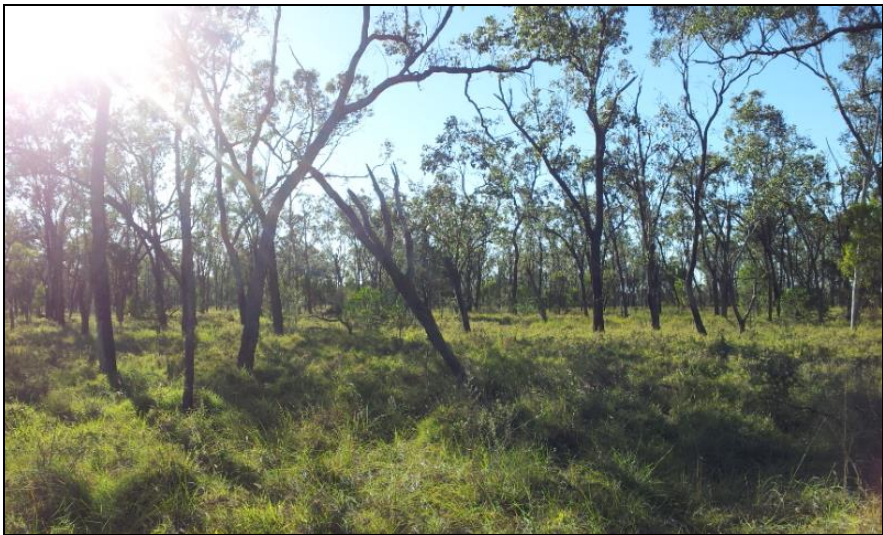
Item	Description
SMU	T2
Representative Site Number	Site PD-21
Representative Site photograph

Site survey type	Detailed. Hand auger.
Vegetation	Poplar box with associated ironbark, whitewood and bloodwood.
Location	617341E 7547648N
Disturbance	Good condition with 60% buffel cover
Landform element /pattern	Level plain, flat
Micro relief	Nil
Permeability	<i>GTE assessment – moderate</i>
Slope (%)	0.0
Drainage	<i>GTE assessment – moderate to well drained</i>
Surface coarse fragments	No coarse fragments reported
Surface condition	Firm/hard setting sandy
Substrate	n/a
ASC Order (s)	Brown sodosol
Land suitability summary	<p><b>Estimated effective rooting depth:</b> 0.20-0.30 m</p> <p><b>Estimated soil water storage:</b> 40-80 mm</p> <p><b>Cropping suitability class:</b> 5</p> <p><b>Grazing suitability class:</b> 3</p> <p>Preferred Use: n/a</p> <p><b>Agricultural Land Class:</b> C2</p>
Erosion potential	<p>Laboratory results indicated;</p> <ul style="list-style-type: none"> <li>ESP is marginally sodic in the topsoil and decreasing with depth profile becoming non-sodic below 0.60 mbgl.</li> <li>Calcium and magnesium ratio are high to very high.</li> </ul> <p><i>GTE assessment - Erosion potential for dispersion is assessed as low in topsoils decreasing with depth. Appropriate management of bare earths must be considered when stockpiling and for reuse of this SMU</i></p>

Item	Description
	<i>for rehabilitation activities.</i>
<b>Soil quality for mine rehabilitation</b>	<p><u>Recommended soil strip depth:</u> 0.00-0.20 mbgl</p> <p><u>Recommended soil use:</u> The T2 SMU at 10 – 20 cm horizon is a well-drained and higher quality soil which overlies very dense fine sandy loam. It is expected to set hard and seal if placed over rehabilitation.</p> <p>The preferred rehabilitation application is Flat sites only due to high erosion potential.</p> <p><u>Recommended subsoil strip depth:</u> 0.20 – 0.60 mbgl</p> <p><u>Recommended subsoil use:</u> The use of this soil beneath this horizon is not recommended due to hard sealing, however the salinity and sodicity are not major issues for this horizon. If a significant topsoil deficit exists in this area, the use of the subsoil (to the clay layer) may be considered. It may be useful to establish a trial of this material on rehabilitation to better establish its worth.</p> <p><i>GTE recommendation – subsoils may be used as either additional topsoil reserves or as supporting buried subsoils for topsoil placement.</i></p>

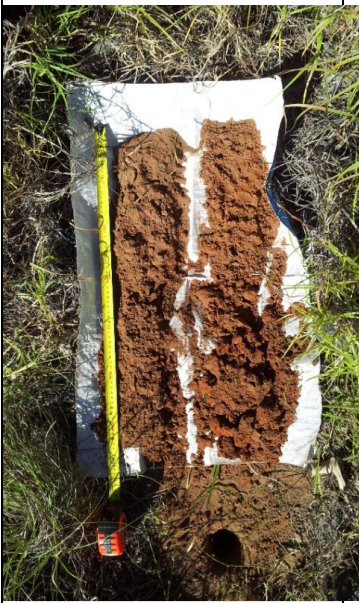
Site PD-21	Depth (cm)	Description	pH

0 – 50	A11, Fine sandy loam, 5YR4/4, massive structure, no inclusions/mottles, slight change to;	n/a
	50 – 80	A12, Fine sandy loam, 5YR5/4, weak structure, moderate drainage, no inclusions/mottles. End of borehole	n/a
