# Restoration Plan to Support RIDA Application Saraji East Project

Final V4  
15 July 2021

GT Environmental Pty Ltd  
[www.gtenvironmental.com.au](http://www.gtenvironmental.com.au)

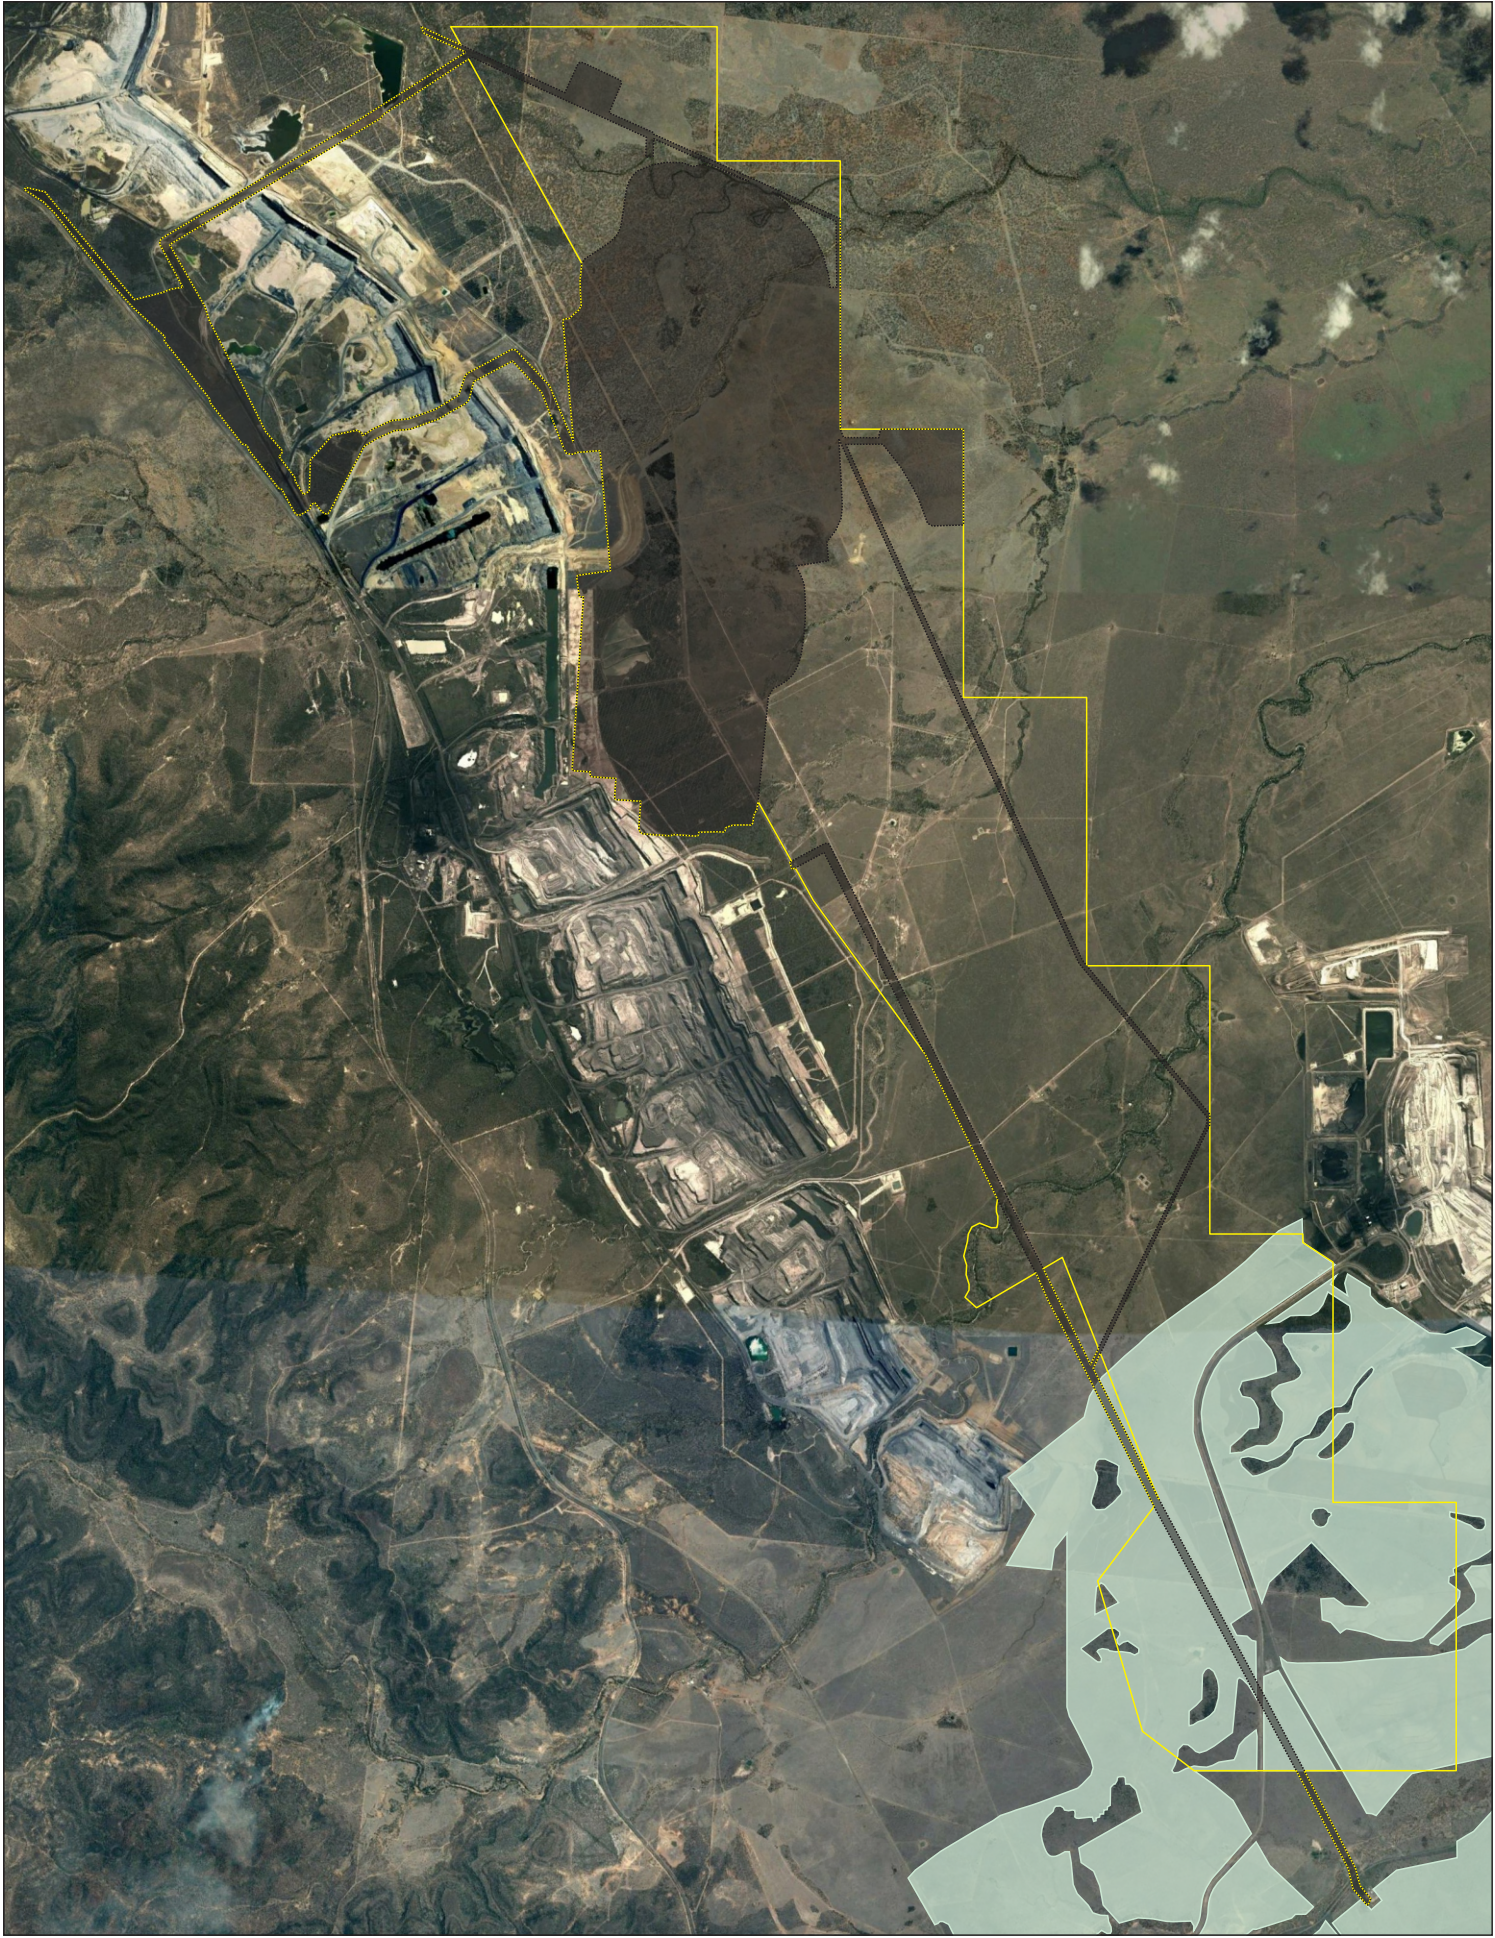
Figure 6: Strategic Cropping Land

- Legend
- Project site
  - Project footprint
  - 0.00m
  - 0.10m
  - 0.15m
  - 0.20m
  - 0.25m
  - 0.30m
  - 0.40m
  - 0.50m
  - Disturbed

GTE conducted an SCL assessment which was undertaken for SCL Trigger Map identified in the southern area of the Project Site (Figure 6). Additional soil sampling and laboratory analysis was undertaken in accordance with *RPI Guideline 08/14 How to demonstrate that land in the strategic cropping area does not meet the criteria for strategic cropping land* (RPI 08/14).

Strategic Cropping Areas (SCAs) (as determined by the Queensland Government) are shown on the Strategic Cropping Land (SCL) Trigger Map. A review of the SCL Trigger Map indicates that there are areas identified in the southern area of the Project Site, as shown in Figure 6. As the Project Site encroaches on the mapped SCL a standalone SCL assessment has been conducted (GTE, 2020).

The Project Site is located in a Regional Planning Interests Areas of SCA. An assessment was undertaken to identify SCL in the Project Site. The SCL trigger map area is presented in Figure 6. The Project Site does not encroach on any PLAs, SEAs or PAAs.

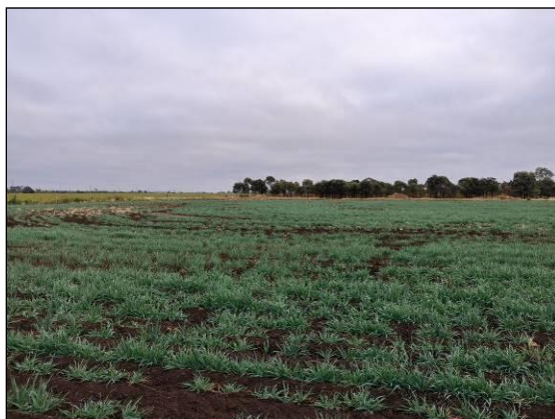
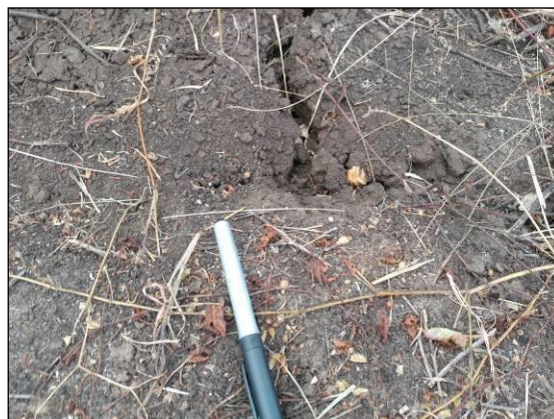
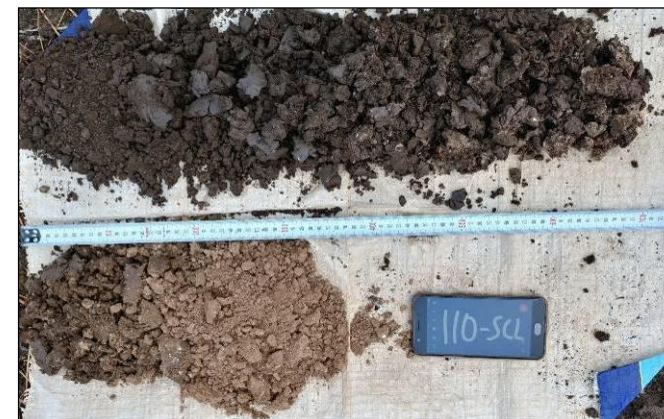
<b>Soil Mapping Unit</b> E2	<b>Location (GDA94 ZONE 56):</b> 644310mE 7508052mN	<b>Aust. Soil Class.:</b> Black Vertosol	<b>Site Survey Type:</b> Detailed - 50mm hand auger	<b>Survey Date:</b> 30/06/2018
--------------------------------	--	---	--	-----------------------------------

Land use Landform Pattern, Element, Slope	Vegetation	Microrelief Disturbance Erosion	Surface condition, surface rock	Soil Profile Description									
				Horizon Depth (m), Boundary	Field Texture	Structure, Strength	Inclusions Segregations	Colour, Mottle, Bleaching	Moisture, Drainage	Roots	Depth (m) / Field pH	Sample (m)	Observations
Cropping Flat plain, level, 0.0/0.0	Cropping	Nil microrelief Cropping disturbance No erosion	Cracking 20- 40mm, fine surface mulch Nil coarse fragments	A1 0.0-0.13 Abrupt	Light clay	Weak, firm, <10mm sub- angular	2% 2-6mm coarse fragments	10YR3/2 Very dark greyish brown  Nil mottles/bleach	Dry, moderate	Fine, few	0.10 / 6.5	0.00-0.10 0.20-0.30 0.50-0.60 0.70-0.80 0.90-1.00	Nil additional observations
				B21 0.13-0.38 Abrupt	Medium clay	Moderate, firm <40% 20- 60mm, <20% 60- 100 sub- angular blocky peds	<1% black nodules <1% calcium carbonate nodules	10YR4/2 Dark greyish brown  Nil mottles/bleach	Dry, moderate	Very fine, very few	0.30 / 6.5

B22 0.38-0.82 Abrupt	Medium clay	Moderate, firm <40% 20- 60mm, <20% 60- 100 sub-	<5% calcium carbonate nodules	10YR4/2 Dark greyish brown  Nil mottles/bleach	Dry, moderate	Very fine, very few	0.60 / 8.0

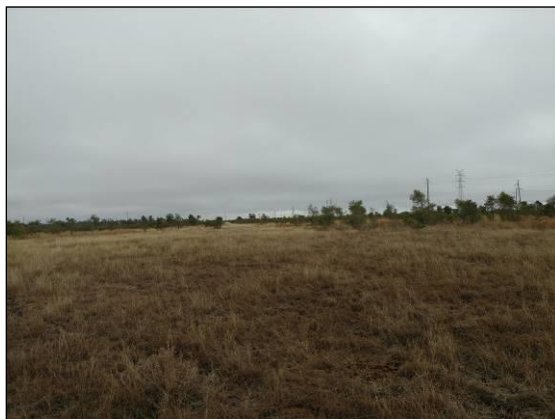
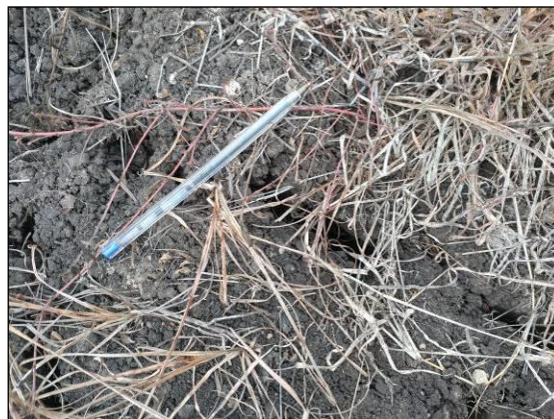
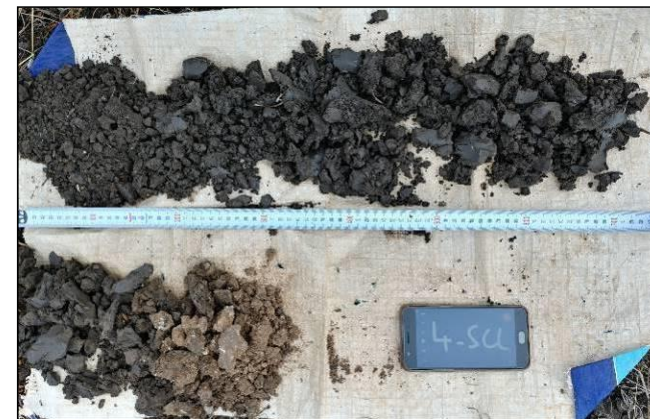
<b>Soil Mapping Unit</b> E2	<b>Location (GDA94 ZONE 56):</b> 643527mE 7507664mN	<b>Aust. Soil Class.:</b> Black Vertosol	<b>Site Survey Type:</b> Detailed - 50mm hand auger	<b>Survey Date:</b> 30/06/2018
--------------------------------	--	---	--	-----------------------------------

Land use Landform Pattern, Element, Slope	Vegetation	Microrelief Disturbance Erosion	Surface condition, surface rock	Soil Profile Description									
				Horizon Depth (m), Boundary	Field Texture	Structure, Strength	Inclusions Segregations	Colour, Mottle, Bleaching	Moisture, Drainage	Roots	Depth (m) / Field pH	Sample (m)	Observations
Grazing, Very gently undulating plains, upper slope, <1.0/1.0	Cleared, very sparse mixed regrowth	Nil microrelief Semi cleared, Nil erosion	Cracking 20- 40mm, self mulching Nil coarse fragments	A1 0.00-0.14 Abrupt	Light clay	Weak, firm, <10mm sub- angular	Nil inclusion or segregations	10YR3/2 Very dark greyish brown Nil mottles/bleach	Dry, moderate	Fine, few	0.10 / 6.5	0.00-0.10 0.20-0.30 0.50-0.60 0.70-0.80 0.90-1.00	Nil additional observations
				B21 0.14-0.90 Abrupt	Medium clay	Moderate, firm <40% 20- 60mm, <20% 60- 100 sub- angular blocky peds	<1% calcium carbonate nodules	10YR3/2 Very dark greyish brown Nil mottles/bleach	Dry, moderate	Very fine, very few	0.30 / 6.5 0.60 / 7.5

B22 0.90-1.00	Medium clay	Moderate, firm <40% 20- 60mm, <20% 60- 100 sub-	2% calcium carbonate nodules	10YR4/2 Dark greyish brown Mottles 2% 10YR3/2 Very dark greyish brown Nil bleach	Dry, Imperfect	Very fine, very few	0.90 / 8.0

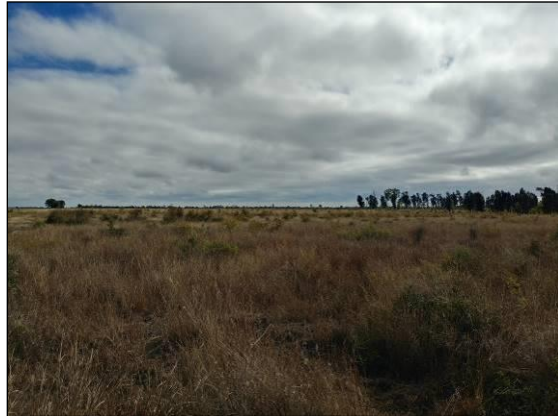
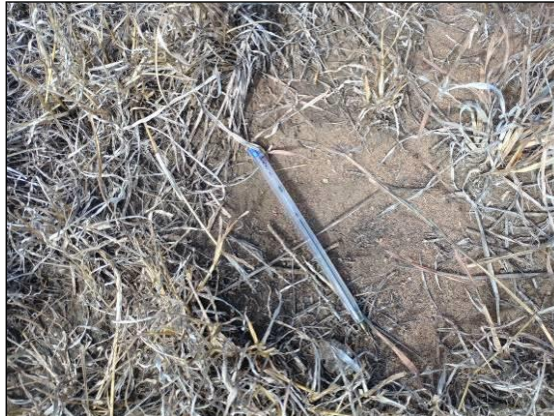
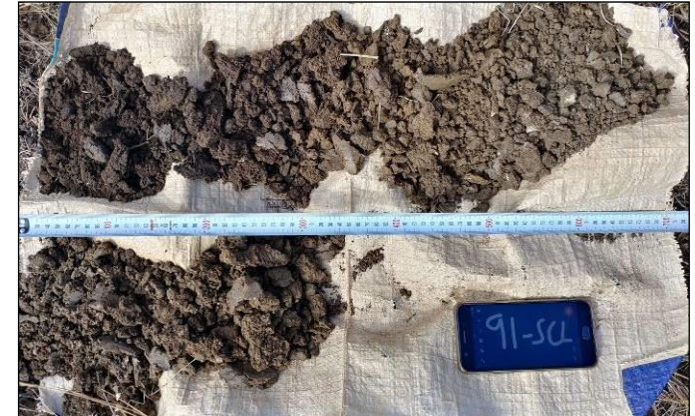
<b>Soil Mapping Unit</b> B1	<b>Location (GDA94 ZONE 56):</b> 643899mE 7510777mN	<b>Aust. Soil Class.:</b> Dark Vertosol	<b>Site Survey Type:</b> Detailed - 50mm hand auger	<b>Survey Date:</b> 30/06/2018
--------------------------------	--	--	--	-----------------------------------

Land use Landform Pattern, Element, Slope	Vegetation	Microrelief Disturbance Erosion	Surface condition, surface rock	Soil Profile Description									
				Horizon Depth (m), Boundary	Field Texture	Structure, Strength	Inclusions Segregations	Colour, Mottle, Bleaching	Moisture, Drainage	Roots	Depth (m) / Field pH	Sample (m)	Observations
Grazing, Very gently undulating plain, Midslope 2.0/1.0	Cleared, nearby remnant Belah	Nil microrelief Nil disturbance Nil erosion	Minor cracking, firm, Nil coarse fragments	A1 0.00-0.12 Abrupt	Sandy Clay	Moderate, weak <20mm sub- angular	Nil inclusions and segregations	10YR2/1 Black Nil mottles/bleach	Dry, moderate	Few, fine	0.10 / 6.0	0.00-0.10 0.20-0.30 0.50-0.60 0.80-0.90 0.90-1.00	Nil additional observations
				B21 0.12-0.50 Clear	Light sandy clay	Moderate, firm 20- 50mm sub- angular	Nil inclusions and segregations	10YR2/2 Very dark brown Nil mottles/bleach	Dry, moderate	Few, fine	0.30 / 6.5

B22 0.50-1.00	Light clay	Moderate, firm 20- 50mm sub- angular blocky	<2% calcium carbonate nodules	10YR3/3 Dark brown Mottles <2% 10YR5/3 Brown Nil bleach	Dry, moderate	Very few, very fine	0.60 / 7.0 0.60 / 7.5

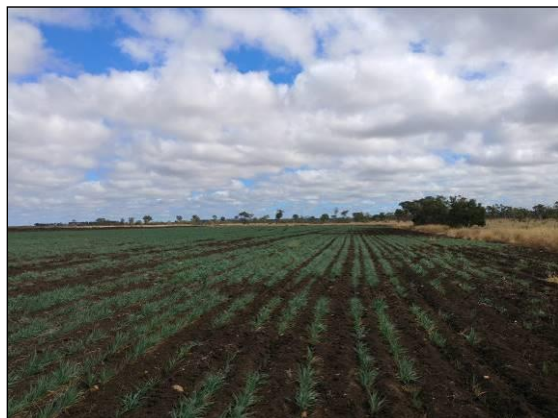
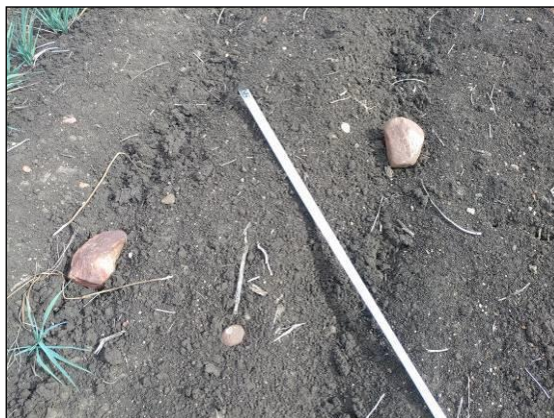
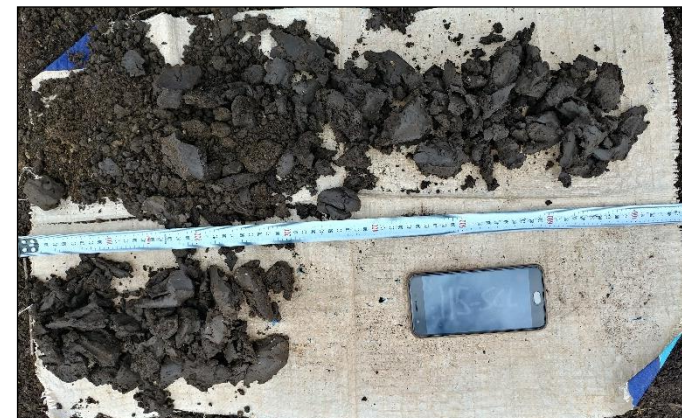
<b>Soil Mapping Unit</b> E2	<b>Location (GDA94 ZONE 56):</b> 645410mE 7509123mN	<b>Aust. Soil Class.:</b> Black Vertosol	<b>Site Survey Type:</b> Detailed - 50mm hand auger	<b>Survey Date:</b> 30/06/2018
--------------------------------	--	---	--	-----------------------------------

Land use Landform Pattern, Element, Slope	Vegetation	Microrelief Disturbance Erosion	Surface condition, surface rock	Soil Profile Description									
				Horizon Depth (m), Boundary	Field Texture	Structure, Strength	Inclusions Segregations	Colour, Mottle, Bleaching	Moisture, Drainage	Roots	Depth (m) / Field pH	Sample (m)	Observations
Cropping Very gently undulating plain Flat plain 1.0/1.0	Cropping	Nil microrelief Cropping disturbance Nil erosion	2-5% medium pebbles >600mm Soft, loose	0.00-0.16 Abrupt	Light clay	Moderate, weak <10mm sub- angular blocky	<2% calcium carbonate nodules	10YR3/2 Very dark grayish brown Nil mottles/bleach	Dry, moderate	Few fine	0.10 / 6.0	0.00-0.10 0.20-0.30 0.50-0.60 0.80-0.90 0.90-1.00	Nil additional observations

0.16-1.00	Medium clay	Strong, firm <10mm sub- angular blocky	Nil inclusions and segregations	10YR3/2 Very dark grayish brown Nil mottles/bleach	Dry, omoderate	Very fine, very few	0.30 / 6.5 0.60 / 7.0 0.90 / 7.5

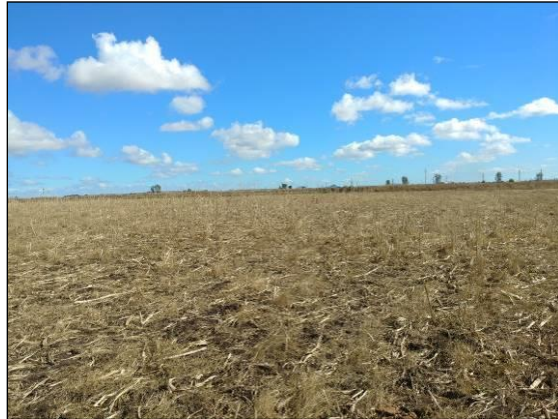
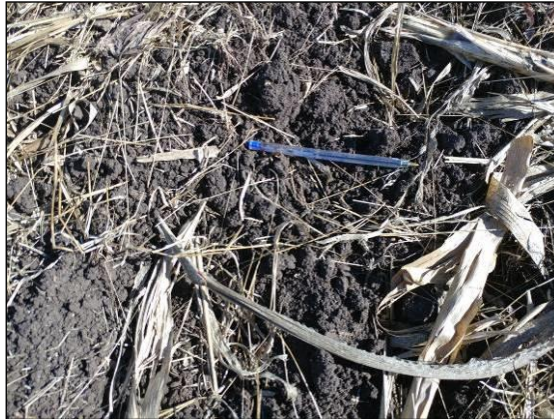
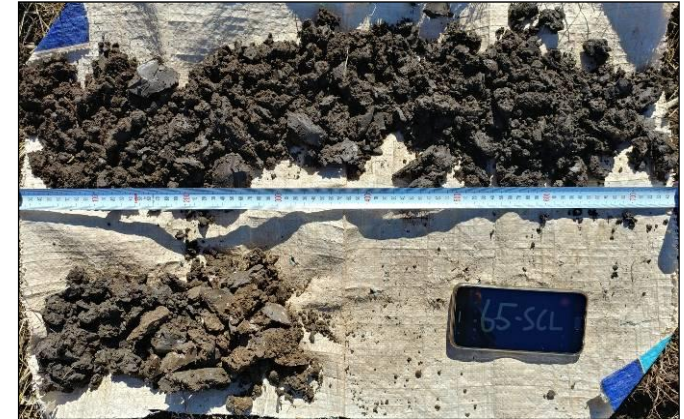
<b>Soil Mapping Unit</b> B1	<b>Location (GDA94 ZONE 56):</b> 643019mE 7513552mN	<b>Aust. Soil Class.:</b> Dark Vertosol	<b>Site Survey Type:</b> Detailed - 50mm hand auger	<b>Survey Date:</b> 30/06/2018
--------------------------------	--	--	--	-----------------------------------

Land use Landform Pattern, Element, Slope	Vegetation	Microrelief Disturbance Erosion	Surface condition, surface rock	Soil Profile Description									
				Horizon Depth (m), Boundary	Field Texture	Structure, Strength	Inclusions Segregations	Colour, Mottle, Bleaching	Moisture, Drainage	Roots	Depth (m) / Field pH	Sample (m)	Observations
Cropping Very gently undulating plain Flat plain 1.0/1.0	Cropping, Brigalow 100- 200m nearby	Nil microrelief Cropping disturbance Nil erosion	Soft, loose, Nil coarse fragments	A1 0.00-0.11 Abrupt	Light clay	Moderate, weak <10mm sub- angular	Nil inclusions and segregations	10YR3/1 Very dary grey Nil mottles/bleach	Dry, moderate	Few fine	0.10 / 6.0	0.00-0.10 0.20-0.30 0.50-0.60 0.80-0.90 0.90-1.00	Nil additional observations
				B21 0.11-0.80 Abrupt	Medium clay	Moderate, weak <10mm sub- angular	Nil inclusions and segregations	10YR2/2 Very dark brown Nil mottles/bleach	Dry, moderate	Very fine, very few	0.30 / 6.5 0.60 / 7.0

B22 0.80-1.00	Medium clay	Moderate, weak <10mm sub- angular	2% calcium carbonate nodules	10YR3/3 Dark brown Nil mottles/bleach	Dry, moderate	Very fine, very few	0.90 / 7.5

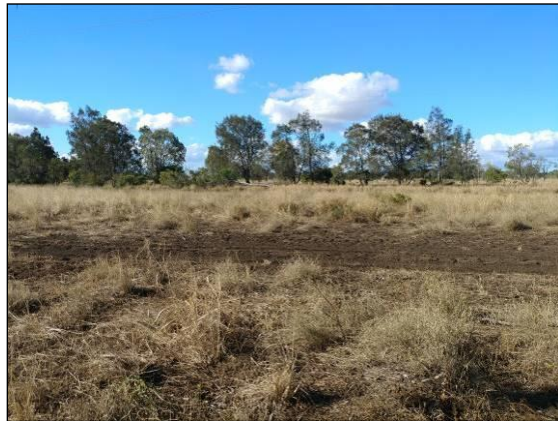
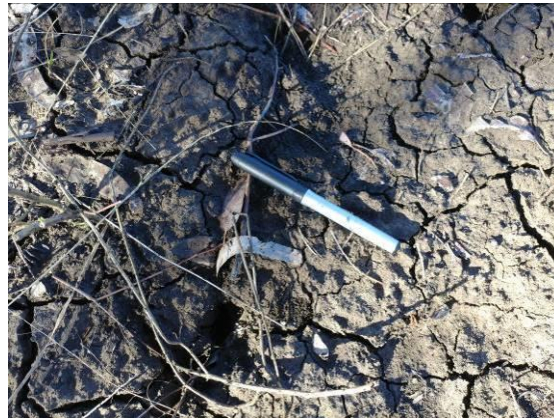
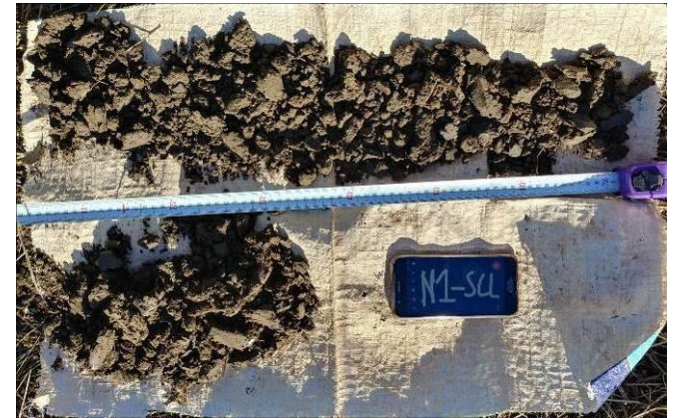
<b>Soil Mapping Unit</b> A2	<b>Location (GDA94 ZONE 56):</b> 641005 mE 7512573 mN	<b>Aust. Soil Class.:</b> Crusting Brown Vertosol	<b>Site Survey Type:</b> Detailed - 50mm hand auger	<b>Survey Date:</b> 30/06/2018
--------------------------------	--	--	--	-----------------------------------

Land use Landform Pattern, Element, Slope	Vegetation	Microrelief Disturbance Erosion	Surface condition, surface rock	Soil Profile Description									
				Horizon Depth (m), Boundary	Field Texture	Structure, Strength	Inclusions Segregations	Colour, Mottle, Bleaching	Moisture, Drainage	Roots	Depth (m) / Field pH	Sample (m)	Observations
Grazing Very gentle undulating plains, Open depression 2.0/1.0	Mount coolabah, semi-cleared	Nil microrelief Semi-cleared Nil erosion	Cracking 2- 6mm, crust Nil coarse fragments	A11 0.00-0.02 Abrupt	Light clay	Moderate, firm <10mm sub- angular	Nil inclusions and segregations	10YR3/1 Very dark gray Dark gray brown Nil mottles Nil bleaching	Moderately moist, moderate	Few fine	0.02 / 6.5	0.00-0.10 0.20-0.30 0.50-0.60 0.80-0.90 0.90-1.00	Nil additional observations
				A12 0.02-0.10 Abrupt	Light clay	Moderate, firm 10- 30mm sub- angular	<1% calcium carbonate	10YR2/2 Very dark brown Nil mottles Nil bleaching	Dry, moderate	Few fine	0.10 / 6.5

B21 0.10-0.70 Abrupt	Medium clay	Moderate, firm 10- 30mm sub- angular	2% calcium carbonate nodules	10YR2/2 Very dark brown Nil mottles Nil bleaching	Dry, moderate	Very fine, very few	0.30 / 7.0 0.60 / 7.5		
				B22 0.70-1.00	Medium clay	Moderate, firm 10- 30mm sub- angular	2% calcium carbonate nodules	10YR4/2 Dark grayish brown Nil mottles Nil bleaching	Dry, moderate	Very fine, very few	0.90 / 7.5

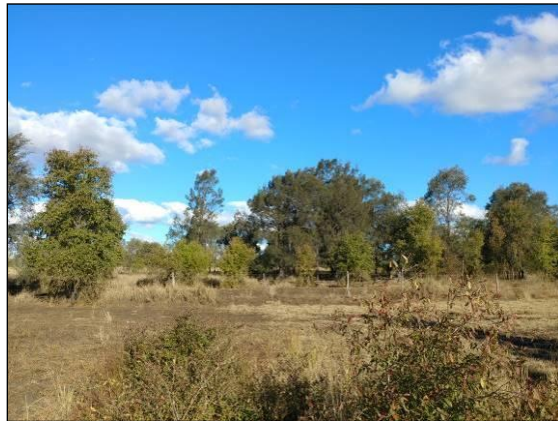
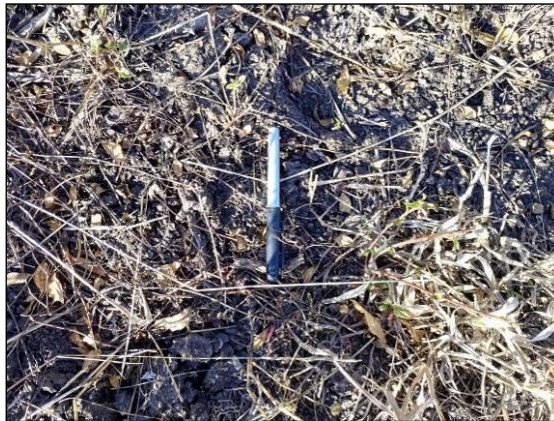
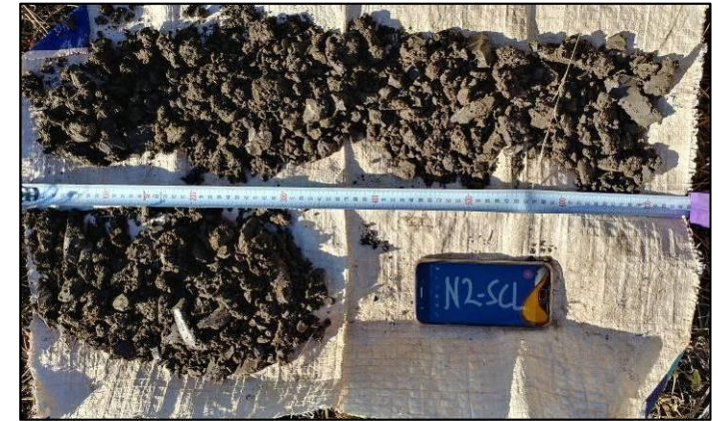
<b>Soil Mapping Unit</b> A2	<b>Location (GDA94 ZONE 56):</b> 641096mE 7512914mN	<b>Aust. Soil Class.:</b> Crusting Brown Vertosol	<b>Site Survey Type:</b> Detailed - 50mm hand auger	<b>Survey Date:</b> 30/06/2018
--------------------------------	--	--	--	-----------------------------------

Land use Landform Pattern, Element, Slope	Vegetation	Microrelief Disturbance Erosion	Surface condition, surface rock	Soil Profile Description									
				Horizon Depth (m), Boundary	Field Texture	Structure, Strength	Inclusions Segregations	Colour, Mottle, Bleaching	Moisture, Drainage	Roots	Depth (m) / Field pH	Sample (m)	Observations
Grazing Very gently undulating plain 2.0/1.0	Various shrubs	Nil microrelief Nil disturbance Nil erosion	Cracking 2- 6mm, crust Nil coarse fragments	A1 0.00-0.14 Abrupt	Light clay	Moderate, soft <10mm sub- angular	Nil inclusions and segregations	10YR3/1 Very dark gray  Nil mottles/bleach	Moderate moist, moderate	Few fine	0.10 / 6.0	0.00-0.10 0.20-0.30 0.50-0.60 0.80-0.90 0.90-1.00	Nil additional observations
				B2 0.14-1.00	Medium clay	Moderate, firm <10mm sub- angular	<2% black nodules	10YR4/2 Dark grayish brown  Nil mottles/bleach	Dry, moderate	Very fine, very few	0.30 / 6.5 0.60 / 7.0 0.90 / 7.5

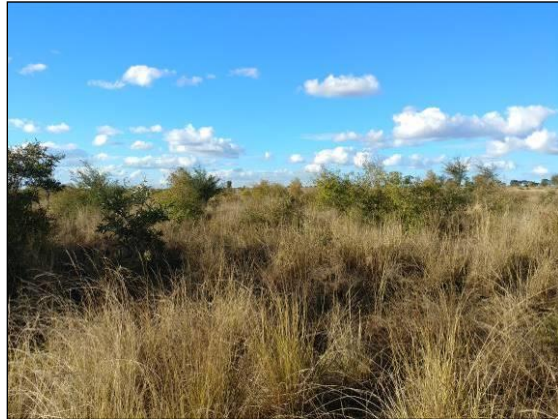
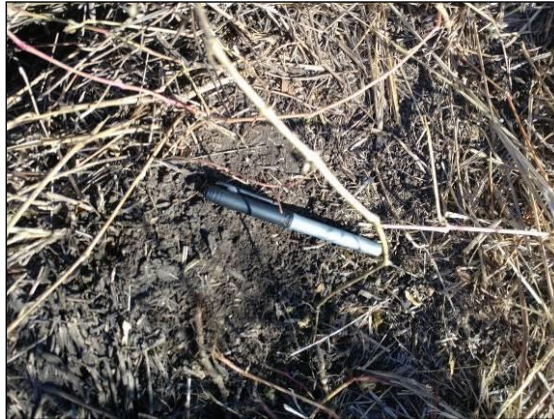
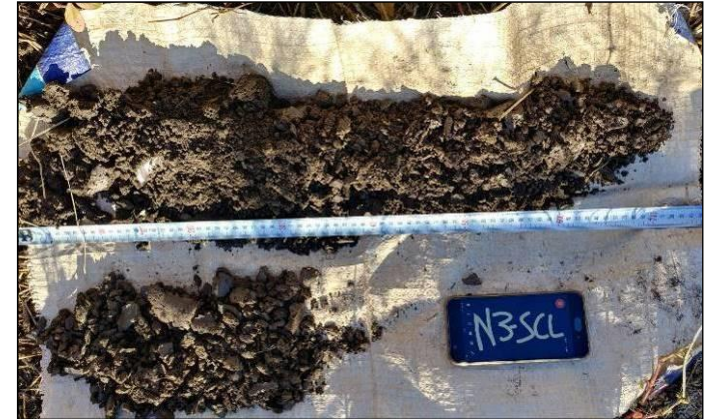
**SITE N3-SCL**

<b>Soil Mapping Unit</b> A2	<b>Location (GDA94 ZONE 56):</b> 641074mE 7513152mN	<b>Aust. Soil Class.:</b> Crusting Brown Vertosol	<b>Site Survey Type:</b> Detailed - 50mm hand auger	<b>Survey Date:</b> 30/06/2018
--------------------------------	--	--	--	-----------------------------------

Land use Landform Pattern, Element, Slope	Vegetation	Microrelief Disturbance Erosion	Surface condition, surface rock	Soil Profile Description									
				Horizon Depth (m), Boundary	Field Texture	Structure, Strength	Inclusions Segregations	Colour, Mottle, Bleaching	Moisture, Drainage	Roots	Depth (m) / Field pH	Sample (m)	Observations
Grazing Very gently undulating plain 2.0/1.0	Various shrubs	Nil microrelief Nil disturbance Nil erosion	Cracking 2- 6mm, crust Nil coarse fragments	A1 0.00-0.16 Abrupt	Light clay	Moderate, soft <10mm sub- angular	Nil inclusions and segregations	10YR3/1 Very dark gray  Nil mottles/bleach	Moderate moist, moderate	Few fine	0.10 / 6.0	0.00-0.10 0.20-0.30 0.50-0.60 0.80-0.90 0.90-1.00	Nil additional observations
				B2 0.16-1.00	Medium clay	Moderate, firm <10mm sub- angular	<2% black nodules	10YR4/2 Dark grayish brown  Nil mottles/bleach	Dry, moderate	Very fine, very few	0.30 / 6.5 0.60 / 7.0 0.90 / 7.5

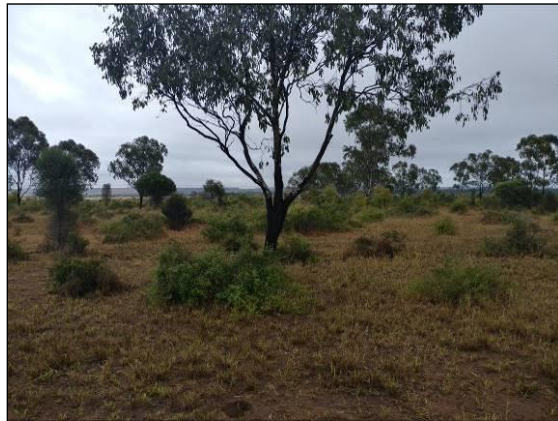
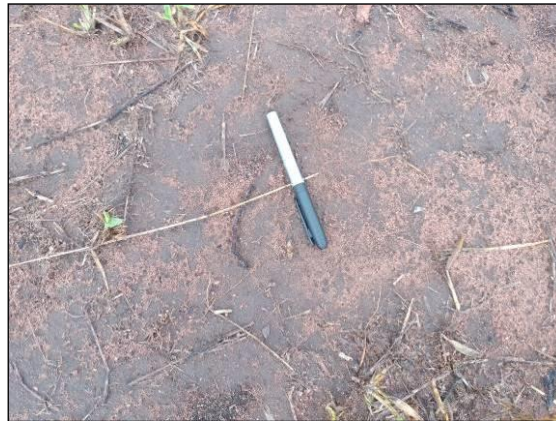
**SITE N4-SCL**

<b>Soil Mapping Unit</b> B2V	<b>Location (GDA94 ZONE 56):</b> 641871mE 7513601mN	<b>Aust. Soil Class.:</b> Brown Dermosol	<b>Site Survey Type:</b> Detailed - 50mm hand auger	<b>Survey Date:</b> 1/07/2018
---------------------------------	--	---	--	----------------------------------

Land use Landform Pattern, Element, Slope	Vegetation	Microrelief Disturbance Erosion	Surface condition, surface rock	Soil Profile Description									
				Horizon Depth (m), Boundary	Field Texture	Structure, Strength	Inclusions Segregations	Colour, Mottle, Bleaching	Moisture, Drainage	Roots	Depth (m) / Field pH	Sample (m)	Observations
Grazing Very gently undulating plain 2.0/1.0	Eucalyptus species	Nil microrelief Semi disturbed Nil erosion	Soft, <5% 2-6mm coarse fragments	A1 0.00-0.17 Abrupt	Sandy loam	Weak, soft <10mm sub- rounded	Nil inclusions and segregations	10YR3/2 Very dark grayish brown Very dark grayish brown Nil mottles/bleach	Moderate moist, rapid	Few fine	0.10 / 6.0	0.00-0.10 0.20-0.30 0.50-0.60 0.80-0.90 0.90-1.00	Nil additional observations
				B21 0.17-0.44 Abrupt	Light clay with minor sand	Moderate, firm <30mm sub- angular	<2% pale red nodules	10YR4/2 Dark grayish brown Dark grayish brown Nil mottles/bleach	Moderately moist, moderate	Very fine, very few	0.30 / 7.5

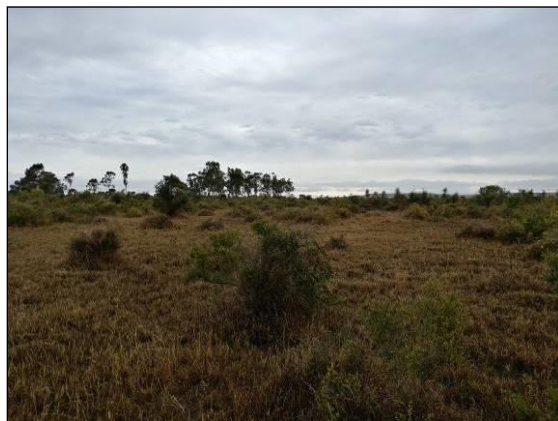
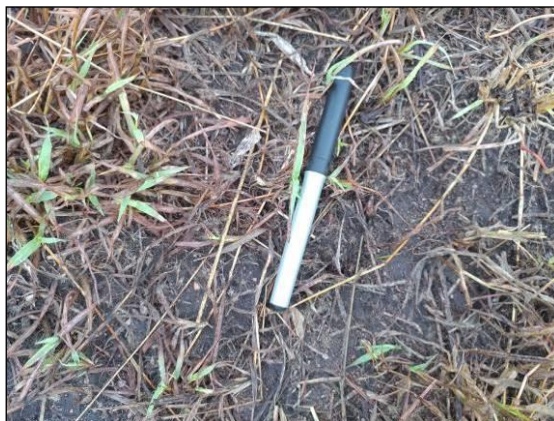
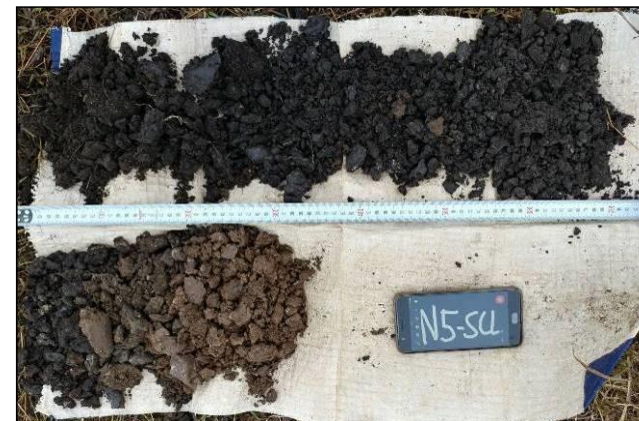
<b>Soil Mapping Unit</b> B2V	<b>Location (GDA94 ZONE 56):</b> 641792mE 7513825mN	<b>Aust. Soil Class.:</b> Brown Dermosol	<b>Site Survey Type:</b> Detailed - 50mm hand auger	<b>Survey Date:</b> 1/07/2018
---------------------------------	--	---	--	----------------------------------

Land use Landform Pattern, Element, Slope	Vegetation	Microrelief Disturbance Erosion	Surface condition, surface rock	Soil Profile Description									
				Horizon Depth (m), Boundary	Field Texture	Structure, Strength	Inclusions Segregations	Colour, Mottle, Bleaching	Moisture, Drainage	Roots	Depth (m) / Field pH	Sample (m)	Observations
Grazing Very gently undulating plain midslope 3.0/3.0	Sparse shrub species	Nil microrelief Nil disturbance Nil erosion	Soft, Nil coarse fragments	0.00-0.12 Abrupt	Sandy loam	Weak, soft <10mm sub- rounded	Nil inclusions and segregations	10YR3/1 Very dark gray Black Nil mottles/bleach	Moderate moist, rapid	Few fine	0.10 / 6.5	0.00-0.10 0.20-0.30 0.50-0.60 0.80-0.90 0.90-1.00	Nil additional observations

0.12-0.45 Abrupt	Light clay with minor sand	Moderate, firm <30mm sub- angular	Nil inclusions and segregations	10YR2/1 Black Nil mottles/bleach	Moderately moist, moderate	Very fine, very few	0.30 / 7.5

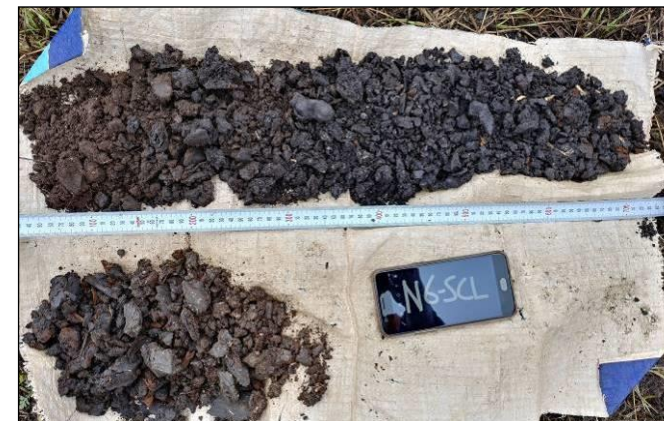
**Soil Profile**

Land use Landform Pattern, Element, Slope	Vegetation	Microrelief Disturbance Erosion	Surface condition, surface rock	Soil Profile Description									
				Horizon Depth (m), Boundary	Field Texture	Structure, Strength	Inclusions Segregations	Colour, Mottle, Bleaching	Moisture, Drainage	Roots	Depth (m) / Field pH	Sample (m)	Observations
Grazing Very gently undulating plain midslope 3.0/3.0	Buffel grass	Nil microrelief Semi disturbed Nil erosion	Cracking, soft Nil coarse fragments	A1 0.00-0.17 Abrupt	Clay Loam	Moderate, firm<30mm sub- angular	Nil inclusions and segregations	10YR3/2 Very dark grayish brown Nil mottles/bleach	Moderate moist, rapid	Few fine	0.10 / 7.0	0.00-0.10 0.20-0.30 0.50-0.60 0.77-0.87 0.90-1.00	Large root encountered at 0.60 mbgl
				B21 0.17-0.89 Abrupt	Medium clay	Moderate, firm<50mm sub- angular	5% calcium carbonate nodules	10YR3/1 Very dark gray Very dark gray Nil mottles/bleach	Dry, moderate	Very fine, very few	0.30 / 7.0 0.60 / 8.0

B22 0.89-1.00	Medium clay	Moderate, firm<50mm sub- angular	5% calcium carbonate nodules	10YR3/2 Very dark grayish brown Nil mottles/bleach	Dry, moderate	Very fine, very few	0.90 / 8.5

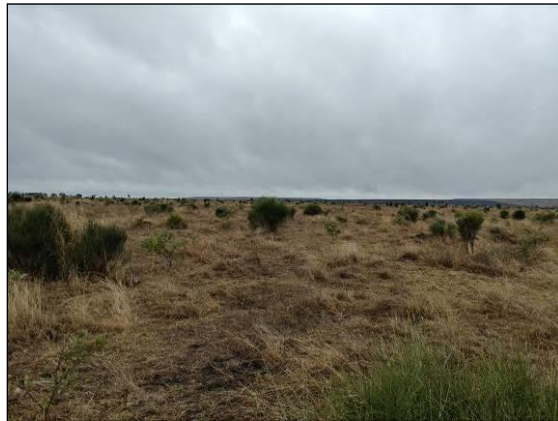
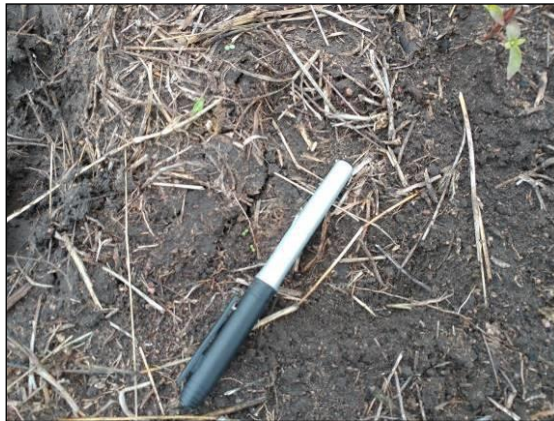
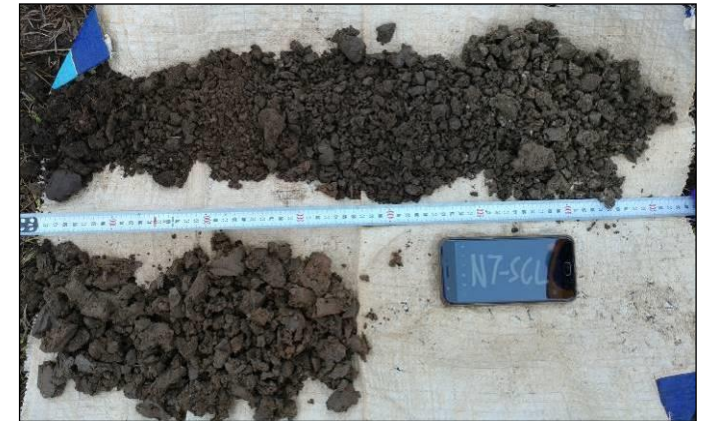
<b>Soil Mapping Unit</b> B2	<b>Location (GDA94 ZONE 56):</b> 643071mE 7514453mN	<b>Aust. Soil Class.:</b> Brown dermosol	<b>Site Survey Type:</b> Detailed - 50mm hand auger	<b>Survey Date:</b> 1/07/2018
--------------------------------	--	---	--	----------------------------------

Land use Landform Pattern, Element, Slope	Vegetation	Microrelief Disturbance Erosion	Surface condition, surface rock	Soil Profile Description									
				Horizon Depth (m), Boundary	Field Texture	Structure, Strength	Inclusions Segregations	Colour, Mottle, Bleaching	Moisture, Drainage	Roots	Depth (m) / Field pH	Sample (m)	Observations
Grazing Very gently undulating plain midslope 2.0/2.0	Buffel grass, nearby brigalow	Nil microrelief Nil disturbance Nil erosion	Firm, minor cracking, Nil coarse fragments	A1 0.00-0.15 Abrupt	Clay loam with minor sands	Moderate, firm<30mm sub- angular	Nil inclusions and segregations	10YR3/1 Very dark gray Black Nil mottles/bleach	Moderate moist, rapid	Few fine	0.10 / 6.5	0.00-0.10 0.20-0.30 0.50-0.60 0.80-0.90 0.90-1.00	Nil additional observations
				B21 0.15-0.50 Abrupt	Light clay with minor sands	Moderate, firm<50mm sub- angular	Nil inclusions and segregations	10YR3/1 Very dark gray Very dark gray Nil mottles/bleach	Dry, moderate	Very fine, very few	0.30 / 7.0

B22 0.50-0.70 Abrupt	Medium clay	Moderate, firm<50mm sub- angular	5% calcium carbonate nodules	10YR3/2 Very dark grayish brown Nil mottles/bleach	Dry, moderate	Very fine, very few	0.60 / 8.0		
				B23 0.70-1.00	Medium clay	Moderate, firm<50mm sub- angular	Nil inclusions and segregations	10YR3/2 Very dark grayish brown Nil mottles/bleach	Dry, moderate	Very fine, very few	0.90 / 8.0

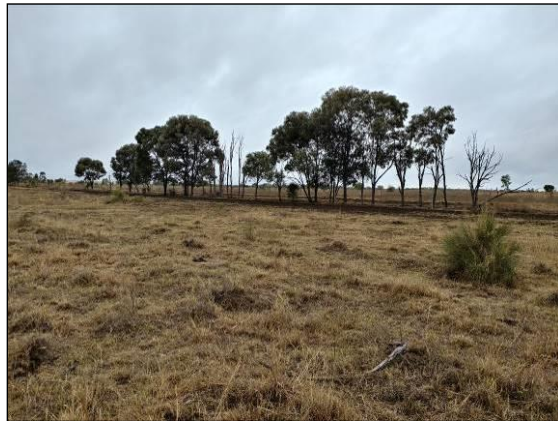
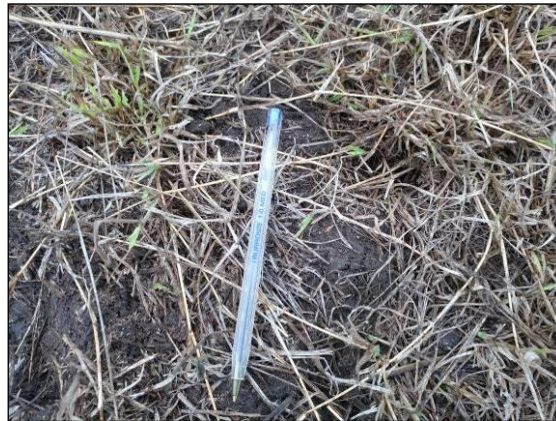
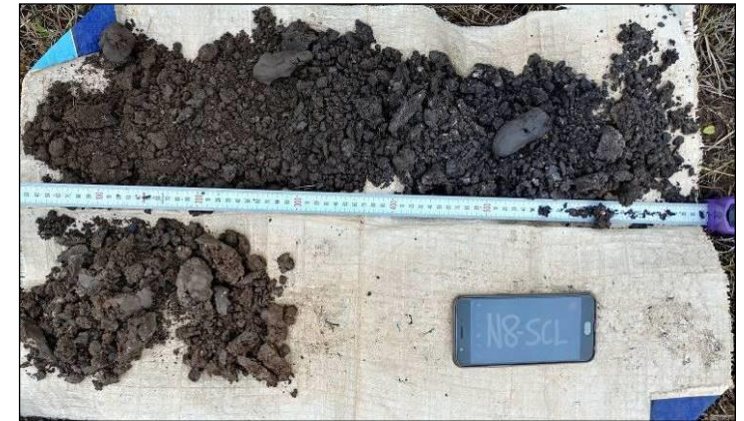
<b>Soil Mapping Unit</b> B2	<b>Location (GDA94 ZONE 56):</b> 642368mE 7513895mN	<b>Aust. Soil Class.:</b> Brown dermosol	<b>Site Survey Type:</b> Detailed - 50mm hand auger	<b>Survey Date:</b> 1/07/2018
--------------------------------	--	---	--	----------------------------------

Land use Landform Pattern, Element, Slope	Vegetation	Microrelief Disturbance Erosion	Surface condition, surface rock	Soil Profile Description									
				Horizon Depth (m), Boundary	Field Texture	Structure, Strength	Inclusions Segregations	Colour, Mottle, Bleaching	Moisture, Drainage	Roots	Depth (m) / Field pH	Sample (m)	Observations
Grazing Very gently undulating plain midslope 2.0/2.0	Buffel grass	Nil microrelief Extensively disturbed Nil erosion	Soft, cracking, <10% 10- 15mm coarse fragments	A11 0.00-0.17 Abrupt	Sandy clay loam	Moderate, soft, sub- rounded	Nil inclusions and segregations	10YR3/1 Very dark gray Black Nil mottles/bleach	Moderate moist, rapid	Few fine	0.10 / 7.0	0.00-0.10 0.20-0.30 0.50-0.60 0.80-0.90 0.90-1.00	Nil additional observations
				A12 0.17-0.37 Abrupt	Clay loam	Moderate, soft, sub- angular	Nil inclusions and segregations	10YR4/1 Dark gray Nil mottles/bleach	Dry, moderate	Very fine, very few	0.30 / 7.5

B21 0.37-0.70 Abrupt	Medium clay	Moderate, soft, sub- angular	<2% calcium carbonate nodules	10YR3/1 Very dark gray Nil mottles/bleach	Dry, moderate	Very fine, very few	0.60 / 7.0		
				B22 0.70-1.00	Medium clay	Moderate, soft, sub- angular	Nil inclusions and segregations	10YR4/2 Dark grayish brown Nil mottles/bleach	Dry, moderate	Very fine, very few	0.90 / 7.0

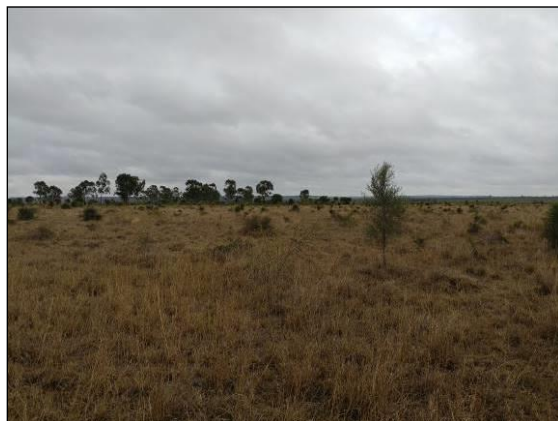
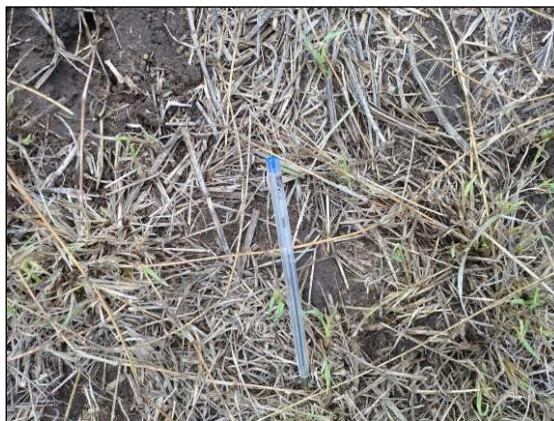
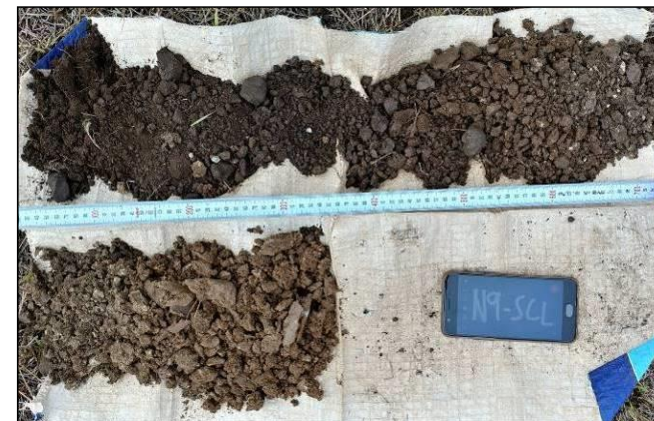
<b>Soil Mapping Unit</b> B2V	<b>Location (GDA94 ZONE 56):</b> 642032mE 7513619mN	<b>Aust. Soil Class.:</b> Brown Dermosol	<b>Site Survey Type:</b> Detailed - 50mm hand auger	<b>Survey Date:</b> 1/07/2018
---------------------------------	--	---	--	----------------------------------

Land use Landform Pattern, Element, Slope	Vegetation	Microrelief Disturbance Erosion	Surface condition, surface rock	Soil Profile Description									
				Horizon Depth (m), Boundary	Field Texture	Structure, Strength	Inclusions Segregations	Colour, Mottle, Bleaching	Moisture, Drainage	Roots	Depth (m) / Field pH	Sample (m)	Observations
Grazing Very gently undulating plain midslope 2.0/2.0	Buffel grass, Brigalow, and belah on fenceline, 100 m nearby	Nil microrelief Nil disturbed Nil erosion	Soft, moist, nil coarse fragments	0.00-0.09 Abrupt	Sandy loam	Weak, loose	Nil inclusions and segregations	10YR2/2 Very dark brown Nil mottles	Moderate moist, rapid	Few fine	0.10 / 6.5	0.00-0.10 0.20-0.30 0.55-0.65 0.75-0.85 0.90-1.00	Nil additional observations

0.09-0.35 Clear	Sandy Loam	Weak, loose	Nil inclusions and segregations	10YR2/1 Black Nil mottles	Dry, moderate	Very fine, very few	0.30 / 7.5		
				0.35-0.55 Abrupt	Medium clay	Moderate, strong, sub- angular <20 mm	Nil inclusions and segregations	10YR2/1 Black Nil mottles	Dry, moderate	Very fine, very few	-

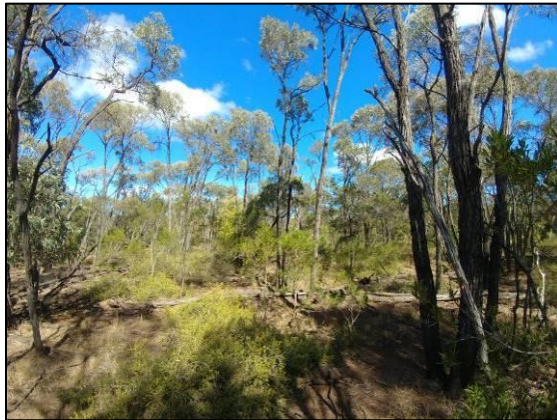
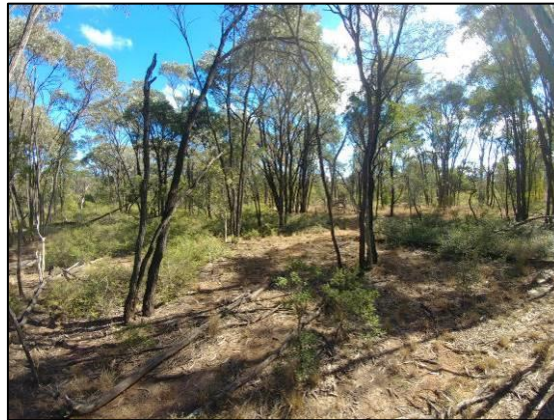
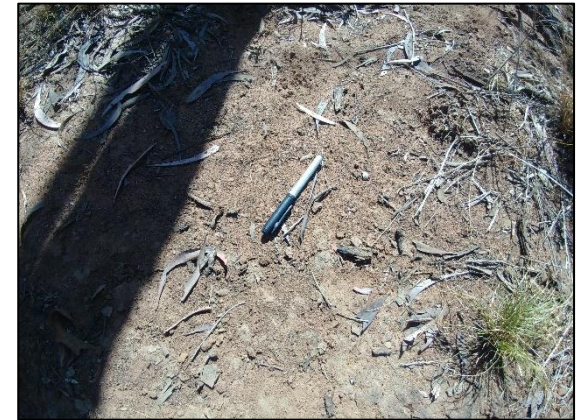
<b>Soil Mapping Unit</b> E1	<b>Location (GDA94 ZONE 56):</b> 632909 mE 7531055 mN	<b>Aust. Soil Class.:</b> Chromosol	<b>Site Survey Type:</b> Surface and landscape observation	<b>Survey Date:</b> 29/06/2018
--------------------------------	--	--	---	-----------------------------------

Land use Landform Pattern, Element, Slope	Vegetation	Microrelief Disturbance Erosion	Surface condition, surface rock	Soil Profile Description									
				Horizon Depth (m), Boundary	Texture	Structure, Strength	Inclusions Segregations	Colour, Mottle, Bleaching	Moisture, Drainage	Roots	Depth (m) / Field pH	Sample (m)	Observations
Grazing Very gently undulating plains Midslope 2%	Silver leaf ironbark, minor poplar box	Nil microrelief Nil disturbance Nil erosion	Sandy loam, no coarse fragments	-	-	-	-	-	-	-	-	N-	Nil additional observations

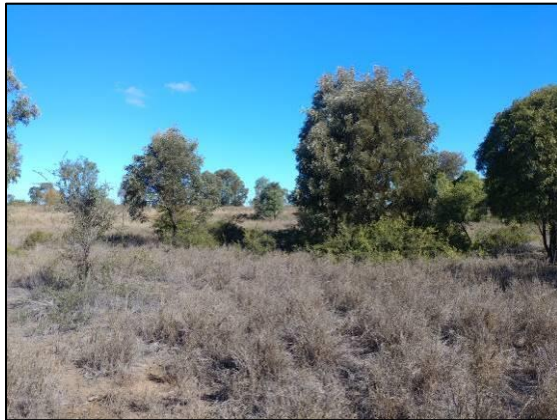
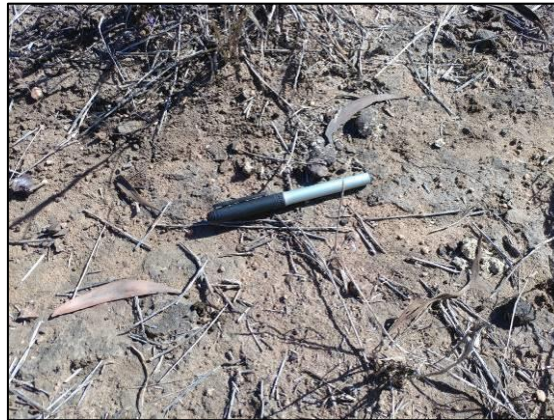
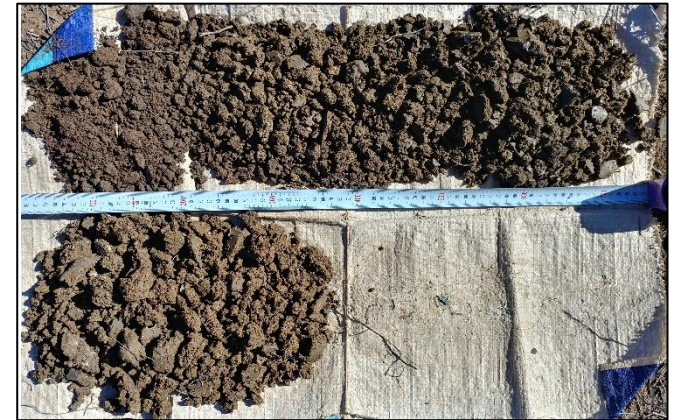
<b>Soil Mapping Unit</b> 5	<b>Location (GDA94 ZONE 56):</b> 628878 mE 7526555 mN	<b>Aust. Soil Class.:</b> Endohypersodic Brown Vertosol	<b>Site Survey Type:</b> Detailed - 50mm hand auger	<b>Survey Date:</b> 29/06/2018
-------------------------------	--	--	--	-----------------------------------

Land use Landform Pattern, Element, Slope	Vegetation	Microrelief Disturbance Erosion	Surface condition, surface rock	Soil Profile Description									
				Horizon Depth (m), Boundary	Texture	Structure, Strength	Inclusions Segregations	Colour, Mottle, Bleaching	Moisture, Drainage	Roots	Depth (m) / Field pH	Sample (m)	Observations
Very gently undulating, 2%	Mixed vegetation including brigalow	Nil microrelief Nil disturbance Nil erosion	Firm, some occasional 2-6mm cracking, very minor 6-10mm cracking	A1 0.0-0.20 Abrupt	Silty clay loam	Weak, firm	5% 2-6mm coarse fragments	10YR3/2 Very dark grey brown Nil mottles	Dry, moderate - imperfect	Few, fine	0.05 – 6.0	No samples	Nil additional observations
				B21 0.20-0.75 Abrupt	Medium clay	Moderate, strong, sub-angular 5-20mm	<2% calcium carbonate nodules <2% 2-6mm coarse fragments	10YR3/2 Very dark grey brown Nil mottles	Dry, moderate – imperfect	Very few, very fine	0.30 – 7.5 0.60 – 7.5

B22 0.75 – 10.00	Medium clay	Moderate, strong, sub-angular 5-20mm	-	10YR4/2 Nil mottles	Dry, moderate – imperfect	Very few, very fine	0.90 – 8.0

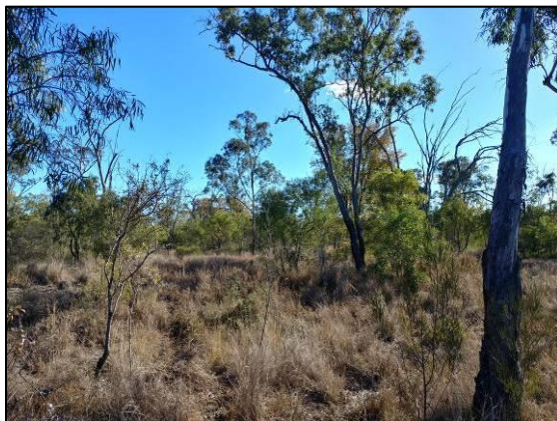
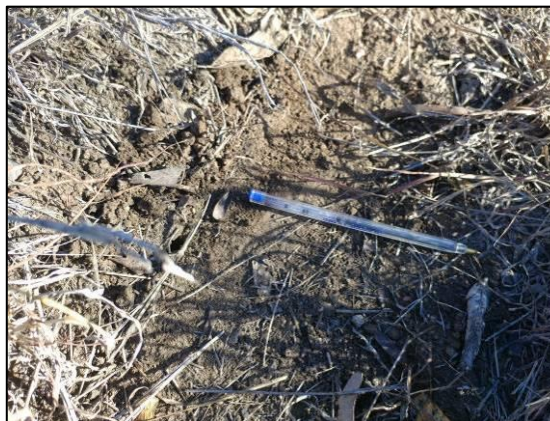
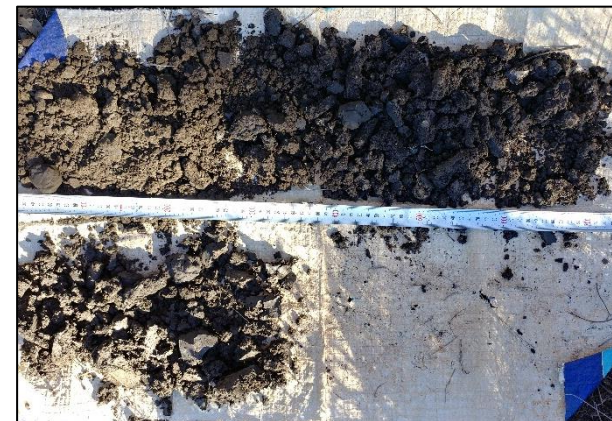
<b>Soil Mapping Unit</b> 5	<b>Location (GDA94 ZONE 56):</b> 627919 mE 7527968 mN	<b>Aust. Soil Class.:</b> Endohypersodic Brown Vertosol	<b>Site Survey Type:</b> Detailed - 50mm hand auger	<b>Survey Date:</b> 29/06/2018
-------------------------------	--	--	--	-----------------------------------

Land use Landform Pattern, Element, Slope	Vegetation	Microrelief Disturbance Erosion	Surface condition, surface rock	Soil Profile Description									
				Horizon Depth (m), Boundary	Texture	Structure, Strength	Inclusions Segregations	Colour, Mottle, Bleaching	Moisture, Drainage	Roots	Depth (m) / Field pH	Sample (m)	Observations
Grazing, Very gently undulating plains Midslope 1%	Eucalyptus species	Nil microrelief Very minor disturbance Nil erosion	Soft, no coarse fragments	A1 0-0.17 Abrupt	Silty clay loam	Weak, firm	Nil inclusions or segregations	10YR2/1 Nil mottles	Dry, imperfect	0.05 – 7.5	Few, very fine	No samples	Nil additional observations
				B2 0.17-1.00 End of borehole	Medium clay	Moderate, firm/strong	<2% calcium carbonate nodules	10YR2/1 Nil mottles	Dry, imperfect	0.30 – 7.5 0.60 – 7.5 0.90 – 7.5	Very fine, very few
