# Restoration Plan to Support RIDA Application Saraji East Project

Final V4  
15 July 2021

GT Environmental Pty Ltd  
[www.gtenvironmental.com.au](http://www.gtenvironmental.com.au)

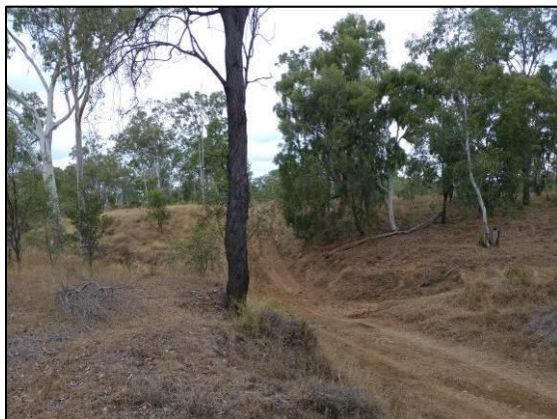
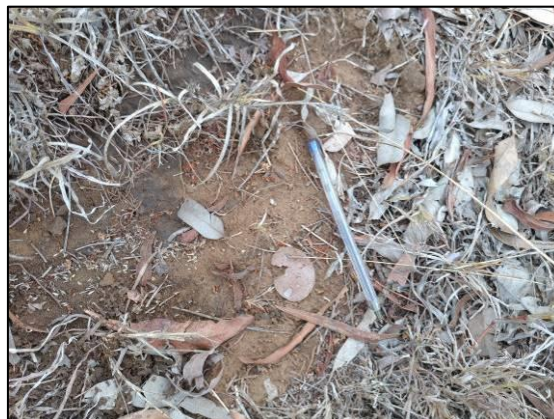
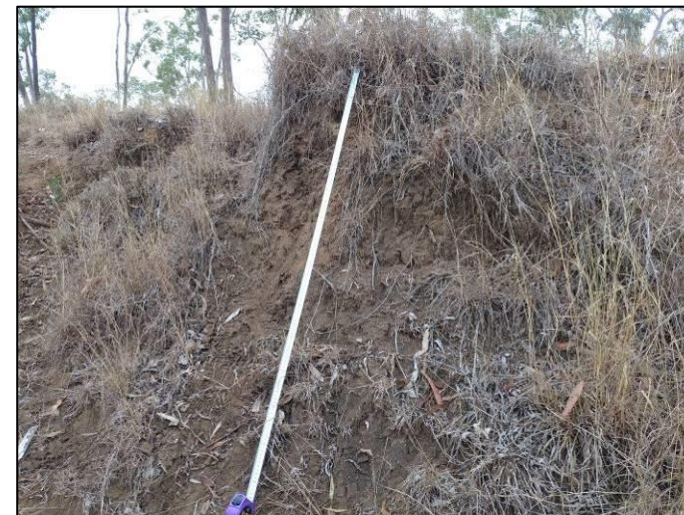
<b>Soil Mapping Unit</b> A1V	<b>Location (GDA94 ZONE 56):</b> 644413 mE 7506526 mN	<b>Aust. Soil Class.:</b> Red brown sodosol	<b>Site Survey Type:</b> Detailed – exposed soil profile	<b>Survey Date:</b> 1/07/2018
---------------------------------	--	--	---	----------------------------------

Land use Landform Pattern, Element, Slope	Vegetation	Microrelief Disturbance Erosion	Surface condition, surface rock	Soil Profile Description									
				Horizon Depth (m), Boundary	Texture	Structure, Strength	Inclusions Segregations	Colour, Mottle, Bleaching	Moisture, Drainage	Roots	Depth (m) / Field pH	Sample (m)	Observations
Drainage line	Poplar Box, Eucalyptus species	Nil microrelief Nil disturbance Gully erosion	Firm, nil coarse fragments	0.00-0.25 Abrupt	Sandy loam	Weak, massive	Nil inclusions and segregations	10YR4/2  Nil mottles	Dry, rapid	Few fine	0.10 / 6.5	Nil samples	Nil additional observations

0.25-0.70 Abrupt	Silty clay loam	Weak, massive	Nil inclusions and segregations	7.5YR4/2 Brown Nil mottles	Dry, rapid	Few fine	0.30 / 6.5 0.60 / 6.5

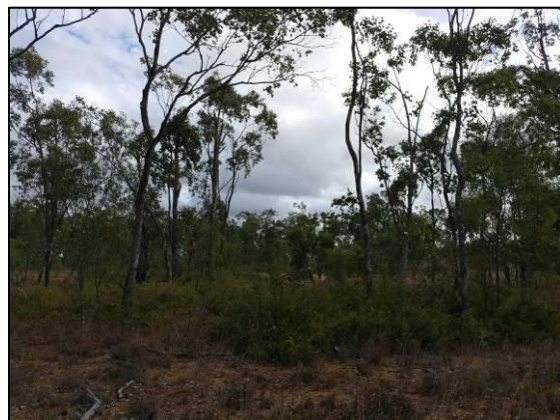
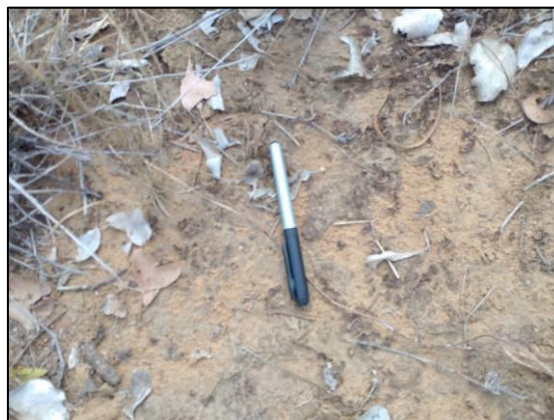
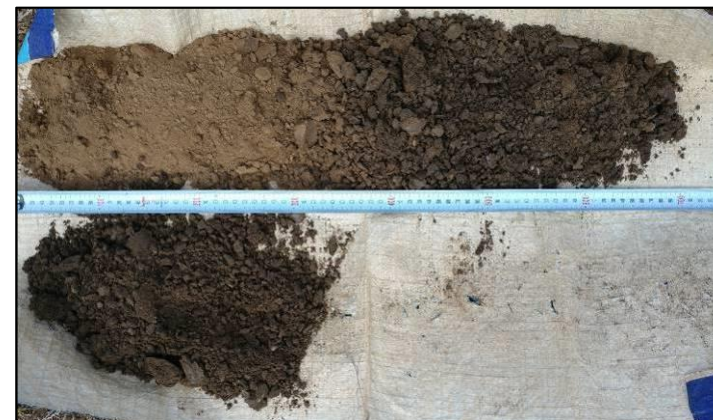
<b>Soil Mapping Unit</b> A1V	<b>Location (GDA94 ZONE 56):</b> 644354 mE 7506225 mN	<b>Aust. Soil Class.:</b> Brown sodosol	<b>Site Survey Type:</b> Detailed - 50mm hand auger	<b>Survey Date:</b> 1/07/2018
---------------------------------	--	--	--	----------------------------------

Land use Landform Pattern, Element, Slope	Vegetation	Microrelief Disturbance Erosion	Surface condition, surface rock	Soil Profile Description									
				Horizon Depth (m), Boundary	Texture	Structure, Strength	Inclusions Segregations	Colour, Mottle, Bleaching	Moisture, Drainage	Roots	Depth (m) / Field pH	Sample (m)	Observations
Grazing Very gently undulating plain midslope 1.0/2.0	Poplar Box	Nil microrelief Nil disturbance Nil erosion	Firm to hard setting, nil coarse fragments	0.00-0.27 Abrupt	Sandy loam	Weak, massive	Nil inclusions and segregations	10YR4/2  Nil mottles	Dry, rapid	Very fine, very few	0.10 / 6.5	Nil samples	Nil additional observations

0.27-0.68 Abrupt	Light clay	Moderate, firm<30mm sub- angular	Nil inclusions and segregations	7.5YR4/2 Brown Nil mottles	Dry, rapid	Very fine, very few	0.30 / 6.5 0.60 / 6.5

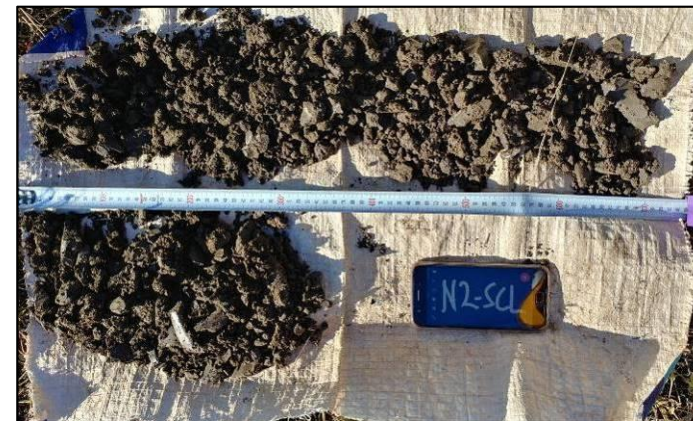
**Soil Profile**

Land use Landform Pattern, Element, Slope	Vegetation	Microrelief Disturbance Erosion	Surface condition, surface rock	Soil Profile Description									
				Horizon Depth (m), Boundary	Field Texture	Structure, Strength	Inclusions Segregations	Colour, Mottle, Bleaching	Moisture, Drainage	Roots	Depth (m) / Field pH	Sample (m)	Observations
Grazing Very gently undulating plain 2.0/1.0	Various shrubs	Nil microrelief Nil disturbance Nil erosion	Cracking 2- 6mm, crust Nil coarse fragments	A1 0.00-0.14 Abrupt	Light clay	Moderate, soft <10mm sub- angular	Nil inclusions and segregations	10YR3/1 Very dark grey Nil mottles/bleach	Moderate moist, moderate	Few fine	0.10 / 6.0	0.00-0.10 0.20-0.30 0.50-0.60 0.80-0.90 0.90-1.00	Nil additional observations
				B2 0.14-1.00	Medium clay	Moderate, firm <10mm sub- angular	<2% black nodules	10YR4/2 Dark greyish brown Nil mottles/bleach	Dry, moderate	Very fine, very few	0.30 / 6.5 0.60 / 7.0 0.90 / 7.5

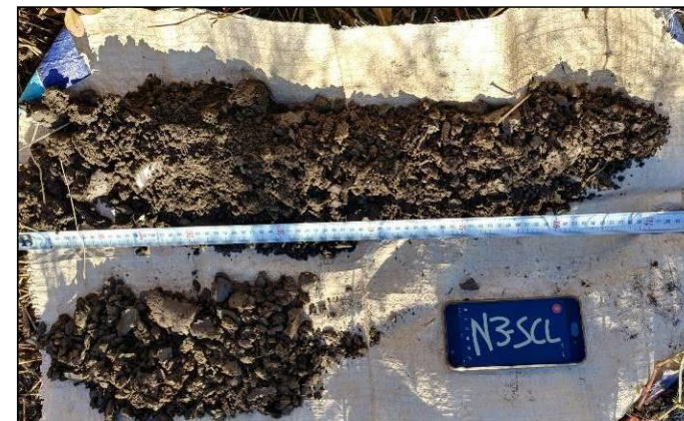
**Soil Profile**

Land use Landform Pattern, Element, Slope	Vegetation	Microrelief Disturbance Erosion	Surface condition, surface rock	Soil Profile Description									
				Horizon Depth (m), Boundary	Field Texture	Structure, Strength	Inclusions Segregations	Colour, Mottle, Bleaching	Moisture, Drainage	Roots	Depth (m) / Field pH	Sample (m)	Observations
Grazing Very gently undulating plain 2.0/1.0	Various shrubs	Nil microrelief Nil disturbance Nil erosion	Crusting with cracking 2- 6mm, Nil coarse fragments	A1 0.00-0.16 Abrupt	Light clay	Moderate, soft <10mm sub- angular	Nil inclusions and segregations	10YR3/1 Very dark grey Nil mottles/bleach	Moderate moist, moderate	Few fine	0.10 / 6.0	0.00-0.10 0.20-0.30 0.50-0.60 0.80-0.90 0.90-1.00	Nil additional observations
				B2 0.16-1.00	Medium clay	Moderate, firm <10mm sub- angular	<2% black nodules	10YR4/2 Dark greyish brown Nil mottles/bleach	Dry, moderate	Very fine, very few	0.30 / 6.5 0.60 / 7.0 0.90 / 7.5

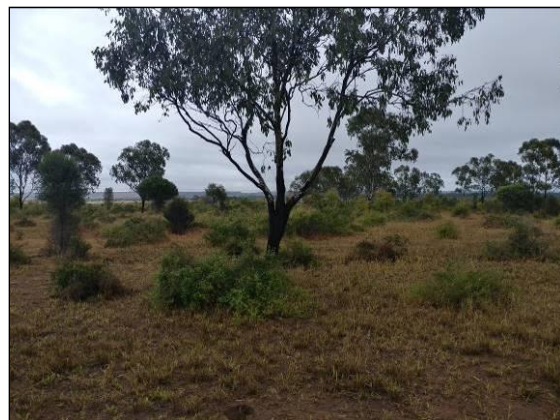
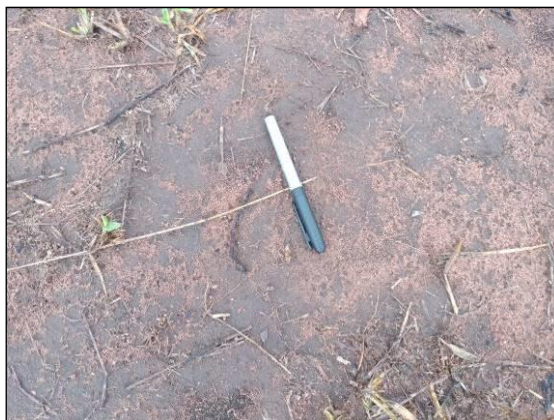
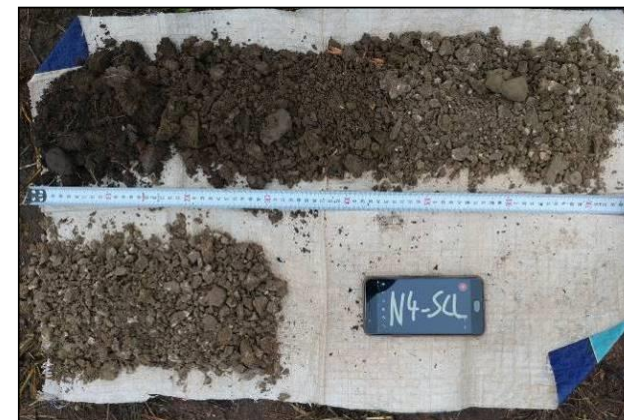
<b>Map Unit</b> B2g	<b>Location (GDA94 ZONE 55):</b> 641871mE 7513601mN	<b>Aust. Soil Class.:</b> Black chromosol (with minor grey chromosol variant)	<b>Site Survey Type:</b> Detailed - 50mm hand auger	<b>Survey Date:</b> 1/07/2018
------------------------	--	--	--	----------------------------------

Land use Landform Pattern, Element, Slope	Vegetation	Microrelief Disturbance Erosion	Surface condition, surface rock	Soil Profile Description									
				Horizon Depth (m), Boundary	Field Texture	Structure, Strength	Inclusions Segregations	Colour, Mottle, Bleaching	Moisture, Drainage	Roots	Depth (m) / Field pH	Sample (m)	Observations
Grazing Very gently undulating plain 2.0/1.0	Eucalyptus species	Nil microrelief Semi disturbed Nil erosion	Soft, <5% 2-6mm coarse fragments	A1 0.00-0.17 Abrupt	Sandy loam	Weak, soft <10mm sub- rounded	Nil inclusions and segregations	10YR3/2 Very dark greyish brown Nil mottles/bleach	Moderate moist, rapid	Few fine	0.10 / 6.0	0.00-0.10 0.20-0.30 0.50-0.60 0.80-0.90 0.90-1.00	Nil additional observations
				B21 0.17-0.44 Abrupt	Light clay with minor sand	Moderate, firm <30mm sub- angular	<2% pale red nodules	10YR4/2 Dark greyish brown Nil mottles/bleach	Moderately moist, moderate	Very fine, very few	0.30 / 7.5

B22 0.44-1.00 EOBH	Medium clay	Moderate, firm <30mm sub- angular	10-15% calcium carbonate nodules	10YR5/3 Brown Nil mottles/bleach	Dry, moderate	Very fine, very few	0.60 / 7.5 0.90 / 7.5

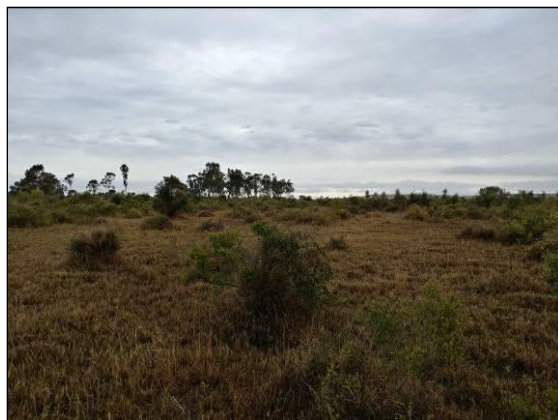
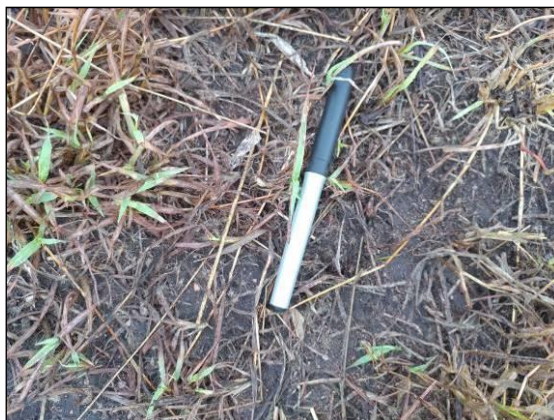
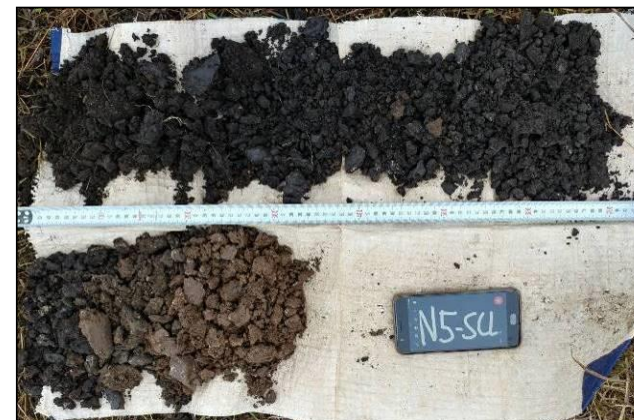
<b>Map Unit</b> B2g	<b>Location (GDA94 ZONE 55):</b> 641792mE 7513825mN	<b>Aust. Soil Class.:</b> Black chromosol (with minor grey chromosol variant)	<b>Site Survey Type:</b> Detailed - 50mm hand auger	<b>Survey Date:</b> 1/07/2018
------------------------	--	--	--	----------------------------------

Land use Landform Pattern, Element, Slope	Vegetation	Microrelief Disturbance Erosion	Surface condition, surface rock	Soil Profile Description									
				Horizon Depth (m), Boundary	Field Texture	Structure, Strength	Inclusions Segregations	Colour, Mottle, Bleaching	Moisture, Drainage	Roots	Depth (m) / Field pH	Sample (m)	Observations
Grazing Very gently undulating plain midslope 3.0/3.0	Sparse shrub species	Nil microrelief Nil disturbance Nil erosion	Soft, Nil coarse fragments	A1 0.00-0.12 Abrupt	Sandy loam	Weak, soft <10mm sub-rounded	Nil inclusions and segregations	10YR3/1 Very dark grey Nil mottles/bleach	Moderate moist, rapid	Few fine	0.10 / 6.5	0.00-0.10	Nil additional observations
				B21 0.12-0.45 Abrupt	Light clay with minor sand	Moderate, firm <30mm sub-angular	Nil inclusions and segregations	10YR2/1 Black Nil mottles/bleach	Moderately moist, moderate	Very fine, very few	0.30 / 7.5	0.20-0.30

B22 0.45-0.80 Abrupt	Medium clay	Moderate, firm <30mm sub-angular	2% calcium carbonate nodules	10YR2/1 Black Nil mottles/bleach	Dry, moderate	Very fine, very few	0.60 / 8.0	0.50-0.60	
				B23 0.80-1.00	Medium clay	Moderate, strong <30mm sub-angular	2% calcium carbonate nodules	10YR3/3 Dark brown Nil mottles/bleach	Dry, moderate	Very fine, very few	0.90 / 8.0	0.80-0.90 0.90-1.00

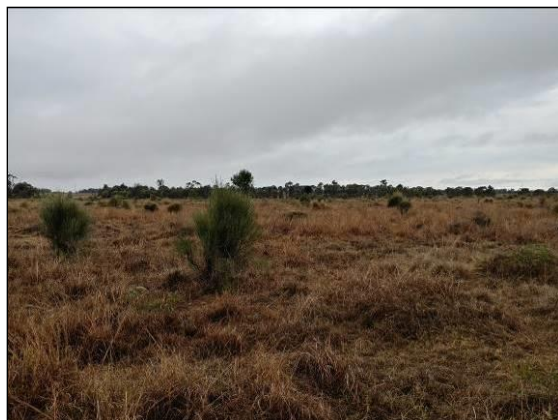
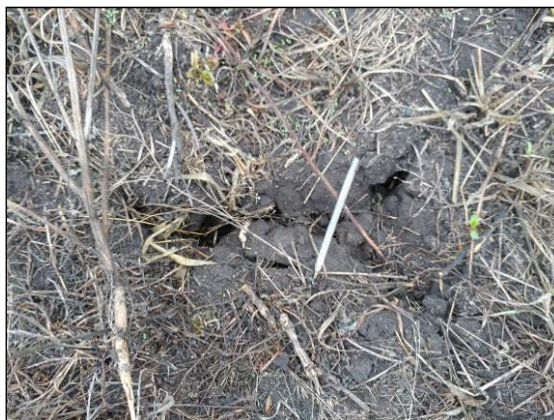
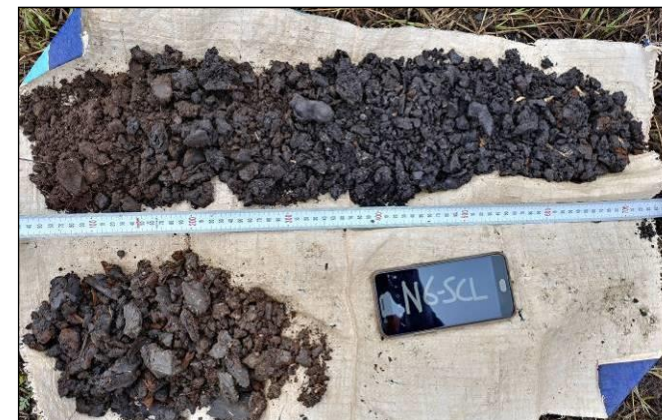
<b>Map Unit</b> B2g	<b>Location (GDA94 ZONE 55):</b> 643271mE 7514881mN	<b>Aust. Soil Class.:</b> Black chromosol (with minor grey chromosol variant)	<b>Site Survey Type:</b> Detailed - 50mm hand auger	<b>Survey Date:</b> 1/07/2018
------------------------	--	--	--	----------------------------------

Land use Landform Pattern, Element, Slope	Vegetation	Microrelief Disturbance Erosion	Surface condition, surface rock	Soil Profile Description									
				Horizon Depth (m), Boundary	Field Texture	Structure, Strength	Inclusions Segregations	Colour, Mottle, Bleaching	Moisture, Drainage	Roots	Depth (m) / Field pH	Sample (m)	Observations
Grazing Very gently undulating plain midslope 3.0/3.0	Buffel grass	Nil microrelief Semi disturbed Nil erosion	Cracking, soft Nil coarse fragments	A1 0.00-0.17 Abrupt	Clay Loam	Moderate, firm<30mm sub- angular	Nil inclusions and segregations	10YR3/2 Very dark greyish brown Nil mottles/bleach	Moderate moist, rapid	Few fine	0.10 / 7.0	0.00-0.10 0.20-0.30 0.50-0.60 0.77-0.87 0.90-1.00	Large root encountered at 0.60 mbgl
				B21 0.17-0.89 Abrupt	Medium clay	Moderate, firm<50mm sub- angular	5% calcium carbonate nodules	10YR3/1 Very dark grey Very dark grey Nil mottles/bleach	Dry, moderate	Very fine, very few	0.30 / 7.0 0.60 / 8.0

B22 0.89-1.00	Medium clay	Moderate, firm<50mm sub- angular	5% calcium carbonate nodules	10YR3/2 Very dark greyish brown Nil mottles/bleach	Dry, moderate	Very fine, very few	0.90 / 8.5

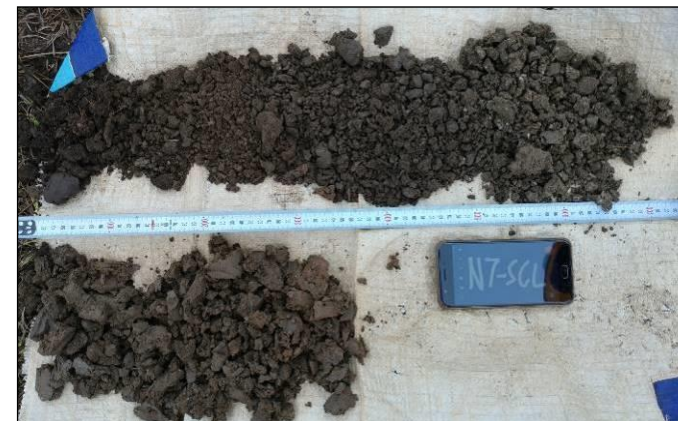
**Soil Profile**

Land use Landform Pattern, Element, Slope	Vegetation	Microrelief Disturbance Erosion	Surface condition, surface rock	Soil Profile Description									
				Horizon Depth (m), Boundary	Field Texture	Structure, Strength	Inclusions Segregations	Colour, Mottle, Bleaching	Moisture, Drainage	Roots	Depth (m) / Field pH	Sample (m)	Observations
Grazing Very gently undulating plain midslope 2.0/2.0	Buffel grass, nearby brigalow	Nil microrelief Nil disturbance Nil erosion	Firm, minor cracking, Nil coarse fragments	A1 0.00-0.15 Abrupt	Clay loam with minor sands	Moderate, firm<30mm sub- angular	Nil inclusions and segregations	10YR3/1 Very dark grey Black Nil mottles/bleach	Moderate moist, rapid	Few fine	0.10 / 6.5	0.00-0.10 0.20-0.30 0.50-0.60 0.80-0.90 0.90-1.00	Nil additional observations
				B21 0.15-0.50 Abrupt	Light clay with minor sands	Moderate, firm<50mm sub- angular	Nil inclusions and segregations	10YR3/1 Very dark grey Nil mottles/bleach	Dry, moderate	Very fine, very few	0.30 / 7.0

B22 0.50-0.70 Abrupt	Medium clay	Moderate, firm<50mm sub- angular	5% calcium carbonate nodules	10YR3/2 Very dark greyish brown Nil mottles/bleach	Dry, moderate	Very fine, very few	0.60 / 8.0		
				B23 0.70-1.00	Medium clay	Moderate, firm<50mm sub- angular	Nil inclusions and segregations	10YR3/2 Very dark greyish brown Nil mottles/bleach	Dry, moderate	Very fine, very few	0.90 / 8.0

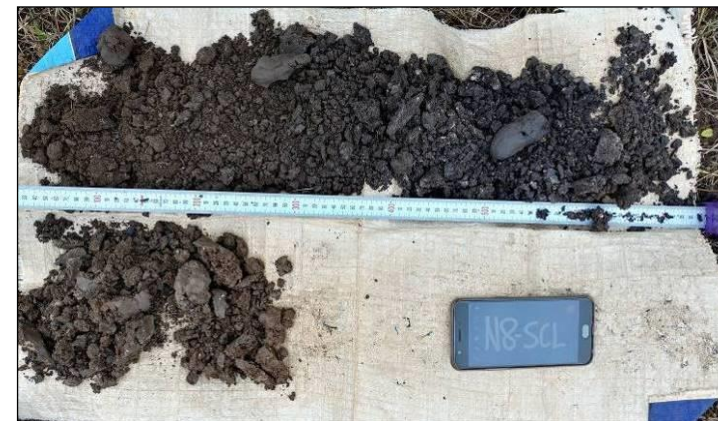
**Soil Profile**

Land use Landform Pattern, Element, Slope	Vegetation	Microrelief Disturbance Erosion	Surface condition, surface rock	Soil Profile Description									
				Horizon Depth (m), Boundary	Field Texture	Structure, Strength	Inclusions Segregations	Colour, Mottle, Bleaching	Moisture, Drainage	Roots	Depth (m) / Field pH	Sample (m)	Observations
Grazing Very gently undulating plain midslope 2.0/2.0	Buffel grass	Nil microrelief Extensively disturbed Nil erosion	Soft, cracking, <10% 10- 15mm coarse fragments	A11 0.00-0.17 Abrupt	Sandy clay loam	Moderate, soft, sub- rounded	Nil inclusions and segregations	10YR3/1 Very dark grey Black Nil mottles/bleach	Moderate moist, rapid	Few fine	0.10 / 7.0	0.00-0.10 0.20-0.30 0.50-0.60 0.80-0.90 0.90-1.00	Nil additional observations
				A12 0.17-0.37 Abrupt	Clay loam	Moderate, soft, sub- angular	Nil inclusions and segregations	10YR4/1 Dark grey Nil mottles/bleach	Dry, moderate	Very fine, very few	0.30 / 7.5

B21 0.37-0.70 Abrupt	Medium clay	Moderate, soft, sub- angular	<2% calcium carbonate nodules	10YR3/1 Very dark grey Nil mottles/bleach	Dry, moderate	Very fine, very few	0.60 / 7.0		
				B22 0.70-1.00	Medium clay	Moderate, soft, sub- angular	Nil inclusions and segregations	10YR4/2 Dark greyish brown Nil mottles/bleach	Dry, moderate	Very fine, very few	0.90 / 7.0

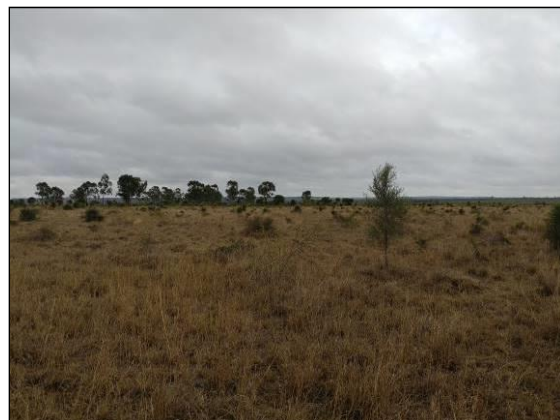
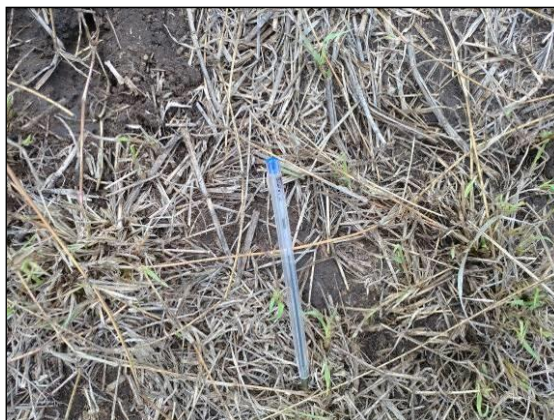
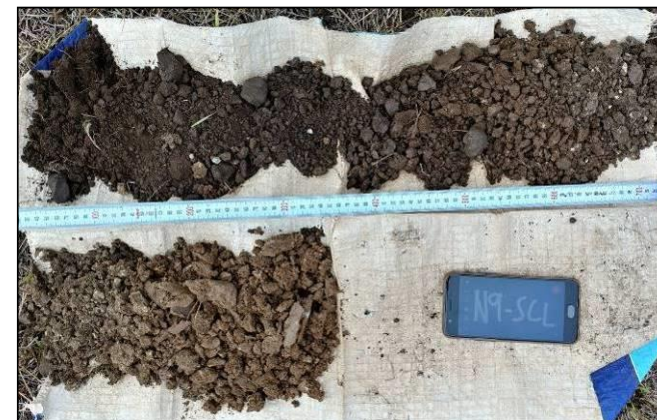
Land use Landform Pattern, Element, Slope	Vegetation	Microrelief Disturbance Erosion	Surface condition, surface rock	Soil Profile Description									
				Horizon Depth (m), Boundary	Field Texture	Structure, Strength	Inclusions Segregations	Colour, Mottle, Bleaching	Moisture, Drainage	Roots	Depth (m) / Field pH	Sample (m)	Observations
Very gently undulating plain mid slope 2.0/2.0	Buffel grass, Brigalow, and belah on fence line, 100 m nearby	Nil microrelief Nil disturbed Nil erosion	Soft, moist, nil coarse fragments	A11 0.00-0.09 Abrupt	Sandy loam	Weak, loose	Nil inclusions and segregations	10YR2/2 Very dark brown Nil mottles	Moderate moist, rapid	Few fine	0.10 / 6.5	0.00-0.10 0.20-0.30 0.55-0.65 0.75-0.85 0.90-1.00	Nil additional observations
				A12 0.09-0.35 Clear	Sandy Loam	Weak, loose	Nil inclusions and segregations	10YR2/1 Black Nil mottles/bleach	Dry, moderate	Very fine, very few	0.30 / 7.5

B21 0.35-0.55 Abrupt	Medium clay	Moderate, strong, sub-angular <20 mm	Nil inclusions and segregations	10YR2/1 Black Nil mottles/bleach	Dry, moderate	Very fine, very few	-		
				B22 0.55-0.85 Abrupt	Medium clay	Moderate, strong, sub-angular <20 mm	<2% calcium carbonate nodules	10YR2/1 Black Nil mottles/bleach	Dry, moderate	-	0.60 / 8.5		
				B23 0.85-1.00	Medium clay	Moderate, strong, sub-angular <20 mm	Nil inclusions and segregations	10YR3/3 Dark brown Nil mottles/bleach	Dry, moderate	-	0.90 / 7.5

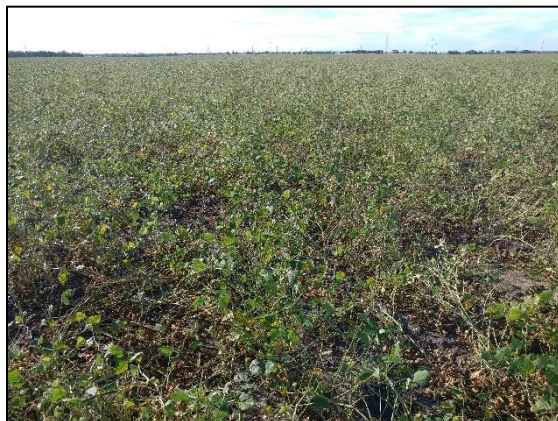
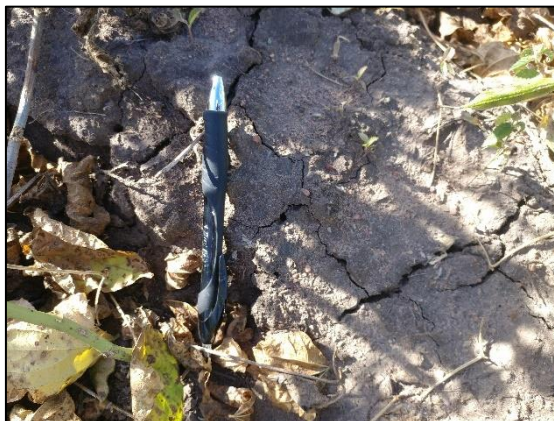
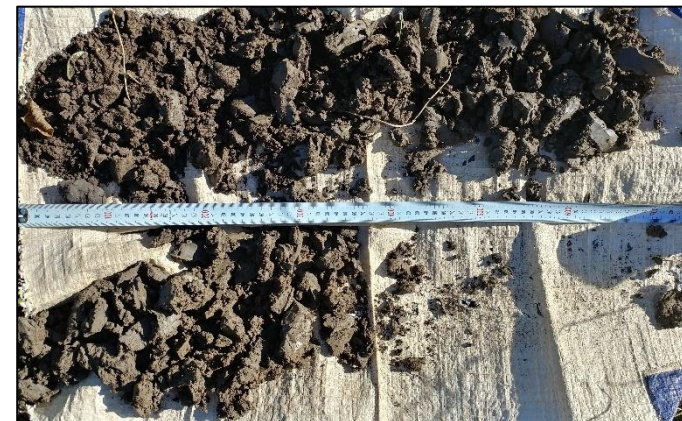
<b>Map Unit</b> B1	<b>Location (GDA94 ZONE 55):</b> 641522mE 7510593mN	<b>Aust. Soil Class.:</b> Black Vertosol	<b>Site Survey Type:</b> Detailed - 50mm hand auger	<b>Survey Date:</b> 04/06/2019
-----------------------	--	---	--	-----------------------------------

Land use Landform Pattern, Element, Slope	Vegetation	Microrelief Disturbance Erosion	Surface condition, surface rock	Soil Profile Description									
				Horizon Depth (m), Boundary	Field Texture	Structure, Strength	Inclusions Segregations	Colour, Mottle, Bleaching	Moisture, Drainage	Roots	Depth (m) / Field pH	Sample (m)	Observations
Cropping, Very gently undulating plain, mid-slope, 1% slope	Forage crops	Nil microrelief Extensively disturbed for cropping Nil erosion	Self-mulching with crust 2-6 mm thick, minor sand on surface. Coarse fragments <5 mm <5%	A1 0.00 – 0.12 Abrupt	Light clay, sandy	Subangular blocky, peds 10-30 mm, firm	Nil inclusions and segregations	10YR2/1 Black Nil mottles / bleaching	Humid, well drained	Fine, very few	0.10 / 7.0	0.00-0.10 0.20-0.30 0.50-0.60 0.80-0.90 0.90-1.00	Nil additional observations
				B21 0.12 – 0.68 Abrupt	Medium heavy clay	Subangular blocky, peds 20-30 mm, strong	<5% calcium carbonate	10YR2/1 Black Nil mottles / bleaching	Humid, well drained	Fine, very few	0.30 / 7.0 0.60 / 6.5

B22 0.68 – 1.00 EOBH	Medium heavy clay, sandy	Subangular blocky, peds 40-60 mm, strong	<1% red nodules <2mm	10YR3/1 Very dark grey Nil mottles / bleaching	Humid, well drained	Nil	0.90 / 6.5

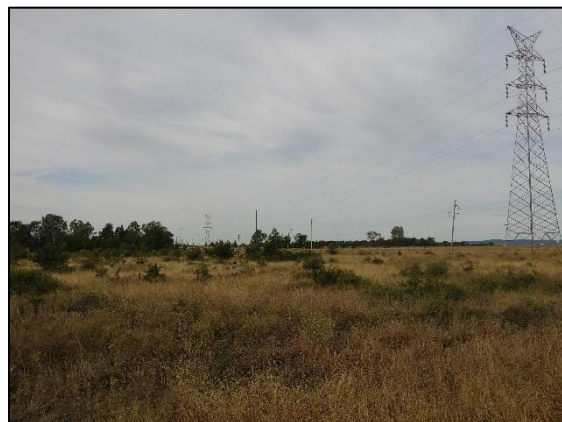
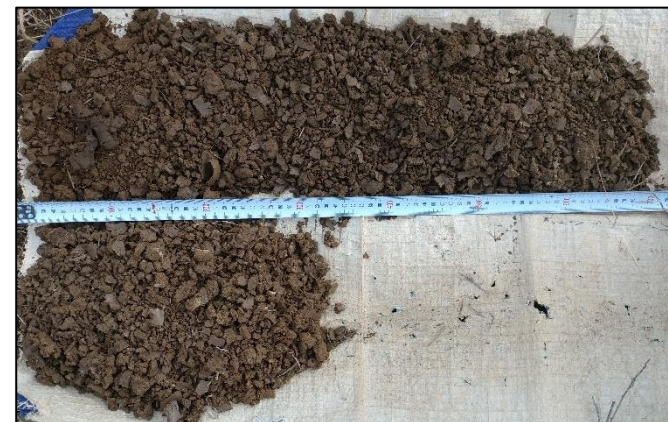
<b>Map Unit</b> B2s	<b>Location (GDA94 ZONE 55):</b> 640984mE 7512975mN	<b>Aust. Soil Class.:</b> Black chromosol	<b>Site Survey Type:</b> Detailed - 50mm hand auger	<b>Survey Date:</b> 05/06/2019
------------------------	--	--	--	-----------------------------------

Land use Landform Pattern, Element, Slope	Vegetation	Microrelief Disturbance Erosion	Surface condition, surface rock	Soil Profile Description									
				Horizon Depth (m), Boundary	Field Texture	Structure, Strength	Inclusions Segregations	Colour, Mottle, Bleaching	Moisture, Drainage	Roots	Depth (m) / Field pH	Sample (m)	Observations
GUP Mid-slope	Grasses	Nil microrelief Semi disturbance Nil erosion	Cracking, Nil coarse fragments	A1 0.00-0.11 Abrupt	Sandy clay loam	Weak to moderate. Soft, sub rounded <10mm	Nil inclusions and segregations	10YR3/2 Very dark greyish brown Nil mottles/bleaching	Dry, well	Present	0.10 / 7.0	0.00-0.10 0.20-0.30 0.50-0.60 0.80-0.90 0.90-1.00	Nil additional observations
				B21 0.11-0.62 gradual	Light clay	Weak to moderate. Firm, sub rounded <20mm	Nil inclusions and segregations	10YR3/2 Very dark greyish brown Nil mottles/bleaching	Dry, moderate – well	Present	0.30 / 7.5 0.60 / 7.5

B22 0.62-1.00 EOBH	Light clay	Weak to moderate. Firm, sub rounded <20mm	Nil inclusions and segregations	10YR3/2 Very dark greyish brown Nil mottles/bleaching	Dry, moderate – well	Present	0.90 / 7.5

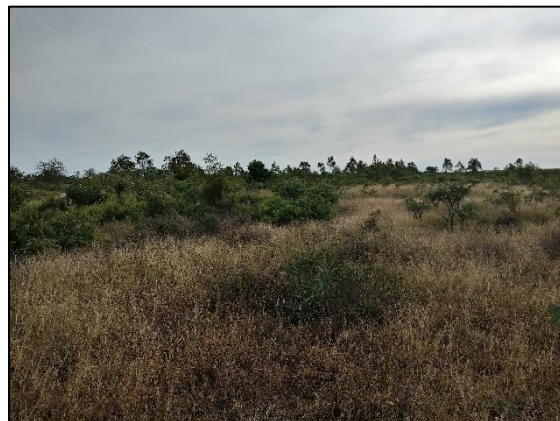
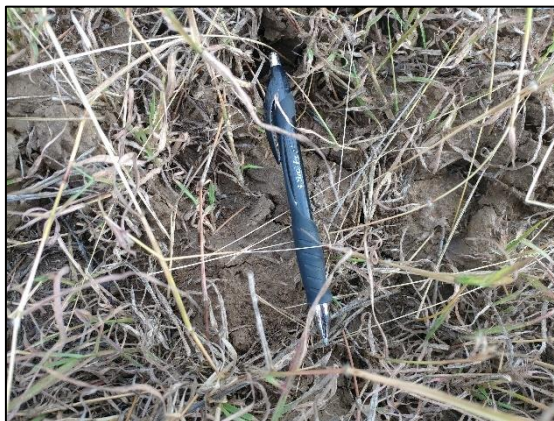
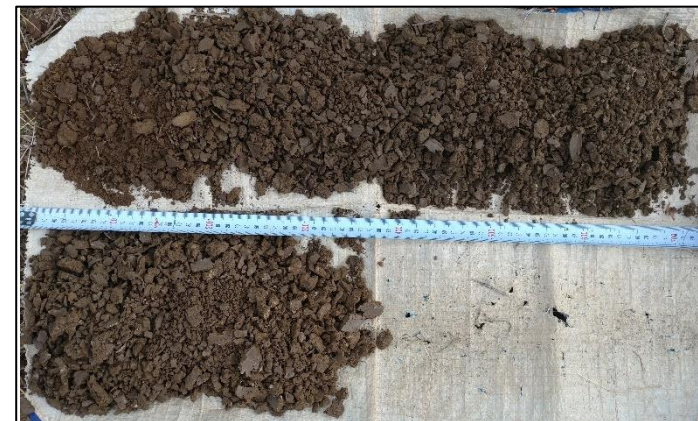
<b>Map Unit</b> B2s	<b>Location (GDA94 ZONE 55):</b> 640940mE 7512735mN	<b>Aust. Soil Class.:</b> Black chromosol	<b>Site Survey Type:</b> Detailed - 50mm hand auger	<b>Survey Date:</b> 05/06/2019
------------------------	--	--	--	-----------------------------------

Land use Landform Pattern, Element, Slope	Vegetation	Microrelief Disturbance Erosion	Surface condition, surface rock	Soil Profile Description									
				Horizon Depth (m), Boundary	Field Texture	Structure, Strength	Inclusions Segregations	Colour, Mottle, Bleaching	Moisture, Drainage	Roots	Depth (m) / Field pH	Sample (m)	Observations
GUP Mid-slope <2.0/<2.0	Grasses	Nil microrelief Extensive disturbance Nil erosion	Cracking, Nil coarse fragments	A1 0.00-0.15 Abrupt	Sandy clay loam	Weak to moderate. Soft, sub rounded <10mm	Nil inclusions and segregations	10YR3/2 Very dark greyish brown Nil mottles/bleaching	Dry, well	Present	0.10 / 7.0	0.00-0.10 0.20-0.30 0.50-0.60 0.80-0.90 0.90-1.00	Nil additional observations
				B21 0.15-0.75 gradual	Light clay	Weak to moderate. Firm, sub rounded <20mm	Nil inclusions and segregations	10YR3/2 Very dark greyish brown Nil mottles/bleaching	Dry, moderate – well	Present	0.30 / 7.5 0.60 / 7.5

B22 0.75-1.00 EOBH	Light clay	Weak to moderate. Firm, sub rounded <20mm	Nil inclusions and segregations	10YR3/2 Very dark greyish brown Nil mottles/bleaching	Dry, moderate – well	Present	0.90 / 7.5

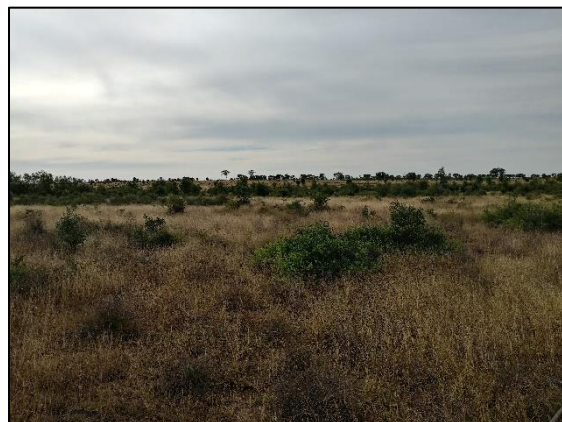
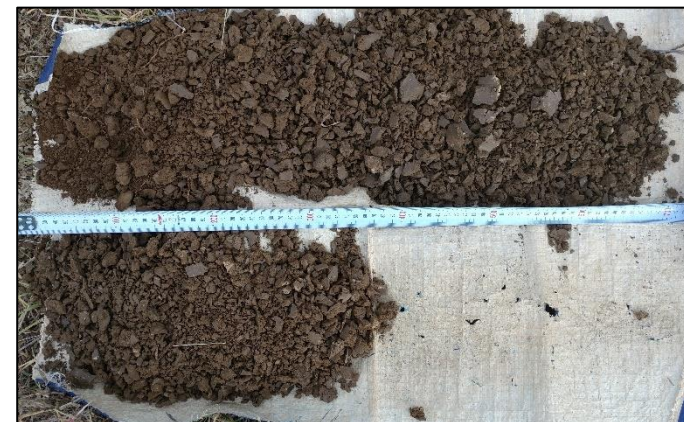
<b>Map Unit</b> B2s	<b>Location (GDA94 ZONE 55):</b> 640810mE 7512936mN	<b>Aust. Soil Class.:</b> Black chromosol	<b>Site Survey Type:</b> Detailed - 50mm hand auger	<b>Survey Date:</b> 05/06/2019
------------------------	--	--	--	-----------------------------------

Land use Landform Pattern, Element, Slope	Vegetation	Microrelief Disturbance Erosion	Surface condition, surface rock	Soil Profile Description									
				Horizon Depth (m), Boundary	Field Texture	Structure, Strength	Inclusions Segregations	Colour, Mottle, Bleaching	Moisture, Drainage	Roots	Depth (m) / Field pH	Sample (m)	Observations
GUP Mid-slope	Grasses	Nil microrelief Extensive disturbance Nil erosion	Cracking, Nil coarse fragments	A1 0.00-0.15 Abrupt	Sandy clay loam	Weak to moderate. Soft, sub rounded <10mm	Nil inclusions and segregations	10YR3/2 Very dark greyish brown Nil mottles/bleaching	Dry, well	Present	0.10 / 7.0	0.00-0.10 0.20-0.30 0.50-0.60 0.80-0.90 0.90-1.00	Nil additional observations
				B21 0.15-0.75 gradual	Light clay	Weak to moderate. Firm, sub rounded <20mm	Nil inclusions and segregations	10YR3/2 Very dark greyish brown Nil mottles/bleaching	Dry, moderate – well	Present	0.30 / 7.5 0.60 / 7.5

B22 0.75-1.00 EOBH	Light clay	Weak to moderate. Firm, sub rounded <20mm	Nil inclusions and segregations	10YR3/2 Very dark greyish brown Nil mottles/bleaching	Dry, moderate – well	Present	0.90 / 7.5

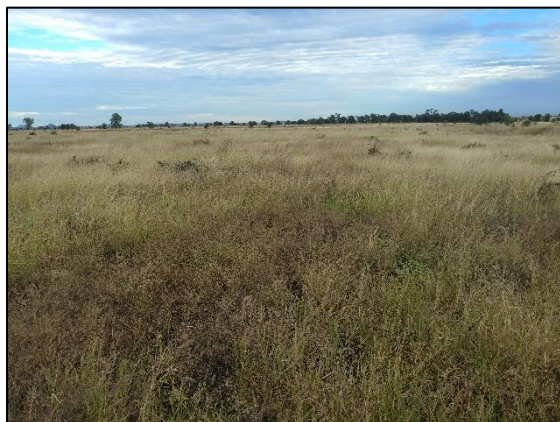
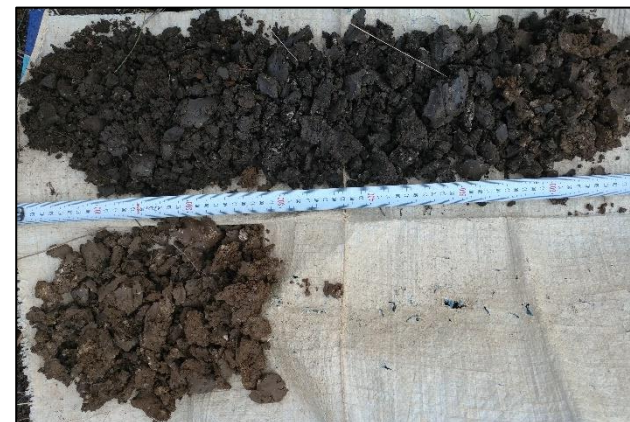
<b>Map Unit</b> B1	<b>Location (GDA94 ZONE 55):</b> 643200mE 7514334mN	<b>Aust. Soil Class.:</b> Black Vertosol	<b>Site Survey Type:</b> Detailed - 50mm hand auger	<b>Survey Date:</b> 06/06/2019
-----------------------	--	---	--	-----------------------------------

Land use Landform Pattern, Element, Slope	Vegetation	Microrelief Disturbance Erosion	Surface condition, surface rock	Soil Profile Description									
				Horizon Depth (m), Boundary	Field Texture	Structure, Strength	Inclusions Segregations	Colour, Mottle, Bleaching	Moisture, Drainage	Roots	Depth (m) / Field pH	Sample (m)	Observations
Cropping, upper-slope, 1%/2% slope	Grasses	Nil microrelief  Nil erosion  Extensively disturbed	Self-mulching, cracking 2- 6+mm	A1 0.0 – 0.15 Abrupt	Light clay	Moderate, Sub- rounded, peds <10 mm, soft	Nil inclusions or segregations	10YR3/2 Very dark greyish brown Nil mottles	Dry, well drained	Fine, very few	0.10 / 7.0	0.00-0.10 0.20-0.30 0.55-0.60 0.80-0.90 0.90-1.00	Nil additional observations
				B21 0.15 – 0.55 Abrupt	Medium clay	Moderate, Subangular blocky, peds <20 mm, firm	Nil inclusions or segregations	10YR2/1 Black 2% brown mottle	Dry, well drained	Very fine, very few	0.30 / 7.5

B22 0.55 – 1.00	Medium clay	Moderate, Subangular blocky, peds <20 mm, firm	<2% calcium carbonate	7.5YR3/2 Dark brown Nil mottles	Dry, moderately well drained	Nil roots	0.60 / 7.0 0.90 / 7.0

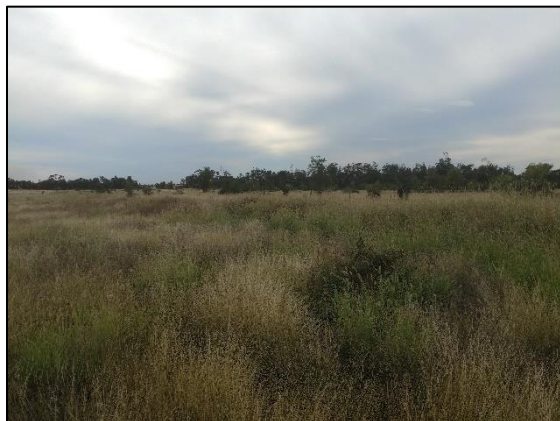
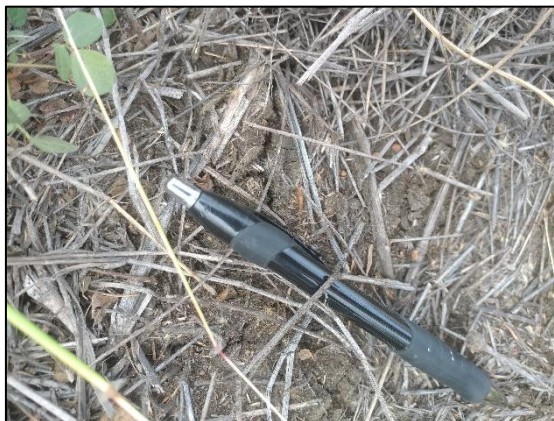
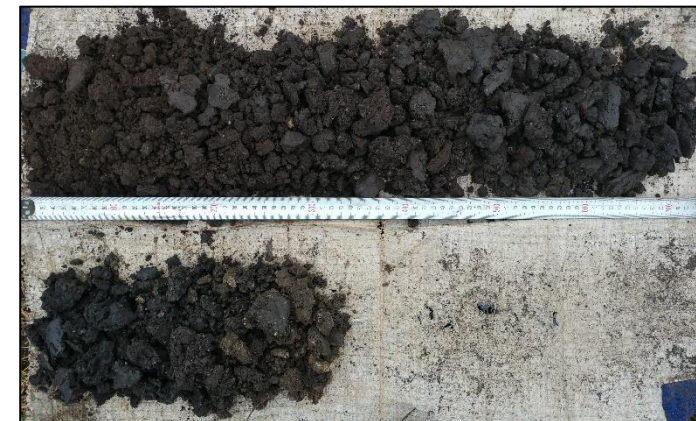
<b>Map Unit</b> B1	<b>Location (GDA94 ZONE 55):</b> 643734mE 7514136mN	<b>Aust. Soil Class.:</b> Black Vertosol	<b>Site Survey Type:</b> Detailed - 50mm hand auger	<b>Survey Date:</b> 06/06/2019
-----------------------	--	---	--	-----------------------------------

Land use Landform Pattern, Element, Slope	Vegetation	Microrelief Disturbance Erosion	Surface condition, surface rock	Soil Profile Description									
				Horizon Depth (m), Boundary	Field Texture	Structure, Strength	Inclusions Segregations	Colour, Mottle, Bleaching	Moisture, Drainage	Roots	Depth (m) / Field pH	Sample (m)	Observations
Cropping, upper-slope, 1%/1% slope	Grasses	Nil microrelief  Nil erosion  extensively disturbed	self- mulching, cracking 2- 6+mm	A1 0.0 – 0.12 Abrupt	Light clay	Moderate, Sub- rounded, peds <10 mm, soft	Nil inclusions or segregations	10YR3/2 Very dark greyish brown Nil mottles	Humid, well drained	Fine, very few	0.10 / 6.5	0.00-0.10 0.20-0.30 0.50-0.60 0.80-0.90 0.90-1.00	Nil additional observations
				B21 0.12 – 0.40 Abrupt	Medium clay	Moderate, Subangular blocky, peds <20 mm, firm	Nil inclusions or segregations	10YR3/2 Very dark greyish brown Nil mottles	Dry, well drained	Very fine, very few	0.30 / 6.5

B22 0.40 – 0.50 Abrupt	Medium clay	Moderate, Subangular blocky, peds <20 mm, very firm	Nil inclusions or segregations	7.5YR3/3 Dark brown 5% brown mottle	Dry, well drained	Very fine, very few	0.45 / 7.0		
				B23 0.50 – 0.80 Abrupt	Medium clay	Moderate, Subangular blocky, peds <20 mm, very firm	<1% calcium carbonate	10YR3/2 Very dark greyish brown Nil mottles	Dry, moderately well drained	Nil roots	0.60 / 7.0		
				B24 0.80 – 1.00	Medium clay	Moderate, Subangular blocky, peds <20 mm, very firm	<2% calcium carbonate	10YR3/2 Nil mottles 5% brown mottle	Dry, moderately well drained	Nil roots	0.90 / 7.0

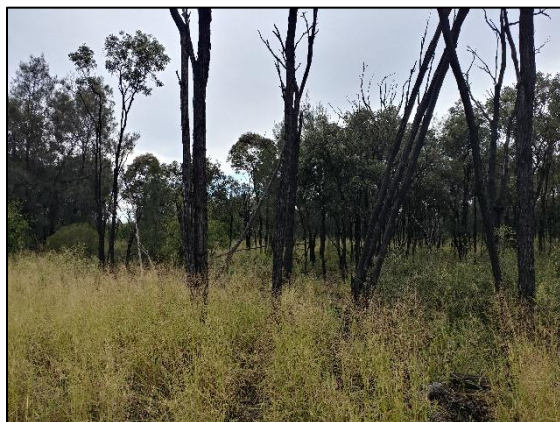
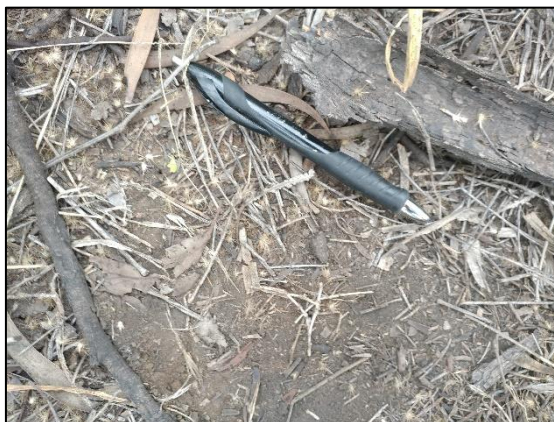
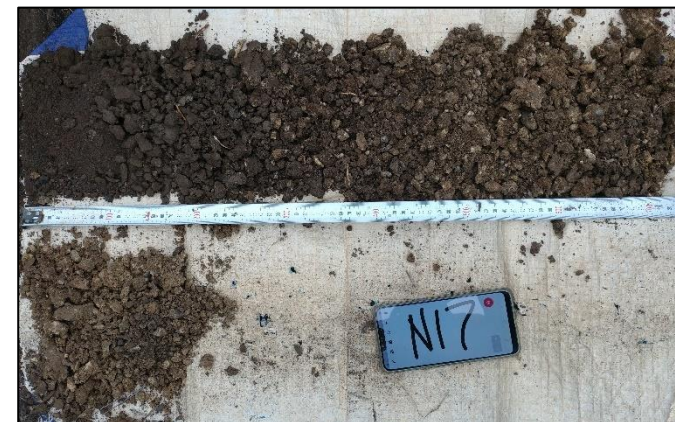
<b>Map Unit</b> A4	<b>Location (GDA94 ZONE 55):</b> 643797mE 7514822mN	<b>Aust. Soil Class.:</b> Black Dermosol	<b>Site Survey Type:</b> Detailed - 50mm hand auger	<b>Survey Date:</b> 06/06/2019
-----------------------	--	---	--	-----------------------------------

Land use Landform Pattern, Element, Slope	Vegetation	Microrelief Disturbance Erosion	Surface condition, surface rock	Soil Profile Description									
				Horizon Depth (m), Boundary	Field Texture	Structure, Strength	Inclusions Segregations	Colour, Mottle, Bleaching	Moisture, Drainage	Roots	Depth (m) / Field pH	Sample (m)	Observations
Grazing GUP Stream channel / Depression <2% / <2%	Brigalow, Mount Coolibah	Nil microrelief Nil disturbance Nil erosion	Soft, Nil coarse fragments	A1 0.00-0.10 Abrupt	Loamy sand	Massive, loose	<1% coarse fragments	10YR3/1 Very dark grey Nil mottles / bleaching	Dry, well	Present	0.10 / 8.5	0.00-0.10 0.10-0.20 0.20-0.30 0.50-0.60 0.80-0.88	Nil additional observations
				B21 0.10-0.20 Abrupt	Sandy loam	Moderate, very firm sub- angular <20mm	<1% coarse fragments	10YR3/1 Very dark grey Nil mottles / bleaching	Dry, well – moderate	Present	0.20 / 8.5		
				B22 0.20-0.47 Abrupt	Sandy loam	Moderate, very firm sub- angular <10mm	<10% coarse fragments	10YR3/1 Very dark grey Nil mottles / bleaching	Dry, well – moderate	Present	0.30 / 8.5

B23 0.47-0.88 EOBH	Sandy loam	Moderate, very firm sub- angular <10mm	<20% coarse fragments	10YR4/2 Brown Nil mottles / bleaching	Dry, well – moderate	Present – 0.60mbgl	0.60 / 8.5

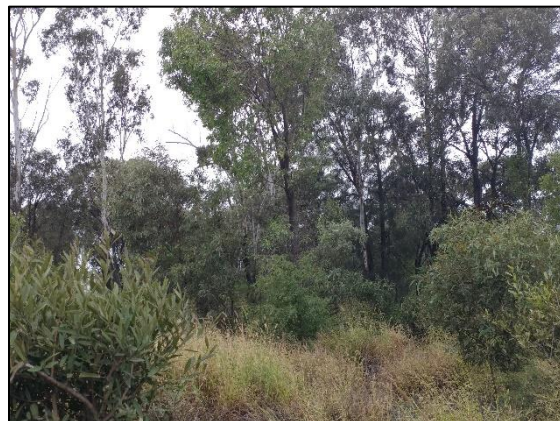
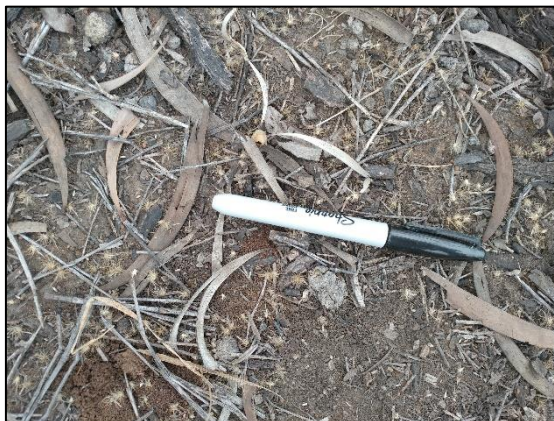
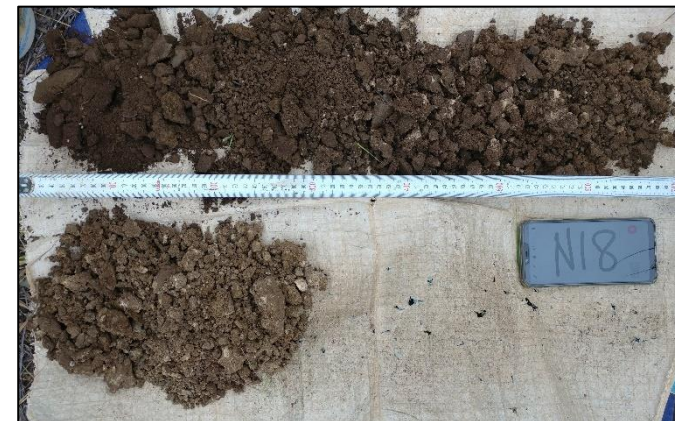
<b>Map Unit</b> A4	<b>Location (GDA94 ZONE 55):</b> 643600mE 7514680mN	<b>Aust. Soil Class.:</b> Black Dermosol	<b>Site Survey Type:</b> Detailed - 50mm hand auger	<b>Survey Date:</b> 06/06/2019
-----------------------	--	---	--	-----------------------------------

Land use Landform Pattern, Element, Slope	Vegetation	Microrelief Disturbance Erosion	Surface condition, surface rock	Soil Profile Description									
				Horizon Depth (m), Boundary	Field Texture	Structure, Strength	Inclusions Segregations	Colour, Mottle, Bleaching	Moisture, Drainage	Roots	Depth (m) / Field pH	Sample (m)	Observations
GUP mid slope <1% / <1%	Brigalow, Mount Coolibah	Nil micro relief Nil disturbance Nil erosion	Soft, Nil coarse fragments	A1 0.00-0.14 Abrupt	Loamy sand	Massive, loose	<1% coarse fragments	10YR3/1 Very dark grey Nil mottles / bleaching	Dry, well	Present	0.10 / 8.5	0.00-0.10 0.20-0.30 0.50-0.60 0.80-0.90 0.90-1.00	Nil additional observations
				B21 0.14-0.32 Abrupt	Sandy loam	Moderate, very firm sub- angular <20mm	<1% coarse fragments	10YR3/1 Very dark grey Nil mottles / bleaching	Dry, well – moderate	Present	0.20 / 8.5		
				B22 0.32-0.60 Diffused	Sandy loam	Moderate, very firm sub- angular <10mm	<10% coarse fragments	10YR3/1 Very dark grey 2% 10YR6/4 mottle. Nil bleaching	Dry, well – moderate	Present	0.30 / 8.5

B23 0.60-1.00 EOBH	Sandy loam	Moderate, very firm sub- angular <10mm	<20% coarse fragments	10YR4/2 Brown Nil mottles / bleaching	Dry, well – moderate	Present – 0.60mbgl	0.60 / 8.5

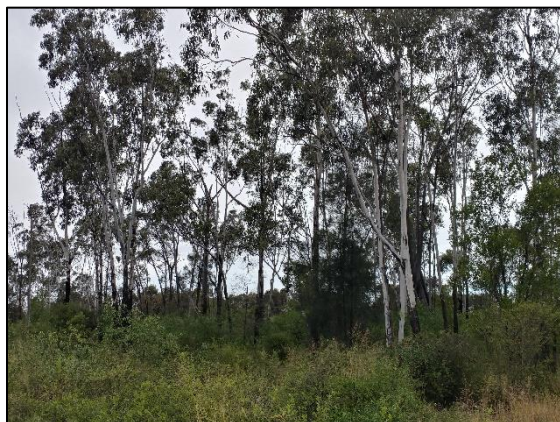
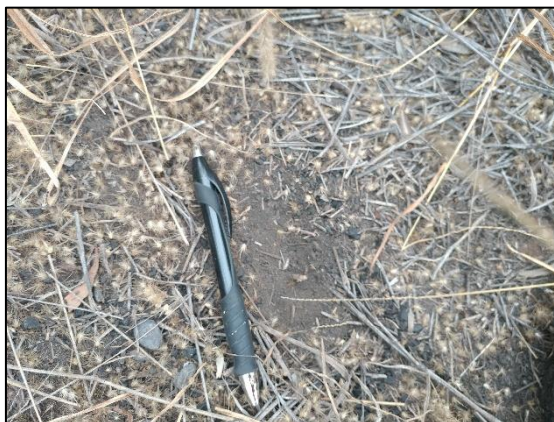
<b>Map Unit</b> A4	<b>Location (GDA94 ZONE 55):</b> 643668mE 7514813mN	<b>Aust. Soil Class.:</b> Black Dermosol	<b>Site Survey Type:</b> Detailed - 50mm hand auger	<b>Survey Date:</b> 06/06/2019
-----------------------	--	---	--	-----------------------------------

Land use Landform Pattern, Element, Slope	Vegetation	Microrelief Disturbance Erosion	Surface condition, surface rock	Soil Profile Description									
				Horizon Depth (m), Boundary	Field Texture	Structure, Strength	Inclusions Segregations	Colour, Mottle, Bleaching	Moisture, Drainage	Roots	Depth (m) / Field pH	Sample (m)	Observations
GUP Upper slope <2% / <2%	Brigalow, Mount Coolibah	Nil micro relief Nil disturbance Nil erosion	Soft, Nil coarse fragments	A1 0.00-0.18 Abrupt	Loamy sand	Massive, loose	<1% coarse fragments	10YR3/1 Very dark grey Nil mottles / bleaching	Dry, well	Present	0.10 / 8.5	0.00-0.10 0.20-0.30 0.50-0.60 0.80-0.90 0.90-0.95	Nil additional observations
				B21 0.18-0.33 Abrupt	Sandy loam	Moderate, very firm sub-angular <20mm	<1% coarse fragments	10YR3/1 Very dark grey Nil mottles / bleaching	Dry, well – moderate	Present	0.20 / 8.5		
				B22 0.33-0.68 Diffuse	Sandy loam	Moderate, very firm sub-angular <10mm	<10% coarse fragments	10YR3/1 Very dark grey 2% 10YR6/4 mottle. Nil bleaching	Dry, well – moderate	Present	0.30 / 8.5

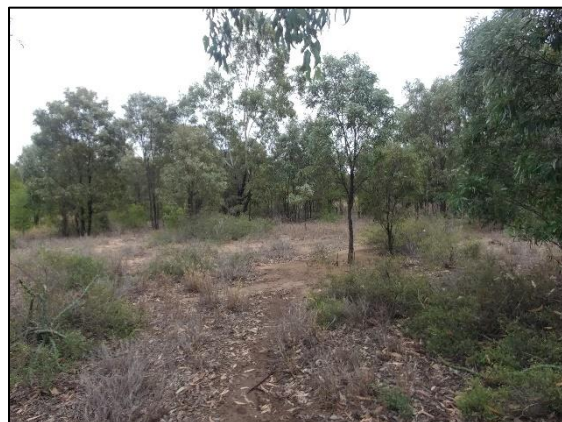
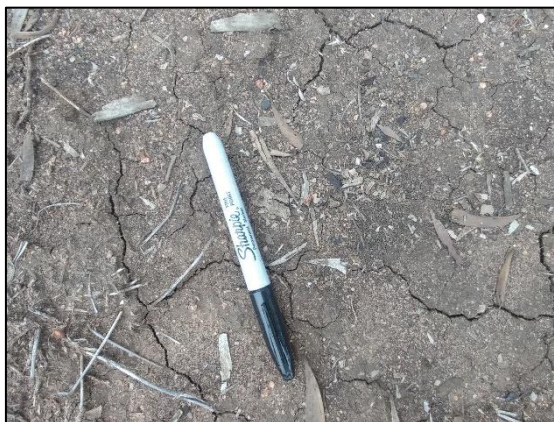
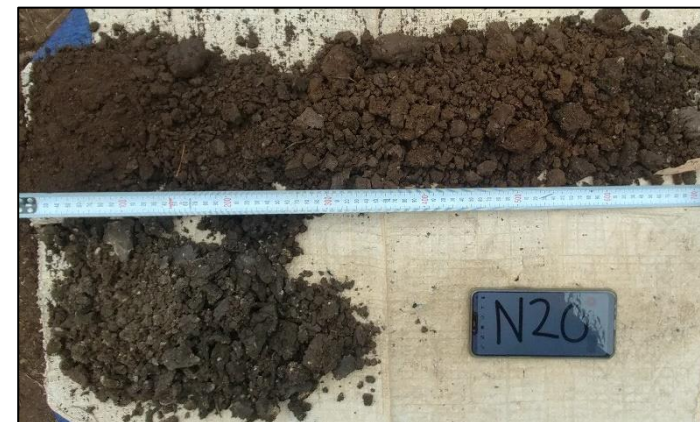
<b>Map Unit</b> A4c	<b>Location (GDA94 ZONE 55):</b> 642943mE 7513907mN	<b>Aust. Soil Class.:</b> Black Dermosol	<b>Site Survey Type:</b> Detailed - 50mm hand auger	<b>Survey Date:</b> 07/06/2019
------------------------	--	---	--	-----------------------------------

Land use Landform Pattern, Element, Slope	Vegetation	Microrelief Disturbance Erosion	Surface condition, surface rock	Soil Profile Description									
				Horizon Depth (m), Boundary	Field Texture	Structure, Strength	Inclusions Segregations	Colour, Mottle, Bleaching	Moisture, Drainage	Roots	Depth (m) / Field pH	Sample (m)	Observations
Grazing Alluvial near stream channel 1% / 0%	Brigalow	Nil microrelief Nil disturbance Nearby sheet / gully erosion	Minor cracking Soft, <10% coarse fragments <5mm	A1 0.00-0.12 Abrupt	Sandy loam	Weak to moderate, soft sub-rounded <10mm	Nil inclusions / segregations	10YR3/1 Very dark grey Nil mottles / bleaching	Dry, well	Present	0.10 / 8.5	0.00-0.10 0.20-0.30 0.50-0.60 0.75-0.85 0.90-1.00	Nil additional observations
				B21 0.12-0.37 Abrupt	Sandy loam	Moderate, firm sub-rounded <10mm	Nil inclusions / segregations	10YR3/2 Very dark greyish brown Nil mottles / bleaching	Dry, well – moderate	Present	0.20 / 8.5

B22 0.37-0.68 Abrupt	Sandy loam	Moderate, firm sub-rounded <20mm	<2% calcium carbonate	7.5YR3/2 Dark brown Nil mottle / bleaching	Dry, well – moderate	Present	0.30 / 8.5		
				B23 0.68-0.85 Abrupt	Sandy clay loam	Moderate, very firm sub-rounded <20mm	<20% calcium carbonate	10YR3/2 Very dark greyish brown Nil mottles / bleaching	Dry, well – moderate	Present	-		
				B24 0.85-1.00 EOBH	Sandy clay loam	Moderate, very firm sub-rounded <20mm	<5% calcium carbonate	10YR3/2 Very dark greyish brown Nil mottles / bleaching	Dry, well – moderate	-	0.90 / 8.5

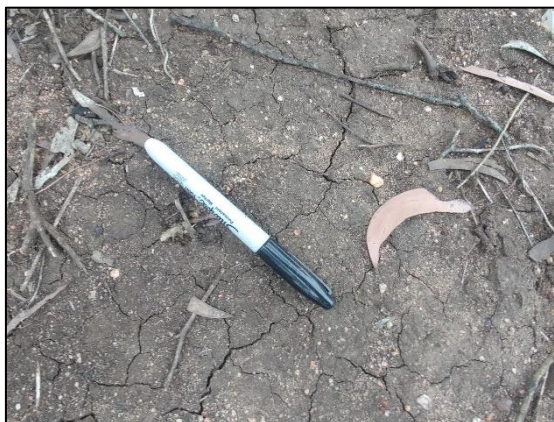
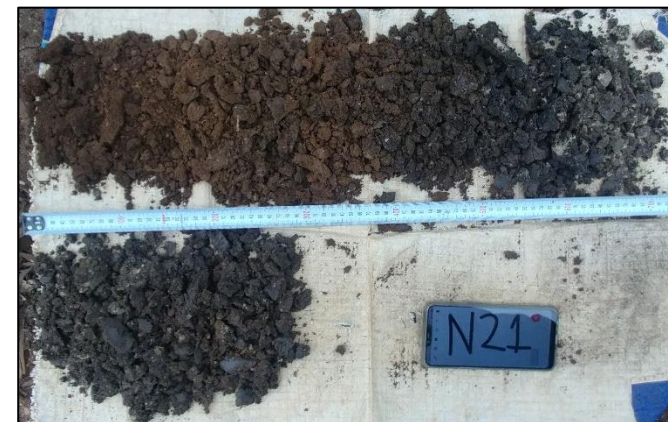
Land use Landform Pattern, Element, Slope	Vegetation	Microrelief Disturbance Erosion	Surface condition, surface rock	Soil Profile Description									
				Horizon Depth (m), Boundary	Field Texture	Structure, Strength	Inclusions Segregations	Colour, Mottle, Bleaching	Moisture, Drainage	Roots	Depth (m) / Field pH	Sample (m)	Observations
Grazing Alluvial near stream channel 1% / 0%	Brigalow	Nil microrelief Nil disturbance Nearby sheet / gully erosion	Minor cracking Soft, <10% coarse fragments <5mm	A1 0.00-0.10 Abrupt	Sandy loam	Weak to moderate, soft sub-rounded <10mm	Nil inclusions / segregations	10YR3/1 Very dark grey Nil mottles / bleaching	Dry, well	Present	0.10 / 7.5	0.00-0.10	Nil additional observations
				B21 0.10-0.40 Abrupt	Sandy loam	Moderate, firm sub- rounded <10mm	Nil inclusions / segregations	10YR3/2 Very dark greyish brown Nil mottles / bleaching	Dry, well – moderate	Present	0.20 / 8.5	0.20-0.30

B22 0.40-0.58 Abrupt	Sandy loam	Moderate, firm sub- rounded <20mm	<2% calcium carbonate	7.5YR3/2 Dark brown Nil mottle / bleaching	Dry, well – moderate	Present	0.30 / 8.5	0.50-0.60	
				B23 0.58-0.90 Abrupt	Sandy clay loam	Moderate, very firm sub-rounded <20mm	10% calcium carbonate	10YR3/2 Very dark greyish brown Nil mottles / bleaching	Dry, well – moderate	Present	-	0.80-0.90	
				B24 0.90-1.00 EOBH	Sandy clay loam	Moderate, very firm sub-rounded <20mm	<5% calcium carbonate	10YR3/2 Very dark greyish brown Nil mottles / bleaching	Dry, well – moderate			0.90-1.00

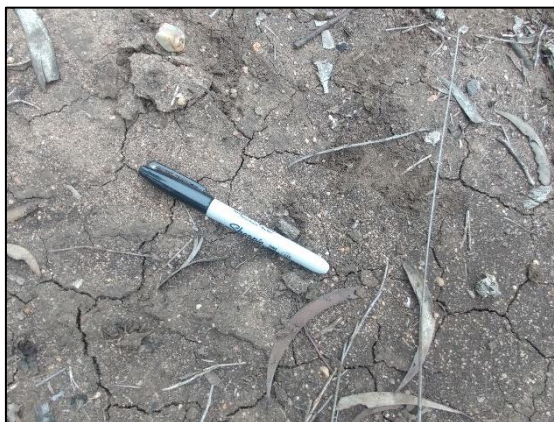
Land use Landform Pattern, Element, Slope	Vegetation	Microrelief Disturbance Erosion	Surface condition, surface rock	Soil Profile Description									
				Horizon Depth (m), Boundary	Field Texture	Structure, Strength	Inclusions Segregations	Colour, Mottle, Bleaching	Moisture, Drainage	Roots	Depth (m) / Field pH	Sample (m)	Observations
Grazing Depression <1% / <1%	Brigalow woodlands	Nil microrelief Semi disturbance Minor sheet erosion	Minor cracking Soft, <10% coarse fragments <5mm	A1 0.00-0.11 Abrupt	Sandy loam	Weak to moderate, soft sub- rounded <10mm	Nil inclusions / segregations	10YR3/1 Very dark grey Nil mottles / bleaching	Dry, well	Present	0.10 / 7.5	0.00-0.10 0.20-0.30 0.50-0.60 0.80-0.90 0.90-1.00	Nil additional observations
				B21 0.11-0.48 Abrupt	Sandy loam	Moderate, firm sub- rounded <10mm	Nil inclusions / segregations	10YR3/1 Very dark grey Nil mottles / bleaching	Dry, well – moderate	Present	0.30 / 8.5
