# Restoration Plan to Support RIDA Application Saraji East Project

Final V4  
15 July 2021

GT Environmental Pty Ltd  
[www.gtenvironmental.com.au](http://www.gtenvironmental.com.au)

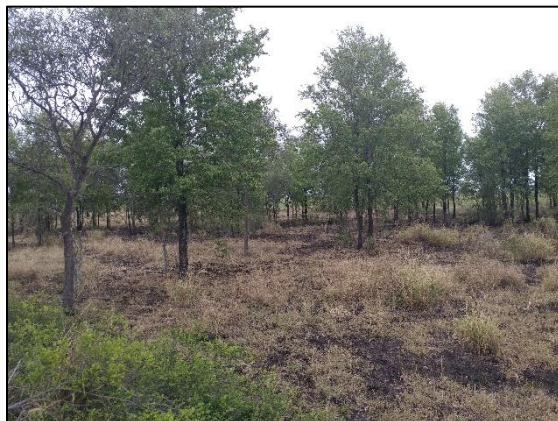
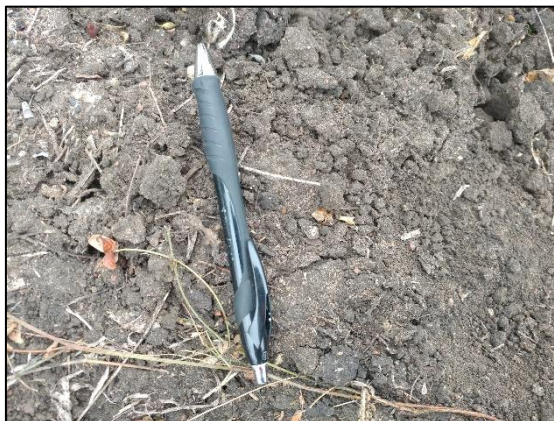
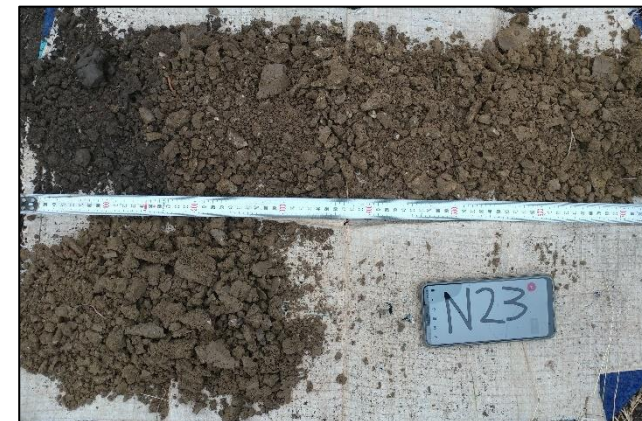
<b>Map Unit</b> A5	<b>Location (GDA94 ZONE 55):</b> 642506mE 7511103mN	<b>Aust. Soil Class.:</b> Grey Dermosol	<b>Site Survey Type:</b> Detailed - 50mm hand auger	<b>Survey Date:</b> 07/06/2019
-----------------------	--	--	--	-----------------------------------

Land use Landform Pattern, Element, Slope	Vegetation	Microrelief Disturbance Erosion	Surface condition, surface rock	Soil Profile Description									
				Horizon Depth (m), Boundary	Field Texture	Structure, Strength	Inclusions Segregations	Colour, Mottle, Bleaching	Moisture, Drainage	Roots	Depth (m) / Field pH	Sample (m)	Observations
Grazing Depression Alluvial / stream channel nearby <1% / <1%	Mixed vegetation	Nil microrelief Cropping nearby disturbance Nil erosion	Cracking Firm Nil coarse fragments	A1 0.00-0.12 Abrupt	Clay loam	Weak, soft sub- rounded <10mm	Nil inclusions / segregations	10YR3/1 Very dark grey Nil mottles / bleaching	Dry, well	Present	0.10 / 8.5	0.00-0.10 0.20-0.30 0.50-0.60 0.80-0.90 0.90-1.00	Nil additional observations
				B21 0.12-0.48 gradual	Light clay	Weak to moderate, firm sub- rounded <10mm	<5% weathered rock	10YR4/2 Dark greyish brown Nil mottles / bleaching	Dry, well – moderate	Present	0.30 / 8.5

B22 0.48-1.00 EOBH	Light clay	Moderate, very firm sub- rounded <20mm	<5% calcium carbonate	10YR4/2 Dark greyish brown Nil mottles / bleaching	Dry, well – moderate	Present	0.60 / 8.5 0.90 / 8.5

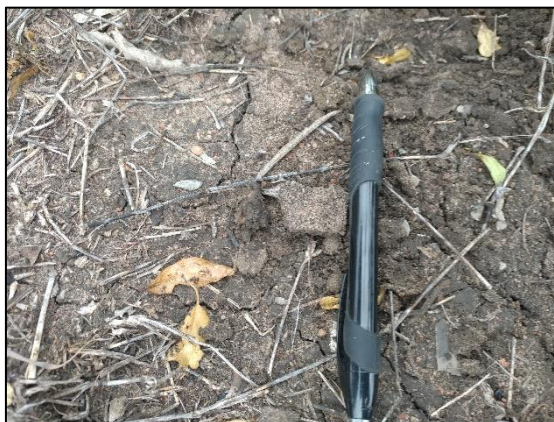
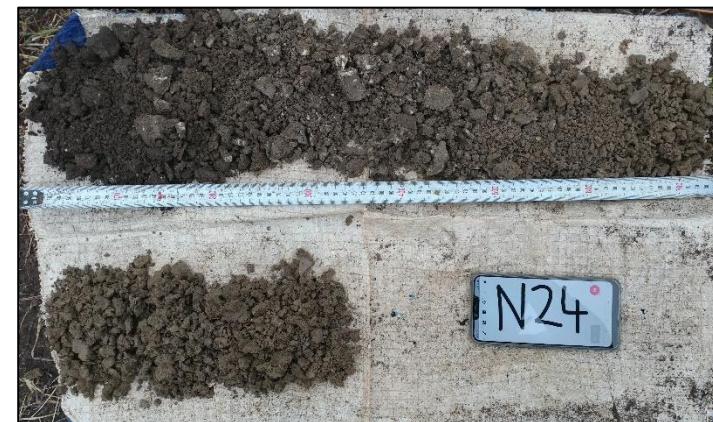
Land use Landform Pattern, Element, Slope	Vegetation	Microrelief Disturbance Erosion	Surface condition, surface rock	Soil Profile Description									
				Horizon Depth (m), Boundary	Field Texture	Structure, Strength	Inclusions Segregations	Colour, Mottle, Bleaching	Moisture, Drainage	Roots	Depth (m) / Field pH	Sample (m)	Observations
Grazing Depression Alluvial / stream channel nearby <1% / <1%	Mixed vegetation	Nil microrelief Cropping nearby disturbance Nil erosion	Cracking Firm Nil coarse fragments	A1 0.00-0.15 Abrupt	Clay loam	Weak, soft sub- rounded <10mm	Nil inclusions / segregations	10YR3/1 Very dark grey Nil mottles / bleaching	Dry, well	Present	0.10 / 8.5	0.00-0.10 0.20-0.30 0.50-0.60 0.80-0.90 0.90-1.00	Nil additional observations
				B21 0.15-0.50 gradual	Light clay	Weak to moderate, firm sub- rounded <10mm	<5% calcium carbonate	10YR4/2 Dark greyish brown Nil mottles / bleaching	Dry, well – moderate	Present	0.30 / 8.5

B22 0.50-1.00 EOBH	Light clay	Moderate, very firm sub- rounded <20mm	Nil inclusions / segregations	10YR4/2 Dark greyish brown Nil mottles / bleaching	Dry, well – moderate	Present	0.60 / 8.5 0.90 / 8.5

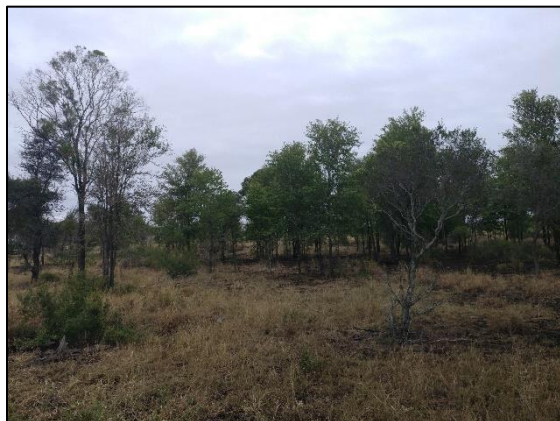
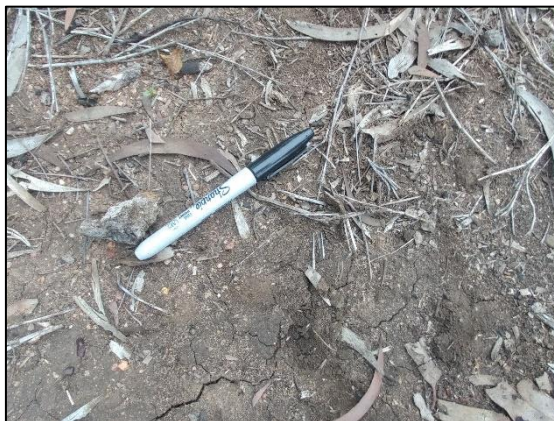
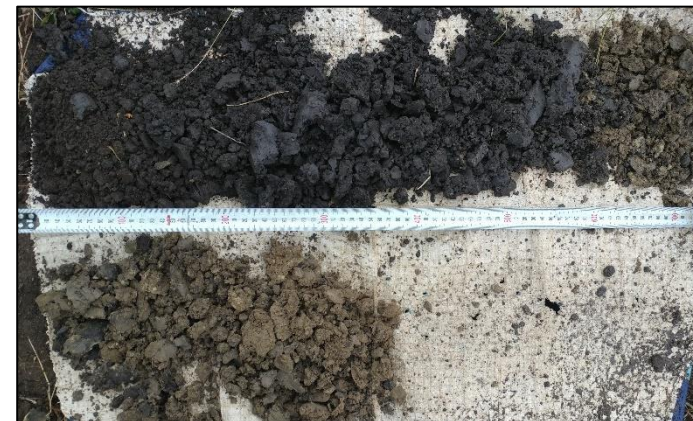
<b>Map Unit</b> A5	<b>Location (GDA94 ZONE 55):</b> 642810mE 7511185mN	<b>Aust. Soil Class.:</b> Grey Dermosol	<b>Site Survey Type:</b> Detailed - 50mm hand auger	<b>Survey Date:</b> 28/06/2019
-----------------------	--	--	--	-----------------------------------

Land use Landform Pattern, Element, Slope	Vegetation	Microrelief Disturbance Erosion	Surface condition, surface rock	Soil Profile Description									
				Horizon Depth (m), Boundary	Field Texture	Structure, Strength	Inclusions Segregations	Colour, Mottle, Bleaching	Moisture, Drainage	Roots	Depth (m) / Field pH	Sample (m)	Observations
Grazing Depression Alluvial / stream channel nearby <1% / <1%	Mixed vegetation	Nil microrelief Cropping nearby disturbance Nil erosion	Cracking Firm Nil coarse fragments	A1 0.00-0.12 Abrupt	Clay loam	Weak, soft sub- rounded <10mm	Nil inclusions / segregations	10YR3/1 Very dark grey Nil mottles / bleaching	Dry, well	Present	0.10 / 8.5	0.00-0.10 0.20-0.30 0.50-0.60 0.80-0.90 0.90-1.00	Nil additional observations
				B21 0.12-0.62 gradual	Light clay	Weak to moderate, firm sub- rounded <10mm	Nil inclusions / segregations	10YR4/2 Dark greyish brown Nil mottles / bleaching	Dry, well – moderate	Present	0.30 / 8.5

B22 0.62-1.00 EOBH	Light clay	Moderate, very firm sub- rounded <20mm	<5% calcium carbonate	10YR4/2 Dark greyish brown Nil mottles / bleaching	Dry, well – moderate	Present	0.60 / 8.5 0.90 / 8.5

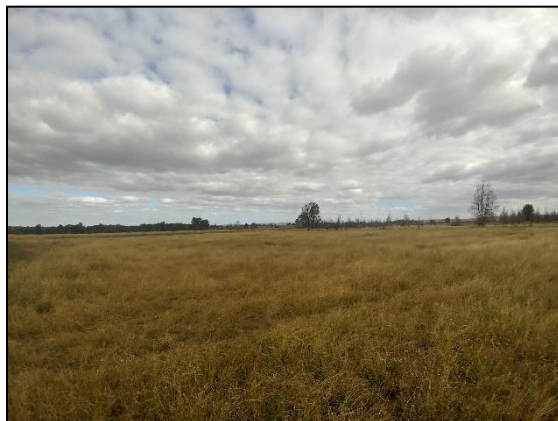
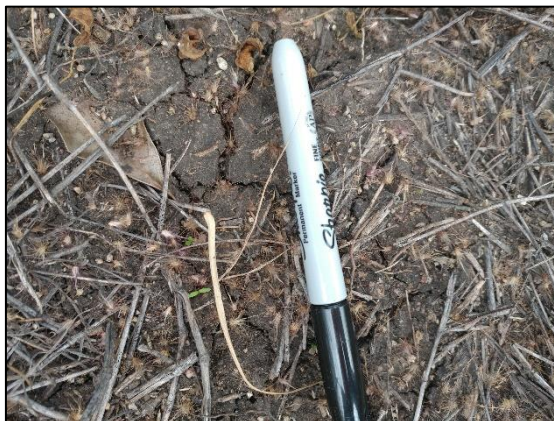
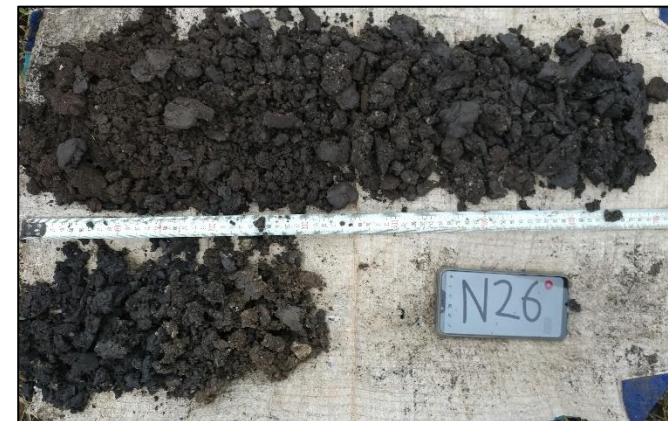
<b>Map Unit</b> B2bl	<b>Location (GDA94 ZONE 55):</b> 642370mE 7512434mN	<b>Aust. Soil Class.:</b> Black Dermosol	<b>Site Survey Type:</b> Detailed - 50mm hand auger	<b>Survey Date:</b> 28/06/2019
-------------------------	--	---	--	-----------------------------------

Land use Landform Pattern, Element, Slope	Vegetation	Microrelief Disturbance Erosion	Surface condition, surface rock	Soil Profile Description									
				Horizon Depth (m), Boundary	Field Texture	Structure, Strength	Inclusions Segregations	Colour, Mottle, Bleaching	Moisture, Drainage	Roots	Depth (m) / Field pH	Sample (m)	Observations
Grazing GUP Lower slope 1% / 1%	Short grasses	Nil microrelief Extensive disturbance Nil erosion	Minor cracking	A1 0.00-0.14 Clear	Sandy clay	Weak, soft sub- rounded <10mm	Nil inclusions / segregations	10YR3/1 Very dark grey Nil mottles/bleach	Dry, moderate	Few fine	0.10 / 6.0	0.00-0.10 0.20-0.30 0.50-0.60 0.80-0.90 0.90-1.00	Nil additional observations
				B21 0.14-0.33 clear	Medium clay	Weak to moderate, firm sub- rounded <10mm	Nil inclusions / segregations	10YR2/2 Very dark brown Nil mottles/bleach	Dry, moderate	Very fine, very few	0.30 / 6.5		
				B22 0.33-0.90 gradual	Medium clay	Moderate, firm sub- rounded <20mm	Nil inclusions / segregations	10YR3/3 Dark brown Nil mottles/bleach	Dry, moderate	Very fine, very few	0.60 / 7.0

B23 0.90-1.00 EOBH	Medium clay	Moderate, very firm sub- rounded <20mm	<2% calcium carbonate	10YR3/3 Dark brown Nil mottles/bleach	Dry, moderate	Very fine, very few	0.90 / 7.5

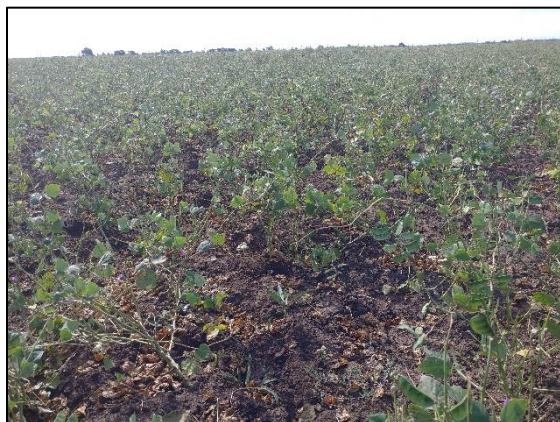
<b>Map Unit</b> B2bl	<b>Location (GDA94 ZONE 55):</b> 642614mE 7510764mN	<b>Aust. Soil Class.:</b> Black Dermosol	<b>Site Survey Type:</b> Detailed - 50mm hand auger	<b>Survey Date:</b> 28/06/2019
-------------------------	--	---	--	-----------------------------------

Land use Landform Pattern, Element, Slope	Vegetation	Microrelief Disturbance Erosion	Surface condition, surface rock	Soil Profile Description									
				Horizon Depth (m), Boundary	Field Texture	Structure, Strength	Inclusions Segregations	Colour, Mottle, Bleaching	Moisture, Drainage	Roots	Depth (m) / Field pH	Sample (m)	Observations
Mid-slope, 1% slope	Forage cropping	Nil Microrelief  Nil erosion  Extensively cleared	Firm, cracking 2mm, Nil coarse fragments	A1 0.0 – 0.13 Abrupt	Sandy clay loam	Weak, sub- rounded peds 5-20 mm, firm	Nil inclusions or segregations	10YR3/1 Very dark grey Nil mottles	Humid, well drained	Fine, very few	0.10 / 6.5	0.00-0.10 0.20-0.30 0.50-0.60 0.80-0.90 0.90-1.00	Nil additional observations
				B21 0.13 – 0.50 gradual	Sandy clay loam	Moderate, peds 30-40 mm, very firm	Nil inclusions or segregations	10YR2/1 Black Nil mottles	Humid, well drained	Nil roots	0.30 / 6.5

B22 0.50 – 0.75 clear	Light clay, sandy	Subangular blocky, moderate, peds <20 mm, very firm	<2% calcium carbonate	10YR2/1 Nil mottles Black	Humid, moderately well drained	Nil roots	0.60 / 6.5		
				B23 0.75 – 1.00	Medium clay, sandy	Subangular blocky, moderate, peds <20 mm, very firm	<2% calcium carbonate	10YR3/1 Very dark grey Nil mottles	Humid, moderately well drained	Nil roots	0.90 / 6.5

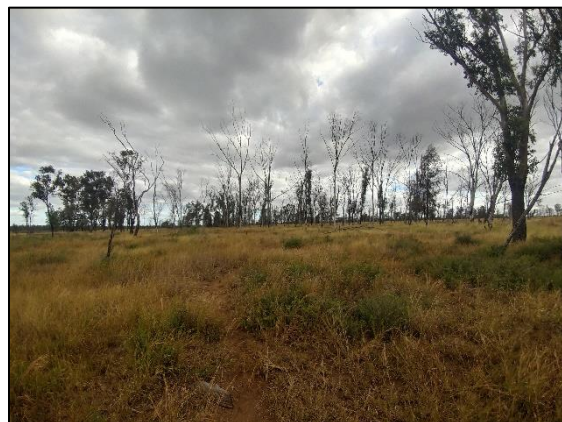
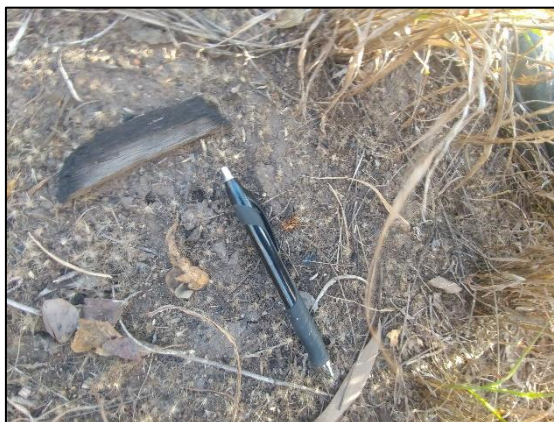
<b>Map Unit</b> B5	<b>Location (GDA94 ZONE 55):</b> 643924mE 7513310mN	<b>Aust. Soil Class.:</b> Black Dermosol	<b>Site Survey Type:</b> Detailed - 50mm hand auger	<b>Survey Date:</b> 28/07/2019
-----------------------	--	---	--	-----------------------------------

Land use Landform Pattern, Element, Slope	Vegetation	Microrelief Disturbance Erosion	Surface condition, surface rock	Soil Profile Description									
				Horizon Depth (m), Boundary	Field Texture	Structure, Strength	Inclusions Segregations	Colour, Mottle, Bleaching	Moisture, Drainage	Roots	Depth (m) / Field pH	Sample (m)	Observations
Grazing GUP lower slope <2% / <2%	Eucalyptus species	Nil microrelief Semi disturbed, contour banks nearby	Minor cracks, firm, Nil coarse fragments	A11 0.0 – 0.08 Abrupt	Sandy clay loam	Massive	Nil inclusions or segregations	10YR3/2 Very dark greyish brown Nil mottles / bleaching	Dry, well drained	Present	0.10 / 7.5	0.00-0.05 0.20-0.30 0.50-0.60 0.80-0.90 0.90-1.00	Nil additional observations
				A12 0.08 – 0.35 gradual	Sandy clay loam	Weak, sub- rounded peds <10 mm	Nil inclusions or segregations	10YR3/2 Very dark greyish brown Nil mottles / bleaching	Dry, well drained	Present	0.20 / 7.5

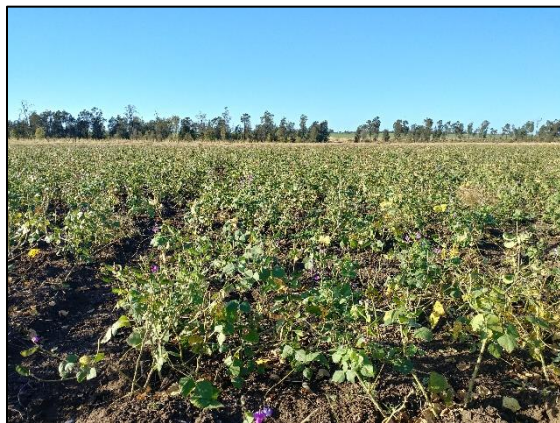
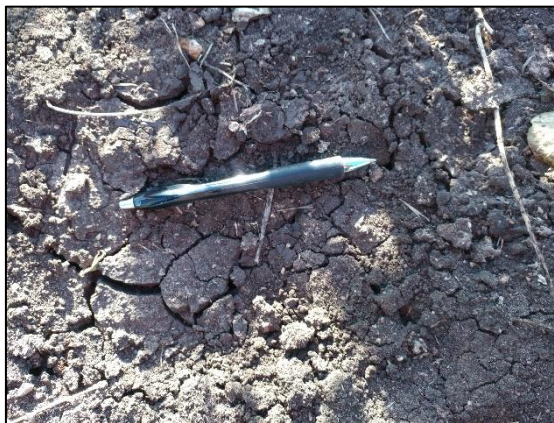
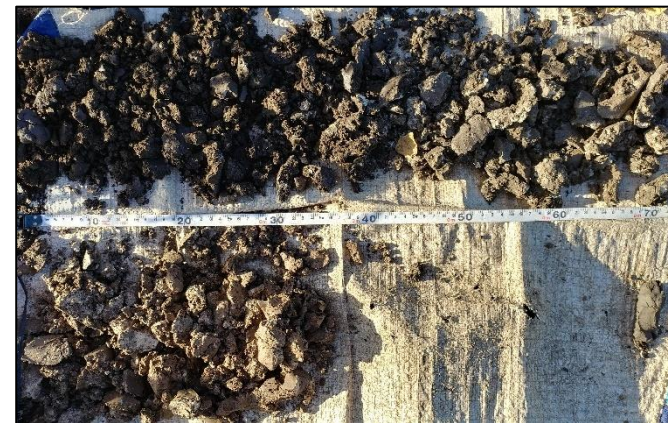
<b>Map Unit</b> B1	<b>Location (GDA94 ZONE 55):</b> 643062mE 7512049mN	<b>Aust. Soil Class.:</b> Black Vertosol	<b>Site Survey Type:</b> Detailed - 50mm hand auger	<b>Survey Date:</b> 28/06/2019
-----------------------	--	---	--	-----------------------------------

Land use Landform Pattern, Element, Slope	Vegetation	Microrelief Disturbance Erosion	Surface condition, surface rock	Soil Profile Description									
				Horizon Depth (m), Boundary	Field Texture	Structure, Strength	Inclusions Segregations	Colour, Mottle, Bleaching	Moisture, Drainage	Roots	Depth (m) / Field pH	Sample (m)	Observations
Cropping / Grazing GUP mid slope 2% / 2%	Cropping	Nil microrelief Extensive disturbed, contour banks nearby	Cracking, firm, Nil coarse fragments	A11 0.0 – 0.11 Abrupt	Light medium clay	Moderate, firm, sub- rounded peds <10 mm	<1% coarse fragments <2mm	10YR3/2 Very dark greyish brown Nil mottles / bleaching	Dry, well drained	Present	0.10 / 8.0	0.00-0.10 0.20-0.30 0.50-0.60 0.80-0.90 0.90-1.00	Nil additional observations
				B21 0.11 – 0.35 Abrupt	Medium clay	Moderate - strong, firm, sub-rounded peds 20 mm	<2% calcium carbonate	10YR3/2 Very dark greyish brown Nil mottles / bleaching	Dry, well- moderate drained	Present	0.30 / 8.0

B22 0.35 – 0.66 Clear	Medium clay	Moderate - strong, firm, sub-rounded peds 20 mm	<30% calcium carbonate	10YR3/2 Very dark greyish brown Nil mottles / bleaching	Dry, well- moderate drained	Present	0.60 / 8.0		
				B23 0.66 – 1.00 EOBH	Medium clay	Moderate - strong, firm, sub-rounded peds 20 mm	<20% calcium carbonate	10YR4/4 Dark yellowish brown Nil mottles / bleaching	Dry, well- moderate drained	Nil	0.90 / 8.0

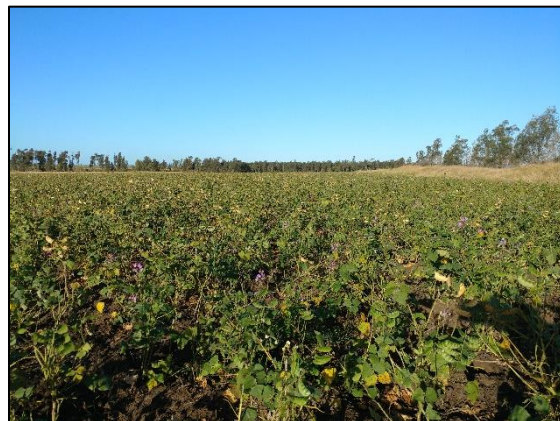
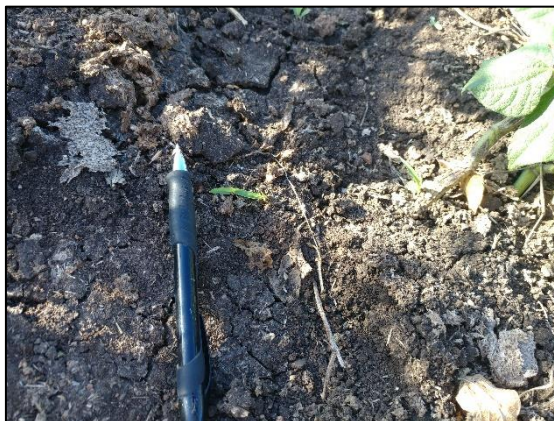
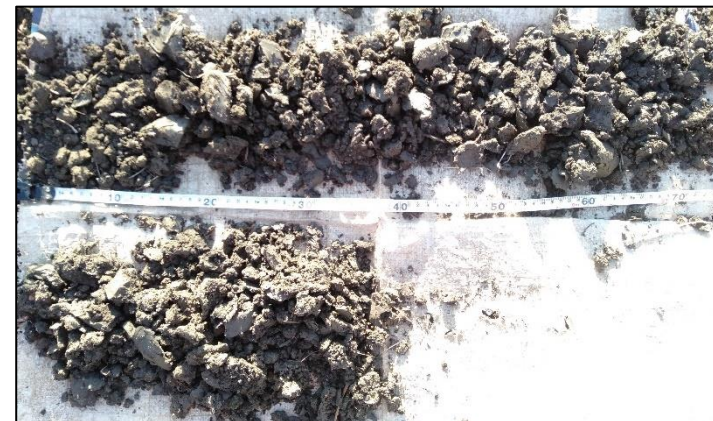
<b>Map Unit</b> B1	<b>Location (GDA94 ZONE 55):</b> 643464mE 7512936mN	<b>Aust. Soil Class.:</b> Black Vertosol	<b>Site Survey Type:</b> Detailed - 50mm hand auger	<b>Survey Date:</b> 29/06/2019
-----------------------	--	---	--	-----------------------------------

Land use Landform Pattern, Element, Slope	Vegetation	Microrelief Disturbance Erosion	Surface condition, surface rock	Soil Profile Description									
				Horizon Depth (m), Boundary	Field Texture	Structure, Strength	Inclusions Segregations	Colour, Mottle, Bleaching	Moisture, Drainage	Roots	Depth (m) / Field pH	Sample (m)	Observations
Cropping / Grazing GUP upper slope 2% / 2%	Cropping	Nil microrelief Extensive disturbed, contour banks nearby	Cracking, firm, Nil coarse fragments	A11 0.0 – 0.11 Abrupt	Light medium clay	Moderate, firm, sub- rounded peds <10 mm	<1% coarse fragments <2mm	10YR3/2 Very dark greyish brown Nil mottles / bleaching	Dry, well drained	Present	0.10 / 8.0	0.00-0.10 0.20-0.30 0.50-0.60 0.80-0.90 0.90-1.00	Nil additional observations
				B21 0.11 – 0.35 Abrupt	Medium clay	Moderate - strong, firm, sub-rounded peds 20 mm	<2% calcium carbonate	10YR3/2 Very dark greyish brown Nil mottles / bleaching	Dry, well- moderate drained	Present	0.30 / 8.0

B22 0.35 – 0.66 Clear	Medium clay	Moderate - strong, firm, sub-rounded peds 20 mm	<30% calcium carbonate	10YR3/2 Very dark greyish brown Nil mottles / bleaching	Dry, well- moderate drained	Present	0.60 / 8.0		
				B23 0.66 – 1.00 EOBH	Medium clay	Moderate - strong, firm, sub-rounded peds 20 mm	<10% calcium carbonate	10YR4/4 Dark yellowish brown Nil mottles / bleaching	Dry, well- moderate drained	Nil	0.90 / 8.0

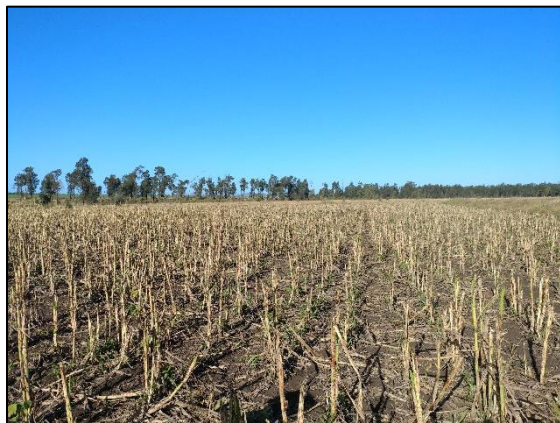
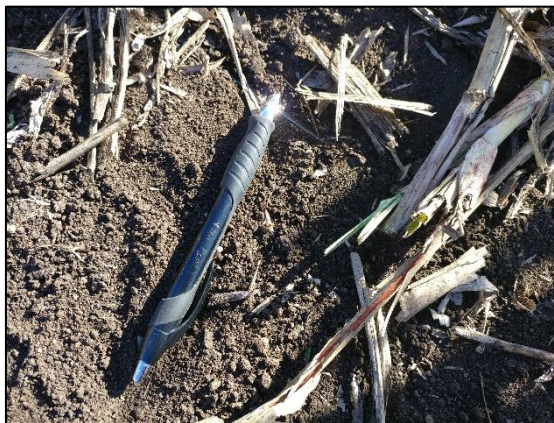
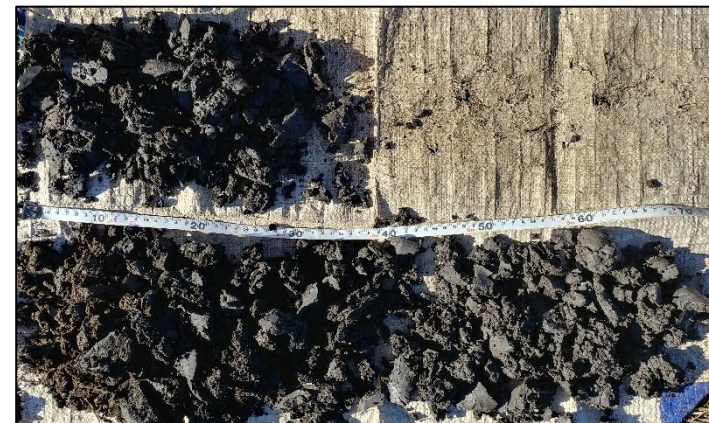
<b>Map Unit</b> B1	<b>Location (GDA94 ZONE 55):</b> 643487mE 7512205mN	<b>Aust. Soil Class.:</b> Black Vertosol	<b>Site Survey Type:</b> Detailed - 50mm hand auger	<b>Survey Date:</b> 29 29/06/2019
-----------------------	--	---	--	--------------------------------------

Land use Landform Pattern, Element, Slope	Vegetation	Microrelief Disturbance Erosion	Surface condition, surface rock	Soil Profile Description									
				Horizon Depth (m), Boundary	Field Texture	Structure, Strength	Inclusions Segregations	Colour, Mottle, Bleaching	Moisture, Drainage	Roots	Depth (m) / Field pH	Sample (m)	Observations
Cropping / Grazing GUP Lower slope / flat plain <1% / 1%	Cropping	Nil microrelief Extensive disturbed, contour banks nearby	Cracking, firm, Nil coarse fragments	A11 0.0 – 0.10 Abrupt	Light clay	Weak, firm, sub- rounded peds <10 mm	Nil inclusions or segregations	10YR3/2 Very dark greyish brown Nil mottles / bleaching	Dry, well drained	Present	0.10 / 8.0	0.00-0.10 0.20-0.30 0.50-0.60 0.80-0.90 0.90-1.00	Nil additional observations
				B21 0.11 – 0.50 Abrupt	Medium clay	Moderate - strong, firm, sub- angular peds <20 mm	Nil inclusions or segregations	10YR3/1 Very dark grey Nil mottles / bleaching	Dry, well- moderate drained	Present	0.30 / 8.0

B22 0.50 – 1.00 EOBH	Medium clay	Moderate - strong, firm, sub- angular peds <20 mm	<2% calcium carbonate	10YR3/1 Very dark grey Nil mottles / bleaching	Dry, well- moderate drained	Present	0.60 / 7.0 0.90 / 7.0

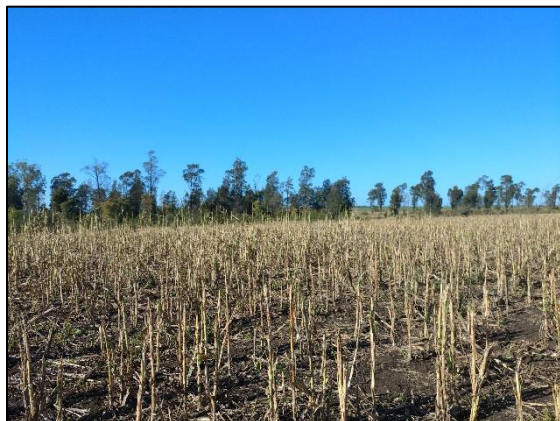
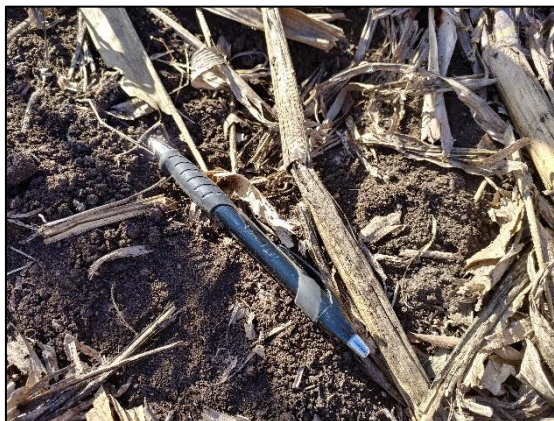
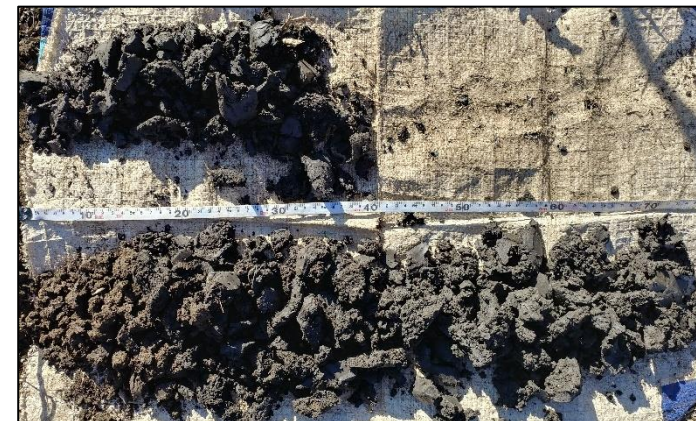
<b>Map Unit</b> B1	<b>Location (GDA94 ZONE 55):</b> 644077mE 7512794mN	<b>Aust. Soil Class.:</b> Black Vertosol	<b>Site Survey Type:</b> Detailed - 50mm hand auger	<b>Survey Date:</b> 29/06/2019
-----------------------	--	---	--	-----------------------------------

Land use Landform Pattern, Element, Slope	Vegetation	Microrelief Disturbance Erosion	Surface condition, surface rock	Soil Profile Description									
				Horizon Depth (m), Boundary	Field Texture	Structure, Strength	Inclusions Segregations	Colour, Mottle, Bleaching	Moisture, Drainage	Roots	Depth (m) / Field pH	Sample (m)	Observations
Cropping / Grazing GUP Lower slope / flat plain <1% / 1%	Cropping	Nil microrelief Extensive disturbed, contour banks nearby	Cracking, firm, Nil coarse fragments	A11 0.0 – 0.10 Abrupt	Light clay	Weak, firm, sub- rounded peds <10 mm	Nil inclusions or segregations	10YR3/2 Very dark greyish brown Nil mottles / bleaching	Dry, well drained	Present	0.10 / 8.0	0.00-0.10 0.20-0.30 0.50-0.60 0.80-0.90 0.90-1.00	Nil additional observations
				B21 0.11 – 0.53 Abrupt	Medium clay	Moderate - strong, firm, sub- angular peds 20-40 mm	Nil inclusions or segregations	10YR3/1 Very dark grey Nil mottles / bleaching	Dry, well- moderate drained	Present	0.30 / 8.0

B22 0.53 – 1.00 EOBH	Medium clay	Moderate - strong, firm, sub- angular peds 20-40 mm	<2% calcium carbonate	10YR3/1 Very dark grey Nil mottles / bleaching	Dry, well- moderate drained	Present	0.60 / 7.0 0.90 / 7.0

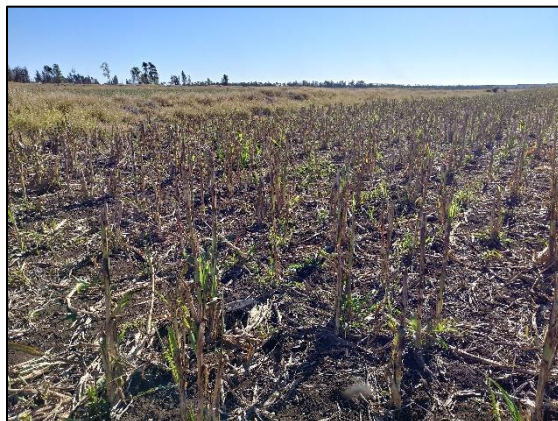
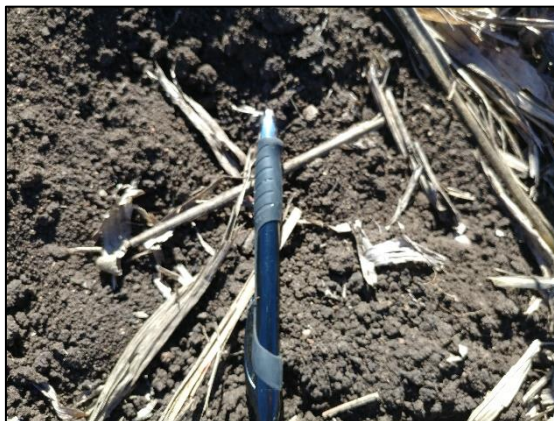
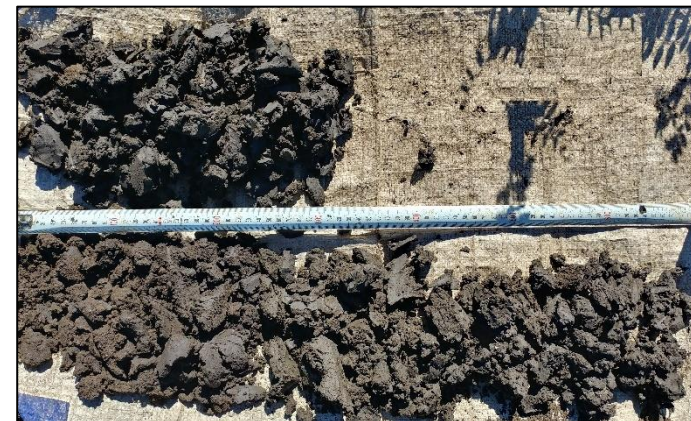
<b>Map Unit</b> B1	<b>Location (GDA94 ZONE 55):</b> 643707mE 7512426mN	<b>Aust. Soil Class.:</b> Black Vertosol	<b>Site Survey Type:</b> Detailed - 50mm hand auger	<b>Survey Date:</b> 29/06/2019
-----------------------	--	---	--	-----------------------------------

Land use Landform Pattern, Element, Slope	Vegetation	Microrelief Disturbance Erosion	Surface condition, surface rock	Soil Profile Description									
				Horizon Depth (m), Boundary	Field Texture	Structure, Strength	Inclusions Segregations	Colour, Mottle, Bleaching	Moisture, Drainage	Roots	Depth (m) / Field pH	Sample (m)	Observations
Cropping / Grazing GUP Lower slope / flat plain <1% / 1%	Cropping	Nil microrelief Extensive disturbed, contour banks nearby	Cracking, firm, Nil coarse fragments	A11 0.0 – 0.12 Abrupt	Light clay	Weak, firm, sub-rounded peds <10 mm	Nil inclusions / segregations	10YR3/2 Very dark greyish brown Nil mottles / bleaching	Dry, well drained	Present	0.10 / 8.0	0.00-0.10 0.20-0.30 0.50-0.60 0.80-0.90 0.90-1.00	Nil additional observations
				B21 0.12 – 0.45 Abrupt	Medium clay	Moderate - strong, firm, sub-angular peds 20-40 mm	Nil inclusions / segregations	10YR3/1 Very dark grey Nil mottles / bleaching	Dry, well- moderate drained	Present	0.30 / 8.0

B22 0.45 – 0.60 Abrupt	Medium clay	Moderate - strong, firm, sub-angular peds 30-60 mm	Nil inclusions / segregations	10YR3/1 Very dark grey Nil mottles / bleaching	Dry, well- moderate drained	Present	0.60 / 7.0		
				B22 0.45 – 0.60 Abrupt	Medium clay	Moderate - strong, firm, sub-angular peds 30-60 mm	<2% calcium carbonate	10YR3/1 Very dark grey Nil mottles / bleaching	Dry, well- moderate drained	Present	0.90 / 7.0

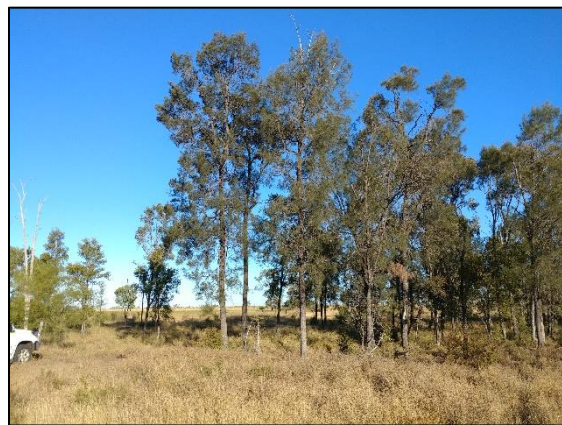
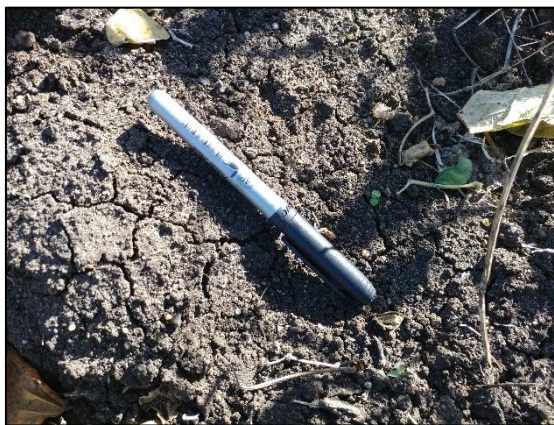
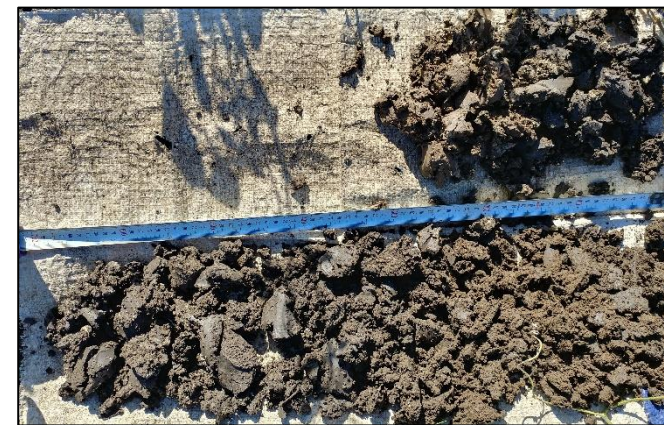
<b>Map Unit</b> B1	<b>Location (GDA94 ZONE 55):</b> 643069mE 7512379mN	<b>Aust. Soil Class.:</b> Black Vertosol	<b>Site Survey Type:</b> Detailed - 50mm hand auger	<b>Survey Date:</b> 29/06/2019
-----------------------	--	---	--	-----------------------------------

<b><u>Land use</u> <u>Landform</u> <u>Pattern,</u> <u>Element,</u> <u>Slope</u></b>	<b><u>Vegetation</u></b>	<b><u>Microrelief</u> <u>Disturbance</u> <u>Erosion</u></b>	<b><u>Surface</u> <u>condition,</u> <u>surface rock</u></b>	<b><u>Soil Profile Description</u></b>									
				<b><u>Horizon</u> <u>Depth (m),</u> <u>Boundary</u></b>	<b><u>Field</u> <u>Texture</u></b>	<b><u>Structure,</u> <u>Strength</u></b>	<b><u>Inclusions</u> <u>Segregations</u></b>	<b><u>Colour, Mottle,</u> <u>Bleaching</u></b>	<b><u>Moisture,</u> <u>Drainage</u></b>	<b><u>Roots</u></b>	<b><u>Depth (m) /</u> <u>Field pH</u></b>	<b><u>Sample (m)</u></b>	<b><u>Observations</u></b>
Cropping / Grazing GUP mid slope 2% / 2%	Cropping	Nil microrelief Extensive disturbed, contour banks nearby	Cracking, firm, Nil coarse fragments	A11 0.0 – 0.20 Abrupt	Light medium clay	Moderate, firm, sub- rounded peds <10 mm	Nil inclusions / segregations	10YR3/2 Very dark greyish brown Nil mottles / bleaching	Dry, well drained	Present	0.10 / 8.0	0.00-0.10 0.20-0.30 0.50-0.60 0.80-0.90 0.90-1.00	Nil additional observations

B21 0.20 – 0.46 Abrupt	Medium clay	Moderate - strong, firm, sub-rounded peds 20 mm	Nil inclusions / segregations	10YR3/2 Very dark greyish brown Nil mottles / bleaching	Dry, well- moderate drained	Present	0.30 / 8.0		
				B22 0.46 – 0.80 Abrupt	Medium clay	Moderate - strong, firm, sub-rounded peds 20 mm	<2% calcium carbonate	10YR3/2 Very dark greyish brown Nil mottles / bleaching	Dry, well- moderate drained	Present	0.60 / 8.0		
				B23 0.80 – 1.00 EOBH	Medium clay	Moderate - strong, firm, sub-rounded peds 20 mm	<2% calcium carbonate	10YR4/4 Dark yellowish brown Nil mottles / bleaching	Dry, well- moderate drained	Nil	0.90 / 8.0

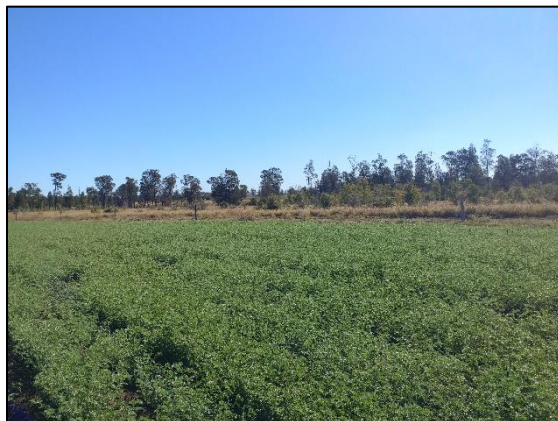
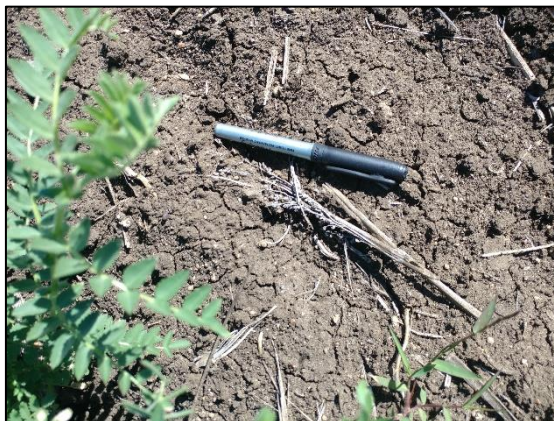
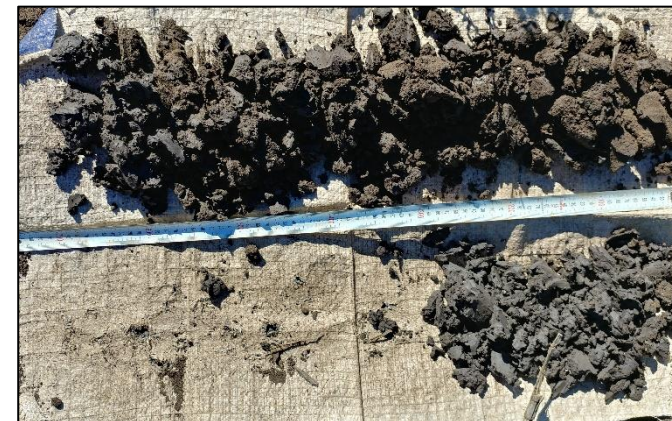
<b>Map Unit</b> B1	<b>Location (GDA94 ZONE 55):</b> 643659mE 7511986mN	<b>Aust. Soil Class.:</b> Black Vertosol	<b>Site Survey Type:</b> Detailed - 50mm hand auger	<b>Survey Date:</b> 29/06/2019
-----------------------	--	---	--	-----------------------------------

Land use Landform Pattern, Element, Slope	Vegetation	Microrelief Disturbance Erosion	Surface condition, surface rock	Soil Profile Description									
				Horizon Depth (m), Boundary	Field Texture	Structure, Strength	Inclusions Segregation s	Colour, Mottle, Bleaching	Moisture, Drainage	Roots	Depth (m) / Field pH	Sample (m)	Observations
Cropping / Grazing GUP mid slope 2% / 2%	Cropping	Nil microrelief Extensive disturbed, Nil erosion	Minor cracking, self- mulching, Nil coarse fragments	A11 0.0 – 0.04 Abrupt	Light medium clay	Moderate, firm, sub-rounded peds 20-50 mm	Nil inclusions / segregations	10YR3/2 Very dark greyish brown Nil mottles / bleaching	Dry, well drained	Present	0.10 / 8.0	0.00-0.04 0.20-0.30 0.50-0.60 0.80-0.90 0.90-1.00	Nil additional observations
				A12 0.04 – 0.20 Abrupt	Medium clay	Moderate, firm, sub-rounded peds 50-80 mm	Nil inclusions / segregations	10YR3/2 Very dark greyish brown Nil mottles / bleaching	Dry, well- moderate drained	Present	0.30 / 8.0

B21 0.20 – 0.45 Abrupt	Medium heavy clay	Moderate, - strong firm, sub-rounded peds 50-80 mm	Nil inclusions / segregations	10YR2/1 Black Nil mottles / bleaching	Dry, well- moderate drained	Present	0.60 / 8.0		
				B22 0.45 – 1.00 EOBH	Medium heavy clay	Moderate, - strong firm, sub-rounded peds 50-80 mm	Nil inclusions / segregations	10YR2/1 Black Nil mottles / bleaching	Dry, well- moderate drained	Nil	0.90 / 8.0

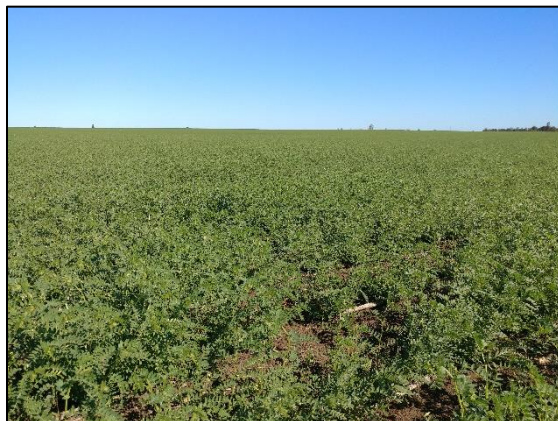
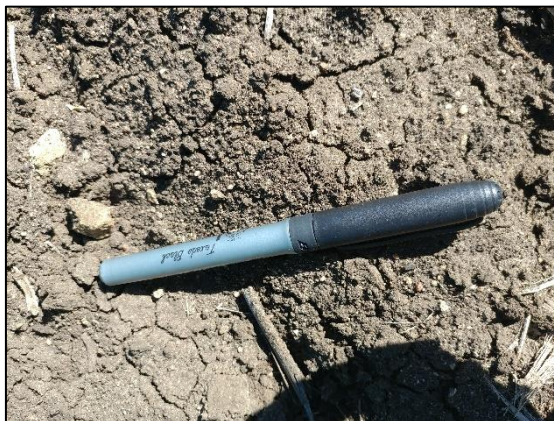
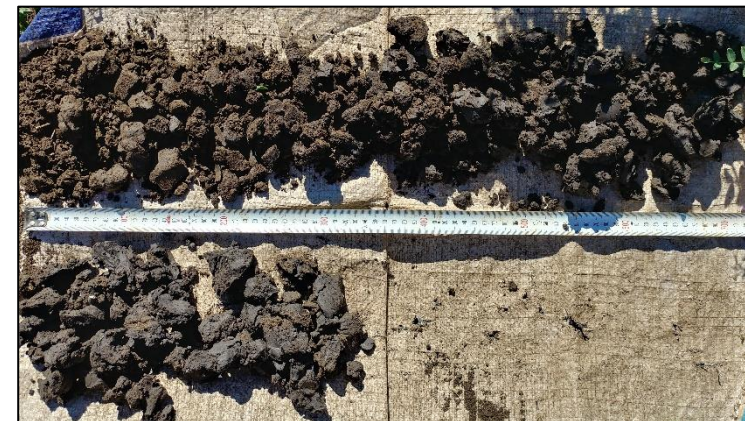
<b>Map Unit</b> B1	<b>Location (GDA94 ZONE 55):</b> 644933mE 7511241mN	<b>Aust. Soil Class.:</b> Black Vertosol	<b>Site Survey Type:</b> Detailed - 50mm hand auger	<b>Survey Date:</b> 30/06/2019
-----------------------	--	---	--	-----------------------------------

Land use Landform Pattern, Element, Slope	Vegetation	Microrelief Disturbance Erosion	Surface condition, surface rock	Soil Profile Description									
				Horizon Depth (m), Boundary	Field Texture	Structure, Strength	Inclusions Segregation s	Colour, Mottle, Bleaching	Moisture, Drainage	Roots	Depth (m) / Field pH	Sample (m)	Observations
Cropping / Grazing GUP mid slope 2% / 2%	Cropping	Nil microrelief Extensive disturbed, Nil erosion	Minor cracking, self- mulching, Nil coarse fragments	A11 0.0 – 0.06 Abrupt	Light medium clay	Moderate, firm, sub-rounded peds 20-50 mm	Nil inclusions / segregations	10YR3/2 Very dark greyish brown Nil mottles / bleaching	Dry, well drained	Present	0.10 / 8.0	0.00-0.10 0.20-0.30 0.50-0.60 0.80-0.90 0.90-1.00	Nil additional observations
				A12 0.06 – 0.22 Abrupt	Medium clay	Moderate, firm, sub-rounded peds 50-80 mm	Nil inclusions / segregations	10YR3/2 Very dark greyish brown Nil mottles / bleaching	Dry, well- moderate drained	Present	0.30 / 8.0

B21 0.22 – 0.50 Abrupt	Medium heavy clay	Moderate, - strong firm, sub-rounded peds 50-80 mm	Nil inclusions / segregations	10YR2/1 Black Nil mottles / bleaching	Dry, well- moderate drained	Present	0.60 / 8.0		
				B22 0.50 – 1.00 EOBH	Medium heavy clay	Moderate, - strong firm, sub-rounded peds 50-80 mm	Nil inclusions / segregations	10YR2/1 Black Nil mottles / bleaching	Dry, well- moderate drained	Nil	0.90 / 8.0

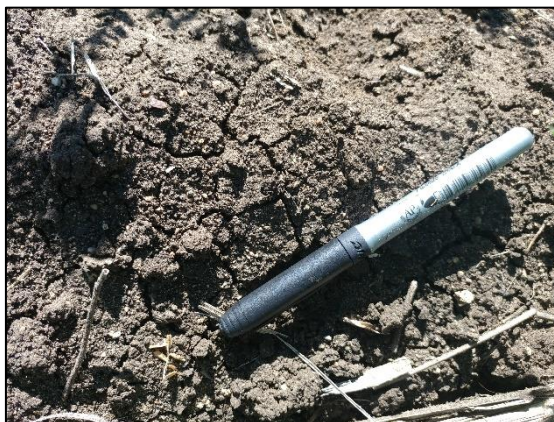
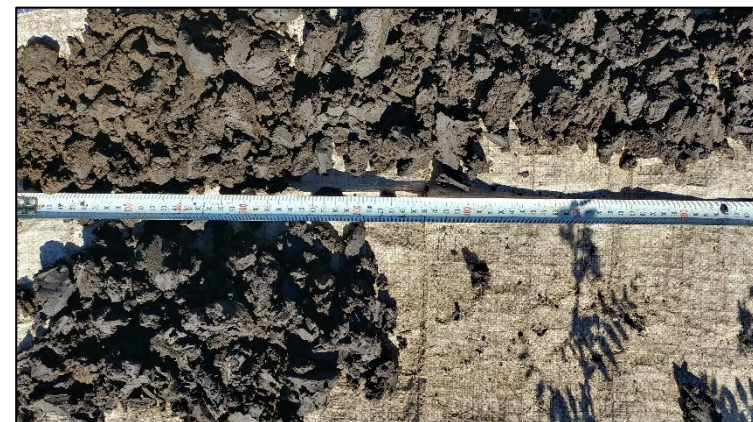
Land use Landform Pattern, Element, Slope	Vegetation	Microrelief Disturbance Erosion	Surface condition, surface rock	Soil Profile Description									
				Horizon Depth (m), Boundary	Field Texture	Structure, Strength	Inclusions Segregations	Colour, Mottle, Bleaching	Moisture, Drainage	Roots	Depth (m) / Field pH	Sample (m)	Observations
Cropping / Grazing GUP mid slope 2% / 2%	Cropping	Nil microrelief Extensive disturbed, Nil erosion	Minor cracking, self- mulching, Nil coarse fragments	A11 0.0 – 0.04 Abrupt	Light medium clay	Moderate, firm, sub-rounded peds 20-50 mm	Nil inclusions / segregations	10YR3/2 Very dark greyish brown Nil mottles / bleaching	Dry, well drained	Present	0.10 / 8.0	0.00-0.10 0.20-0.30 0.50-0.60 0.80-0.90 0.90-1.00	Nil additional observations
				A12 0.04 – 0.23 Abrupt	Medium clay	Moderate, firm, sub-rounded peds 50-80 mm	Nil inclusions / segregations	10YR3/2 Very dark greyish brown Nil mottles / bleaching	Dry, well- moderate drained	Present	0.30 / 8.0

B21 0.23 – 0.47 Abrupt	Medium heavy clay	Moderate, - strong firm, sub-rounded peds 50-80 mm	Nil inclusions / segregations	10YR2/1 Black Nil mottles / bleaching	Dry, well- moderate drained	Present	0.60 / 8.0		
				B22 0.47 – 1.00 EOBH	Medium heavy clay	Moderate, - strong firm, sub-rounded peds 50-80 mm	Nil inclusions / segregations	10YR2/1 Black Nil mottles / bleaching	Dry, well- moderate drained	Nil	0.90 / 8.0

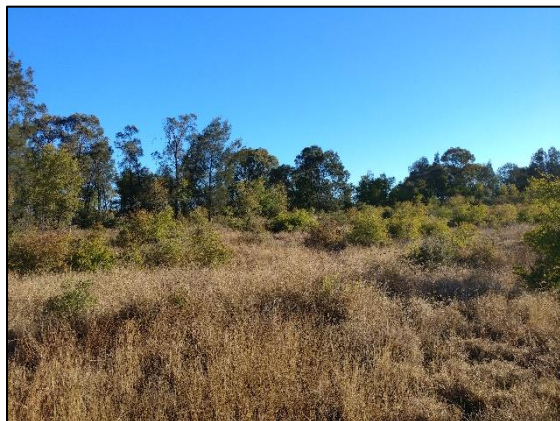
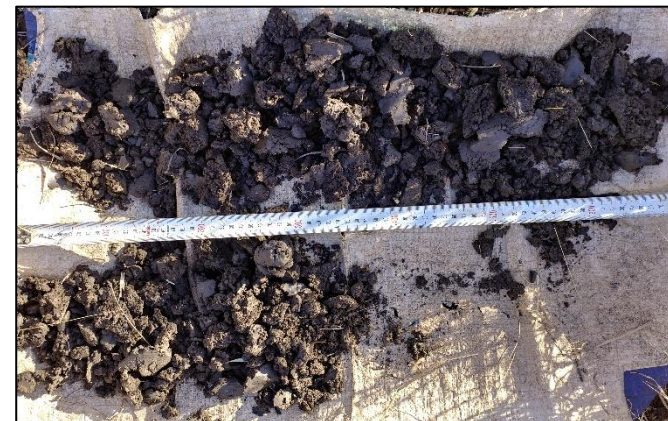
<b>Map Unit</b> B1	<b>Location (GDA94 ZONE 55):</b> 645726mE 7510395mN	<b>Aust. Soil Class.:</b> Black Vertosol	<b>Site Survey Type:</b> Detailed - 50mm hand auger	<b>Survey Date:</b> 30/06/2019
-----------------------	--	---	--	-----------------------------------

Land use Landform Pattern, Element, Slope	Vegetation	Microrelief Disturbance Erosion	Surface condition, surface rock	Soil Profile Description									
				Horizon Depth (m), Boundary	Field Texture	Structure, Strength	Inclusions Segregations	Colour, Mottle, Bleaching	Moisture, Drainage	Roots	Depth (m) / Field pH	Sample (m)	Observations
Grazing GUP Lower slope to depression 1% / 2%	Mixed vegetation, eucalyptus species, Grasses	Nil microrelief Semi disturbed, Nil erosion	Cracking, <2% coarse fragments <5mm	A11 0.0 – 0.12 Abrupt	Light clay	Moderate, firm, sub- angular <20 mm	Nil inclusions / segregations	10YR3/2 Very dark greyish brown Nil mottles / bleaching	Dry, well drained	Present	0.10 / 7.0	0.00-0.10 0.20-0.30 0.50-0.60 0.80-0.90 0.90-1.00	Nil additional observations
				B21 0.12 – 0.90 Abrupt	Medium clay	Moderate- strong, strong, sub- angular <20 mm	Nil inclusions / segregations	10YR3/2 Very dark greyish brown Nil mottles / bleaching	Dry, well- moderate drained	Present	0.30 / 7.5 0.60 / 7.5

B22 0.90 – 1.00 EOBH	Medium clay	Moderate- strong, strong, sub- angular <20 mm	<2% calcium carbonate	10YR3/2 Very dark greyish brown Nil mottles / bleaching	Dry, well- moderate drained	Present	0.90 / 8.0

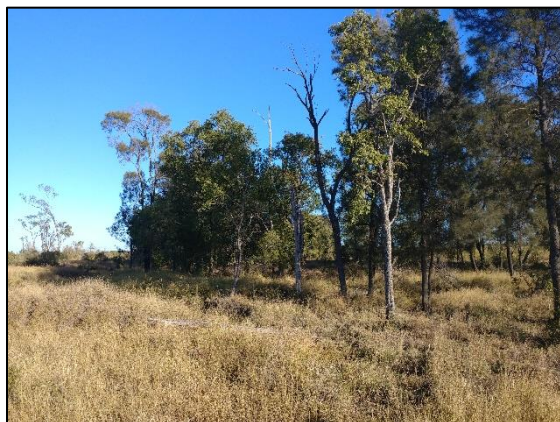
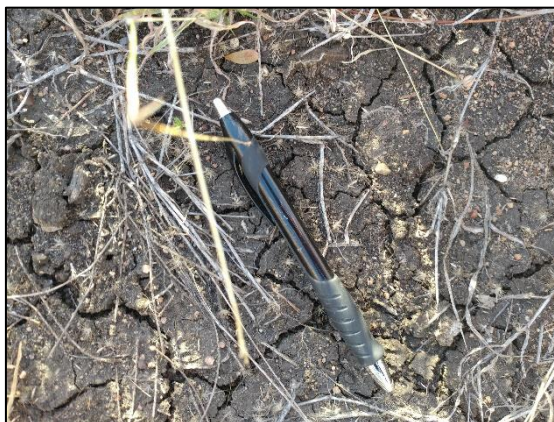
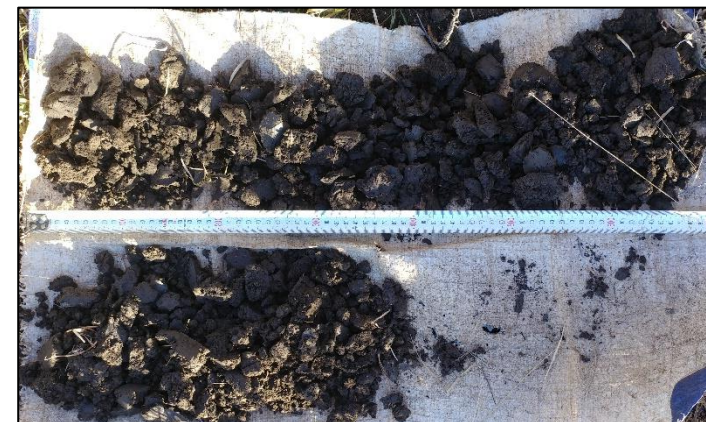
<b>Map Unit</b> B1	<b>Location (GDA94 ZONE 55):</b> 645496mE 7510399mN	<b>Aust. Soil Class.:</b> Black Vertosol	<b>Site Survey Type:</b> Detailed - 50mm hand auger	<b>Survey Date:</b> 30/06/2019
-----------------------	--	---	--	-----------------------------------

Land use Landform Pattern, Element, Slope	Vegetation	Microrelief Disturbance Erosion	Surface condition, surface rock	Soil Profile Description									
				Horizon Depth (m), Boundary	Field Texture	Structure, Strength	Inclusions Segregations	Colour, Mottle, Bleaching	Moisture, Drainage	Roots	Depth (m) / Field pH	Sample (m)	Observations
Grazing GUP Lower slope to depression 1% / 2%	Mixed vegetation, eucalyptus species, Grasses	Nil microrelief Semi disturbed, Nil erosion	Cracking, <2% coarse fragments <5mm	A11 0.0 – 0.13 Abrupt	Light clay	Moderate, firm, sub- angular <20 mm	Nil inclusions / segregations	10YR3/2 Very dark greyish brown Nil mottles / bleaching	Dry, well drained	Present	0.10 / 7.0	0.00-0.10 0.20-0.30 0.50-0.60 0.80-0.90 0.90-1.00	Nil additional observations
				B21 0.13 – 0.85 Abrupt	Medium clay	Moderate- strong, strong, sub- angular <20 mm	Nil inclusions / segregations	10YR3/2 Very dark greyish brown Nil mottles / bleaching	Dry, well- moderate drained	Present	0.30 / 7.5 0.60 / 7.5

B22 0.85 – 1.00 EOBH	Medium clay	Moderate- strong, strong, sub- angular <20 mm	<2% calcium carbonate	10YR3/2 Very dark greyish brown Nil mottles / bleaching	Dry, well- moderate drained	Present	0.90 / 8.0

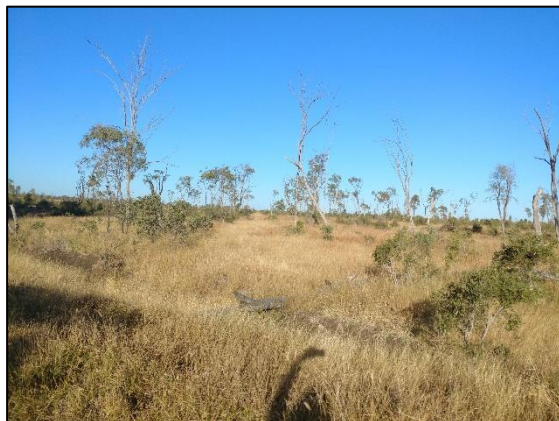
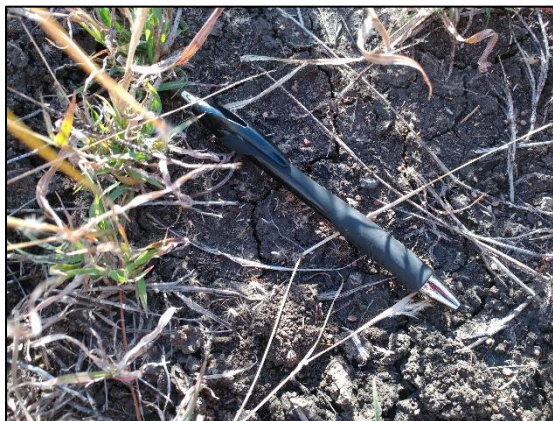
<b>Map Unit</b> B1	<b>Location (GDA94 ZONE 55):</b> 644518mE 7510978mN	<b>Aust. Soil Class.:</b> Black Vertosol	<b>Site Survey Type:</b> Detailed - 50mm hand auger	<b>Survey Date:</b> 30/06/2019
-----------------------	--	---	--	-----------------------------------

Land use Landform Pattern, Element, Slope	Vegetation	Microrelief Disturbance Erosion	Surface condition, surface rock	Soil Profile Description									
				Horizon Depth (m), Boundary	Field Texture	Structure, Strength	Inclusions Segregations	Colour, Mottle, Bleaching	Moisture, Drainage	Roots	Depth (m) / Field pH	Sample (m)	Observations
Grazing GUP mid slope 1% / 2%	Mixed vegetation, eucalyptus species, Grasses	Nil microrelief Semi disturbed, Nil erosion	Cracking, <2% coarse fragments <5mm	A11 0.0 – 0.14 Abrupt	Light clay	Moderate, firm, sub- angular <20 mm	Nil inclusions / segregations	10YR3/2 Very dark greyish brown Nil mottles / bleaching	Dry, well drained	Present	0.10 / 7.0	0.00-0.10 0.20-0.30 0.50-0.60 0.80-0.90 0.90-1.00	Nil additional observations
				B21 0.14 – 1.00 EOBH	Medium clay	Moderate- strong, strong, sub- angular <20 mm	Nil inclusions / segregations	10YR3/2 Very dark greyish brown Nil mottles / bleaching	Dry, well- moderate drained	Present	0.30 / 7.5 0.60 / 7.5 0.90 / 8.0

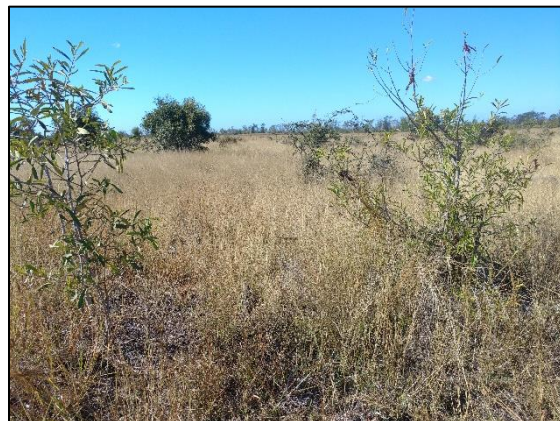
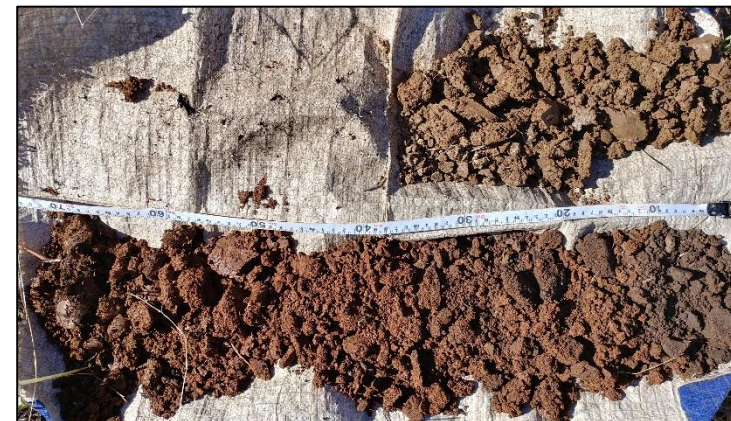
<b>Map Unit</b> E1r	<b>Location (GDA94 ZONE 55):</b> 642742mE 7510104mN	<b>Aust. Soil Class.:</b> Red Chromosol	<b>Site Survey Type:</b> Detailed - 50mm hand auger	<b>Survey Date:</b> 30/06/2019
------------------------	--	--	--	-----------------------------------

Land use Landform Pattern, Element, Slope	Vegetation	Microrelief Disturbance Erosion	Surface condition, surface rock	Soil Profile Description									
				Horizon Depth (m), Boundary	Field Texture	Structure, Strength	Inclusions Segregations	Colour, Mottle, Bleaching	Moisture, Drainage	Roots	Depth (m) / Field pH	Sample (m)	Observations
Grazing GUP Mid - lower slope <2% / <2%	Grasses	Nil microrelief Extensive disturbed, Nil erosion	Firm Nil coarse fragments	A11 0.0 – 0.12 Abrupt	Sandy loam	Weak- moderate, firm, sub- rounded <20 mm	Nil inclusions / segregations	10YR3/2 Very dark greyish brown Nil mottles / bleaching	Dry, well drained	Present	0.10 / 6.5	0.00-0.10 0.20-0.30 0.50-0.60 0.80-0.90 0.90-1.00	Nil additional observations
				B21 0.12 – 0.70 Abrupt	Sandy clay loam	Moderate, firm, sub- angular <20 mm	Nil inclusions / segregations	5YR4/3 Reddish brown Nil mottles / bleaching	Dry, well- moderate drained	Present	0.30 / 7.0 0.60 / 7.5

B22 0.70 – 1.00 EOBH	Light clay	Moderate, v.firm, sub- angular <20 mm	<5% calcium carbonate	7.5YR4/4 Brown Nil mottles / bleaching	Dry, well- moderate drained	Present	0.90 / 7.5

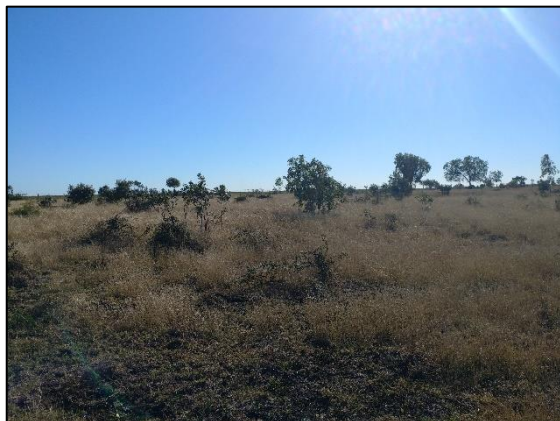
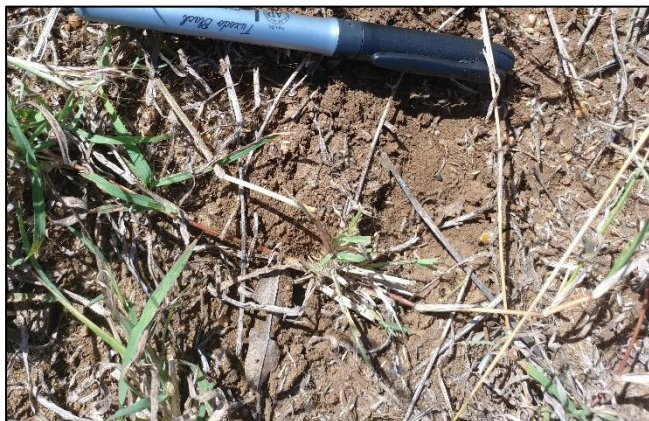
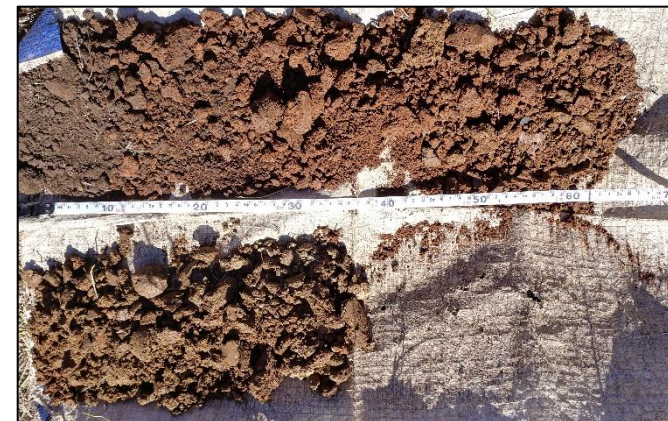
<b>Map Unit</b> E1r	<b>Location (GDA94 ZONE 55):</b> 642252mE 7510143mN	<b>Aust. Soil Class.:</b> Red Chromosol	<b>Site Survey Type:</b> Detailed - 50mm hand auger	<b>Survey Date:</b> 01/07/2019
------------------------	--	--	--	-----------------------------------

Land use Landform Pattern, Element, Slope	Vegetation	Microrelief Disturbance Erosion	Surface condition, surface rock	Soil Profile Description									
				Horizon Depth (m), Boundary	Field Texture	Structure, Strength	Inclusions Segregations	Colour, Mottle, Bleaching	Moisture, Drainage	Roots	Depth (m) / Field pH	Sample (m)	Observations
Grazing GUP Mid - lower slope <2% / <2%	Grasses	Nil microrelief Extensive disturbed, Nil erosion	Firm Nil coarse fragments	A11 0.0 – 0.14 Clear	Sandy loam	Weak- moderate, firm, sub- rounded <20 mm	Nil inclusions / segregations	10YR3/2 Very dark greyish brown Nil mottles / bleaching	Dry, well drained	Present	0.10 / 6.5	0.00-0.10 0.20-0.30 0.50-0.60 0.80-0.90 0.90-1.00	Nil additional observations
				B21 0.14 – 0.70 Abrupt	Light clay	Moderate, firm, sub- angular <20 mm	Nil inclusions / segregations	5YR4/3 Reddish brown Nil mottles / bleaching	Dry, well- moderate drained	Present	0.30 / 7.0 0.60 / 7.5

B22 0.70 – 1.00 EOBH	Light clay	Moderate, v.firm, sub- angular <20 mm	<5% calcium carbonate	7.5YR4/4 Brown Nil mottles / bleaching	Dry, well- moderate drained	Present	0.90 / 7.5
