# Restoration Plan to Support RIDA Application Saraji East Project

Final V4  
15 July 2021

GT Environmental Pty Ltd  
[www.gtenvironmental.com.au](http://www.gtenvironmental.com.au)

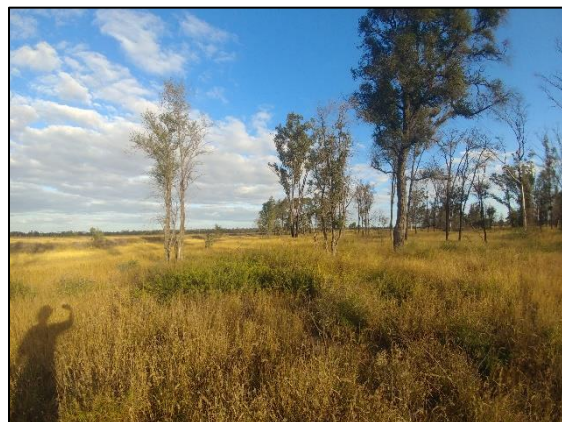
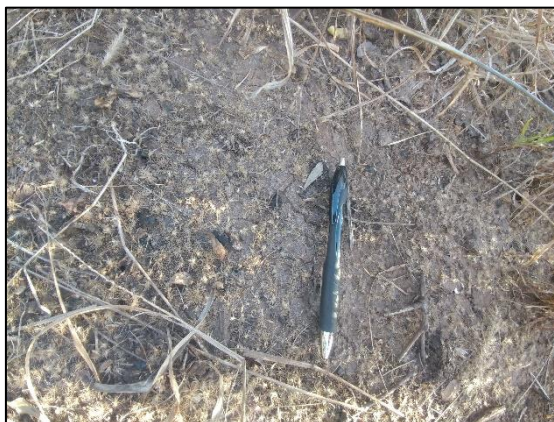
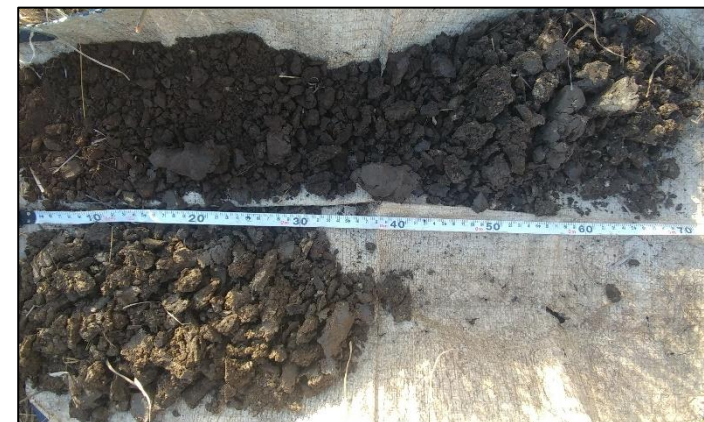
<b>Map Unit</b> B3	<b>Location (GDA94 ZONE 55):</b> 643716mE 7513193mN	<b>Aust. Soil Class.:</b> Black Dermosol	<b>Site Survey Type:</b> Detailed - 50mm hand auger	<b>Survey Date:</b> 011/07/2019
-----------------------	--	---	--	------------------------------------

Land use Landform Pattern, Element, Slope	Vegetation	Microrelief Disturbance Erosion	Surface condition, surface rock	Soil Profile Description									
				Horizon Depth (m), Boundary	Field Texture	Structure, Strength	Inclusions Segregations	Colour, Mottle, Bleaching	Moisture, Drainage	Roots	Depth (m) / Field pH	Sample (m)	Observations
Grazing GUP upper slope <2% / <2%	Eucalyptus species	Nil microrelief Semi disturbed, contour banks nearby Nil erosion	Minor cracking, firm, nil coarse fragments	A11 0.0 – 0.06 Abrupt	Sandy clay loam	Massive	Nil inclusions or segregations	10YR3/2 Very dark greyish brown Nil mottles / bleaching	Dry, well drained	Present	0.10 / 7.5	0.00-0.10 0.20-0.30 0.50-0.60 0.80-0.90 0.90-1.00	Nil additional observations
				A12 0.06 – 0.20 gradual	Sandy clay loam	Weak, sub- rounded peds <10 mm	Nil inclusions or segregations	10YR3/2 Very dark greyish brown Nil mottles / bleaching	Dry, well drained	Present	0.20 / 7.5

B21 0.20 – 0.46 gradual	Sandy clay loam	Subangular blocky, moderate, peds <20 mm, firm	Nil inclusions or segregations	10YR3/2 Very dark greyish brown Nil mottles / bleaching	Dry, well drained	Present	0.30 / 7.5		
				B22 0.46 – 1.00 EOBH	Medium clay, sandy	Subangular blocky, moderate, peds <20 mm, firm	<20% calcium carbonate	10YR3/3 Dark reddish brown Nil mottles / bleaching	Dry, well – moderate drained	Present	0.60 / 7.5 0.90 / 7.5

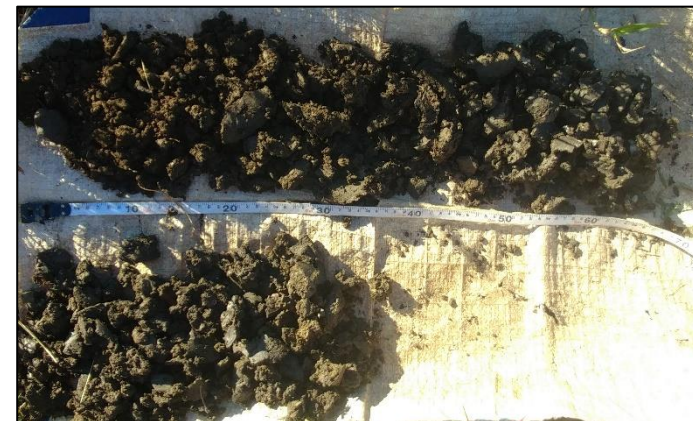
**Soil Profile**

<b>Map Unit</b> E2	<b>Location (GDA94 ZONE 55):</b> 643817mE 7508323mN	<b>Aust. Soil Class.:</b> Black Vertosol	<b>Site Survey Type:</b> Detailed - 50mm hand auger	<b>Survey Date:</b> 01/07/2019
-----------------------	--	---	--	-----------------------------------

Land use Landform Pattern, Element, Slope	Vegetation	Microrelief Disturbance Erosion	Surface condition, surface rock	Soil Profile Description									
				Horizon Depth (m), Boundary	Field Texture	Structure, Strength	Inclusions Segregations	Colour, Mottle, Bleaching	Moisture, Drainage	Roots	Depth (m) / Field pH	Sample (m)	Observations
Grazing GUP Lower slope 1% / 1%	Short grasses	Nil microrelief Extensive disturbance Nil erosion	Minor cracking	A1 0.00-0.15 Abrupt	Light clay	Weak, soft sub- rounded <10mm	Nil inclusions / segregations	10YR3/1 Very dark grey Nil mottles/bleach	Dry, moderate	Few fine	0.10 / 6.0	0.00-0.10 0.20-0.30 0.50-0.60 0.80-0.90 0.90-1.00	Nil additional observations
				B21 0.15-0.45 Abrupt	Medium clay	Weak to moderate, firm sub- rounded <10mm	Nil inclusions / segregations	10YR2/2 Very dark brown Nil mottles/bleach	Dry, moderate	Very fine, very few	0.30 / 6.5		
				B22 0.45-1.00 EOBH	Medium clay	Moderate, firm sub- rounded <20mm	Nil inclusions / segregations	10YR3/3 Dark brown Nil mottles/bleach	Dry, moderate	Very fine, very few	0.60 / 7.0 0.90 / 7.0

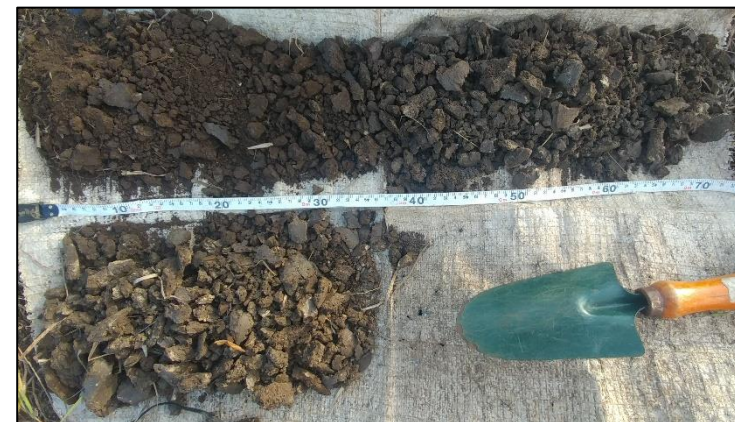
**Soil Profile**

<b>Map Unit</b> B5	<b>Location (GDA94 ZONE 55):</b> 643622mE 7513388mN	<b>Aust. Soil Class.:</b> Black Dermosol	<b>Site Survey Type:</b> Detailed - 50mm hand auger	<b>Survey Date:</b> 01/07/2019
-----------------------	--	---	--	-----------------------------------

Land use Landform Pattern, Element, Slope	Vegetation	Microrelief Disturbance Erosion	Surface condition, surface rock	Soil Profile Description									
				Horizon Depth (m), Boundary	Field Texture	Structure, Strength	Inclusions Segregations	Colour, Mottle, Bleaching	Moisture, Drainage	Roots	Depth (m) / Field pH	Sample (m)	Observations
Grazing GUP upper slope <2% / <2%	Eucalyptus species	Nil microrelief Semi disturbed, contour banks nearby	Minor cracks, firm, Nil coarse fragments	A11 0.0 – 0.09 Abrupt	Sandy clay loam	Massive	Nil inclusions or segregations	10YR3/2 Very dark greyish brown Nil mottles / bleaching	Dry, well drained	Present	0.10 / 7.5	0.00-0.10 0.20-0.30 0.50-0.60 0.80-0.90 0.90-1.00	Nil additional observations
				A12 0.09 – 0.25 gradual	Sandy clay loam	Weak, sub- rounded peds <10 mm	Nil inclusions or segregations	10YR3/2 Very dark greyish brown Nil mottles / bleaching	Dry, well drained	Present	0.20 / 7.5

B22 0.25 – 0.50 gradual	Sandy clay loam	Subangular blocky, moderate, peds <20 mm, firm	Nil inclusions or segregations	10YR3/2 Very dark greyish brown Nil mottles / bleaching	Dry, well drained	Present	0.30 / 7.5		
				B23 0.50 – 1.00 EOBH	Medium clay, sandy	Subangular blocky, moderate, peds <20 mm, firm	<20% calcium carbonate	10YR3/3 Dark brown Nil mottles / bleaching	Dry, well – moderate drained	Present	0.60 / 7.5 0.90 / 7.5

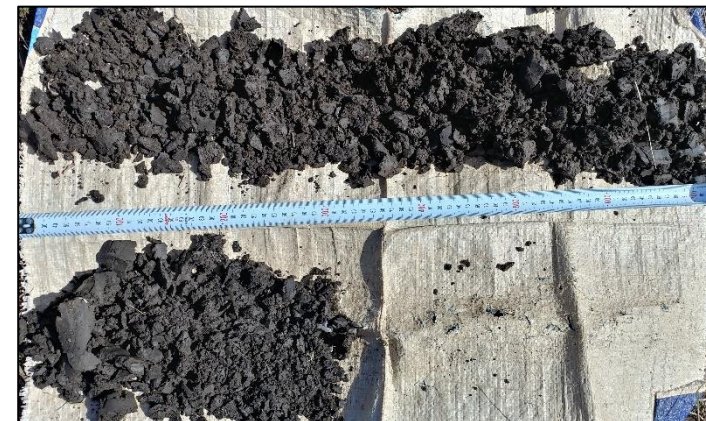
**Soil Profile**

<b>Map Unit</b> B3bl	<b>Location (GDA94 ZONE 55):</b> 642166mE 7508999mN	<b>Aust. Soil Class.:</b> Black Vertosol	<b>Site Survey Type:</b> Detailed - 50mm hand auger	<b>Survey Date:</b> 04/06/2019
-------------------------	--	---	--	-----------------------------------

Land use Landform Pattern, Element, Slope	Vegetation	Microrelief Disturbance Erosion	Surface condition, surface rock	Soil Profile Description									
				Horizon Depth (m), Boundary	Field Texture	Structure, Strength	Inclusions Segregations	Colour, Mottle, Bleaching	Moisture, Drainage	Roots	Depth (m) / Field pH	Sample (m)	Observations
Gently undulating plain 2.0/2.0	Grasses, recent regrowth and shrubs	Microrelief present – Depression <0.2m deep, 40% coverage Extensive clearing Nil Erosion	Self-mulching with cracking Nil coarse fragments	A1 0.00-0.17 Abrupt	Light medium clay	Weak, firm <20mm sub-angular	<1% Calcium carbonate <2mm	10YR3/1 Very dark grey Nil mottle / bleaching	Dry, Well drained	Common, medium	0.10 / 6.5	0.00-0.10 0.20-0.30 0.50-0.60 0.80-0.90 0.90-1.00	Nil additional observations
				B2 0.17-1.00 Abrupt	Medium heavy clay	Moderate, Very firm 20-40mm sub-angular	<2% Calcium carbonate <2mm	10YR3/2 Very dark greyish brown Nil mottle / bleaching	Dry, Moderate drained	Few, medium	0.30 / 6.5 0.60 / 6.5 0.90 / 6.5

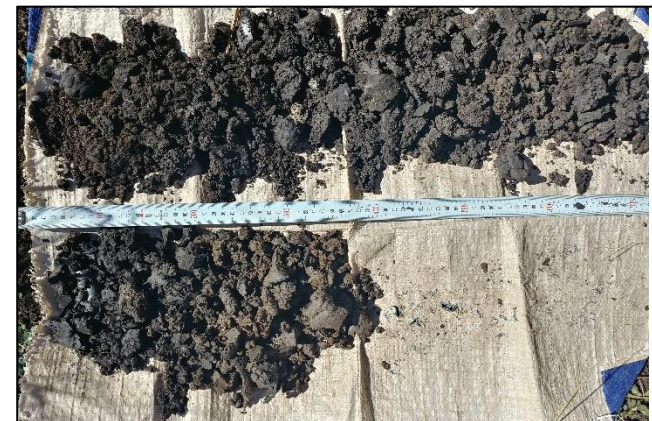
**Soil Profile**

<b>Map Unit</b> B1	<b>Location (GDA94 ZONE 55):</b> 641287mE 7510129mN	<b>Aust. Soil Class:</b> Black Vertosol	<b>Site Survey Type:</b> Detailed - 50mm hand auger	<b>Survey Date:</b> 03/06/2019
-----------------------	--	--	--	-----------------------------------

Land use Landform Pattern, Element, Slope	Vegetation	Microrelief Disturbance Erosion	Surface condition, surface rock	Soil Profile Description									
				Horizon Depth (m), Boundary	Field Texture	Structure, Strength	Inclusions Segregations	Colour, Mottle, Bleaching	Moisture, Drainage	Roots	Depth (m) / Field pH	Sample (m)	Observations
Grazing, mid-slope, 2.0/2.0	Grasses	Nil microrelief Extensively disturbance Nil erosion	Humid self- mulching with crust 2-6 mm thick, minor sand on surface. Coarse fragments`<5 mm <5%	A1 0.00 – 0.15 Abrupt	Light clay, sandy	Weak, firm Subangular blocky, peds 10-30 mm,	Nil inclusions and segregations	10YR2/1 Black Nil mottles / bleaching	Humid, Well – moderate drained	Fine, very few	0.10 / 6.5	0.00-0.10 0.20-0.30 0.50-0.60 0.80-0.90 0.90-1.00	Nil additional observations
				B21 0.15 – 0.30 Abrupt	Medium heavy clay	Weak, firm Subangular blocky, peds 20-30 mm,	Nil inclusions and segregations	10YR2/1 Black Nil mottles / bleaching	Humid, Well – moderate drained	Fine, very few	0.35 / 7.0

B22 0.30 – 0.80 Abrupt	Medium heavy clay	Weak to moderate, very firm Subangular blocky, peds 20-30 mm,	<5% calcium carbonate	10YR2/1 Black Nil mottles / bleaching	Humid, Well – moderate drained	Fine, very few	0.60 / 7.0		
				B23 0.80 – 1.00 EOBH	Medium heavy clay, sandy	Weak to moderate, very firm Subangular blocky, peds 40-60 mm,	Nil inclusions and segregations	10YR4/2 Dark greyish brown Nil mottles / bleaching	Humid, Well – moderate drained	Nil roots	0.90 / 7.5

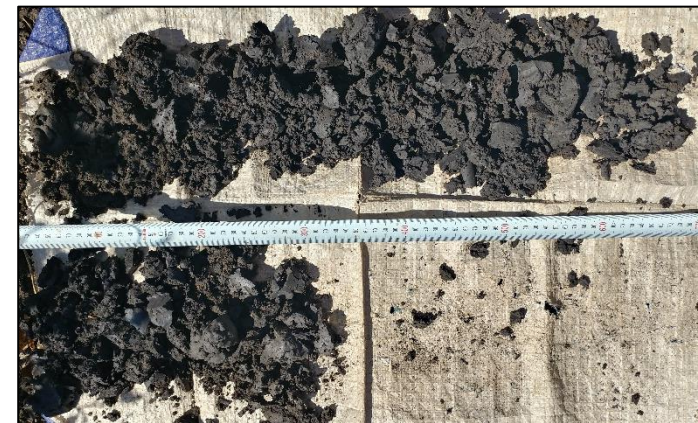
**Soil Profile**

<b>Map Unit</b> B1	<b>Location (GDA94 ZONE 55):</b> 641694mE 7510274 mN	<b>Aust. Soil Class.:</b> Black Vertosol	<b>Site Survey Type:</b> Detailed - 50mm hand auger	<b>Survey Date:</b> 03/06/2019
-----------------------	---	---	--	-----------------------------------

Land use Landform Pattern, Element, Slope	Vegetation	Microrelief Disturbance Erosion	Surface condition, surface rock	Soil Profile Description									
				Horizon Depth (m), Boundary	Field Texture	Structure, Strength	Inclusions Segregations	Colour, Mottle, Bleaching	Moisture, Drainage	Roots	Depth (m) / Field pH	Sample (m)	Observations
Cropping, mid-slope, 2% slope	Forage crops	Nil microrelief Nil erosion  Extensively disturbed for cropping	Humid, soft, cracking <2mm, occasional course fragments <5mm	A1 0.0 – 0.10 Abrupt	Medium Clay	Subangular blocky, peds 20-30 mm, firm	Nil inclusions and segregations	10YR2/1 Black Nil mottles / bleaching	Humid, well drained	Fine, very few	0.10 / 6.5	0.00-0.10 0.20-0.30 0.50-0.60 0.80-0.90 0.90-1.00	Nil additional observations
				B21 0.10 – 0.70 Abrupt	Medium heavy clay	Subangular blocky, peds 20-30 mm, strong	Nil inclusions and segregations	10YR2/1 Black Nil mottles / bleaching	Humid, well drained	Fine, very few	0.30 / 6.5 0.60 / 7.0

B22 0.70 – 1.00	Medium heavy clay	Subangular blocky, peds 40-60 mm, strong	Nil inclusions and segregations	10YR3/2 Very dark greyish brown Nil mottles / bleaching	Humid, well drained	Nil roots	0.90 / 6.5

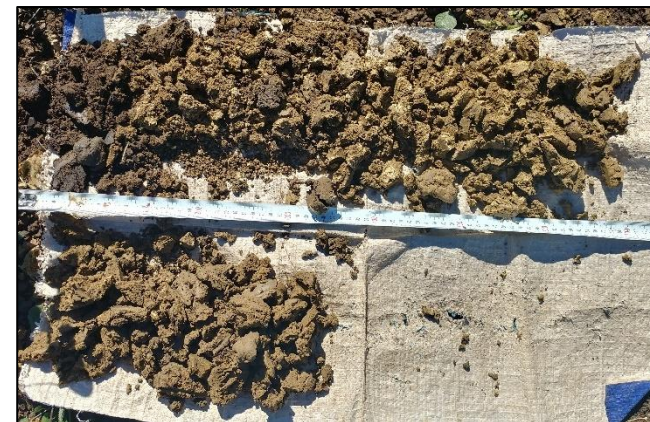
**Soil Profile**

<b>Map Unit</b> E1r	<b>Location (GDA94 ZONE 55):</b> 641919mE 7510236mN	<b>Aust. Soil Class.:</b> Red Chromosol (Brown Chromosol sub-dominant)	<b>Site Survey Type:</b> Detailed - 50mm hand auger	<b>Survey Date:</b> 03/06/2019
------------------------	--	---	--	-----------------------------------

Land use Landform Pattern, Element, Slope	Vegetation	Microrelief Disturbance Erosion	Surface condition, surface rock	Soil Profile Description									
				Horizon Depth (m), Boundary	Field Texture	Structure, Strength	Inclusions Segregations	Colour, Mottle, Bleaching	Moisture, Drainage	Roots	Depth (m) / Field pH	Sample (m)	Observations
Cropping, mid-slope, 2% slope	Forage crops	Nil microrelief Nil erosion  Extensively disturbed for cropping	Self-mulching, Minor cracking <2mm, Nil coarse fragments	A1 0.0 – 0.07 Abrupt	Light clay, sandy	Subangular blocky, peds 20-30 mm, firm	Nil inclusions and segregations	10YR3/2 Greyish brown Nil mottles / bleaching	Humid, well drained	Fine, very few	0.10 / 6.5	0.00-0.10 0.20-0.30 0.50-0.60 0.80-0.90 0.90-1.00	Nil additional observations
				B2 0.07 – 0.60 Abrupt	Light clay, sandy	Subangular blocky, peds 20-30 mm, strong	20% calcium carbonate	10YR4/3 Brown Mottle: 5% 10YR6/4 light yellowish brown	Humid, moderately well drained	Fine, very few	0.30 / 7.0 0.60 / 7.0

B2 0.60 – 1.00	Medium clay	Subangular blocky, moderate, peds 40-60 mm, firm	Nil inclusions and segregations	10YR4/4 Dark yellowish brown Nil mottles / bleaching	dry, well drained	Nil roots	0.90 / 7.0

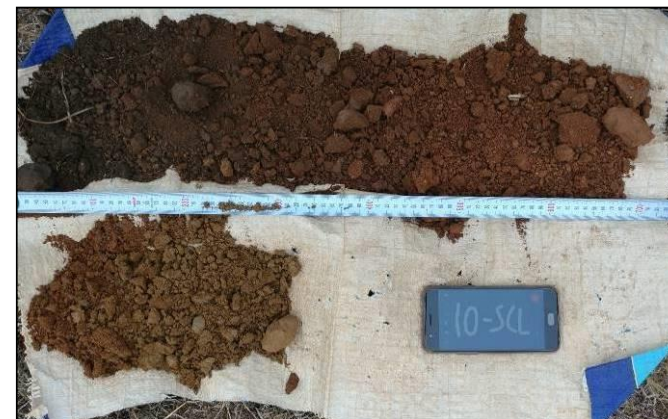
**Soil Profile**

<b>Map Unit</b> E1r	<b>Location (GDA94 ZONE 55):</b> 642525mE 7510097mN	<b>Aust. Soil Class.:</b> Red Chromosol (Brown Chromosol sub-dominant)	<b>Site Survey Type:</b> Detailed - 50mm hand auger	<b>Survey Date:</b> 30/06/2018
------------------------	--	---	--	-----------------------------------

Land use Landform Pattern, Element, Slope	Vegetation	Microrelief Disturbance Erosion	Surface condition, surface rock	Soil Profile Description									
				Horizon Depth (m), Boundary	Field Texture	Structure, Strength	Inclusions Segregations	Colour, Mottle, Bleaching	Moisture, Drainage	Roots	Depth (m) / Field pH	Sample (m)	Observations
Grazing Very gently undulating plain, Midslope 2.0/1.0	Buffel grass	Nil microrelief Extensive cleared Nil erosion	Minor cracking 2- 6mm, soft, Nil coarse fragments	A1 0.00-0.13 Abrupt	Sandy clay	Moderate, firm, <10mm sub-angular	<1% calcium carbonate nodules	10YR3/2 Very dark greyish brown Nil mottles / bleaching	Dry, moderate	Few, fine	0.10 / 7.0	0.00-0.10	First borehole, 0.20 mbgl Second borehole 0.40 mbgl Refusal likely due to roots, no physical barrier
				A2 0.13-0.39 Abrupt	Light sandy clay	Moderate, firm, <10mm sub-angular	Nil inclusion or segregations	10YR3/3 Dark Brown Nil mottles / bleaching	Dry, moderate	Few, fine	0.30 / 7.0	0.20-0.30 0.50-0.60 0.70-0.80 0.90-1.00

B21 0.39-0.84 Abrupt	Light sandy clay	Moderate, firm, <10mm sub-angular	<10% calcium carbonate nodules	5YR4/4 Reddish brown Nil mottles / bleaching	Dry, moderate	Few, fine	0.60 / 7.5		
				B22 0.84-1.00 EOBH	Light clay	Moderate, firm, <10mm sub-angular	<2% calcium carbonate nodules	10YR4/4 Dark yellowish brown Nil mottles/bleach	Dry, moderate	Very few, very fine	0.90 / 8.5

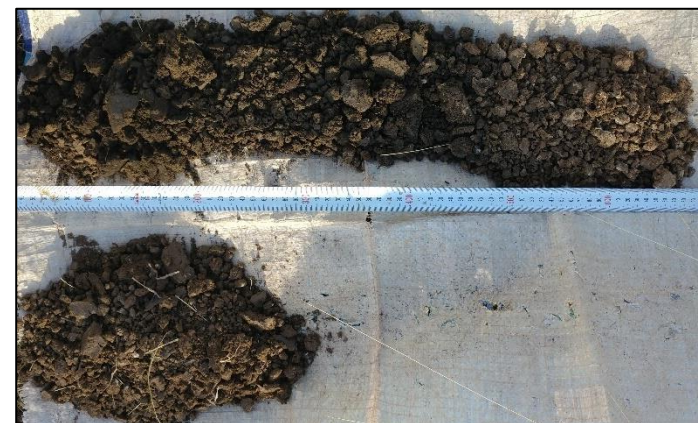
<b>Map Unit</b> B2bl	<b>Location (GDA94 ZONE 55):</b> 641452mE 7512060mN	<b>Aust. Soil Class.:</b> Black Dermosol	<b>Site Survey Type:</b> Detailed - 50mm hand auger	<b>Survey Date:</b> 05/06/2019
-------------------------	--	---	--	-----------------------------------

Land use Landform Pattern, Element, Slope	Vegetation	Microrelief Disturbance Erosion	Surface condition, surface rock	Soil Profile Description									
				Horizon Depth (m), Boundary	Field Texture	Structure, Strength	Inclusions Segregations	Colour, Mottle, Bleaching	Moisture, Drainage	Roots	Depth (m) / Field pH	Sample (m)	Observations
Upper- slope, 2% slope	Grasses, with Brigalow nearby	Nil Microrelief  Nil erosion  Extensively cleared	Firm, cracking 2mm, Nil coarse fragments	A1 0.0 – 0.12 gradual	Sandy clay loam	Weak, sub- rounded peds <10 mm, soft	Nil inclusions or segregations	10YR2/2 Very dark brown Nil mottles / bleaching	Humid, well drained	Fine, very few	0.10 / 6.5	0.00-0.10 0.20-0.30 0.50-0.60 0.80-0.90 0.90-1.00	Nil additional observations
				B21 0.12 – 0.22 gradual	Sandy clay loam	Weak, peds <10 mm, very firm	Nil inclusions or segregations	10YR2/2 Very dark brown Nil mottles / bleaching	Humid, well drained	Fine, very few	0.20 / 6.5

B22 0.22 – 0.55 gradual	Light clay, sandy	Subangular blocky, moderate, peds <20 mm, very firm	<2% calcium carbonate	10YR3/2 Very dark greyish brown Nil mottles / bleaching	Humid, moderate y well drained	Nil roots	0.30 / 6.5		
				B23 0.55 – 1.00	Medium clay, sandy	Subangular blocky, moderate, peds <20 mm, very firm	<2% calcium carbonate	10YR3/2 Very dark greyish brown Nil mottles / bleaching	Humid, moderate y well drained	Nil roots	0.60 / 7.0 0.90 / 6.5

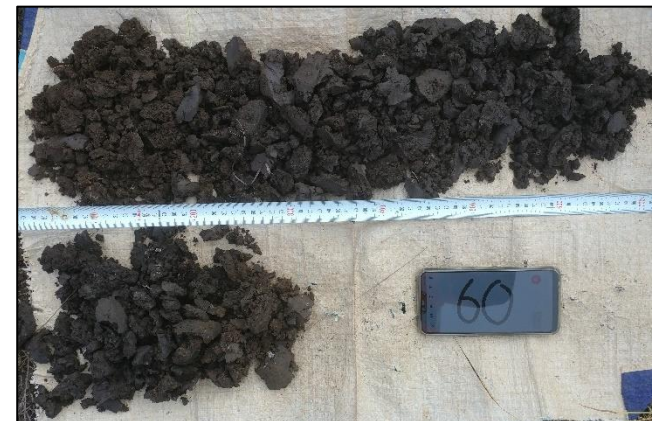
**Soil Profile**

<b>Map Unit</b> B1	<b>Location (GDA94 ZONE 55):</b> 643839mE 7514447mN	<b>Aust. Soil Class.:</b> Black Vertosol	<b>Site Survey Type:</b> Detailed - 50mm hand auger	<b>Survey Date:</b> 07/06/2019
-----------------------	--	---	--	-----------------------------------

Land use Landform Pattern, Element, Slope	Vegetation	Microrelief Disturbance Erosion	Surface condition, surface rock	Soil Profile Description									
				Horizon Depth (m), Boundary	Field Texture	Structure, Strength	Inclusions Segregation s	Colour, Mottle, Bleaching	Moisture, Drainage	Roots	Depth (m) / Field pH	Sample (m)	Observations
Cropping, upper-slope, 0% / 2% slope	Grasses	Nil microrelief  Nil erosion  extensively disturbed	self-mulching, cracking 6+mm Nil coarse fragments	A1 0.0 – 0.13 Abrupt	Light clay	Moderate, Sub- rounded, peds <10 mm, soft	Nil inclusions or segregations	10YR3/2 Very dark greyish brown Nil mottles / bleaching	Dry, well drained	Fine, very few	0.10 / 7.0	0.00-0.10 0.20-0.30 0.50-0.60 0.80-0.90 0.90-1.00	Nil additional observations
				B21 0.13 – 0.41 Abrupt	Medium clay	Moderate, Subangular blocky, peds <20 mm, firm	Nil inclusions or segregations	10YR2/1 Black Nil mottles / bleaching	Dry, well drained	Very fine, very few	0.30 / 7.5

B22 0.41 – 1.00	Medium clay	Moderate, Subangular blocky, peds <20 mm, firm	<2% calcium carbonate	10YR2/1 Black Nil mottles / bleaching	Dry, moderately well drained	Nil roots	0.60 / 7.0 0.90 / 7.0

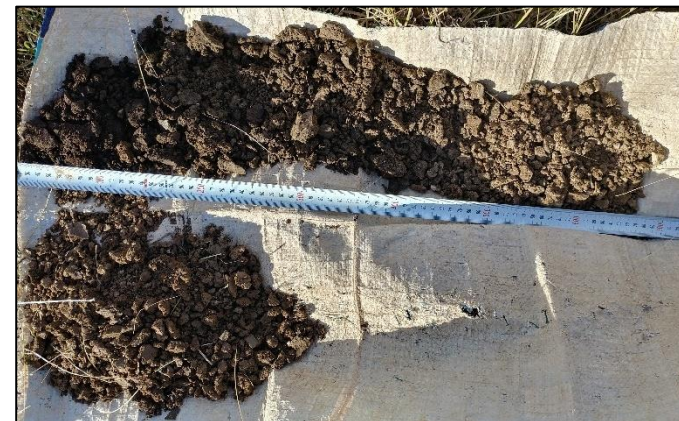
**Soil Profile**

<b>Map Unit</b> B2bl	<b>Location (GDA94 ZONE 55):</b> 642045mE 7511689mN	<b>Aust. Soil Class.:</b> Black Dermosol	<b>Site Survey Type:</b> Detailed - 50mm hand auger	<b>Survey Date:</b> 05/06/2019
-------------------------	--	---	--	-----------------------------------

Land use Landform Pattern, Element, Slope	Vegetation	Microrelief Disturbance Erosion	Surface condition, surface rock	Soil Profile Description									
				Horizon Depth (m), Boundary	Field Texture	Structure, Strength	Inclusions Segregations	Colour, Mottle, Bleaching	Moisture, Drainage	Roots	Depth (m) / Field pH	Sample (m)	Observations
Upper- slope, 2% slope	Grasses, with Brigalow nearby	Nil Microrelief  Nil erosion  Extensively cleared	Firm, cracking 2mm, Nil coarse fragments	A1 0.0 – 0.11 Abrupt	Sandy clay loam	Weak, sub- rounded peds <10 mm, soft	Nil inclusions or segregations	10YR2/2 Very dark brown Nil mottles / bleaching	Humid, well drained	Fine, very few	0.10 / 6.5	0.00-0.10 0.20-0.30 0.50-0.60 0.80-0.90 0.90-1.00	Nil additional observations
				A2 0.11 – 0.22 clear	Sandy clay loam	Weak, peds <10 mm, very firm	Nil inclusions or segregations	10YR2/2 Nil mottles / bleaching	Humid, well drained	Nil roots	0.20 / 6.5

B21 0.22 – 0.49 gradual	Light clay, sandy	Subangular blocky, moderate, peds <20 mm, very firm	<2% calcium carbonate	10YR3/1 Very dark grey Nil mottles / bleaching	Humid, moderately well drained	Nil roots	0.30 / 7.0		
				B22 0.49 – 1.00 EOBH	Medium clay, sandy	Subangular blocky, moderate, peds <20 mm, very firm	<1% calcium carbonate	10YR3/2 Very dark greyish brown Nil mottles / bleaching	Humid, moderately well drained	Nil roots	0.60 / 7.0 0.90 / 6.5

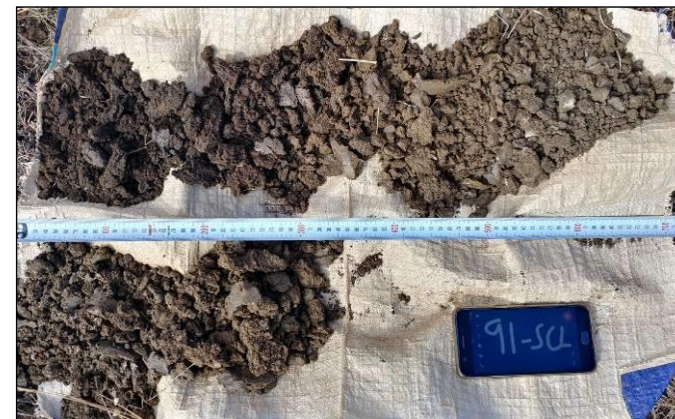
**Soil Profile**

Land use Landform Pattern, Element, Slope	Vegetation	Microrelief Disturbance Erosion	Surface condition, surface rock	Soil Profile Description									
				Horizon Depth (m), Boundary	Field Texture	Structure, Strength	Inclusions Segregations	Colour, Mottle, Bleaching	Moisture, Drainage	Roots	Depth (m) / Field pH	Sample (m)	Observations
Grazing, Gently undulating plain, Midslope 2.0/1.0	Cleared, nearby remnant Belah	Nil microrelief Extensive disturbance Nil erosion	Minor cracking, firm, Nil coarse fragments	A1 0.00-0.12 Abrupt	Sandy Clay	Moderate, weak <20mm sub- angular	Nil inclusions and segregations	10YR2/1 Black Nil mottles / bleaching	Dry, moderate	Few, fine	0.10 / 6.0	0.00-0.10 0.20-0.30 0.50-0.60 0.80-0.90 0.90-1.00	Nil additional observations
				B21 0.12-0.50 Clear	Light sandy clay	Moderate, firm 20- 50mm sub- angular	Nil inclusions and segregations	10YR2/2 Very dark brown Nil mottles / bleaching	Dry, moderate	Few, fine	0.30 / 6.5

B22 0.50-1.00 EOBH	Light clay	Moderate, firm 20- 50mm sub- angular blocky	<2% calcium carbonate nodules	10YR3/3 Dark brown Mottles: <2% 10YR5/3 Brown Nil bleach	Dry, moderate	Very few, very fine	0.60 / 7.0 0.60 / 7.5

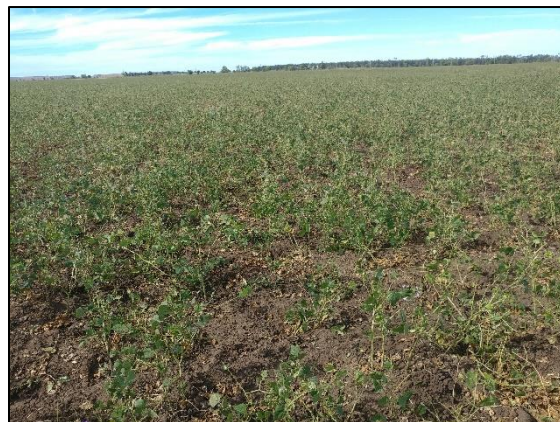
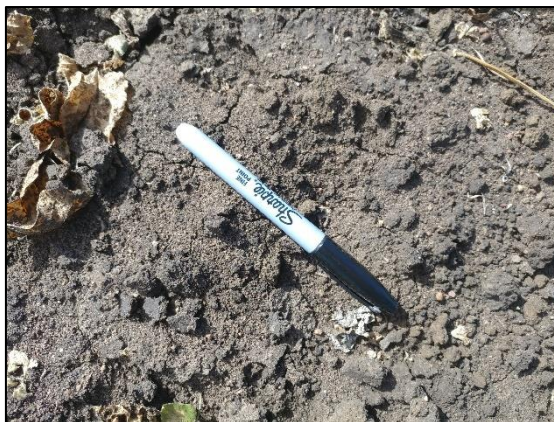
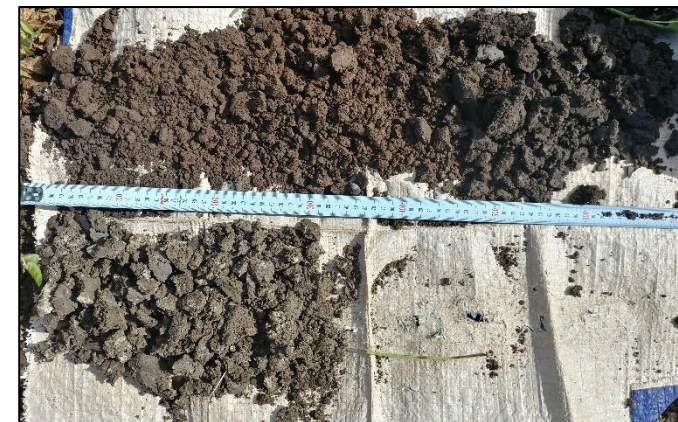
<b>Map Unit</b> E1r	<b>Location (GDA94 ZONE 55):</b> 642351mE 7510427mN	<b>Aust. Soil Class.:</b> Red Chromosol (Brown Chromosol sub-dominant)	<b>Site Survey Type:</b> Detailed - 50mm hand auger	<b>Survey Date:</b> 04/06/2019
------------------------	--	---	--	-----------------------------------

Land use Landform Pattern, Element, Slope	Vegetation	Microrelief Disturbance Erosion	Surface condition, surface rock	Soil Profile Description									
				Horizon Depth (m), Boundary	Field Texture	Structure, Strength	Inclusions Segregations	Colour, Mottle, Bleaching	Moisture, Drainage	Roots	Depth (m) / Field pH	Sample (m)	Observations
Mid-slope, 1% slope	Forage cropping	Nil Microrelief  Nil erosion  Extensively cleared	Firm, cracking 2mm, Nil coarse fragments	A1 0.0 – 0.08 Abrupt	Sandy loam	Weak, sub- rounded peds 5-20 mm, firm	Nil inclusions or segregations	10YR3/1 Very dark grey Nil mottles / bleaching	Humid, well drained	Fine, very few	0.05 / 6.5	0.00-0.10 0.20-0.30 0.50-0.60 0.80-0.90 0.90-1.00	Nil additional observations
				B21 0.08 – 0.47 Abrupt	Sandy clay loam	Moderate, peds 30-40 mm, very firm	Nil inclusions or segregations	10YR3/2 Very dark greyish brown Nil mottles / bleaching	Humid, well drained	Nil roots	0.30 / 6.5

B22 0.47 – 0.70 Abrupt	Light clay, sandy	Subangular blocky, moderate, peds <30 mm, very firm	<1% calcium carbonate	10YR2/1 Black Nil mottles / bleaching	Humid, moderately well drained	Nil roots	0.60 / 6.5		
				B23 0.70 – 1.00	Medium clay, sandy	Subangular blocky, moderate,	<10% calcium carbonate	10YR3/2 Very dark greyish brown	Humid, moderately well drained	Nil roots	0.90 / 6.5

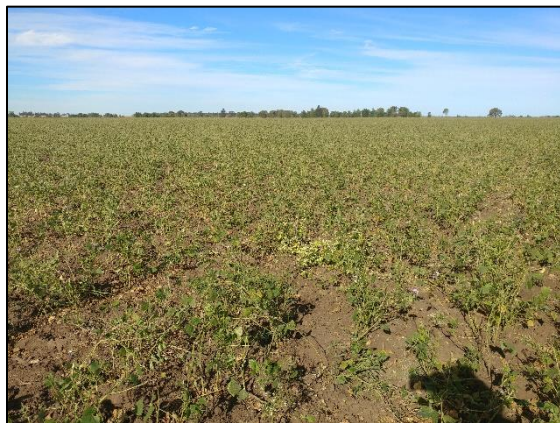
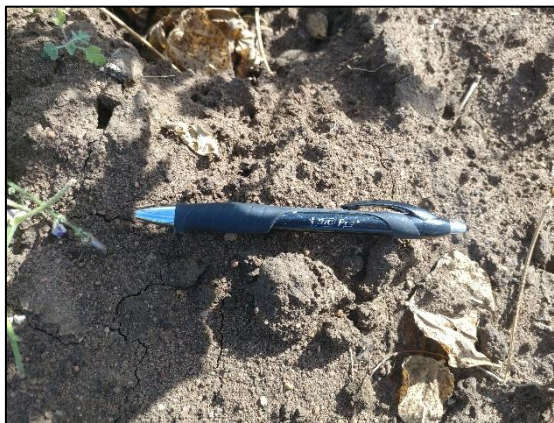
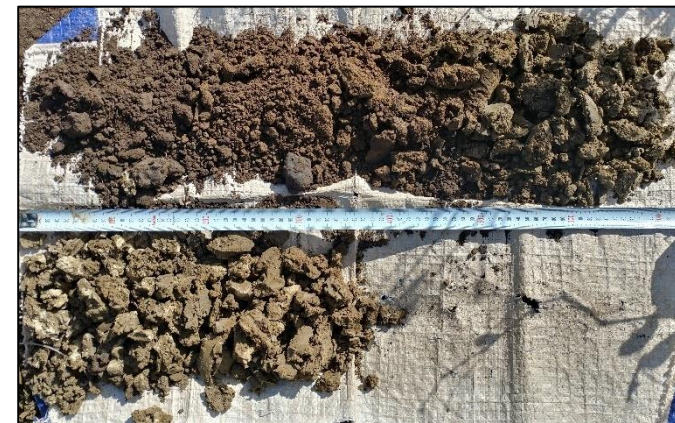
<b>Map Unit</b> B2bl	<b>Location (GDA94 ZONE 55):</b> 7510427mE 7511265mN	<b>Aust. Soil Class.:</b>	<b>Site Survey Type:</b> Detailed - 50mm hand auger	<b>Survey Date:</b> 04/06/2019
-------------------------	---	---------------------------	--	-----------------------------------

Land use Landform Pattern, Element, Slope	Vegetation	Microrelief Disturbance Erosion	Surface condition, surface rock	Soil Profile Description									
				Horizon Depth (m), Boundary	Field Texture	Structure, Strength	Inclusions Segregations	Colour, Mottle, Bleaching	Moisture, Drainage	Roots	Depth (m) / Field pH	Sample (m)	Observations
Mid-slope, <1% slope	Forage cropping	Nil Microrelief  Nil erosion  Extensively cleared	Firm, cracking 2mm, Nil coarse fragments	A1 0.0 – 0.18 Abrupt	Sandy loam	Weak, sub- rounded peds 5-20 mm, firm	Nil inclusions or segregations	10YR3/1 Very dark grey Nil mottles / bleaching	Humid, well drained	Fine, very few	0.10 / 6.5	0.00-0.10 0.20-0.30 0.50-0.60 0.80-0.90 0.90-1.00	Nil additional observations
				B21 0.18 – 0.50 Abrupt	Sandy clay loam	Moderate, peds 30-40 mm, very firm	Nil inclusions or segregations	10YR2/1 Black Nil mottles / bleaching	Humid, well drained	Nil roots	0.30 / 6.5

B22 0.50 – 1.00	Light clay, sandy	Subangular blocky, moderate, peds <40 mm, very firm	<5% calcium carbonate	10YR2/1 Black Nil mottles / bleaching	Humid, moderately well drained	Nil roots	0.60 / 6.5

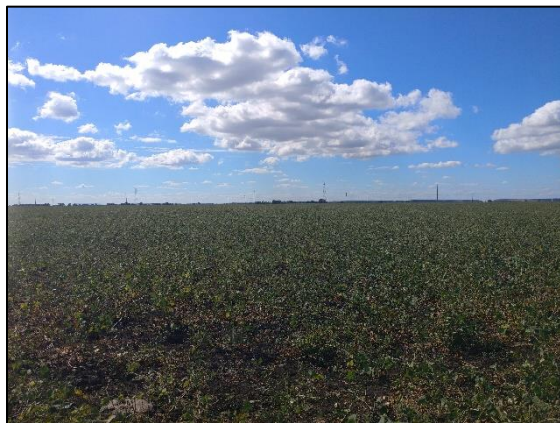
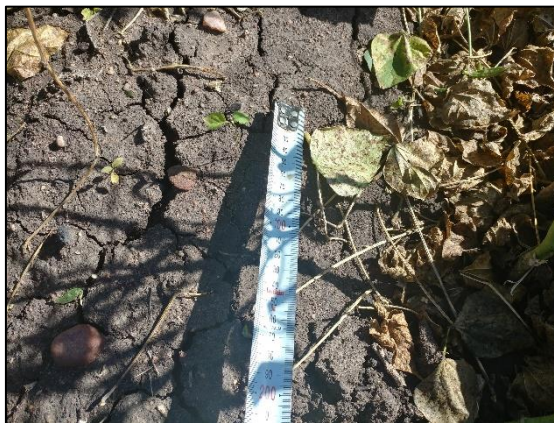
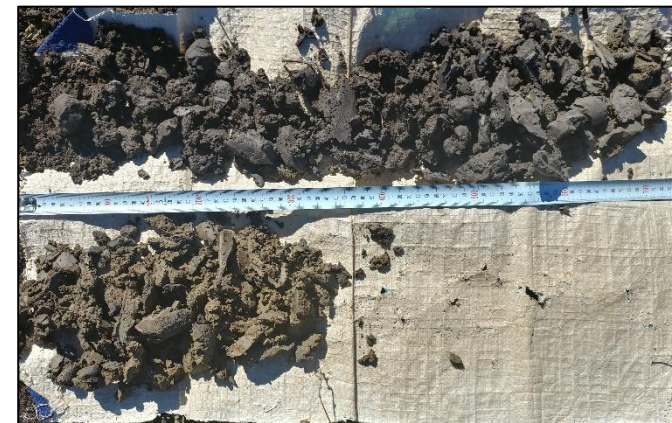
<b>Map Unit</b> B1	<b>Location (GDA94 ZONE 55):</b> 641820mE 7510822mN	<b>Aust. Soil Class.:</b> Black Vertosol	<b>Site Survey Type:</b> Detailed - 50mm hand auger	<b>Survey Date:</b> 03/06/2019
-----------------------	--	---	--	-----------------------------------

Land use Landform Pattern, Element, Slope	Vegetation	Microrelief Disturbance Erosion	Surface condition, surface rock	Soil Profile Description									
				Horizon Depth (m), Boundary	Field Texture	Structure, Strength	Inclusions Segregations	Colour, Mottle, Bleaching	Moisture, Drainage	Roots	Depth (m) / Field pH	Sample (m)	Observations
Cropping, upper-slope, 1% / 2% slope	Forage crops	Nil microrelief  Nil erosion  Extensively disturbed for cropping	Self-mulching, minor crust, cracking 2- 6+mm	A1 0.0 – 0.17 Abrupt	Light clay	Subangular blocky, weak, peds <20 mm, firm	<5% coarse fragments	10YR3/1 Very dark grey Nil mottles / bleaching	Humid, well drained	Fine, very few	0.10 / 6.5	0.00-0.10 0.20-0.30 0.50-0.60 0.80-0.90 0.90-1.00	Nil additional observations
				B2 0.17 – 1.00	Medium clay	Subangular blocky, weak, peds <30 mm, very firm	<1% coarse fragments	10YR3/1 Very dark grey Nil mottles / bleaching	Humid, Moderately well drained	Nil roots	0.30 / 7.0 0.60 / 7.0 0.90 / 6.5

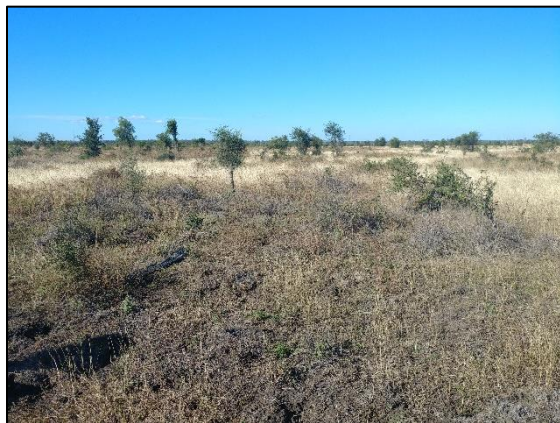
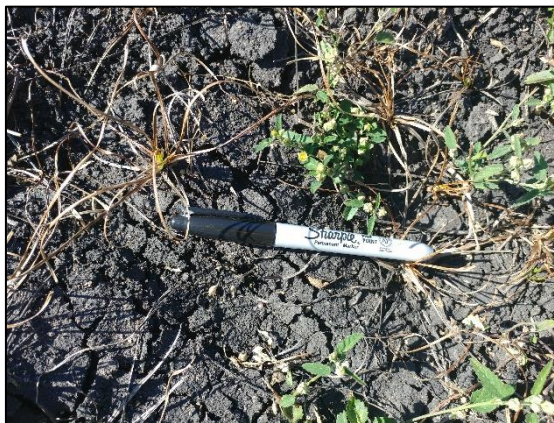
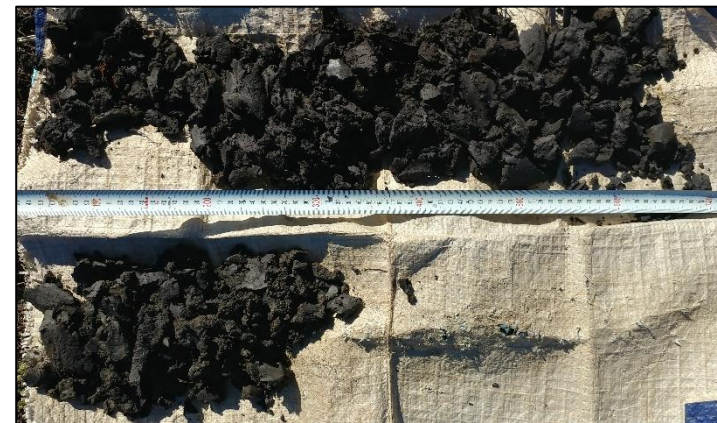
**SITE 101-SCL**

<b>Map Unit</b> B3bl	<b>Location (GDA94 ZONE 55):</b> 641451mE 7509683mN	<b>Aust. Soil Class.:</b> Black Vertosol	<b>Site Survey Type:</b> Detailed - 50mm hand auger	<b>Survey Date:</b> 03/06/2019
-------------------------	--	---	--	-----------------------------------

Land use Landform Pattern, Element, Slope	Vegetation	Microrelief Disturbance Erosion	Surface condition, surface rock	Soil Profile Description									
				Horizon Depth (m), Boundary	Field Texture	Structure, Strength	Inclusions Segregations	Colour, Mottle, Bleaching	Moisture, Drainage	Roots	Depth (m) / Field pH	Sample (m)	Observations
Grazing, mid-slope, 1% / 2% slope	Grasses, recent regrowth and shrubs	Normal gilgai <0.2 m deep, 30-40% coverage  Nil erosion  Extensively disturbed for cropping	Self-mulching, minor crust, cracking 2- 6+mm	A1 0.0 – 0.13 Abrupt	Medium Clay	Subangular blocky, moderate, peds <20 mm, soft	Nil inclusions or segregations	10YR3/1 Very dark grey Nil mottles / bleaching	Humid, well drained	Fine, very few	0.10 / 6.5	No samples taken	Nil additional observations
				B21 0.13 – 0.62 Abrupt	Medium clay	Subangular blocky, moderate, peds <30 mm, firm	Nil inclusions or segregations	10YR3/1 Very dark grey Nil mottles / bleaching	Humid, well drained	Nil roots	0.30 / 7.0 0.60 / 7.0

B22 0.62 – 1.00	Medium clay	Subangular blocky, moderate, peds <30 mm, very firm	<2% calcium carbonate	10YR3/1 Very dark grey Nil mottles / bleaching	Humid, moderately well drained	Nil roots	0.90 / 6.5

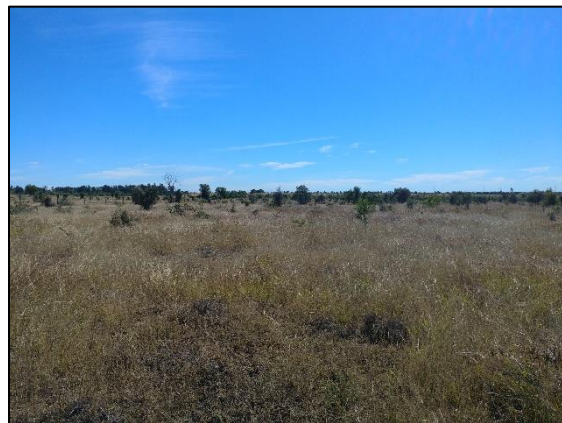
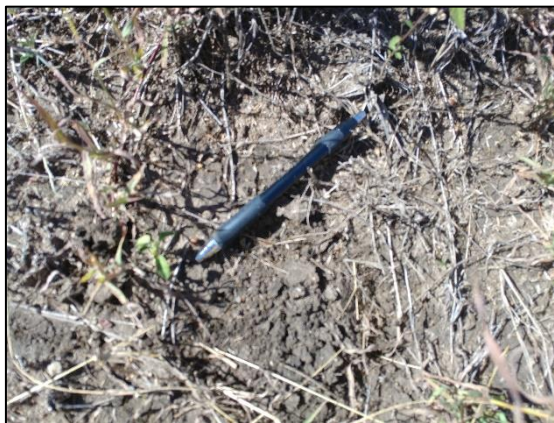
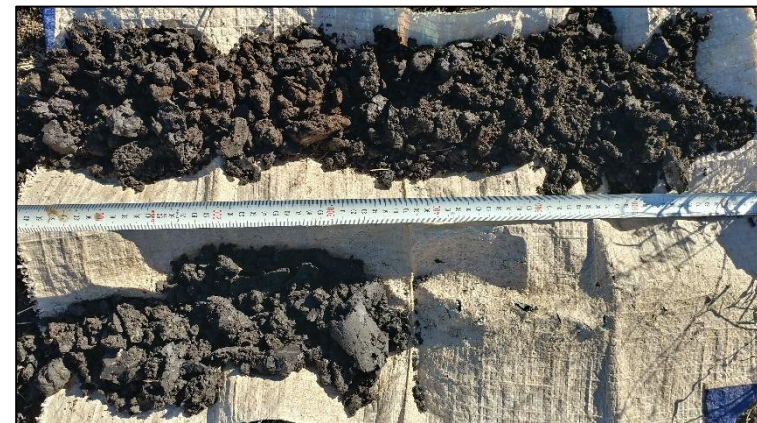
<b>Map Unit</b> B3bl	<b>Location (GDA94 ZONE 55):</b> 641658mE 7508739mN	<b>Aust. Soil Class.:</b> Black Vertosol	<b>Site Survey Type:</b> Detailed - 50mm hand auger	<b>Survey Date:</b> 03/06/2019
-------------------------	--	---	--	-----------------------------------

Land use Landform Pattern, Element, Slope	Vegetation	Microrelief Disturbance Erosion	Surface condition, surface rock	Soil Profile Description									
				Horizon Depth (m), Boundary	Field Texture	Structure, Strength	Inclusions Segregation s	Colour, Mottle, Bleaching	Moisture, Drainage	Roots	Depth (m) / Field pH	Sample (m)	Observations
Grazing, mid-slope, 2% slope, Gilgai depression	Grasses, recent regrowth and shrubs	Crabhole gilgai <0.2 m deep, 30% coverage  Nil erosion  Extensively disturbed for cropping	Self-mulching, minor crust, cracking 2- 6+mm	A1 0.0 – 0.10 Abrupt	Medium Clay	Subangular blocky, moderate, peds <20 mm, soft	Nil inclusions or segregations	10YR2/1 Black Nil mottles / bleaching	Humid, well drained	Fine, very few	0.10 / 6.5	0.00-0.10 0.20-0.30 0.50-0.60 0.80-0.90 0.90-1.00	Nil additional observations
				B21 0.10 – 0.60 Abrupt	Medium heavy clay	Subangular blocky, moderate, peds <30 mm, firm	Nil inclusions or segregations	10YR2/1 Black Nil mottles / bleaching	Humid, well drained	Fine, very few	0.30 / 7.0 0.60 / 7.0

B23 0.60 – 1.00	Medium heavy clay	Subangular blocky, moderate, peds <30 mm, very firm	<2% calcium carbonate	10YR2/1 Black Nil mottles / bleaching	Humid, moderately well drained	Nil roots	0.90 / 6.5

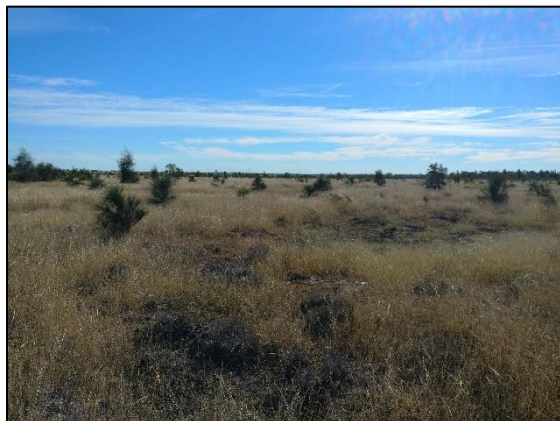
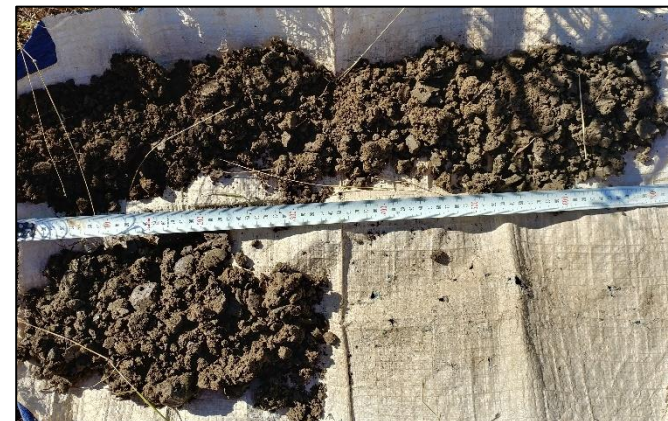
<b>Map Unit</b> B3bl	<b>Location (GDA94 ZONE 55):</b> 641736mE 7508275mN	<b>Aust. Soil Class.:</b> Black Vertosol	<b>Site Survey Type:</b> Detailed - 50mm hand auger	<b>Survey Date:</b> 04/06/2019
-------------------------	--	---	--	-----------------------------------

Land use Landform Pattern, Element, Slope	Vegetation	Microrelief Disturbance Erosion	Surface condition, surface rock	Soil Profile Description									
				Horizon Depth (m), Boundary	Field Texture	Structure, Strength	Inclusions Segregations	Colour, Mottle, Bleaching	Moisture, Drainage	Roots	Depth (m) / Field pH	Sample (m)	Observations
Grazing, mid-slope, 2% slope, Gilgai depression	Grasses, recent regrowth and shrubs	Crabhole gilgai <0.2 m deep, 50% coverage  Nil erosion  Extensively disturbed for cropping	Self-mulching, minor crust, cracking 2- 6+mm	A1 0.0 – 0.12 Abrupt	Light clay	Subangular blocky, moderate, peds <10 mm, soft	Nil inclusions or segregations	10YR3/1 Very dark grey Nil mottles / bleaching	Humid, well drained	Fine, very few	0.10 / 6.5	0.00-0.10 0.20-0.30 0.50-0.60 0.80-0.90 0.90-1.00	Nil additional observations
				B21 0.12 – 0.60 Abrupt	Medium clay	Subangular blocky, moderate, peds <30 mm, firm	Nil inclusions or segregations	10YR3/2 Very dark greyish brown Nil mottles / bleaching	Humid, well drained	Fine, very few	0.30 / 7.0 0.60 / 7.0

B22 0.60 – 1.00	Medium heavy clay	Subangular blocky, moderate, peds <30 mm, very firm	<2% calcium carbonate	10YR4/2 Dark greyish brown Nil mottles / bleaching	Humid, moderately well drained	Nil roots	0.90 / 6.5

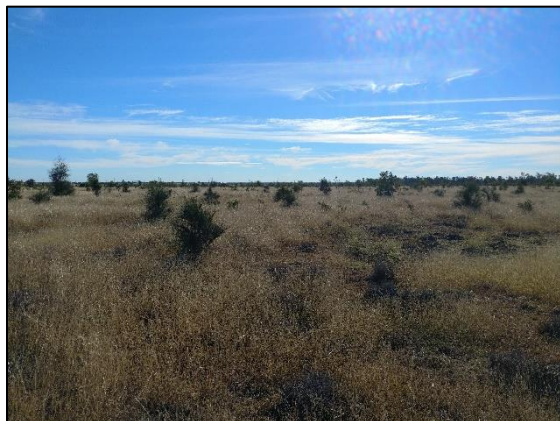
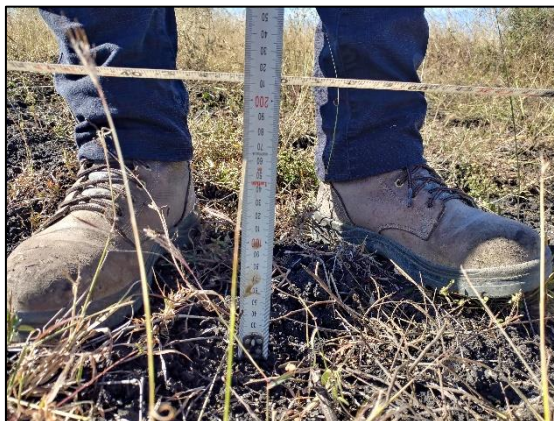
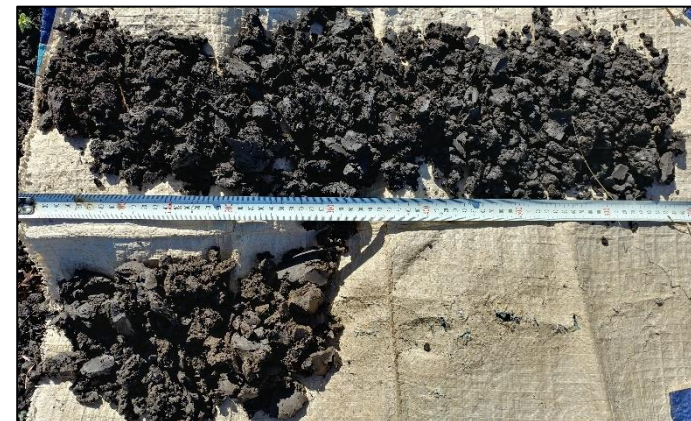
<b>Map Unit</b> B3bl	<b>Location (GDA94 ZONE 55):</b> 641732mE 7508275mN	<b>Aust. Soil Class.:</b> Black Vertosol	<b>Site Survey Type:</b> Detailed - 50mm hand auger	<b>Survey Date:</b> 04/06/2019
-------------------------	--	---	--	-----------------------------------

Land use Landform Pattern, Element, Slope	Vegetation	Microrelief Disturbance Erosion	Surface condition, surface rock	Soil Profile Description									
				Horizon Depth (m), Boundary	Field Texture	Structure, Strength	Inclusions Segregations	Colour, Mottle, Bleaching	Moisture, Drainage	Roots	Depth (m) / Field pH	Sample (m)	Observations
Grazing, mid-slope, 2% slope, Gilgai depression	Grasses, recent regrowth and shrubs	Crabhole gilgai <0.22 m deep, 50% coverage  Nil erosion  Extensively disturbed for cropping	Self-mulching, minor crust, cracking 2- 6+mm	A1 0.0 – 0.10 Abrupt	Light Medium Clay	Subangular blocky, moderate, peds <20 mm, weak	<1% calcium carbonate	10YR3/1 Very dark grey Nil mottles / bleaching	Humid, well drained	Fine, very few	0.10 / 7.0	0.00-0.10 0.20-0.30 0.50-0.60 0.83-0.90 0.90-1.00	Nil additional observations
				B21 0.10 – 0.83 Abrupt	Medium heavy clay	Subangular blocky, moderate, peds 20-40 mm, very firm	<2% calcium carbonate	10YR3/1 Very dark grey Nil mottles / bleaching	Dry, moderately well drained	Fine, very few	0.30 / 6.5 0.60 / 6.5

B23 0.83 – 1.00	Medium heavy clay	Subangular blocky, moderate, peds 20-40 mm, very firm	Nil inclusions or segregations	10YR3/2 Very dark greyish brown Nil mottles / bleaching	Dry, moderately well drained	Nil roots	0.90 / 6.5

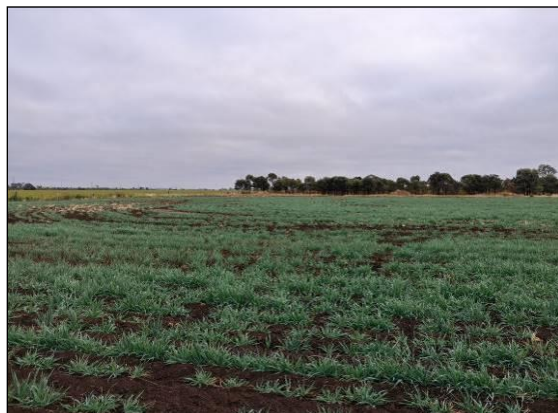
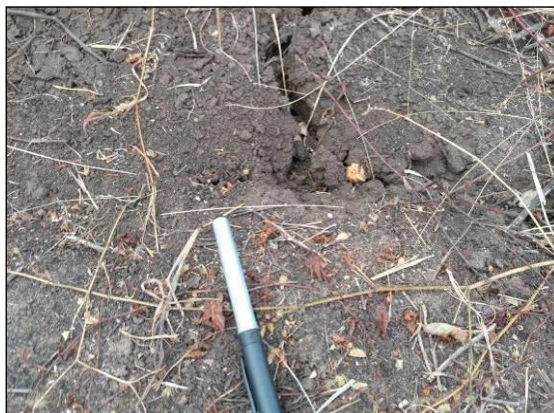
<b>Map Unit</b> E2	<b>Location (GDA94 ZONE 55):</b> 644310mE 7508052mN	<b>Aust. Soil Class.:</b> Black Vertosol	<b>Site Survey Type:</b> Detailed - 50mm hand auger	<b>Survey Date:</b> 30/06/2018
-----------------------	--	---	--	-----------------------------------

Land use Landform Pattern, Element, Slope	Vegetation	Microrelief Disturbance Erosion	Surface condition, surface rock	Soil Profile Description									
				Horizon Depth (m), Boundary	Field Texture	Structure, Strength	Inclusions Segregations	Colour, Mottle, Bleaching	Moisture, Drainage	Roots	Depth (m) / Field pH	Sample (m)	Observations
Cropping Flat plain, level, 0.0/0.0%	Cropping	Nil microrelief Cropping disturbance Nil erosion	Cracking 20- 40mm, fine surface mulch Nil coarse fragments	A1 0.0-0.13 Abrupt	Light clay	Weak, firm, <10mm sub-angular	2% 2-6mm coarse fragments	10YR3/2 Very dark greyish brown Nil mottles / bleaching	Dry, moderate	Fine, few	0.10 / 6.5	0.00-0.10	Nil additional observations
				B21 0.13-0.38 Abrupt	Medium clay	Moderate, firm <40% 20-60mm, <20% 60-100 sub- angular blocky peds	<1% black nodules <1% calcium carbonate nodules	10YR3/2 Very dark greyish brown Nil mottles / bleaching	Dry, moderate	Very fine, very few	0.30 / 6.5	0.20-0.30 0.50-0.60

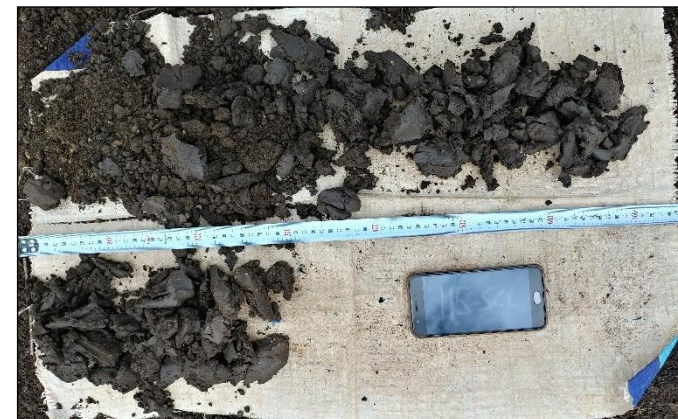
Land use Landform Pattern, Element, Slope	Vegetation	Microrelief Disturbance Erosion	Surface condition, surface rock	Soil Profile Description									
				Horizon Depth (m), Boundary	Field Texture	Structure, Strength	Inclusions Segregations	Colour, Mottle, Bleaching	Moisture, Drainage	Roots	Depth (m) / Field pH	Sample (m)	Observations
Cropping Very gently undulating plain Flat plain 1.0/1.0	Cropping	Nil microrelief Cropping disturbance Nil erosion	2-5% medium pebbles >600mm Soft, loose	A1 0.00-0.16 Abrupt	Light clay	Moderate, weak <10mm sub- angular blocky	<2% calcium carbonate nodules	10YR3/2 Very dark greyish brown Nil mottles / bleaching	Dry, moderate	Few fine	0.10 / 6.0	0.00-0.10 0.20-0.30 0.50-0.60 0.80-0.90 0.90-1.00	Nil additional observations
				B2 0.16-1.00	Medium clay	Strong, firm <10mm sub- angular blocky	Nil inclusions and segregations	10YR3/2 Very dark greyish brown Nil mottles / bleaching	Dry, moderate	Very fine, very few	0.30 / 6.5 0.60 / 7.0 0.90 / 7.5

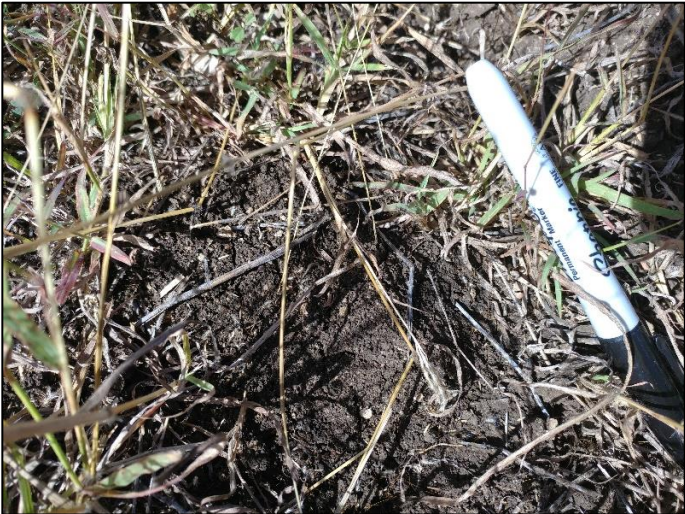
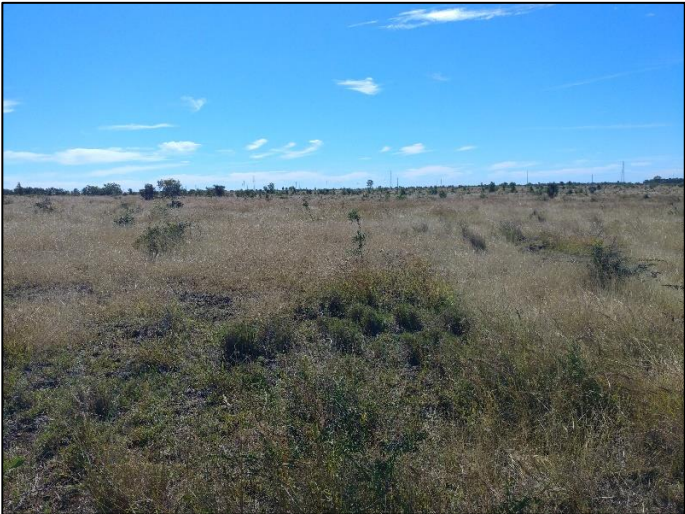
Site No.	Location - mE, mN (GDA94 Zone 56)	Map Unit	Comments	Pictures
NC-2	641972 7509347	B3bl	Gently undulating plain, lower slope, 1% Crabhole and linear gilgai, 50% coverage 150-200 mm deep Surface – cracking and self mulching

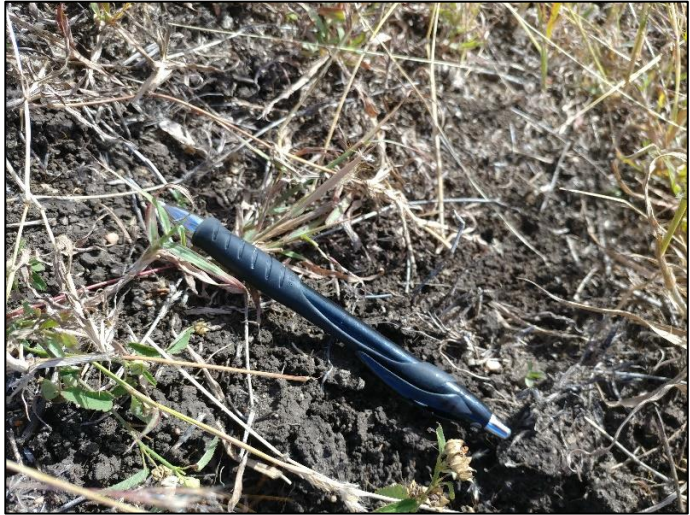
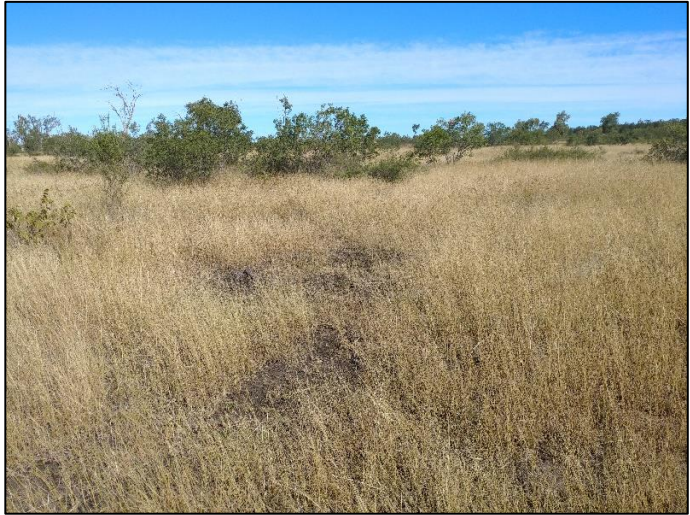
Site No.	Location - mE, mN (GDA94 Zone 56)	Map Unit	Comments	Pictures
NC-3	642749 7508963	B3bl	Gently undulating plain, lower slope, 1% Normal gilgai, 40% coverage 150-200 mm deep Surface – cracking and self mulching

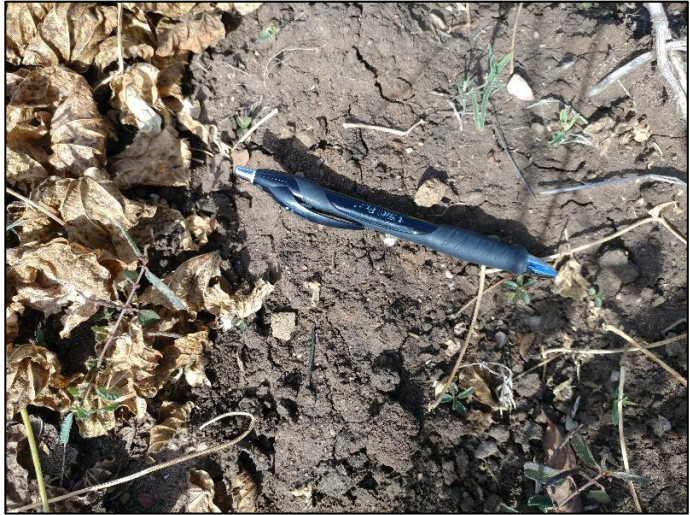
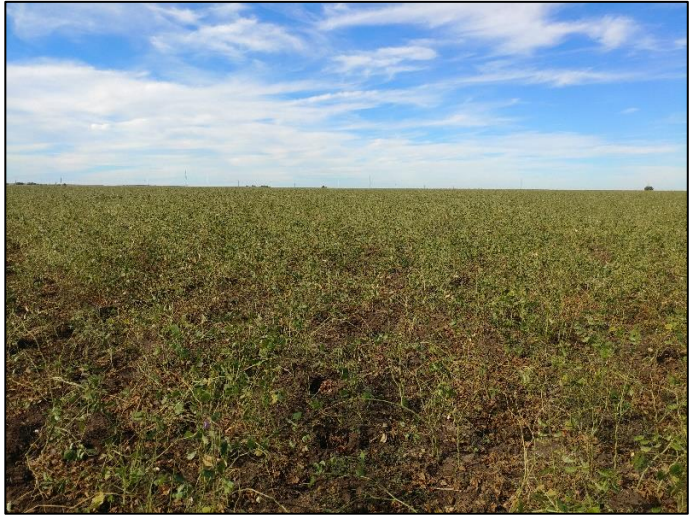
Site No.	Location - mE, mN (GDA94 Zone 56)	Map Unit	Comments	Pictures
NC-5	641073 7510547	B1	Gently undulating plain, Cropping, extensively disturbed, lower slope Surface cracking, light clay, no coarse fragments

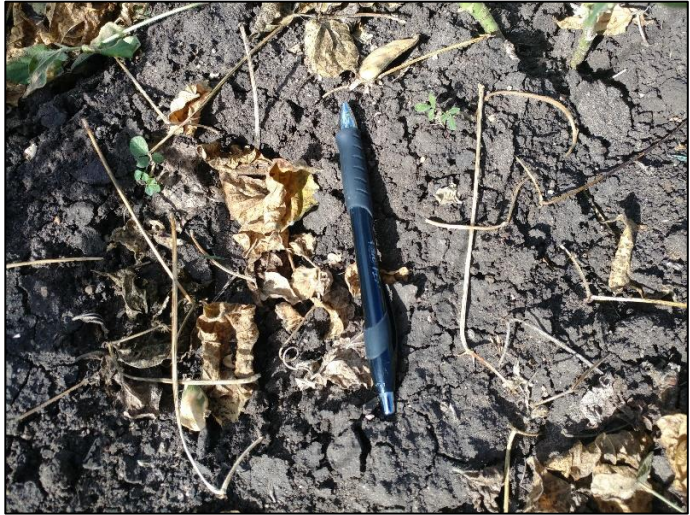
Site No.	Location - mE, mN (GDA94 Zone 56)	Map Unit	Comments	Pictures
NC-6	641305 7510835	B1	Gently undulating plain, Cropping, extensively disturbed, lower slope Surface cracking, light clay, no coarse fragments

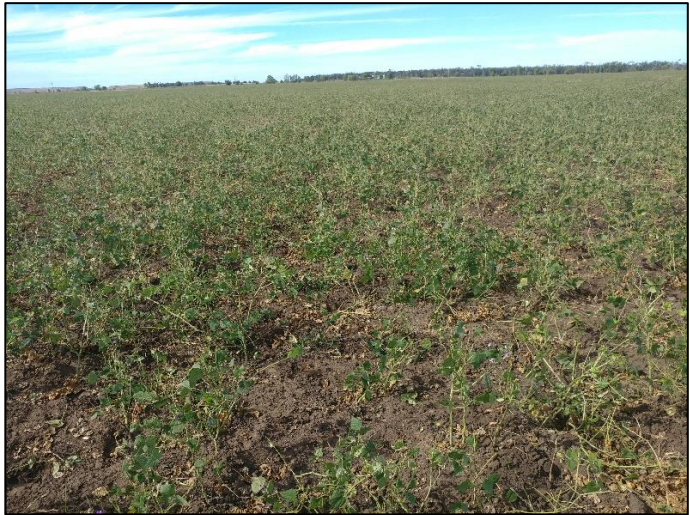
NC-7	641985 7510605	B1	Gently undulating plain, Cropping, extensively disturbed, lower slope Surface cracking, light clay, no coarse fragments

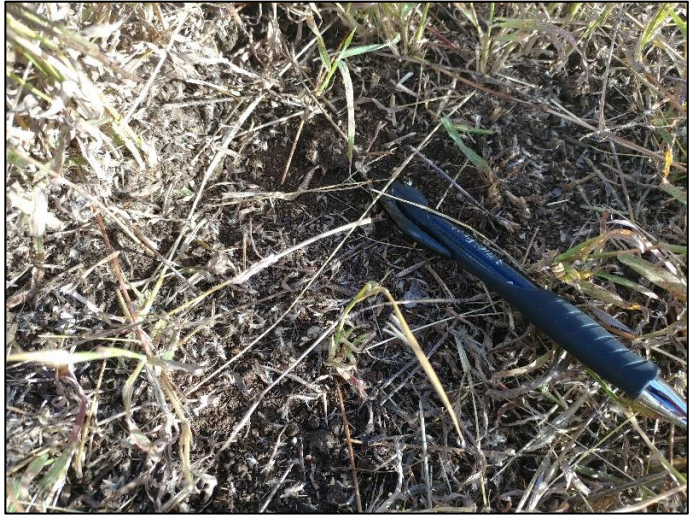
Site No.	Location - mE, mN (GDA94 Zone 56)	Map Unit	Comments	Pictures
NC-8	641519 7511677	B2bl	Gently undulating plain, mid slope Surface 2 mm cracking, sandy clay loam, no coarse fragments
