# Restoration Plan to Support RIDA Application Saraji East Project

Final V4  
15 July 2021

GT Environmental Pty Ltd  
[www.gtenvironmental.com.au](http://www.gtenvironmental.com.au)

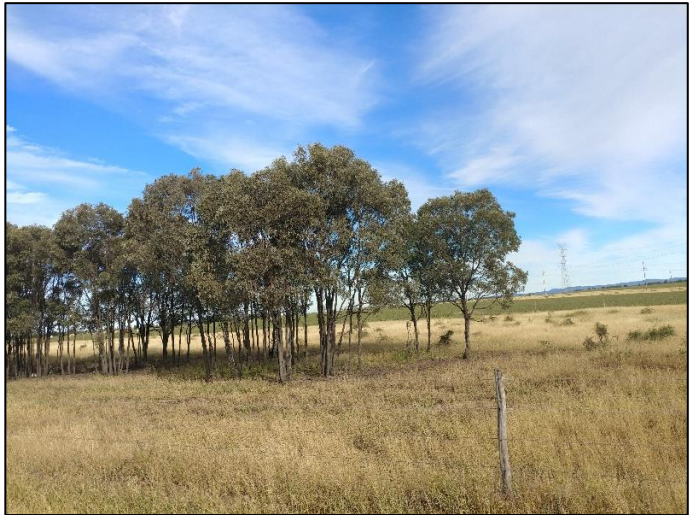
NC-9	641777 7511708	B2bl	Gently undulating plain, mid slope, Brigalow Surface 2 mm cracking, sandy clay loam, no coarse fragments

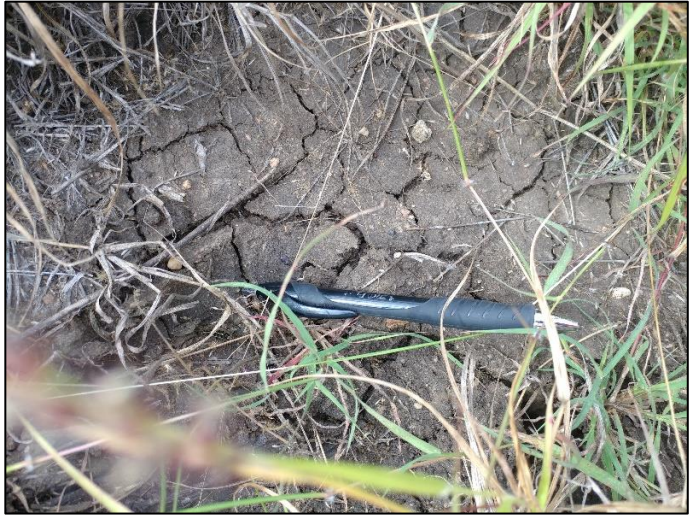
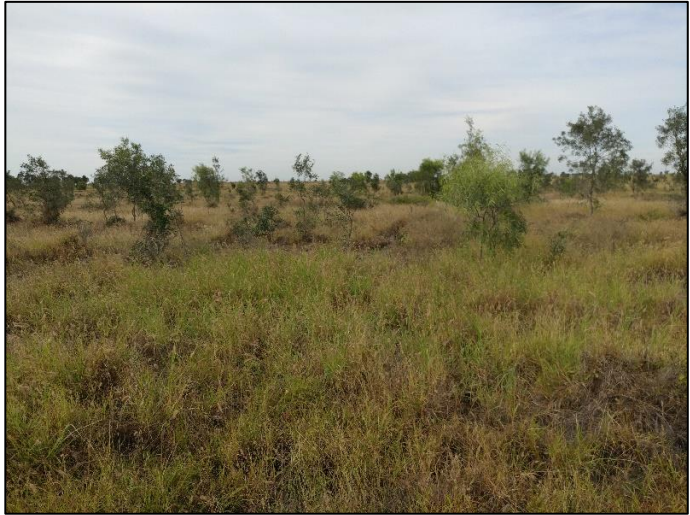
Site No.	Location - mE, mN (GDA94 Zone 56)	Map Unit	Comments	Pictures
NC-10	641414 7513101	B2bl	Gently undulating plain, lower slope, 1%, 2% Grass, various trees regrowth Surface – cracking 2-6mm, light clay

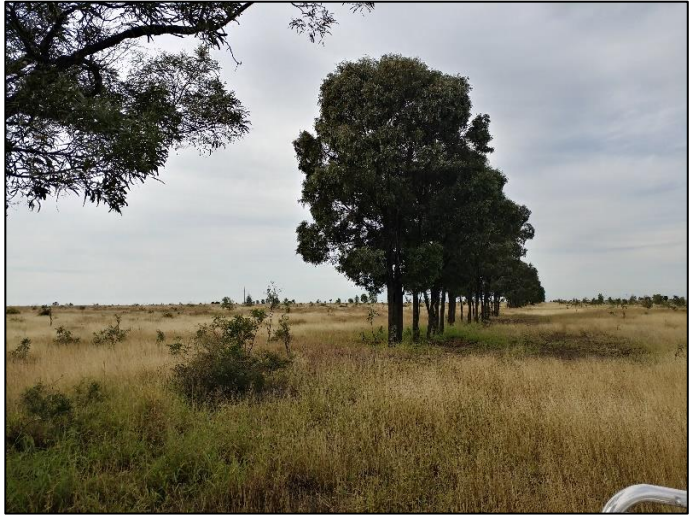
Site No.	Location - mE, mN (GDA94 Zone 56)	Map Unit	Comments	Pictures
NC-11	641676 7513156	B2bl	Gently undulating plain, lower slope, 1%, 2% Limited disturbance, Brigalow Surface – cracking and self mulching, light clay

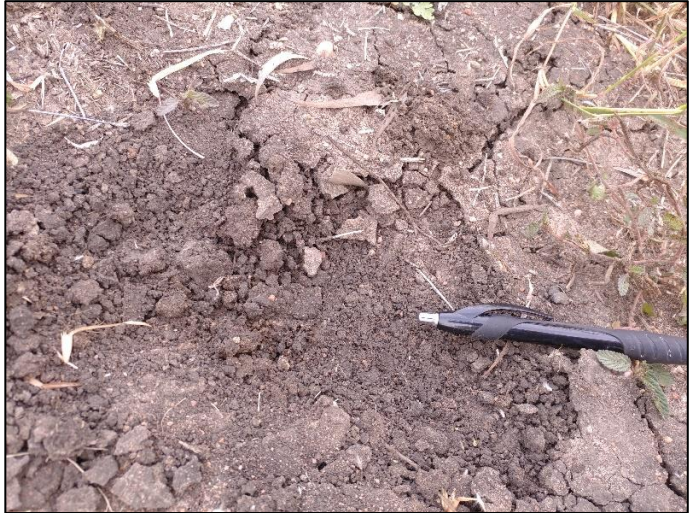
NC-12	642118 7512668	B2bl	Gently undulating plain, flat plain Limited disturbance, Brigalow Surface – cracking and crusting, light sandy clay

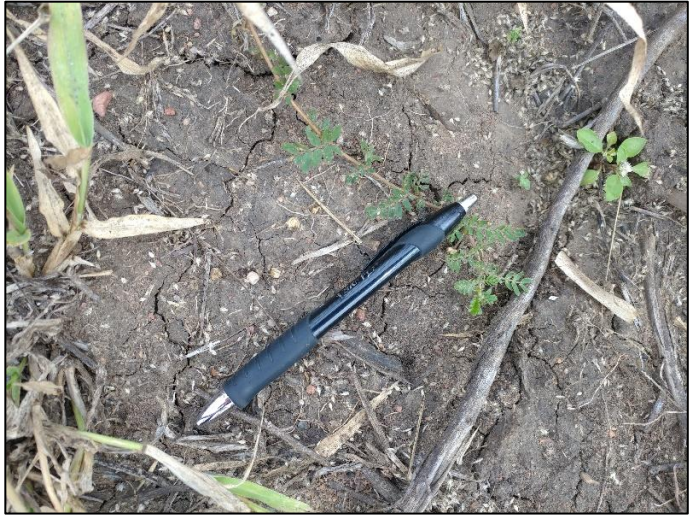
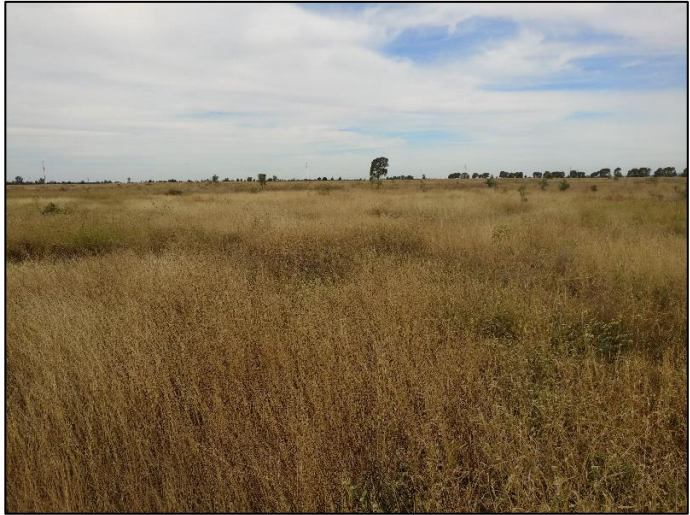
Site No.	Location - mE, mN (GDA94 Zone 56)	Map Unit	Comments	Pictures
NC-13	641869 7513464	B2bl	Gently undulating plain, crest, 1%, 0% Limited disturbance, Brigalow Surface – cracking <2 mm, light clay

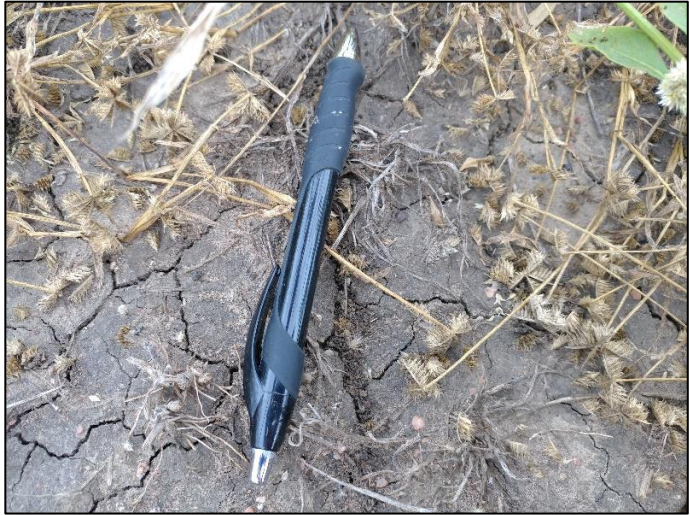
Site No.	Location - mE, mN (GDA94 Zone 56)	Map Unit	Comments	Pictures
NC-14	642641 7514052	B2bl	Gently undulating plain, crest, 1%, 0% Limited disturbance, Brigalow, Belah Surface – cracking <4 mm, clay loam 10YR3/1

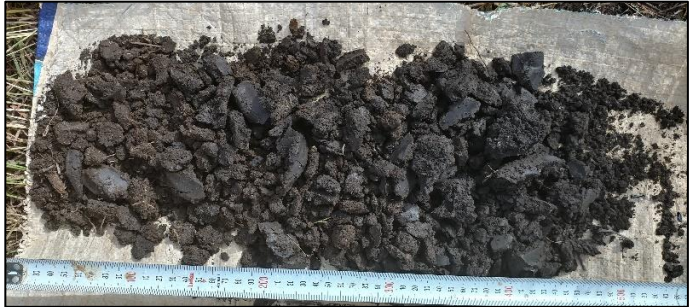
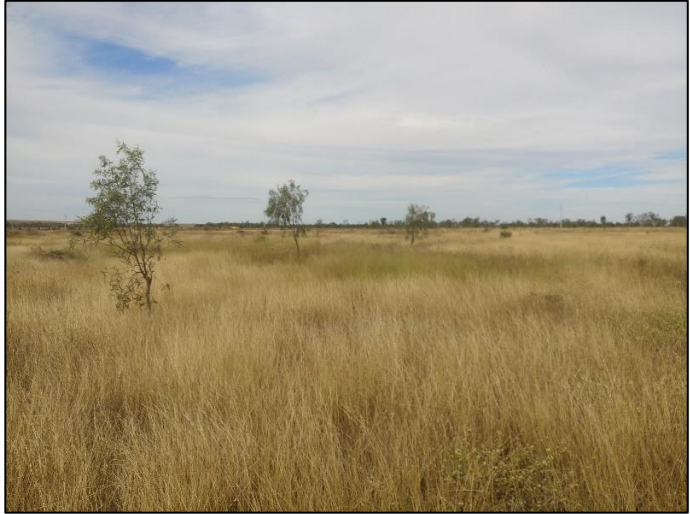
Site No.	Location - mE, mN (GDA94 Zone 56)	Map Unit	Comments	Pictures
NC-15	643244 7514499	B2s	<p>Gently undulating plain, lower slope &lt;2%</p> <p>Limited disturbance, Brigalow</p> <p>Surface – cracking 2-6 mm, light clay, no coarse fragments</p> <p>0.00 – 0.11 m</p> <p>Clay loam</p> <p>Moderate, firm, peds &lt;20 mm</p> <p>10YR3/1</p> <p>0.11 – 0.30+ m</p> <p>Medium clay</p> <p>Moderate, very firm, peds 20-40 mm</p> <p>10YR2/1</p>

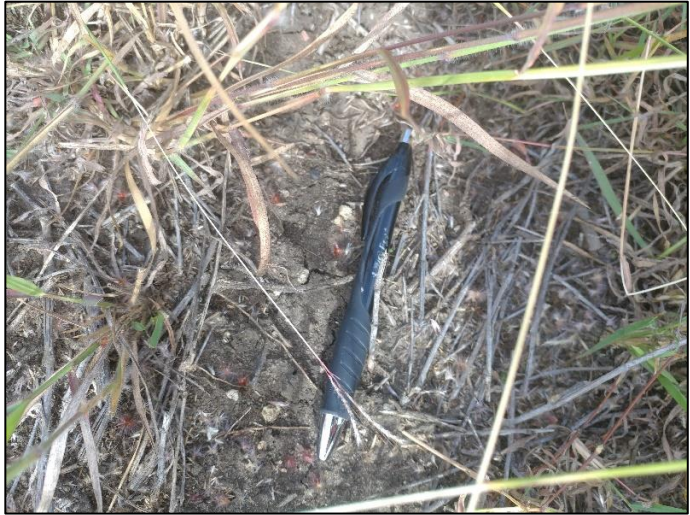
Site No.	Location - mE, mN (GDA94 Zone 56)	Map Unit	Comments	Pictures
NC-16	642934 7514283	B2S	<p>Gently undulating plain, mid slope &lt;2%</p> <p>Limited disturbance</p> <p>Surface – cracking 2-6 mm, light clay, no coarse fragments</p> <p>0.00 – 0.11 m</p> <p>Clay loam</p> <p>Moderate, firm, peds &lt;20 mm</p> <p>10YR3/2</p> <p>0.11 – 0.45+ m</p> <p>Medium clay</p> <p>Moderate, very firm, peds 20-40 mm</p> <p>10YR2/1</p>

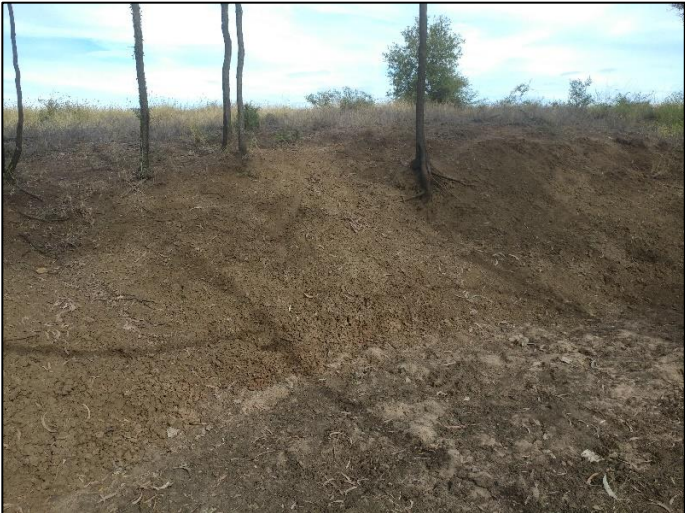
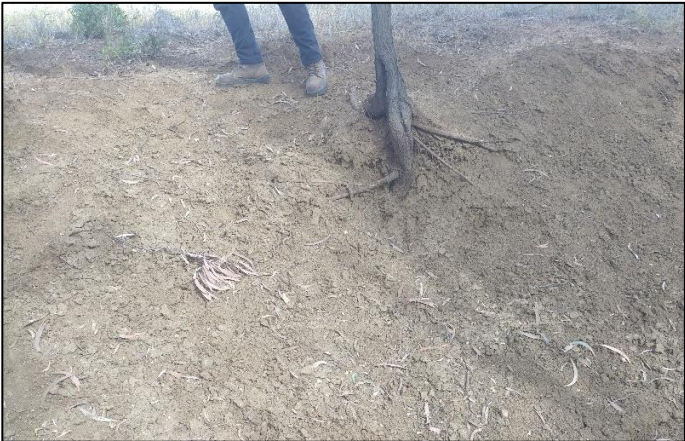
Site No.	Location - mE, mN (GDA94 Zone 56)	Map Unit	Comments	Pictures
NC-17	643327 7514558	A4	Gully erosion, drainage line  0-0.30 m sandy loam 0.30-1.00 m + Sandy clay loam

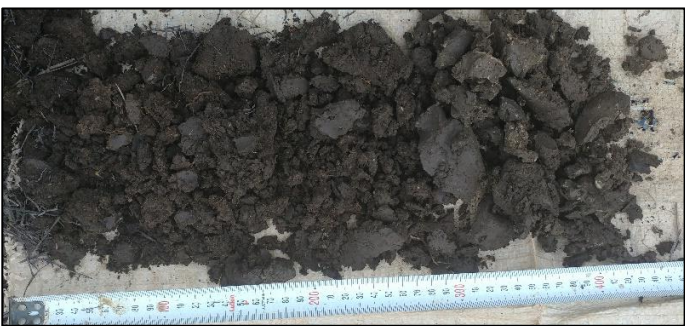
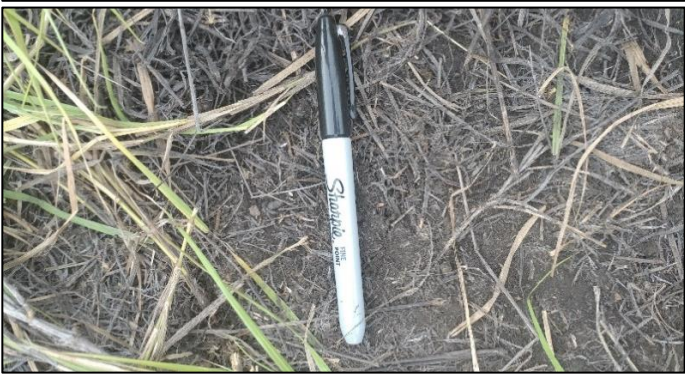
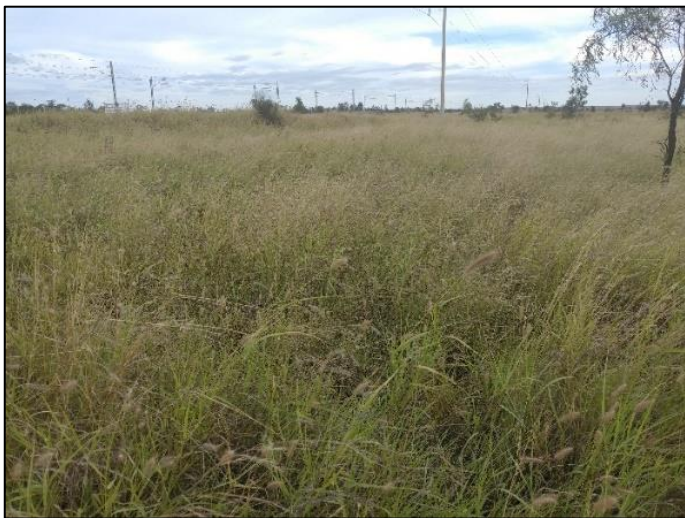
NC-19	644123 7514610	B2s	<p>Gently undulating plain, upper slope 1%, 2%</p> <p>Limited disturbance, Surface – cracking &lt;2 mm, and self mulching, light clay, no coarse fragments</p> <p>0.00 – 0.11 m Clay loam Moderate, firm, peds &lt;10 mm 10YR3/2</p> <p>0.11 – 0.30 m Medium clay Moderate, subangular blocky, peds &lt;20 mm 10YR2/1</p> <p>0.30 – 0.40+ m Medium clay with &lt;2% calcium carbonate Moderate, subangular blocky, peds &lt;20 mm 10YR2/1</p>

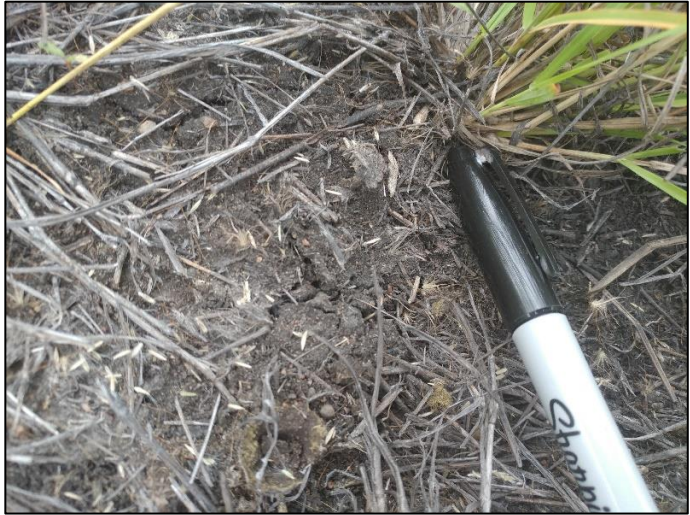
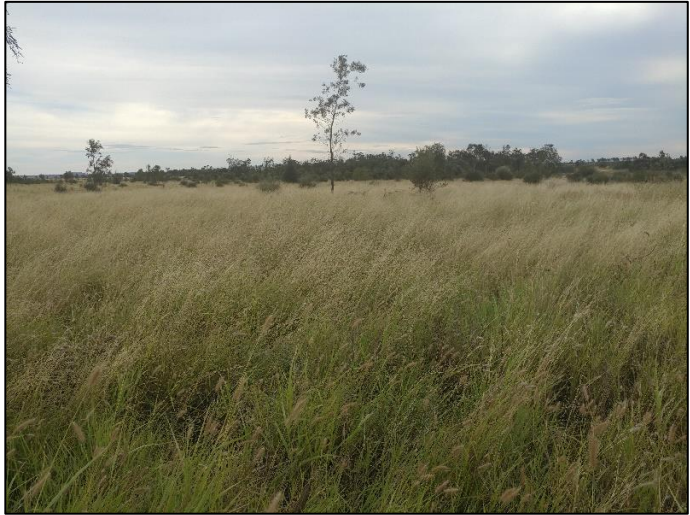
Site No.	Location - mE, mN (GDA94 Zone 56)	Map Unit	Comments	Pictures
NC-20	643734 7514870	A4	Gently undulating plain, lower slope 1%, 2% Limited disturbance, Surface – cracking <2 mm, and self mulching, clay loam, no coarse fragments Brigalow, Belah

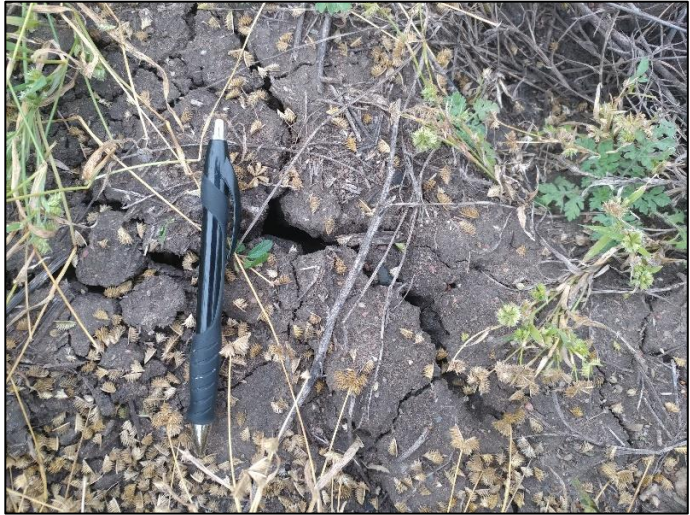
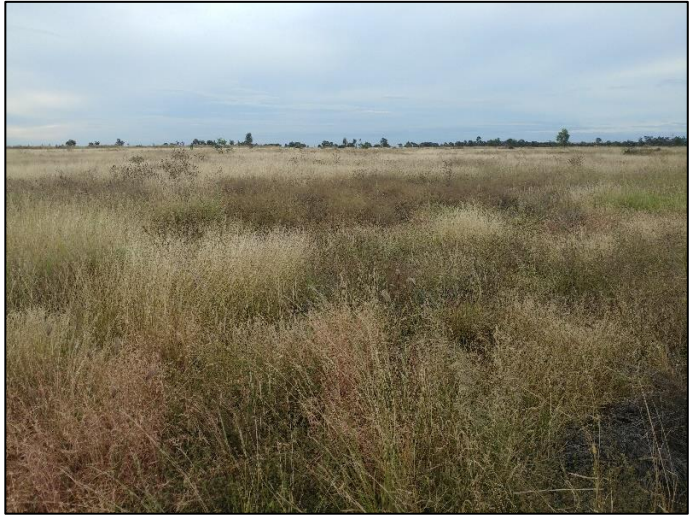
Site No.	Location - mE, mN (GDA94 Zone 56)	Map Unit	Comments	Pictures
NC-21	643283 7514051	B1	Gently undulating plain, upper slope 1%, 2% Brigalow, Belah Limited disturbance, Surface – cracking 2-8 mm, and self mulching, sandy clay loam, no coarse fragments

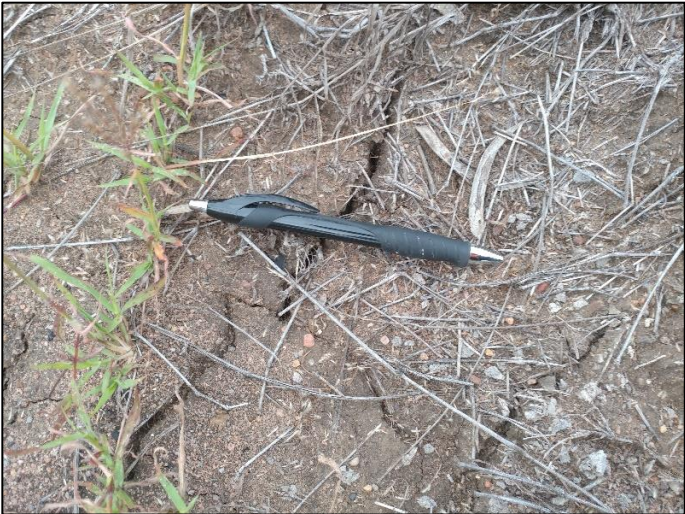
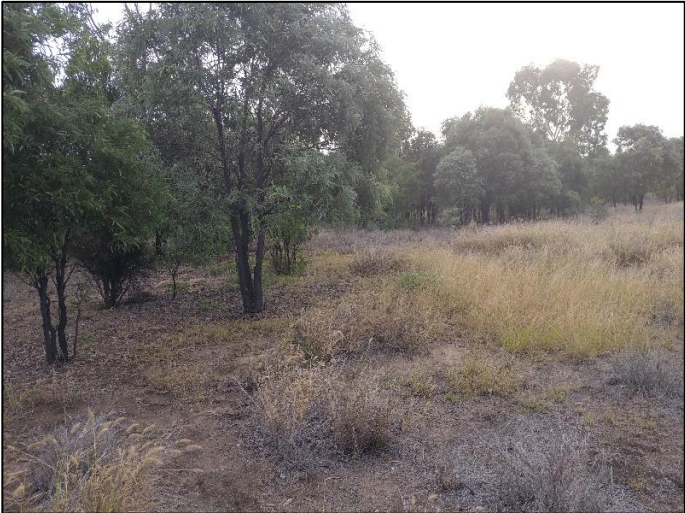
Site No.	Location - mE, mN (GDA94 Zone 56)	Map Unit	Comments	Pictures
NC-22	642804 7514097	A4c	Gently undulating plain, lower slope 1%, 2% Wide depression, inactive drainage line Brigalow, Belah Surface – cracking 2-8 mm, and self mulching, sandy clay loam <2% coarse fragments <2 mm

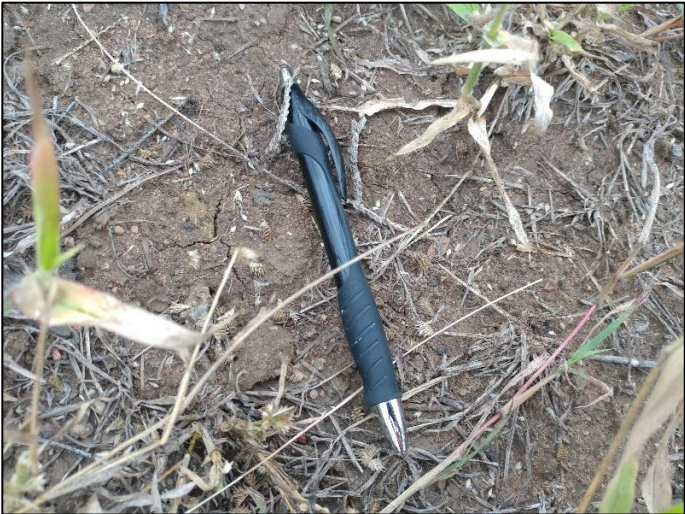
Site No.	Location - mE, mN (GDA94 Zone 56)	Map Unit	Comments	Pictures
NC-24	642191 7512204	B2bl	Gently undulating plain, mid slope 1%, 1% Limited disturbance, Surface sandy clay loam 10YR3/1, cracking 2 mm, no coarse fragments

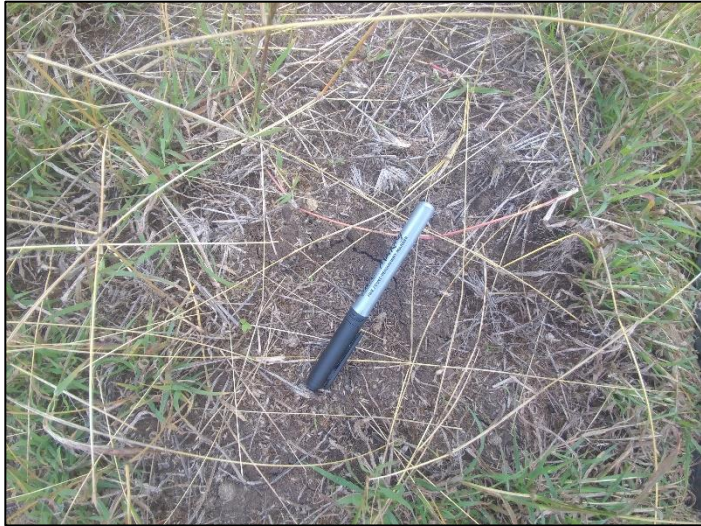
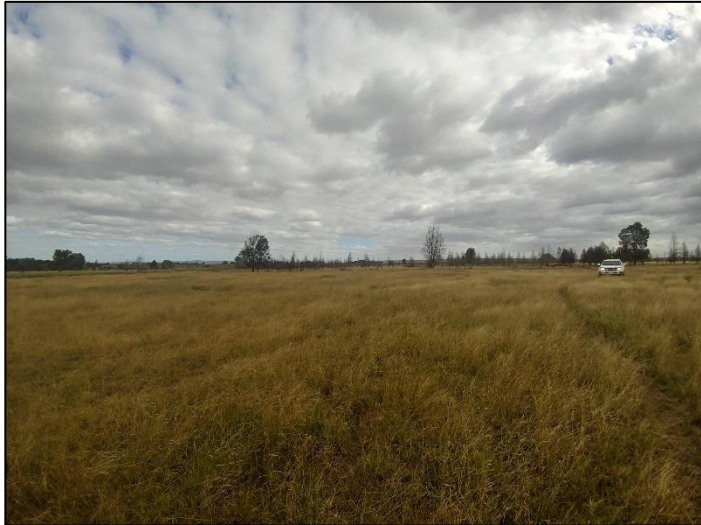
Site No.	Location - mE, mN (GDA94 Zone 56)	Map Unit	Comments	Pictures
NC-25	642541 7512279	B1	Gently undulating plain, flat plain Surface light clay, self mulching, no coarse fragments Cropping nearby

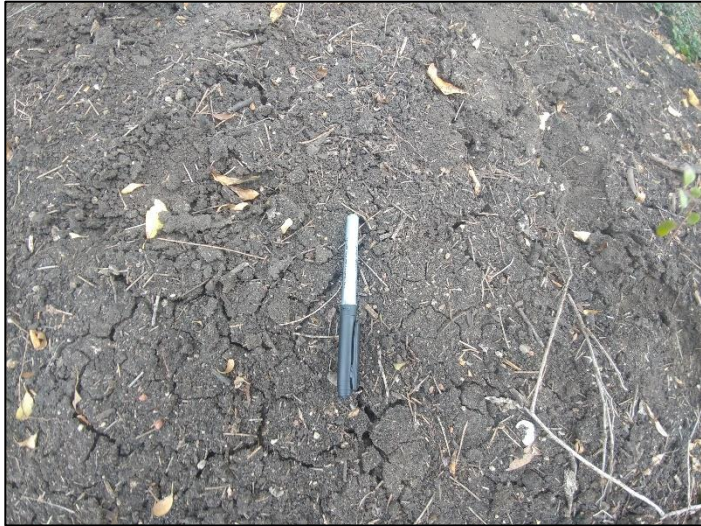
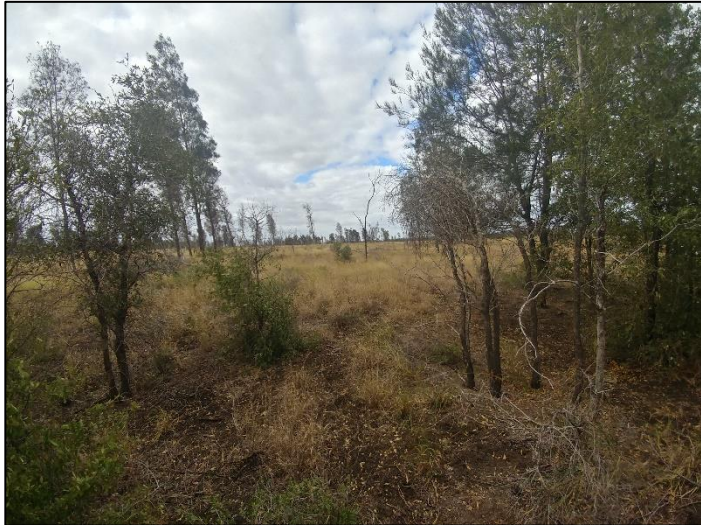
Site No.	Location - mE, mN (GDA94 Zone 56)	Map Unit	Comments	Pictures
NC-26	643047 7512703	B1	Gently undulating plain, lower slope 1%, Surface light clay, cracking 2-6 mm, self mulching, no coarse fragments Cropping nearby

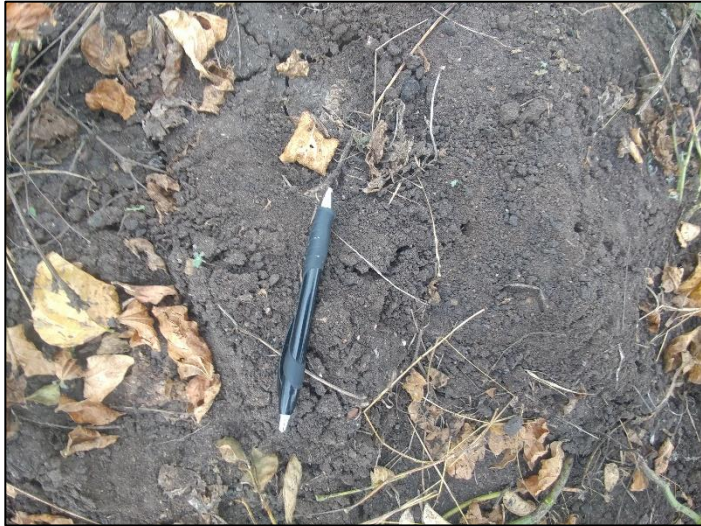
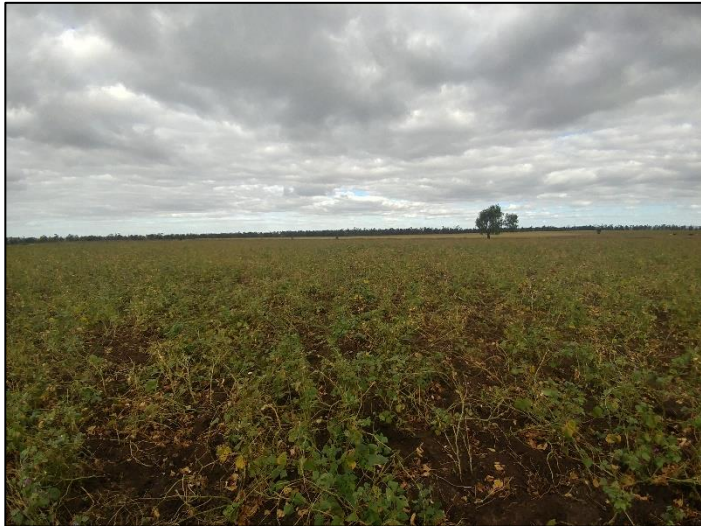
Site No.	Location - mE, mN (GDA94 Zone 56)	Map Unit	Comments	Pictures
NC-28	643790 7513018	B1	Gently undulating plain, lower slope 1%, Surface light clay, cracking 2-6 mm, self mulching, no coarse fragments Cropping nearby

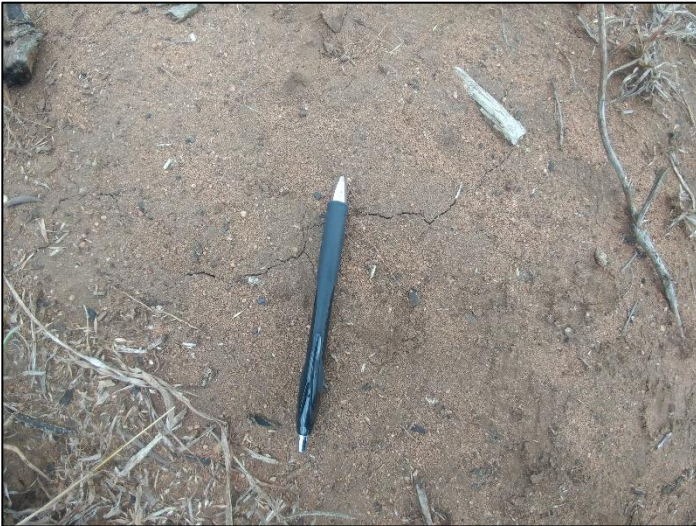
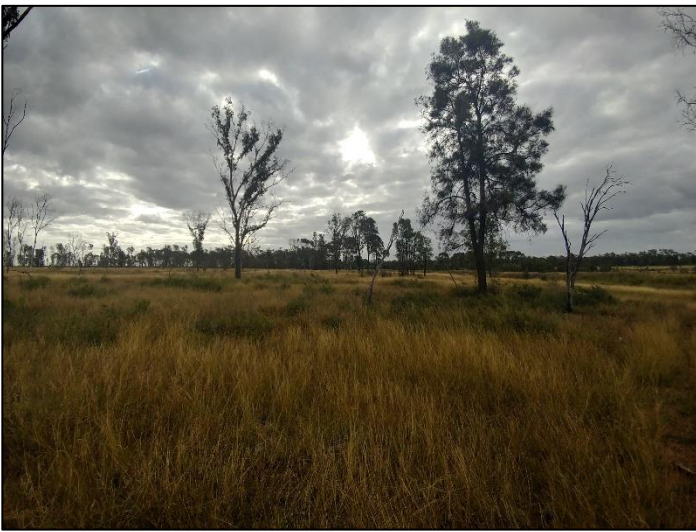
Site No.	Location - mE, mN (GDA94 Zone 56)	Map Unit	Comments	Pictures
NC-29	643707 7513294	B5	Gently undulating plain, upper slope 2%, 2% Surface sandy clay loam, minor cracking 2 mm, no coarse fragments

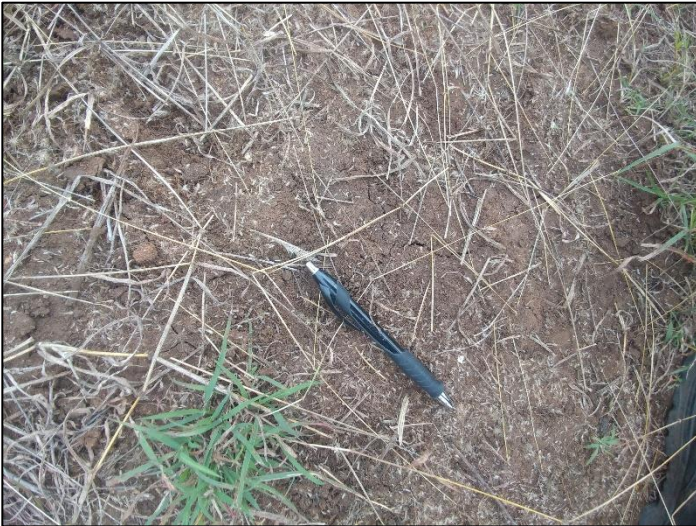
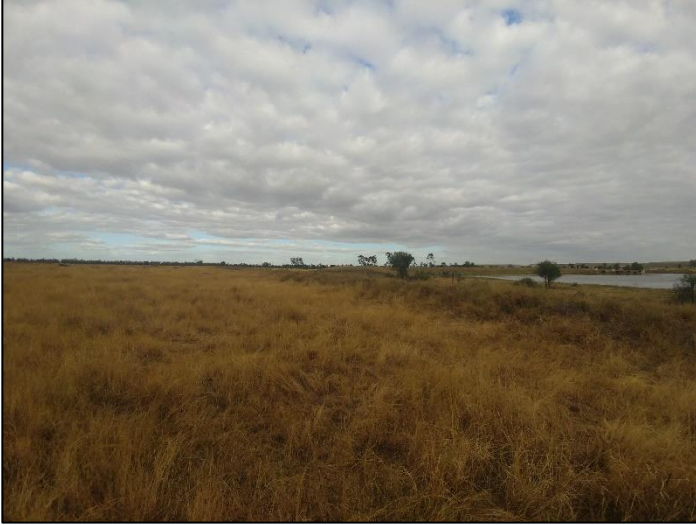
Site No.	Location - mE, mN (GDA94 Zone 56)	Map Unit	Comments	Pictures
NC-30	643918 7513548	B5	Gently undulating plain, upper slope 2% Surface sandy clay loam, minor cracking <2 mm, <2% <2mm coarse fragments

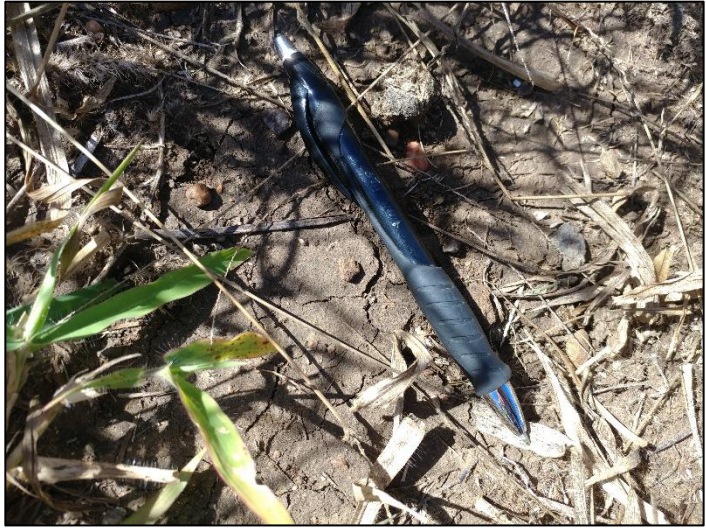
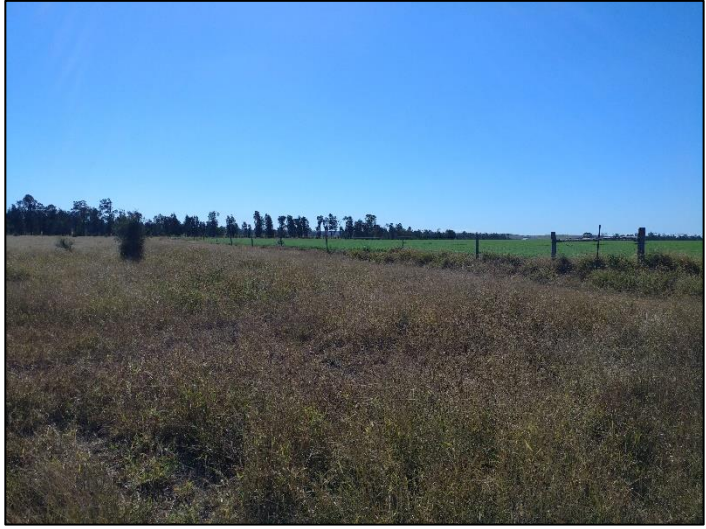
Site No.	Location - mE, mN (GDA94 Zone 56)	Map Unit	Comments	Pictures
NC-31	643165 7511509	B2bl	Gently undulating plain, lower slope 1% Surface light clay, minor cracking 2 mm, some crusting, no coarse fragments Limited disturbance

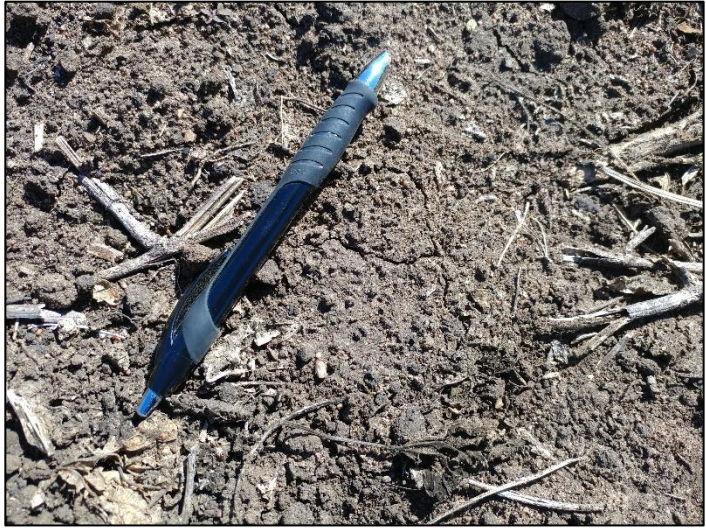
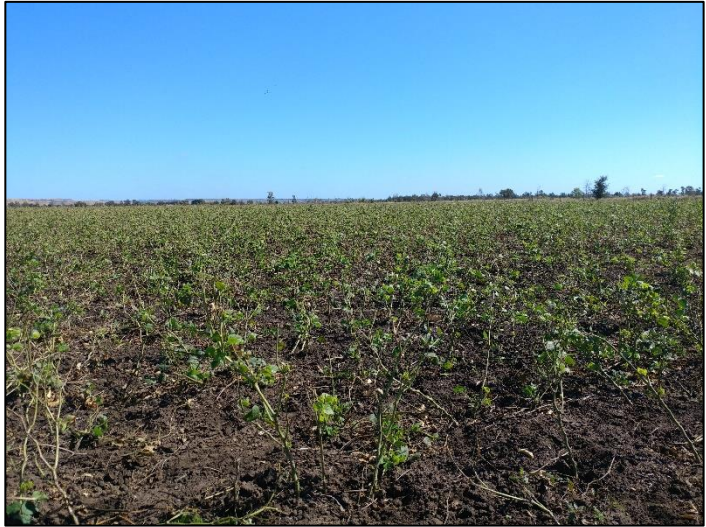
Site No.	Location - mE, mN (GDA94 Zone 56)	Map Unit	Comments	Pictures
NC-32	643661 7511295	B2bl	Gently undulating plain, mid slope 1%, 1% Surface, soft, sandy clay loam, minor cracking 2 mm, no coarse fragments Forage cropping disturbance

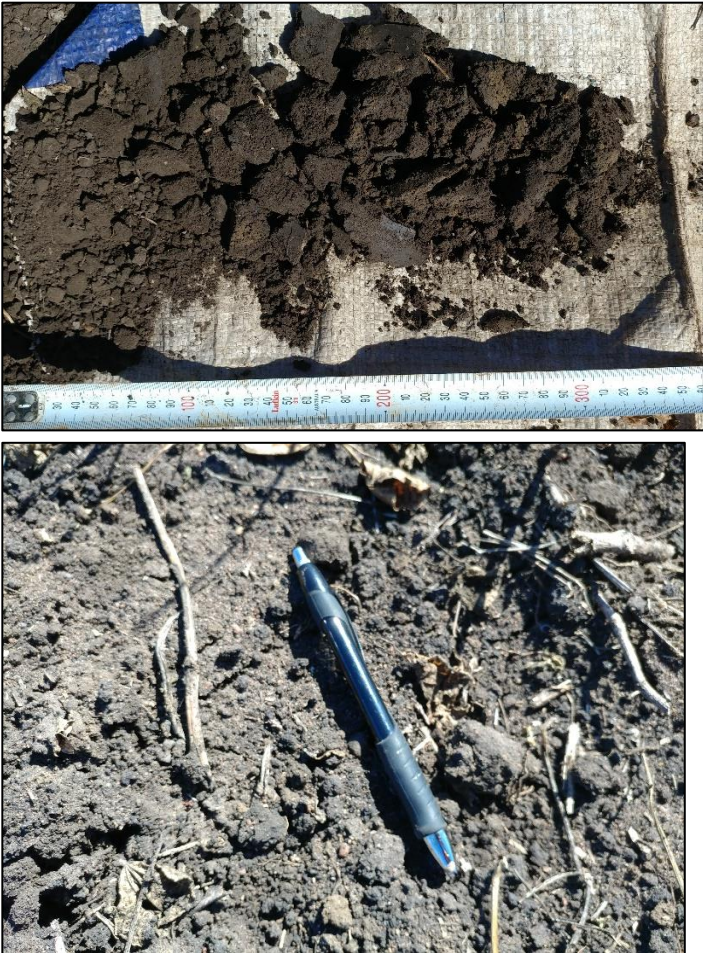
Site No.	Location - mE, mN (GDA94 Zone 56)	Map Unit	Comments	Pictures
NC-33	643394 7510738	B2bl	<p>Gently undulating plain, upper slope 1%, 1%</p> <p>Surface, soft, minor cracking 2 mm, no coarse fragments</p> <p>Forage cropping disturbance</p> <p>0.00 – 0.09 m</p> <p>Sandy loam, massive, weak, peds &lt;100mm</p> <p>10YR3/2</p> <p>0.09 – 0.30+ m</p> <p>Sandy clay loam, peds &lt;200mm</p> <p>10YR3/2</p>

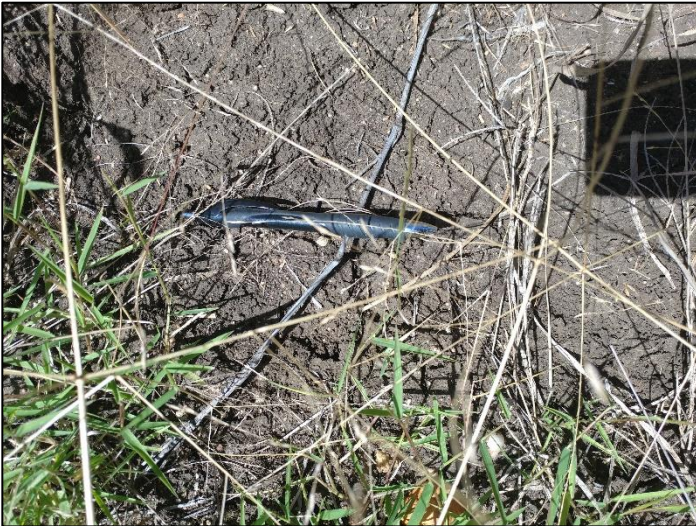
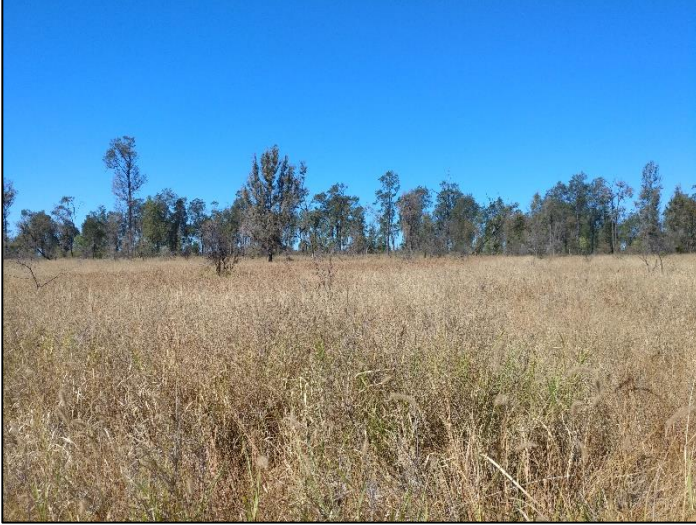
Site No.	Location - mE, mN (GDA94 Zone 56)	Map Unit	Comments	Pictures
NC-34	644122 7512307	B1	Gently undulating plain, flat plain Surface light clay 10YR3/2, cracking 2 mm, no coarse fragments Limited disturbance

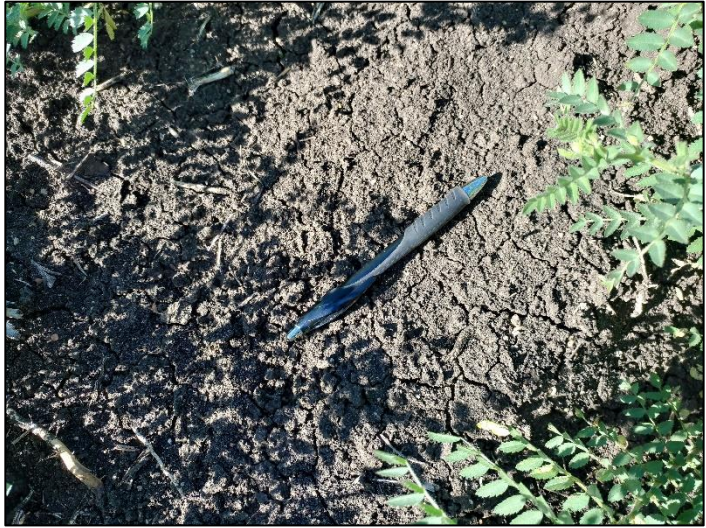
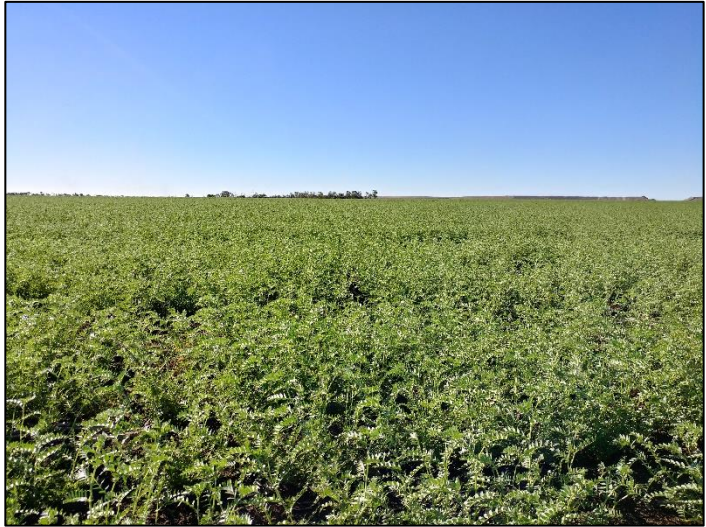
Site No.	Location - mE, mN (GDA94 Zone 56)	Map Unit	Comments	Pictures
NC-35	644475 7511295	B1	Gently undulating plain, mid slope 1%, 1% Surface light clay 10YR3/2, cracking 2-6 mm, no coarse fragments Cropping disturbance

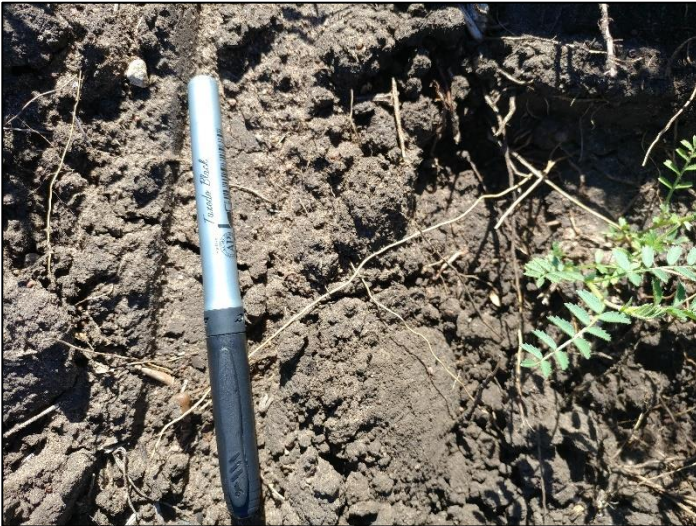
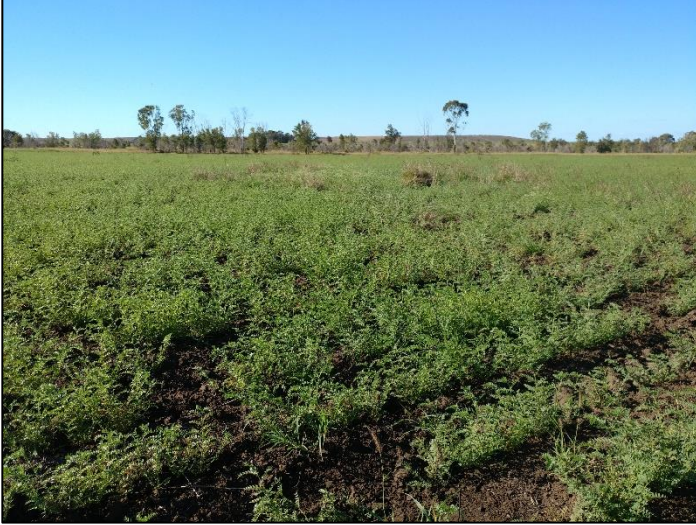
Site No.	Location - mE, mN (GDA94 Zone 56)	Map Unit	Comments	Pictures
NC-36	645158 7511201	B1	Gently undulating plain, mid slope 1%, 1% Surface light clay 10YR3/2, cracking <2 mm, self mulching, no coarse fragments Cropping disturbance

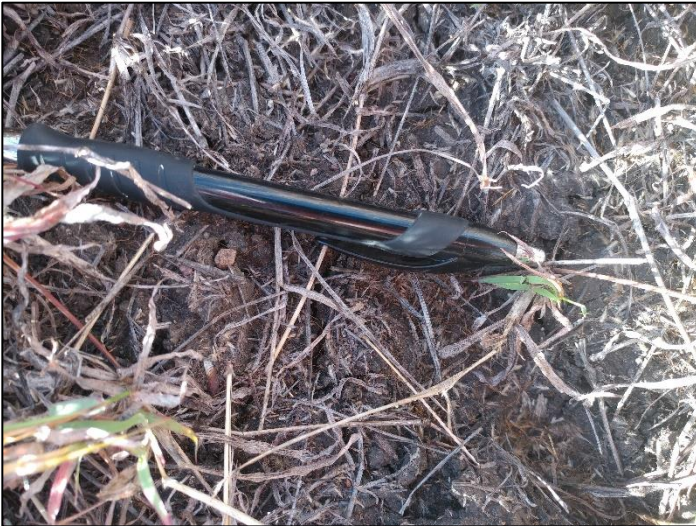
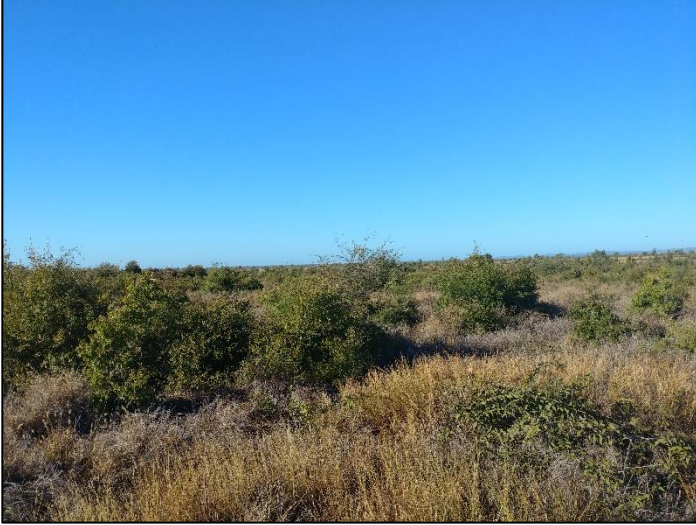
Site No.	Location - mE, mN (GDA94 Zone 56)	Map Unit	Comments	Pictures
NC-37	644857 7511101	B1	Gently undulating plain, upper slope <2%, <3% Surface light clay 10YR3/2, cracking 2-6 mm, no coarse fragments

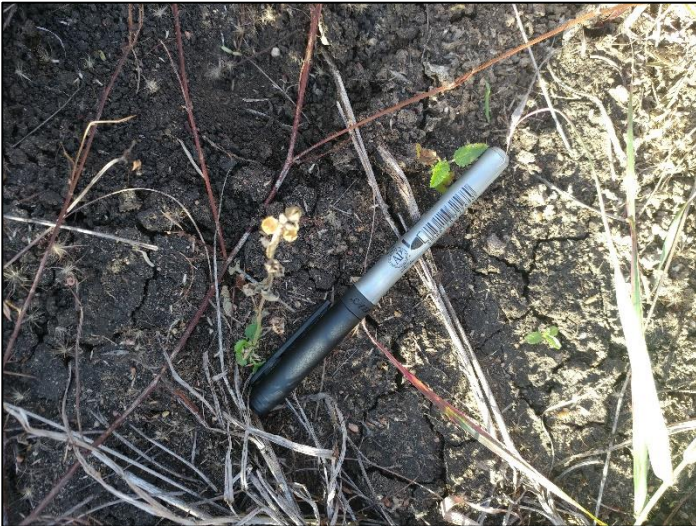
Site No.	Location - mE, mN (GDA94 Zone 56)	Map Unit	Comments	Pictures
NC-38	645563 7511106	B1	Gently undulating plain, upper slope 2%, 2% Surface light clay 10YR3/2, cracking 2-6 mm, no coarse fragments

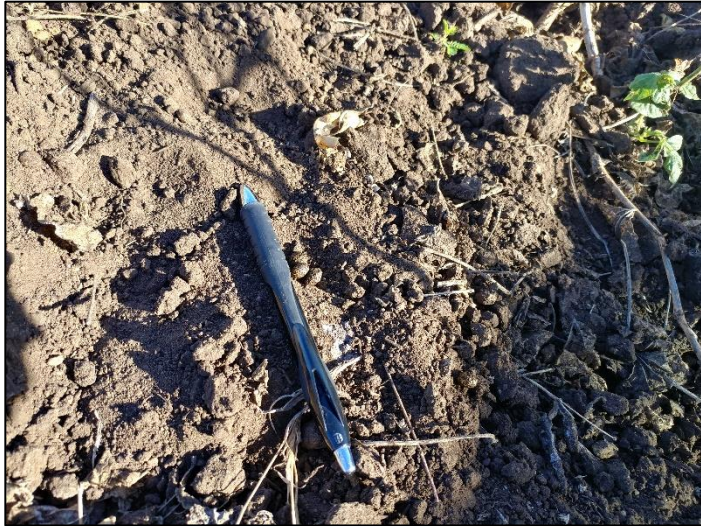
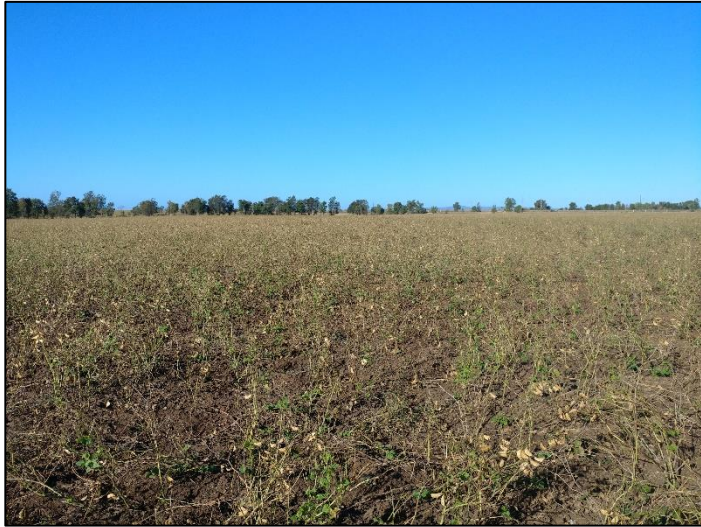
Site No.	Location - mE, mN (GDA94 Zone 56)	Map Unit	Comments	Pictures
NC-39	642769 7511490	B2bl	Gently undulating plain, mid slope 2%, 2% Surface light clay 10YR3/2, self mulching, no coarse fragments Forage cropping disturbance

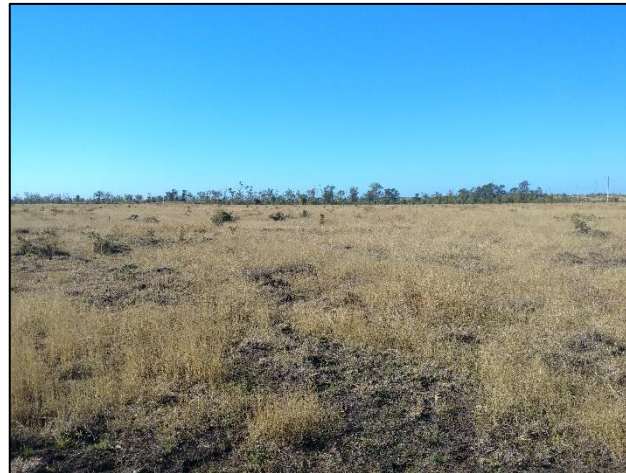
Site No.	Location - mE, mN (GDA94 Zone 56)	Map Unit	Comments	Pictures
NC-40	642555 7510052	B3bl	<p>Gently undulating plain, upper slope 1%, 1%</p> <p>Surface light clay 10YR3/2, cracking &lt;2 mm, self mulching, no coarse fragments.</p> <p>Gilgai located in area, map boundary</p> <p>Limited disturbance</p> <p>0.00 – 0.20 m</p> <p>Light clay, moderate, 10YR3/2</p> <p>0.20 – 0.40+ m</p> <p>Medium clay, subangular blocky, 10YR3/1</p>

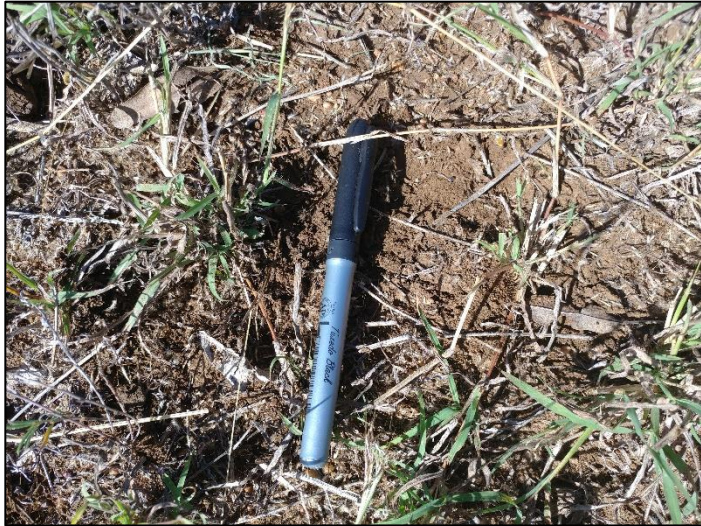
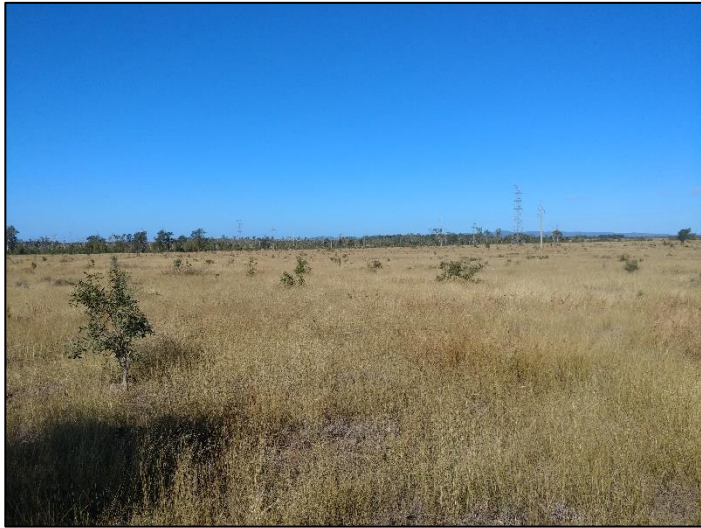
Site No.	Location - mE, mN (GDA94 Zone 56)	Map Unit	Comments	Pictures
NC-41	642161 7510152	E1r	<p>Brown surface colour to the north, change to grey surface colour nearby towards the south</p> <p>Surface - firm, sandy loam, 10YR3/3</p> <p>No coarse fragments, mid slope 1%</p>

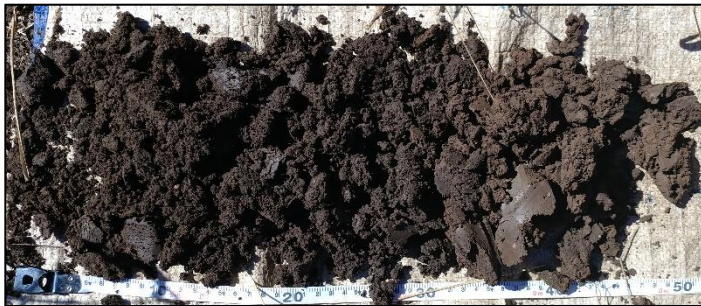
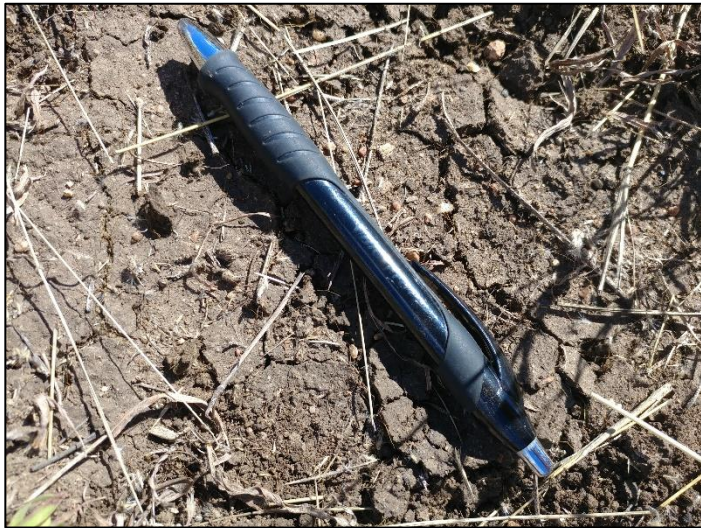
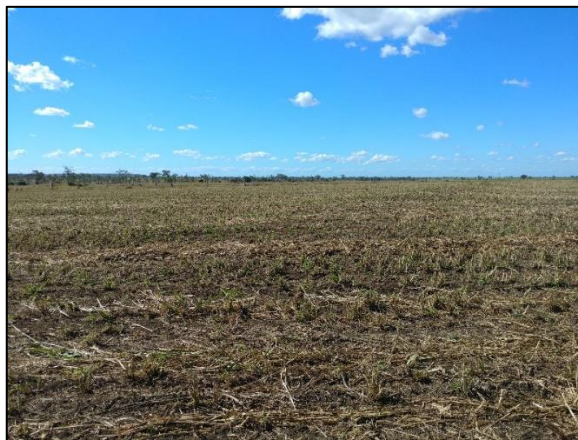
Site No.	Location - mE, mN (GDA94 Zone 56)	Map Unit	Comments	Pictures
NC-42	643510 7508834	E2	<p>Gently undulating plain, upper slope 1%, 1%</p> <p>Surface cracking &lt;2 mm, self mulching, no coarse fragments</p> <p>Cropping disturbance</p> <p>0.00 – 0.10 m Light clay, 10YR3/2</p> <p>0.10 – 0.35 m Medium clay, 10YR3/2</p> <p>0.35 – 0.50+ m Medium clay, 10YR4/2</p>

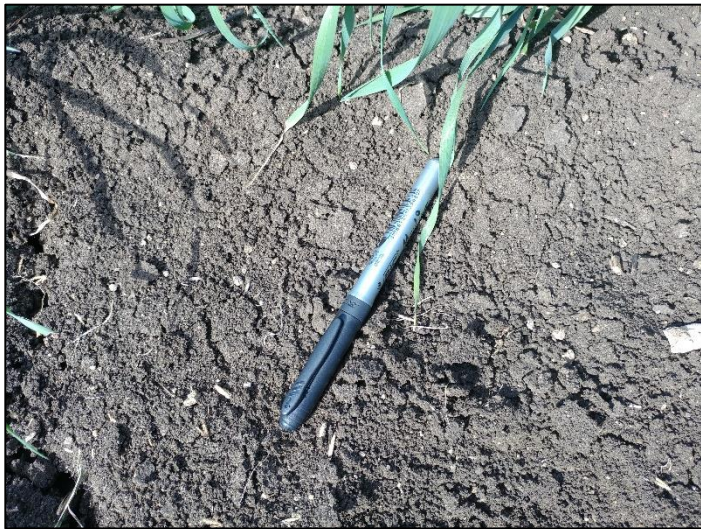
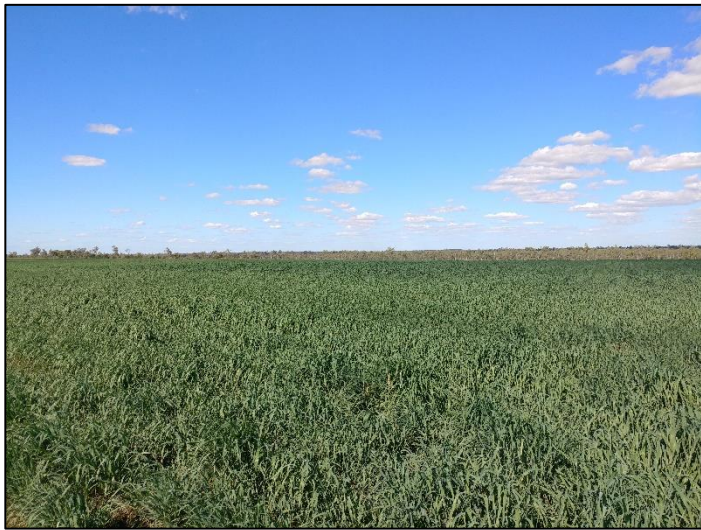
Site No.	Location - mE, mN (GDA94 Zone 56)	Map Unit	Comments	Pictures
NC-44	645697 7508528	E2	Gently undulating plain, mid slope <2%, 1% Surface light clay 10YR3/2, cracking <2 mm, self mulching, <2% coarse fragments Cropping disturbance
