# Restoration Plan to Support RIDA Application Saraji East Project

Final V4  
15 July 2021

GT Environmental Pty Ltd  
[www.gtenvironmental.com.au](http://www.gtenvironmental.com.au)

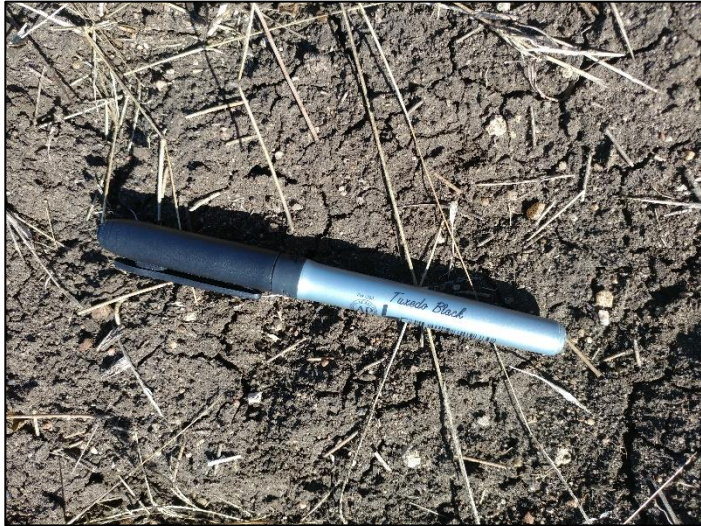
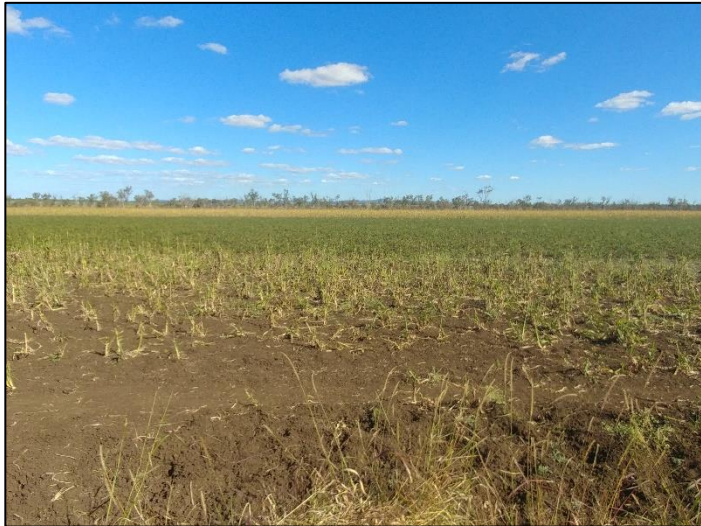
Site No.	Location - mE, mN (GDA94 Zone 56)	Map Unit	Comments	Pictures
NC-45	644367 7509819	E2	Gently undulating plain, mid slope 1%, 1% Surface light clay 10YR3/2, cracking <2 mm, self mulching, <2% coarse fragments Cropping disturbance

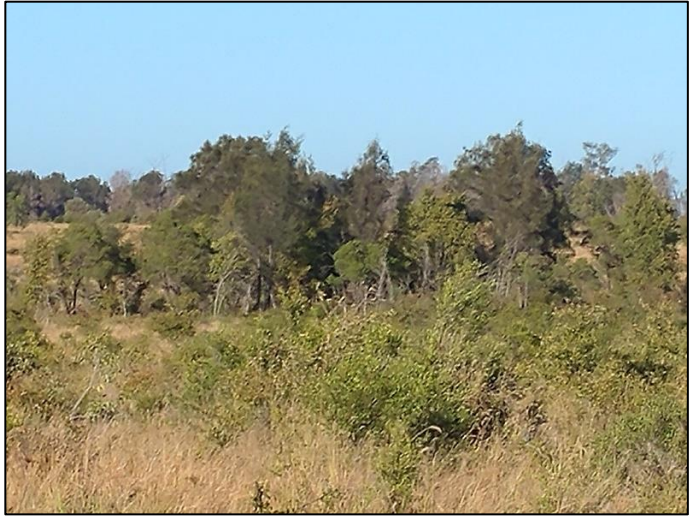
Site No.	Location - mE, mN (GDA94 Zone 56)	Map Unit	Comments	Pictures
NC-46	644024 7510908	B1	Gently undulating plain, lower slope 2%, 1% Surface light clay 10YR3/2, cracking 2-6 mm, No coarse fragments

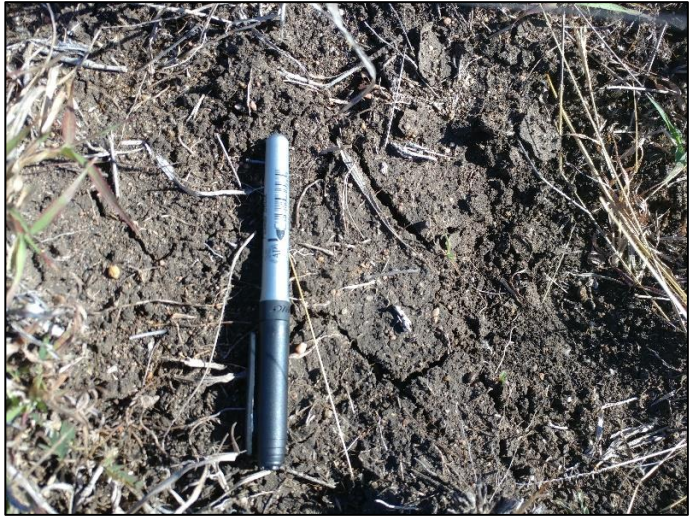
NC-47	640942 7512659	B2s	Gently undulating plain, mid slope 1%, 1% Surface light clay 10YR3/2, cracking 2-6 mm, no coarse fragments

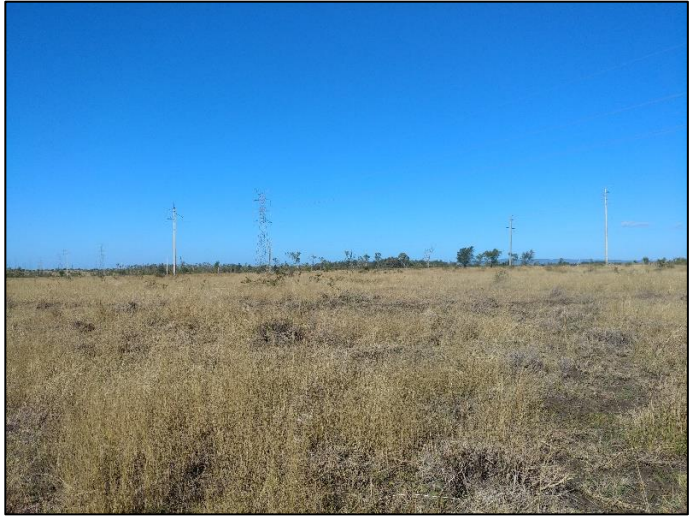
Site No.	Location - mE, mN (GDA94 Zone 56)	Map Unit	Comments	Pictures
NC-48	640883 7512861	B2s	Gently undulating plain, mid slope 1%, 1% Surface light clay 10YR3/2, cracking 2-6 mm, no coarse fragments

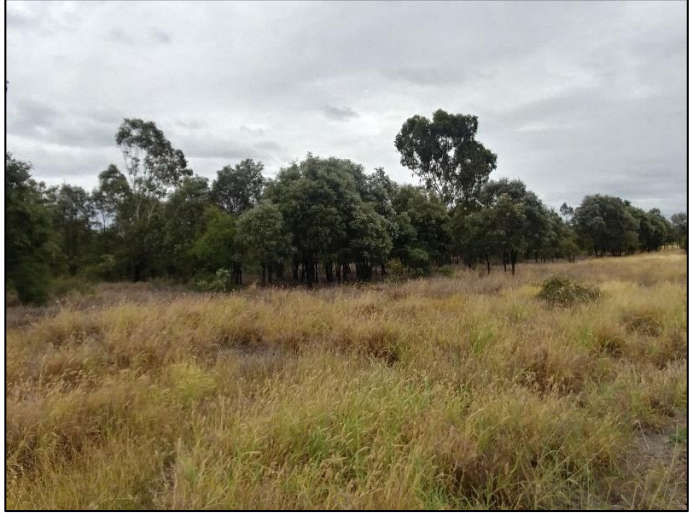
NC-49	642978 7511443	A5	Wide depression, drainage line, lower slope 2%, 1% Surface sandy light clay, cracking 2-6 mm, No coarse fragments Sheet erosion

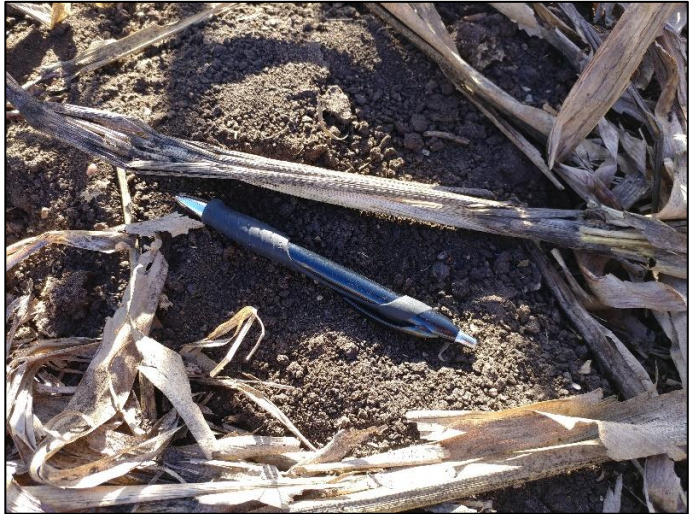
Site No.	Location - mE, mN (GDA94 Zone 56)	Map Unit	Comments	Pictures
NC-52	643635 7512290	B1	Gently undulating plain, lower slope 2%, 2% Surface light clay, self mulching, no coarse fragments Cropping disturbance

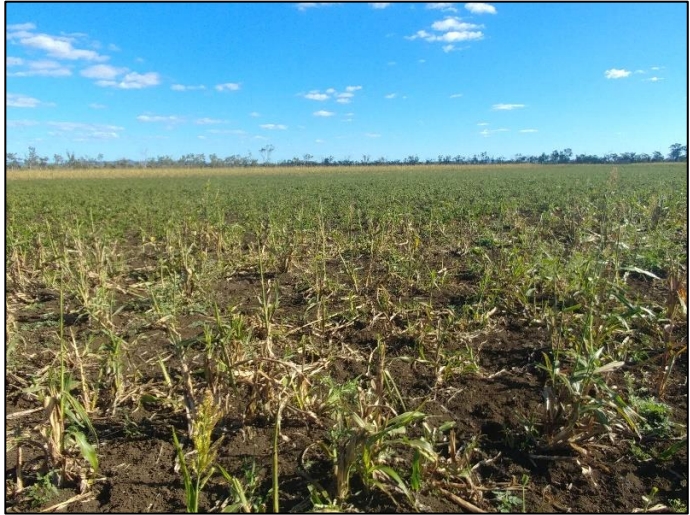
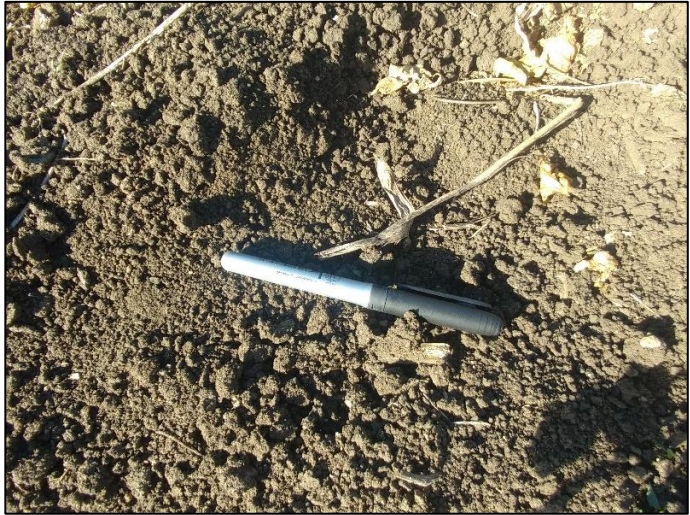
Site No.	Location - mE, mN (GDA94 Zone 56)	Map Unit	Comments	Pictures
NC-54	645704 7510053	E2	Gently undulating plain, upper slope 1%, 1% Surface light clay, self mulching, no coarse fragments Cropping disturbance

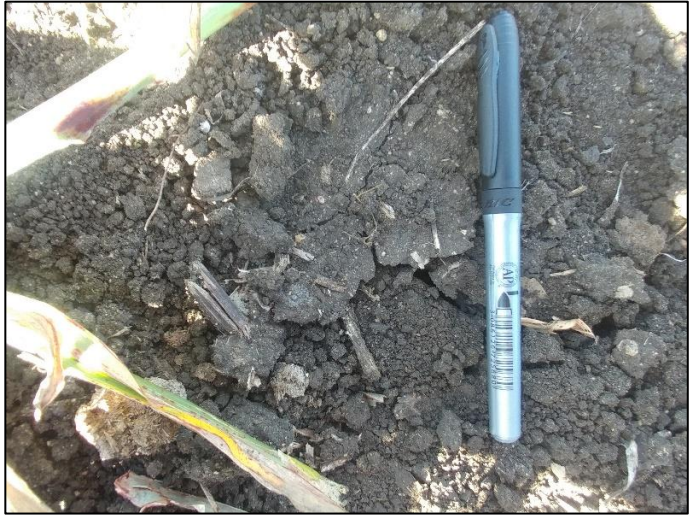
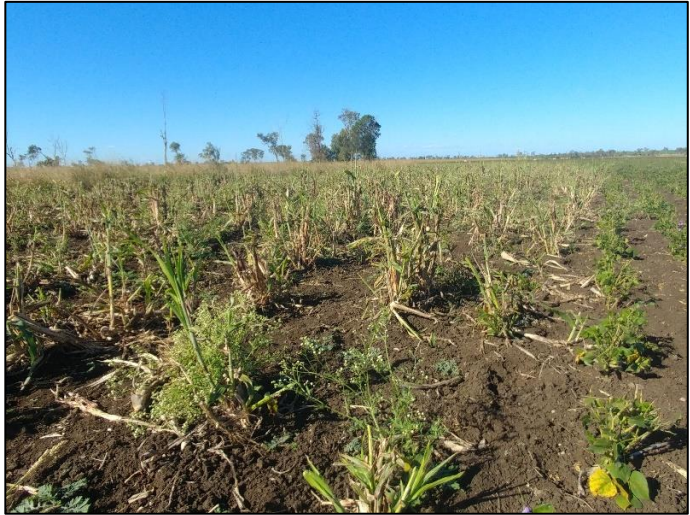
Site No.	Location - mE, mN (GDA94 Zone 56)	Map Unit	Comments	Pictures
NC-55	645506 7509704	E2	Gently undulating plain, upper slope 1%, 1% Surface light clay, self mulching, Some cracking 2-6 mm, No coarse fragments, Cropping disturbance

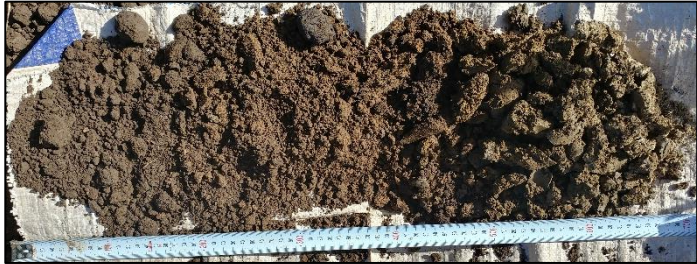
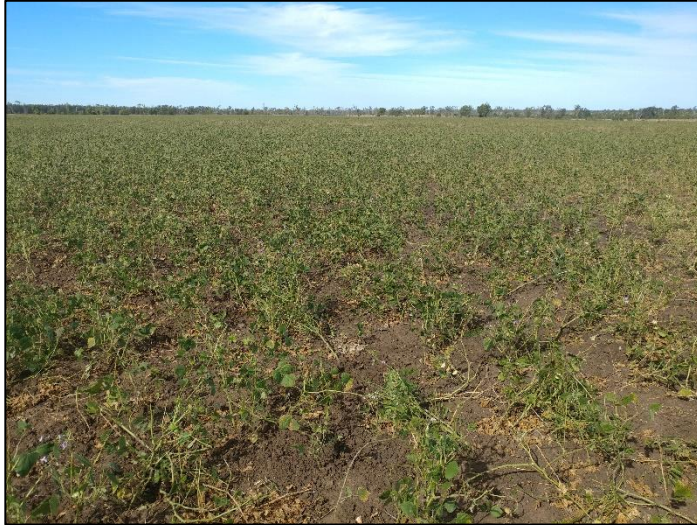
Site No.	Location - mE, mN (GDA94 Zone 56)	Map Unit	Comments	Pictures
NC-56	643093 7510114	E1r	<p>Gently undulating plain, mid slope 1%</p> <p>Surface - firm, sandy loam, 10YR3/3, no coarse fragments</p> <p>0.00 – 0.10 m Sandy loam 10YR3/3</p> <p>0.10 – 0.42 m Sandy clay loam 5YR4/3</p> <p>0.42 – 0.65 + m Sandy clay loam 7.5Y4/4 &lt;5% calcium carbonate</p>

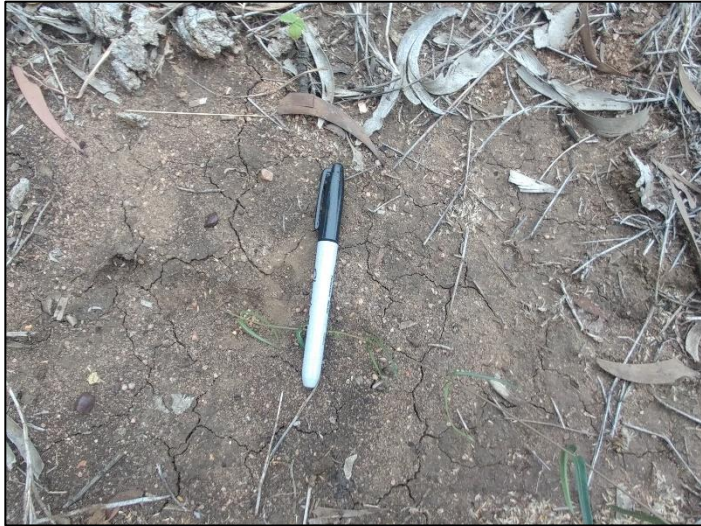
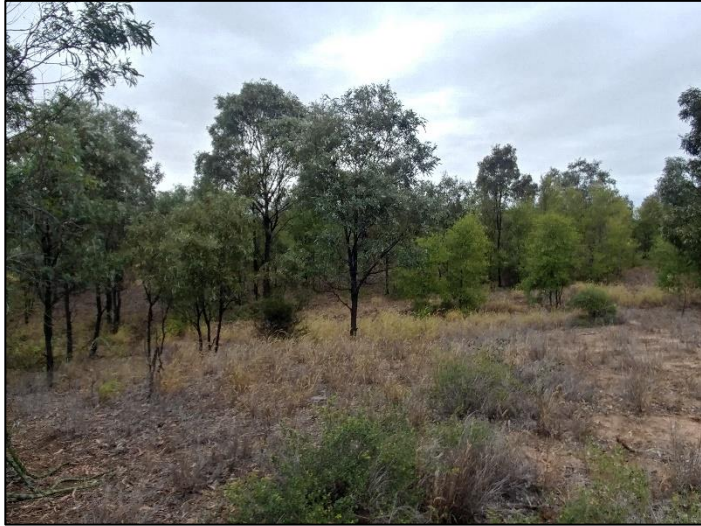
Site No.	Location - mE, mN (GDA94 Zone 56)	Map Unit	Comments	Pictures
NC-57	642985 7513858	A4c	Gently undulating plain, lower slope 1%, 2% Wide depression, inactive drainage line Brigalow, Belah Surface – firm, cracking 2 mm, sandy clay loam <2% coarse fragments <2 mm

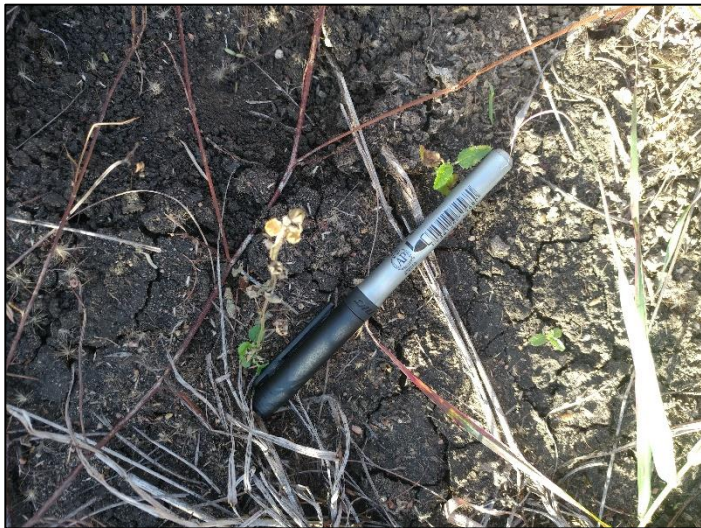
Site No.	Location - mE, mN (GDA94 Zone 56)	Map Unit	Comments	Pictures
NC-58	644239 7511127	B1	Gently undulating plain, mid slope 2%, 1% Surface light clay 10YR3/2, cracking 2-6 mm, No coarse fragments

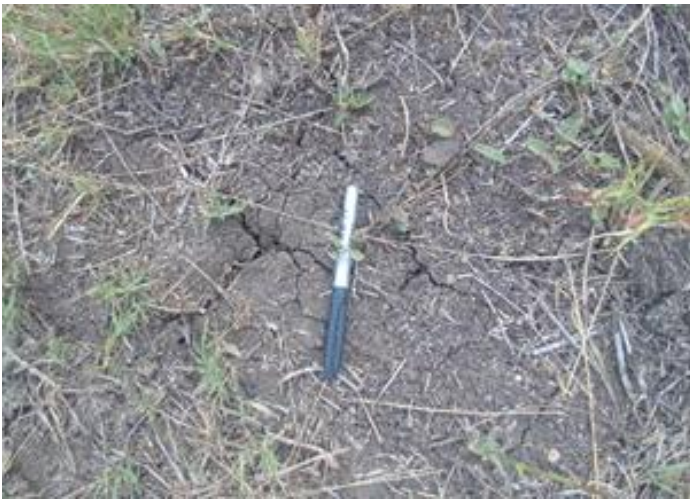
NC-59	644073 7514265	B1	Gently undulating plain, upper slope 1%, 2% Brigalow, Belah Limited disturbance, Surface – cracking 2-8 mm, and self mulching, sandy clay loam, no coarse fragments

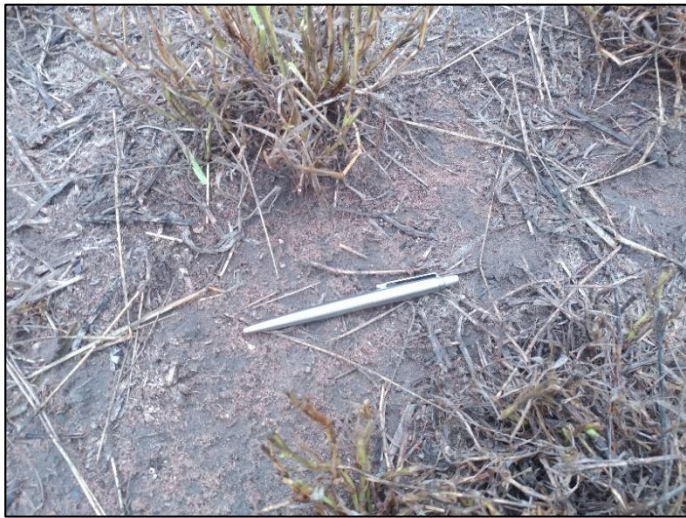
Site No.	Location - mE, mN (GDA94 Zone 56)	Map Unit	Comments	Pictures
NC-60	641787 7514024	B2g	Same as sites N4 and N5, mid slope 2.0%, no erosion or microrelief, soft surface with no coarse fragments. Surface texture black sandy loam.

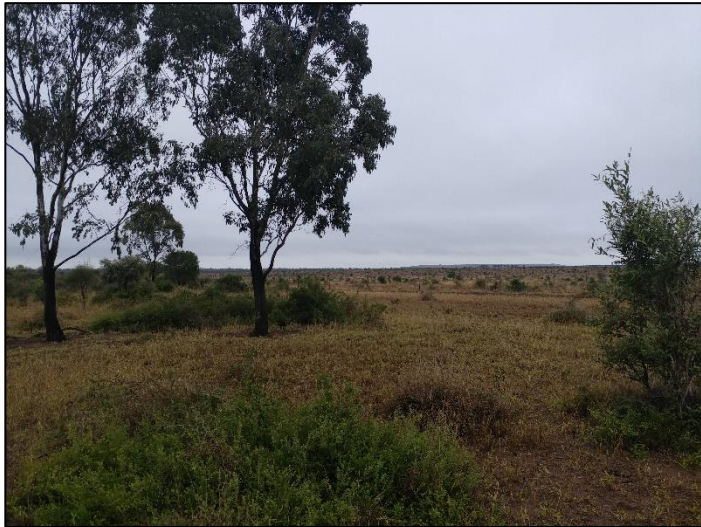
NC-61	641691 7514197	B2g	Same as sites N4 and N5, mid slope 2.0%, no erosion or microrelief, soft surface with no coarse fragments. Surface texture black sandy loam.

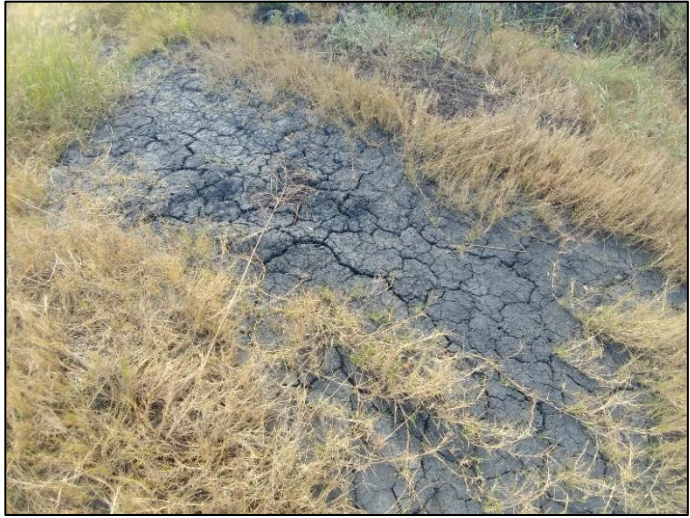
Site No.	Location - mE, mN (GDA94 Zone 56)	Map Unit	Comments	Pictures
NC-62	641100 7512707	A2g	Wide depression, surface hard setting with cracking 2-6mm. Surface texture light clay.
