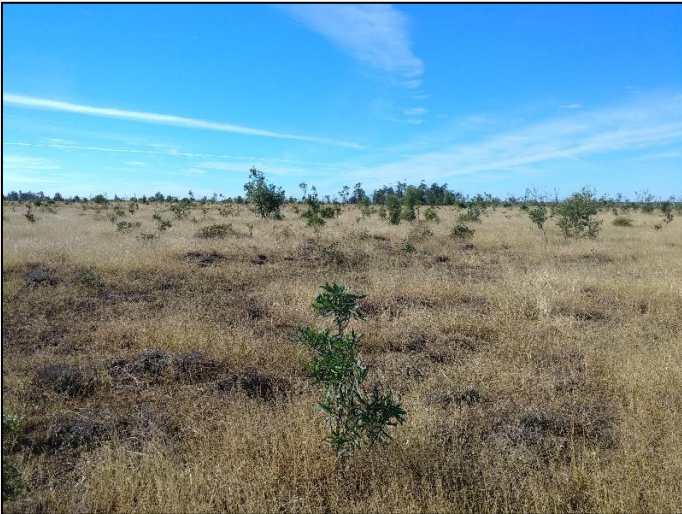
Site No.	Location - mE, mN (GDA94 Zone 56)	Map Unit	Comments	Pictures
NC-1	641651 7508111	16	Gently undulating plain, lower slope, 1%, 2% Crabhole gilgai, 50% coverage <200 mm deep Surface – cracking and self mulching

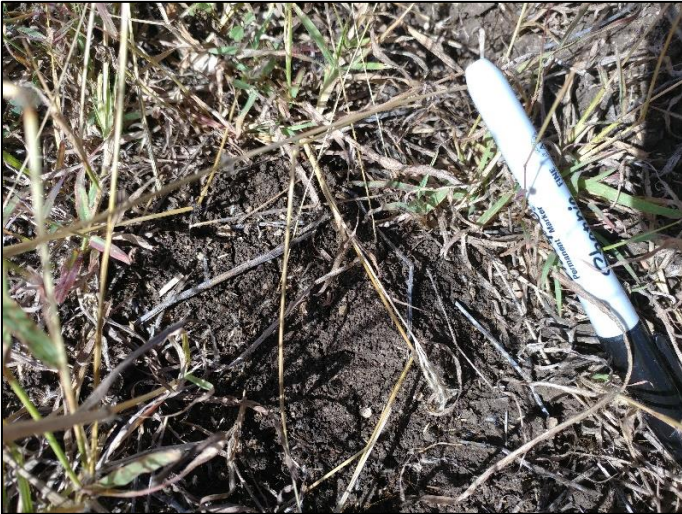
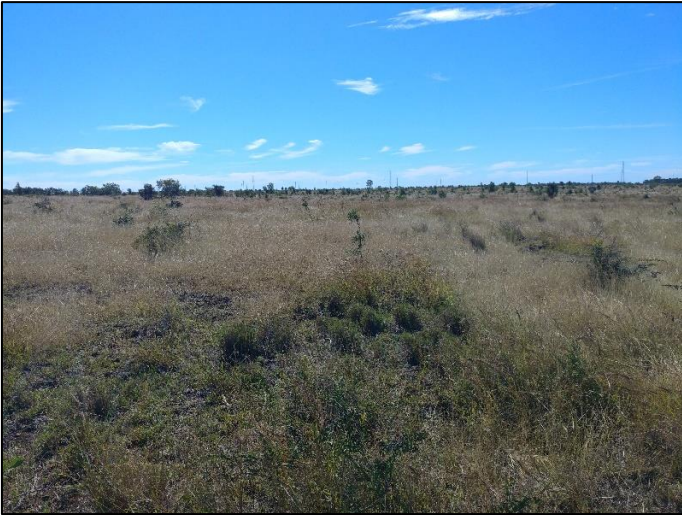
Site No.	Location - mE, mN (GDA94 Zone 56)	Map Unit	Comments	Pictures
NC-2	641972 7509347	16	Gently undulating plain, lower slope, 1% Crabhole and linear gilgai, 50% coverage 150-200 mm deep Surface – cracking and self mulching

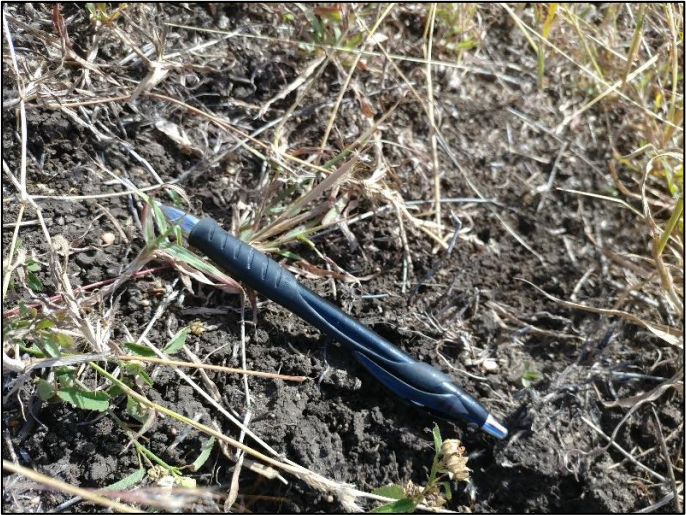
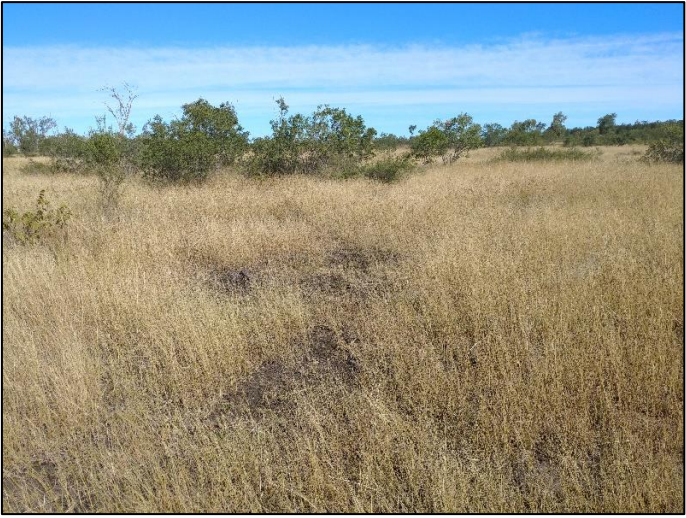
Site No.	Location - mE, mN (GDA94 Zone 56)	Map Unit	Comments	Pictures
NC-3	642749 7508963	16	Gently undulating plain, lower slope, 1% Normal gilgai, 40% coverage 150-200 mm deep Surface – cracking and self mulching

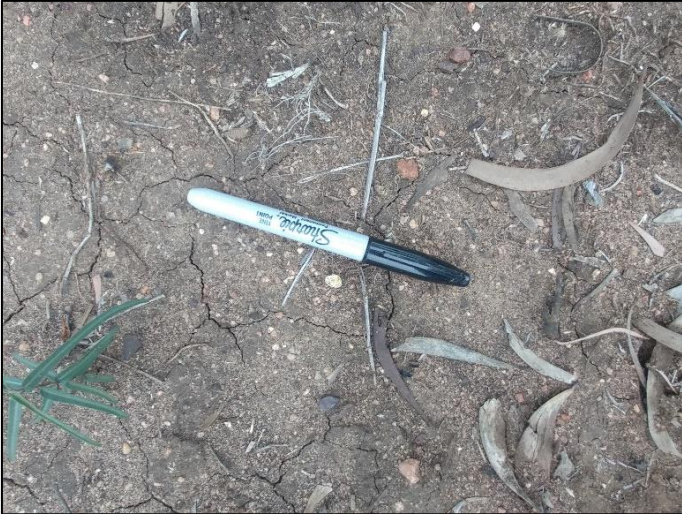
Site No.	Location - mE, mN (GDA94 Zone 56)	Map Unit	Comments	Pictures
NC-4	642189 7511009	11	Wide depression, drainage line Cracking surface, with <2% <6mm coarse fragments

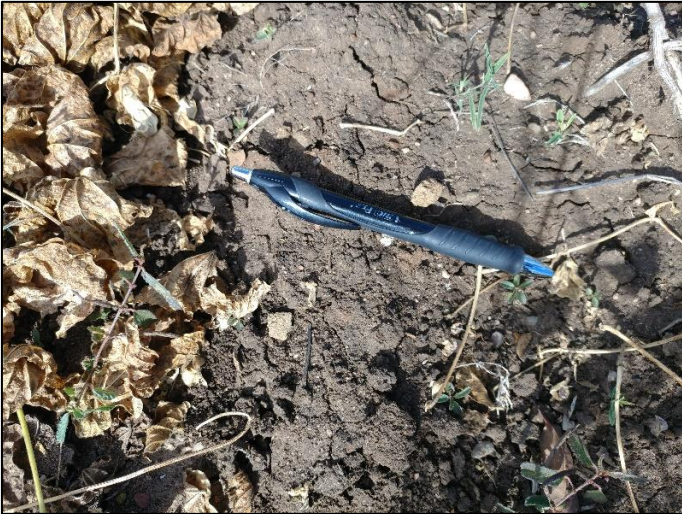
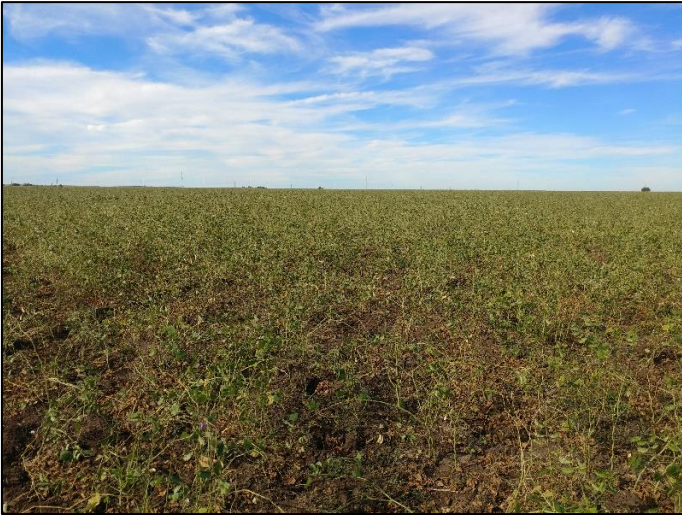
Site No.	Location - mE, mN (GDA94 Zone 56)	Map Unit	Comments	Pictures
NC-5	641073 7510547	13	Gently undulating plain, Cropping, extensively disturbed, lower slope Surface cracking, light clay, no coarse fragments

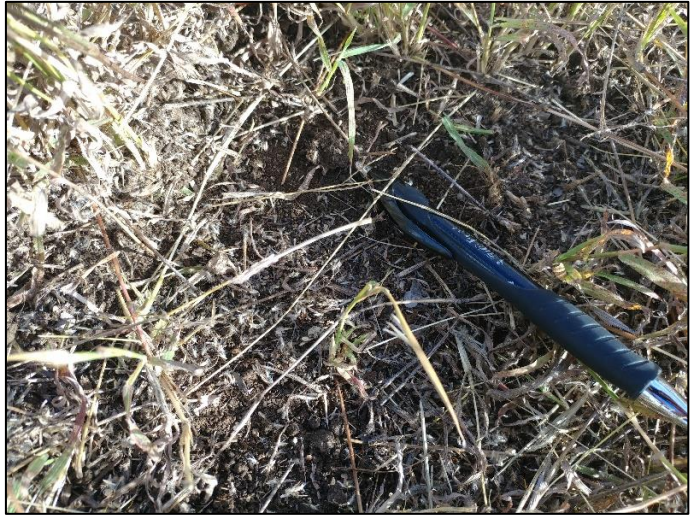
Site No.	Location - mE, mN (GDA94 Zone 56)	Map Unit	Comments	Pictures
NC-8	641519 7511677	6	Gently undulating plain, mid slope Surface 2 mm cracking, sandy clay loam, no coarse fragments

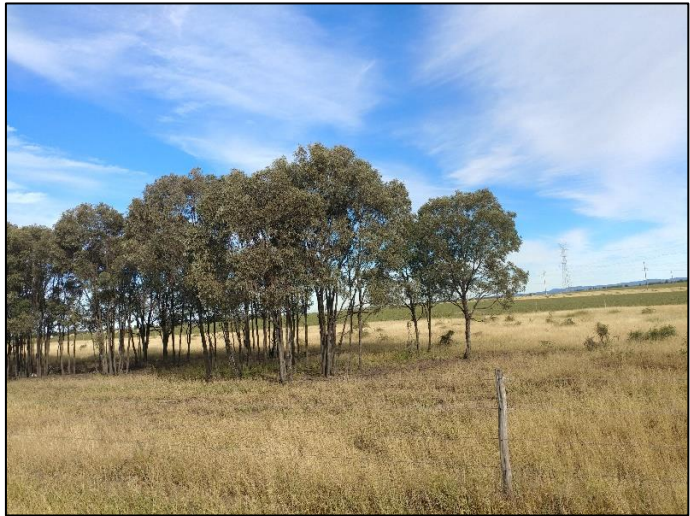
NC-9	641777 7511708	6	Gently undulating plain, mid slope, Brigalow Surface 2 mm cracking, sandy clay loam, no coarse fragments

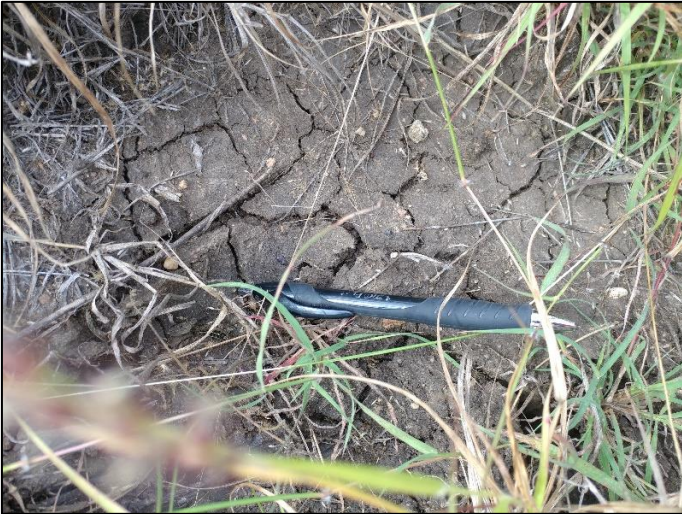
Site No.	Location - mE, mN (GDA94 Zone 56)	Map Unit	Comments	Pictures
NC-10	641414 7513101	6	Gently undulating plain, lower slope, 1%, 2% Grass, various trees regrowth Surface – cracking 2-6mm, light clay

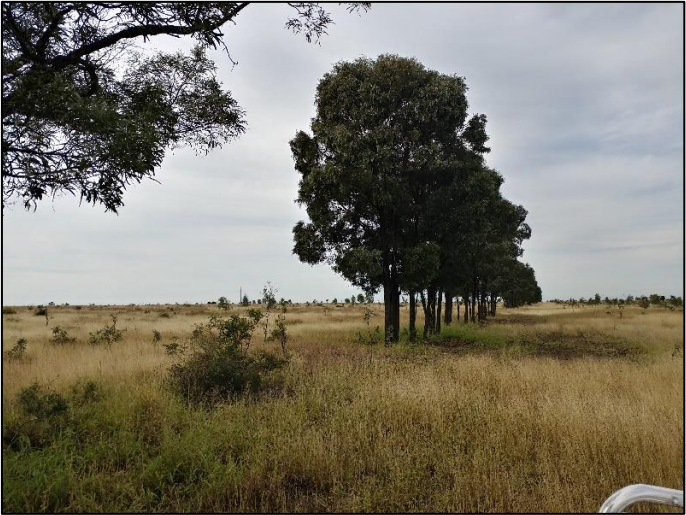
Site No.	Location - mE, mN (GDA94 Zone 56)	Map Unit	Comments	Pictures
NC-11	641676 7513156	6	Gently undulating plain, lower slope, 1%, 2% Limited disturbance, Brigalow Surface – cracking and self mulching, light clay

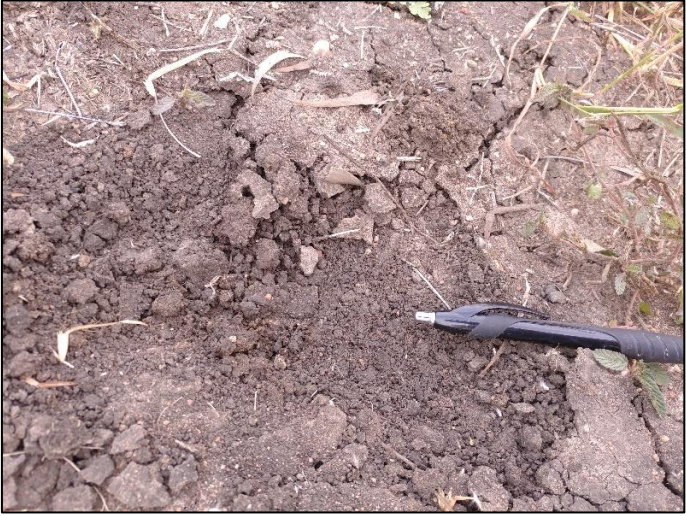
NC-12	642118 7512668	6	Gently undulating plain, flat plain Limited disturbance, Brigalow Surface – cracking and crusting, light sandy clay

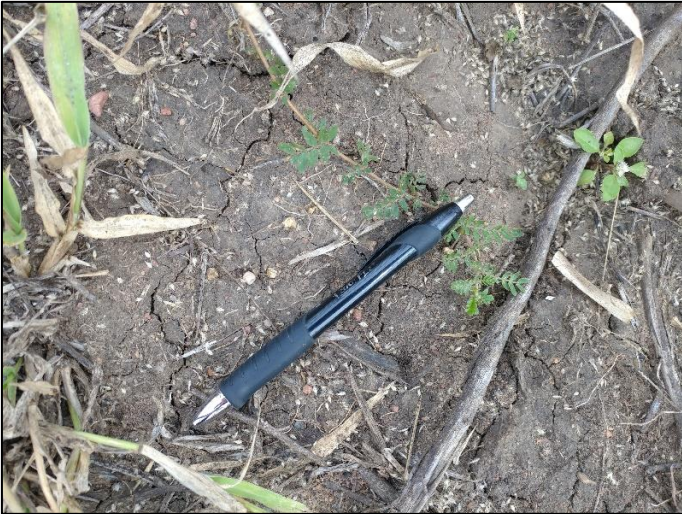
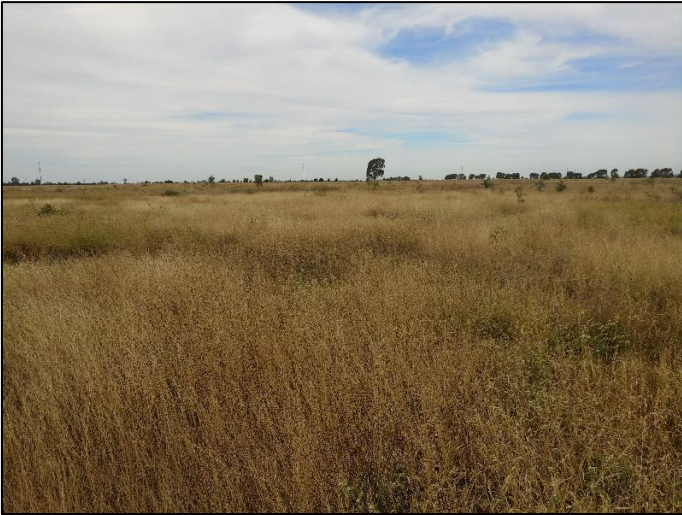
Site No.	Location - mE, mN (GDA94 Zone 56)	Map Unit	Comments	Pictures
NC-13	641869 7513464	6	Gently undulating plain, crest, 1%, 0% Limited disturbance, Brigalow Surface – cracking <2 mm, black light clay

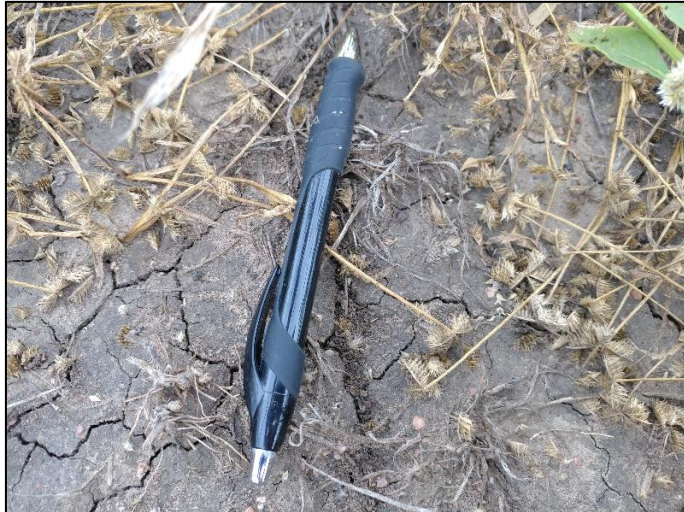
Site No.	Location - mE, mN (GDA94 Zone 56)	Map Unit	Comments	Pictures
NC-14	642641 7514052	6	Gently undulating plain, crest, 1%, 0% Limited disturbance, Brigalow, Belah Surface – cracking <4 mm, clay loam 10YR3/1

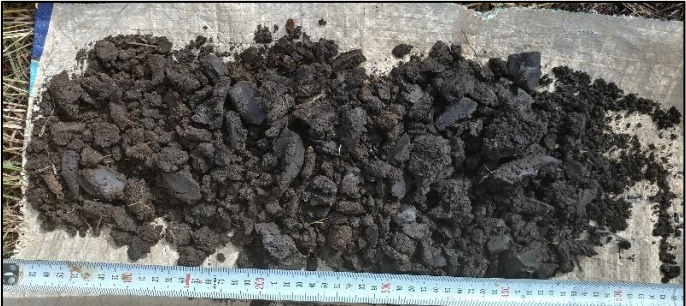
Site No.	Location - mE, mN (GDA94 Zone 56)	Map Unit	Comments	Pictures
NC-15	643244 7514499	1	<p>Gently undulating plain, lower slope &lt;2%</p> <p>Limited disturbance, Brigalow</p> <p>Surface – cracking 2-6 mm, light clay, no coarse fragments</p> <p>0.00 – 0.11 m</p> <p>Clay loam</p> <p>Moderate, firm, peds &lt;20 mm</p> <p>10YR3/1</p> <p>0.11 – 0.30+ m</p> <p>Medium clay</p> <p>Moderate, very firm, peds 20-40 mm</p> <p>10YR2/1</p>

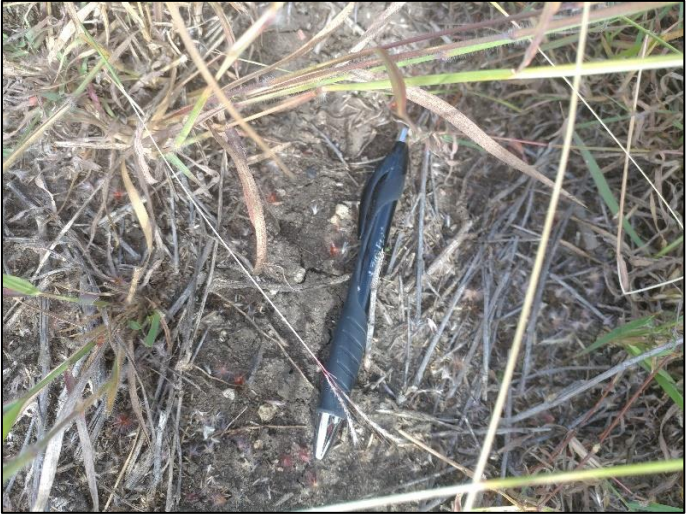
Site No.	Location - mE, mN (GDA94 Zone 56)	Map Unit	Comments	Pictures
NC-16	642934 7514283	1	<p>Gently undulating plain, mid slope &lt;2%</p> <p>Limited disturbance</p> <p>Surface – cracking 2-6 mm, light clay, no coarse fragments</p> <p>0.00 – 0.11 m</p> <p>Clay loam</p> <p>Moderate, firm, peds &lt;20 mm</p> <p>10YR3/2</p> <p>0.11 – 0.45+ m</p> <p>Medium clay</p> <p>Moderate, very firm, peds 20-40 mm</p> <p>10YR2/1</p>

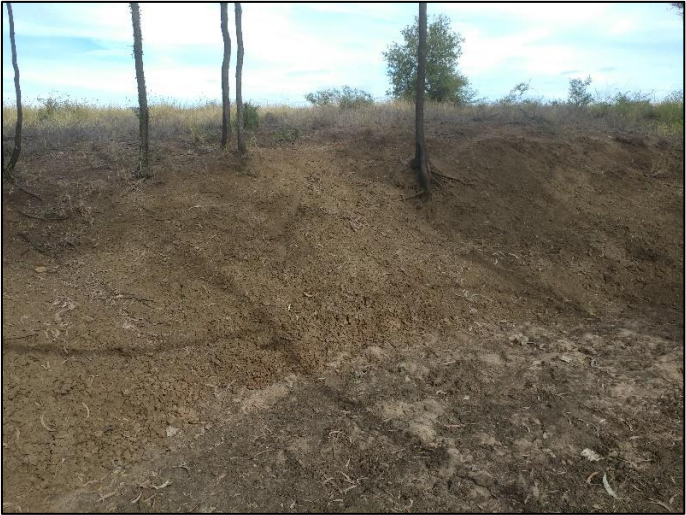
Site No.	Location - mE, mN (GDA94 Zone 56)	Map Unit	Comments	Pictures
NC-17	643327 7514558	2	Gully erosion, drainage line  0-0.30 m sandy loam 0.30-1.00 m + Sandy clay loam

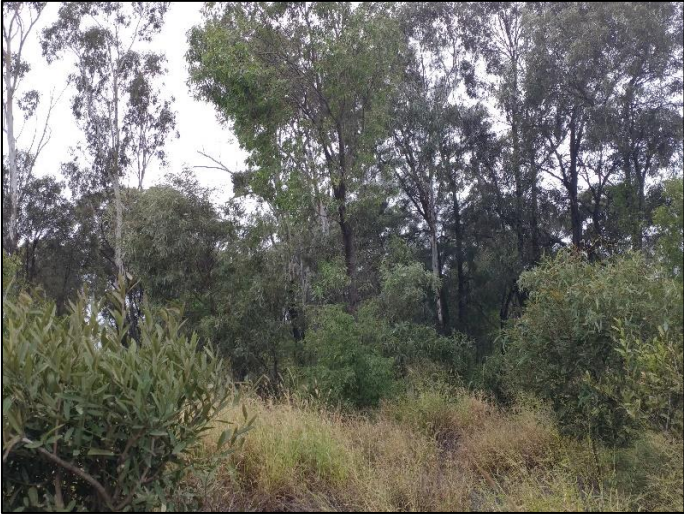
Site No.	Location - mE, mN (GDA94 Zone 56)	Map Unit	Comments	Pictures
NC-18	643487 7514650	2	Gully erosion, drainage line Gums Surface non-cracking

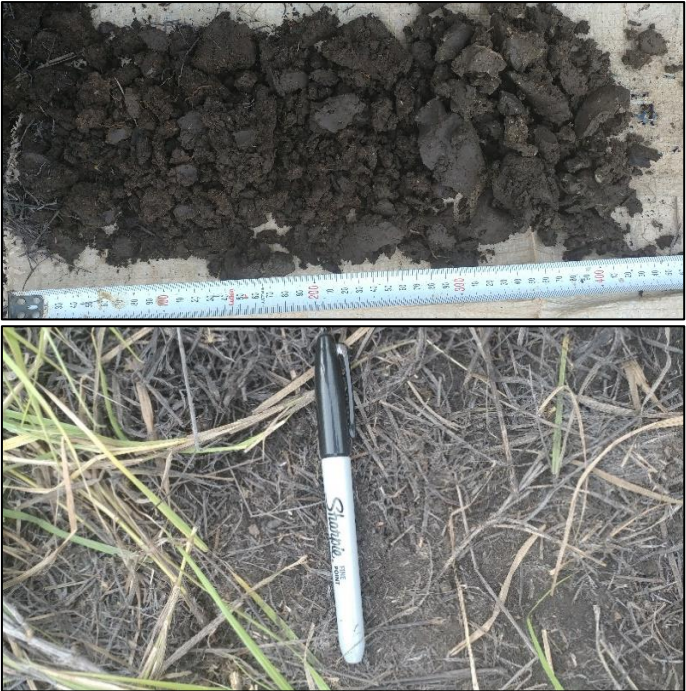
NC-19	644123 7514610	1	<p>Gently undulating plain, upper slope 1%, 2% Limited disturbance, Surface – cracking &lt;2 mm, and self mulching, light clay, no coarse fragments</p> <p>0.00 – 0.11 m Clay loam Moderate, firm, peds &lt;10 mm 10YR3/2</p> <p>0.11 – 0.30 m Medium clay Moderate, subangular blocky, peds &lt;20 mm 10YR2/1</p> <p>0.30 – 0.40+ m Medium clay with &lt;2% calcium carbonate Moderate, subangular blocky, peds &lt;20 mm 10YR2/1</p>

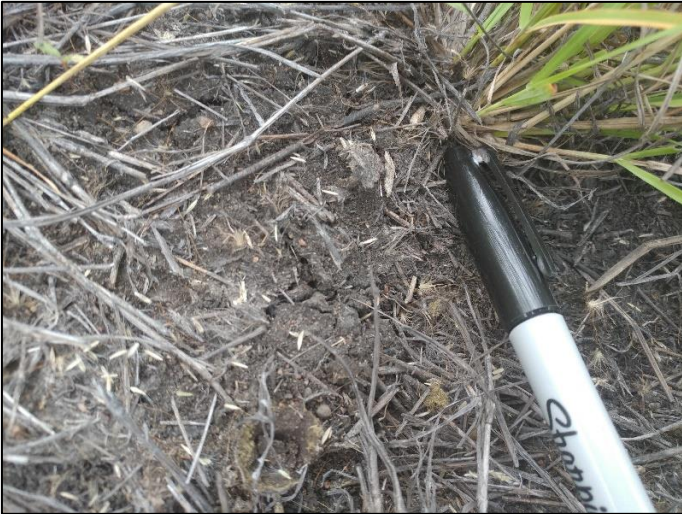
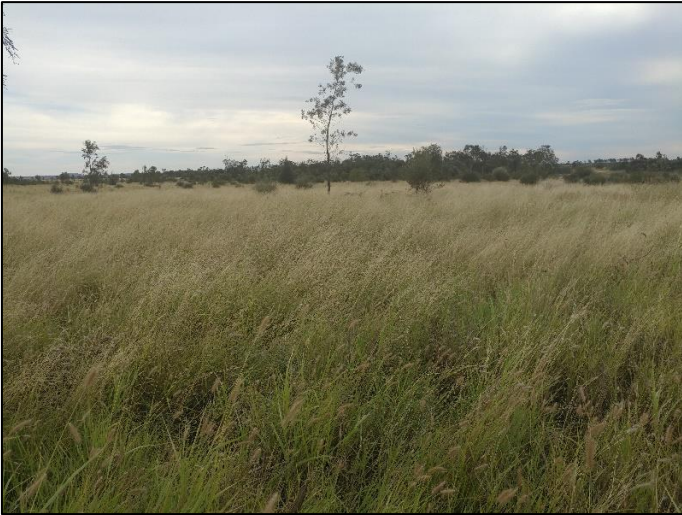
Site No.	Location - mE, mN (GDA94 Zone 56)	Map Unit	Comments	Pictures
NC-20	643734 7514870	2	Gently undulating plain, lower slope 1%, 2% Limited disturbance, Surface – cracking <2 mm, and self mulching, clay loam, no coarse fragments Brigalow, Belah

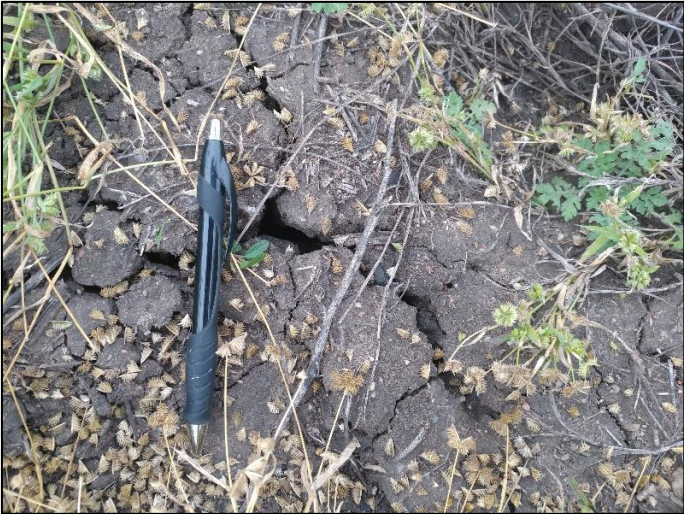
Site No.	Location - mE, mN (GDA94 Zone 56)	Map Unit	Comments	Pictures
NC-21	643283 7514051	3	Gently undulating plain, upper slope 1%, 2% Brigalow, Belah Limited disturbance, Surface – cracking 2-8 mm, and self mulching, sandy clay loam, no coarse fragments

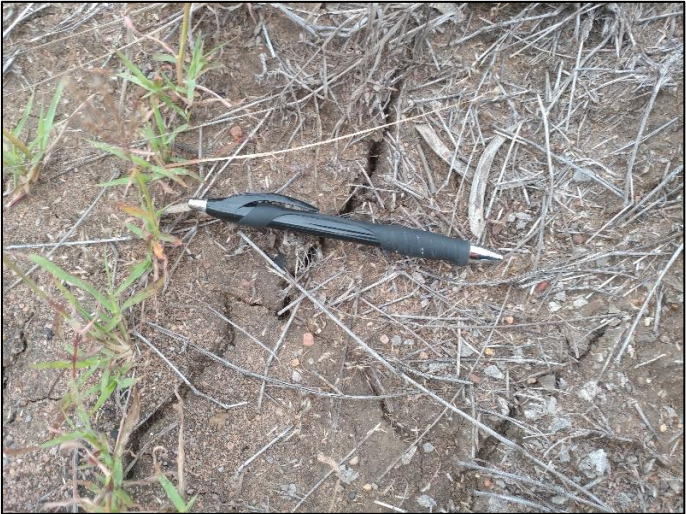
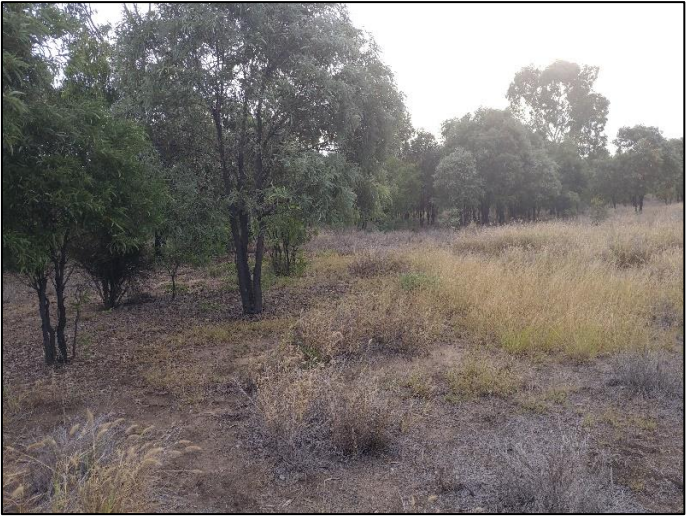
Site No.	Location - mE, mN (GDA94 Zone 56)	Map Unit	Comments	Pictures
NC-22	642804 7514097	4	Gently undulating plain, lower slope 1%, 2% Wide depression, inactive drainage line Brigalow, Belah Surface – cracking 2-8 mm, and self mulching, sandy clay loam <2% coarse fragments <2 mm

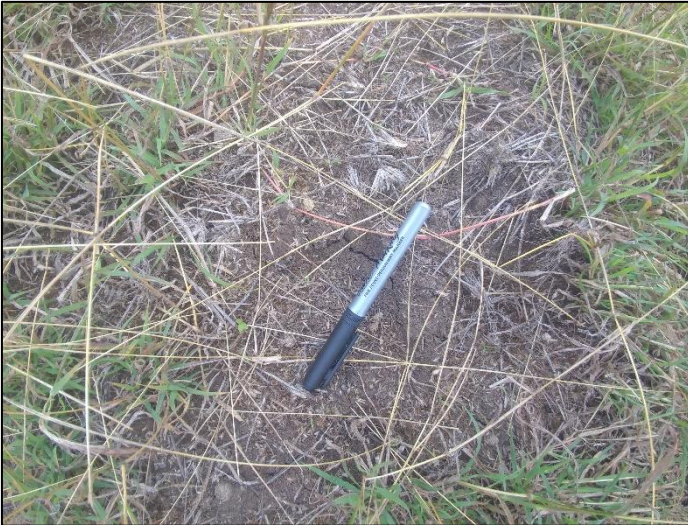
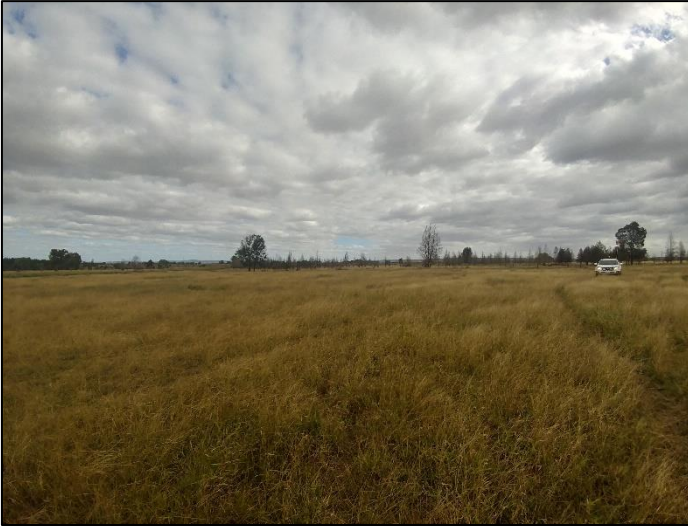
Site No.	Location - mE, mN (GDA94 Zone 56)	Map Unit	Comments	Pictures
NC-25	642541 7512279	9	Gently undulating plain, flat plain Surface light clay, self mulching, no coarse fragments Cropping nearby

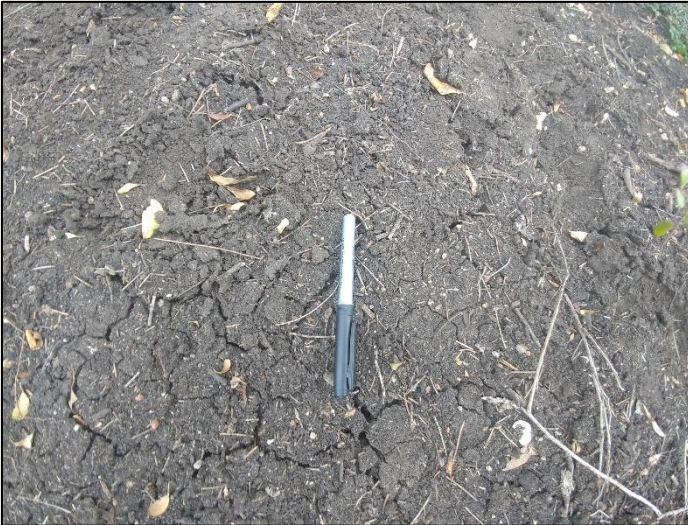
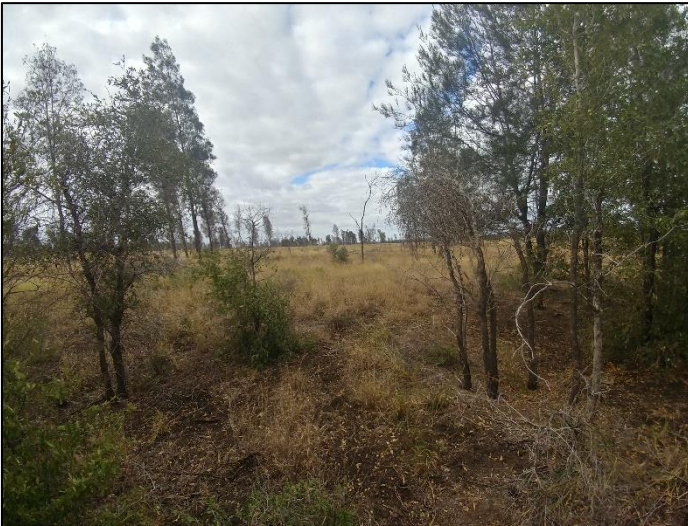
Site No.	Location - mE, mN (GDA94 Zone 56)	Map Unit	Comments	Pictures
NC-26	643047 7512703	9	Gently undulating plain, lower slope 1%, Surface light clay, cracking 2-6 mm, self mulching, no coarse fragments Cropping nearby

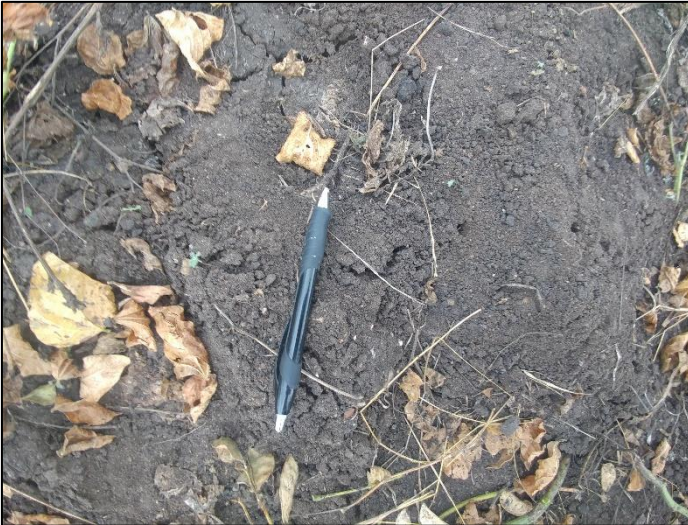
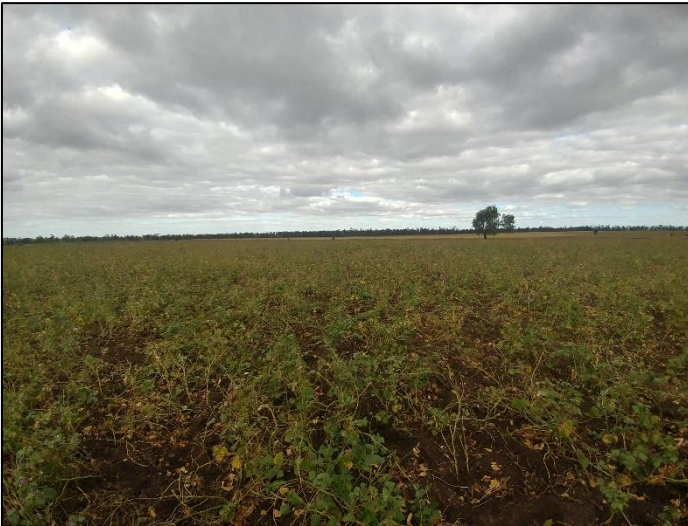
Site No.	Location - mE, mN (GDA94 Zone 56)	Map Unit	Comments	Pictures
NC-28	643790 7513018	9	Gently undulating plain, lower slope 1%, Surface light clay, cracking 2-6 mm, self mulching, no coarse fragments Cropping nearby

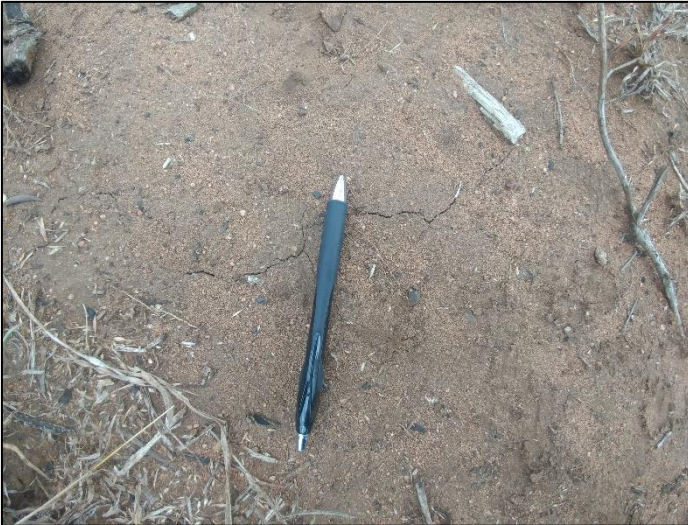
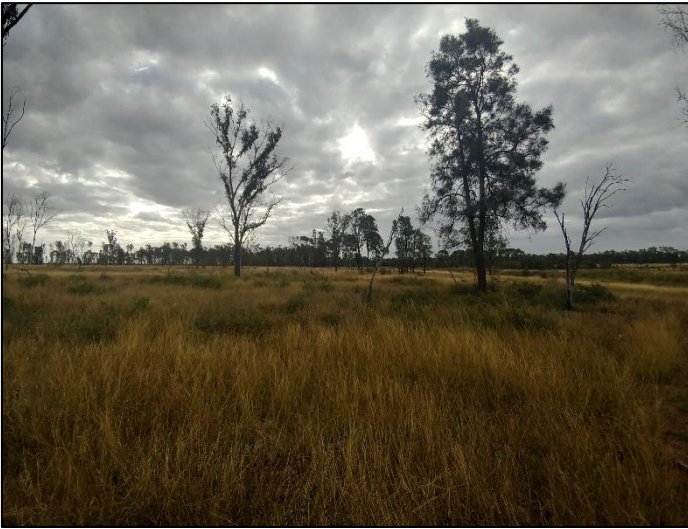
Site No.	Location - mE, mN (GDA94 Zone 56)	Map Unit	Comments	Pictures
NC-29	643707 7513294	10	Gently undulating plain, upper slope 2%, 2% Surface sandy clay loam, minor cracking 2 mm, no coarse fragments

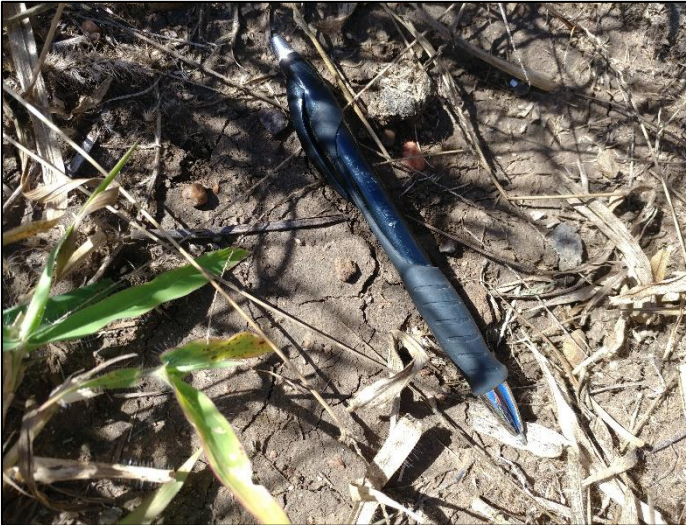
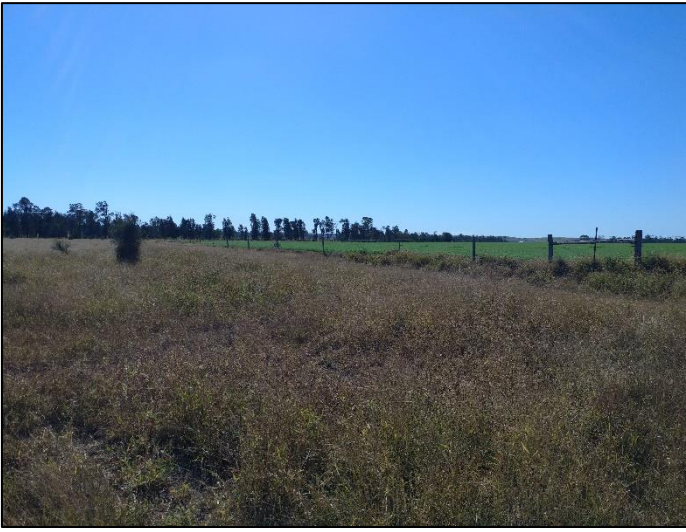
Site No.	Location - mE, mN (GDA94 Zone 56)	Map Unit	Comments	Pictures
NC-31	643165 7511509	6	Gently undulating plain, lower slope 1% Surface light clay, minor cracking 2 mm, some crusting, no coarse fragments Limited disturbance

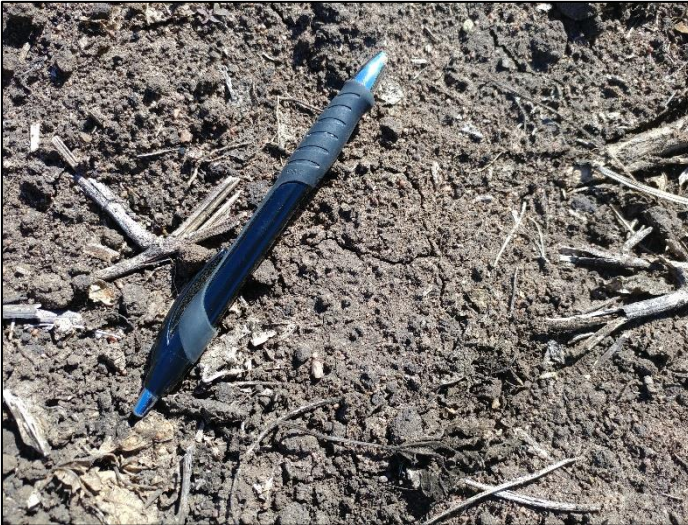
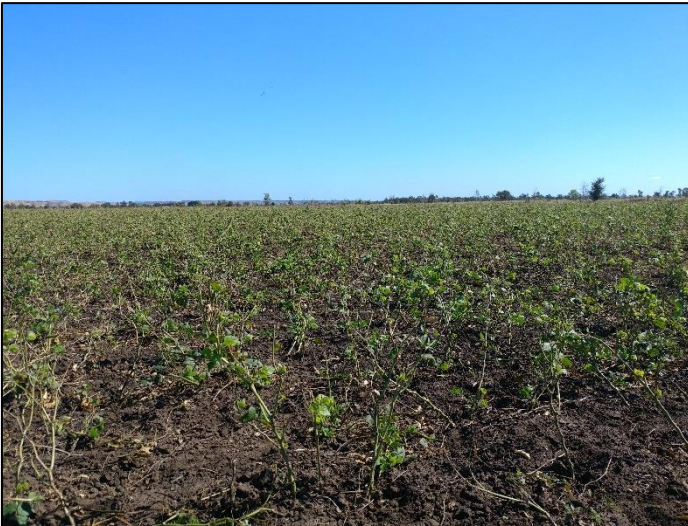
Site No.	Location - mE, mN (GDA94 Zone 56)	Map Unit	Comments	Pictures
NC-32	643661 7511295	6	Gently undulating plain, mid slope 1%, 1% Surface, soft, sandy clay loam, minor cracking 2 mm, no coarse fragments Forage cropping disturbance

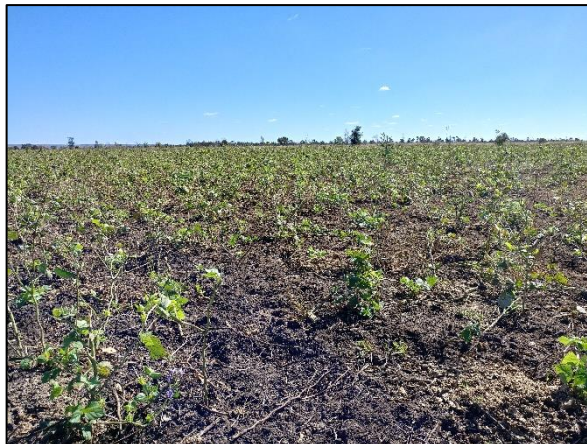
Site No.	Location - mE, mN (GDA94 Zone 56)	Map Unit	Comments	Pictures
NC-33	643394 7510738	6	<p>Gently undulating plain, upper slope 1%, 1%</p> <p>Surface, soft, minor cracking 2 mm, no coarse fragments</p> <p>Forage cropping disturbance</p> <p>0.00 – 0.09 m Sandy loam, massive, weak, peds &lt;100mm 10YR3/2</p> <p>0.09 – 0.30+ m Sandy clay loam, peds &lt;200mm 10YR3/2</p>

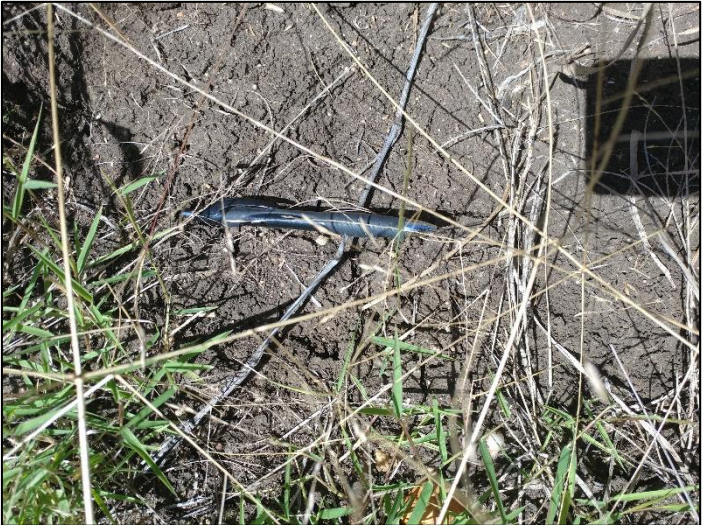
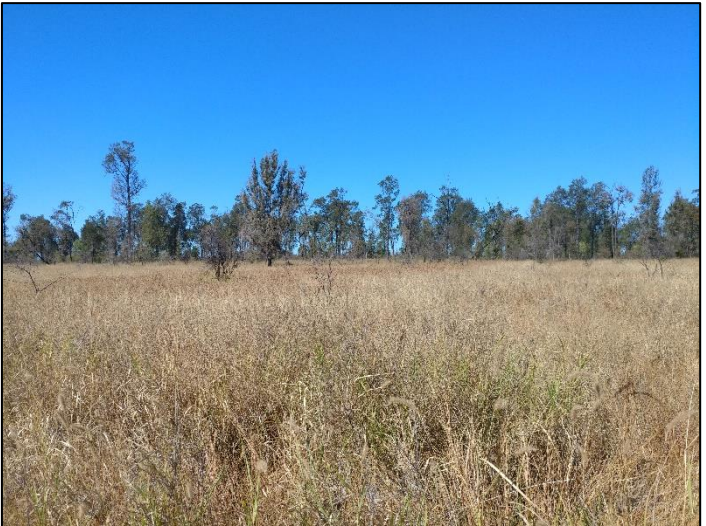
Site No.	Location - mE, mN (GDA94 Zone 56)	Map Unit	Comments	Pictures
NC-34	644122 7512307	12	Gently undulating plain, flat plain Surface light clay 10YR3/2, cracking 2 mm, no coarse fragments Limited disturbance

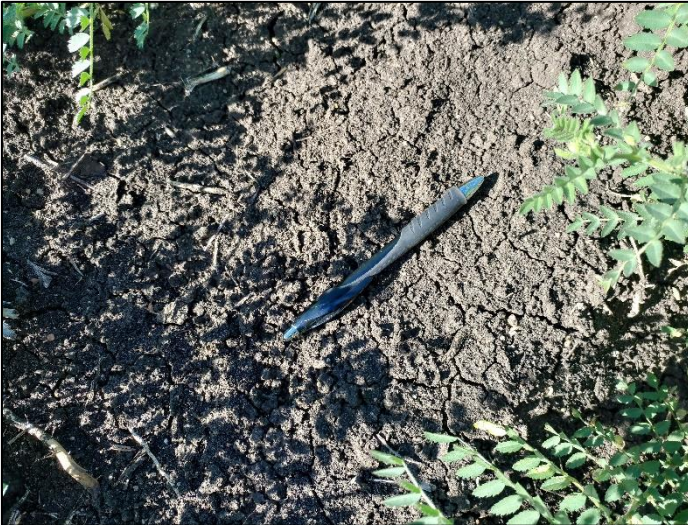
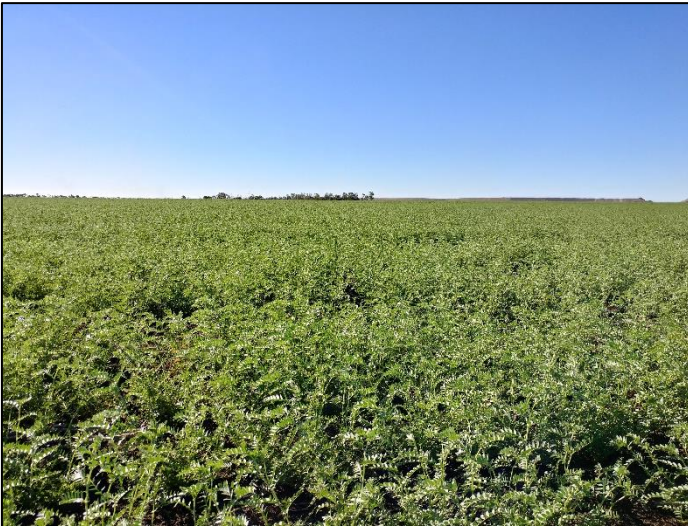
Site No.	Location - mE, mN (GDA94 Zone 56)	Map Unit	Comments	Pictures
NC-35	644475 7511295	12	Gently undulating plain, mid slope 1%, 1% Surface light clay 10YR3/2, cracking 2-6 mm, no coarse fragments Cropping disturbance

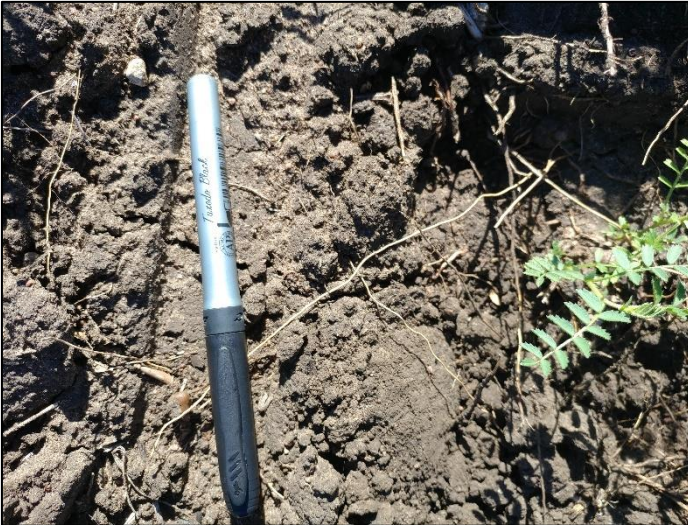
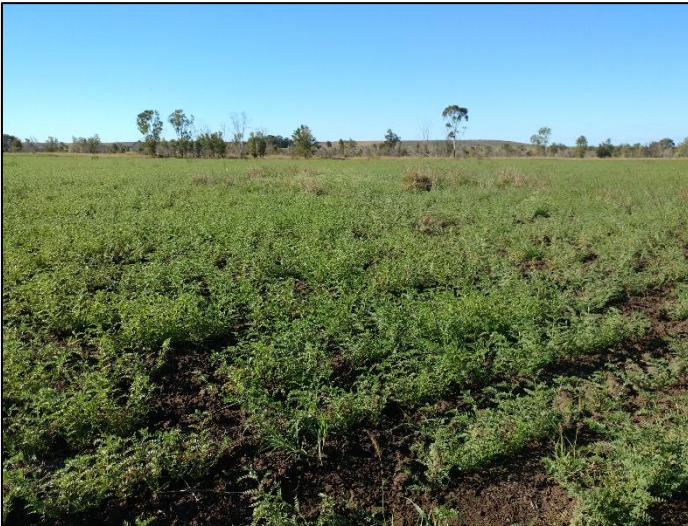
Site No.	Location - mE, mN (GDA94 Zone 56)	Map Unit	Comments	Pictures
NC-36	645158 7511201	12	Gently undulating plain, mid slope 1%, 1% Surface light clay 10YR3/2, cracking <2 mm, self mulching, no coarse fragments Cropping disturbance

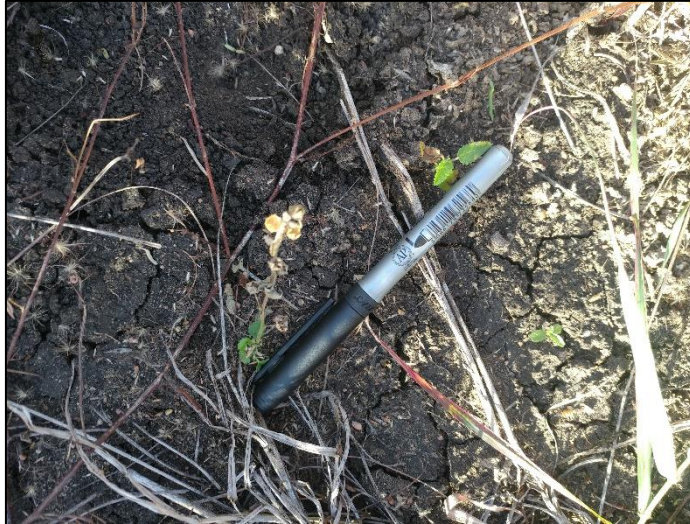
Site No.	Location - mE, mN (GDA94 Zone 56)	Map Unit	Comments	Pictures
NC-38	645563 7511106	12	Gently undulating plain, upper slope 2%, 2% Surface light clay 10YR3/2, cracking 2-6 mm, no coarse fragments

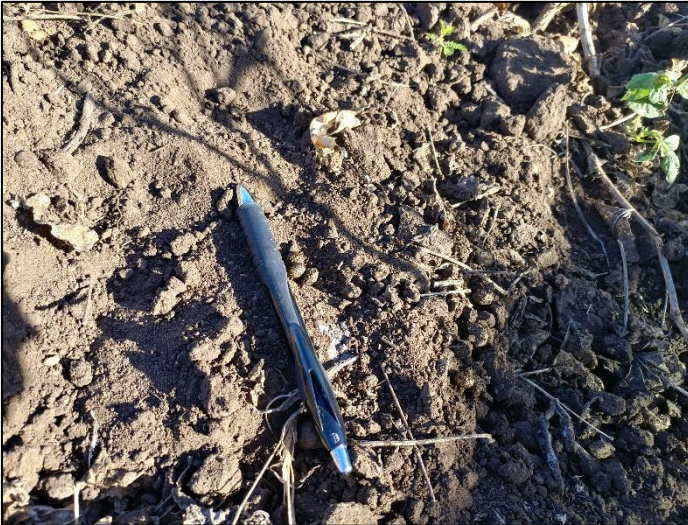
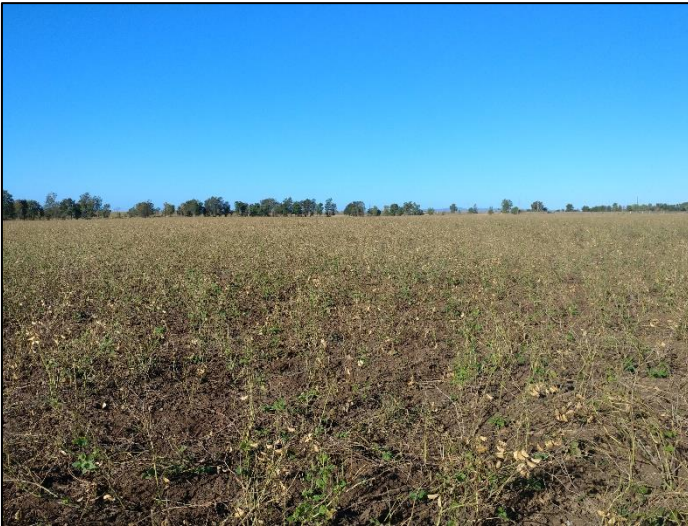
Site No.	Location - mE, mN (GDA94 Zone 56)	Map Unit	Comments	Pictures
NC-39	642769 7511490	6	Gently undulating plain, mid slope 2%, 2% Surface light clay 10YR3/2, self mulching, no coarse fragments Forage cropping disturbance

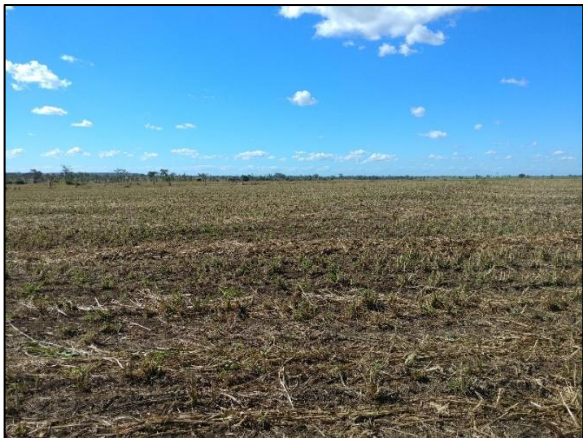
Site No.	Location - mE, mN (GDA94 Zone 56)	Map Unit	Comments	Pictures
NC-42	643510 7508834	17	<p>Gently undulating plain, upper slope 1%, 1%</p> <p>Surface cracking &lt;2 mm, self mulching, no coarse fragments</p> <p>Cropping disturbance</p> <p>0.00 – 0.10 m Light clay, 10YR3/2</p> <p>0.10 – 0.35 m Medium clay, 10YR3/2</p> <p>0.35 – 0.50+ m Medium clay, 10YR4/2</p>

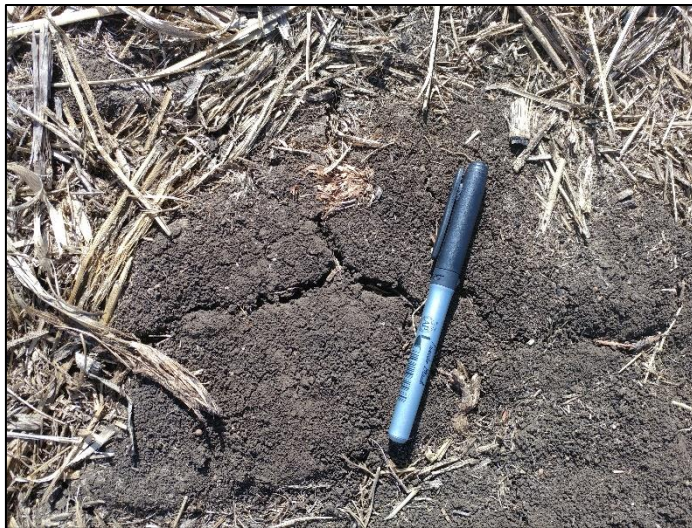
Site No.	Location - mE, mN (GDA94 Zone 56)	Map Unit	Comments	Pictures
NC-43	644026 7507963	17	<p>Gently undulating plain, lower slope 2%, 2% Surface cracking 2-6 mm, no coarse fragments Cropping disturbance</p> <p>0.00 – 0.07 m Light clay, 10YR3/2 Weak, peds &lt;10 mm</p> <p>0.07 – 0.50 + m Medium clay, 10YR3/2 Moderate, subangular blocky, peds &lt;30 mm very firm</p>

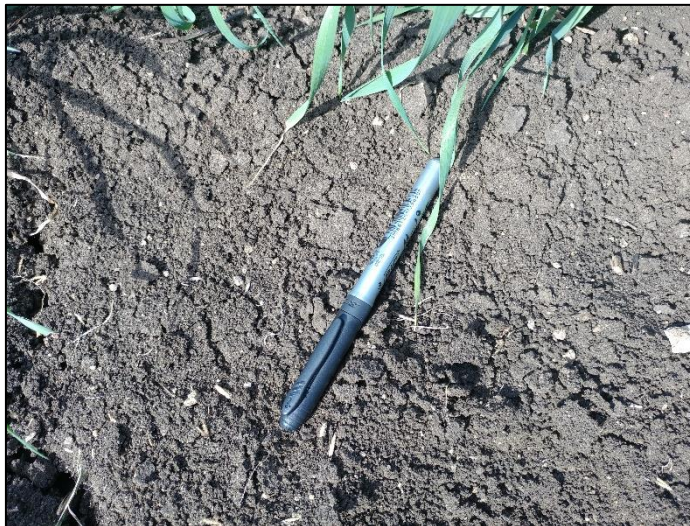
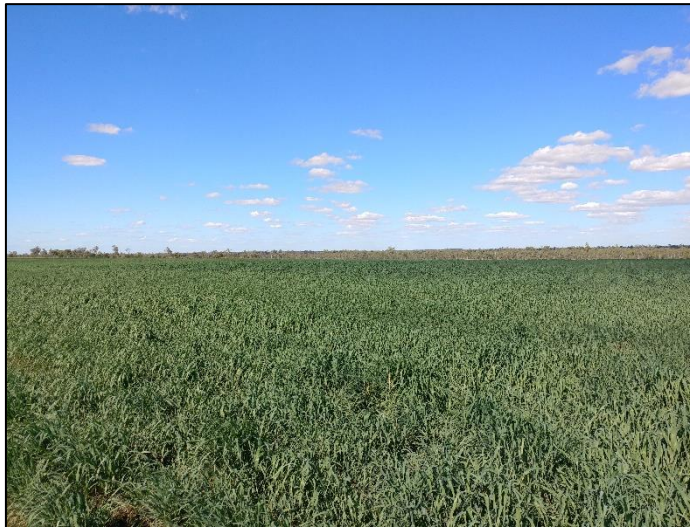
Site No.	Location - mE, mN (GDA94 Zone 56)	Map Unit	Comments	Pictures
NC-44	645697 7508528	17	Gently undulating plain, mid slope <2%, 1% Surface light clay 10YR3/2, cracking <2 mm, self mulching, <2% coarse fragments Cropping disturbance

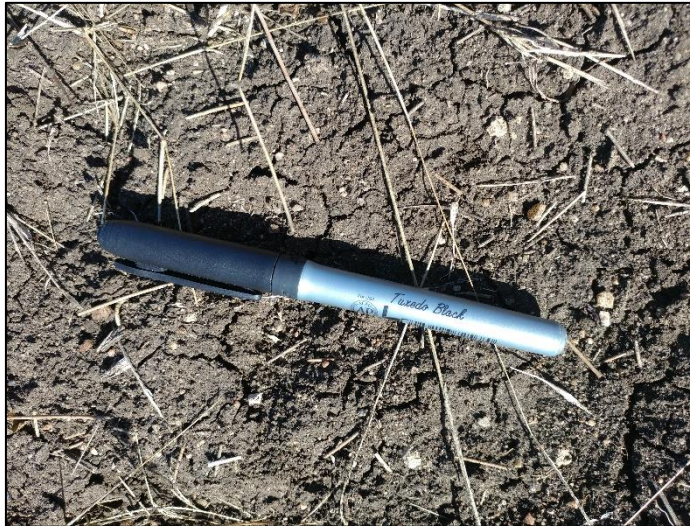
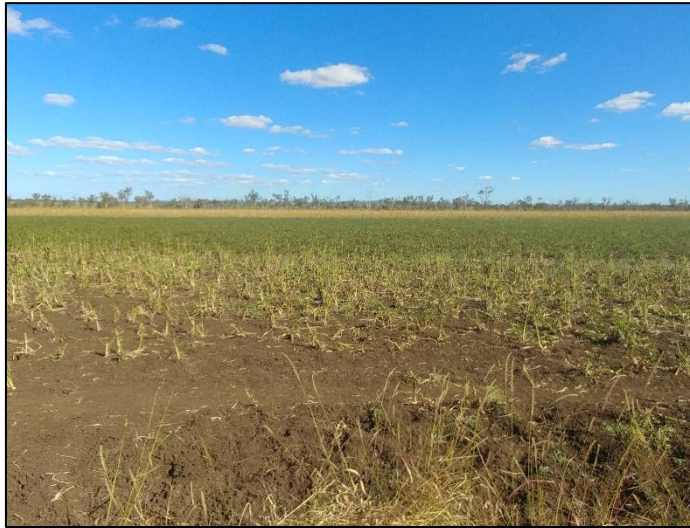
Site No.	Location - mE, mN (GDA94 Zone 56)	Map Unit	Comments	Pictures
NC-45	644367 7509819	17	Gently undulating plain, mid slope 1%, 1% Surface light clay 10YR3/2, cracking <2 mm, self mulching, <2% coarse fragments Cropping disturbance

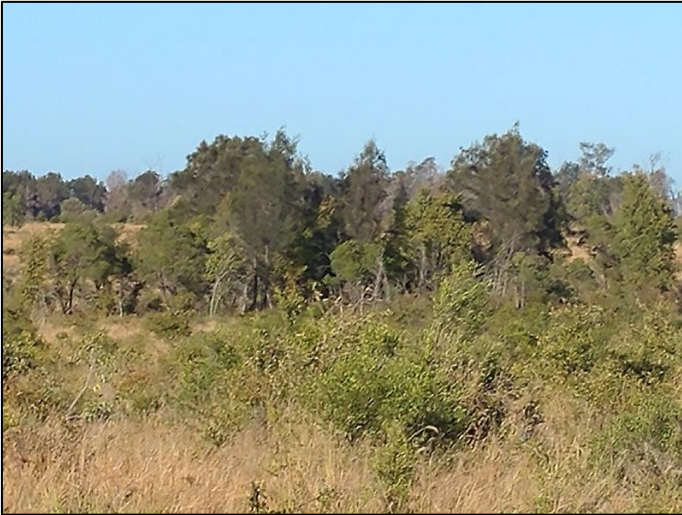
Site No.	Location - mE, mN (GDA94 Zone 56)	Map Unit	Comments	Pictures
NC-46	644024 7510908	15	Gently undulating plain, lower slope 2%, 1% Surface light clay 10YR3/2, cracking 2-6 mm, No coarse fragments

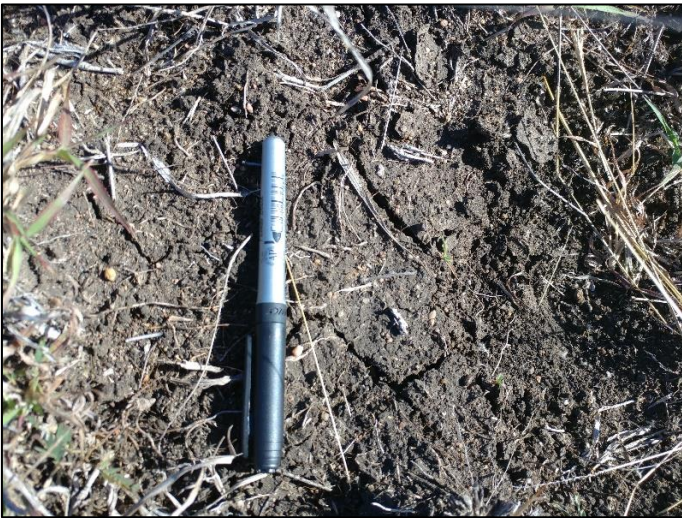
NC-47	640942 7512659	8	Gently undulating plain, mid slope 1%, 1% Surface light clay 10YR3/2, cracking 2-6 mm, no coarse fragments

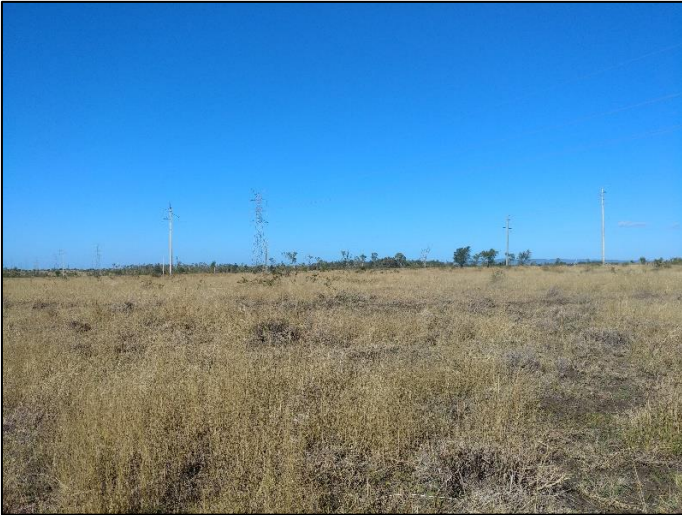
Site No.	Location - mE, mN (GDA94 Zone 56)	Map Unit	Comments	Pictures
NC-48	640883 7512861	8	Gently undulating plain, mid slope 1%, 1% Surface light clay 10YR3/2, cracking 2-6 mm, no coarse fragments

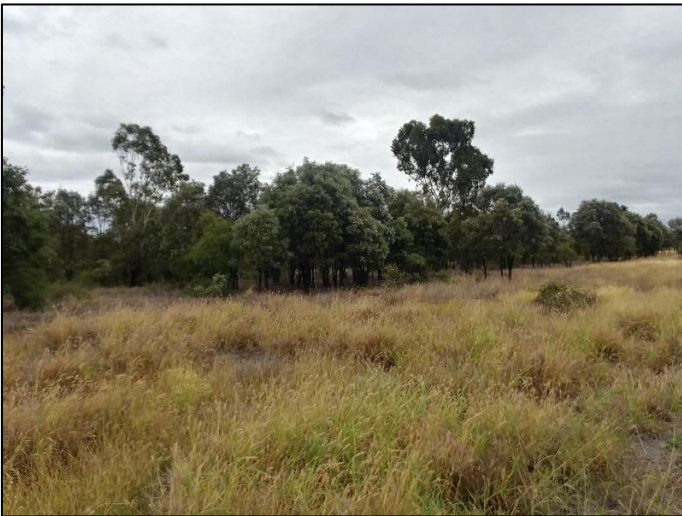
NC-49	642978 7511443	11	Wide depression, drainage line, lower slope 2%, 1% Surface sandy light clay, cracking 2-6 mm, No coarse fragments Sheet erosion
