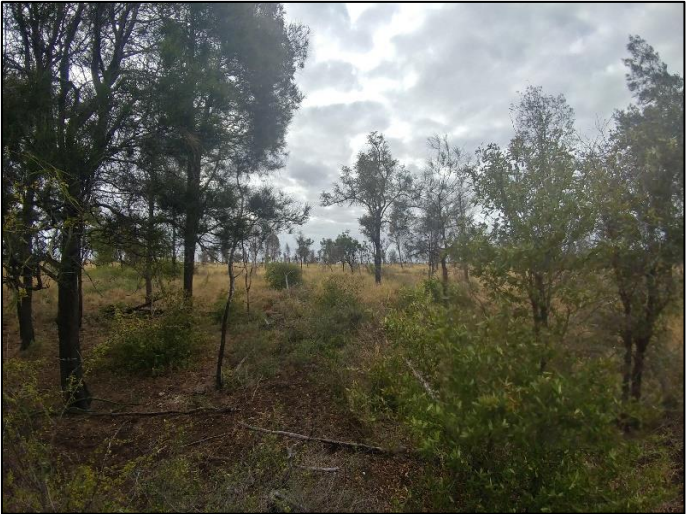
Site No.	Location - mE, mN (GDA94 Zone 56)	Map Unit	Comments	Pictures
NC-50	643674 7513508	4	Wide depression, drainage line, lower slope 2% Surface sandy light clay, cracking 2-6 mm, No coarse fragments Sheet erosion

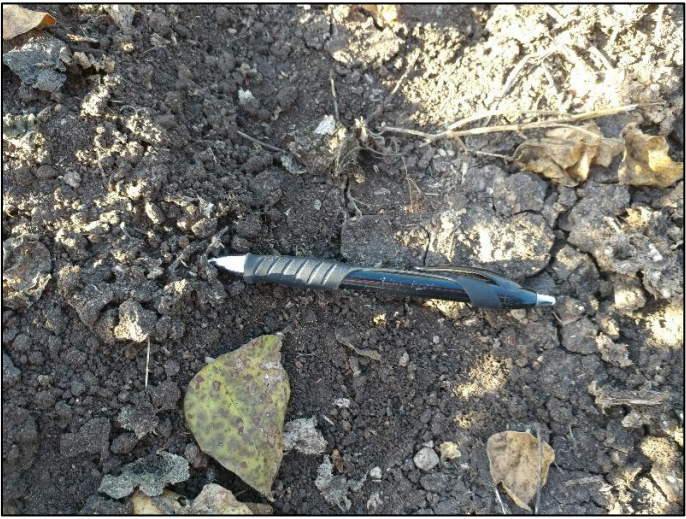
NC-51	644005 7512609	9	Gently undulating plain, lower slope 2%, 2% Surface light clay, cracking 2-6 mm, self mulching, no coarse fragments Cropping disturbance

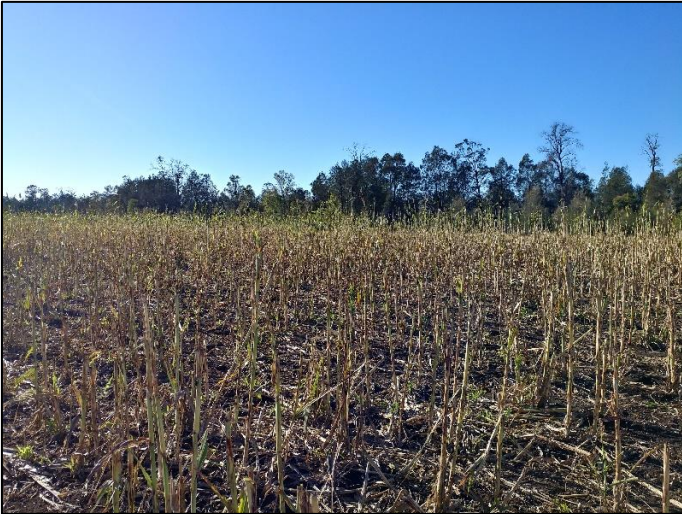
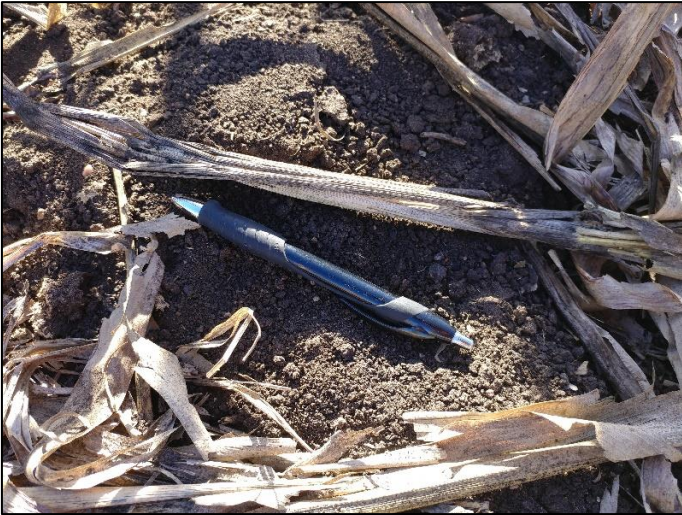
Site No.	Location - mE, mN (GDA94 Zone 56)	Map Unit	Comments	Pictures
NC-52	643635 7512290	9	Gently undulating plain, lower slope 2%, 2% Surface light clay, self mulching, no coarse fragments Cropping disturbance

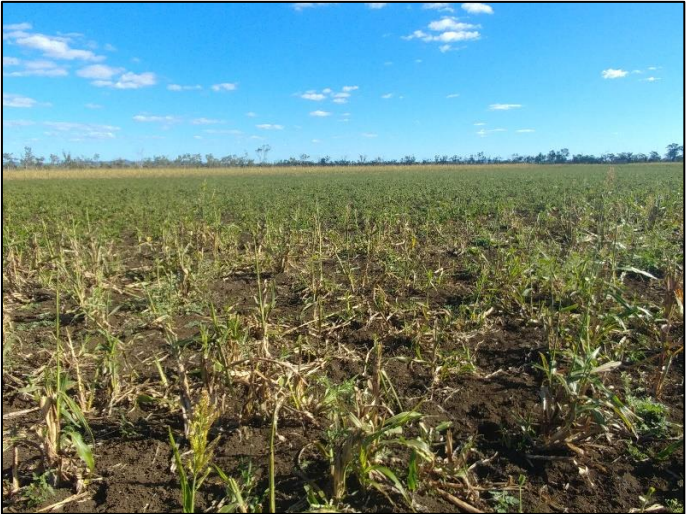
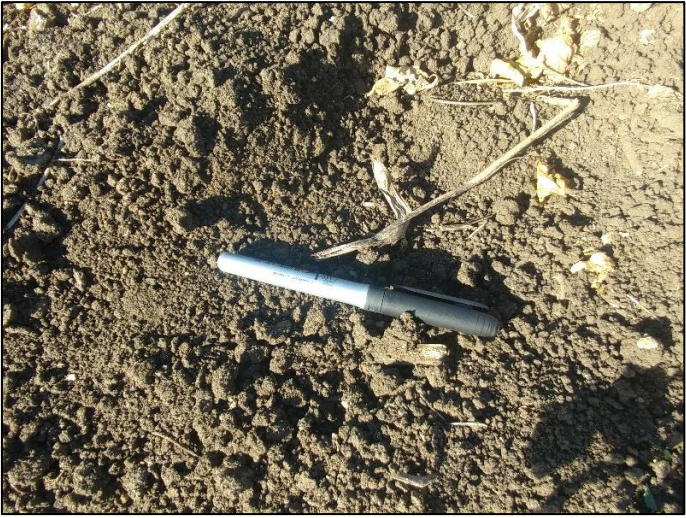
Site No.	Location - mE, mN (GDA94 Zone 56)	Map Unit	Comments	Pictures
NC-54	645704 7510053	17	Gently undulating plain, upper slope 1%, 1% Surface light clay, self mulching, no coarse fragments Cropping disturbance

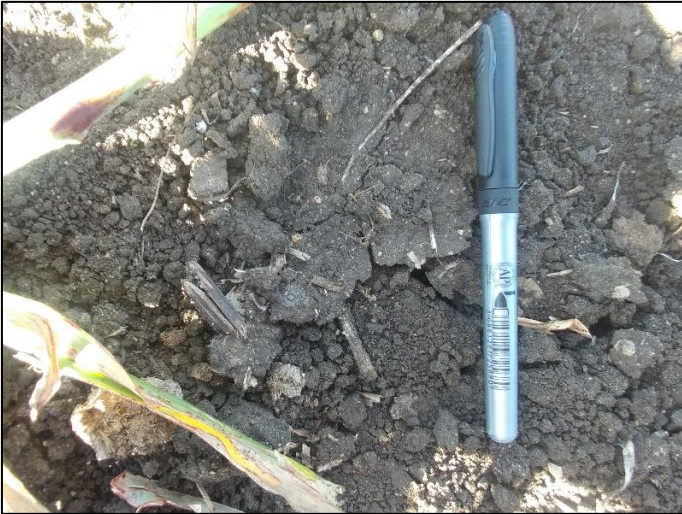
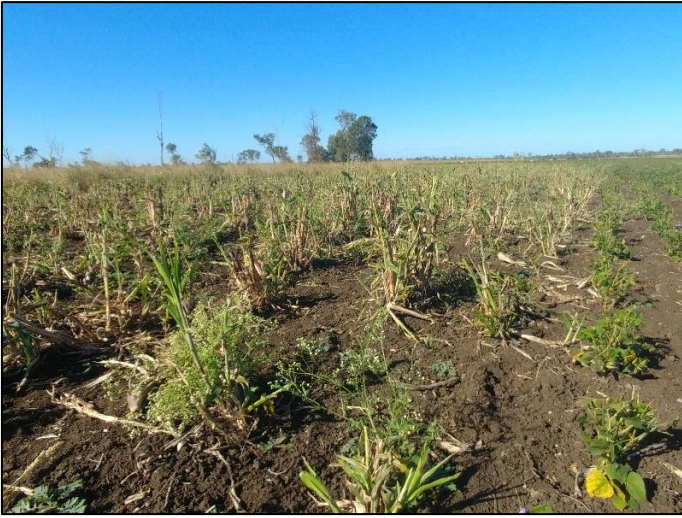
Site No.	Location - mE, mN (GDA94 Zone 56)	Map Unit	Comments	Pictures
NC-55	645506 7509704	17	Gently undulating plain, upper slope 1%, 1% Surface light clay, self mulching, Some cracking 2-6 mm, No coarse fragments, Cropping disturbance

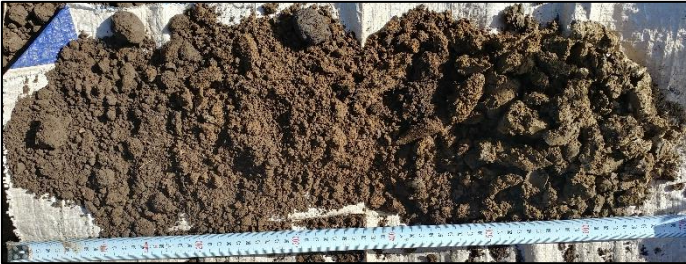
Site No.	Location - mE, mN (GDA94 Zone 56)	Map Unit	Comments	Pictures
NC-56	643093 7510114	14	<p>Gently undulating plain, mid slope 1%</p> <p>Surface - firm, sandy loam, 10YR3/3, no coarse fragments</p> <p>0.00 – 0.10 m Sandy loam 10YR3/3</p> <p>0.10 – 0.42 m Sandy clay loam 5YR4/3</p> <p>0.42 – 0.65 + m Sandy clay loam 7.5Y4/4 &lt;5% calcium carbonate</p>

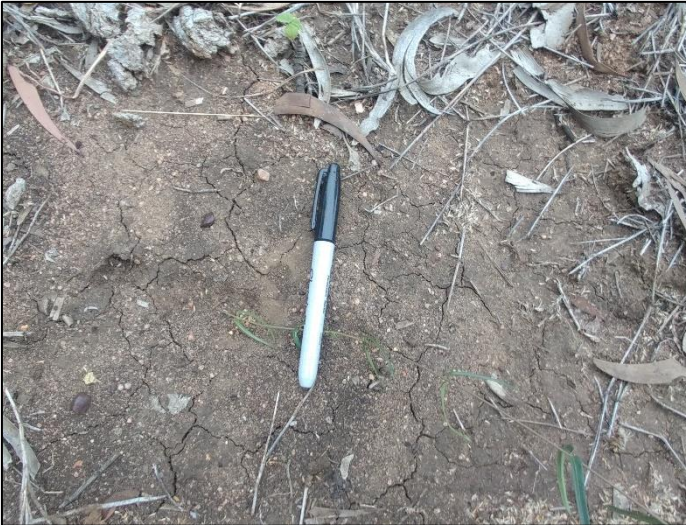
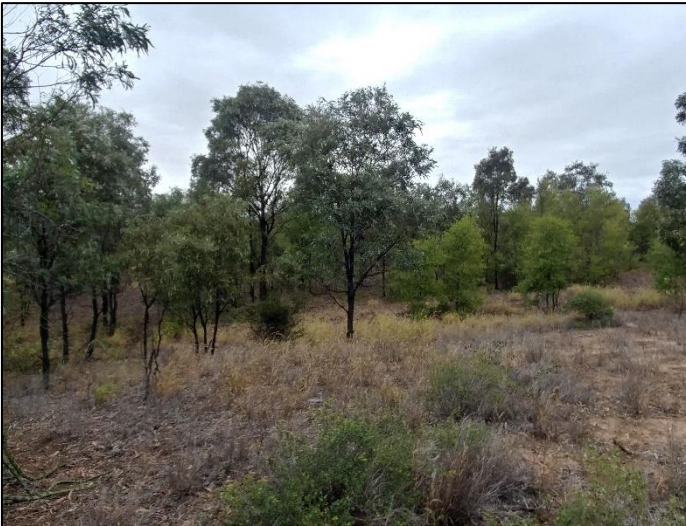
Site No.	Location - mE, mN (GDA94 Zone 56)	Map Unit	Comments	Pictures
NC-57	642985 7513858	4	Gently undulating plain, lower slope 1%, 2% Wide depression, inactive drainage line Brigalow, Belah Surface – firm, cracking 2 mm, sandy clay loam <2% coarse fragments <2 mm

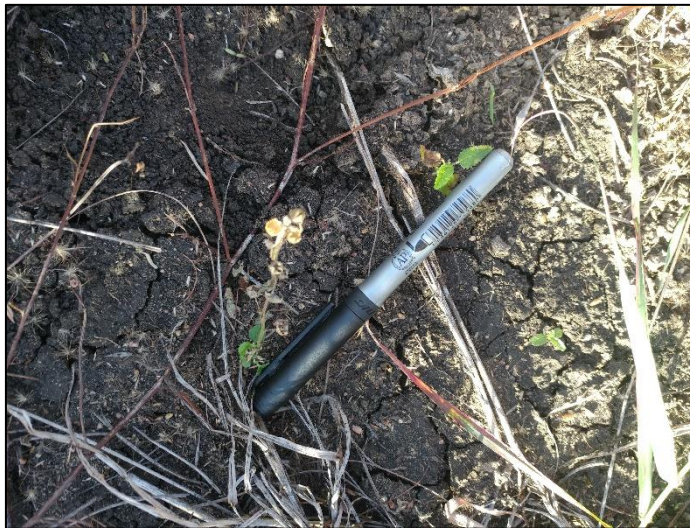
Site No.	Location - mE, mN (GDA94 Zone 56)	Map Unit	Comments	Pictures
NC-58	644239 7511127	15	Gently undulating plain, mid slope 2%, 1% Surface light clay 10YR3/2, cracking 2-6 mm, No coarse fragments

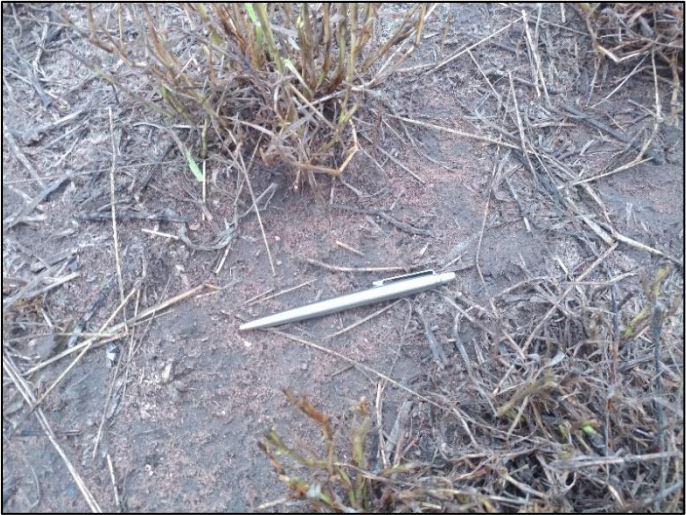
Site No.	Location - mE, mN (GDA94 Zone 56)	Map Unit	Comments	Pictures
NC-60	641787 7514024	5	Same as sites N4 and N5, mid slope 2.0%, no erosion or microrelief, soft surface with no coarse fragments. Surface texture black sandy loam.

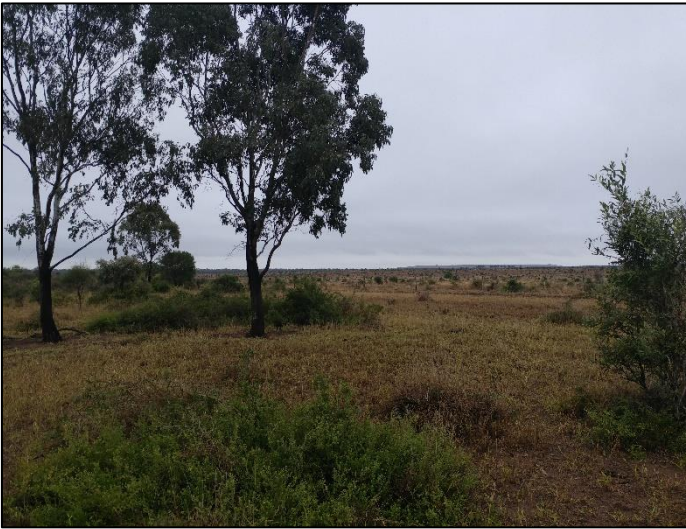
NC-61	641691 7514197	5	Same as sites N4 and N5, mid slope 2.0%, no erosion or microrelief, soft surface with no coarse fragments. Surface texture black sandy loam.

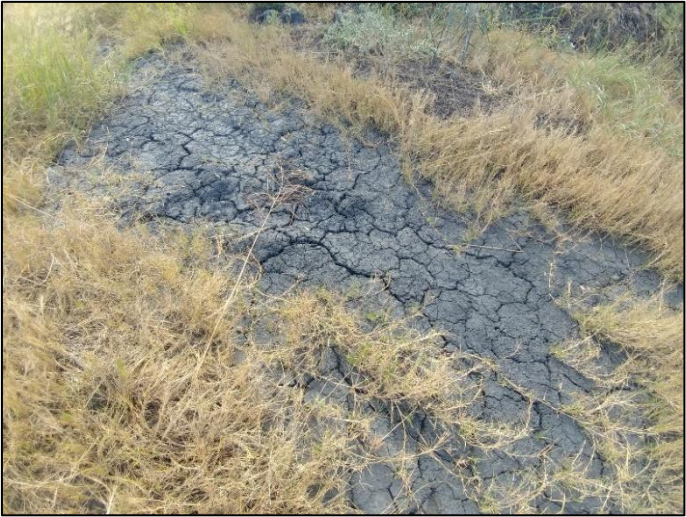
Site No.	Location - mE, mN (GDA94 Zone 56)	Map Unit	Comments	Pictures
NC-62	641100 7512707	7	Wide depression, surface hard setting with cracking 2-6mm. Surface texture light clay.
