SITE N1

Map Unit 7	Location (GDA94 ZONE 55): 641005 mE 7512573 mN	Aust. Soil Class.: Crusting Grey (minor black) Vertosol	Site Survey Type: Detailed - 50mm hand auger	Survey Date: 30/06/2018
----------------------	--	---	--	-----------------------------------

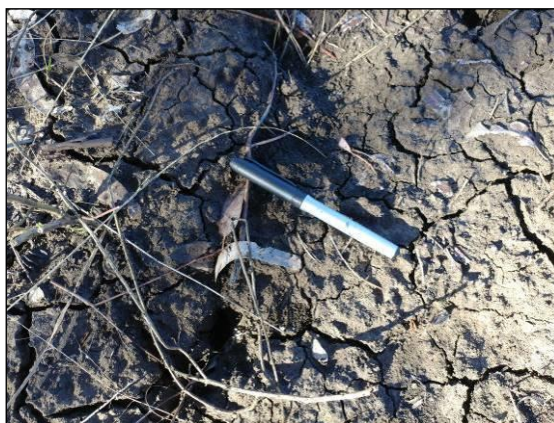
Land use Landform Pattern, Element, Slope	Vegetation	Microrelief Disturbance Erosion	Surface condition, surface rock	Soil Profile Description									
				Horizon Depth (m), Boundary	Field Texture	Structure, Strength	Inclusions Segregations	Colour, Mottle, Bleaching	Moisture, Drainage	Roots	Depth (m) / Field pH	Sample (m)	Observations
Grazing Gently undulating plains, Open depression 2.0/1.0	Mount coolabah, semi-cleared	Nil microrelief Semi-cleared Nil erosion	Cracking 2- 6mm, crust Nil coarse fragments	A11 0.00-0.02 Abrupt	Light clay	Moderate, firm<10mm sub- angular	Nil inclusions and segregations	10YR3/1 Very dark grey Nil mottles/bleach	Moderately moist, moderate	Few fine	0.02 / 6.5	0.00-0.10 0.20-0.30 0.50-0.60 0.80-0.90 0.90-1.00	Nil additional observations
				A12 0.02-0.10 Abrupt	Light clay	Moderate, firm10- 30mm sub- angular	<1% calcium carbonate	10YR2/2 Very dark brown Nil mottles/bleach	Dry, moderate	Few fine	0.10 / 6.5

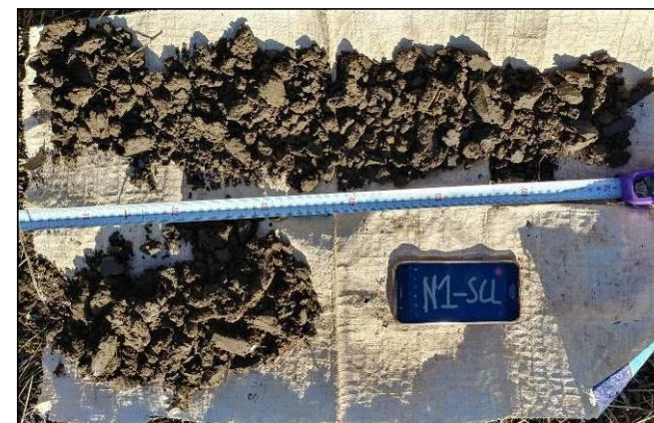
Soil Profile

B21 0.10-0.70 Abrupt	Medium clay	Moderate, firm10- 30mm sub- angular	2% calcium carbonate nodules	10YR2/2 Very dark brown Nil mottles/bleach	Dry, moderate	Very fine, very few	0.30 / 7.0 0.60 / 7.5		
				B22 0.70-1.00 EOBH	Medium clay	Moderate, firm10- 30mm sub- angular	2% calcium carbonate nodules	10YR4/2 Dark greyish brown Nil mottles/bleach	Dry, moderate	Very fine, very few	0.90 / 7.5

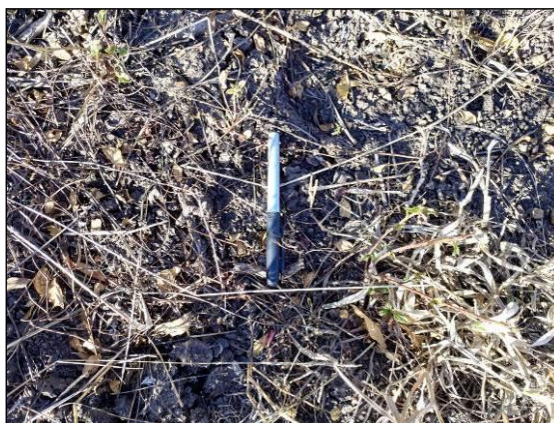
Land use Landform Pattern, Element, Slope	Vegetation	Microrelief Disturbance Erosion	Surface condition, surface rock	Soil Profile Description									
				Horizon Depth (m), Boundary	Field Texture	Structure, Strength	Inclusions Segregations	Colour, Mottle, Bleaching	Moisture, Drainage	Roots	Depth (m) / Field pH	Sample (m)	Observations
Grazing Very gently undulating plain 2.0/1.0	Various shrubs	Nil microrelief Nil to semi disturbance Nil erosion	Cracking 2- 6mm, crust Nil coarse fragments	A1 0.00-0.14 Abrupt	Light clay	Moderate, soft <10mm sub- angular	Nil inclusions and segregations	10YR3/1 Very dark grey Nil mottles/bleach	Moderate moist, moderate	Few fine	0.10 / 6.0	0.00-0.10 0.20-0.30 0.50-0.60 0.80-0.90 0.90-1.00	Nil additional observations
				B2 0.14-1.00 EOBH	Medium clay	Moderate, firm <10mm sub- angular	<2% black nodules	10YR4/2 Dark greyish brown Nil mottles/bleach	Dry, moderate	Very fine, very few	0.30 / 6.5 0.60 / 7.0 0.90 / 7.5

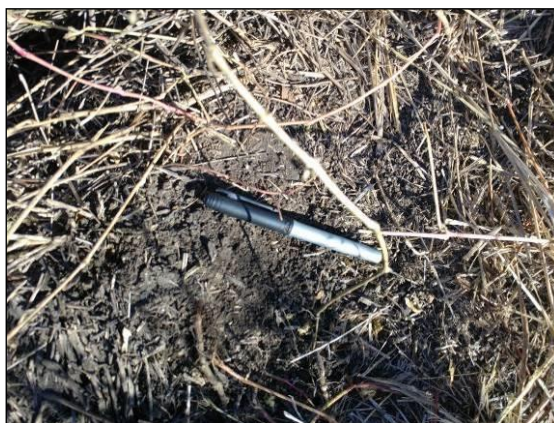
Land use Landform Pattern, Element, Slope	Vegetation	Microrelief Disturbance Erosion	Surface condition, surface rock	Soil Profile Description									
				Horizon Depth (m), Boundary	Field Texture	Structure, Strength	Inclusions Segregations	Colour, Mottle, Bleaching	Moisture, Drainage	Roots	Depth (m) / Field pH	Sample (m)	Observations
Grazing Very gently undulating plain 2.0/1.0	Various shrubs	Nil microrelief Nil disturbance Nil erosion	Crusting with cracking 2- 6mm, Nil coarse fragments	A1 0.00-0.16 Abrupt	Light clay	Moderate, soft <10mm sub- angular	Nil inclusions and segregations	10YR3/1 Very dark grey Nil mottles/bleach	Moderate moist, moderate	Few fine	0.10 / 6.0	0.00-0.10 0.20-0.30 0.50-0.60 0.80-0.90 0.90-1.00	Nil additional observations
				B2 0.16-1.00 EOBH	Medium clay	Moderate, firm <10mm sub- angular	<2% black nodules	10YR4/2 Dark greyish brown Nil mottles/bleach	Dry, moderate	Very fine, very few	0.30 / 6.5 0.60 / 7.0 0.90 / 7.5

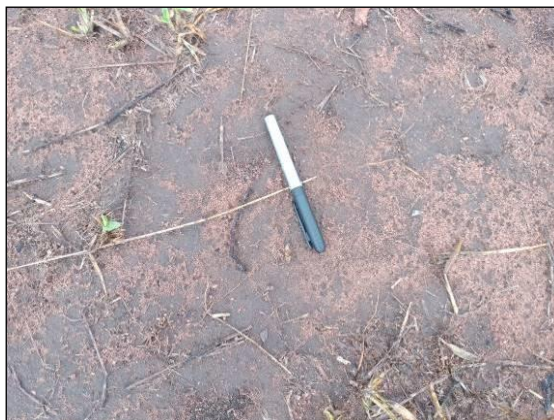
Land use Landform Pattern, Element, Slope	Vegetation	Microrelief Disturbance Erosion	Surface condition, surface rock	Soil Profile Description									
				Horizon Depth (m), Boundary	Field Texture	Structure, Strength	Inclusions Segregations	Colour, Mottle, Bleaching	Moisture, Drainage	Roots	Depth (m) / Field pH	Sample (m)	Observations
Grazing Very gently undulating plain 2.0/1.0	Eucalyptus species	Nil microrelief Semi disturbed Nil erosion	Soft, <5% 2-6mm coarse fragments	A1 0.00-0.17 Abrupt	Sandy loam	Weak, soft <10mm sub-rounded	Nil inclusions and segregations	10YR3/2 Very dark greyish brown Nil mottles/bleach	Moderate moist, rapid	Few fine	0.10 / 6.0	0.00-0.10	Nil additional observations
				B21 0.17-0.44 Abrupt	Light clay with minor sand	Moderate, firm <30mm sub-angular	<2% pale red nodules	10YR4/2 Dark greyish brown Nil mottles/bleach	Moderately moist, moderate	Very fine, very few	0.30 / 7.5	0.20-0.30

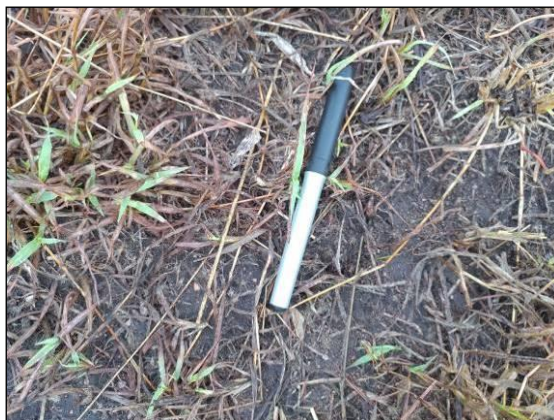
Land use Landform Pattern, Element, Slope	Vegetation	Microrelief Disturbance Erosion	Surface condition, surface rock	Soil Profile Description									
				Horizon Depth (m), Boundary	Field Texture	Structure, Strength	Inclusions Segregations	Colour, Mottle, Bleaching	Moisture, Drainage	Roots	Depth (m) / Field pH	Sample (m)	Observations
Grazing Very gently undulating plain midslope 3.0/3.0	Sparse shrub species	Nil microrelief Nil disturbance Nil erosion	Soft, Nil coarse fragments	A1 0.00-0.12 Abrupt	Sandy loam	Weak, soft <10mm sub-rounded	Nil inclusions and segregations	10YR3/1 Very dark grey Nil mottles/bleach	Moderate moist, rapid	Few fine	0.10 / 6.5	0.00-0.10	Nil additional observations
				B21 0.12-0.45 Abrupt	Light clay with minor sand	Moderate, firm <30mm sub-angular	Nil inclusions and segregations	10YR2/1 Black Nil mottles/bleach	Moderately moist, moderate	Very fine, very few	0.30 / 7.5	0.20-0.30

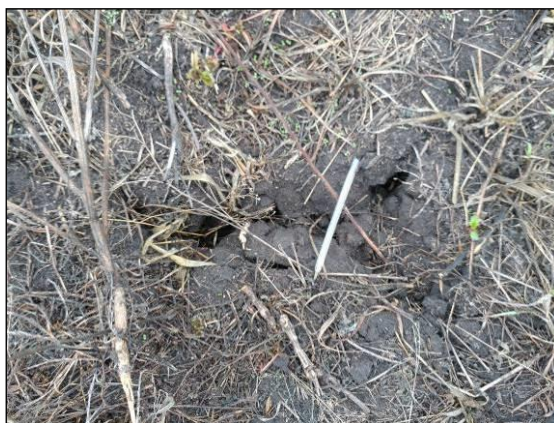
Land use Landform Pattern, Element, Slope	Vegetation	Microrelief Disturbance Erosion	Surface condition, surface rock	Soil Profile Description									
				Horizon Depth (m), Boundary	Field Texture	Structure, Strength	Inclusions Segregations	Colour, Mottle, Bleaching	Moisture, Drainage	Roots	Depth (m) / Field pH	Sample (m)	Observations
Grazing Very gently undulating plain midslope 3.0/3.0	Buffel grass	Nil microrelief Semi disturbed Nil erosion	Cracking, soft Nil coarse fragments	A1 0.00-0.17 Abrupt	Clay Loam	Moderate, firm<30mm sub- angular	Nil inclusions and segregations	10YR3/2 Very dark greyish brown Nil mottles/bleach	Moderate moist, rapid	Few fine	0.10 / 7.0	0.00-0.10 0.20-0.30 0.50-0.60 0.77-0.87 0.90-1.00	Large root encountered at 0.60 mbgl
				B21 0.17-0.89 Abrupt	Medium clay	Moderate, firm<50mm sub- angular	5% calcium carbonate nodules	10YR3/1 Very dark grey Very dark grey Nil mottles/bleach	Dry, moderate	Very fine, very few	0.30 / 7.0 0.60 / 8.0

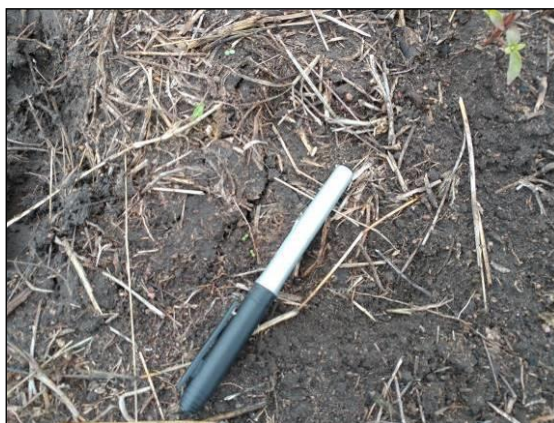
Land use Landform Pattern, Element, Slope	Vegetation	Microrelief Disturbance Erosion	Surface condition, surface rock	Soil Profile Description									
				Horizon Depth (m), Boundary	Field Texture	Structure, Strength	Inclusions Segregations	Colour, Mottle, Bleaching	Moisture, Drainage	Roots	Depth (m) / Field pH	Sample (m)	Observations
Grazing Very gently undulating plain midslope 2.0/2.0	Buffel grass, nearby brigalow	Nil microrelief Nil disturbance Nil erosion	Firm, minor cracking, Nil coarse fragments	A1 0.00-0.15 Abrupt	Clay loam with minor sands	Moderate, firm<30mm sub- angular	Nil inclusions and segregations	10YR3/1 Very dark grey Black Nil mottles/bleach	Moderate moist, rapid	Few fine	0.10 / 6.5	0.00-0.10	Nil additional observations
				B21 0.15-0.50 Abrupt	Light clay with minor sands	Moderate, firm<50mm sub- angular	Nil inclusions and segregations	10YR3/1 Very dark grey Nil mottles/bleach	Dry, moderate	Very fine, very few	0.30 / 7.0	0.20-0.30

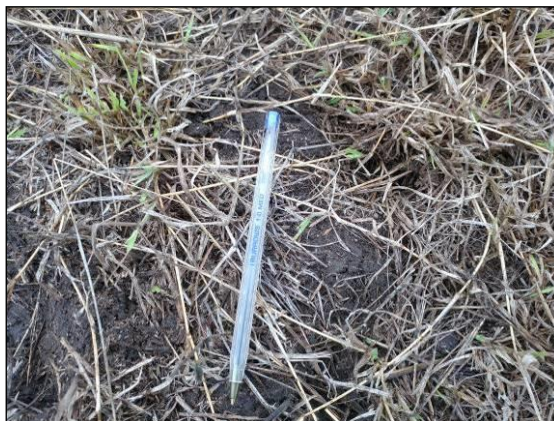
Land use Landform Pattern, Element, Slope	Vegetation	Microrelief Disturbance Erosion	Surface condition, surface rock	Soil Profile Description									
				Horizon Depth (m), Boundary	Field Texture	Structure, Strength	Inclusions Segregations	Colour, Mottle, Bleaching	Moisture, Drainage	Roots	Depth (m) / Field pH	Sample (m)	Observations
Grazing Very gently undulating plain midslope 2.0/2.0	Buffel grass	Nil microrelief Extensively disturbed Nil erosion	Soft, cracking, <10% 10- 15mm coarse fragments	A11 0.00-0.17 Abrupt	Sandy clay loam	Moderate, soft, sub- rounded	Nil inclusions and segregations	10YR3/1 Very dark grey Black Nil mottles/bleach	Moderate moist, rapid	Few fine	0.10 / 7.0	0.00-0.10 0.20-0.30 0.50-0.60 0.80-0.90 0.90-1.00	Nil additional observations
				A12 0.17-0.37 Abrupt	Clay loam	Moderate, soft, sub- angular	Nil inclusions and segregations	10YR4/1 Dark grey Nil mottles/bleach	Dry, moderate	Very fine, very few	0.30 / 7.5

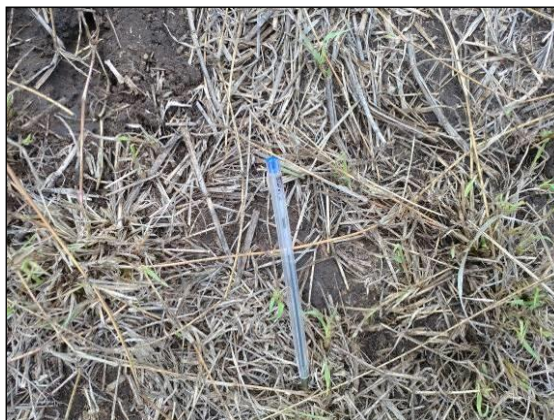
Land use Landform Pattern, Element, Slope	Vegetation	Microrelief Disturbance Erosion	Surface condition, surface rock	Soil Profile Description									
				Horizon Depth (m), Boundary	Field Texture	Structure, Strength	Inclusions Segregations	Colour, Mottle, Bleaching	Moisture, Drainage	Roots	Depth (m) / Field pH	Sample (m)	Observations
Very gently undulating plain mid slope 2.0/2.0	Buffel grass, Brigalow, and belah on fence line, 100 m nearby	Nil microrelief Nil disturbed Nil erosion	Soft, moist, nil coarse fragments	A11 0.00-0.09 Abrupt	Sandy loam	Weak, loose	Nil inclusions and segregations	10YR2/2 Very dark brown Nil mottles	Moderate moist, rapid	Few fine	0.10 / 6.5	0.00-0.10 0.20-0.30 0.55-0.65 0.75-0.85 0.90-1.00	Nil additional observations
				A12 0.09-0.35 Clear	Sandy Loam	Weak, loose	Nil inclusions and segregations	10YR2/1 Black Nil mottles/bleach	Dry, moderate	Very fine, very few	0.30 / 7.5

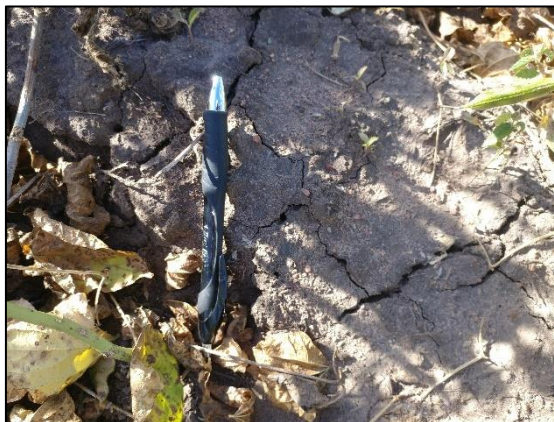
Land use Landform Pattern, Element, Slope	Vegetation	Microrelief Disturbance Erosion	Surface condition, surface rock	Soil Profile Description									
				Horizon Depth (m), Boundary	Field Texture	Structure, Strength	Inclusions Segregations	Colour, Mottle, Bleaching	Moisture, Drainage	Roots	Depth (m) / Field pH	Sample (m)	Observations
Cropping, Very gently undulating plain, mid-slope, 1% slope	Forage crops	Nil microrelief Extensively disturbed for cropping Nil erosion	Self-mulching with crust 2-6 mm thick, minor sand on surface. Coarse fragments <5 mm <5%	A1 0.00 – 0.12 Abrupt	Light clay, sandy	Subangular blocky, peds 10-30 mm, firm	Nil inclusions and segregations	10YR2/1 Black Nil mottles / bleaching	Humid, well drained	Fine, very few	0.10 / 7.0	0.00-0.10 0.20-0.30 0.50-0.60 0.80-0.90 0.90-1.00	Nil additional observations
				B21 0.12 – 0.68 Abrupt	Medium heavy clay	Subangular blocky, peds 20-30 mm, strong	<5% calcium carbonate	10YR2/1 Black Nil mottles / bleaching	Humid, well drained	Fine, very few	0.30 / 7.0 0.60 / 6.5

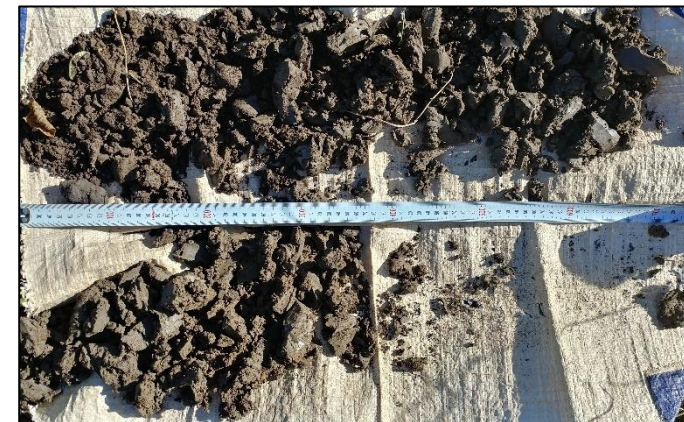
B22 0.68 – 1.00 EOBH	Medium heavy clay, sandy	Subangular blocky, peds 40-60 mm, strong	<1% red nodules <2mm	10YR3/1 Very dark grey Nil mottles / bleaching	Humid, well drained	Nil	0.90 / 6.5

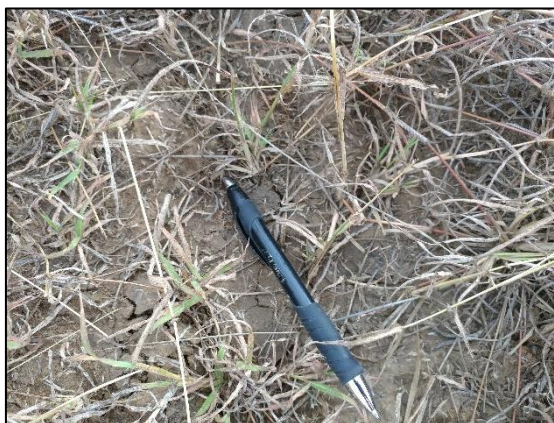
Land use Landform Pattern, Element, Slope	Vegetation	Microrelief Disturbance Erosion	Surface condition, surface rock	Soil Profile Description									
				Horizon Depth (m), Boundary	Field Texture	Structure, Strength	Inclusions Segregations	Colour, Mottle, Bleaching	Moisture, Drainage	Roots	Depth (m) / Field pH	Sample (m)	Observations
GUP Mid-slope	Grasses	Nil microrelief Semi disturbance Nil erosion	Cracking, Nil coarse fragments	A1 0.00-0.11 Abrupt	Sandy clay loam	Weak to moderate. Soft, sub rounded <10mm	Nil inclusions and segregations	10YR3/2 Very dark greyish brown Nil mottles/bleaching	Dry, well	Present	0.10 / 7.0	0.00-0.10 0.20-0.30 0.50-0.60 0.80-0.90 0.90-1.00	Nil additional observations
				B21 0.11-0.62 gradual	Light clay	Weak to moderate. Firm, sub rounded <20mm	Nil inclusions and segregations	10YR3/2 Very dark greyish brown Nil mottles/bleaching	Dry, moderate – well	Present	0.30 / 7.5 0.60 / 7.5

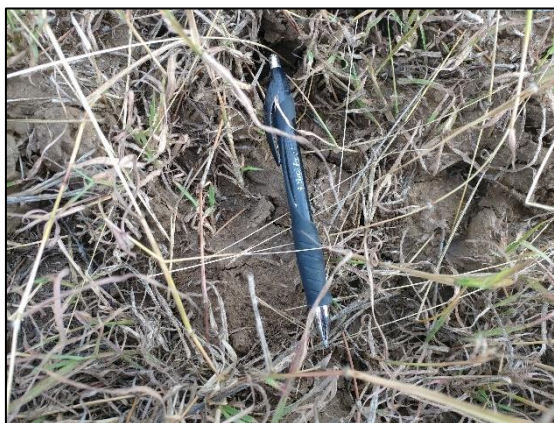
Land use Landform Pattern, Element, Slope	Vegetation	Microrelief Disturbance Erosion	Surface condition, surface rock	Soil Profile Description									
				Horizon Depth (m), Boundary	Field Texture	Structure, Strength	Inclusions Segregations	Colour, Mottle, Bleaching	Moisture, Drainage	Roots	Depth (m) / Field pH	Sample (m)	Observations
GUP Mid-slope <2.0/<2.0	Grasses	Nil microrelief Extensive disturbance Nil erosion	Cracking, Nil coarse fragments	A1 0.00-0.15 Abrupt	Sandy clay loam	Weak to moderate. Soft, sub rounded <10mm	Nil inclusions and segregations	10YR3/2 Very dark greyish brown Nil mottles/bleaching	Dry, well	Present	0.10 / 7.0	0.00-0.10 0.20-0.30 0.50-0.60 0.80-0.90 0.90-1.00	Nil additional observations
				B21 0.15-0.75 gradual	Light clay	Weak to moderate. Firm, sub rounded <20mm	Nil inclusions and segregations	10YR3/2 Very dark greyish brown Nil mottles/bleaching	Dry, moderate – well	Present	0.30 / 7.5 0.60 / 7.5

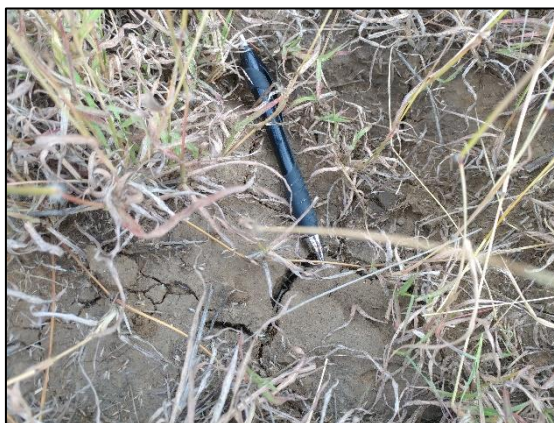
Land use Landform Pattern, Element, Slope	Vegetation	Microrelief Disturbance Erosion	Surface condition, surface rock	Soil Profile Description									
				Horizon Depth (m), Boundary	Field Texture	Structure, Strength	Inclusions Segregations	Colour, Mottle, Bleaching	Moisture, Drainage	Roots	Depth (m) / Field pH	Sample (m)	Observations
GUP Mid-slope	Grasses	Nil microrelief Extensive disturbance Nil erosion	Cracking, Nil coarse fragments	A1 0.00-0.15 Abrupt	Sandy clay loam	Weak to moderate. Soft, sub rounded <10mm	Nil inclusions and segregations	10YR3/2 Very dark greyish brown Nil mottles/bleaching	Dry, well	Present	0.10 / 7.0	0.00-0.10 0.20-0.30 0.50-0.60 0.80-0.90 0.90-1.00	Nil additional observations
				B21 0.15-0.75 gradual	Light clay	Weak to moderate. Firm, sub rounded <20mm	Nil inclusions and segregations	10YR3/2 Very dark greyish brown Nil mottles/bleaching	Dry, moderate – well	Present	0.30 / 7.5 0.60 / 7.5

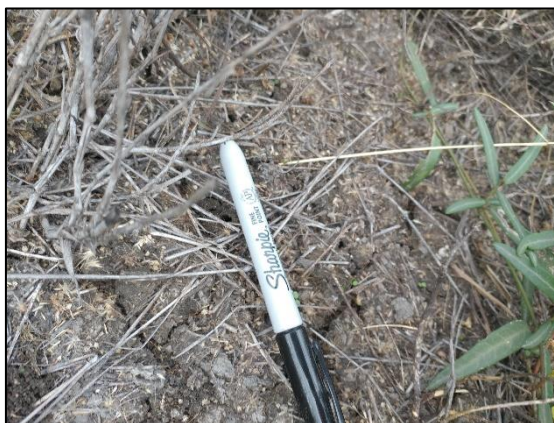
Land use Landform Pattern, Element, Slope	Vegetation	Microrelief Disturbance Erosion	Surface condition, surface rock	Soil Profile Description									
				Horizon Depth (m), Boundary	Field Texture	Structure, Strength	Inclusions Segregations	Colour, Mottle, Bleaching	Moisture, Drainage	Roots	Depth (m) / Field pH	Sample (m)	Observations
Cropping, upper-slope, 1%/2% slope	Grasses	Nil microrelief Nil erosion Extensively disturbed	Self-mulching, cracking 2- 6+mm	A1 0.0 – 0.15 Abrupt	Light clay	Moderate, Sub- rounded, peds <10 mm, soft	Nil inclusions or segregations	10YR3/2 Very dark greyish brown Nil mottles	Dry, well drained	Fine, very few	0.10 / 7.0	0.00-0.10 0.20-0.30 0.55-0.60 0.80-0.90 0.90-1.00	Nil additional observations
				B21 0.15 – 0.55 Abrupt	Medium clay	Moderate, Subangular blocky, peds <20 mm, firm	Nil inclusions or segregations	10YR2/1 Black 2% brown mottle	Dry, well drained	Very fine, very few	0.30 / 7.5

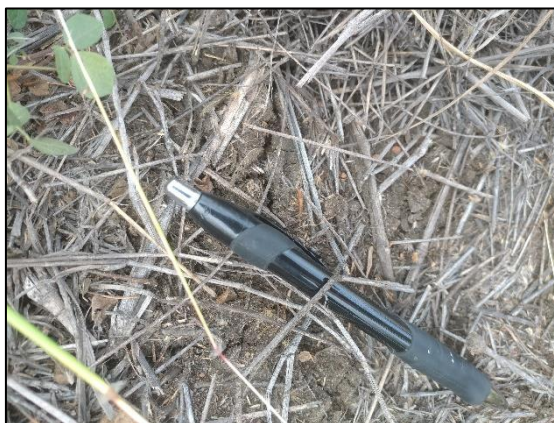
Land use Landform Pattern, Element, Slope	Vegetation	Microrelief Disturbance Erosion	Surface condition, surface rock	Soil Profile Description									
				Horizon Depth (m), Boundary	Field Texture	Structure, Strength	Inclusions Segregations	Colour, Mottle, Bleaching	Moisture, Drainage	Roots	Depth (m) / Field pH	Sample (m)	Observations
Cropping, upper-slope, 1%/1% slope	Grasses	Nil microrelief Nil erosion extensively disturbed	self- mulching, cracking 2- 6+mm	A1 0.0 – 0.12 Abrupt	Light clay	Moderate, Sub- rounded, peds <10 mm, soft	Nil inclusions or segregations	10YR3/2 Very dark greyish brown Nil mottles	Humid, well drained	Fine, very few	0.10 / 6.5	0.00-0.10 0.20-0.30 0.50-0.60 0.80-0.90 0.90-1.00	Nil additional observations
				B21 0.12 – 0.40 Abrupt	Medium clay	Moderate, Subangular blocky, peds <20 mm, firm	Nil inclusions or segregations	10YR3/2 Very dark greyish brown Nil mottles	Dry, well drained	Very fine, very few	0.30 / 6.5

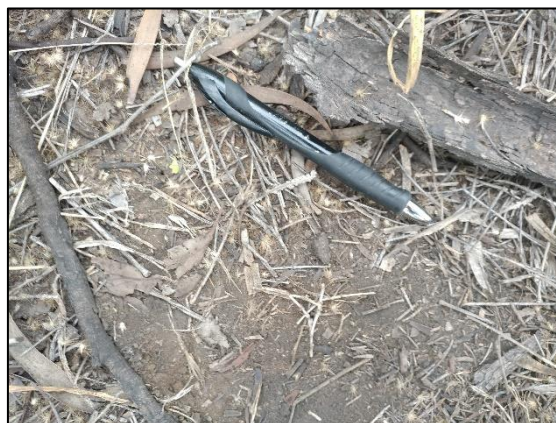
Land use Landform Pattern, Element, Slope	Vegetation	Microrelief Disturbance Erosion	Surface condition, surface rock	Soil Profile Description									
				Horizon Depth (m), Boundary	Field Texture	Structure, Strength	Inclusions Segregations	Colour, Mottle, Bleaching	Moisture, Drainage	Roots	Depth (m) / Field pH	Sample (m)	Observations
Grazing GUP Stream channel / Depression <2% / <2%	Brigalow, Mount Coolibah	Nil microrelief Nil disturbance Nil erosion	Soft, Nil coarse fragments	A1 0.00-0.10 Abrupt	Loamy sand	Massive, loose	<1% coarse fragments	10YR3/1 Very dark grey Nil mottles / bleaching	Dry, well	Present	0.10 / 8.5	0.00-0.10 0.10-0.20 0.20-0.30 0.50-0.60 0.80-0.88	Nil additional observations
				B21 0.10-0.20 Abrupt	Sandy loam	Moderate, very firm sub- angular <20mm	<1% coarse fragments	10YR3/1 Very dark grey Nil mottles / bleaching	Dry, well – moderate	Present	0.20 / 8.5		
				B22 0.20-0.47 Abrupt	Sandy loam	Moderate, very firm sub- angular <10mm	<10% coarse fragments	10YR3/1 Very dark grey Nil mottles / bleaching	Dry, well – moderate	Present	0.30 / 8.5

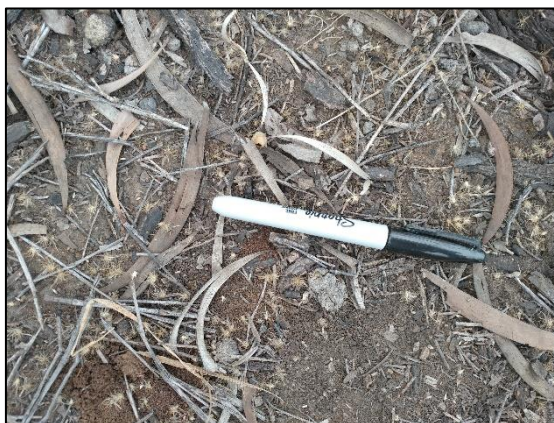
Land use Landform Pattern, Element, Slope	Vegetation	Microrelief Disturbance Erosion	Surface condition, surface rock	Soil Profile Description									
				Horizon Depth (m), Boundary	Field Texture	Structure, Strength	Inclusions Segregations	Colour, Mottle, Bleaching	Moisture, Drainage	Roots	Depth (m) / Field pH	Sample (m)	Observations
GUP mid slope <1% / <1%	Brigalow, Mount Coolibah	Nil micro relief Nil disturbance Nil erosion	Soft, Nil coarse fragments	A1 0.00-0.14 Abrupt	Loamy sand	Massive, loose	<1% coarse fragments	10YR3/1 Very dark grey Nil mottles / bleaching	Dry, well	Present	0.10 / 8.5	0.00-0.10 0.20-0.30 0.50-0.60 0.80-0.90 0.90-1.00	Nil additional observations
				B21 0.14-0.32 Abrupt	Sandy loam	Moderate, very firm sub- angular <20mm	<1% coarse fragments	10YR3/1 Very dark grey Nil mottles / bleaching	Dry, well – moderate	Present	0.20 / 8.5		
				B22 0.32-0.60 Diffused	Sandy loam	Moderate, very firm sub- angular <10mm	<10% coarse fragments	10YR3/1 Very dark grey 2% 10YR6/4 mottle. Nil bleaching	Dry, well – moderate	Present	0.30 / 8.5

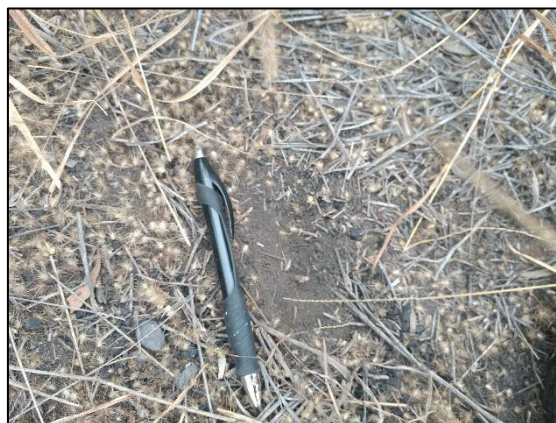
Land use Landform Pattern, Element, Slope	Vegetation	Microrelief Disturbance Erosion	Surface condition, surface rock	Soil Profile Description									
				Horizon Depth (m), Boundary	Field Texture	Structure, Strength	Inclusions Segregations	Colour, Mottle, Bleaching	Moisture, Drainage	Roots	Depth (m) / Field pH	Sample (m)	Observations
GUP Upper slope <2% / <2%	Brigalow, Mount Coolibah	Nil micro relief Nil disturbance Nil erosion	Soft, Nil coarse fragments	A1 0.00-0.18 Abrupt	Loamy sand	Massive, loose	<1% coarse fragments	10YR3/1 Very dark grey Nil mottles / bleaching	Dry, well	Present	0.10 / 8.5	0.00-0.10 0.20-0.30 0.50-0.60 0.80-0.90 0.90-0.95	Nil additional observations
				B21 0.18-0.33 Abrupt	Sandy loam	Moderate, very firm sub-angular <20mm	<1% coarse fragments	10YR3/1 Very dark grey Nil mottles / bleaching	Dry, well – moderate	Present	0.20 / 8.5		
				B22 0.33-0.68 Diffuse	Sandy loam	Moderate, very firm sub-angular <10mm	<10% coarse fragments	10YR3/1 Very dark grey 2% 10YR6/4 mottle. Nil bleaching	Dry, well – moderate	Present	0.30 / 8.5

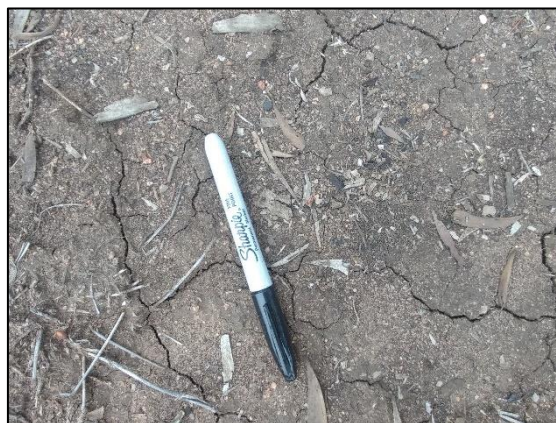
Land use Landform Pattern, Element, Slope	Vegetation	Microrelief Disturbance Erosion	Surface condition, surface rock	Soil Profile Description									
				Horizon Depth (m), Boundary	Field Texture	Structure, Strength	Inclusions Segregations	Colour, Mottle, Bleaching	Moisture, Drainage	Roots	Depth (m) / Field pH	Sample (m)	Observations
Grazing Alluvial near stream channel 1% / 0%	Brigalow	Nil microrelief Nil disturbance Nearby sheet / gully erosion	Minor cracking Soft, <10% coarse fragments <5mm	A1 0.00-0.12 Abrupt	Sandy loam	Weak to moderate, soft sub-rounded <10mm	Nil inclusions / segregations	10YR3/1 Very dark grey Nil mottles / bleaching	Dry, well	Present	0.10 / 8.5	0.00-0.10 0.20-0.30 0.50-0.60 0.75-0.85 0.90-1.00	Nil additional observations
				B21 0.12-0.37 Abrupt	Sandy loam	Moderate, firm sub-rounded <10mm	Nil inclusions / segregations	10YR3/2 Very dark greyish brown Nil mottles / bleaching	Dry, well – moderate	Present	0.20 / 8.5

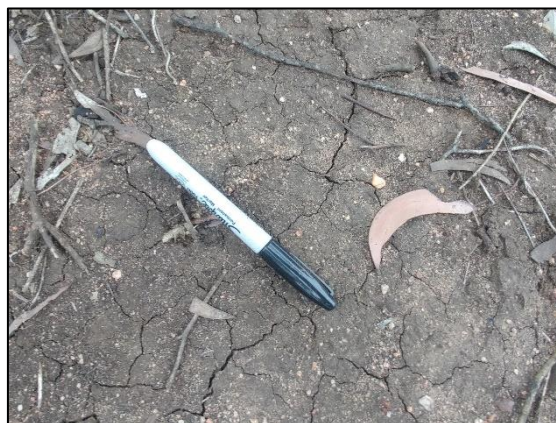
Land use Landform Pattern, Element, Slope	Vegetation	Microrelief Disturbance Erosion	Surface condition, surface rock	Soil Profile Description									
				Horizon Depth (m), Boundary	Field Texture	Structure, Strength	Inclusions Segregations	Colour, Mottle, Bleaching	Moisture, Drainage	Roots	Depth (m) / Field pH	Sample (m)	Observations
Grazing Alluvial near stream channel 1% / 0%	Brigalow	Nil microrelief Nil disturbance Nearby sheet / gully erosion	Minor cracking Soft, <10% coarse fragments <5mm	A1 0.00-0.10 Abrupt	Sandy loam	Weak to moderate, soft sub-rounded <10mm	Nil inclusions / segregations	10YR3/1 Very dark grey Nil mottles / bleaching	Dry, well	Present	0.10 / 7.5	0.00-0.10	Nil additional observations
				B21 0.10-0.40 Abrupt	Sandy loam	Moderate, firm sub- rounded <10mm	Nil inclusions / segregations	10YR3/2 Very dark greyish brown Nil mottles / bleaching	Dry, well – moderate	Present	0.20 / 8.5	0.20-0.30 0.50-0.60 0.80-0.90 0.90-1.00

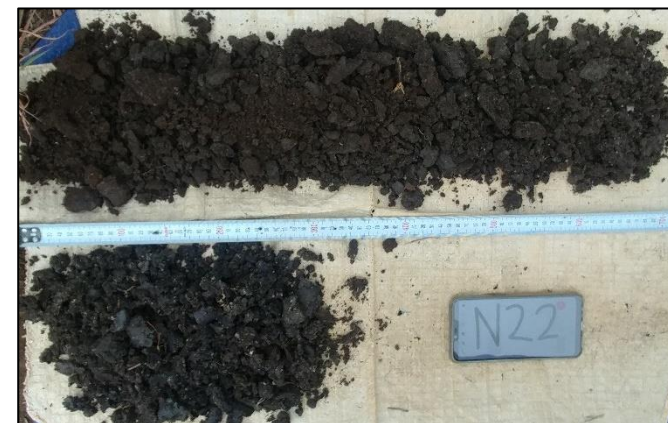
Land use Landform Pattern, Element, Slope	Vegetation	Microrelief Disturbance Erosion	Surface condition, surface rock	Soil Profile Description									
				Horizon Depth (m), Boundary	Field Texture	Structure, Strength	Inclusions Segregations	Colour, Mottle, Bleaching	Moisture, Drainage	Roots	Depth (m) / Field pH	Sample (m)	Observations
Grazing Depression <1% / <1%	Brigalow woodlands	Nil microrelief Semi disturbance Minor sheet erosion	Minor cracking Soft, <10% coarse fragments <5mm	A1 0.00-0.11 Abrupt	Sandy loam	Weak to moderate, soft sub- rounded <10mm	Nil inclusions / segregations	10YR3/1 Very dark grey Nil mottles / bleaching	Dry, well	Present	0.10 / 7.5	0.00-0.10 0.20-0.30 0.50-0.60 0.80-0.90 0.90-1.00	Nil additional observations
				B21 0.11-0.48 Abrupt	Sandy loam	Moderate, firm sub- rounded <10mm	Nil inclusions / segregations	10YR3/1 Very dark grey Nil mottles / bleaching	Dry, well – moderate	Present	0.30 / 8.5

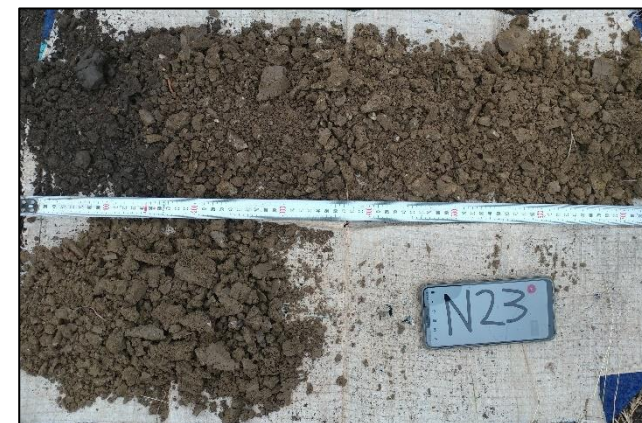
Land use Landform Pattern, Element, Slope	Vegetation	Microrelief Disturbance Erosion	Surface condition, surface rock	Soil Profile Description									
				Horizon Depth (m), Boundary	Field Texture	Structure, Strength	Inclusions Segregations	Colour, Mottle, Bleaching	Moisture, Drainage	Roots	Depth (m) / Field pH	Sample (m)	Observations
Grazing Depression Alluvial / stream channel nearby <1% / <1%	Mixed vegetation	Nil microrelief Cropping nearby disturbance Nil erosion	Cracking Firm Nil coarse fragments	A1 0.00-0.12 Abrupt	Clay loam	Weak, soft sub- rounded <10mm	Nil inclusions / segregations	10YR3/1 Very dark grey Nil mottles / bleaching	Dry, well	Present	0.10 / 8.5	0.00-0.10	Nil additional observations
				B21 0.12-0.48 gradual	Light clay	Weak to moderate, firm sub- rounded <10mm	<5% weathered rock	10YR4/2 Dark greyish brown Nil mottles / bleaching	Dry, well – moderate	Present	0.30 / 8.5	0.20-0.30

B22 0.48-1.00 EOBH	Light clay	Moderate, very firm sub- rounded <20mm	<5% calcium carbonate	10YR4/2 Dark greyish brown Nil mottles / bleaching	Dry, well – moderate	Present	0.60 / 8.5 0.90 / 8.5	0.50-0.60 0.80-0.90 0.90-1.00

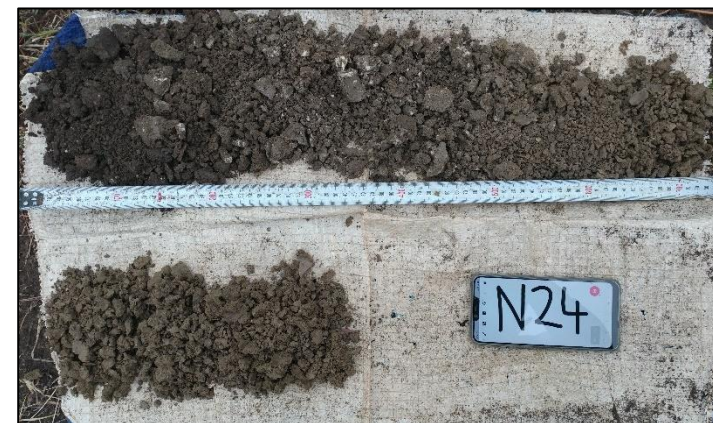
Land use Landform Pattern, Element, Slope	Vegetation	Microrelief Disturbance Erosion	Surface condition, surface rock	Soil Profile Description									
				Horizon Depth (m), Boundary	Field Texture	Structure, Strength	Inclusions Segregations	Colour, Mottle, Bleaching	Moisture, Drainage	Roots	Depth (m) / Field pH	Sample (m)	Observations
Grazing Depression Alluvial / stream channel nearby <1% / <1%	Mixed vegetation	Nil microrelief Cropping nearby disturbance Nil erosion	Cracking Firm Nil coarse fragments	A1 0.00-0.15 Abrupt	Clay loam	Weak, soft sub- rounded <10mm	Nil inclusions / segregations	10YR3/1 Very dark grey Nil mottles / bleaching	Dry, well	Present	0.10 / 8.5	0.00-0.10	Nil additional observations
				B21 0.15-0.50 gradual	Light clay	Weak to moderate, firm sub- rounded <10mm	<5% calcium carbonate	10YR4/2 Dark greyish brown Nil mottles / bleaching	Dry, well – moderate	Present	0.30 / 8.5	0.20-0.30

B22 0.50-1.00 EOBH	Light clay	Moderate, very firm sub- rounded <20mm	Nil inclusions / segregations	10YR4/2 Dark greyish brown Nil mottles / bleaching	Dry, well – moderate	Present	0.60 / 8.5 0.90 / 8.5	0.50-0.60 0.80-0.90 0.90-1.00

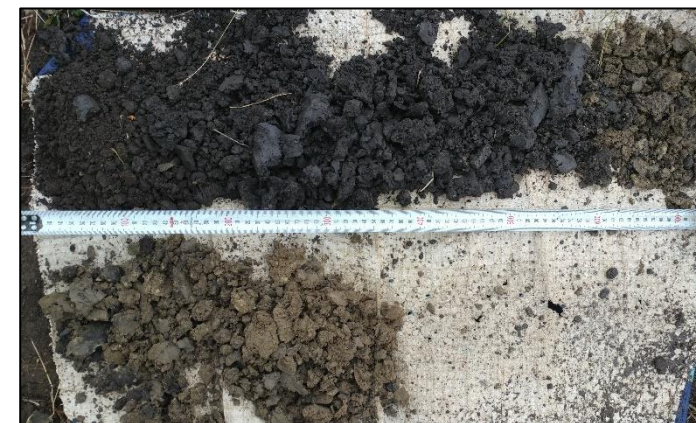
Land use Landform Pattern, Element, Slope	Vegetation	Microrelief Disturbance Erosion	Surface condition, surface rock	Soil Profile Description									
				Horizon Depth (m), Boundary	Field Texture	Structure, Strength	Inclusions Segregations	Colour, Mottle, Bleaching	Moisture, Drainage	Roots	Depth (m) / Field pH	Sample (m)	Observations
Grazing Depression Alluvial / stream channel nearby <1% / <1%	Mixed vegetation	Nil microrelief Cropping nearby disturbance Nil erosion	Cracking Firm Nil coarse fragments	A1 0.00-0.12 Abrupt	Clay loam	Weak, soft sub- rounded <10mm	Nil inclusions / segregations	10YR3/1 Very dark grey Nil mottles / bleaching	Dry, well	Present	0.10 / 8.5	0.00-0.10 0.20-0.30 0.50-0.60 0.80-0.90 0.90-1.00	Nil additional observations
				B21 0.12-0.62 gradual	Light clay	Weak to moderate, firm sub- rounded <10mm	Nil inclusions / segregations	10YR4/2 Dark greyish brown Nil mottles / bleaching	Dry, well – moderate	Present	0.30 / 8.5

B22 0.62-1.00 EOBH	Light clay	Moderate, very firm sub- rounded <20mm	<5% calcium carbonate	10YR4/2 Dark greyish brown Nil mottles / bleaching	Dry, well – moderate	Present	0.60 / 8.5 0.90 / 8.5

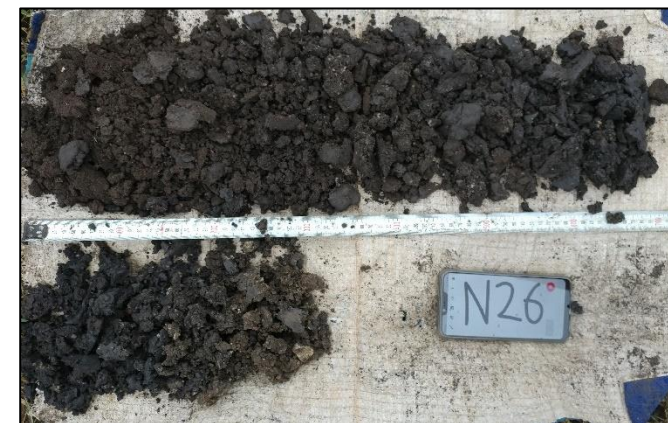
Land use Landform Pattern, Element, Slope	Vegetation	Microrelief Disturbance Erosion	Surface condition, surface rock	Soil Profile Description									
				Horizon Depth (m), Boundary	Field Texture	Structure, Strength	Inclusions Segregations	Colour, Mottle, Bleaching	Moisture, Drainage	Roots	Depth (m) / Field pH	Sample (m)	Observations
Grazing GUP Lower slope 1% / 1%	Short grasses	Nil microrelief Extensive disturbance Nil erosion	Minor cracking	A1 0.00-0.14 Clear	Sandy clay	Weak, soft sub- rounded <10mm	Nil inclusions / segregations	10YR3/1 Very dark grey Nil mottles/bleach	Dry, moderate	Few fine	0.10 / 6.0	0.00-0.10 0.20-0.30 0.50-0.60 0.80-0.90 0.90-1.00	Nil additional observations
				B21 0.14-0.33 clear	Medium clay	Weak to moderate, firm sub- rounded <10mm	Nil inclusions / segregations	10YR2/2 Very dark brown Nil mottles/bleach	Dry, moderate	Very fine, very few	0.30 / 6.5		
				B22 0.33-0.90 gradual	Medium clay	Moderate, firm sub- rounded <20mm	Nil inclusions / segregations	10YR3/3 Dark brown Nil mottles/bleach	Dry, moderate	Very fine, very few	0.60 / 7.0

B23 0.90-1.00 EOBH	Medium clay	Moderate, very firm sub- rounded <20mm	<2% calcium carbonate	10YR3/3 Dark brown Nil mottles/bleach	Dry, moderate	Very fine, very few	0.90 / 7.5

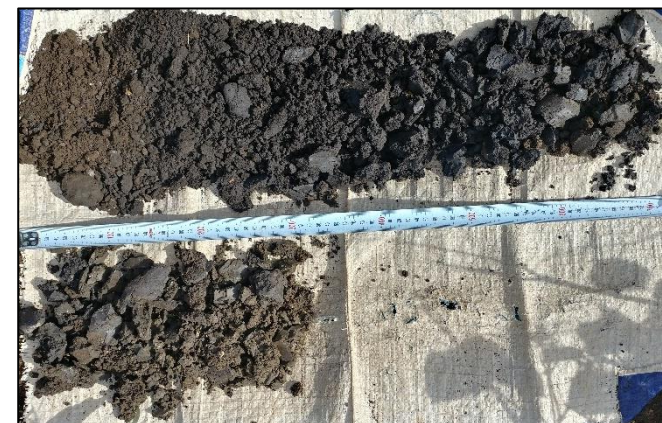
Land use Landform Pattern, Element, Slope	Vegetation	Microrelief Disturbance Erosion	Surface condition, surface rock	Soil Profile Description									
				Horizon Depth (m), Boundary	Field Texture	Structure, Strength	Inclusions Segregations	Colour, Mottle, Bleaching	Moisture, Drainage	Roots	Depth (m) / Field pH	Sample (m)	Observations
Mid-slope, 1% slope	Forage cropping	Nil Microrelief Nil erosion Extensively cleared	Firm, cracking 2mm, Nil coarse fragments	A1 0.0 – 0.13 Abrupt	Sandy clay loam	Weak, sub- rounded peds 5-20 mm, firm	Nil inclusions or segregations	10YR3/1 Very dark grey Nil mottles	Humid, well drained	Fine, very few	0.10 / 6.5	0.00-0.10 0.20-0.30 0.50-0.60 0.80-0.90 0.90-1.00	Nil additional observations
				B21 0.13 – 0.50 gradual	Sandy clay loam	Moderate, peds 30-40 mm, very firm	Nil inclusions or segregations	10YR2/1 Black Nil mottles	Humid, well drained	Nil roots	0.30 / 6.5

B22 0.50 – 0.75 clear	Light clay, sandy	Subangular blocky, moderate, peds <20 mm, very firm	<2% calcium carbonate	10YR2/1 Nil mottles Black	Humid, moderately well drained	Nil roots	0.60 / 6.5		
				B23 0.75 – 1.00 EOBH	Medium clay, sandy	Subangular blocky, moderate, peds <20 mm, very firm	<2% calcium carbonate	10YR3/1 Very dark grey Nil mottles	Humid, moderately well drained	Nil roots	0.90 / 6.5

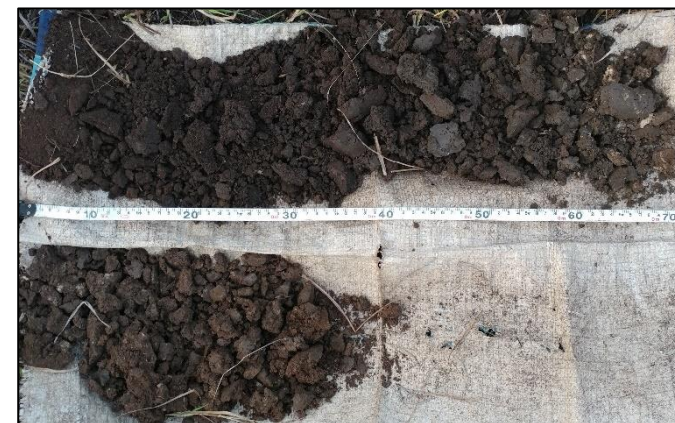
Land use Landform Pattern, Element, Slope	Vegetation	Microrelief Disturbance Erosion	Surface condition, surface rock	Soil Profile Description									
				Horizon Depth (m), Boundary	Field Texture	Structure, Strength	Inclusions Segregations	Colour, Mottle, Bleaching	Moisture, Drainage	Roots	Depth (m) / Field pH	Sample (m)	Observations
Grazing GUP lower slope <2% / <2%	Eucalyptus species	Nil microrelief Semi disturbed, contour banks nearby	Minor cracks, firm, Nil coarse fragments	A11 0.0 – 0.08 Abrupt	Sandy clay loam	Massive	Nil inclusions or segregations	10YR3/2 Very dark greyish brown Nil mottles / bleaching	Dry, well drained	Present	0.10 / 7.5	0.00-0.05	Nil additional observations
				A12 0.08 – 0.35 gradual	Sandy clay loam	Weak, sub- rounded peds <10 mm	Nil inclusions or segregations	10YR3/2 Very dark greyish brown Nil mottles / bleaching	Dry, well drained	Present	0.20 / 7.5	0.20-0.30	
				B22 0.35 – 0.60 gradual	Sandy clay loam	Subangular blocky, moderate, peds <20 mm, firm	Nil inclusions or segregations	10YR3/2 Very dark greyish brown Nil mottles / bleaching	Dry, well drained	Present	0.30 / 7.5	0.50-0.60

B23 0.60 – 1.00 EOBH	Medium clay, sandy	Subangular blocky, moderate, peds <20 mm, firm	<15% calcium carbonate	10YR3/3 Dark brown Nil mottles / bleaching	Dry, well – moderate drained	Present	0.60 / 7.5 0.90 / 7.5	0.80-0.90 0.90-1.00

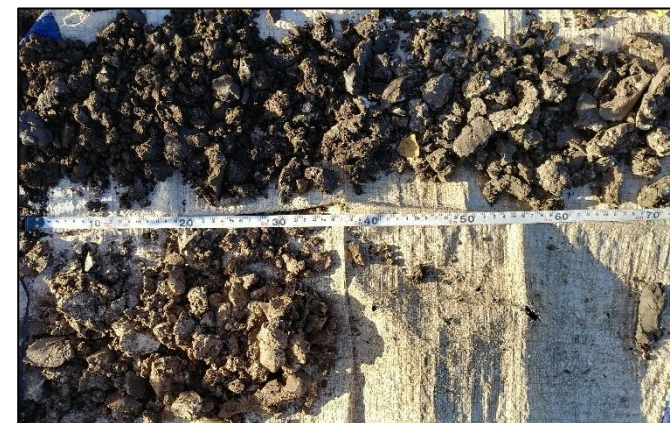
Land use Landform Pattern, Element, Slope	Vegetation	Microrelief Disturbance Erosion	Surface condition, surface rock	Soil Profile Description									
				Horizon Depth (m), Boundary	Field Texture	Structure, Strength	Inclusions Segregations	Colour, Mottle, Bleaching	Moisture, Drainage	Roots	Depth (m) / Field pH	Sample (m)	Observations
Cropping / Grazing GUP mid slope 2% / 2%	Cropping	Nil microrelief Extensive disturbed, contour banks nearby	Cracking, firm, Nil coarse fragments	A11 0.0 – 0.11 Abrupt	Light medium clay	Moderate, firm, sub- rounded peds <10 mm	<1% coarse fragments <2mm	10YR3/2 Very dark greyish brown Nil mottles / bleaching	Dry, well drained	Present	0.10 / 8.0	0.00-0.10 0.20-0.30 0.50-0.60 0.80-0.90 0.90-1.00	Nil additional observations
				B21 0.11 – 0.35 Abrupt	Medium clay	Moderate - strong, firm, sub-rounded peds 20 mm	<2% calcium carbonate	10YR3/2 Very dark greyish brown Nil mottles / bleaching	Dry, well- moderate drained	Present	0.30 / 8.0

B22 0.35 – 0.66 Clear	Medium clay	Moderate - strong, firm, sub-rounded peds 20 mm	<30% calcium carbonate	10YR3/2 Very dark greyish brown Nil mottles / bleaching	Dry, well- moderate drained	Present	0.60 / 8.0		
				B23 0.66 – 1.00 EOBH	Medium clay	Moderate - strong, firm, sub-rounded peds 20 mm	<20% calcium carbonate	10YR4/4 Dark yellowish brown Nil mottles / bleaching	Dry, well- moderate drained	Nil	0.90 / 8.0

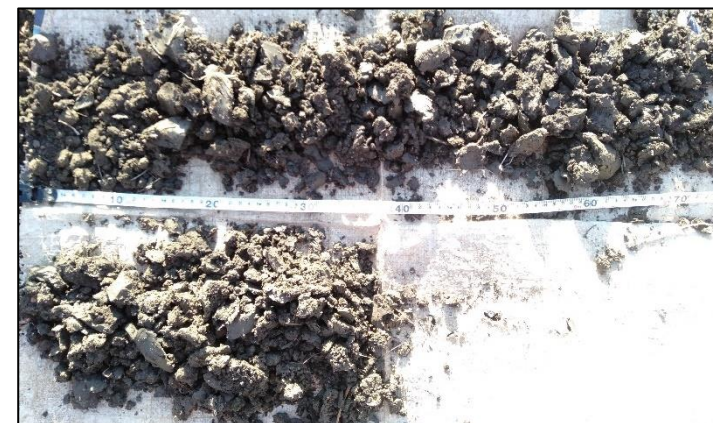
Land use Landform Pattern, Element, Slope	Vegetation	Microrelief Disturbance Erosion	Surface condition, surface rock	Soil Profile Description									
				Horizon Depth (m), Boundary	Field Texture	Structure, Strength	Inclusions Segregations	Colour, Mottle, Bleaching	Moisture, Drainage	Roots	Depth (m) / Field pH	Sample (m)	Observations
Cropping / Grazing GUP upper slope 2% / 2%	Cropping	Nil microrelief Extensive disturbed, contour banks nearby	Cracking, firm, Nil coarse fragments	A11 0.0 – 0.11 Abrupt	Light medium clay	Moderate, firm, sub- rounded peds <10 mm	<1% coarse fragments <2mm	10YR3/2 Very dark greyish brown Nil mottles / bleaching	Dry, well drained	Present	0.10 / 8.0	0.00-0.10 0.20-0.30 0.50-0.60 0.80-0.90 0.90-1.00	Nil additional observations
				B21 0.11 – 0.35 Abrupt	Medium clay	Moderate - strong, firm, sub-rounded peds 20 mm	<2% calcium carbonate	10YR3/2 Very dark greyish brown Nil mottles / bleaching	Dry, well- moderate drained	Present	0.30 / 8.0

B22 0.35 – 0.66 Clear	Medium clay	Moderate - strong, firm, sub-rounded peds 20 mm	<30% calcium carbonate	10YR3/2 Very dark greyish brown Nil mottles / bleaching	Dry, well- moderate drained	Present	0.60 / 8.0		
				B23 0.66 – 1.00 EOBH	Medium clay	Moderate - strong, firm, sub-rounded peds 20 mm	<10% calcium carbonate	10YR4/4 Dark yellowish brown Nil mottles / bleaching	Dry, well- moderate drained	Nil	0.90 / 8.0

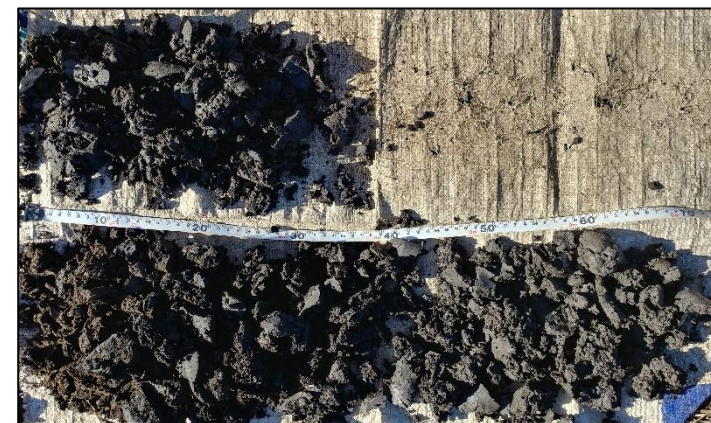
Land use Landform Pattern, Element, Slope	Vegetation	Microrelief Disturbance Erosion	Surface condition, surface rock	Soil Profile Description									
				Horizon Depth (m), Boundary	Field Texture	Structure, Strength	Inclusions Segregations	Colour, Mottle, Bleaching	Moisture, Drainage	Roots	Depth (m) / Field pH	Sample (m)	Observations
Cropping / Grazing GUP Lower slope / flat plain <1% / 1%	Cropping	Nil microrelief Extensive disturbed, contour banks nearby	Cracking, firm, Nil coarse fragments	A11 0.0 – 0.10 Abrupt	Light clay	Weak, firm, sub- rounded peds <10 mm	Nil inclusions or segregations	10YR3/2 Very dark greyish brown Nil mottles / bleaching	Dry, well drained	Present	0.10 / 8.0	0.00-0.10 0.20-0.30 0.50-0.60 0.80-0.90 0.90-1.00	Nil additional observations
				B21 0.11 – 0.50 Abrupt	Medium clay	Moderate - strong, firm, sub- angular peds <20 mm	Nil inclusions or segregations	10YR3/1 Very dark grey Nil mottles / bleaching	Dry, well- moderate drained	Present	0.30 / 8.0

B22 0.50 – 1.00 EOBH	Medium clay	Moderate - strong, firm, sub- angular peds <20 mm	<2% calcium carbonate	10YR3/1 Very dark grey Nil mottles / bleaching	Dry, well- moderate drained	Present	0.60 / 7.0 0.90 / 7.0

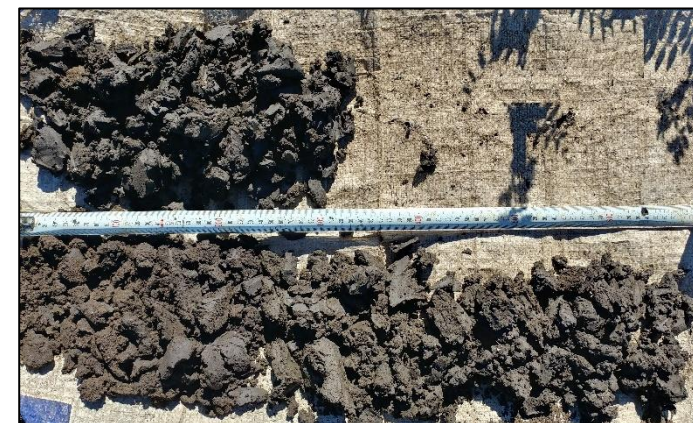
Land use Landform Pattern, Element, Slope	Vegetation	Microrelief Disturbance Erosion	Surface condition, surface rock	Soil Profile Description									
				Horizon Depth (m), Boundary	Field Texture	Structure, Strength	Inclusions Segregations	Colour, Mottle, Bleaching	Moisture, Drainage	Roots	Depth (m) / Field pH	Sample (m)	Observations
Cropping / Grazing GUP Lower slope / flat plain <1% / 1%	Cropping	Nil microrelief Extensive disturbed, contour banks nearby	Cracking, firm, Nil coarse fragments	A11 0.0 – 0.12 Abrupt	Light clay	Weak, firm, sub-rounded peds <10 mm	Nil inclusions / segregations	10YR3/2 Very dark greyish brown Nil mottles / bleaching	Dry, well drained	Present	0.10 / 8.0	0.00-0.10 0.20-0.30 0.50-0.60 0.80-0.90 0.90-1.00	Nil additional observations
				B21 0.12 – 0.45 Abrupt	Medium clay	Moderate - strong, firm, sub-angular peds 20-40 mm	Nil inclusions / segregations	10YR3/1 Very dark grey Nil mottles / bleaching	Dry, well- moderate drained	Present	0.30 / 8.0

B22 0.45 – 0.60 Abrupt	Medium clay	Moderate - strong, firm, sub-angular peds 30-60 mm	Nil inclusions / segregations	10YR3/1 Very dark grey Nil mottles / bleaching	Dry, well- moderate drained	Present	0.60 / 7.0		
				B22 0.60 – 1.00 EOBH	Medium clay	Moderate - strong, firm, sub-angular peds 30-60 mm	<2% calcium carbonate	10YR3/1 Very dark grey Nil mottles / bleaching	Dry, well- moderate drained	Present	0.90 / 7.0

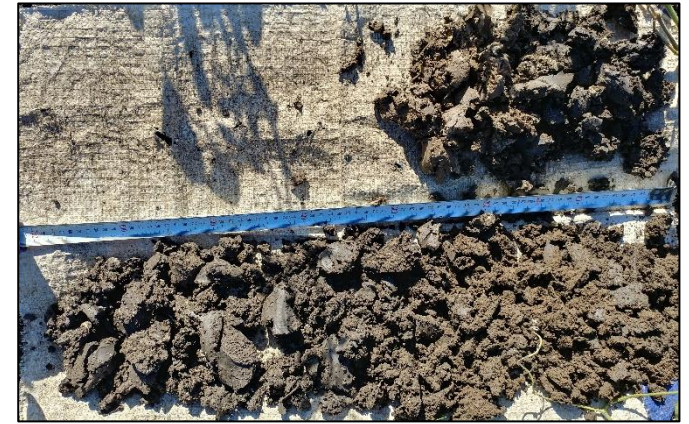
Soil Profile

<u>Land use</u> <u>Landform</u> <u>Pattern,</u> <u>Element,</u> <u>Slope</u>	<u>Vegetation</u>	<u>Microrelief</u> <u>Disturbance</u> <u>Erosion</u>	<u>Surface</u> <u>condition,</u> <u>surface rock</u>	<u>Soil Profile Description</u>									
				<u>Horizon</u> <u>Depth (m),</u> <u>Boundary</u>	<u>Field</u> <u>Texture</u>	<u>Structure,</u> <u>Strength</u>	<u>Inclusions</u> <u>Segregations</u>	<u>Colour, Mottle,</u> <u>Bleaching</u>	<u>Moisture,</u> <u>Drainage</u>	<u>Roots</u>	<u>Depth (m) /</u> <u>Field pH</u>	<u>Sample (m)</u>	<u>Observations</u>
Cropping / Grazing GUP mid slope 2% / 2%	Cropping	Nil microrelief Extensive disturbed, contour banks nearby	Cracking, firm, Nil coarse fragments	A11 0.0 – 0.20 Abrupt	Light medium clay	Moderate, firm, sub- rounded peds <10 mm	Nil inclusions / segregations	10YR3/2 Very dark greyish brown Nil mottles / bleaching	Dry, well drained	Present	0.10 / 8.0	0.00-0.10 0.20-0.30 0.50-0.60 0.80-0.90 0.90-1.00	Nil additional observations

B21 0.20 – 0.46 Abrupt	Medium clay	Moderate - strong, firm, sub-rounded peds 20 mm	Nil inclusions / segregations	10YR3/2 Very dark greyish brown Nil mottles / bleaching	Dry, well- moderate drained	Present	0.30 / 8.0		
				B22 0.46 – 0.80 Abrupt	Medium clay	Moderate - strong, firm, sub-rounded peds 20 mm	<2% calcium carbonate	10YR3/2 Very dark greyish brown Nil mottles / bleaching	Dry, well- moderate drained	Present	0.60 / 8.0		
				B23 0.80 – 1.00 EOBH	Medium clay	Moderate - strong, firm, sub-rounded peds 20 mm	<2% calcium carbonate	10YR4/4 Dark yellowish brown Nil mottles / bleaching	Dry, well- moderate drained	Nil	0.90 / 8.0

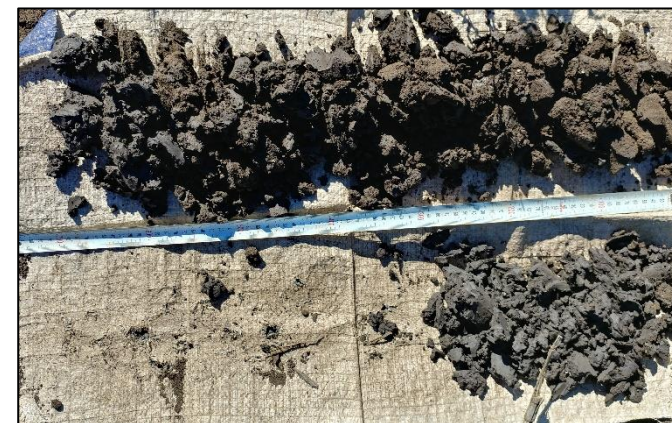
Land use Landform Pattern, Element, Slope	Vegetation	Microrelief Disturbance Erosion	Surface condition, surface rock	Soil Profile Description									
				Horizon Depth (m), Boundary	Field Texture	Structure, Strength	Inclusions Segregation s	Colour, Mottle, Bleaching	Moisture, Drainage	Roots	Depth (m) / Field pH	Sample (m)	Observations
Cropping / Grazing GUP mid slope 2% / 2%	Cropping	Nil microrelief Extensive disturbed, Nil erosion	Minor cracking, self- mulching, Nil coarse fragments	A11 0.0 – 0.04 Abrupt	Light medium clay	Moderate, firm, sub-rounded peds 20-50 mm	Nil inclusions / segregations	10YR3/2 Very dark greyish brown Nil mottles / bleaching	Dry, well drained	Present	0.10 / 8.0	0.00-0.04 0.20-0.30 0.50-0.60 0.80-0.90 0.90-1.00	Nil additional observations
				A12 0.04 – 0.20 Abrupt	Medium clay	Moderate, firm, sub-rounded peds 50-80 mm	Nil inclusions / segregations	10YR3/2 Very dark greyish brown Nil mottles / bleaching	Dry, well- moderate drained	Present	0.30 / 8.0

B21 0.20 – 0.45 Abrupt	Medium heavy clay	Moderate, - strong firm, sub-rounded peds 50-80 mm	Nil inclusions / segregations	10YR2/1 Black Nil mottles / bleaching	Dry, well- moderate drained	Present	0.60 / 8.0		
				B22 0.45 – 1.00 EOBH	Medium heavy clay	Moderate, - strong firm, sub-rounded peds 50-80 mm	Nil inclusions / segregations	10YR2/1 Black Nil mottles / bleaching	Dry, well- moderate drained	Nil	0.90 / 8.0

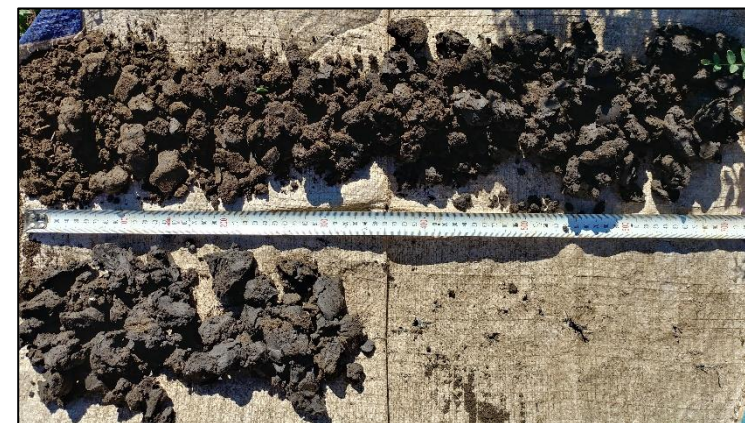
Land use Landform Pattern, Element, Slope	Vegetation	Microrelief Disturbance Erosion	Surface condition, surface rock	Soil Profile Description									
				Horizon Depth (m), Boundary	Field Texture	Structure, Strength	Inclusions Segregation s	Colour, Mottle, Bleaching	Moisture, Drainage	Roots	Depth (m) / Field pH	Sample (m)	Observations
Cropping / Grazing GUP mid slope 2% / 2%	Cropping	Nil microrelief Extensive disturbed, Nil erosion	Minor cracking, self- mulching, Nil coarse fragments	A11 0.0 – 0.06 Abrupt	Light medium clay	Moderate, firm, sub-rounded peds 20-50 mm	Nil inclusions / segregations	10YR3/2 Very dark greyish brown Nil mottles / bleaching	Dry, well drained	Present	0.10 / 8.0	0.00-0.10 0.20-0.30 0.50-0.60 0.80-0.90 0.90-1.00	Nil additional observations
				A12 0.06 – 0.22 Abrupt	Medium clay	Moderate, firm, sub-rounded peds 50-80 mm	Nil inclusions / segregations	10YR3/2 Very dark greyish brown Nil mottles / bleaching	Dry, well- moderate drained	Present	0.30 / 8.0

B21 0.22 – 0.50 Abrupt	Medium heavy clay	Moderate, - strong firm, sub-rounded peds 50-80 mm	Nil inclusions / segregations	10YR2/1 Black Nil mottles / bleaching	Dry, well- moderate drained	Present	0.60 / 8.0		
				B22 0.50 – 1.00 EOBH	Medium heavy clay	Moderate, - strong firm, sub-rounded peds 50-80 mm	Nil inclusions / segregations	10YR2/1 Black Nil mottles / bleaching	Dry, well- moderate drained	Nil	0.90 / 8.0

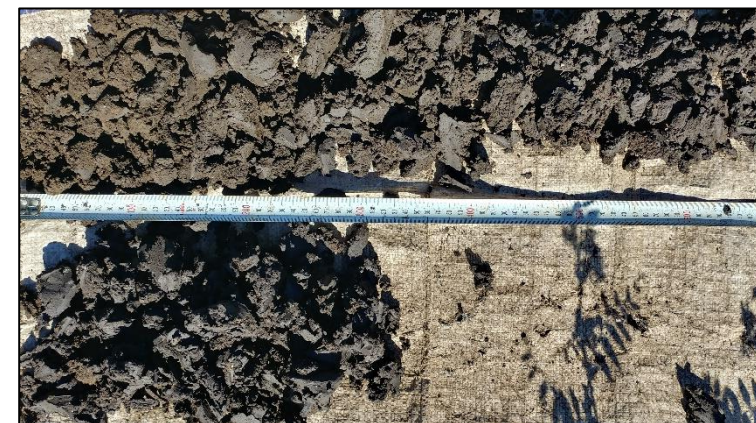
Land use Landform Pattern, Element, Slope	Vegetation	Microrelief Disturbance Erosion	Surface condition, surface rock	Soil Profile Description									
				Horizon Depth (m), Boundary	Field Texture	Structure, Strength	Inclusions Segregations	Colour, Mottle, Bleaching	Moisture, Drainage	Roots	Depth (m) / Field pH	Sample (m)	Observations
Cropping / Grazing GUP mid slope 2% / 2%	Cropping	Nil microrelief Extensive disturbed, Nil erosion	Minor cracking, self- mulching, Nil coarse fragments	A11 0.0 – 0.04 Abrupt	Light medium clay	Moderate, firm, sub-rounded peds 20-50 mm	Nil inclusions / segregations	10YR3/2 Very dark greyish brown Nil mottles / bleaching	Dry, well drained	Present	0.10 / 8.0	0.00-0.10 0.20-0.30 0.50-0.60 0.80-0.90 0.90-1.00	Nil additional observations
				A12 0.04 – 0.23 Abrupt	Medium clay	Moderate, firm, sub-rounded peds 50-80 mm	Nil inclusions / segregations	10YR3/2 Very dark greyish brown Nil mottles / bleaching	Dry, well- moderate drained	Present	0.30 / 8.0

B21 0.23 – 0.47 Abrupt	Medium heavy clay	Moderate, - strong firm, sub-rounded peds 50-80 mm	Nil inclusions / segregations	10YR2/1 Black Nil mottles / bleaching	Dry, well- moderate drained	Present	0.60 / 8.0		
				B22 0.47 – 1.00 EOBH	Medium heavy clay	Moderate, - strong firm, sub-rounded peds 50-80 mm	Nil inclusions / segregations	10YR2/1 Black Nil mottles / bleaching	Dry, well- moderate drained	Nil	0.90 / 8.0

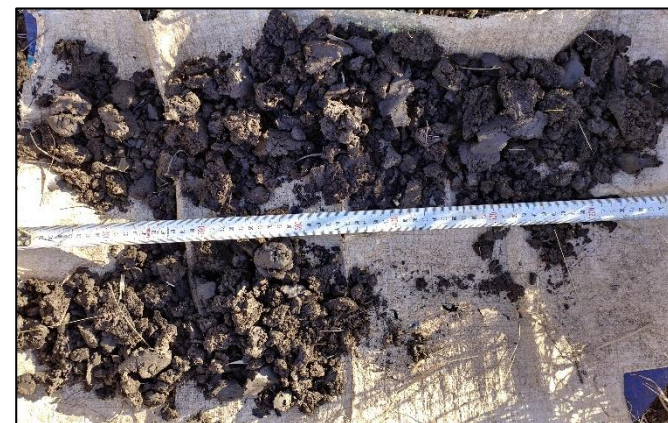
Land use Landform Pattern, Element, Slope	Vegetation	Microrelief Disturbance Erosion	Surface condition, surface rock	Soil Profile Description									
				Horizon Depth (m), Boundary	Field Texture	Structure, Strength	Inclusions Segregations	Colour, Mottle, Bleaching	Moisture, Drainage	Roots	Depth (m) / Field pH	Sample (m)	Observations
Grazing GUP Lower slope to depression 1% / 2%	Mixed vegetation, eucalyptus species, Grasses	Nil microrelief Semi disturbed, Nil erosion	Cracking, <2% coarse fragments <5mm	A11 0.0 – 0.12 Abrupt	Light clay	Moderate, firm, sub- angular <20 mm	Nil inclusions / segregations	10YR3/2 Very dark greyish brown Nil mottles / bleaching	Dry, well drained	Present	0.10 / 7.0	0.00-0.10 0.20-0.30 0.50-0.60 0.80-0.90 0.90-1.00	Nil additional observations
				B21 0.12 – 0.90 Abrupt	Medium clay	Moderate- strong, strong, sub- angular <20 mm	Nil inclusions / segregations	10YR3/2 Very dark greyish brown Nil mottles / bleaching	Dry, well- moderate drained	Present	0.30 / 7.5 0.60 / 7.5

B22 0.90 – 1.00 EOBH	Medium clay	Moderate- strong, strong, sub- angular <20 mm	<2% calcium carbonate	10YR3/2 Very dark greyish brown Nil mottles / bleaching	Dry, well- moderate drained	Present	0.90 / 8.0

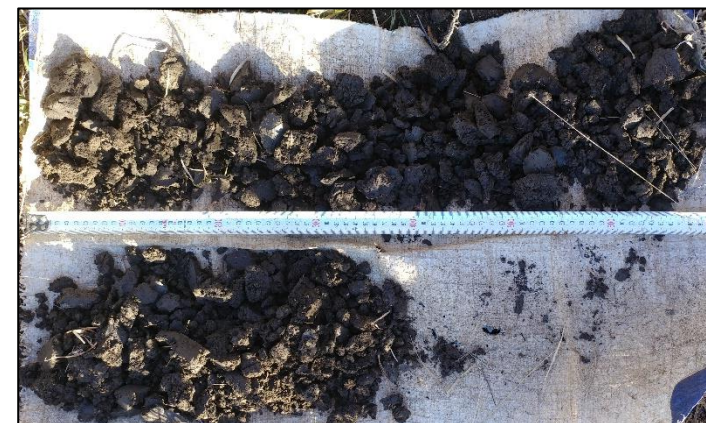
Land use Landform Pattern, Element, Slope	Vegetation	Microrelief Disturbance Erosion	Surface condition, surface rock	Soil Profile Description									
				Horizon Depth (m), Boundary	Field Texture	Structure, Strength	Inclusions Segregations	Colour, Mottle, Bleaching	Moisture, Drainage	Roots	Depth (m) / Field pH	Sample (m)	Observations
Grazing GUP Lower slope to depression 1% / 2%	Mixed vegetation, eucalyptus species, Grasses	Nil microrelief Semi disturbed, Nil erosion	Cracking, <2% coarse fragments <5mm	A11 0.0 – 0.13 Abrupt	Light clay	Moderate, firm, sub- angular <20 mm	Nil inclusions / segregations	10YR3/2 Very dark greyish brown Nil mottles / bleaching	Dry, well drained	Present	0.10 / 7.0	0.00-0.10 0.20-0.30 0.50-0.60 0.80-0.90 0.90-1.00	Nil additional observations
				B21 0.13 – 0.85 Abrupt	Medium clay	Moderate- strong, strong, sub- angular <20 mm	Nil inclusions / segregations	10YR3/2 Very dark greyish brown Nil mottles / bleaching	Dry, well- moderate drained	Present	0.30 / 7.5 0.60 / 7.5

B22 0.85 – 1.00 EOBH	Medium clay	Moderate- strong, strong, sub- angular <20 mm	<2% calcium carbonate	10YR3/2 Very dark greyish brown Nil mottles / bleaching	Dry, well- moderate drained	Present	0.90 / 8.0
