SITE N1

Map Unit 7	Location (GDA94 ZONE 55): 641005 mE 7512573 mN	Aust. Soil Class.: Crusting Grey (minor black) Vertosol	Site Survey Type: Detailed - 50mm hand auger	Survey Date: 30/06/2018
----------------------	--	---	--	-----------------------------------

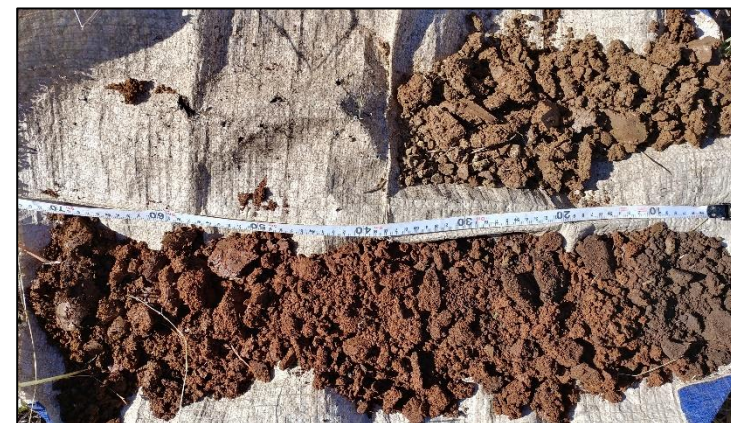
Land use Landform Pattern, Element, Slope	Vegetation	Microrelief Disturbance Erosion	Surface condition, surface rock	Soil Profile Description									
				Horizon Depth (m), Boundary	Field Texture	Structure, Strength	Inclusions Segregations	Colour, Mottle, Bleaching	Moisture, Drainage	Roots	Depth (m) / Field pH	Sample (m)	Observations
Grazing GUP Mid - lower slope <2% / <2%	Grasses	Nil microrelief Extensive disturbed, Nil erosion	Firm Nil coarse fragments	A11 0.0 – 0.12 Abrupt	Sandy loam	Weak- moderate, firm, sub- rounded <20 mm	Nil inclusions / segregations	10YR3/2 Very dark greyish brown Nil mottles / bleaching	Dry, well drained	Present	0.10 / 6.5	0.00-0.10 0.20-0.30 0.50-0.60 0.80-0.90 0.90-1.00	Nil additional observations
				B21 0.12 – 0.70 Abrupt	Sandy clay loam	Moderate, firm, sub- angular <20 mm	Nil inclusions / segregations	5YR4/3 Reddish brown Nil mottles / bleaching	Dry, well- moderate drained	Present	0.30 / 7.0 0.60 / 7.5

B22 0.70 – 1.00 EOBH	Light clay	Moderate, v.firm, sub- angular <20 mm	<5% calcium carbonate	7.5YR4/4 Brown Nil mottles / bleaching	Dry, well- moderate drained	Present	0.90 / 7.5

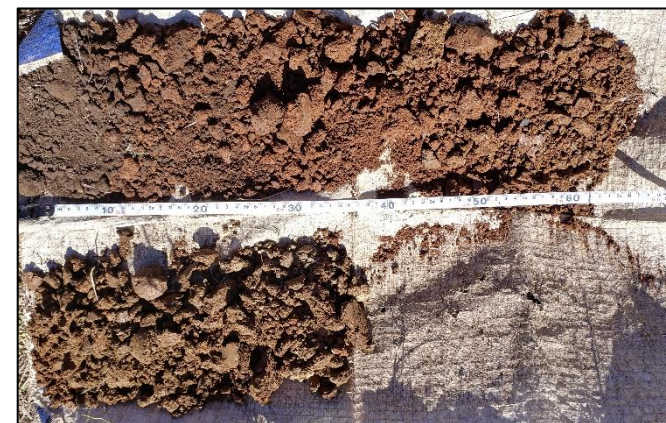
Land use Landform Pattern, Element, Slope	Vegetation	Microrelief Disturbance Erosion	Surface condition, surface rock	Soil Profile Description									
				Horizon Depth (m), Boundary	Field Texture	Structure, Strength	Inclusions Segregations	Colour, Mottle, Bleaching	Moisture, Drainage	Roots	Depth (m) / Field pH	Sample (m)	Observations
Grazing GUP Mid - lower slope <2% / <2%	Grasses	Nil microrelief Extensive disturbed, Nil erosion	Firm Nil coarse fragments	A11 0.0 – 0.14 Clear	Sandy loam	Weak- moderate, firm, sub- rounded <20 mm	Nil inclusions / segregations	10YR3/2 Very dark greyish brown Nil mottles / bleaching	Dry, well drained	Present	0.10 / 6.5	0.00-0.10 0.20-0.30 0.50-0.60 0.80-0.90 0.90-1.00	Nil additional observations
				B21 0.14 – 0.70 Abrupt	Light clay	Moderate, firm, sub- angular <20 mm	Nil inclusions / segregations	5YR4/3 Reddish brown Nil mottles / bleaching	Dry, well- moderate drained	Present	0.30 / 7.0 0.60 / 7.5

B22 0.70 – 1.00 EOBH	Light clay	Moderate, v.firm, sub- angular <20 mm	<5% calcium carbonate	7.5YR4/4 Brown Nil mottles / bleaching	Dry, well- moderate drained	Present	0.90 / 7.5

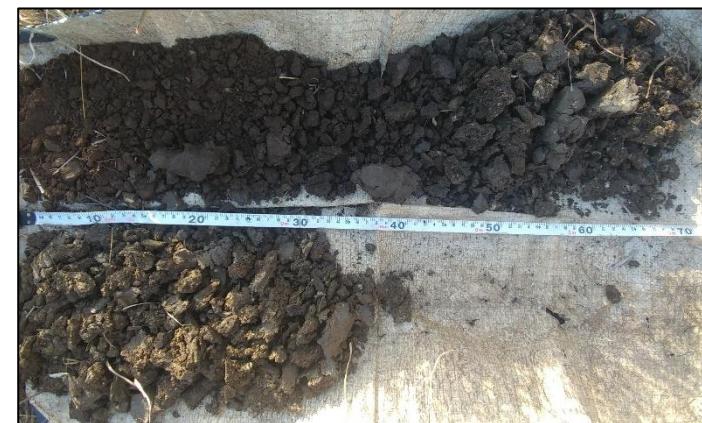
Land use Landform Pattern, Element, Slope	Vegetation	Microrelief Disturbance Erosion	Surface condition, surface rock	Soil Profile Description									
				Horizon Depth (m), Boundary	Field Texture	Structure, Strength	Inclusions Segregations	Colour, Mottle, Bleaching	Moisture, Drainage	Roots	Depth (m) / Field pH	Sample (m)	Observations
Grazing GUP upper slope <2% / <2%	Eucalyptus species	Nil microrelief Semi disturbed, contour banks nearby Nil erosion	Minor cracking, firm, nil coarse fragments	A11 0.0 – 0.06 Abrupt	Sandy clay loam	Massive	Nil inclusions or segregations	10YR3/2 Very dark greyish brown Nil mottles / bleaching	Dry, well drained	Present	0.10 / 7.5	0.00-0.10	Nil additional observations
				A12 0.06 – 0.20 gradual	Sandy clay loam	Weak, sub- rounded peds <10 mm	Nil inclusions or segregations	10YR3/2 Very dark greyish brown Nil mottles / bleaching	Dry, well drained	Present	0.20 / 7.5	0.20-0.30

B21 0.20 – 0.46 gradual	Sandy clay loam	Subangular blocky, moderate, peds <20 mm, firm	Nil inclusions or segregations	10YR3/2 Very dark greyish brown Nil mottles / bleaching	Dry, well drained	Present	0.30 / 7.5	0.50-0.60	
				B22 0.46 – 1.00 EOBH	Medium clay, sandy	Subangular blocky, moderate, peds <20 mm, firm	<20% calcium carbonate	10YR3/3 Dark reddish brown Nil mottles / bleaching	Dry, well – moderate drained	Present	0.60 / 7.5 0.90 / 7.5	0.80-0.90 0.90-1.00

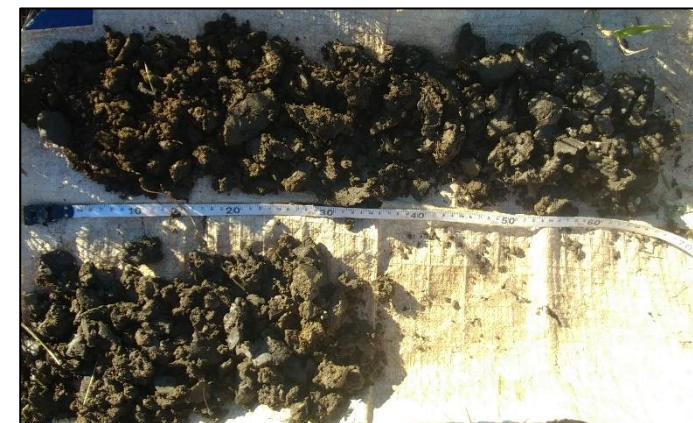
Land use Landform Pattern, Element, Slope	Vegetation	Microrelief Disturbance Erosion	Surface condition, surface rock	Soil Profile Description									
				Horizon Depth (m), Boundary	Field Texture	Structure, Strength	Inclusions Segregations	Colour, Mottle, Bleaching	Moisture, Drainage	Roots	Depth (m) / Field pH	Sample (m)	Observations
Grazing GUP Lower slope 1% / 1%	Short grasses	Nil microrelief Extensive disturbance Nil erosion	Minor cracking	A1 0.00-0.15 Abrupt	Light clay	Weak, soft sub- rounded <10mm	Nil inclusions / segregations	10YR3/1 Very dark grey Nil mottles/bleach	Dry, moderate	Few fine	0.10 / 6.0	0.00-0.10 0.20-0.30 0.50-0.60 0.80-0.90 0.90-1.00	Nil additional observations
				B21 0.15-0.45 Abrupt	Medium clay	Weak to moderate, firm sub- rounded <10mm	Nil inclusions / segregations	10YR2/2 Very dark brown Nil mottles/bleach	Dry, moderate	Very fine, very few	0.30 / 6.5		
				B22 0.45-1.00 EOBH	Medium clay	Moderate, firm sub- rounded <20mm	Nil inclusions / segregations	10YR3/3 Dark brown Nil mottles/bleach	Dry, moderate	Very fine, very few	0.60 / 7.0 0.90 / 7.0

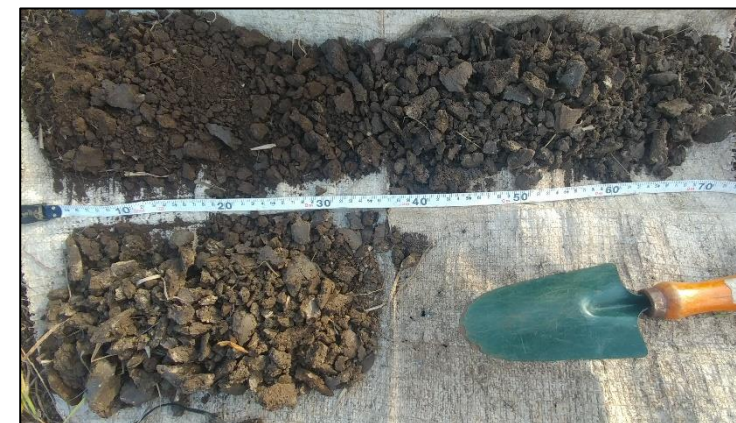
Land use Landform Pattern, Element, Slope	Vegetation	Microrelief Disturbance Erosion	Surface condition, surface rock	Soil Profile Description									
				Horizon Depth (m), Boundary	Field Texture	Structure, Strength	Inclusions Segregations	Colour, Mottle, Bleaching	Moisture, Drainage	Roots	Depth (m) / Field pH	Sample (m)	Observations
Grazing GUP upper slope <2% / <2%	Eucalyptus species	Nil microrelief Semi disturbed, contour banks nearby	Minor cracks, firm, Nil coarse fragments	A11 0.0 – 0.09 Abrupt	Sandy clay loam	Massive	Nil inclusions or segregations	10YR3/2 Very dark greyish brown Nil mottles / bleaching	Dry, well drained	Present	0.10 / 7.5	0.00-0.10	Nil additional observations
				A12 0.09 – 0.25 gradual	Sandy clay loam	Weak, sub- rounded peds <10 mm	Nil inclusions or segregations	10YR3/2 Very dark greyish brown Nil mottles / bleaching	Dry, well drained	Present	0.20 / 7.5	0.20-0.30	
				B22 0.25 – 0.50 gradual	Sandy clay loam	Subangular blocky, moderate, peds <20 mm, firm	Nil inclusions or segregations	10YR3/2 Very dark greyish brown Nil mottles / bleaching	Dry, well drained	Present	0.30 / 7.5	0.50-0.60

B23 0.50 – 1.00 EOBH	Medium clay, sandy	Subangular blocky, moderate, peds <20 mm, firm	<20% calcium carbonate	10YR3/3 Dark brown Nil mottles / bleaching	Dry, well – moderate drained	Present	0.60 / 7.5 0.90 / 7.5	0.80-0.90 0.90-1.00

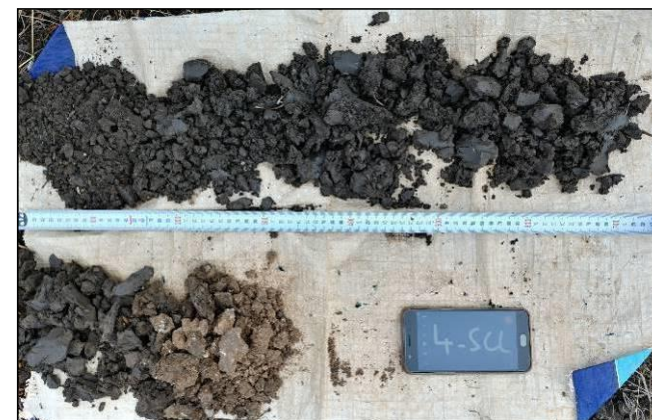
Land use Landform Pattern, Element, Slope	Vegetation	Microrelief Disturbance Erosion	Surface condition, surface rock	Soil Profile Description									
				Horizon Depth (m), Boundary	Field Texture	Structure, Strength	Inclusions Segregations	Colour, Mottle, Bleaching	Moisture, Drainage	Roots	Depth (m) / Field pH	Sample (m)	Observations
Grazing, Very gently undulating plains, upper slope, <1.0/1.0	Cleared, very sparse mixed regrowth	Nil microrelief Semi cleared, Nil erosion	Cracking 20- 40mm, self mulching Nil coarse fragments	A1 0.00-0.14 Abrupt	Light clay	Weak, firm, <10mm sub-angular	Nil inclusion or segregations	10YR3/2 Very dark greyish brown Nil mottles/bleach	Dry, moderate	Fine, few	0.10 / 6.5	0.00-0.10	Nil additional observations
				B21 0.14-0.90 Abrupt	Medium clay	Moderate, firm <40% 20-60mm, <20% 60-100 sub- angular blocky peds	<1% calcium carbonate nodules	10YR3/2 Very dark greyish brown Nil mottles/bleach	Dry, moderate	Very fine, very few	0.30 / 6.5 0.60 / 7.5	0.20-0.30 0.50-0.60 0.70-0.80

B22 0.90-1.00 EOBH	Medium clay	Moderate, firm <40% 20-60mm, <20% 60-100 sub- angular blocky peds	2% calcium carbonate nodules	10YR4/2 Dark greyish brown Mottles 2% 10YR3/2 Very dark greyish brown Nil bleach	Dry, Imperfect	Very fine, very few	0.90 / 8.0	0.90-1.00

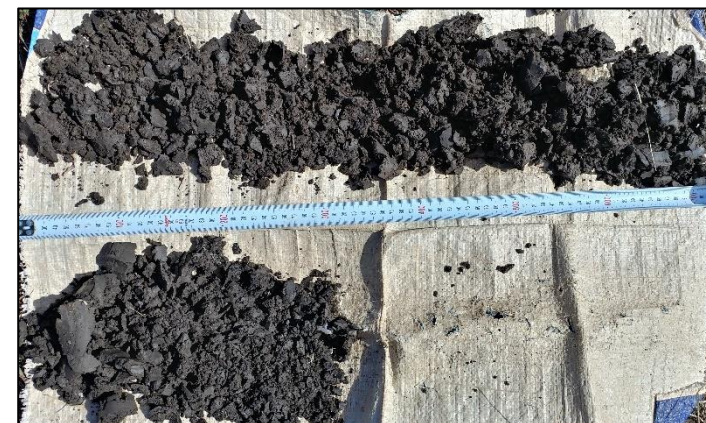
Land use Landform Pattern, Element, Slope	Vegetation	Microrelief Disturbance Erosion	Surface condition, surface rock	Soil Profile Description									
				Horizon Depth (m), Boundary	Field Texture	Structure, Strength	Inclusions Segregations	Colour, Mottle, Bleaching	Moisture, Drainage	Roots	Depth (m) / Field pH	Sample (m)	Observations
Gently undulating plain 2.0/2.0	Grasses, recent regrowth and shrubs	Microrelief present – Depression <0.2m deep, 40% coverage Extensive clearing Nil Erosion	Self-mulching with cracking Nil coarse fragments	A1 0.00-0.17 Abrupt	Light medium clay	Weak, firm <20mm sub-angular	<1% Calcium carbonate <2mm	10YR3/1 Very dark grey Nil mottle / bleaching	Dry, Well drained	Common, medium	0.10 / 6.5	0.00-0.10 0.20-0.30 0.50-0.60 0.80-0.90 0.90-1.00	Nil additional observations
				B2 0.17-1.00 EOBH	Medium heavy clay	Moderate, Very firm 20-40mm sub-angular	<2% Calcium carbonate <2mm	10YR3/2 Very dark greyish brown Nil mottle / bleaching	Dry, Moderate drained	Few, medium	0.30 / 6.5 0.60 / 6.5 0.90 / 6.5

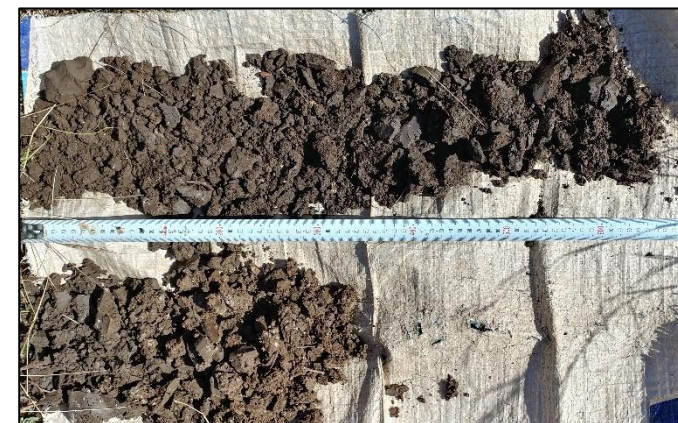
Land use Landform Pattern, Element, Slope	Vegetation	Microrelief Disturbance Erosion	Surface condition, surface rock	Soil Profile Description									
				Horizon Depth (m), Boundary	Field Texture	Structure, Strength	Inclusions Segregations	Colour, Mottle, Bleaching	Moisture, Drainage	Roots	Depth (m) / Field pH	Sample (m)	Observations
Gently undulating plain, mid-slope 2.0/2.0	101	Microrelief present – Mound 40% coverage Extensive clearing Nil Erosion	Self-mulching with cracking Nil coarse fragments	A1 0.00-0.12 Abrupt	Light clay	Moderate, soft <20mm sub-angular	Nil inclusions and segregations	10YR2/1 Black Nil mottle / bleaching	Humid, Well drained	Common, medium	0.10 / 6.5	0.00-0.10 0.20-0.30 0.50-0.60 0.80-0.90 0.90-1.00	Nil additional observations
				B21 0.12-0.60 Abrupt	Medium heavy clay	Moderate, Firm <30mm sub-angular	Nil inclusions and segregations	10YR3/1 Very dark grey Nil mottle / bleaching	Humid, Well drained	Few, medium	0.30 / 7.0

B22 0.60-1.00 EOBH	Medium heavy clay	Moderate, Firm <30mm sub-angular	<2% Calcium carbonate	10YR3/1 Very dark grey Nil mottle / bleaching	Humid, Well - moderate drained	Few, fine	0.10 / 7.0

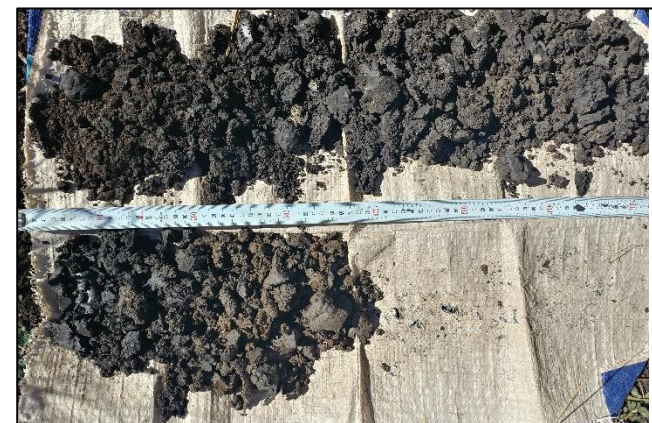
Land use Landform Pattern, Element, Slope	Vegetation	Microrelief Disturbance Erosion	Surface condition, surface rock	Soil Profile Description									
				Horizon Depth (m), Boundary	Field Texture	Structure, Strength	Inclusions Segregations	Colour, Mottle, Bleaching	Moisture, Drainage	Roots	Depth (m) / Field pH	Sample (m)	Observations
Grazing, mid-slope, 2.0/2.0	Grasses	Nil microrelief Extensively disturbance Nil erosion	Humid self- mulching with crust 2-6 mm thick, minor sand on surface. Coarse fragments` <5 mm <5%	A1 0.00 – 0.15 Abrupt	Light clay, sandy	Weak, firm Subangular blocky, peds 10-30 mm,	Nil inclusions and segregations	10YR2/1 Black Nil mottles / bleaching	Humid, Well – moderate drained	Fine, very few	0.10 / 6.5	0.00-0.10 0.20-0.30 0.50-0.60 0.80-0.90 0.90-1.00	Nil additional observations
				B21 0.15 – 0.30 Abrupt	Medium heavy clay	Weak, firm Subangular blocky, peds 20-30 mm,	Nil inclusions and segregations	10YR2/1 Black Nil mottles / bleaching	Humid, Well – moderate drained	Fine, very few	0.35 / 7.0

B22 0.30 – 0.80 Abrupt	Medium heavy clay	Weak to moderate, very firm Subangular blocky, peds 20-30 mm,	<5% calcium carbonate	10YR2/1 Black Nil mottles / bleaching	Humid, Well – moderate drained	Fine, very few	0.60 / 7.0		
				B23 0.80 – 1.00 EOBH	Medium heavy clay, sandy	Weak to moderate, very firm Subangular blocky, peds 40-60 mm,	Nil inclusions and segregations	10YR4/2 Dark greyish brown Nil mottles / bleaching	Humid, Well – moderate drained	Nil roots	0.90 / 7.5

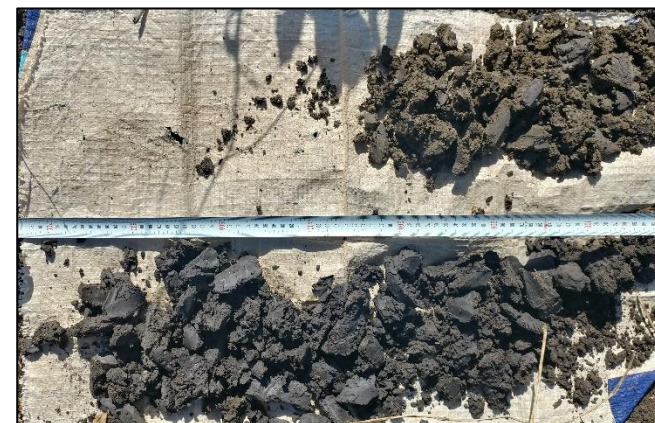
Land use Landform Pattern, Element, Slope	Vegetation	Microrelief Disturbance Erosion	Surface condition, surface rock	Soil Profile Description									
				Horizon Depth (m), Boundary	Field Texture	Structure, Strength	Inclusions Segregations	Colour, Mottle, Bleaching	Moisture, Drainage	Roots	Depth (m) / Field pH	Sample (m)	Observations
Cropping, Very gently undulating plain, mid-slope, 1% slope	Forage crops	Nil microrelief Extensively disturbed for cropping Nil erosion	Self-mulching with crust 2-6 mm thick, minor sand on surface. Coarse fragments <5 mm <5%	A1 0.00 – 0.14 Abrupt	Light clay, sandy	Subangular blocky, peds 10-30 mm, firm	Nil inclusions and segregations	10YR2/1 Black Nil mottles / bleaching	Humid, well drained	Fine, very few	0.10 / 7.0	0.00-0.10 0.20-0.30 0.50-0.60 0.80-0.90 0.90-1.00	Nil additional observations
				B21 0.14 – 0.70 Abrupt	Medium heavy clay	Subangular blocky, peds 20-30 mm, strong	<5% calcium carbonate	10YR2/1 Black Nil mottles / bleaching	Humid, well drained	Fine, very few	0.30 / 7.0 0.60 / 6.5

B22 0.70 – 1.00 EOBH	Medium heavy clay, sandy	Subangular blocky, peds 40-60 mm, strong	<1% red nodules <2mm	10YR3/1 Very dark grey Nil mottles / bleaching	Humid, well drained	Nil roots	0.90 / 6.5

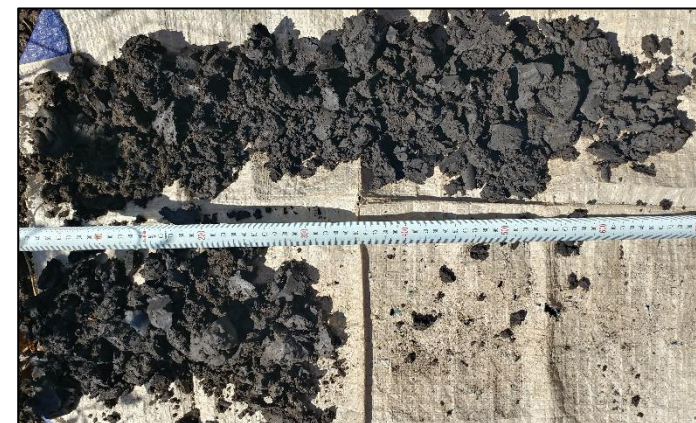
Land use Landform Pattern, Element, Slope	Vegetation	Microrelief Disturbance Erosion	Surface condition, surface rock	Soil Profile Description									
				Horizon Depth (m), Boundary	Field Texture	Structure, Strength	Inclusions Segregations	Colour, Mottle, Bleaching	Moisture, Drainage	Roots	Depth (m) / Field pH	Sample (m)	Observations
Cropping, mid-slope, 2% slope	Forage crops	Nil microrelief Nil erosion Extensively disturbed for cropping	Humid, soft, cracking <2mm, occasional course fragments <5mm	A1 0.0 – 0.10 Abrupt	Medium Clay	Subangular blocky, peds 20-30 mm, firm	Nil inclusions and segregations	10YR2/1 Black Nil mottles / bleaching	Humid, well drained	Fine, very few	0.10 / 6.5	0.00-0.10 0.20-0.30 0.50-0.60 0.80-0.90 0.90-1.00	Nil additional observations
				B21 0.10 – 0.70 Abrupt	Medium heavy clay	Subangular blocky, peds 20-30 mm, strong	Nil inclusions and segregations	10YR2/1 Black Nil mottles / bleaching	Humid, well drained	Fine, very few	0.30 / 6.5 0.60 / 7.0

B22 0.70 – 1.00 EOBH	Medium heavy clay	Subangular blocky, peds 40-60 mm, strong	Nil inclusions and segregations	10YR3/2 Very dark greyish brown Nil mottles / bleaching	Humid, well drained	Nil roots	0.90 / 6.5

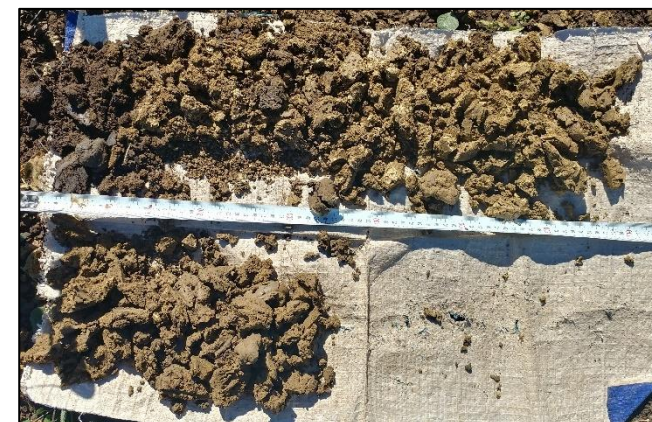
Land use Landform Pattern, Element, Slope	Vegetation	Microrelief Disturbance Erosion	Surface condition, surface rock	Soil Profile Description									
				Horizon Depth (m), Boundary	Field Texture	Structure, Strength	Inclusions Segregations	Colour, Mottle, Bleaching	Moisture, Drainage	Roots	Depth (m) / Field pH	Sample (m)	Observations
Cropping, mid-slope, 2% slope	Forage crops	Nil microrelief Nil erosion Extensively disturbed for cropping	Self-mulching, Minor cracking <2mm, Nil coarse fragments	A1 0.0 – 0.07 Abrupt	Light clay, sandy	Subangular blocky, peds 20-30 mm, firm	Nil inclusions and segregations	10YR3/2 Greyish brown Nil mottles / bleaching	Humid, well drained	Fine, very few	0.10 / 6.5	0.00-0.10 0.20-0.30 0.50-0.60 0.80-0.90 0.90-1.00	Nil additional observations
				B21 0.07 – 0.60 Abrupt	Light clay, sandy	Subangular blocky, peds 20-30 mm, strong	20% calcium carbonate	10YR4/3 Brown Mottle: 5% 10YR6/4 light yellowish brown	Humid, moderately well drained	Fine, very few	0.30 / 7.0 0.60 / 7.0

B22 0.60 – 1.00 EOBH	Medium clay	Subangular blocky, moderate, peds 40-60 mm, firm	Nil inclusions and segregations	10YR4/4 Dark yellowish brown Nil mottles / bleaching	dry, well drained	Nil roots	0.90 / 7.0

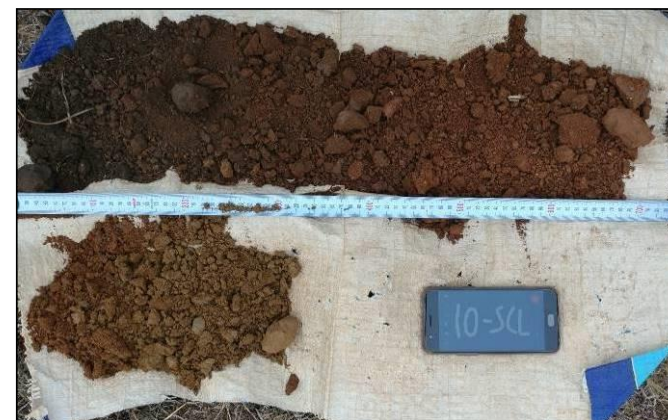
Land use Landform Pattern, Element, Slope	Vegetation	Microrelief Disturbance Erosion	Surface condition, surface rock	Soil Profile Description									
				Horizon Depth (m), Boundary	Field Texture	Structure, Strength	Inclusions Segregations	Colour, Mottle, Bleaching	Moisture, Drainage	Roots	Depth (m) / Field pH	Sample (m)	Observations
Grazing Very gently undulating plain, Midslope 2.0/1.0	Buffel grass	Nil microrelief Extensive cleared Nil erosion	Minor cracking 2- 6mm, soft, Nil coarse fragments	A1 0.00-0.13 Abrupt	Sandy clay	Moderate, firm, <10mm sub-angular	<1% calcium carbonate nodules	10YR3/2 Very dark greyish brown Nil mottles / bleaching	Dry, moderate	Few, fine	0.10 / 7.0	0.00-0.10	First borehole, 0.20 mbgl Second borehole 0.40 mbgl Refusal likely due to roots, no physical barrier
				A2 0.13-0.39 Abrupt	Light sandy clay	Moderate, firm, <10mm sub-angular	Nil inclusion or segregations	10YR3/3 Dark Brown Nil mottles / bleaching	Dry, moderate	Few, fine	0.30 / 7.0	0.20-0.30 0.50-0.60

B21 0.39-0.84 Abrupt	Light sandy clay	Moderate, firm, <10mm sub-angular	<10% calcium carbonate nodules	5YR4/4 Reddish brown Nil mottles / bleaching	Dry, moderate	Few, fine	0.60 / 7.5	0.70-0.80 0.90-1.00	
				B22 0.84-1.00 EOBH	Light clay	Moderate, firm, <10mm sub-angular	<2% calcium carbonate nodules	10YR4/4 Dark yellowish brown Nil mottles/bleach	Dry, moderate	Very few, very fine	0.90 / 8.5

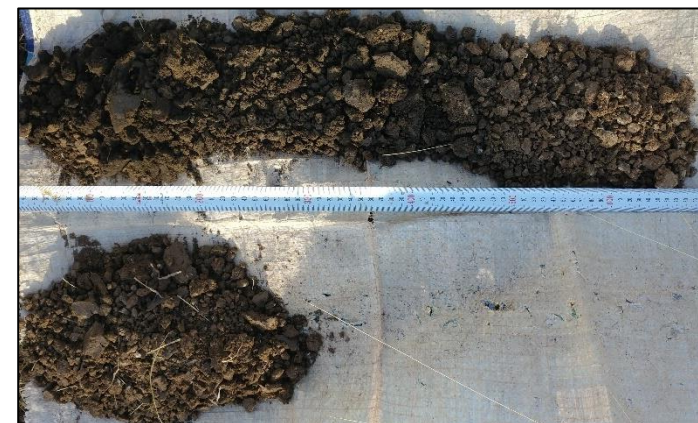
Land use Landform Pattern, Element, Slope	Vegetation	Microrelief Disturbance Erosion	Surface condition, surface rock	Soil Profile Description									
				Horizon Depth (m), Boundary	Field Texture	Structure, Strength	Inclusions Segregations	Colour, Mottle, Bleaching	Moisture, Drainage	Roots	Depth (m) / Field pH	Sample (m)	Observations
Upper- slope, 2% slope	Grasses, with Brigalow nearby	Nil Microrelief Nil erosion Extensively cleared	Firm, cracking 2mm, Nil coarse fragments	A1 0.0 – 0.12 gradual	Sandy clay loam	Weak, sub- rounded peds <10 mm, soft	Nil inclusions or segregations	10YR2/2 Very dark brown Nil mottles / bleaching	Humid, well drained	Fine, very few	0.10 / 6.5	0.00-0.10 0.20-0.30 0.50-0.60 0.80-0.90 0.90-1.00	Nil additional observations
				B21 0.12 – 0.22 gradual	Sandy clay loam	Weak, peds <10 mm, very firm	Nil inclusions or segregations	10YR2/2 Very dark brown Nil mottles / bleaching	Humid, well drained	Fine, very few	0.20 / 6.5

B22 0.22 – 0.55 gradual	Light clay, sandy	Subangular blocky, moderate, peds <20 mm, very firm	<2% calcium carbonate	10YR3/2 Very dark greyish brown Nil mottles / bleaching	Humid, moderate y well drained	Nil roots	0.30 / 6.5		
				B23 0.55 – 1.00 EOBH	Medium clay, sandy	Subangular blocky, moderate, peds <20 mm, very firm	<2% calcium carbonate	10YR3/2 Very dark greyish brown Nil mottles / bleaching	Humid, moderate y well drained	Nil roots	0.60 / 7.0 0.90 / 6.5

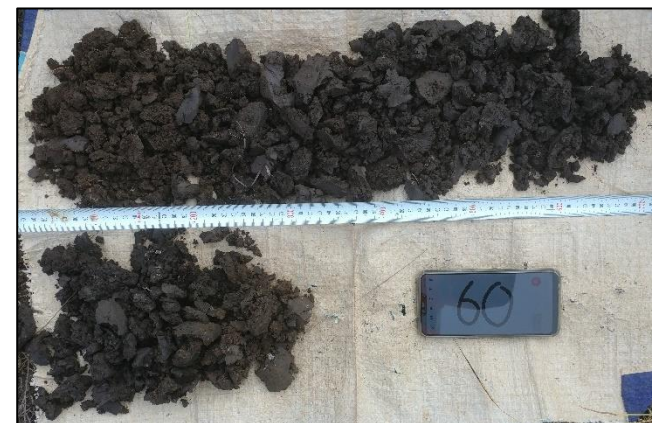
Land use Landform Pattern, Element, Slope	Vegetation	Microrelief Disturbance Erosion	Surface condition, surface rock	Soil Profile Description									
				Horizon Depth (m), Boundary	Field Texture	Structure, Strength	Inclusions Segregation s	Colour, Mottle, Bleaching	Moisture, Drainage	Roots	Depth (m) / Field pH	Sample (m)	Observations
Cropping, upper-slope, 0% / 2% slope	Grasses	Nil microrelief Nil erosion extensively disturbed	self-mulching, cracking 6+mm Nil coarse fragments	A1 0.0 – 0.13 Abrupt	Light clay	Moderate, Sub- rounded, peds <10 mm, soft	Nil inclusions or segregations	10YR3/2 Very dark greyish brown Nil mottles / bleaching	Dry, well drained	Fine, very few	0.10 / 7.0	0.00-0.10 0.20-0.30 0.50-0.60 0.80-0.90 0.90-1.00	Nil additional observations
				B21 0.13 – 0.41 Abrupt	Medium clay	Moderate, Subangular blocky, peds <20 mm, firm	Nil inclusions or segregations	10YR2/1 Black Nil mottles / bleaching	Dry, well drained	Very fine, very few	0.30 / 7.5

B22 0.41 – 1.00 EOBH	Medium clay	Moderate, Subangular blocky, peds <20 mm, firm	<2% calcium carbonate	10YR2/1 Black Nil mottles / bleaching	Dry, moderately well drained	Nil roots	0.60 / 7.0 0.90 / 7.0

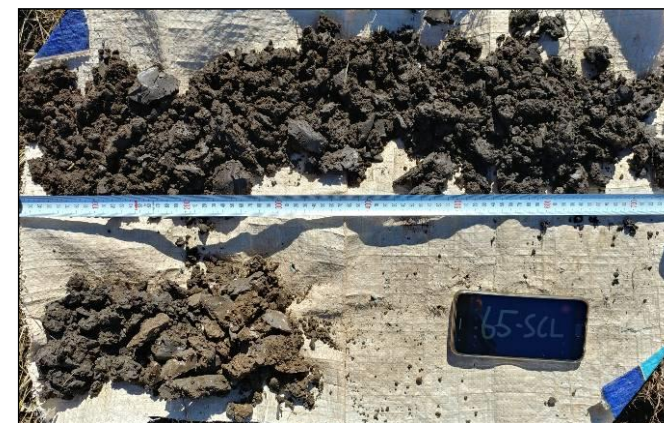
Land use Landform Pattern, Element, Slope	Vegetation	Microrelief Disturbance Erosion	Surface condition, surface rock	Soil Profile Description									
				Horizon Depth (m), Boundary	Field Texture	Structure, Strength	Inclusions Segregations	Colour, Mottle, Bleaching	Moisture, Drainage	Roots	Depth (m) / Field pH	Sample (m)	Observations
Cropping Very gently undulating plain Flat plain 1.0/1.0	Cropping, Brigalow 100-200m nearby	Nil microrelief Cropping disturbance Nil erosion	Soft, loose, Nil coarse fragments	A1 0.00-0.11 Abrupt	Light clay	Moderate, weak < 10mm sub-angular	Nil inclusions and segregations	10YR3/1 Very dark grey Nil mottles / bleaching	Dry, moderate	Few fine	0.10 / 6.0	0.00-0.10 0.20-0.30 0.50-0.60 0.80-0.90 0.90-1.00	Nil additional observations
				B21 0.11-0.80 Abrupt	Medium clay	Moderate, weak < 10mm sub-angular	Nil inclusions and segregations	10YR2/2 Very dark brown Nil mottles / bleaching	Dry, moderate	Very fine, very few	0.30 / 6.5 0.60 / 7.0

B22 0.80-1.00 EOBH	Medium clay	Moderate, weak < 10mm sub-angular	2% calcium carbonate nodules	10YR3/3 Dark brown Nil mottles / bleaching	Dry, moderate	Very fine, very few	0.90 / 7.5

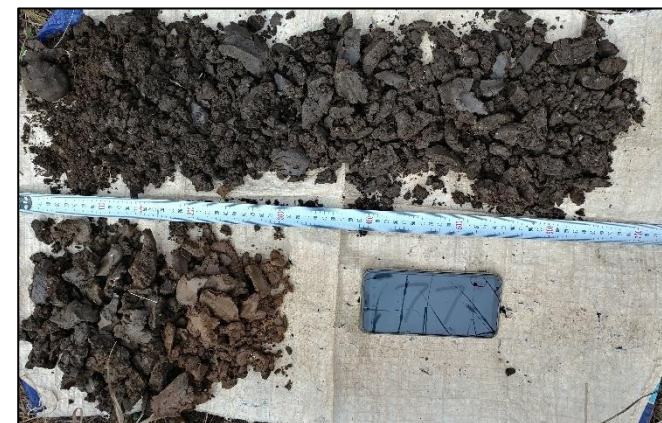
Land use Landform Pattern, Element, Slope	Vegetation	Microrelief Disturbance Erosion	Surface condition, surface rock	Soil Profile Description									
				Horizon Depth (m), Boundary	Field Texture	Structure, Strength	Inclusions Segregations	Colour, Mottle, Bleaching	Moisture, Drainage	Roots	Depth (m) / Field pH	Sample (m)	Observations
Cropping, upper-slope, 1% / 2% slope	Grasses, with Brigalow nearby	Nil microrelief Nil erosion Semi disturbed	Firm with areas of self- mulching, cracking 2- 6+mm	A1 0.0 – 0.13 Abrupt	Sandy clay loam	Weak, Sub- rounded, peds <10 mm, soft	Nil inclusions or segregations	10YR3/1 Very dark grey Nil mottles / bleaching	Humid, well drained	Fine, very few	0.10 / 7.5	0.00-0.10 0.20-0.30 0.50-0.60 0.80-0.90 0.90-1.00	Nil additional observations
				B21 0.13 – 0.39 gradual	Medium clay	Moderate, Subangular blocky, peds <20 mm, firm	Nil inclusions or segregations	10YR3/2 Very dark greyish brown Nil mottles / bleaching	Dry, well drained	Very fine, very few	0.30 / 7.5

B22 0.39 – 0.90 clear	Medium clay	Moderate, Subangular blocky, peds <20 mm, firm	<2% calcium carbonate	10YR3/2 Very dark greyish brown Nil mottles / bleaching	Dry, moderately well drained	Very fine, very few	0.60 / 7.0		
				B23 0.90 – 1.00 EOBH	Medium clay	Moderate, Subangular blocky, peds <20 mm, firm	<2% calcium carbonate	10YR4/2 Dark greyish brown Nil mottles / bleaching	Dry, moderately well drained	Very fine, very few	0.90 / 7.0

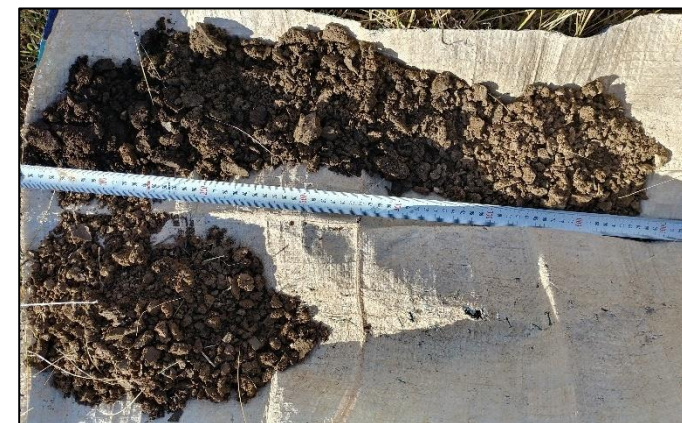
Land use Landform Pattern, Element, Slope	Vegetation	Microrelief Disturbance Erosion	Surface condition, surface rock	Soil Profile Description									
				Horizon Depth (m), Boundary	Field Texture	Structure, Strength	Inclusions Segregations	Colour, Mottle, Bleaching	Moisture, Drainage	Roots	Depth (m) / Field pH	Sample (m)	Observations
Upper- slope, 2% slope	Grasses, with Brigalow nearby	Nil Microrelief Nil erosion Extensively cleared	Firm, cracking 2mm, Nil coarse fragments	A1 0.0 – 0.11 Abrupt	Sandy clay loam	Weak, sub- rounded peds <10 mm, soft	Nil inclusions or segregations	10YR2/2 Very dark brown Nil mottles / bleaching	Humid, well drained	Fine, very few	0.10 / 6.5	0.00-0.10 0.20-0.30 0.50-0.60 0.80-0.90 0.90-1.00	Nil additional observations
				A2 0.11 – 0.22 clear	Sandy clay loam	Weak, peds <10 mm, very firm	Nil inclusions or segregations	10YR2/2 Nil mottles / bleaching	Humid, well drained	Nil roots	0.20 / 6.5

B21 0.22 – 0.49 gradual	Light clay, sandy	Subangular blocky, moderate, peds <20 mm, very firm	<2% calcium carbonate	10YR3/1 Very dark grey Nil mottles / bleaching	Humid, moderately well drained	Nil roots	0.30 / 7.0		
				B22 0.49 – 1.00 EOBH	Medium clay, sandy	Subangular blocky, moderate, peds <20 mm, very firm	<1% calcium carbonate	10YR3/2 Very dark greyish brown Nil mottles / bleaching	Humid, moderately well drained	Nil roots	0.60 / 7.0 0.90 / 6.5

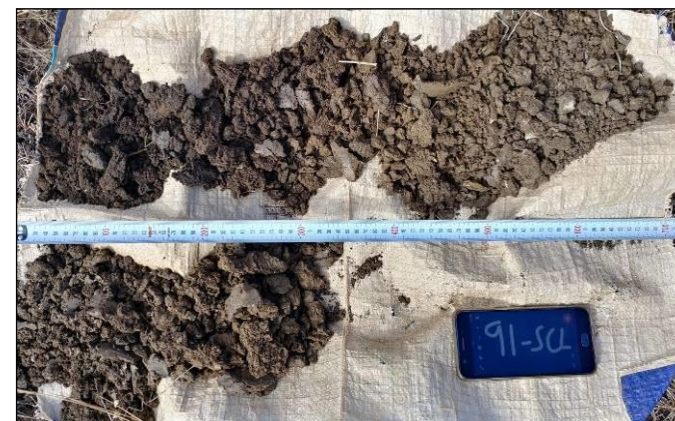
Land use Landform Pattern, Element, Slope	Vegetation	Microrelief Disturbance Erosion	Surface condition, surface rock	Soil Profile Description									
				Horizon Depth (m), Boundary	Field Texture	Structure, Strength	Inclusions Segregations	Colour, Mottle, Bleaching	Moisture, Drainage	Roots	Depth (m) / Field pH	Sample (m)	Observations
Grazing, Gently undulating plain, Midslope 2.0/1.0	Cleared, nearby remnant Belah	Nil microrelief Extensive disturbance Nil erosion	Minor cracking, firm, Nil coarse fragments	A1 0.00-0.12 Abrupt	Sandy Clay	Moderate, weak <20mm sub- angular	Nil inclusions and segregations	10YR2/1 Black Nil mottles / bleaching	Dry, moderate	Few, fine	0.10 / 6.0	0.00-0.10 0.20-0.30 0.50-0.60 0.80-0.90 0.90-1.00	Nil additional observations
				B21 0.12-0.50 Clear	Light sandy clay	Moderate, firm 20- 50mm sub- angular	Nil inclusions and segregations	10YR2/2 Very dark brown Nil mottles / bleaching	Dry, moderate	Few, fine	0.30 / 6.5

B22 0.50-1.00 EOBH	Light clay	Moderate, firm 20- 50mm sub- angular blocky	<2% calcium carbonate nodules	10YR3/3 Dark brown Mottles: <2% 10YR5/3 Brown Nil bleach	Dry, moderate	Very few, very fine	0.60 / 7.0 0.60 / 7.5

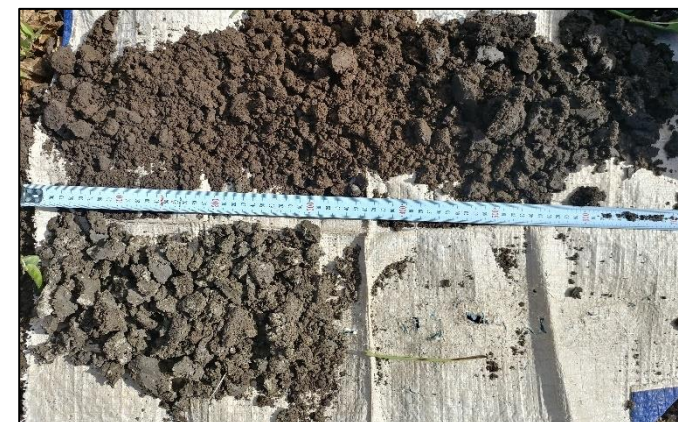
Land use Landform Pattern, Element, Slope	Vegetation	Microrelief Disturbance Erosion	Surface condition, surface rock	Soil Profile Description									
				Horizon Depth (m), Boundary	Field Texture	Structure, Strength	Inclusions Segregations	Colour, Mottle, Bleaching	Moisture, Drainage	Roots	Depth (m) / Field pH	Sample (m)	Observations
Mid-slope, 1% slope	Forage cropping	Nil Microrelief Nil erosion Extensively cleared	Firm, cracking 2mm, Nil coarse fragments	A1 0.0 – 0.08 Abrupt	Sandy loam	Weak, sub- rounded peds 5-20 mm, firm	Nil inclusions or segregations	10YR3/1 Very dark grey Nil mottles / bleaching	Humid, well drained	Fine, very few	0.05 / 6.5	0.00-0.10	Nil additional observations
				B21 0.08 – 0.47 Abrupt	Sandy clay loam	Moderate, peds 30-40 mm, very firm	Nil inclusions or segregations	10YR3/2 Very dark greyish brown Nil mottles / bleaching	Humid, well drained	Nil roots	0.30 / 6.5	0.20-0.30

B22 0.47 – 0.70 Abrupt	Light clay, sandy	Subangular blocky, moderate, peds <30 mm, very firm	<1% calcium carbonate	10YR2/1 Black Nil mottles / bleaching	Humid, moderately well drained	Nil roots	0.60 / 6.5	0.50-0.60	
				B23 0.70 – 1.00 EOBH	Medium clay, sandy	Subangular blocky, moderate,	<10% calcium carbonate	10YR3/2 Very dark greyish brown	Humid, moderately well drained	Nil roots	0.90 / 6.5	0.80-0.90 0.90-1.00

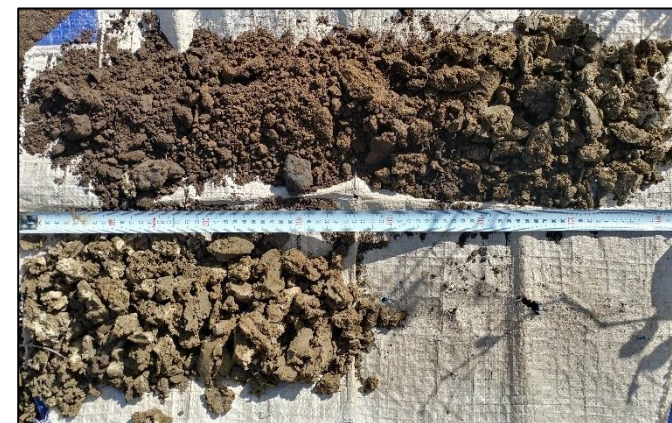
Land use Landform Pattern, Element, Slope	Vegetation	Microrelief Disturbance Erosion	Surface condition, surface rock	Soil Profile Description									
				Horizon Depth (m), Boundary	Field Texture	Structure, Strength	Inclusions Segregations	Colour, Mottle, Bleaching	Moisture, Drainage	Roots	Depth (m) / Field pH	Sample (m)	Observations
Mid-slope, <1% slope	Forage cropping	Nil Microrelief Nil erosion Extensively cleared	Firm, cracking 2mm, Nil coarse fragments	A1 0.0 – 0.18 Abrupt	Sandy loam	Weak, sub- rounded peds 5-20 mm, firm	Nil inclusions or segregations	10YR3/1 Very dark grey Nil mottles / bleaching	Humid, well drained	Fine, very few	0.10 / 6.5	0.00-0.10 0.20-0.30 0.50-0.60 0.80-0.90 0.90-1.00	Nil additional observations
				B21 0.18 – 0.50 Abrupt	Sandy clay loam	Moderate, peds 30-40 mm, very firm	Nil inclusions or segregations	10YR2/1 Black Nil mottles / bleaching	Humid, well drained	Nil roots	0.30 / 6.5

B22 0.50 – 1.00 EOBH	Light clay, sandy	Subangular blocky, moderate, peds <40 mm, very firm	<5% calcium carbonate	10YR2/1 Black Nil mottles / bleaching	Humid, moderately well drained	Nil roots	0.60 / 6.5

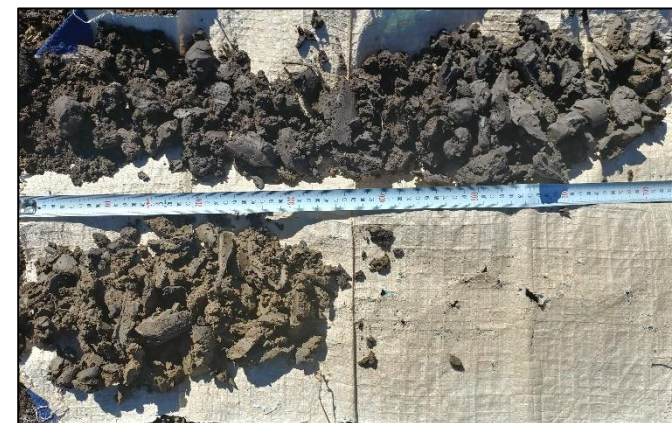
Land use Landform Pattern, Element, Slope	Vegetation	Microrelief Disturbance Erosion	Surface condition, surface rock	Soil Profile Description									
				Horizon Depth (m), Boundary	Field Texture	Structure, Strength	Inclusions Segregations	Colour, Mottle, Bleaching	Moisture, Drainage	Roots	Depth (m) / Field pH	Sample (m)	Observations
Cropping, upper-slope, 1% / 2% slope	Forage crops	Nil microrelief Nil erosion Extensively disturbed for cropping	Self-mulching, minor crust, cracking 2- 6+mm	A1 0.0 – 0.17 Abrupt	Light clay	Subangular blocky, weak, peds <20 mm, firm	<5% coarse fragments	10YR3/1 Very dark grey Nil mottles / bleaching	Humid, well drained	Fine, very few	0.10 / 6.5	0.00-0.10 0.20-0.30 0.50-0.60 0.80-0.90 0.90-1.00	Nil additional observations
				B2 0.17 – 1.00 EOBH	Medium clay	Subangular blocky, weak, peds <30 mm, very firm	<1% coarse fragments	10YR3/1 Very dark grey Nil mottles / bleaching	Humid, Moderately well drained	Nil roots	0.30 / 7.0 0.60 / 7.0 0.90 / 6.5

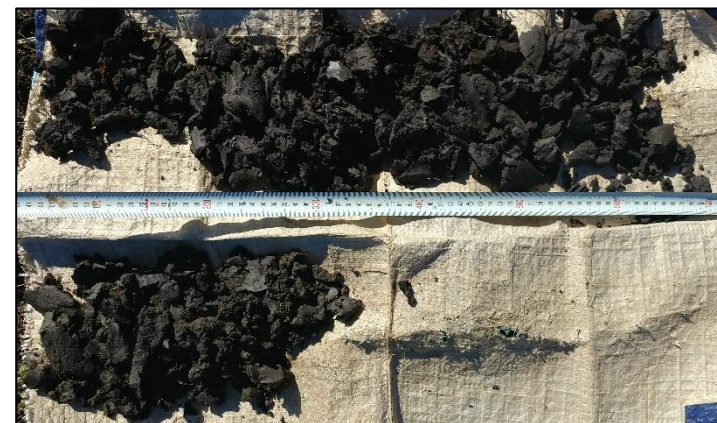
Land use Landform Pattern, Element, Slope	Vegetation	Microrelief Disturbance Erosion	Surface condition, surface rock	Soil Profile Description									
				Horizon Depth (m), Boundary	Field Texture	Structure, Strength	Inclusions Segregations	Colour, Mottle, Bleaching	Moisture, Drainage	Roots	Depth (m) / Field pH	Sample (m)	Observations
Grazing, mid-slope, 1% / 2% slope	Grasses, recent regrowth and shrubs	Normal gilgai <0.2 m deep, 30-40% coverage Nil erosion Extensively disturbed for cropping	Self-mulching, minor crust, cracking 2- 6+mm	A1 0.0 – 0.13 Abrupt	Medium Clay	Subangular blocky, moderate, peds <20 mm, soft	Nil inclusions or segregations	10YR3/1 Very dark grey Nil mottles / bleaching	Humid, well drained	Fine, very few	0.10 / 6.5	No samples taken	Nil additional observations
				B21 0.13 – 0.62 Abrupt	Medium clay	Subangular blocky, moderate, peds <30 mm, firm	Nil inclusions or segregations	10YR3/1 Very dark grey Nil mottles / bleaching	Humid, well drained	Nil roots	0.30 / 7.0 0.60 / 7.0

B22 0.62 – 1.00 EOBH	Medium clay	Subangular blocky, moderate, peds <30 mm, very firm	<2% calcium carbonate	10YR3/1 Very dark grey Nil mottles / bleaching	Humid, moderately well drained	Nil roots	0.90 / 6.5

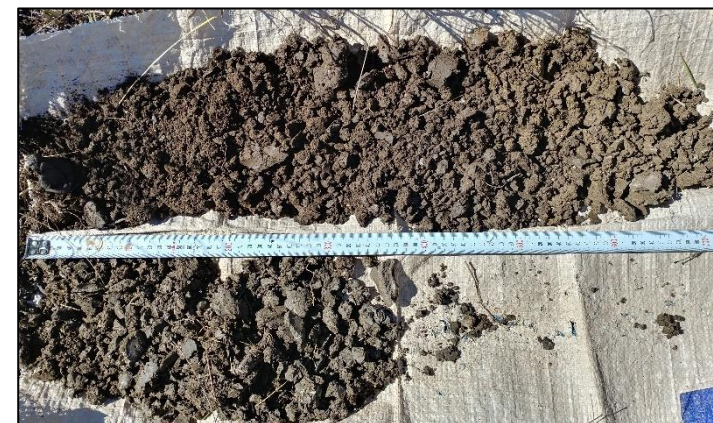
**Soil Profile**

Land use Landform Pattern, Element, Slope	Vegetation	Microrelief Disturbance Erosion	Surface condition, surface rock	Soil Profile Description									
				Horizon Depth (m), Boundary	Field Texture	Structure, Strength	Inclusions Segregations	Colour, Mottle, Bleaching	Moisture, Drainage	Roots	Depth (m) / Field pH	Sample (m)	Observations
Grazing, mid-slope, 2% / 1%	Grasses, recent regrowth and shrubs	Crabhole gilgai <0.2 m deep, 30% coverage Nil erosion Extensively disturbed	Self-mulching, minor crust, cracking 2- 6+mm Nil coarse fragments	A1 0.0 – 0.12 Abrupt	Light clay	Subangular blocky, moderate, peds <20 mm, soft	Nil inclusions or segregations	10YR2/1 Black Nil mottles / bleaching	Humid, well drained	Fine, very few	0.10 / 6.5	0.00-0.10 0.20-0.30 0.50-0.60 0.80-0.90 0.90-1.00	Nil additional observations
				B21 0.12 – 0.50 Abrupt	Medium heavy clay	Subangular blocky, moderate, peds <30 mm, firm	Nil inclusions or segregations	10YR2/1 Black Nil mottles / bleaching	Humid, well drained	Fine, very few	0.30 / 7.0 0.60 / 7.0

B22 0.50 – 1.00 EOBH	Medium heavy clay	Subangular blocky, moderate, peds <30 mm, very firm	<2% calcium carbonate	10YR2/1 Black Nil mottles / bleaching	Humid, moderately well drained	Nil roots	0.90 / 6.5

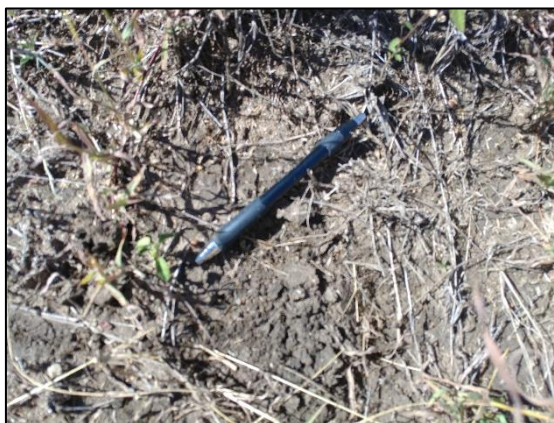
**Surface**

Land use Landform Pattern, Element, Slope	Vegetation	Microrelief Disturbance Erosion	Surface condition, surface rock	Soil Profile Description									
				Horizon Depth (m), Boundary	Field Texture	Structure, Strength	Inclusions Segregation s	Colour, Mottle, Bleaching	Moisture, Drainage	Roots	Depth (m) / Field pH	Sample (m)	Observations
Grazing, mid-slope, 2% slope, Gilgai depression	Grasses, recent regrowth and shrubs	Crabhole gilgai <0.2 m deep, 30% coverage Nil erosion Extensively disturbed for cropping	Self-mulching, minor crust, cracking 2- 6+mm	A1 0.0 – 0.10 Abrupt	Medium Clay	Subangular blocky, moderate, peds <20 mm, soft	Nil inclusions or segregations	10YR2/1 Black Nil mottles / bleaching	Humid, well drained	Fine, very few	0.10 / 6.5	0.00-0.10 0.20-0.30 0.50-0.60 0.80-0.90 0.90-1.00	Nil additional observations
				B21 0.10 – 0.60 Abrupt	Medium heavy clay	Subangular blocky, moderate, peds <30 mm, firm	Nil inclusions or segregations	10YR2/1 Black Nil mottles / bleaching	Humid, well drained	Fine, very few	0.30 / 7.0 0.60 / 7.0

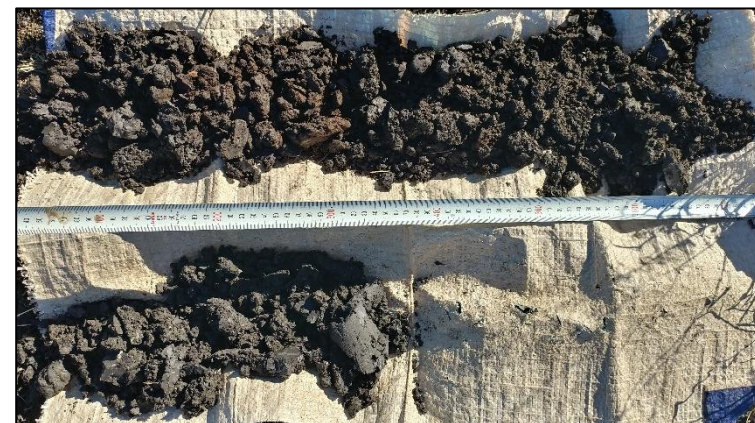
**Soil Profile**

B22 0.60 – 1.00 EOBH	Medium heavy clay	Subangular blocky, moderate, peds <30 mm, very firm	<2% calcium carbonate	10YR2/1 Black Nil mottles / bleaching	Humid, moderately well drained	Nil roots	0.90 / 6.5

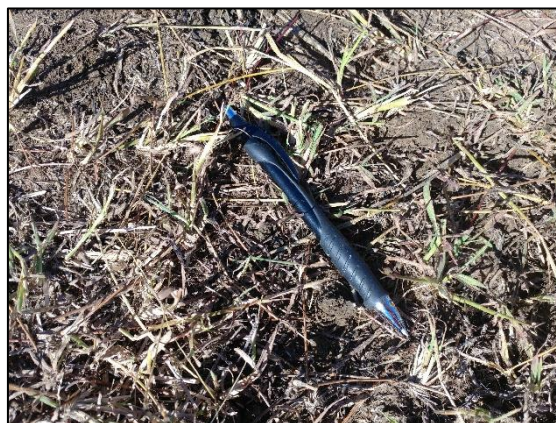
**Surface**

Land use Landform Pattern, Element, Slope	Vegetation	Microrelief Disturbance Erosion	Surface condition, surface rock	Soil Profile Description									
				Horizon Depth (m), Boundary	Field Texture	Structure, Strength	Inclusions Segregations	Colour, Mottle, Bleaching	Moisture, Drainage	Roots	Depth (m) / Field pH	Sample (m)	Observations
Grazing, mid-slope, 2% slope, Gilgai depression	Grasses, recent regrowth and shrubs	Crabhole gilgai <0.2 m deep, 50% coverage Nil erosion Extensively disturbed for cropping	Self-mulching, minor crust, cracking 2- 6+mm	A1 0.0 – 0.12 Abrupt	Light clay	Subangular blocky, moderate, peds <10 mm, soft	Nil inclusions or segregations	10YR3/1 Very dark grey Nil mottles / bleaching	Humid, well drained	Fine, very few	0.10 / 6.5	0.00-0.10 0.20-0.30 0.50-0.60 0.80-0.90 0.90-1.00	Nil additional observations
				B21 0.12 – 0.60 Abrupt	Medium clay	Subangular blocky, moderate, peds <30 mm, firm	Nil inclusions or segregations	10YR3/2 Very dark greyish brown Nil mottles / bleaching	Humid, well drained	Fine, very few	0.30 / 7.0 0.60 / 7.0

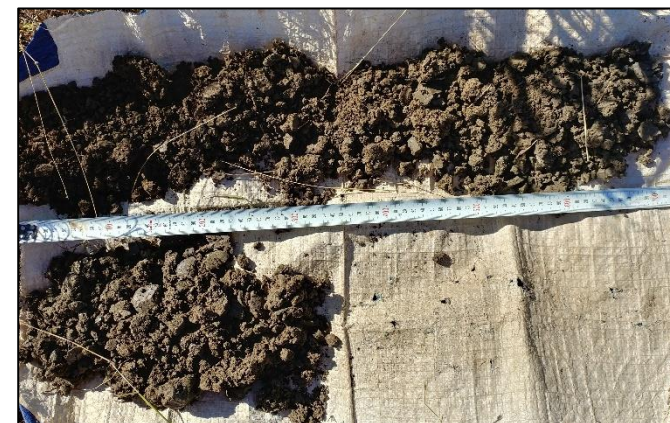
**Soil Profile**

B22 0.60 – 1.00 EOBH	Medium heavy clay	Subangular blocky, moderate, peds <30 mm, very firm	<2% calcium carbonate	10YR4/2 Dark greyish brown Nil mottles / bleaching	Humid, moderately well drained	Nil roots	0.90 / 6.5

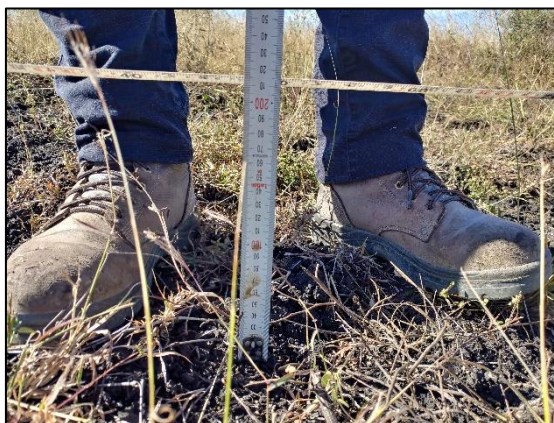
**Surface**

Land use Landform Pattern, Element, Slope	Vegetation	Microrelief Disturbance Erosion	Surface condition, surface rock	Soil Profile Description									
				Horizon Depth (m), Boundary	Field Texture	Structure, Strength	Inclusions Segregations	Colour, Mottle, Bleaching	Moisture, Drainage	Roots	Depth (m) / Field pH	Sample (m)	Observations
Grazing, mid-slope, 2% slope, Gilgai depression	Grasses, recent regrowth and shrubs	Crabhole gilgai <0.22 m deep, 50% coverage Nil erosion Extensively disturbed for cropping	Self-mulching, minor crust, cracking 2- 6+mm	A1 0.0 – 0.10 Abrupt	Light Medium Clay	Subangular blocky, moderate, peds <20 mm, weak	<1% calcium carbonate	10YR3/1 Very dark grey Nil mottles / bleaching	Humid, well drained	Fine, very few	0.10 / 7.0	0.00-0.10 0.20-0.30 0.50-0.60 0.83-0.90 0.90-1.00	Nil additional observations
				B21 0.10 – 0.83 Abrupt	Medium heavy clay	Subangular blocky, moderate, peds 20-40 mm, very firm	<2% calcium carbonate	10YR3/1 Very dark grey Nil mottles / bleaching	Dry, moderately well drained	Fine, very few	0.30 / 6.5 0.60 / 6.5

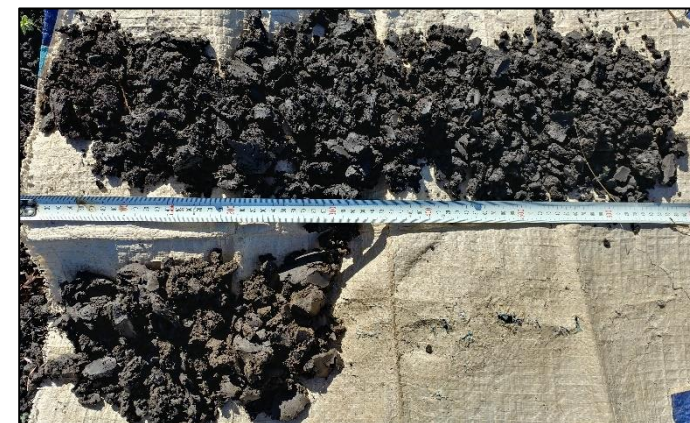
**Soil Profile**

B23 0.83 – 1.00 EOBH	Medium heavy clay	Subangular blocky, moderate, peds 20-40 mm, very firm	Nil inclusions or segregations	10YR3/2 Very dark greyish brown Nil mottles / bleaching	Dry, moderately well drained	Nil roots	0.90 / 6.5

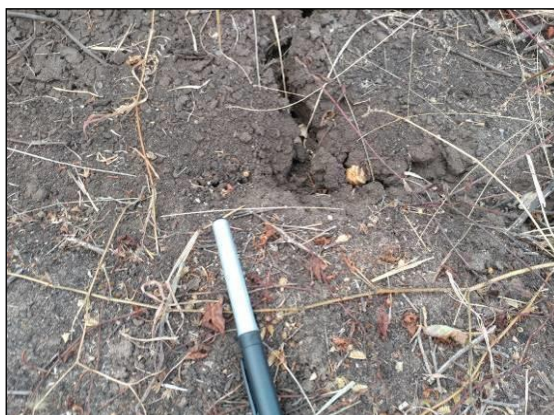
Land use Landform Pattern, Element, Slope	Vegetation	Microrelief Disturbance Erosion	Surface condition, surface rock	Soil Profile Description									
				Horizon Depth (m), Boundary	Field Texture	Structure, Strength	Inclusions Segregations	Colour, Mottle, Bleaching	Moisture, Drainage	Roots	Depth (m) / Field pH	Sample (m)	Observations
Cropping Flat plain, level, 0.0/0.0%	Cropping	Nil microrelief Cropping disturbance Nil erosion	Cracking 20- 40mm, fine surface mulch Nil coarse fragments	A1 0.0-0.13 Abrupt	Light clay	Weak, firm, <10mm sub-angular	2% 2-6mm coarse fragments	10YR3/2 Very dark greyish brown Nil mottles / bleaching	Dry, moderate	Fine, few	0.10 / 6.5	0.00-0.10	Nil additional observations
				B21 0.13-0.38 Abrupt	Medium clay	Moderate, firm <40% 20-60mm, <20% 60-100 sub- angular blocky peds	<1% black nodules <1% calcium carbonate nodules	10YR3/2 Very dark greyish brown Nil mottles / bleaching	Dry, moderate	Very fine, very few	0.30 / 6.5	0.20-0.30 0.50-0.60

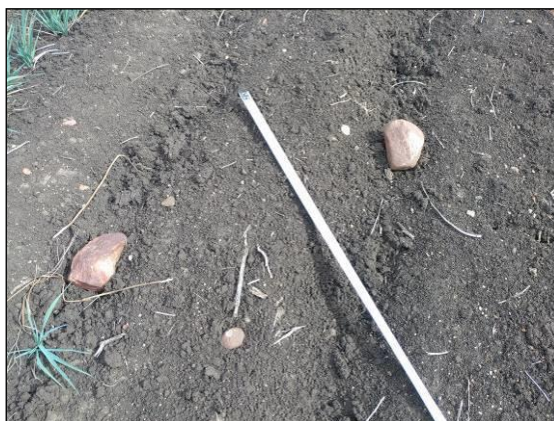
Land use Landform Pattern, Element, Slope	Vegetation	Microrelief Disturbance Erosion	Surface condition, surface rock	Soil Profile Description									
				Horizon Depth (m), Boundary	Field Texture	Structure, Strength	Inclusions Segregations	Colour, Mottle, Bleaching	Moisture, Drainage	Roots	Depth (m) / Field pH	Sample (m)	Observations
Cropping Very gently undulating plain Flat plain 1.0/1.0	Cropping	Nil microrelief Cropping disturbance Nil erosion	2-5% medium pebbles >600mm Soft, loose	A1 0.00-0.16 Abrupt	Light clay	Moderate, weak <10mm sub- angular blocky	<2% calcium carbonate nodules	10YR3/2 Very dark greyish brown Nil mottles / bleaching	Dry, moderate	Few fine	0.10 / 6.0	0.00-0.10 0.20-0.30 0.50-0.60 0.80-0.90 0.90-1.00	Nil additional observations
				B2 0.16-1.00 EOBH	Medium clay	Strong, firm <10mm sub- angular blocky	Nil inclusions and segregations	10YR3/2 Very dark greyish brown Nil mottles / bleaching	Dry, moderate	Very fine, very few	0.30 / 6.5 0.60 / 7.0 0.90 / 7.5
