REGIONAL INTEREST DEVELOPMENT APPLICATION ASSESSMENT REPORT LEGBAR PPL2064

Prepared for: Santos Ltd

T29 Holdings Pty Ltd
ABN 50 628 672 677
E: admin@t29.com.au

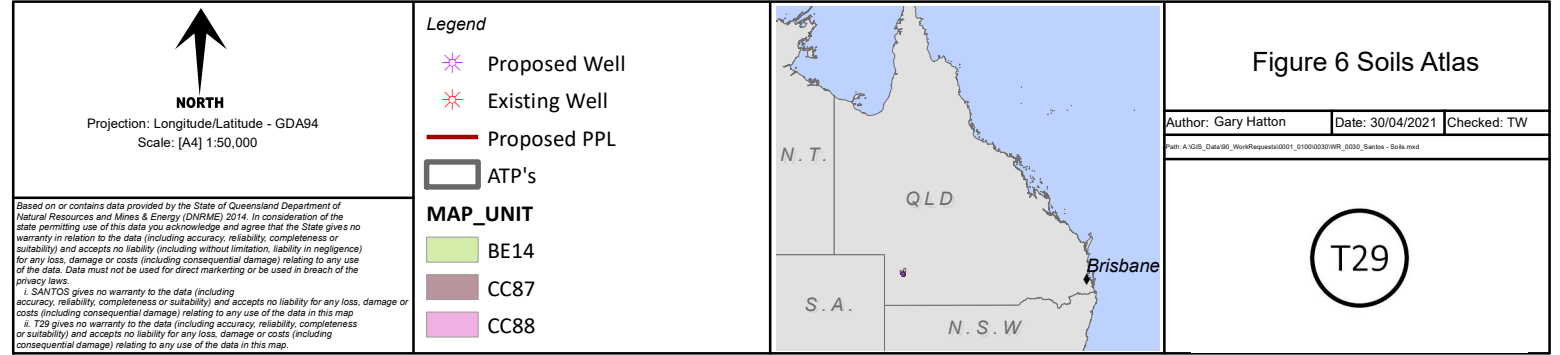
The dominant soil around the proposed Legbar PPL is CC88 (Figure 6): Clay plains marginal to major rivers and not channelled to the same extent as unit CC87; subject to seasonal inundation for the greater part; some sand dune and sand-hill areas: chief soils are grey clays (Ug5.24) but brown clays (Ug5.3) may occur also. There are (Uc1.2) soils on dunes and sand-hills, while other soils (undescribed) may occur on the flanks of the sandy areas.

According to Regional Ecosystem mapping, the dominant land zone traversed by and surrounding the proposed flowline is Land Zone 3 (alluvial river and creek flats including closed depressions, paleo-estuarine deposits currently under freshwater influence, inland lakes and associated wave-built lunettes).
